Date	19/05/2016
Number	0682
Pages	8

### TECHNICAL INFORMATION

MODEL	MT09 / MT09A / FZ09 / MT09TRA / FJ09
SUBJECT	CAM CHAIN TENSIONER (CCT) NOISE

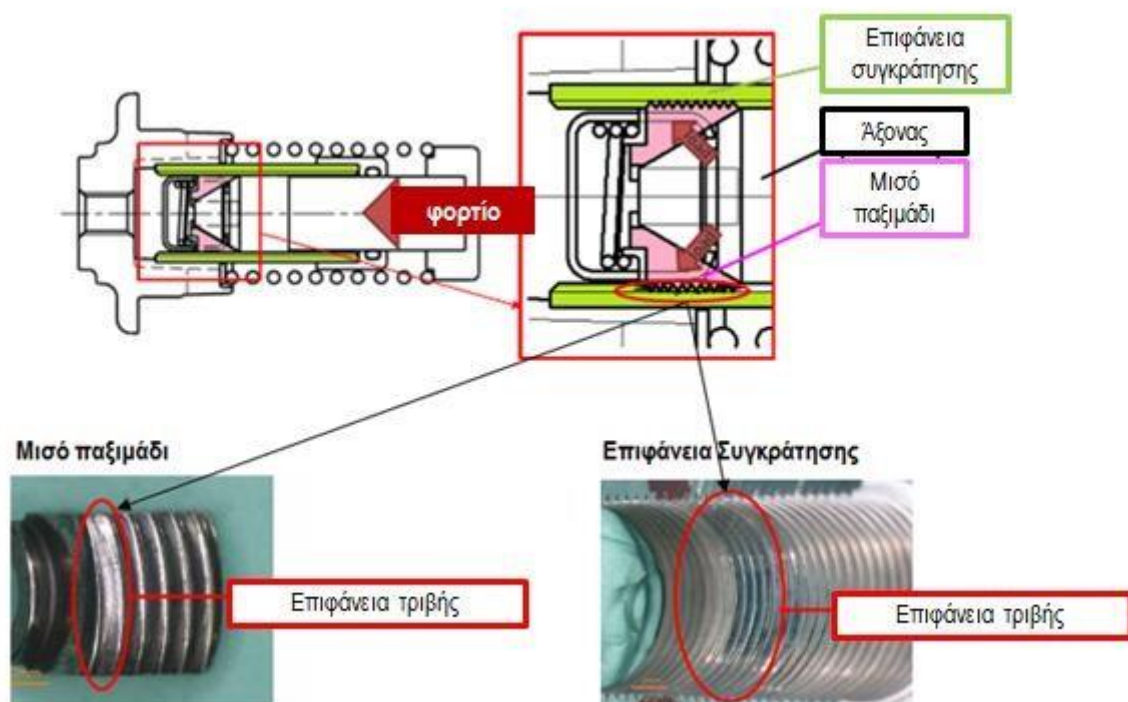
#### Tensioner Construction:

The contact between the threaded half nut and retaining surface damaged due to insufficient lubrication. The wear results in reduced friction and move the half-nut. As a result, the tensioner is not held taut and the chain oscillates causing noise.

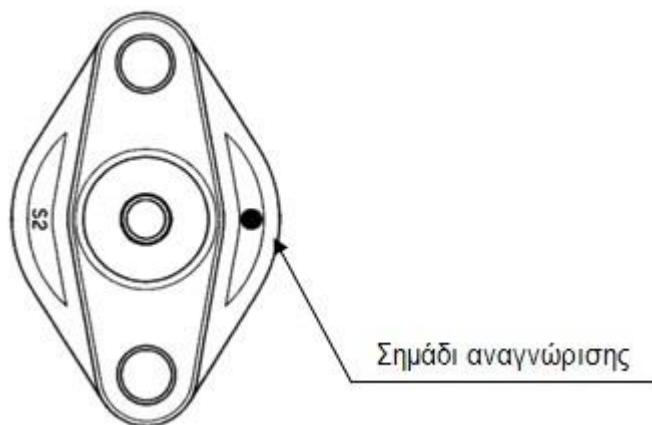
The color identification sign has changed
