## headlamp motor fix

The electric headlamp adjusters on my car had a tendency to hunt up and down when the normal position (Posn 0) on the switch was selected, This is how I solved the problem.

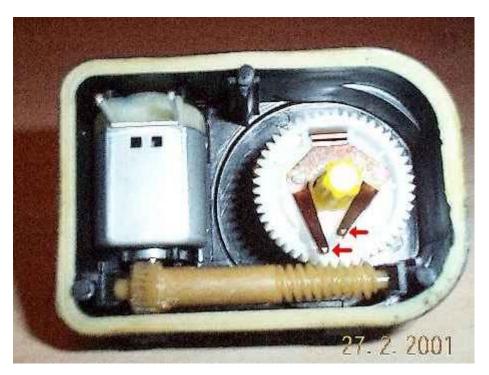
This picture shows the unit after the board has been lifted off. The contact points arrowed are the position feedback for the motor. These get covered in grease from the gears and fail to make a good contact. Carefully clean these

The motor can be seen on the left with it's two power contacts sticking up.

points with a good quality switch cleaner.

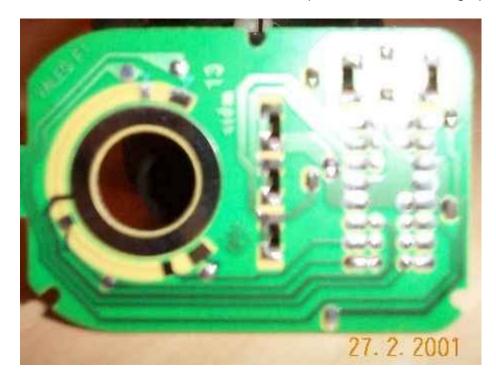
This is the reverse of the circuit board when removed. The feedback contacts run along the circular track on the left. This also gets covered in grease from the drive gears and needs cleaning to remove and grease.

Once this and the feedback contacts are cleaned, the assembly can be fixed together again. The motor now drives the lights to the correct position without overshooting or hunting. Job done!
