YUYO PROJECT IMPLEMENTATION STAGE 1 / 3, HK 3610 TROMMEL START UP AT TAILINGS (No jig)

REF: YUYO PROJECT
10-DAY START UP OPERATIONS

FEBRUARY 8TH, 2023

FIELD REPORT

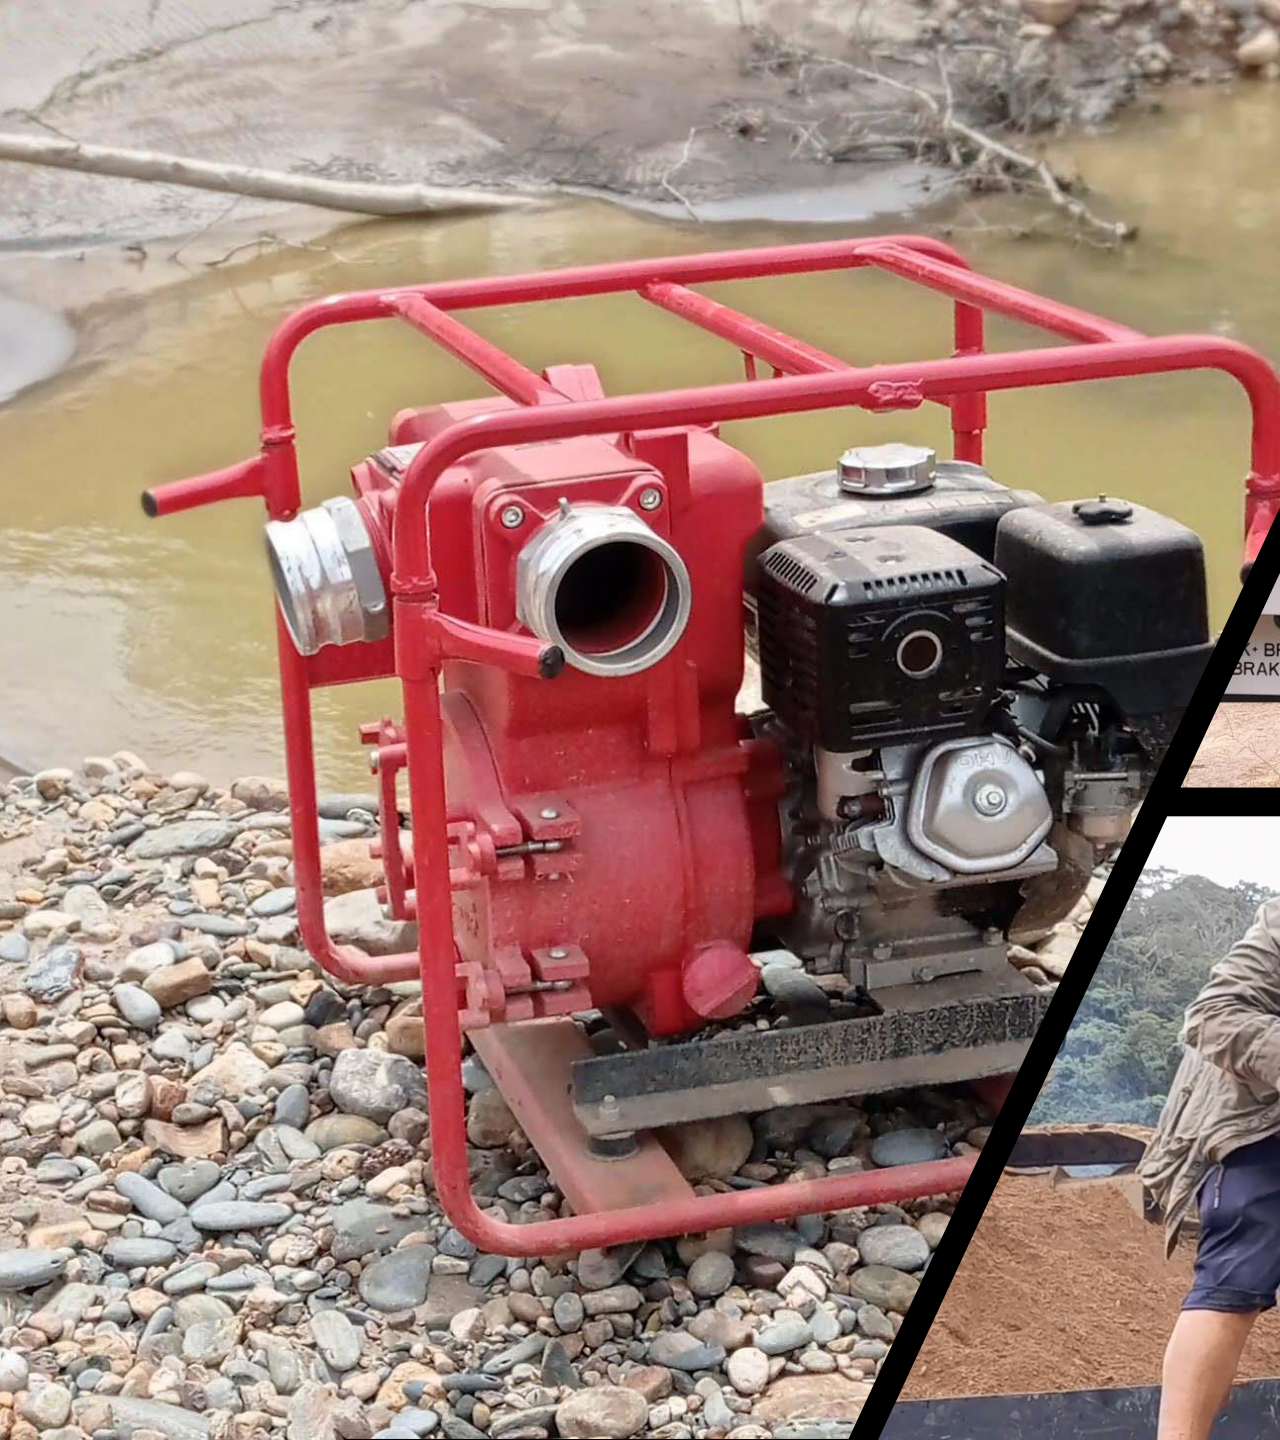
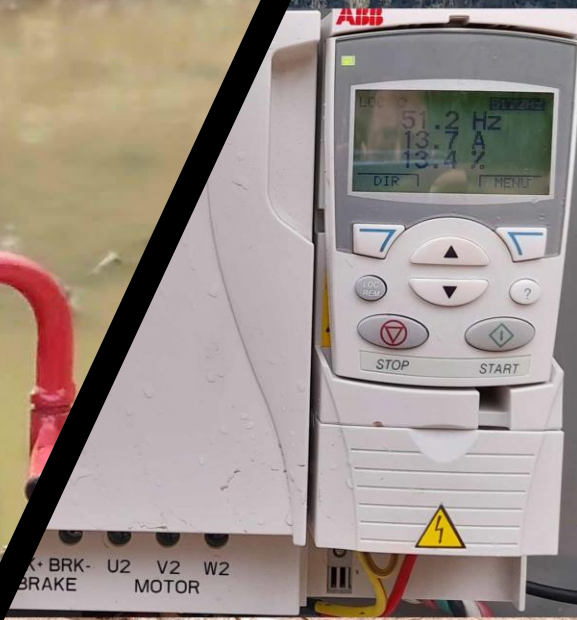
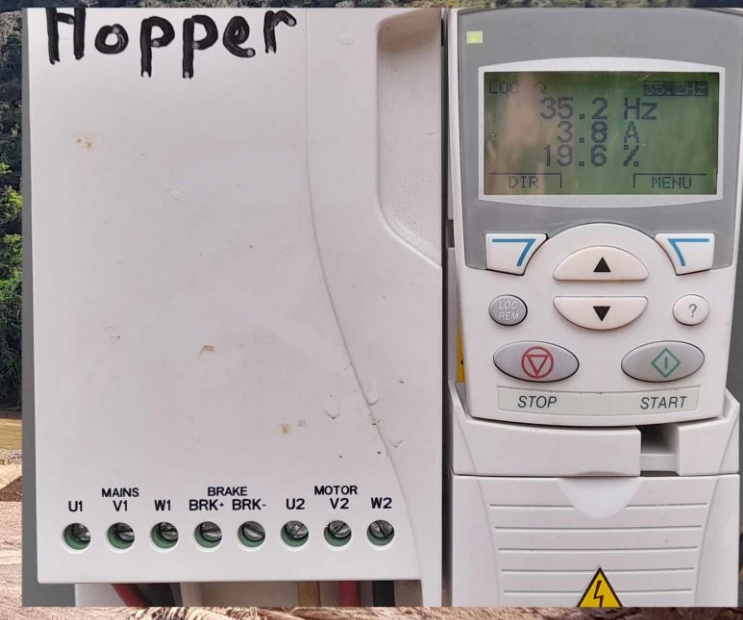
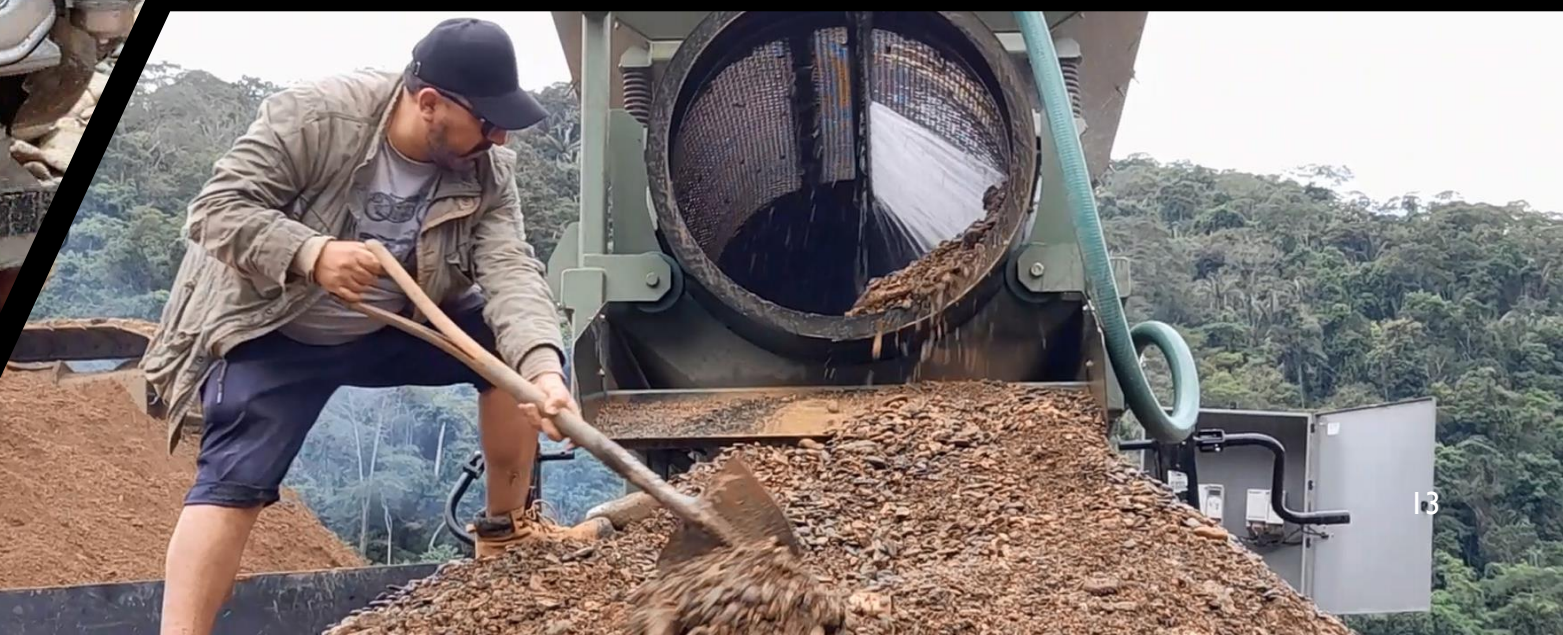
HK 3610 GREEN TROMMEL OBSERVATIONS CONDITIONS AND CURRENT CAPABILITIES

- The pump provided by the fabricant is barely sufficient, and it needs to be replaced immediately by a water source in order to work. Even then, water flow is just under par, generating issues with mud clogging at the loading tray and irregular and insufficient washing in the barrel.
- The excavator used, the only one we could find in the area, is larger than the typical 320 or 323 Cat or equivalents. It is an older model, stronger, but a little slower, and has a large 2.5 cubic meter bucket. Therefore loading was a little rougher than it could have been. Despite this, and as stated before, we did manage to increase from 10 tons per hour (as per the last time we processed) to 24 / 25 tons per hour.
- The loading tray and barrel inclination match those recommended by the plant's fabricant.

We tried speed setting for the loading tray and the barrel, first on equal ratios, starting from the slowest position of vibration and rotation, respectively on each of the parts (loading tray and barrel) and went up on increments of 10 Hz attempting to get to the point of achieving no water loss in the back of the plant and no sand loss on the barrel. Once we have achieved a close to perfect solution, we proceeded to zeroing within that range from 30 to 60 Hz in 5Hz increments, and to make variations in loading tray vibration speed and trommel barrel rotation speed. Finally arriving to 35.9 Hz on the loading tray, and 52.9 Hz on the barrel speed. Once the point was set, some minor adjustments were made in the trommel inclination and in better securing its placement.

- We then proceeded to check the water, sand and gravel flow on the sluice channels, making sure at this point that all the material came into contact with the mesh and carpet. This was done manually covering the whole length of the sluice channel. This time the material was flowing correctly through the system.
- The dump expelled by the trommel's barrel required two personnel constantly shoveling in order to be barely manageable. This being one of the tasks that either a front-end loader or a medium size backhoe is usually assigned to.

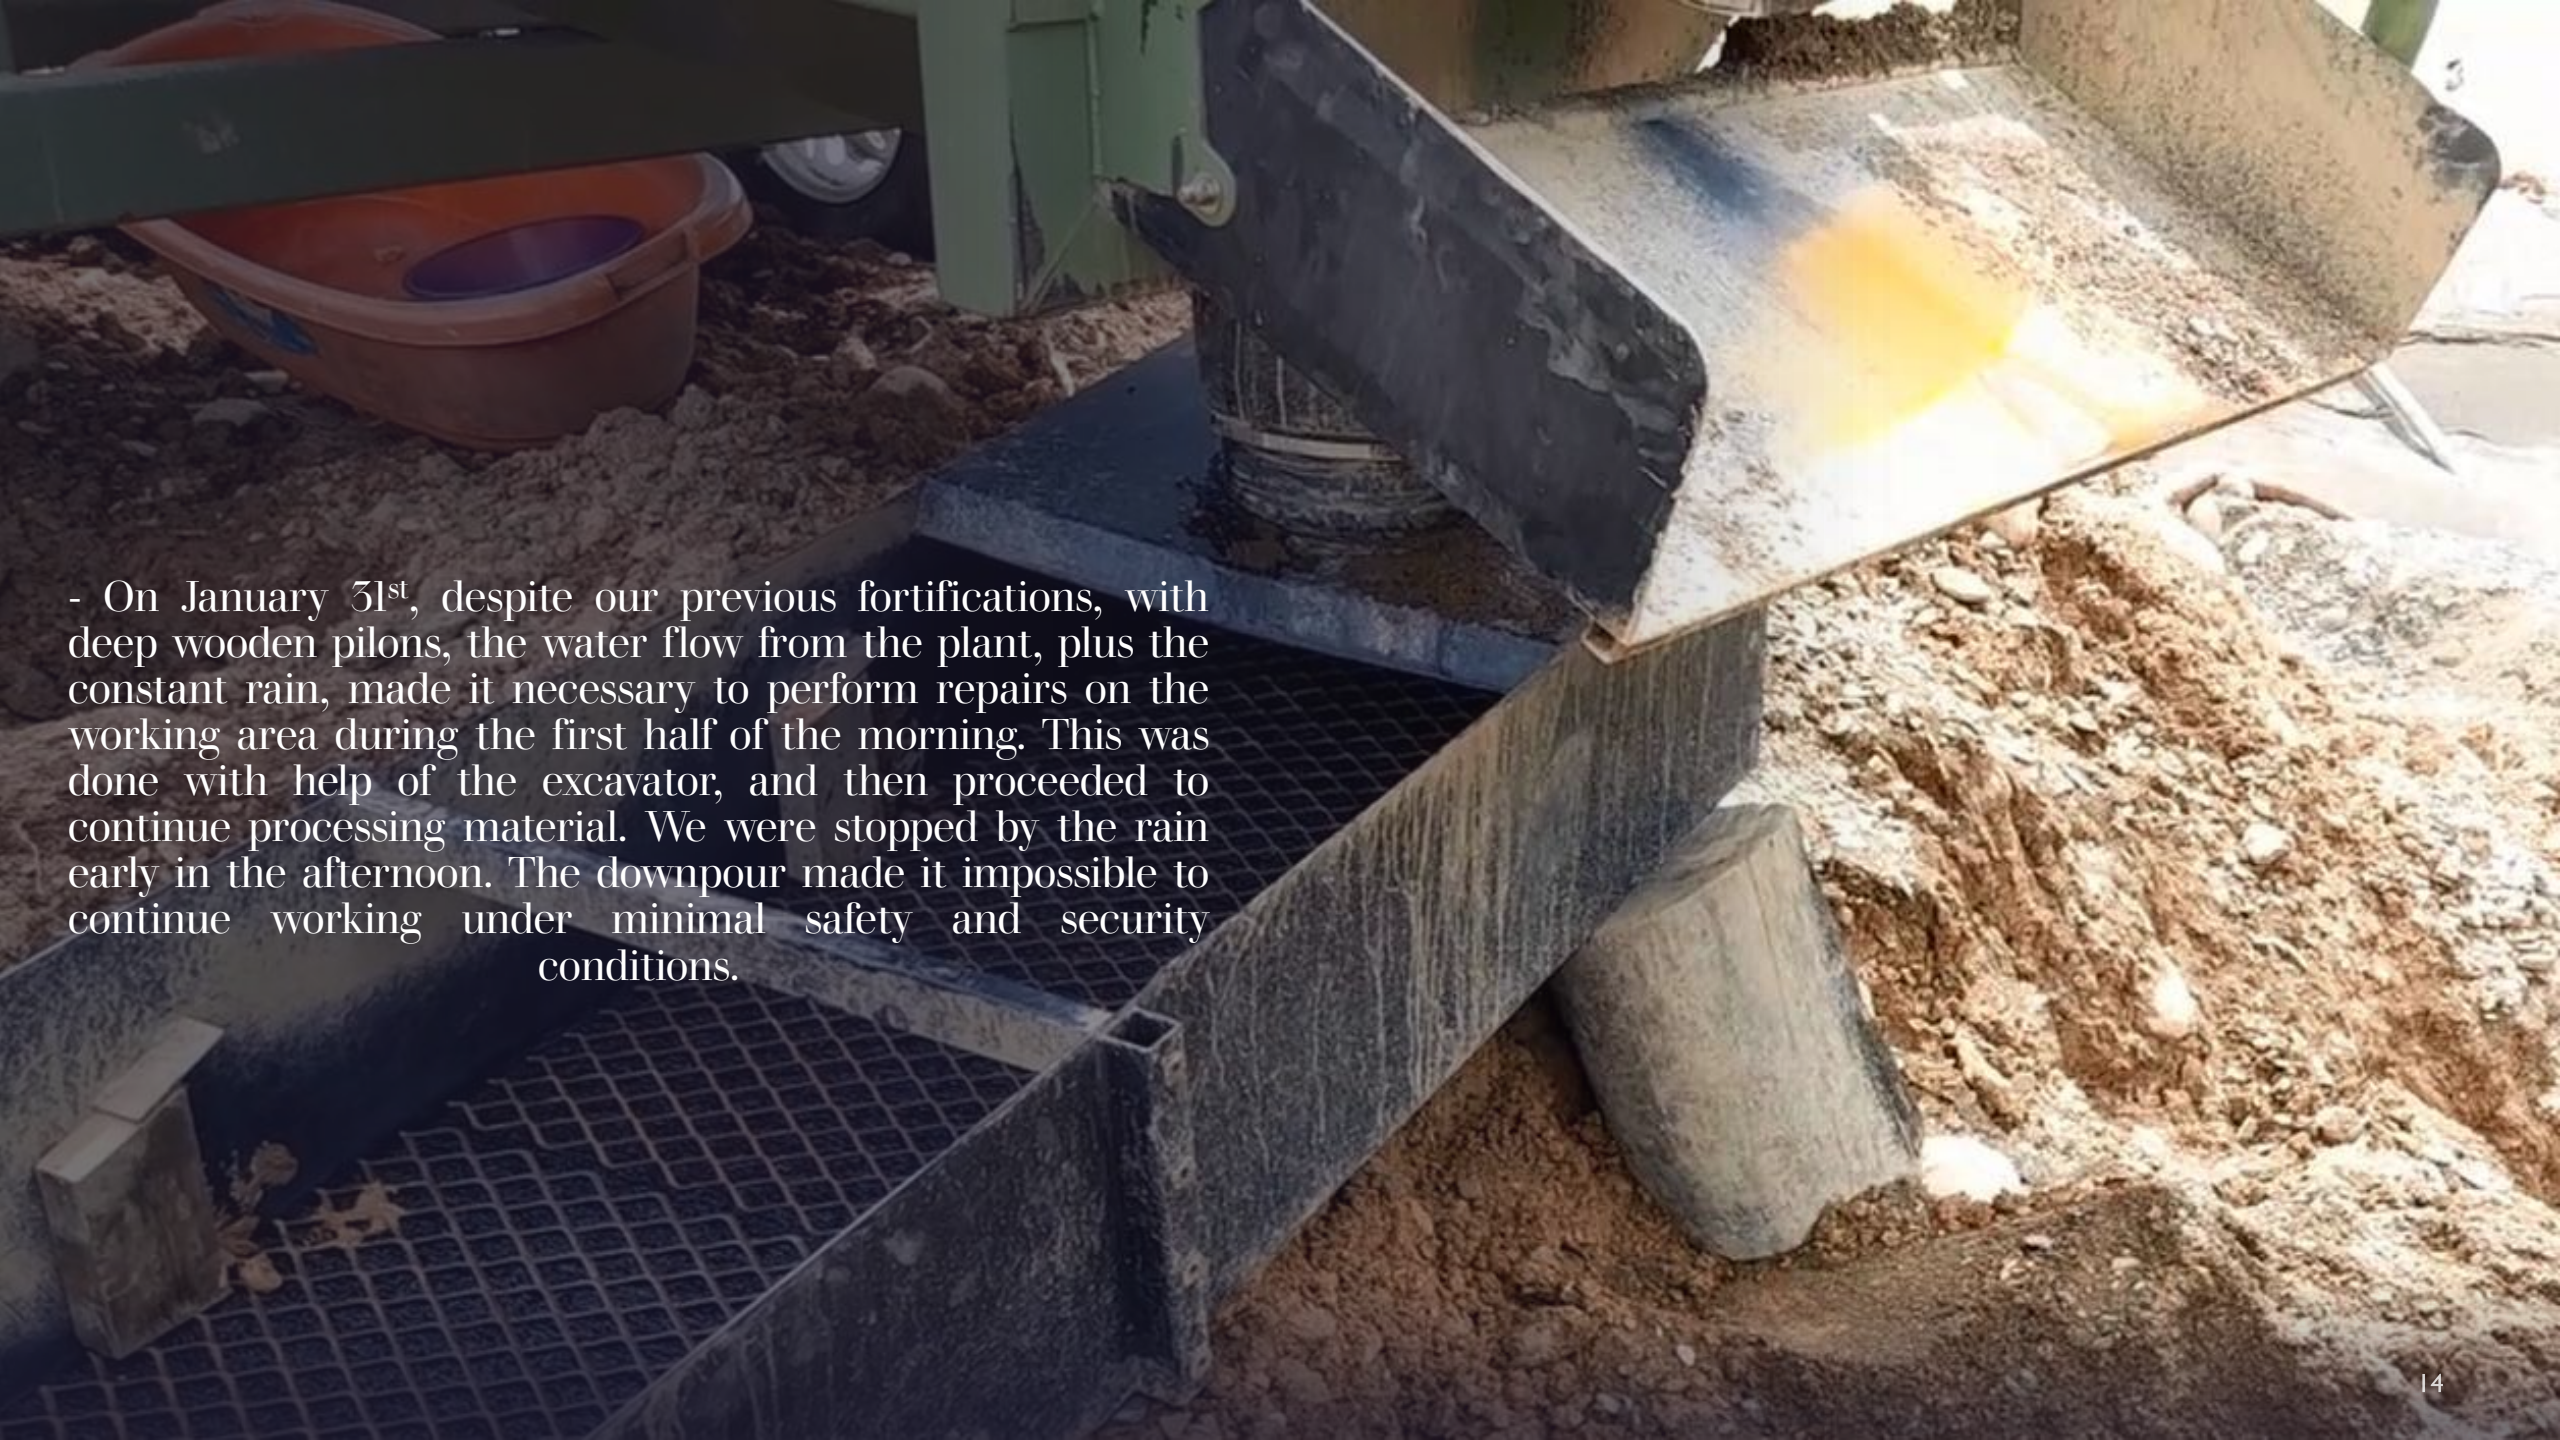
- On January 31st, despite our previous fortifications, with deep wooden pilons, the water flow from the plant, plus the constant rain, made it necessary to perform repairs on the working area during the first half of the morning. This was done with help of the excavator, and then proceeded to continue processing material. We were stopped by the rain early in the afternoon. The downpour made it impossible to continue working under minimal safety and security conditions.

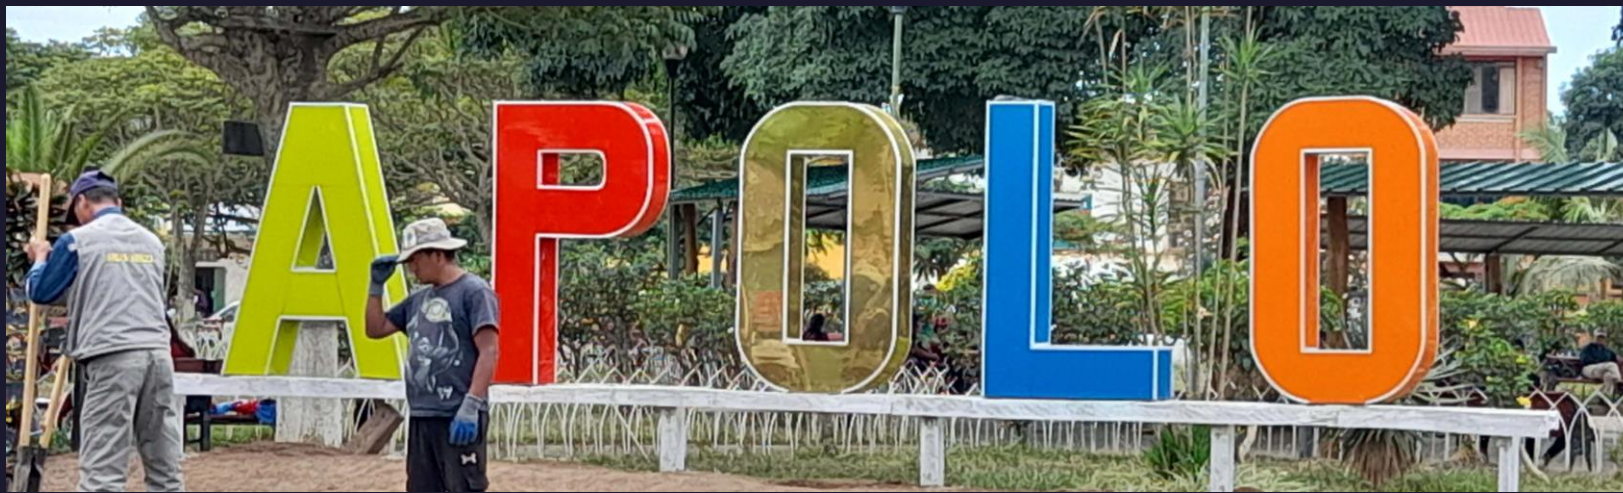
- On February 1st, the rain continued to increase during the night and around 2 am we attempted to reach the labor area, unsuccessfully due to excessive mud and poor visibility. We did go back at 5:30 am to find the pump flooded. We attempted to rescue it, but had to wait until 8:30 am for the pickup to be able to retrieve it. Vice-president sustained a re-injury during the pump rescue procedure. With the rain having subsided to a drizzle, we proceeded to attempt heading out to Apolo, in order to have the pump repaired. As luck would have it, the access road to the mine resisted the inclement weather without significant damage. We proceeded to continue assessing the river's behavior, finding that it had grown to dangerous levels throughout its course. It even flooded an existing yet unmanned operation with two production pools having been completely overtaken by the river in an area immediately adjacent to our cooperative concession.

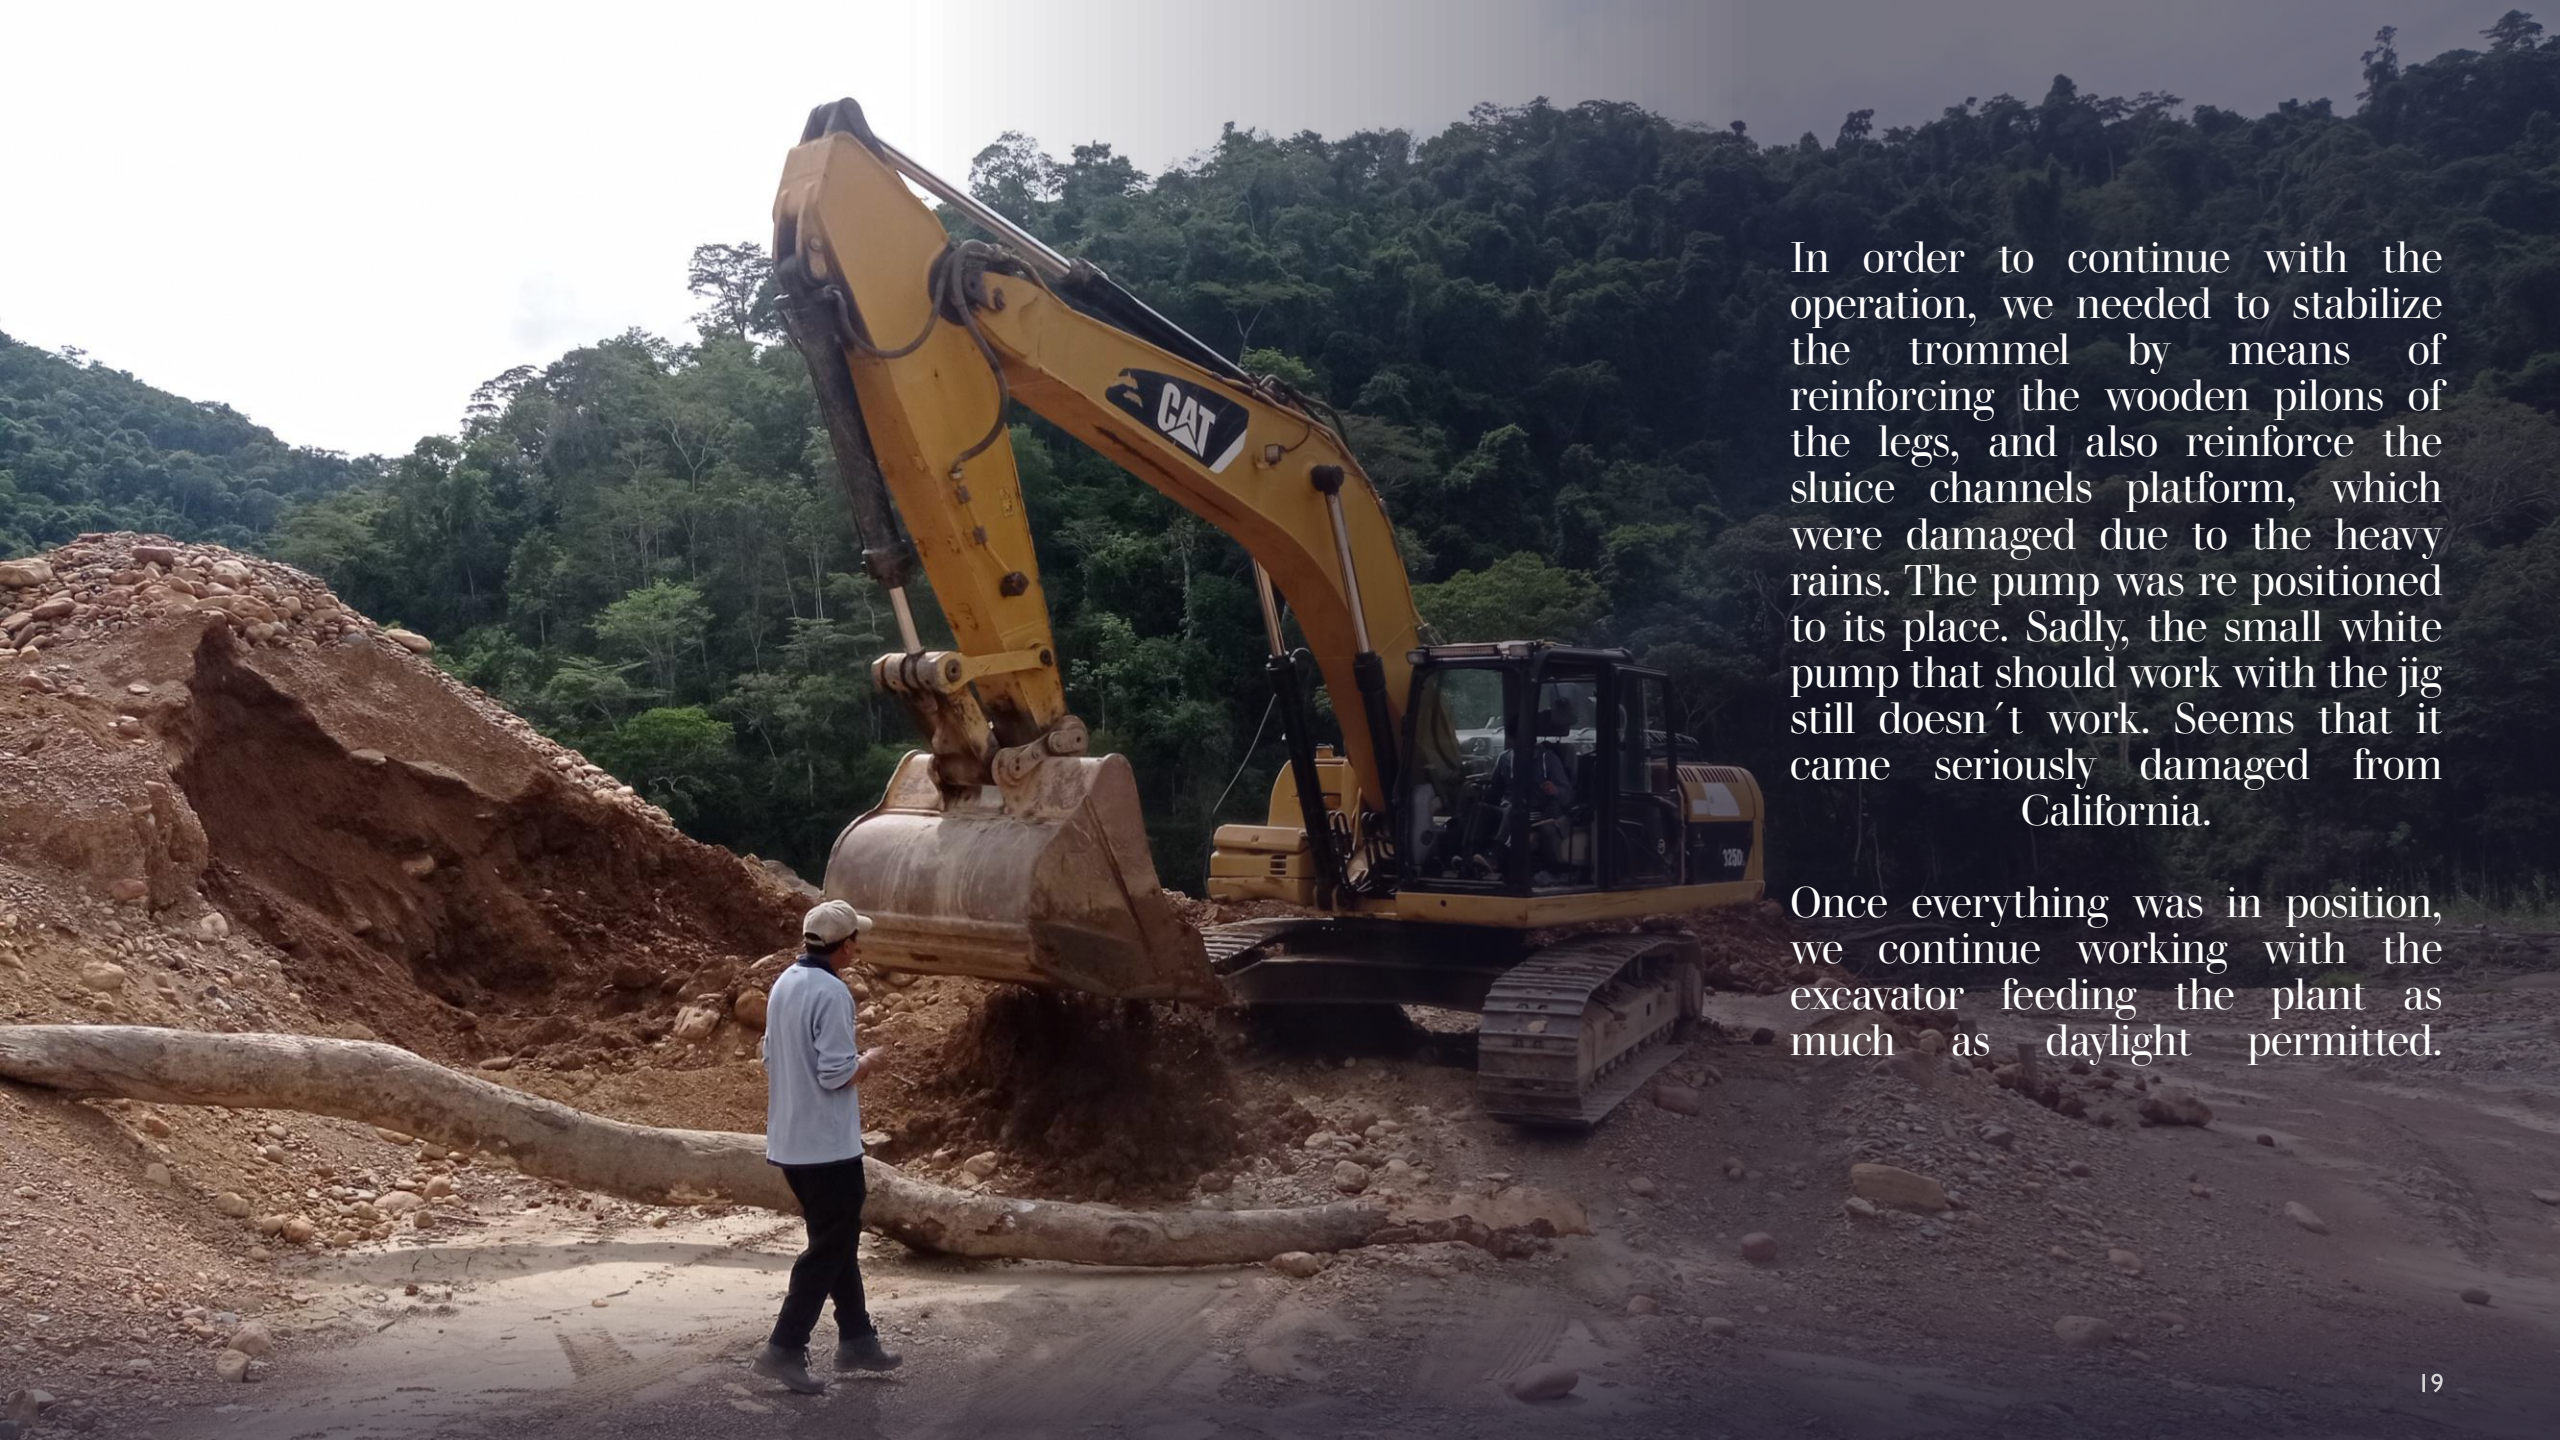
In order to continue with the operation, we needed to stabilize the trommel by means of reinforcing the wooden pilons of the legs, and also reinforce the sluice channels platform, which were damaged due to the heavy rains. The pump was re positioned to its place. Sadly, the small white pump that should work with the jig still doesn't work. Seems that it came seriously damaged from California.
