Lehigh Valley International Airport (ABE)

Airside Pavement Management Plan

Final Working Report – February, 2018

Prepared by
Airport Design Consultants Inc.

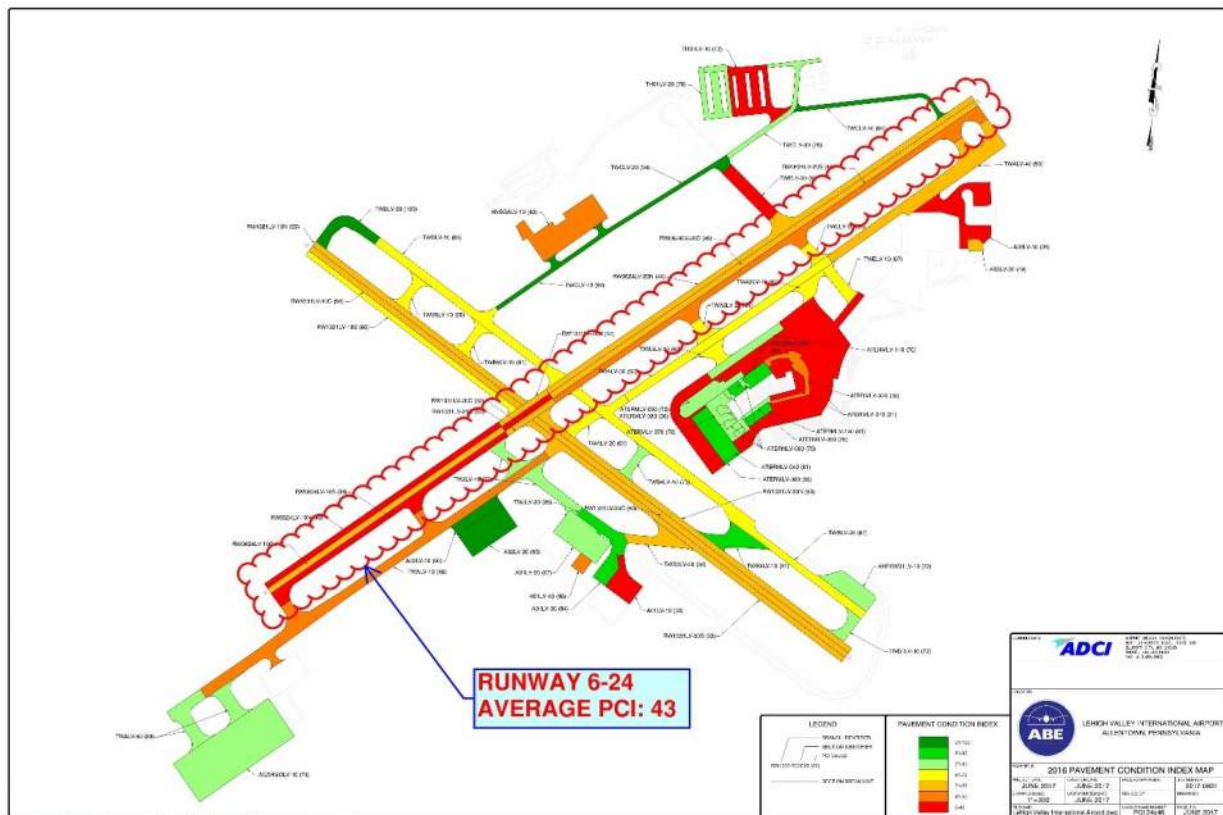
Runway 6-24 PCI

Runway 6-24 contained six sections. All of the sections had low severity block cracking and medium-severity weathering. Medium severity weathering was recorded where missing fine material and asphalt binder were observed. Sections 10N, 10S, 20C, 20N, and 10S had low and medium-severity alligator cracking observed. Low severity alligator cracking was also observed in Section 10C. Low and medium-severity longitudinal and transverse (L&T) cracking was observed in all sections, except Section 10S. Medium severity block cracking was recorded in Sections 10N, 10S, 20N, and 20S where crack widths exceed ¼ inch or where the sealant was in unsatisfactory condition. High severity raveling was observed in Sections 10C, 10S, 20N, and 20S where coarse aggregate was missing from the surface of the pavement. High severity raveling was identified in Sections 10C and 20C. Low severity patching was observed in Sections 10N and 20S. An area of atypical condition in Section 10N was inspected as an additional sample according to PCI procedure. This area had a large high-severity depression observed during the inspection.

Major M&R is required on Runway 6-24 as the last major rehabilitation occurred in 1999. Recommendation is to perform mill and overlay for the entire runway to remediate the existing distresses and prevent future distresses from occurring. An ongoing pavement rehabilitation project for this Runway has been funded by FAA and is currently in construction phase.

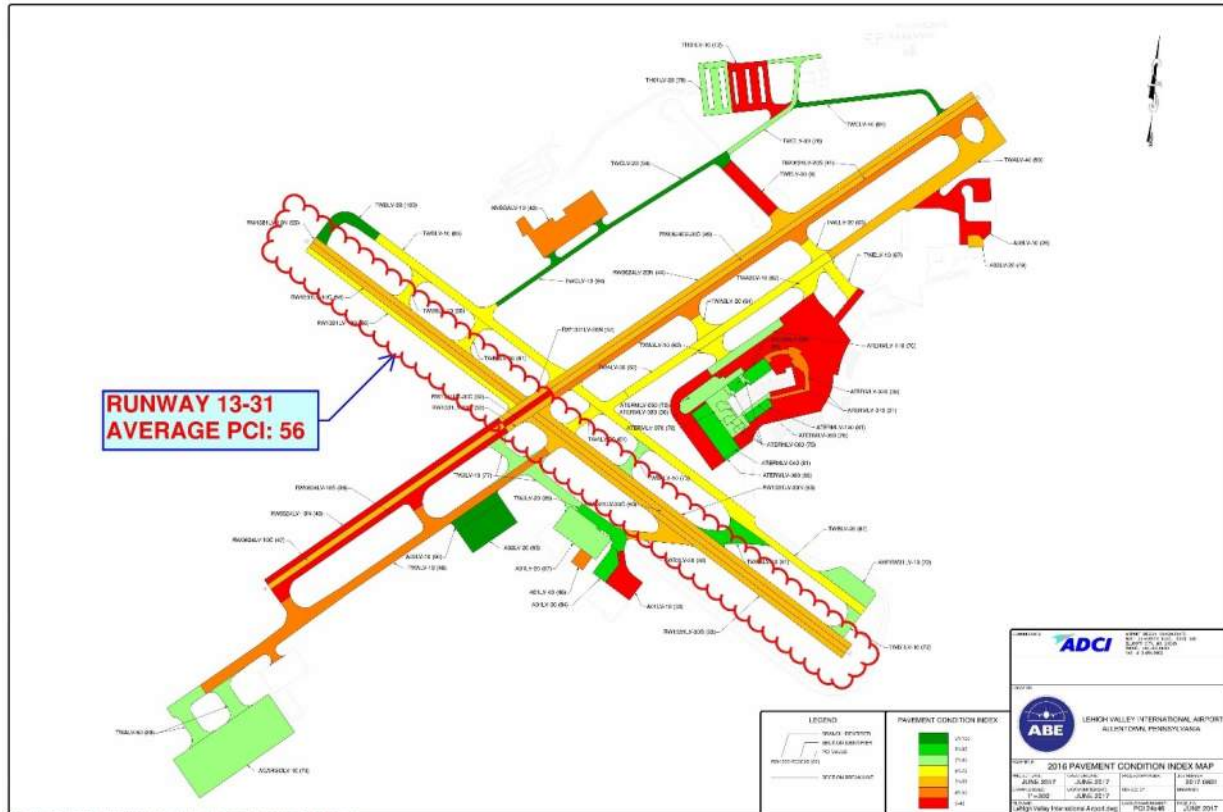
Runway 13-31 PCI

Nine sections comprised Runway 13-31. All sections had low and medium severity L&T cracking identified. Low severity L&T cracking was observed in both the unsealed and sealed conditions. Medium-severity L&T cracking was recorded where crack sealant was no longer performing satisfactorily, unsealed crack widths exceed ¼ inch, or secondary cracking had developed. Low severity weathering was also observed in all sections. Sections 10C, 10N, 20C, 20N, 20S, 30C, 30N, and 30S had low severity alligator cracking.

Sections 10C, 30N, and 30S also had medium severity alligator cracking and raveling. Medium severity weathering was recorded in Sections 10C, 10N, and 10S. Low severity block cracking was observed in Sections 20N and 20S. Isolated amounts of high severity raveling were recorded in Sections 10N and 20C. Small amounts of low severity swelling were observed in Section 10C. Additionally, low severity patching was identified in Section 20C and in an atypical area in Section 30S. The atypical area was inspected as an additional sample according to PCI procedure.

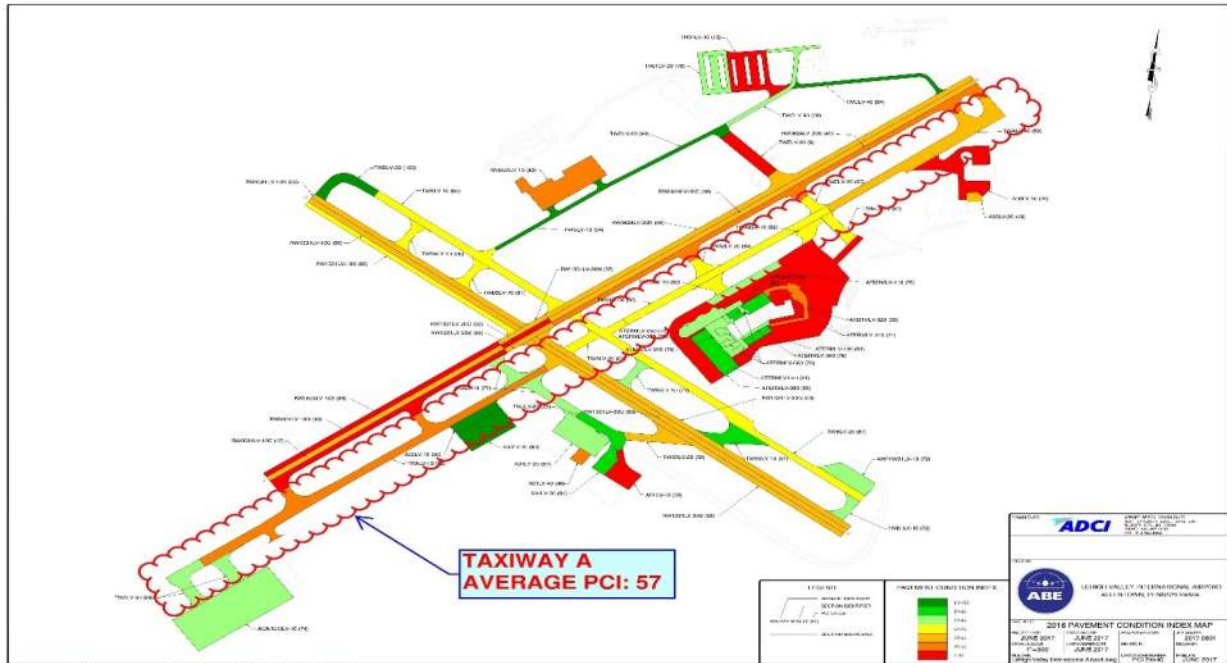
Taxiway A PCI

Taxiway A was comprised of five sections. Low severity L&T cracking and alligator cracking were observed in Sections 10, 20, and 40. Low and medium severity L&T cracking was identified in Sections 10, 20, 30, and 50. Low severity L&T cracking was observed in both the unsealed and sealed conditions, while the medium-severity L&T cracking was recorded where crack sealant was no longer performing satisfactorily, unsealed crack widths exceed ¼ inch, or secondary cracking associated with primary cracking was observed. Sections 10, 30, and 40 had low severity rutting recorded. Low severity weathering was observed in all sections, and medium severity weathering was recorded in all but Section 30. Low severity raveling was identified in Sections 10 and 20, while medium-severity was observed in Sections 10 and 50. Low severity, unsealed block cracking was identified in moderate quantities in Section 40. Bleeding was recorded in Section 30. Low severity patching was observed in Section 20. Isolated quantities of high severity raveling and moderate quantities of medium severity alligator cracking were identified in Section 10.

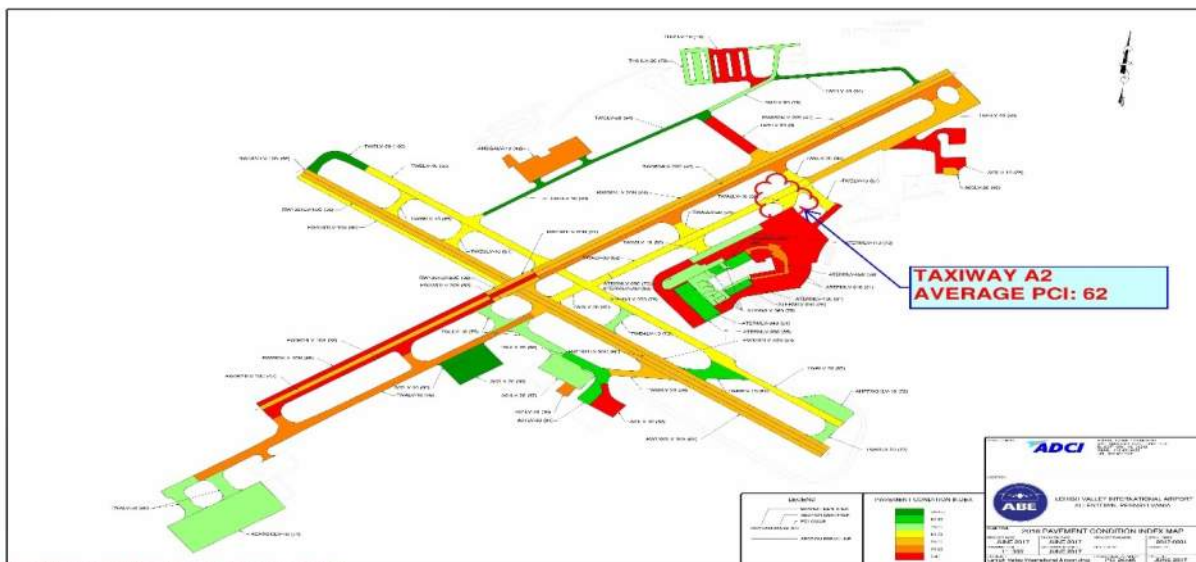
Taxiway A2 PCI

Taxiway A2 consisted of one section that served as a connector for the northern area of the Terminal Apron to Taxiway A. Small amounts of medium severity alligator cracking were observed. Low severity L&T cracking was observed in the unsealed condition, while the medium severity L&T cracking was recorded where crack sealant was in unsatisfactory condition or where unsealed crack widths exceeded ¼ inch. Additionally, low severity depression, weathering, and bleeding were identified.

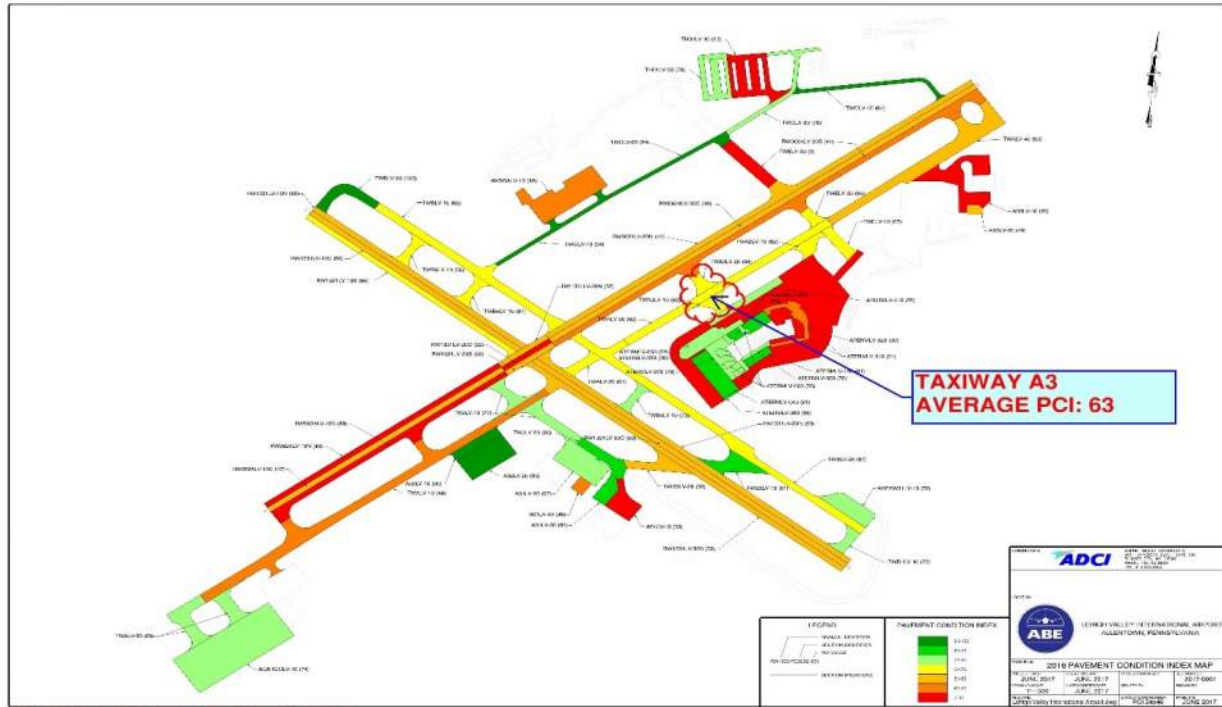
Taxiway A3 PCI

Taxiway A3 was defined by two sections. Sections 10 and 20 were in comparable condition with similar distresses observed during the inspection. Moderate amounts of bleeding were identified. Low and medium severity L&T cracking were also observed. Additionally, low severity weathering was identified where asphalt binder appeared to be missing, leaving aggregate exposed. Section 10 had a large area of medium severity patching identified.

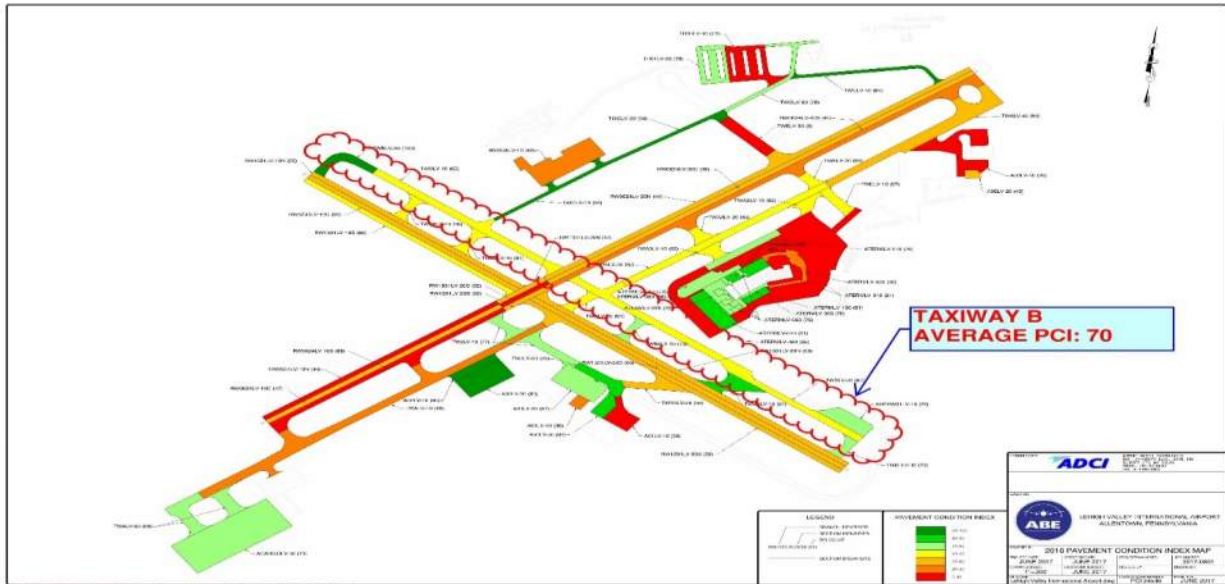
Taxiway B PCI

Taxiway B contained three sections. Sections 10 and 20 were in comparable condition with similar distresses observed during the inspection. Low and medium severity L&T cracking, low severity raveling, and low and medium severity weathering were identified in both sections. Section 10 also had low severity patching, medium severity raveling, and isolated amounts of bleeding. Section 30 defined the connector at the approach end of Runway 13 and was in excellent condition with no distresses recorded.

Major M&R is recommended in the distressed portions of Taxiway B aside from the westernmost section. The last major rehabilitation of the eastern portions occurred in 2005 and 2006. Recommendation is to apply new crack sealant to repair the longitudinal cracking. Partial depth patching should also be done to repair the weathering and raveling. The westernmost portion of Taxiway B was rehabilitated in 2014 and is not in need of any repairs at this time, however the pavement should be regularly monitored and preventive maintenance be performed to ensure that its condition is maintained.

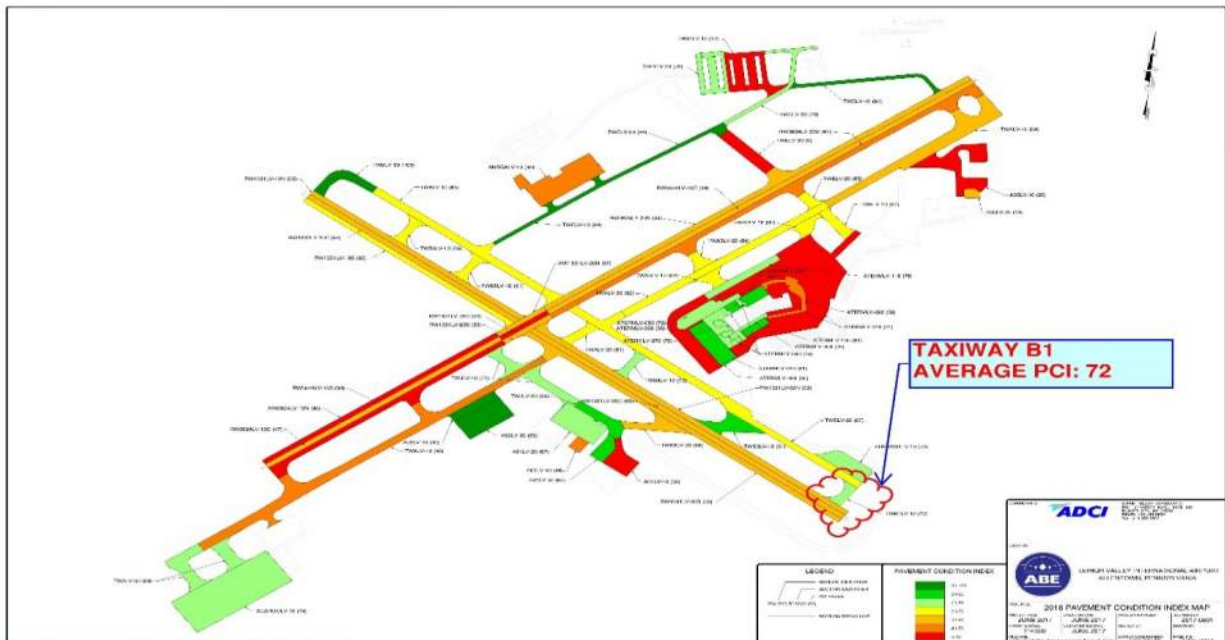
Taxiway B1 PCI

Taxiway B1 consisted of one section. Isolated quantities of medium severity raveling and bleeding were identified. Low severity L&T cracking was observed in the unsealed condition. Additionally, low and medium severity weathering was recorded throughout the majority of the section where an oxidized pavement surface and missing fine material were observed.

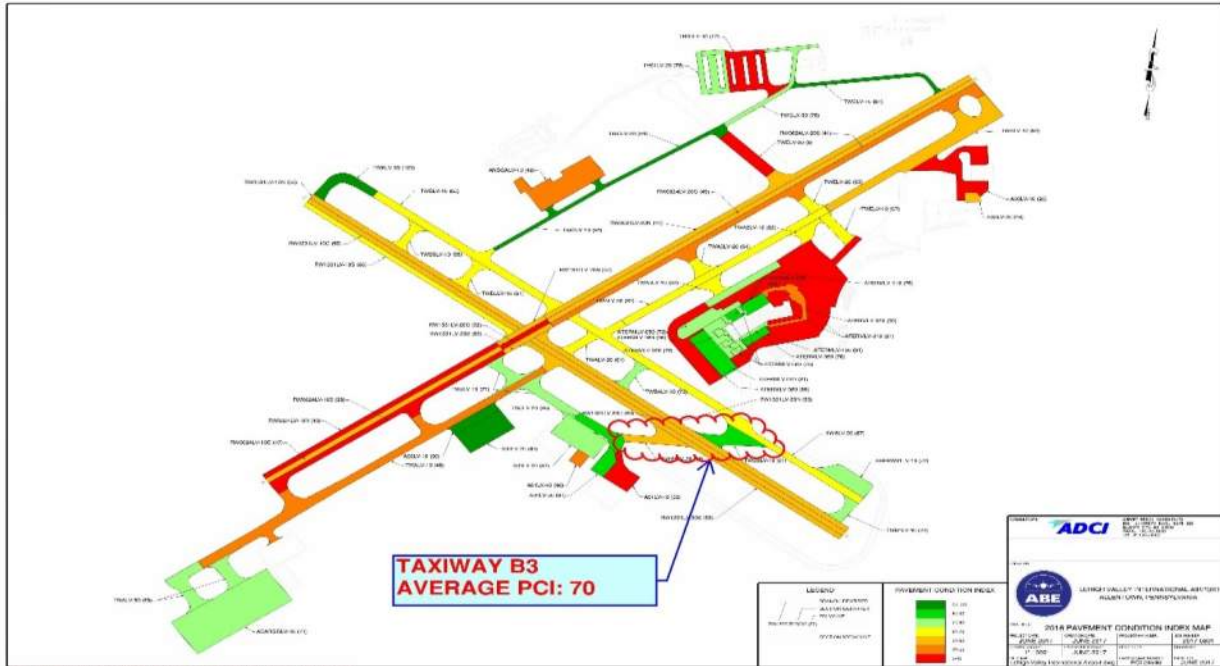
Taxiway B3 PCI

Taxiway B3 contained two sections. Section 10 defined the connector east of Runway 13-31. Low severity, unsealed L&T cracking along with low and medium severity weathering were the only distresses observed at the time of the inspection. Section 20 defined the connector west of Runway 13-31. Low and medium severity L&T cracking and weathering were identified. Low severity patching and alligator cracking were also observed. In addition, areas of medium severity depression were observed.

Substantial M&R is needed for Taxiway B3 as the last rehabilitation was completed in 2001 and its condition is deteriorating. Recommendation is to perform partial-depth patching and AC crack sealing. Localized preventative maintenance should be performed on Taxiway B4 as the last major rehabilitation occurred in 2006. Recommendation is to perform patching to prevent further deterioration from weathering. Major M&R should be performed on Taxiway B5 and Taxiway B6 as the last major rehabilitation occurred in 2005. Recommendation is to apply new crack sealant to repair the longitudinal cracking and patching to repair the weathering. For Taxiway B5 only, patching should be done to repair raveling. Leveling patchwork should be performed on Taxiway B1. The last major rehabilitation for this section occurred in 2006.

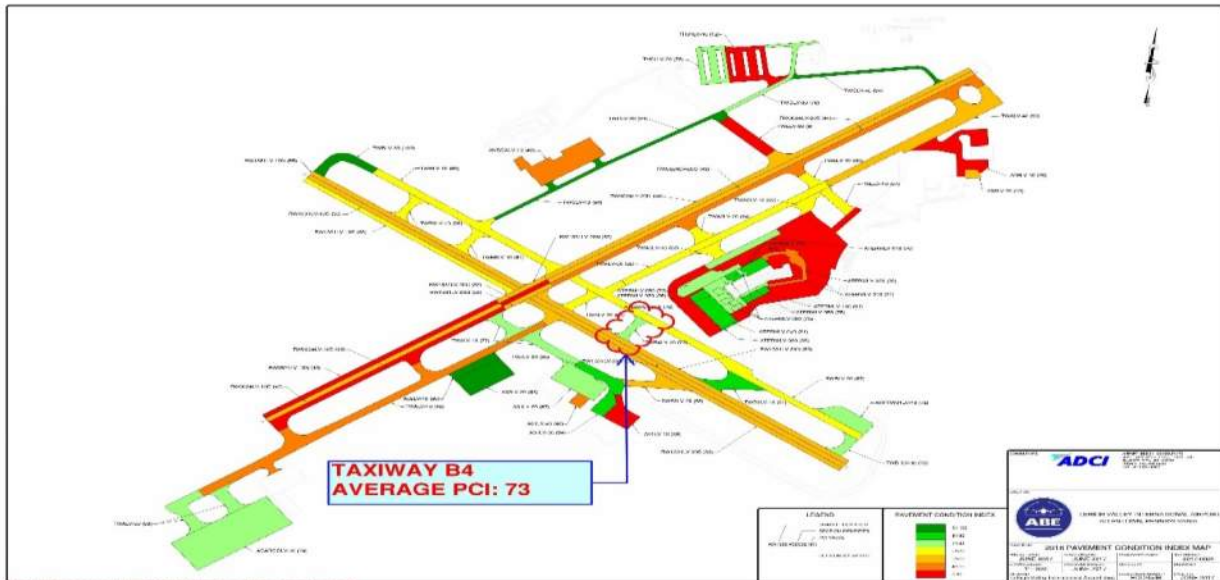
Taxiway B4 PCI

Taxiway B4 consisted of one section. Low severity L&T cracking was identified in the unsealed condition. Isolated amounts of low severity raveling were also observed. All severities of weathering were identified, but only minor amounts of high-severity were recorded.

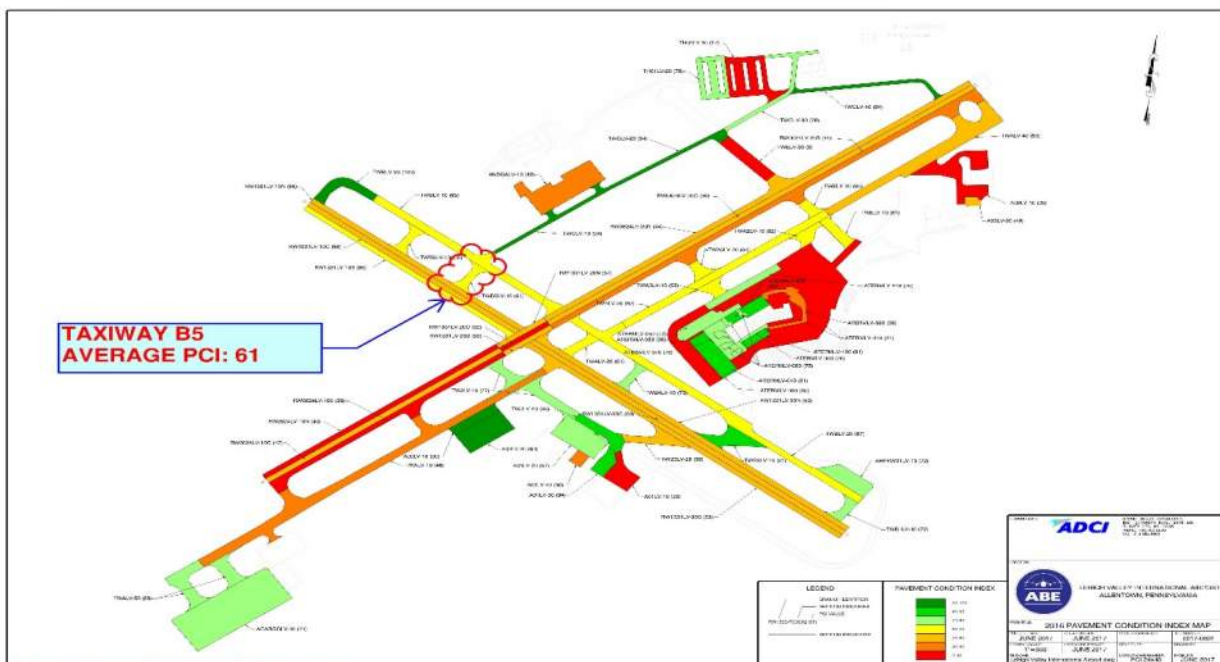
Taxiway B5 PCI

Taxiway B5 was defined by one section. Low and medium severity weathering and L&T cracking were observed. Small amounts of low severity alligator cracking and patching were also identified. Additionally, isolated quantities of raveling were observed.

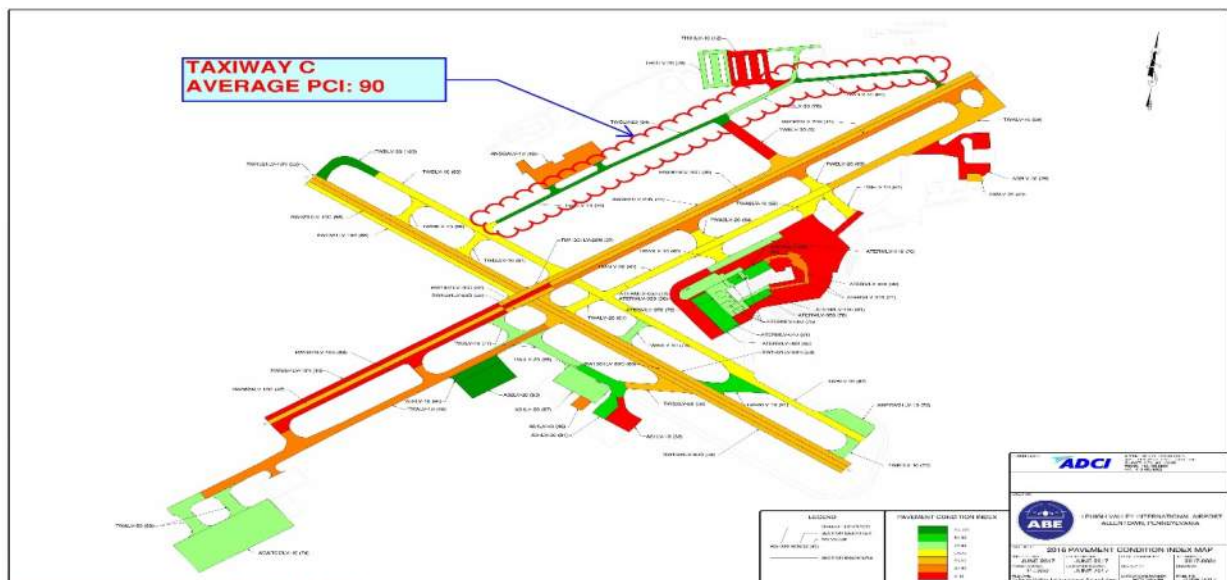
Taxiway C PCI

Taxiway C consisted of four sections. Sections 10, 20, and 40 were in comparable condition with only low severity weathering identified in each section. Section 30 had low severity L&T cracking observed in the unsealed condition, while the medium severity L&T cracking was recorded where unsealed crack widths exceeded ¼ inch. Low severity weathering was also observed in Section 30.

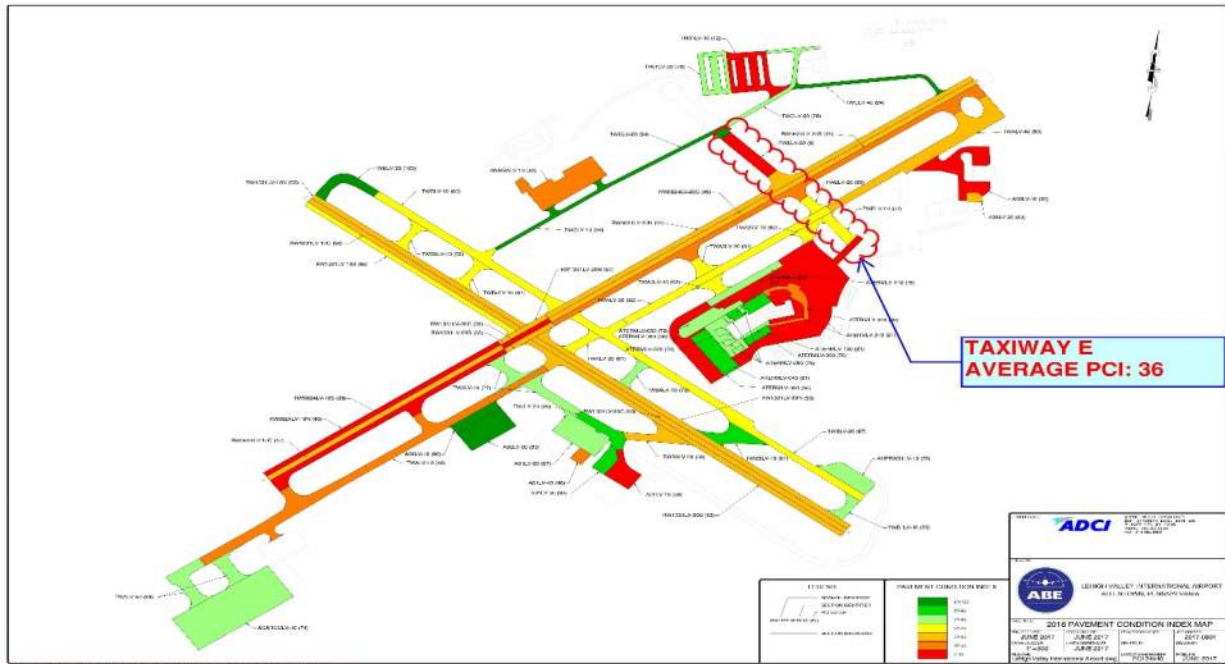
Taxiway E PCI

Taxiway E was defined by three sections. Sections 10 and 20 were in comparable condition with similar distresses observed during the inspection. Low and medium severity L&T cracking, low severity weathering, and bleeding were identified in both sections. Additionally, low severity raveling was observed in Section 10. Section 30 was in poor condition with extensive amounts of alligator cracking and block cracking recorded. Significant quantities of depression, patching, high severity alligator cracking, rutting, and high severity raveling and weathering were also observed throughout the pavement section.

Major M&R is needed. The last rehabilitation was completed in 1975 for the northernmost portion, 1991 for the middle portion, and 1999 for the southernmost portion of Taxiway E. Recommendation is to perform full-depth reconstruction of the northern AC pavement section and apply new crack sealant to repair the longitudinal cracking and to closely monitor the weathering and raveling in the area south of Runway 6-24.

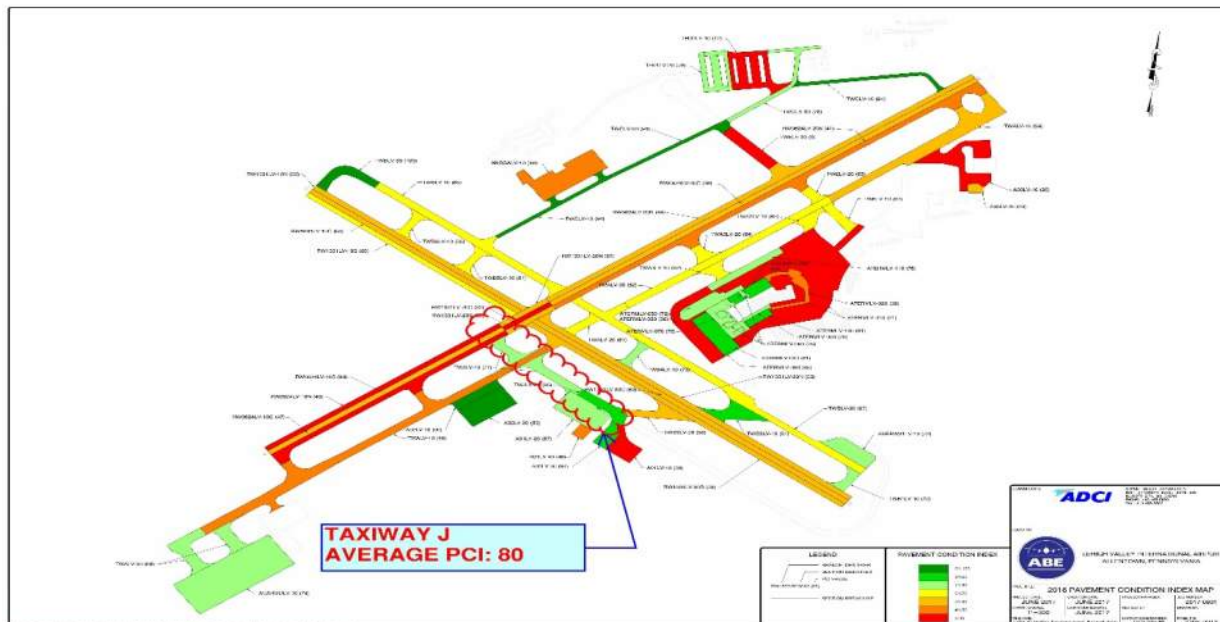
Taxiway J PCI

Taxiway J consisted of two sections. Low severity L&T cracking was observed in both the unsealed and sealed conditions in Section 10. Low severity weathering and alligator cracking were also observed. Low severity, unsealed L&T cracking and weathering were the only distresses observed during the inspection of Section 20.

Localized preventative maintenance should be performed to repair the distresses observed on Taxiway J, however it is not a priority at this time as the pavement is in relatively good condition, compared to adjacent pavements. The last major rehabilitation was completed in 2010. Recommendation is to closely monitor the observed distresses.

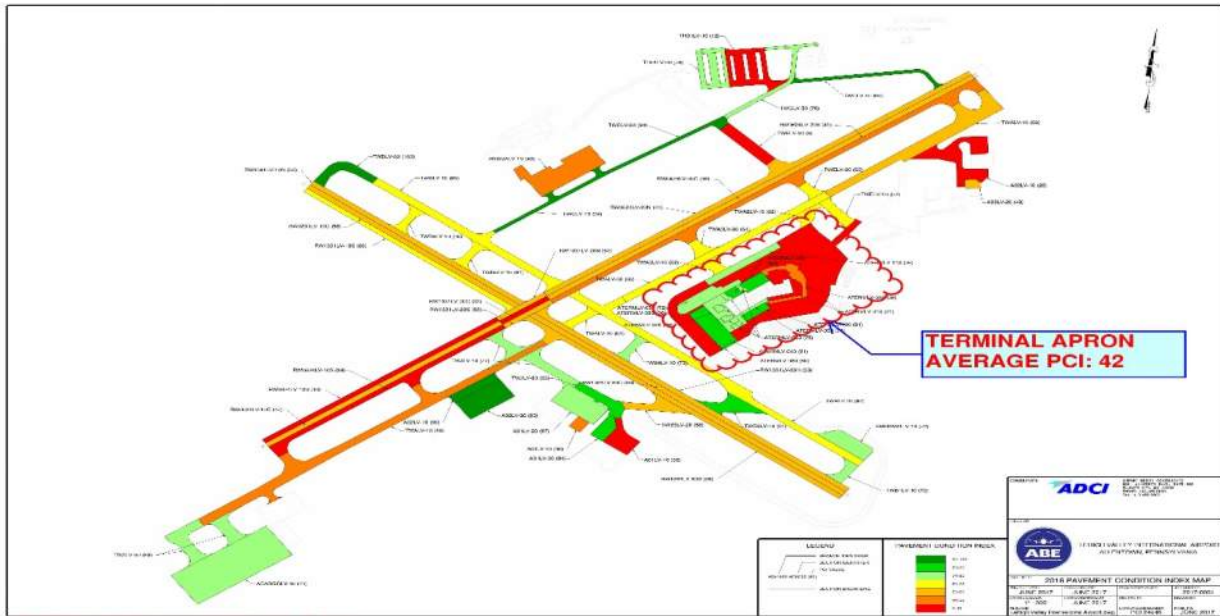
Terminal Apron PCI

The terminal apron comprised of eleven sections. Sections 50 and 110 were in comparable condition with similar distresses observed during the inspection. Both sections had low and medium severity L&T cracking and low severity weathering observed. Section 50 also had small amounts of medium severity alligator cracking and low severity depression identified. Sections 10 and 30 were in poor condition. Each section had significant amounts of low and medium severity alligator cracking, L&T cracking, block cracking, and weathering identified. High severity raveling was also observed in both sections. Medium-severity raveling and high severity L&T cracking were also observed in Section 30. Low and medium-severity depression, low and high severity patching, and low and medium severity rutting were also identified in Section 110. Sections 40, 60, 70, 80, 90, and 100 consisted of PCC pavement. High-severity joint seal damage was observed in Sections 40 and 80, while medium severity was identified in Sections 90 and 100. Shrinkage cracking was observed in each of the sections. High severity corner spalling was observed in Sections 40, 60, 70 and 100. Medium severity joint spalling was observed in Sections 40, 60, 70, 90, and 100. Low severity longitudinal, transverse, and diagonal (LTD) cracking was observed in Sections 60 and 100, while medium severity LTD cracking was recorded in Section 60, 70, and 90. Low severity joint spalling was recorded in Sections 90 and 100. Low severity corner breaks and ASR were also observed in Section 40. Low severity corner spalling was identified in Sections 70 and 90, while medium-severity corner spalling was observed in Section 40, 60, and 90. Small amounts of low severity ASR were also observed in Section 40.

In addition, low severity patching was identified in Sections 70 and 90. Small amounts of high severity joint spalling were observed in Section 70. Section 20 was in poor condition with significant amounts of LTD cracking, joint seal damage, shrinkage cracking, and scaling identified. Additionally, small amounts of shattered slabs, spalling, patching, durability cracking, and corner breaks were recorded.

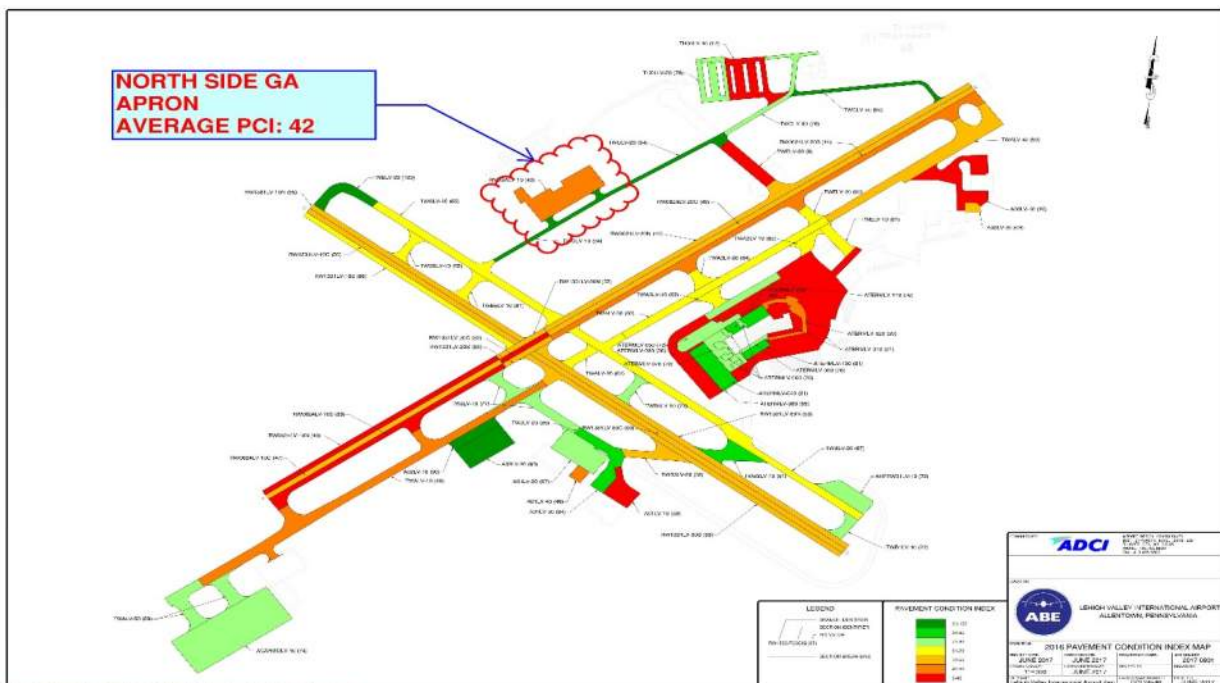
Northside GA Apron PCI

The North Side General Aviation Apron consists of one section with substantial amounts of low and medium severity block and L&T cracking observed. Smaller areas of medium-severity alligator cracking and high severity L&T cracking were recorded. Additionally, low severity weathering and raveling were identified.

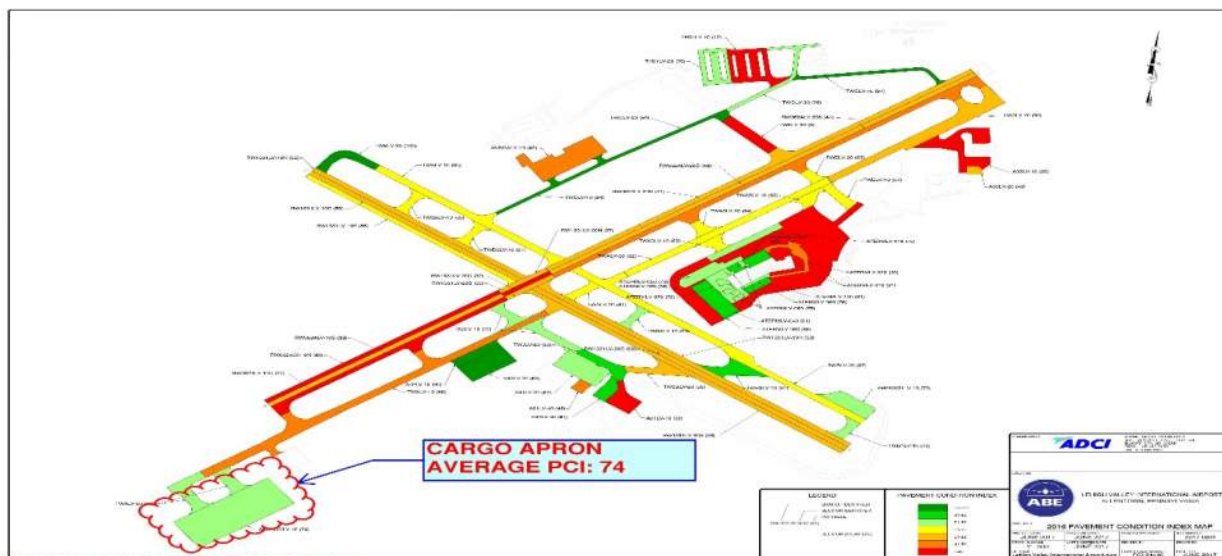
Cargo Apron PCI

The Cargo Apron was defined by one section. Low, medium, and high severity corner spalling, joint spalling, and small patching were observed. In addition, medium and high severity joint seal damage and shrinkage cracking were identified.

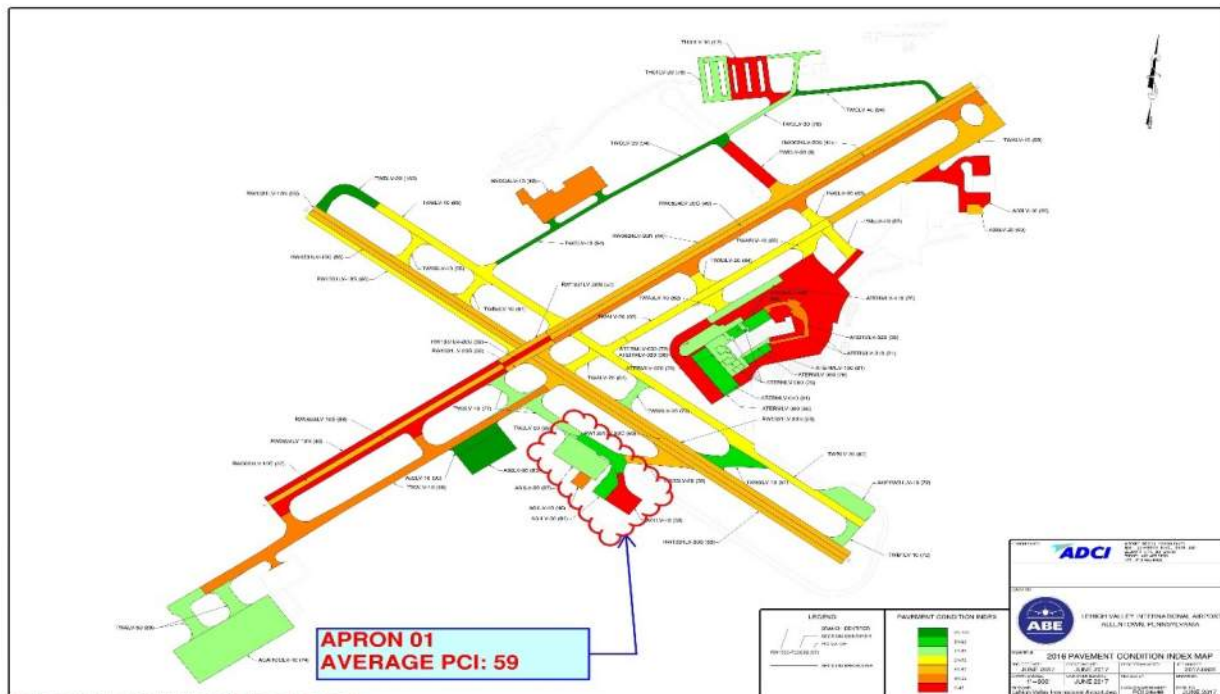
Apron 01 PCI

Apron 01 was defined by four sections. Section 10 was in poor condition with substantial amounts of corner breaks, LTD cracking, shattered slabs, spalling, and Alkali Silica Reactivity (ASR) identified in varying severities. Additionally, shrinkage cracking, low severity faulting, low severity large patching, and high severity joint seal damage was observed. Low severity LTD cracking was observed in the Sections 20, 30, and 40, while medium severity was identified in Sections 20 and 40. Medium severity corner breaks were recorded in Sections 20 and 30, while only low severity corner breaks were identified in Section 40. High severity joint seal damage and shrinkage cracking was observed in each of the three sections. High severity corner spalling was observed in Section 30 producing foreign object debris (FOD) potential. Significant amounts of low and medium severity shattered slabs were observed in Section 40. Additional distress identified in Section 20 included low and medium severity small patching, large patching, ASR, corner spalling, and joint spalling.

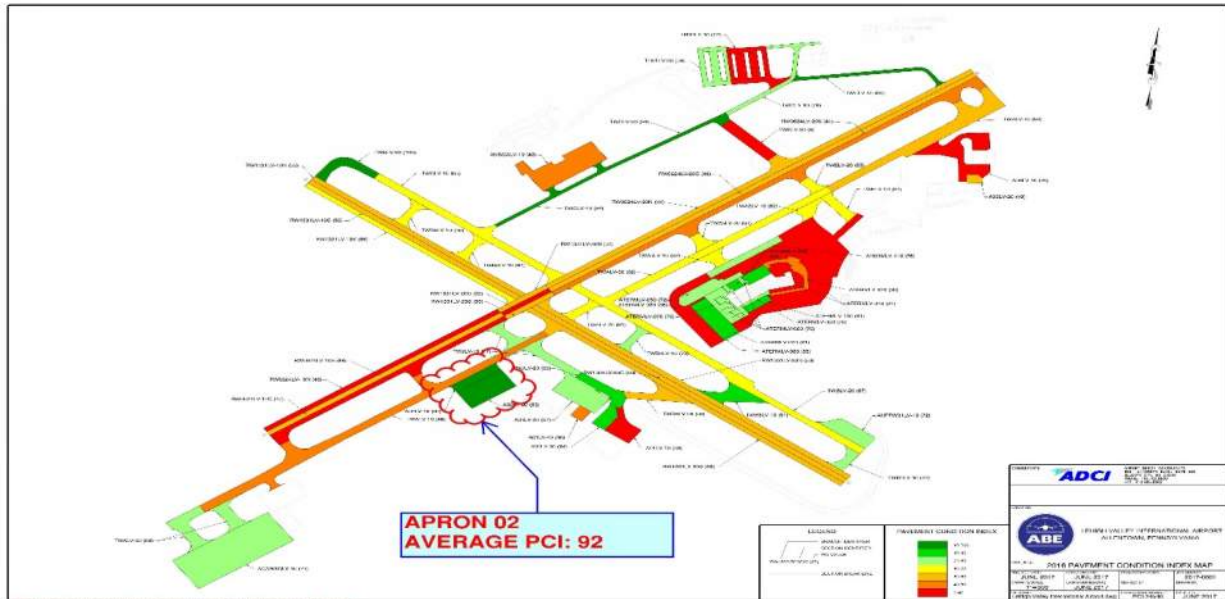
Apron 02 PCI

Apron 02 consisted of two sections. Low severity L&T cracking and weathering were the only distresses observed in Section 10 during the inspection. Section 20 consisted of the PCC portion of Apron 02 and had only medium- and high-severity joint seal damage.

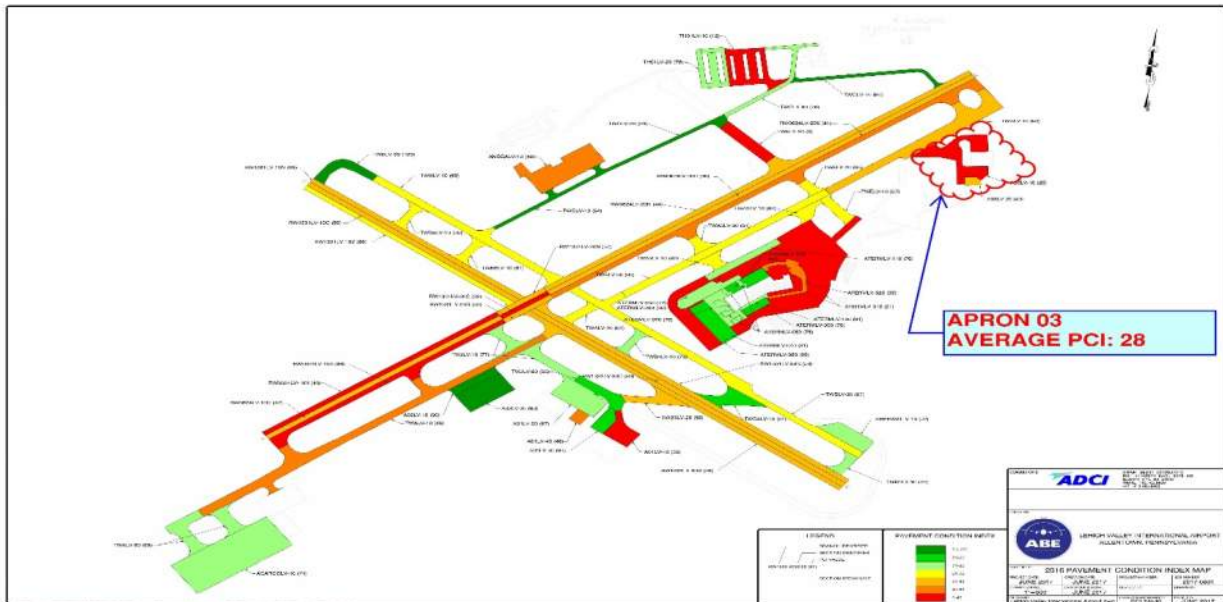
Apron 03 PCI

Apron 03 was comprised of two sections. Section 10 was in poor condition with significant amounts of low and medium severity alligator cracking, block cracking, L&T cracking, patching, and weathering observed. Additional distresses identified included low severity raveling and bleeding. Section 20 had medium severity L&T cracking and joint reflection cracking observed, along with low severity weathering during the time of the inspection.

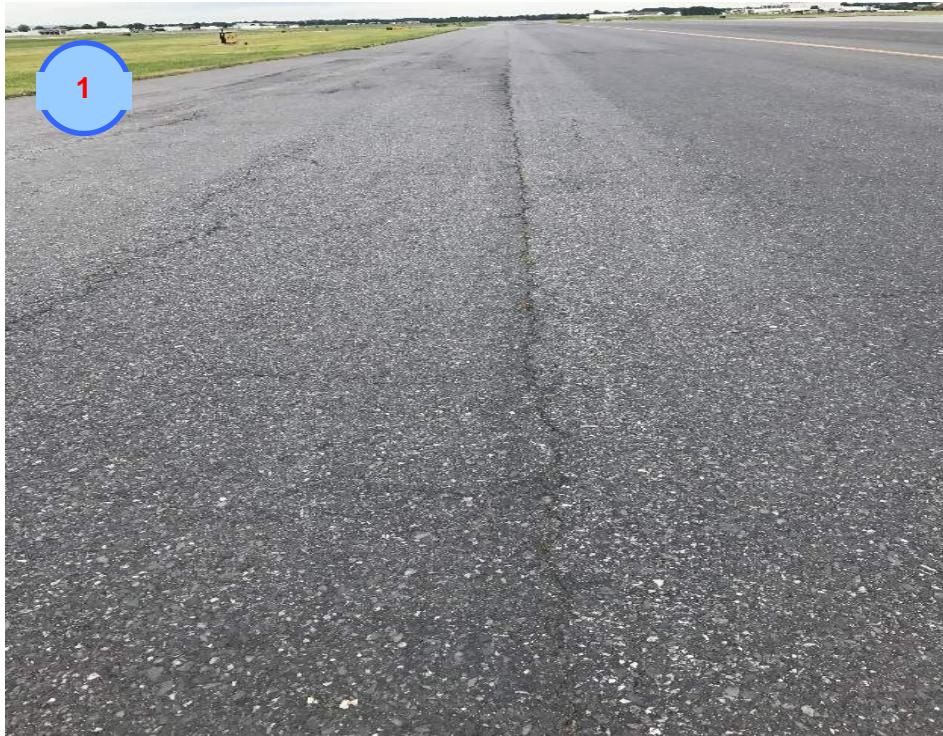
Low Severity Longitudinal Cracking

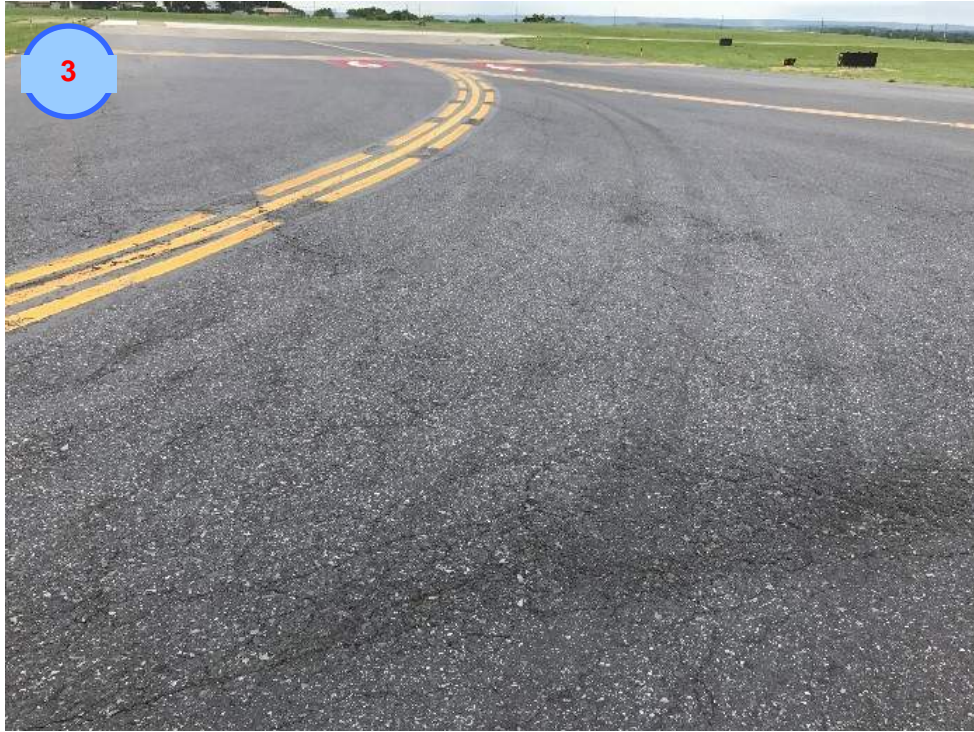
Low severity Weathering and Low Severity Alligator Cracking

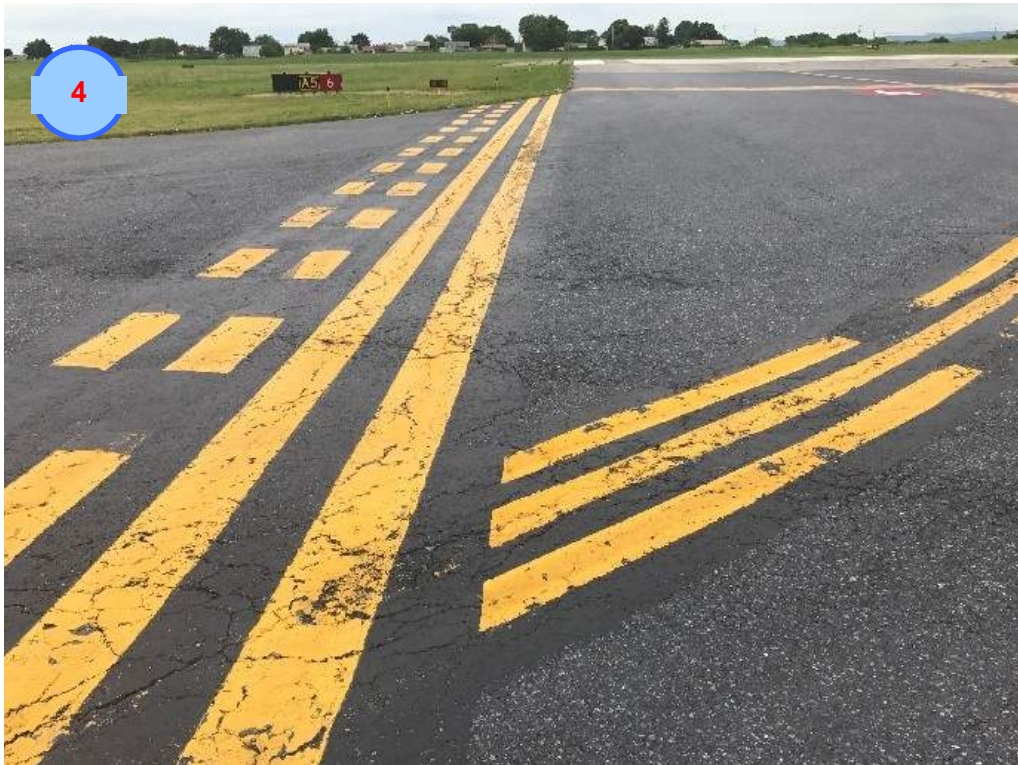
Low Severity Alligator Cracking

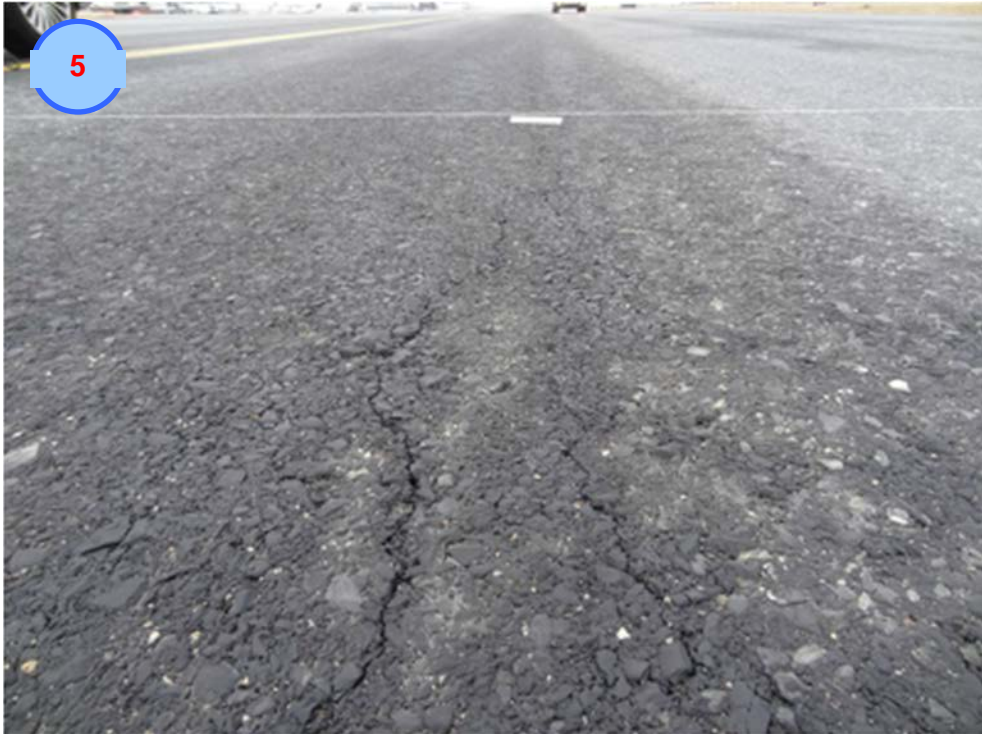
Medium Severity Weathering and Cracking

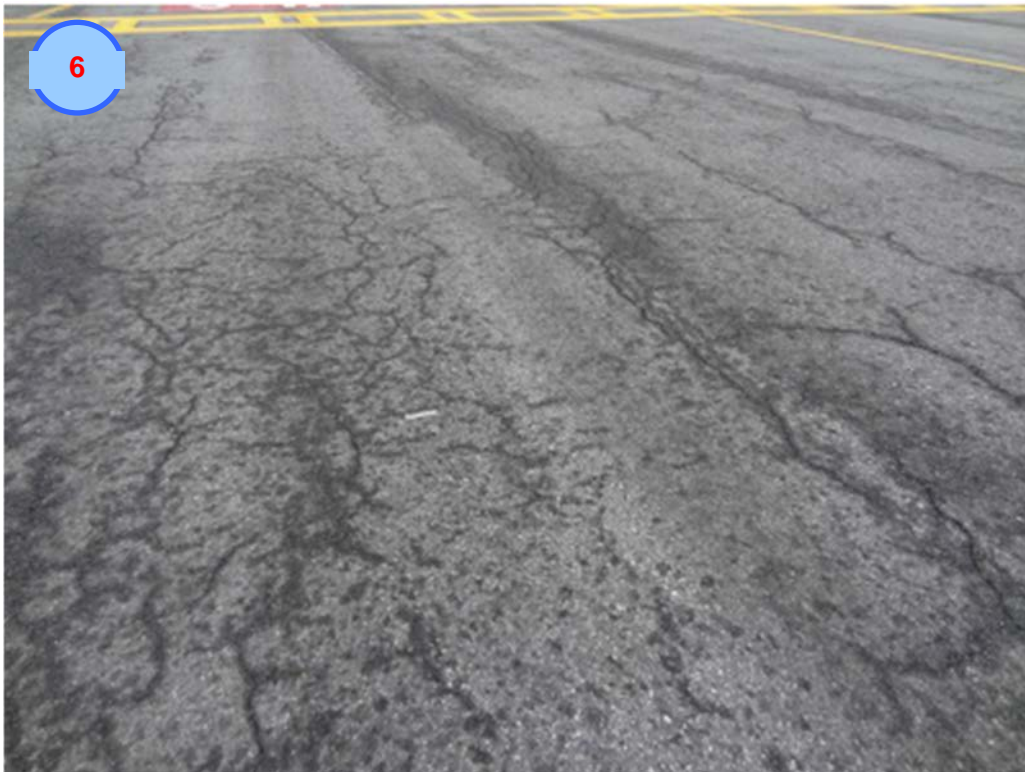
Medium Severity Block Cracking
