Lehigh Valley International Airport (ABE)

Airside Pavement Management Plan

Final Working Report – February, 2018

Prepared by
Airport Design Consultants Inc.

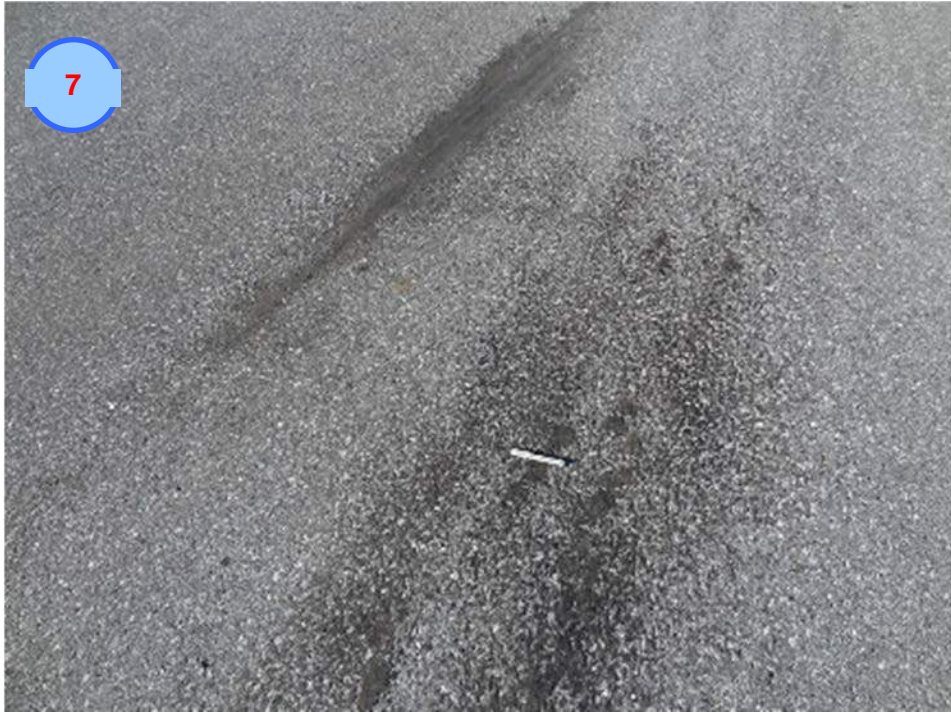
Bleeding

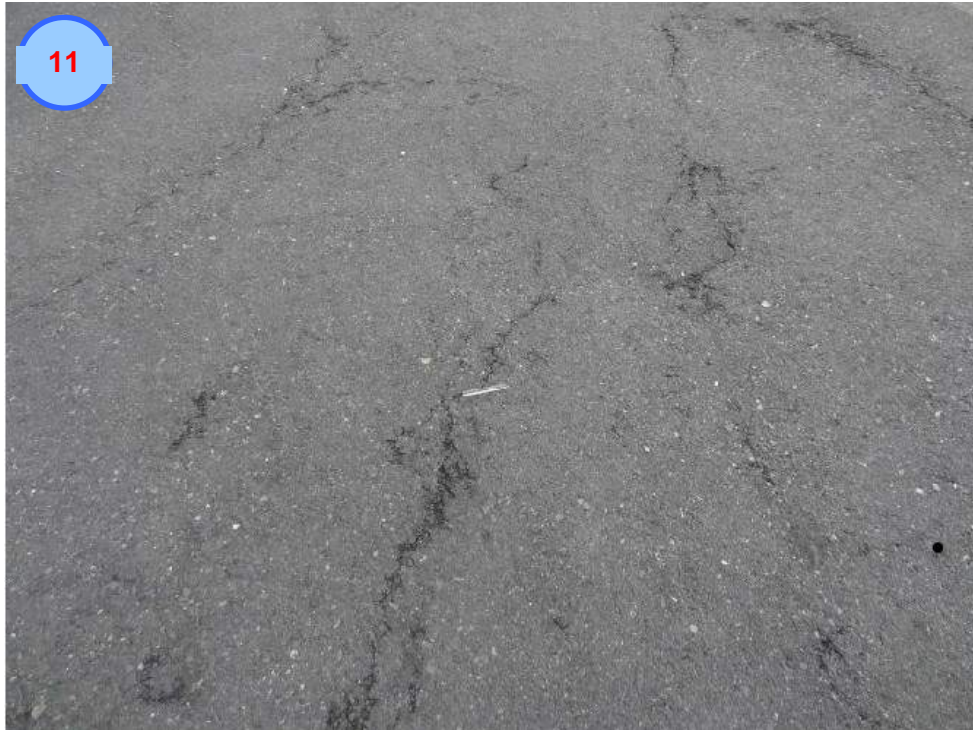
Longitudinal Cracking

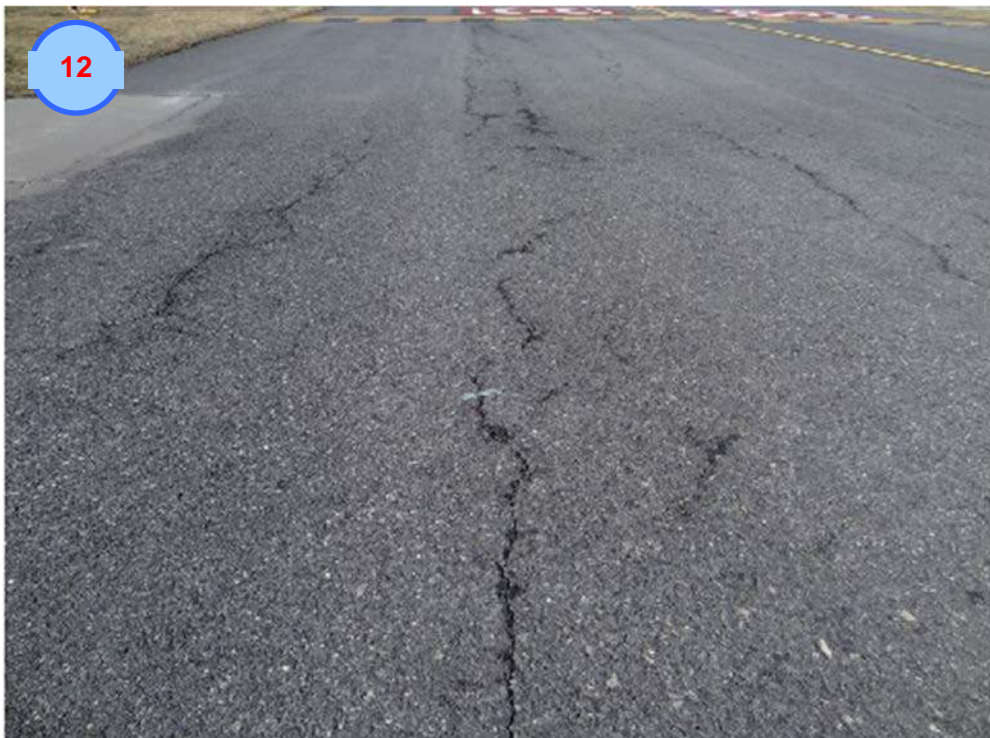
Cracking and Weathering

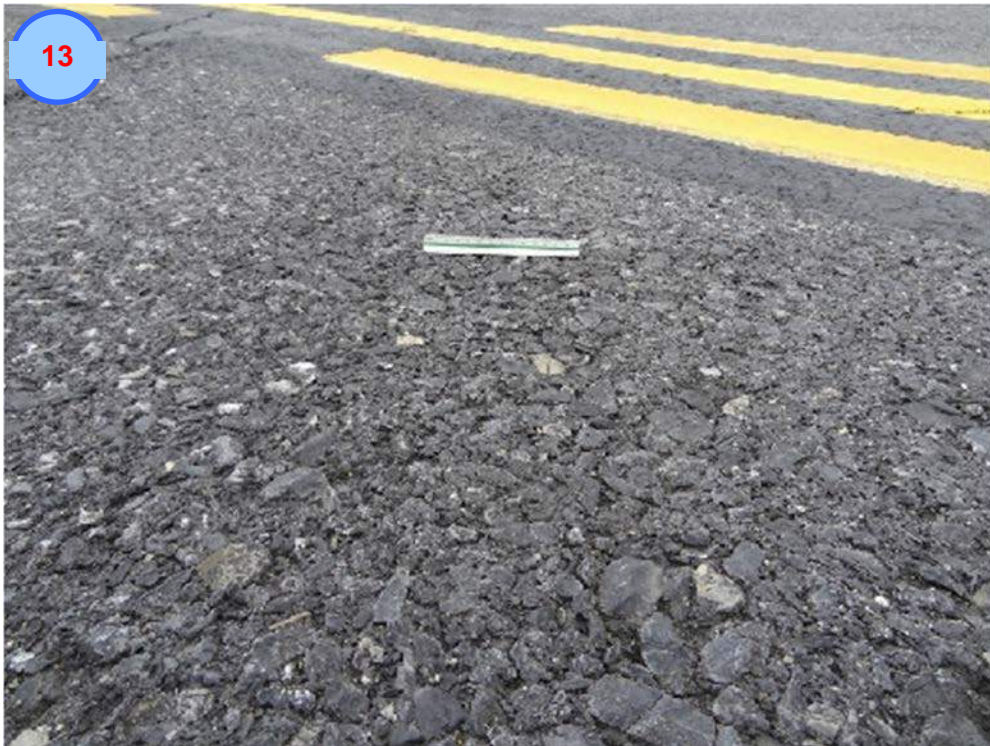
Medium Severity Weathering

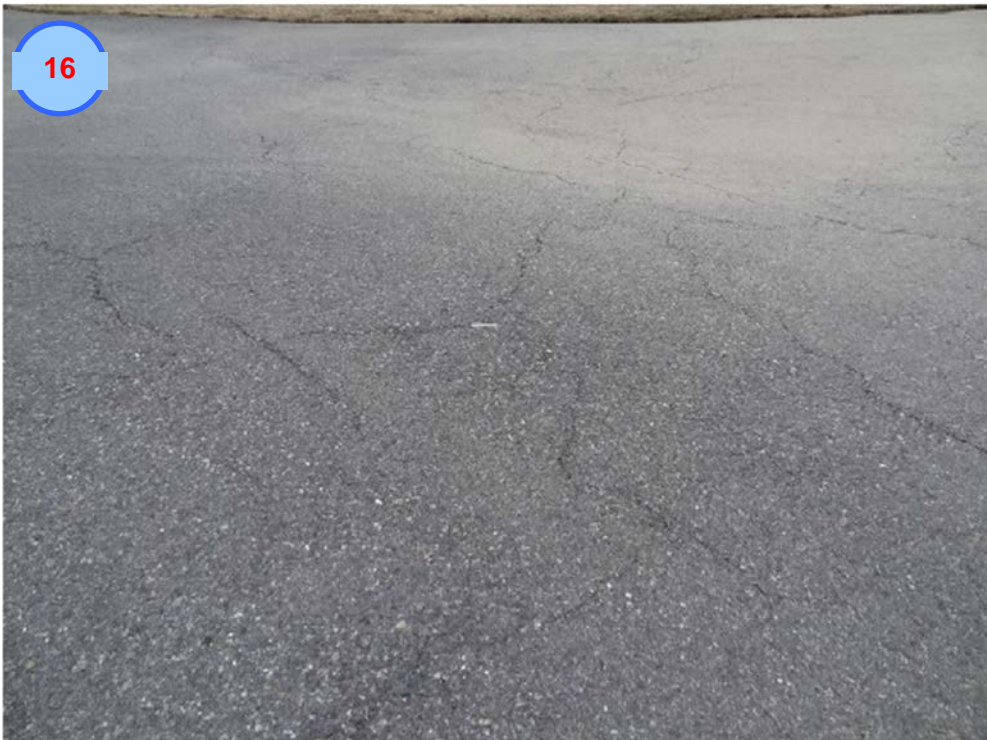
Longitudinal Cracking

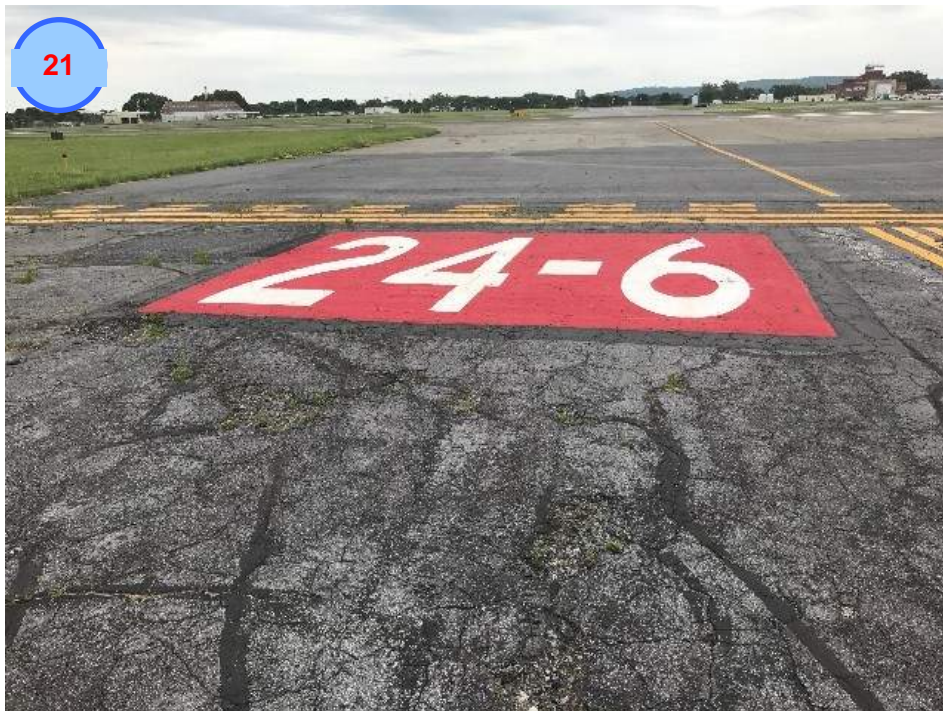
Alligator Cracking and Rutting

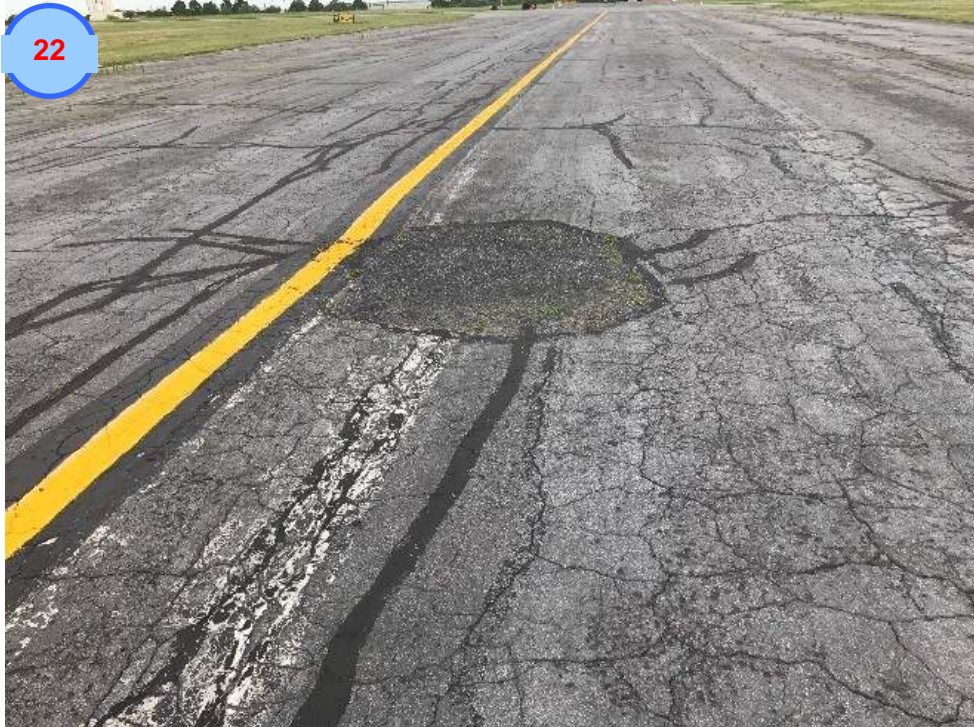
Medium Severity Alligator Cracking, Depression, Rutting, and Patching

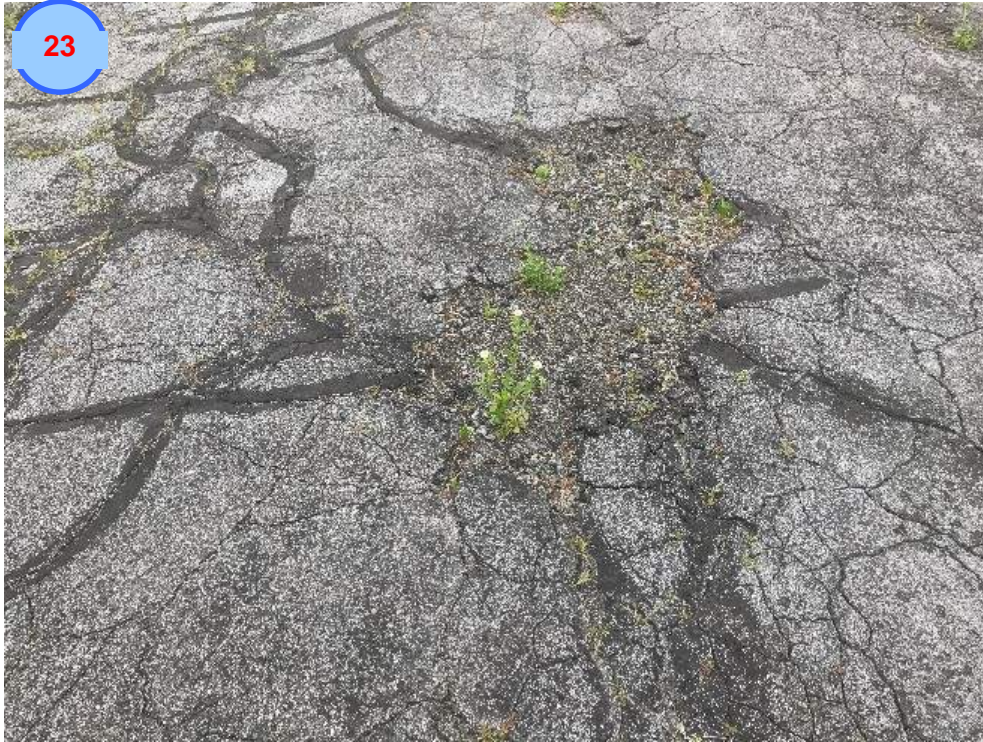
Medium Severity Alligator Cracking, Raveling

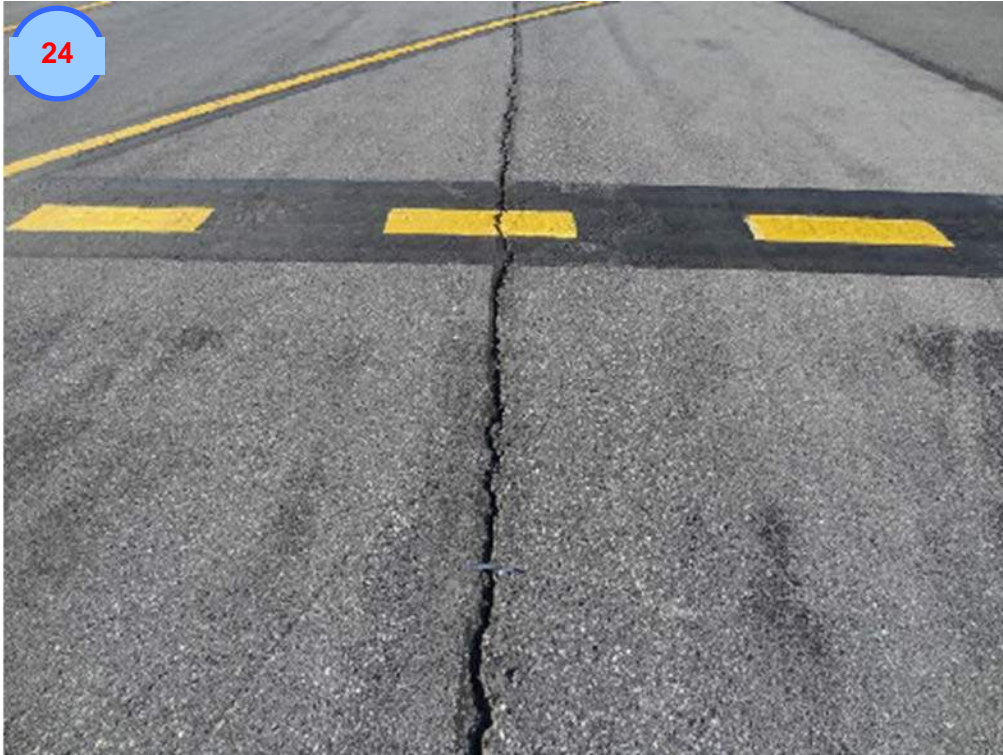
Longitudinal Cracking

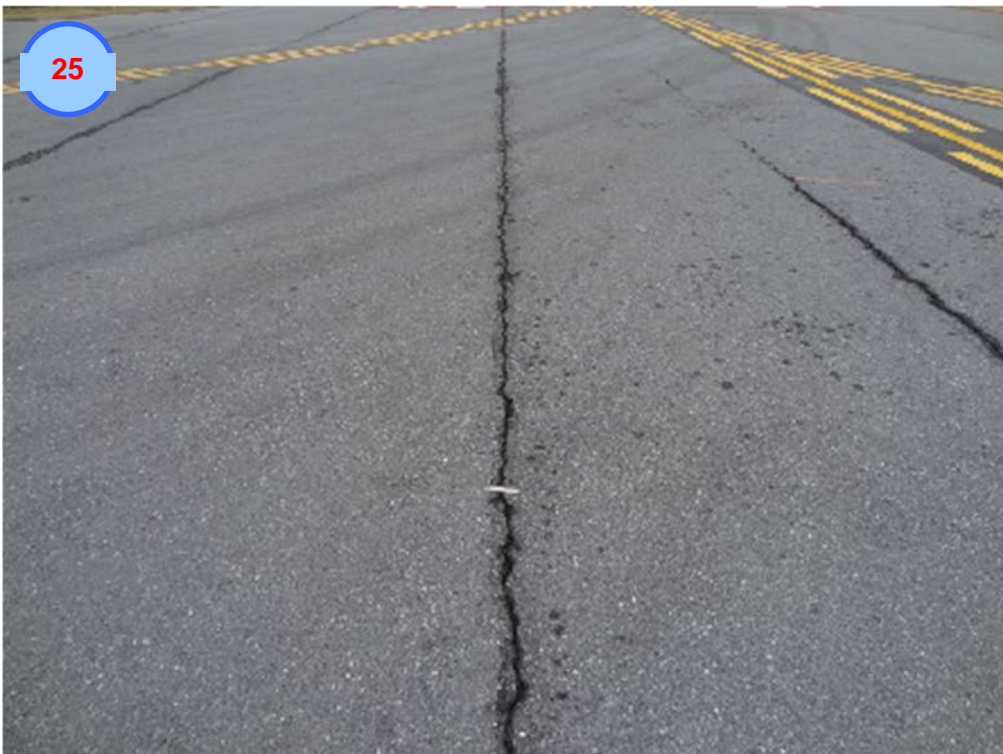
Longitudinal Cracking

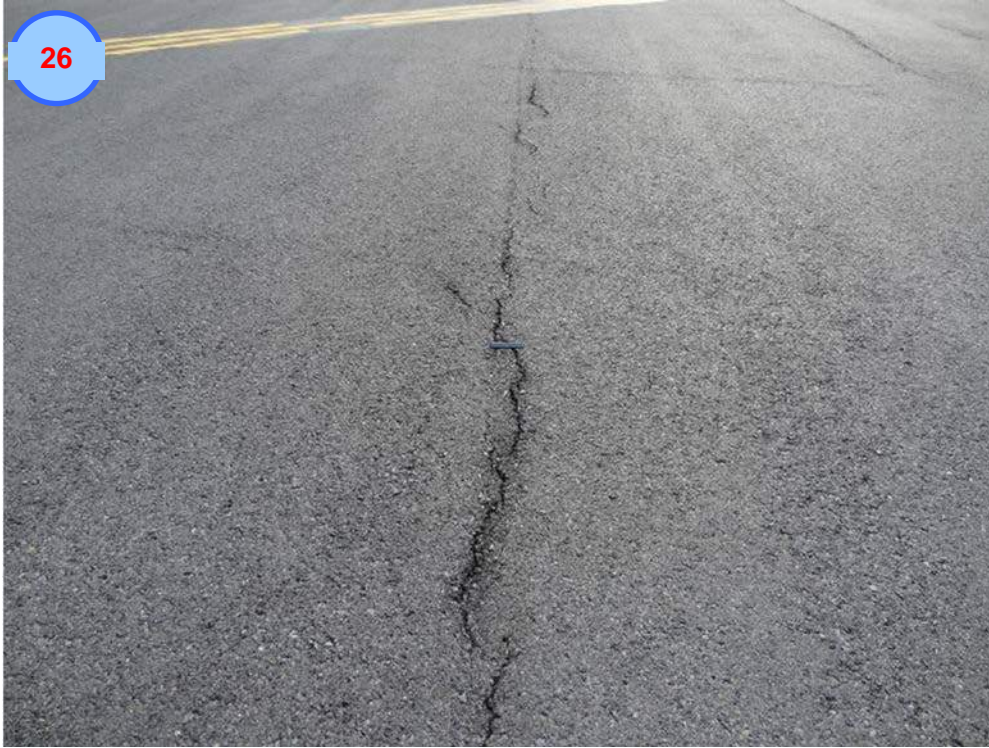
Longitudinal Cracking

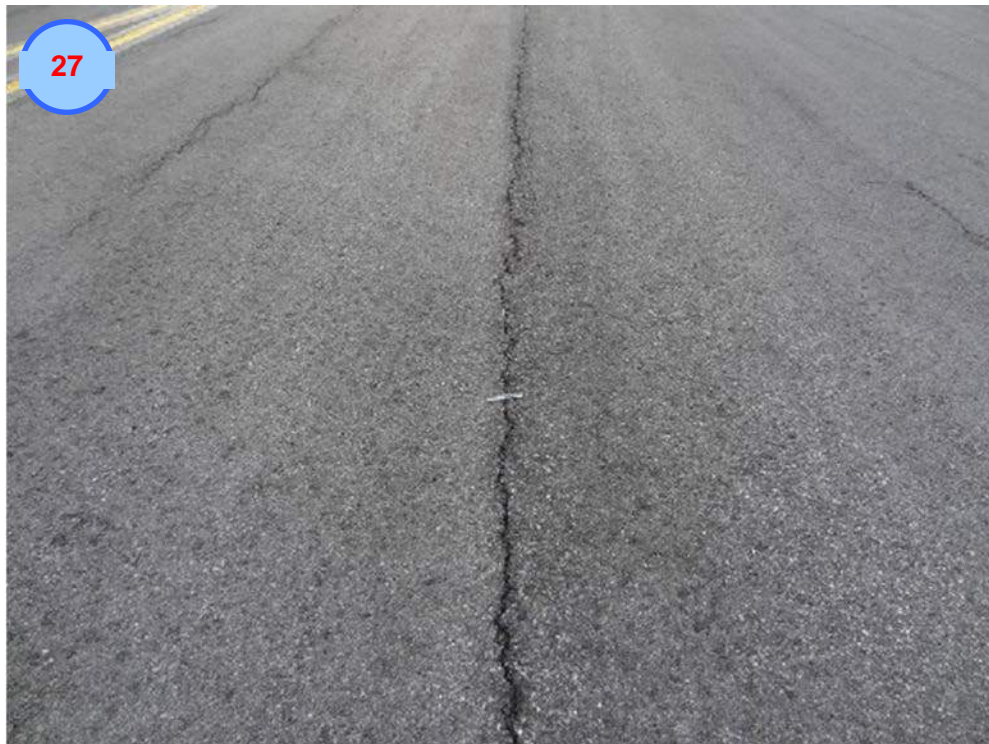
Longitudinal Cracking

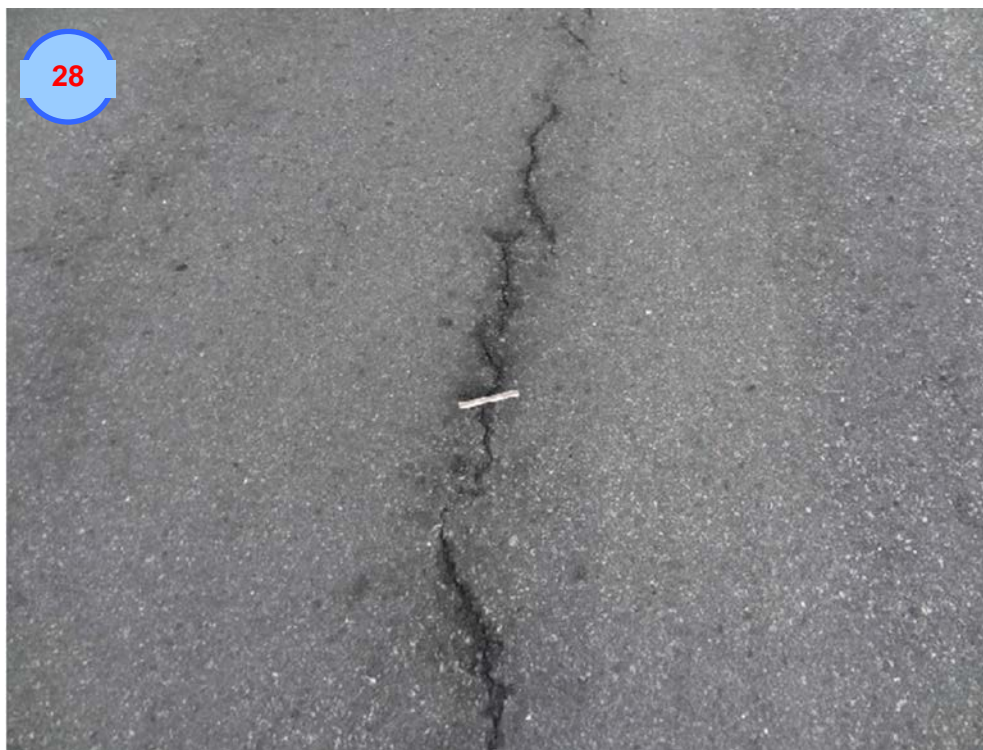
Longitudinal Cracking

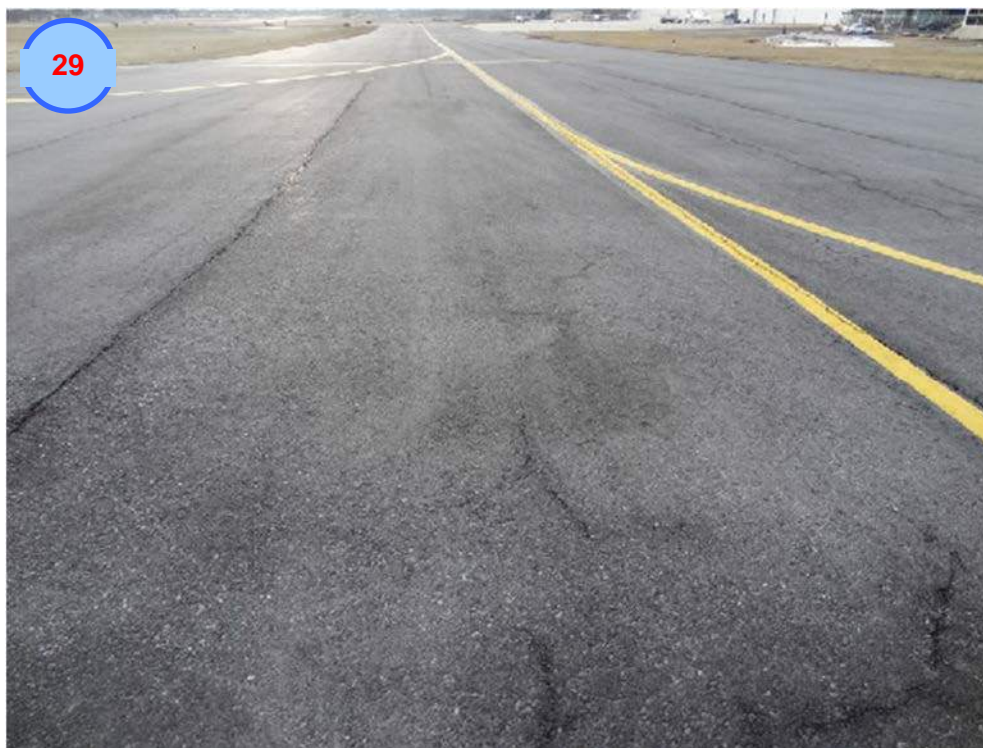
Weathering and Alligator Cracking

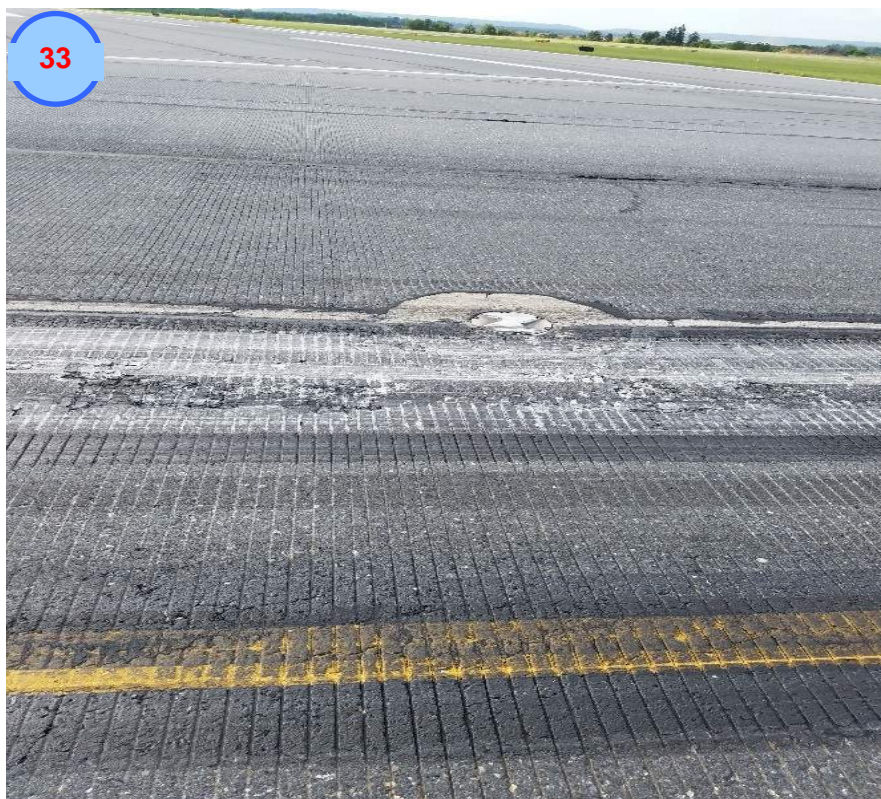
Low severity Weathering, Raveling, and Longitudinal Cracking

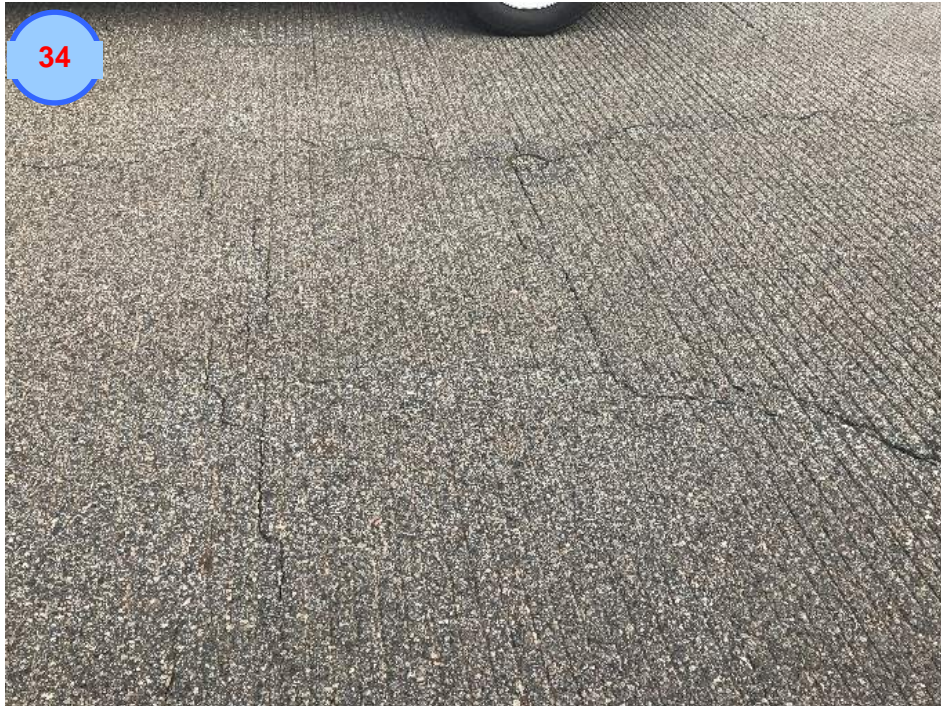
Low severity Longitudinal Cracking and Weathering

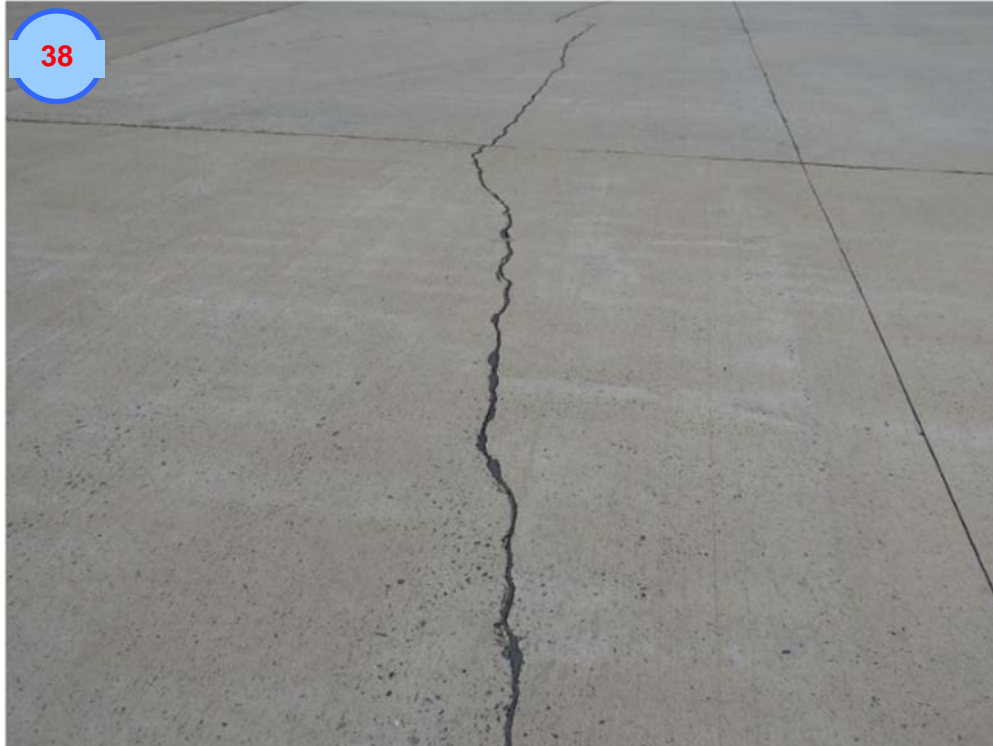
Linear Cracking Northern

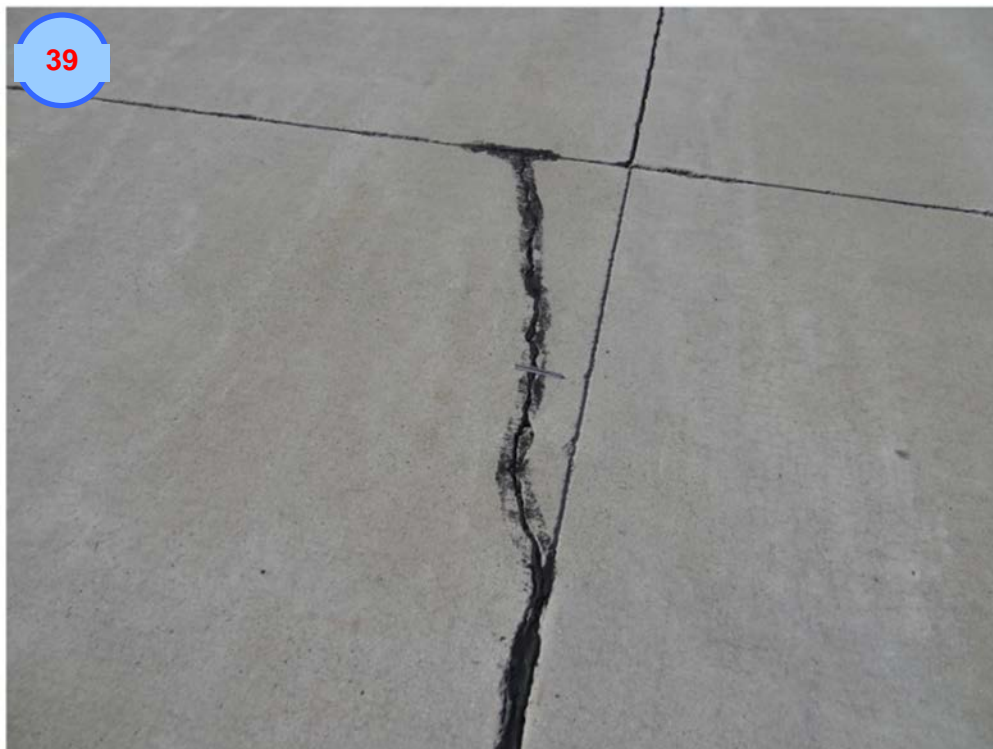
Corner Spalls

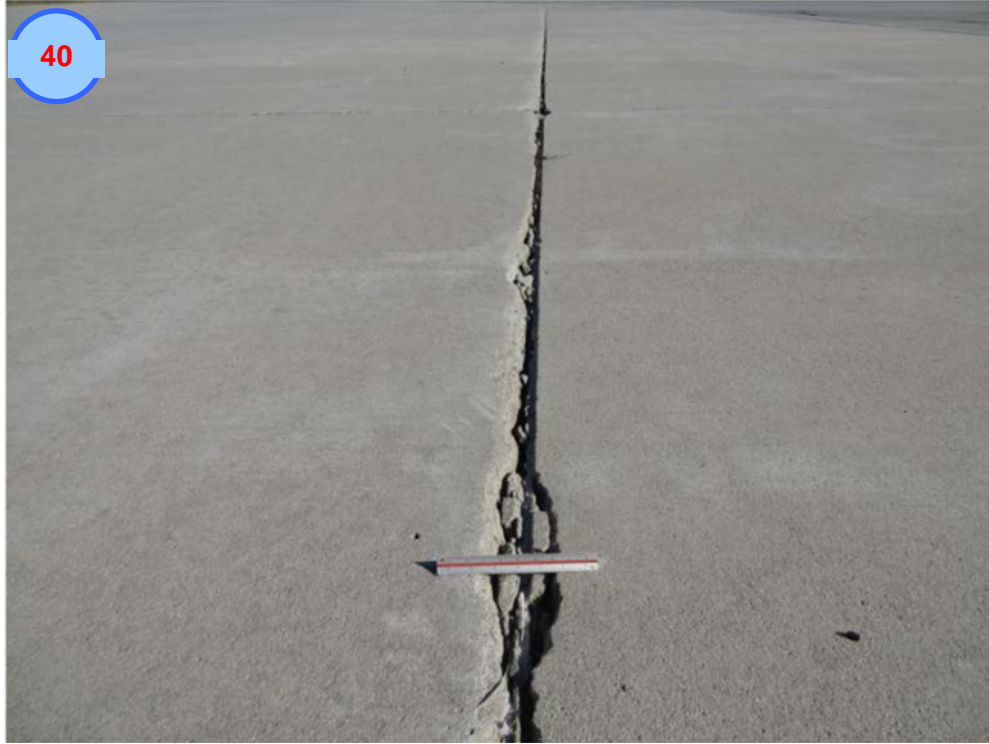
Joint Seal Damage and Joint Spalls Southwestern Portion

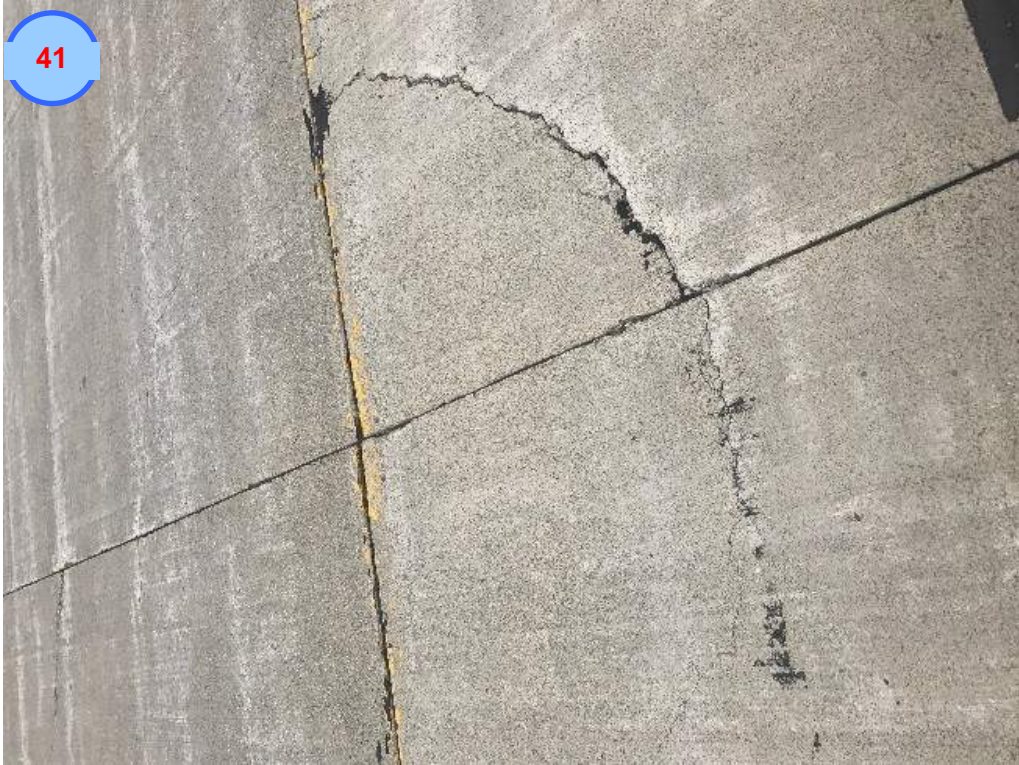
Corner Break

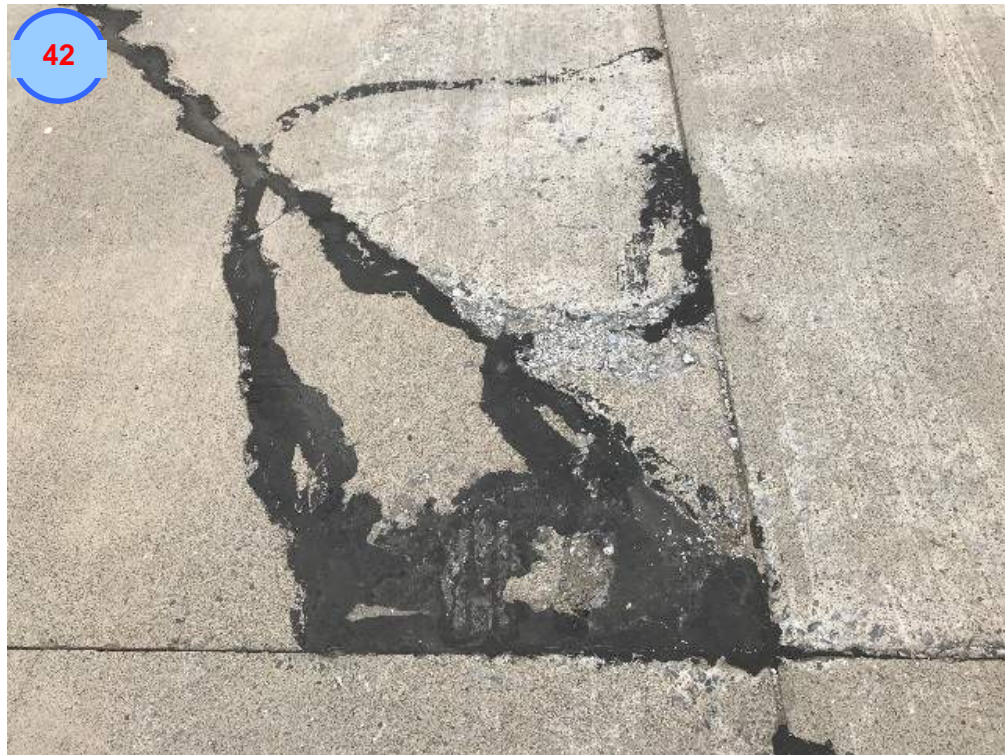
Corner Break and Joint Seal Damage

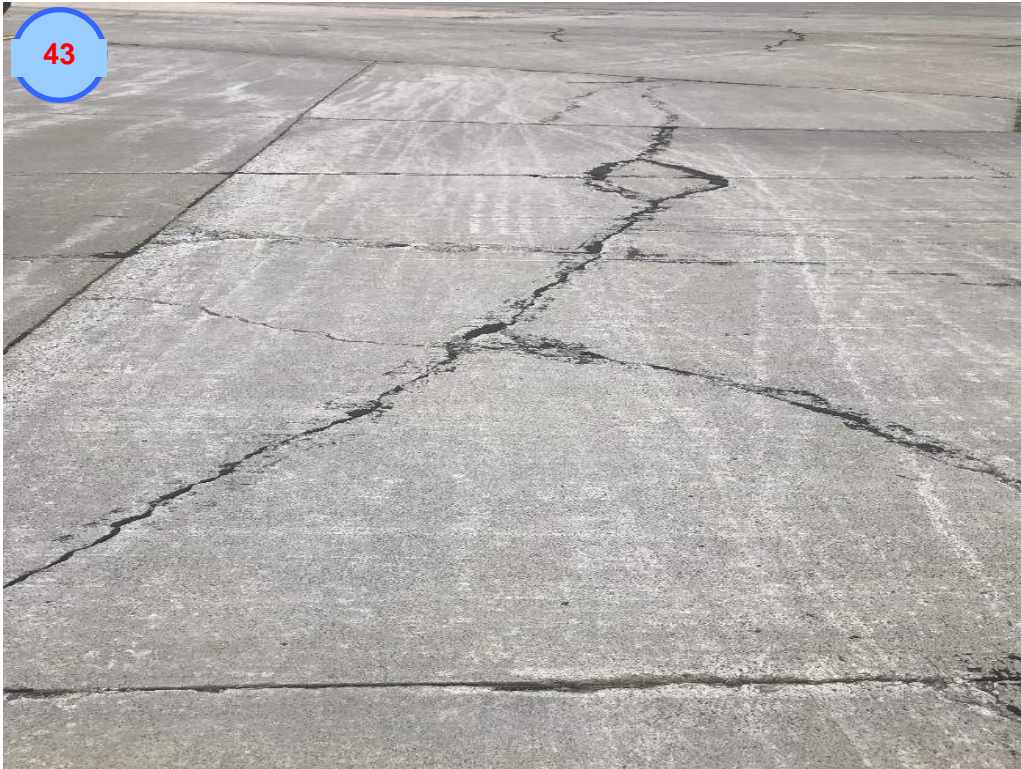
Shattered Slabs

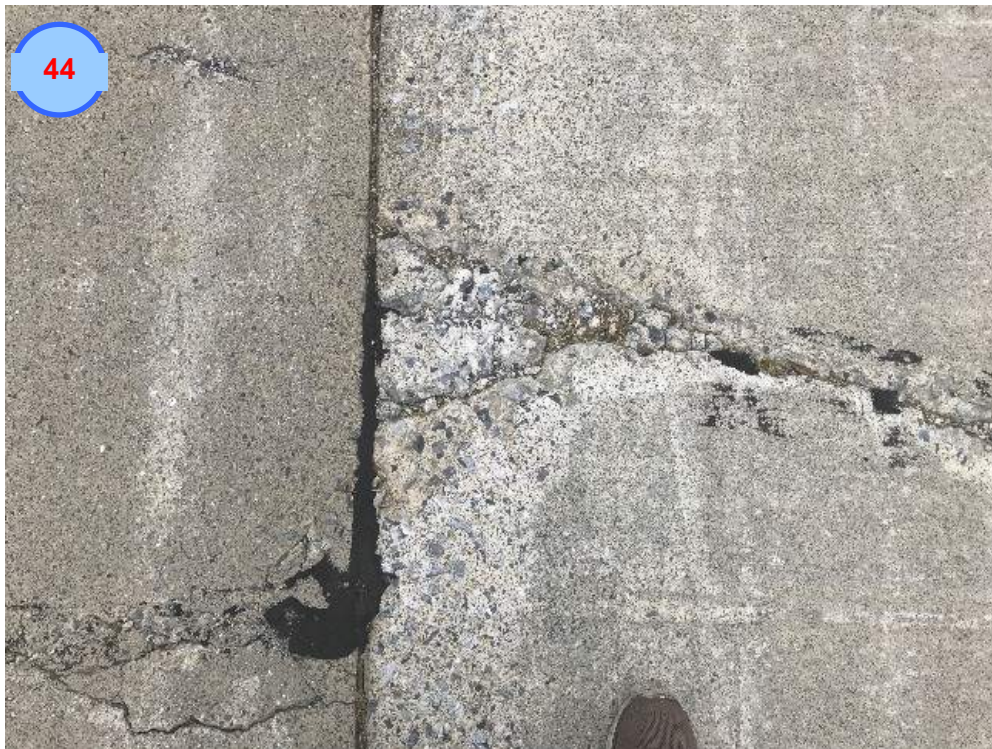
Joint Seal Damage and Spalling

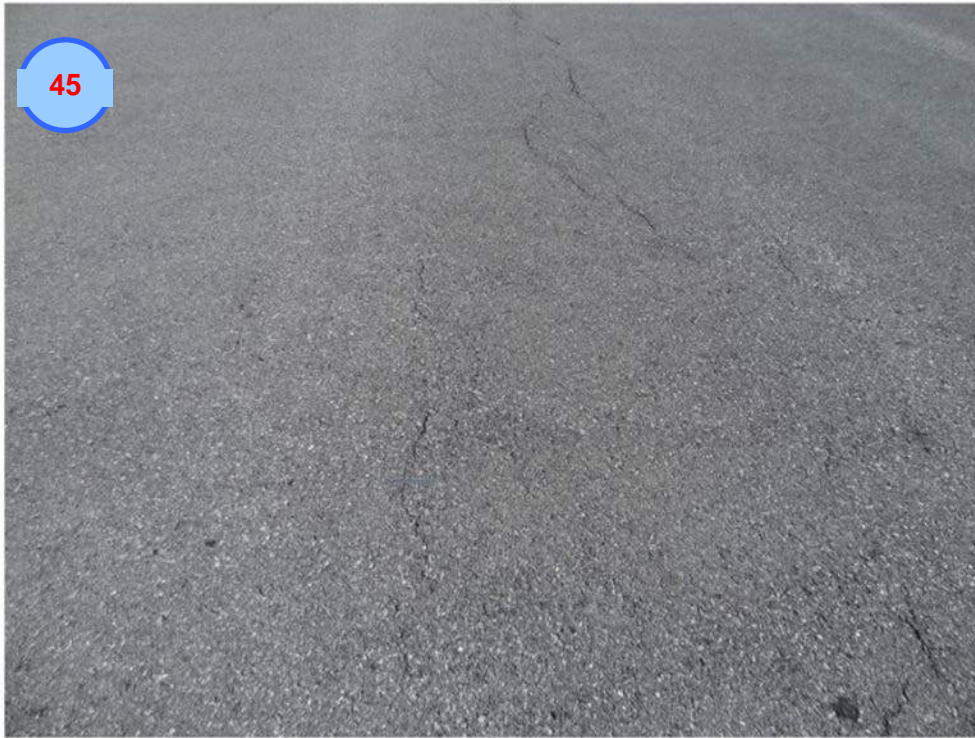
Weathering AC Section

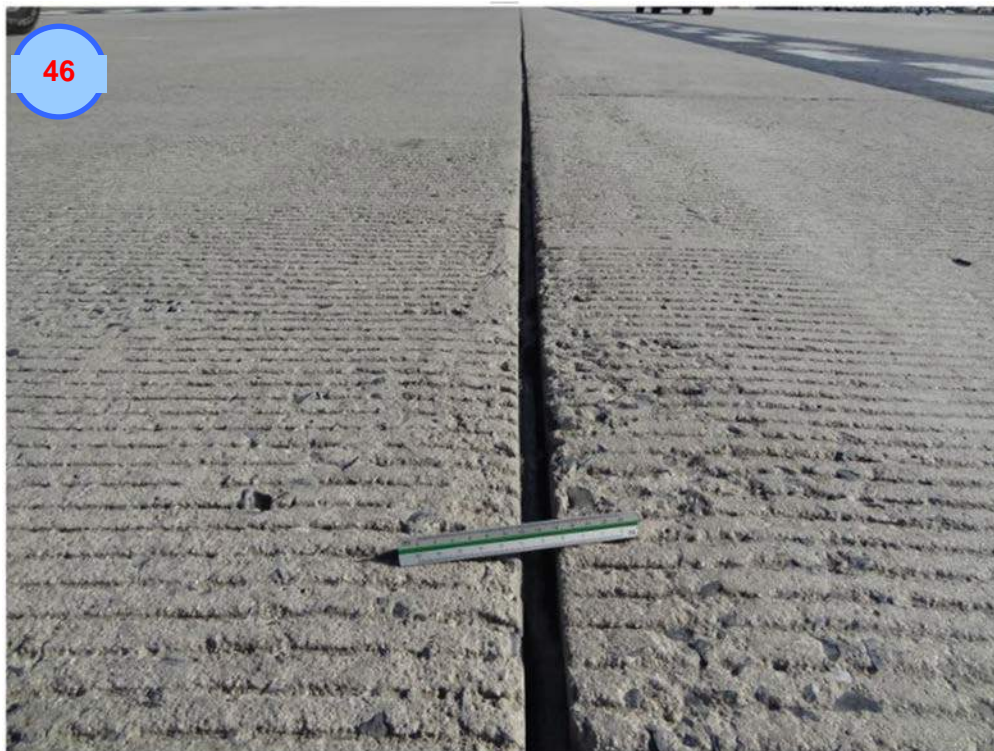
Joint Seal Damage PCC Section

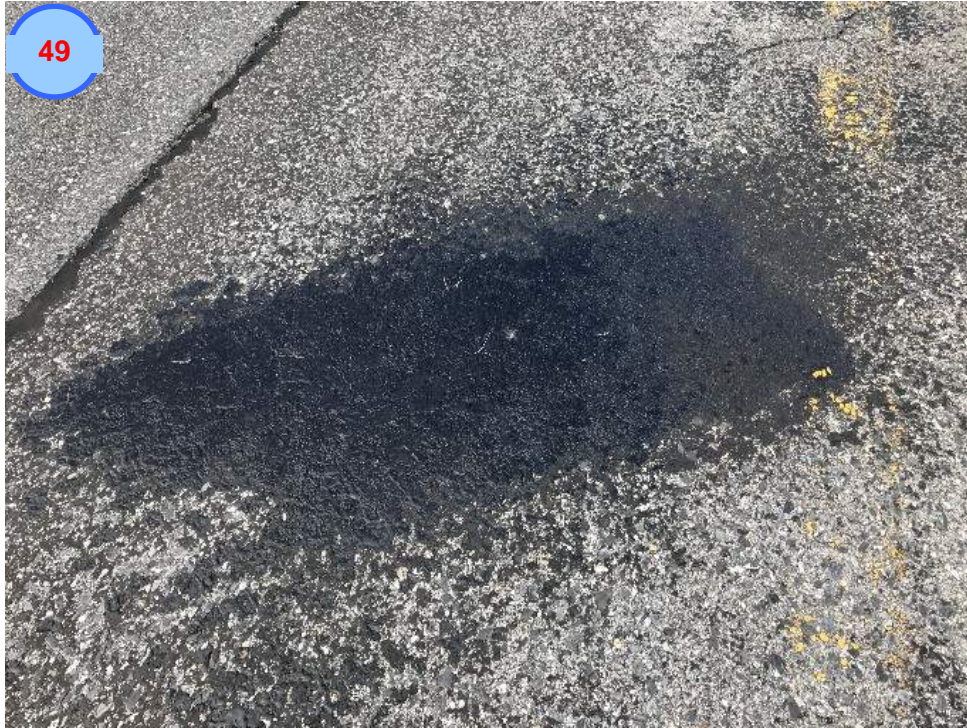
Medium Severity Bleeding and Weathering East Apron

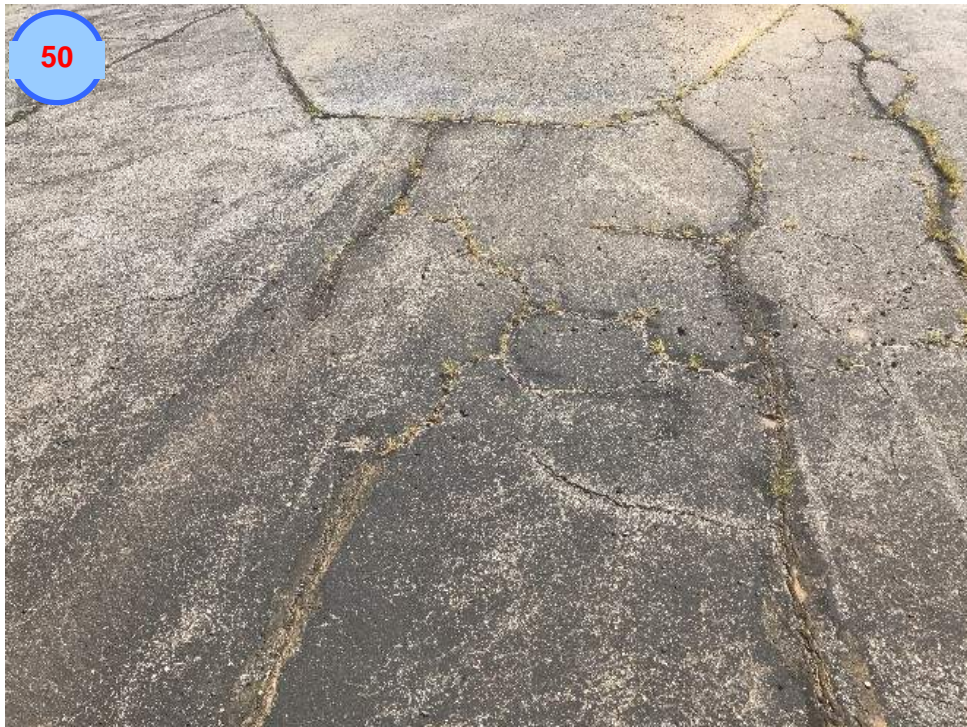
Medium Severity Weathering, Longitudinal Cracking, and Alligator Cracking East Apron

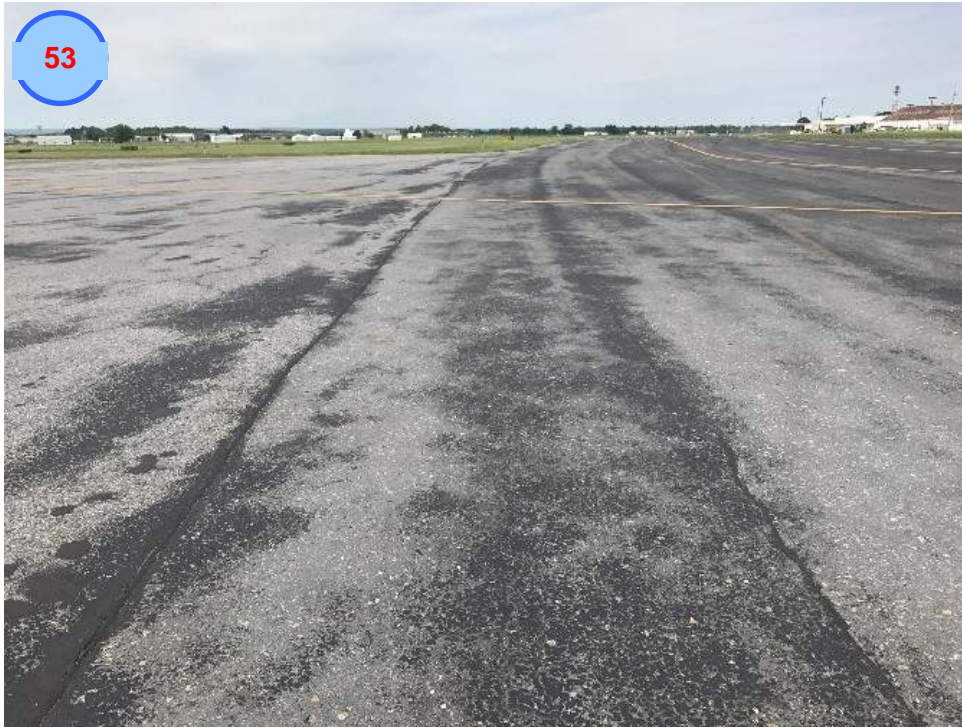
Longitudinal Cracking, Bleeding, and Weathering West Section

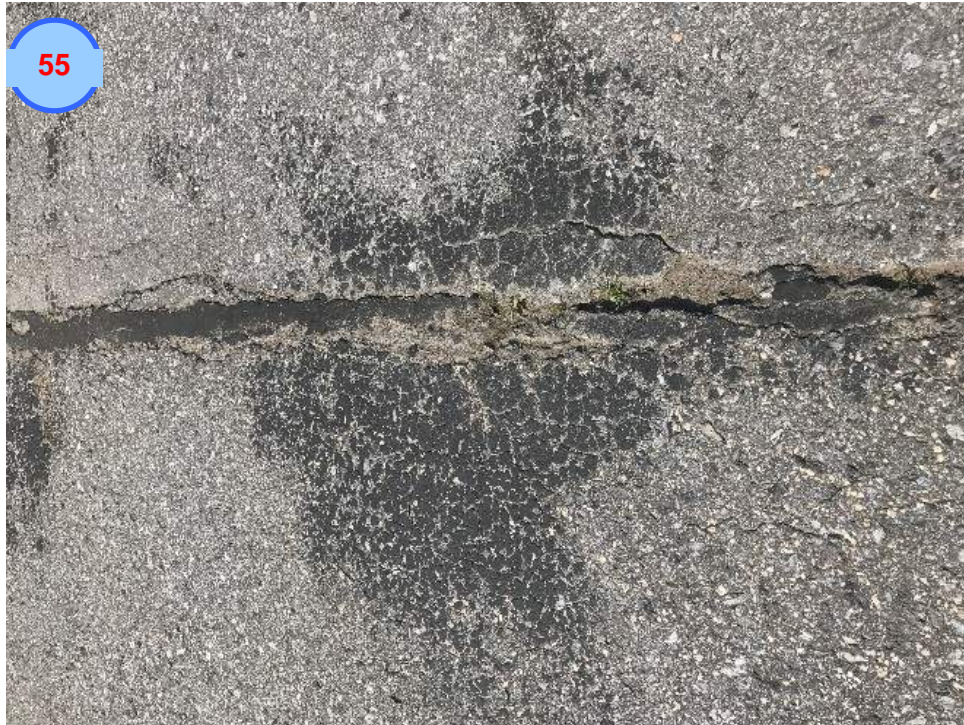
Longitudinal Cracking, Bleeding, and Weathering East Section

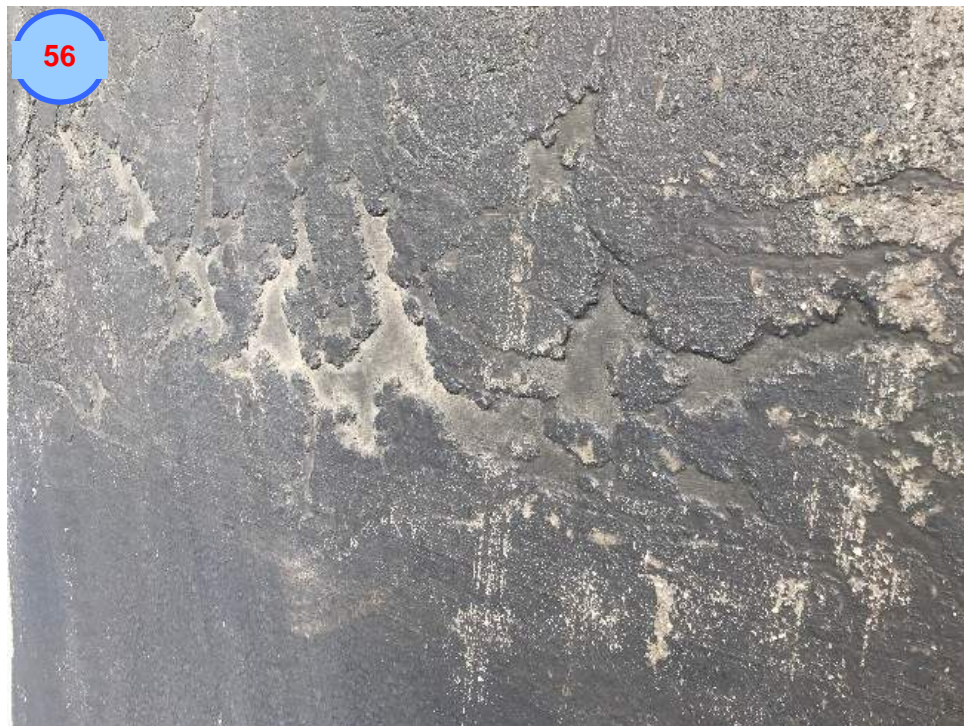
Weathering and Raveling East section

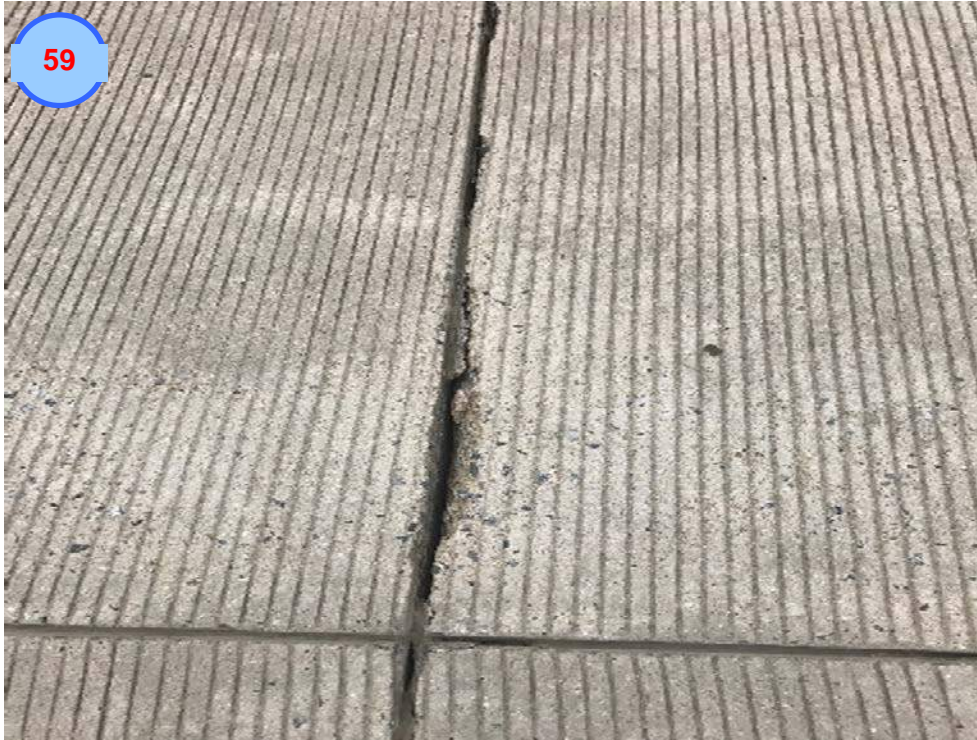
Joint Seal Damage and Spalling PCC Apron
