Lehigh Valley International Airport (ABE)

Airside Pavement Management Plan

Final Working Report – February, 2018

Prepared by
Airport Design Consultants Inc.

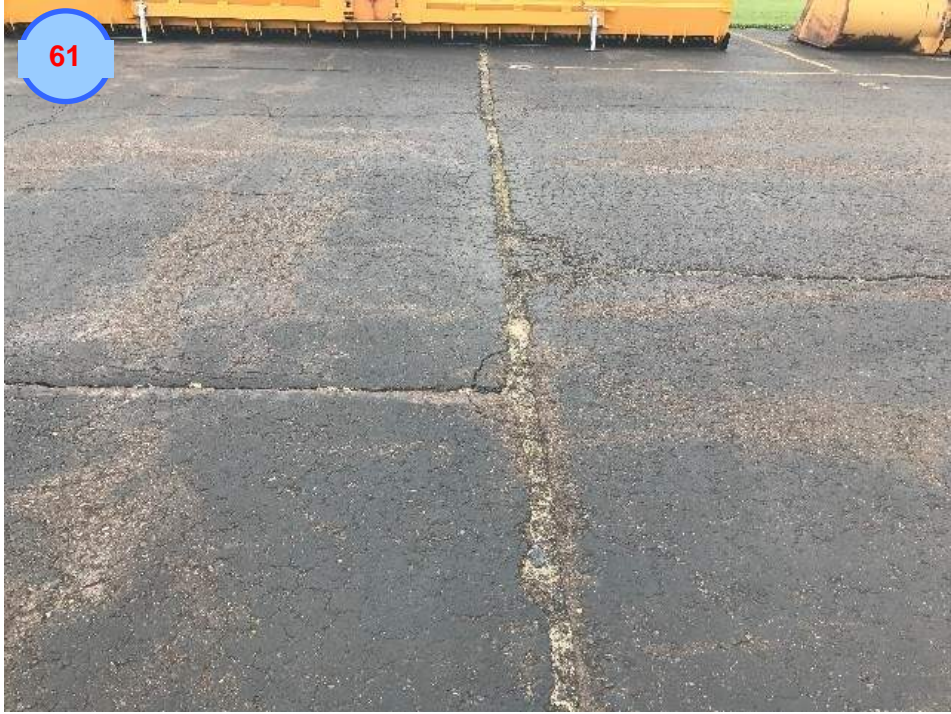
Medium Severity Joint Reflection Cracking

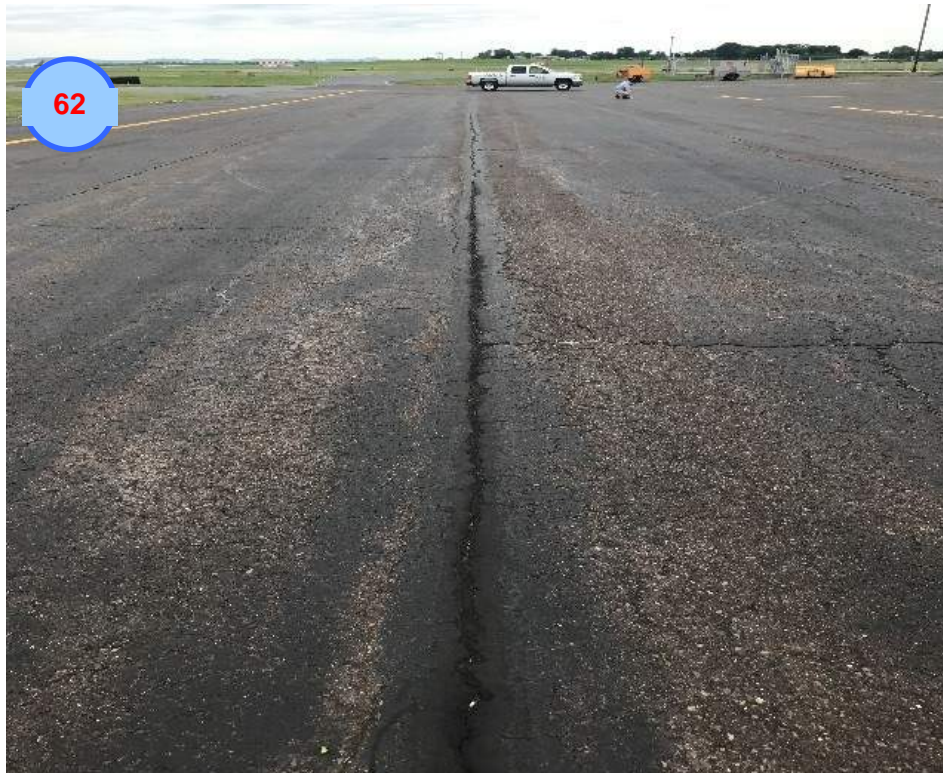
Medium Severity Longitudinal Cracking and Weathering

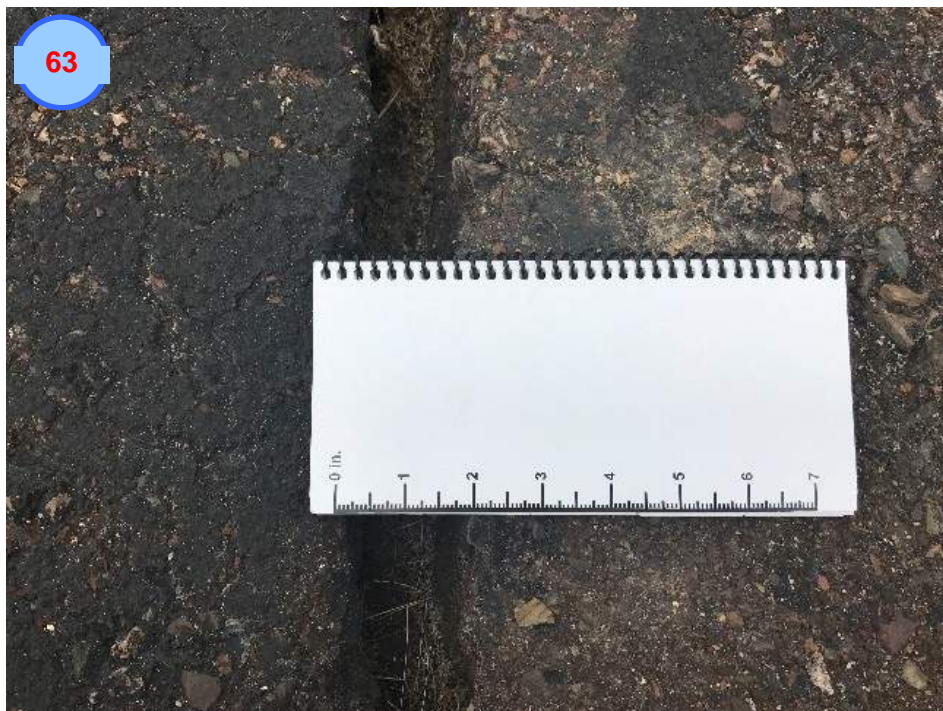
Pavement Separation Gap

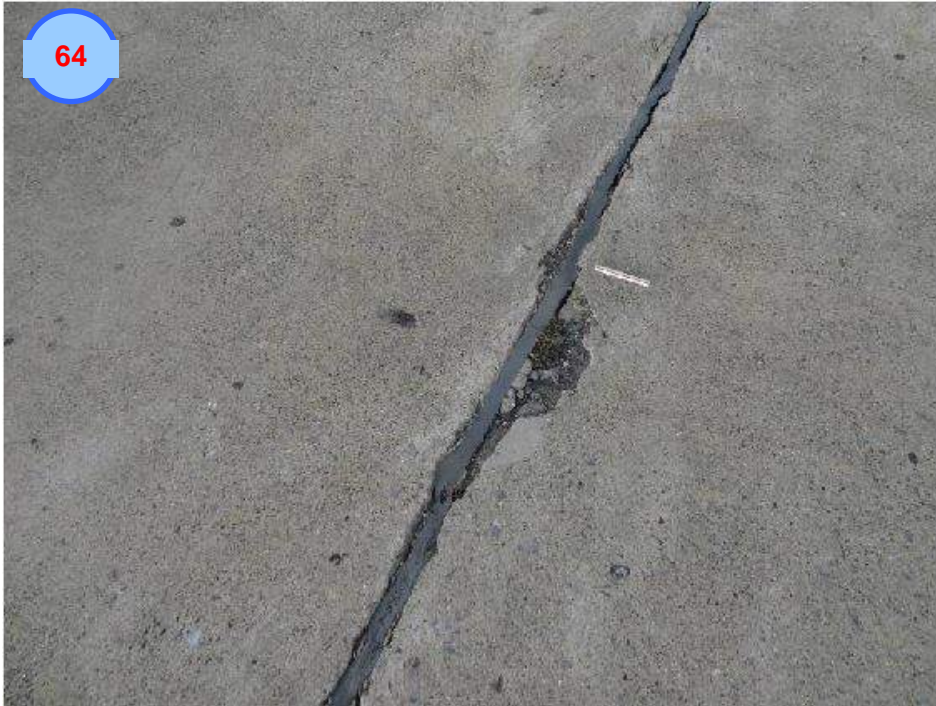
Joint Spalling
