Home Inspection Report

Home Inspection Summary

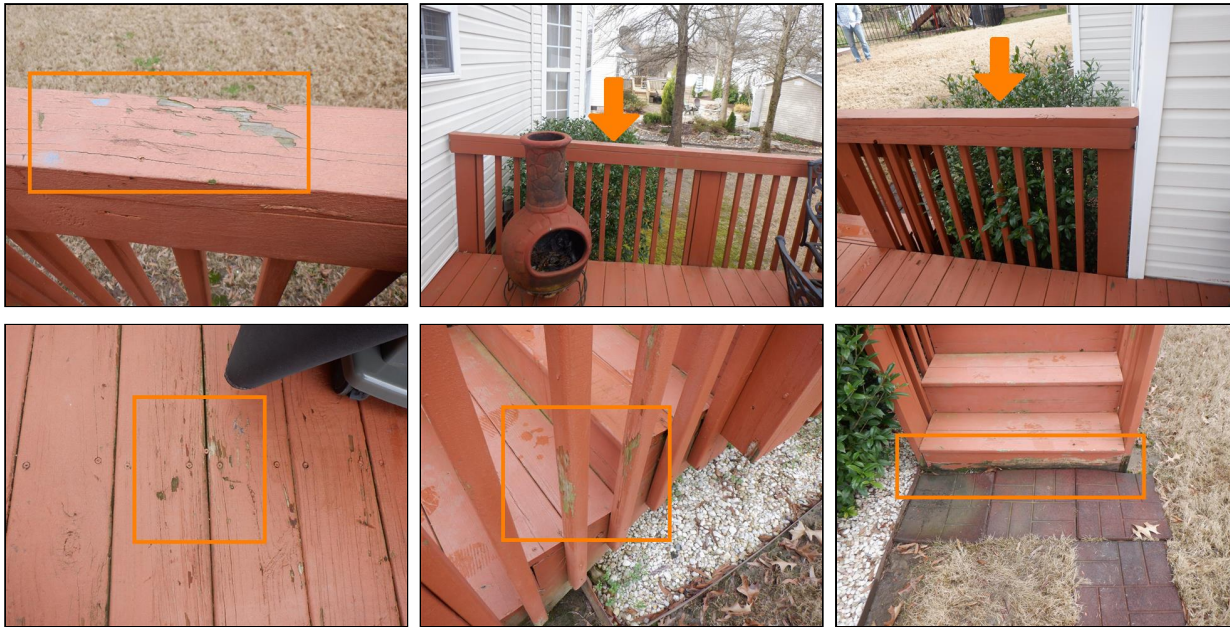
1. Due to the following but not limited to, a qualified licensed contractor should be consulted to further evaluate the deck systems and/or components, as there may be hidden or concealed damage that was unseen or could not be viewed at the time of inspection. Further evaluation is recommended before closing of escrow to completely understand the extent of any damage or repairs required or deemed necessary:
 - A. Loose railing was noted at the rear deck. Corrections are needed to improve safety.
 - B. The railing is supported with 2x6 boards instead of suing posts. This can increase the potential for movement in the railing.
 - C. Moisture damage was noted at the bottom of the stairs. Further damage may occur if not corrected.
 - D. Missing or peeling paint was noted at the rear deck. Corrections are needed to protect the wood from moisture damage.

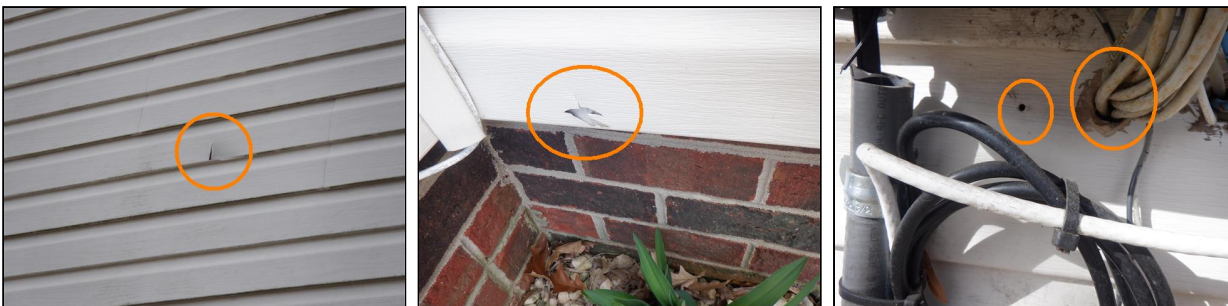
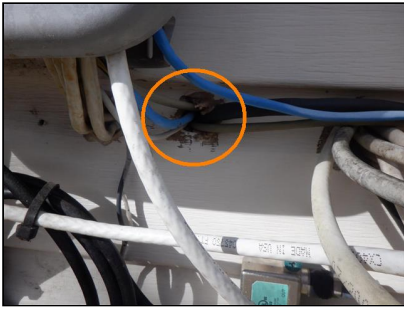
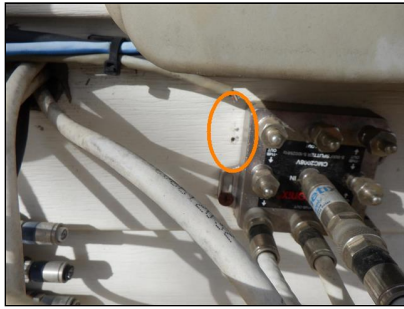
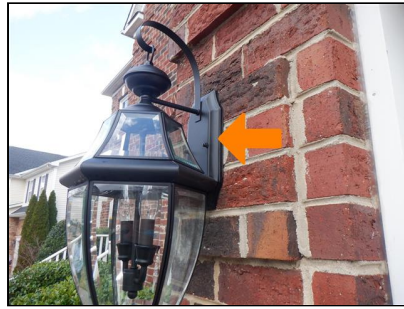
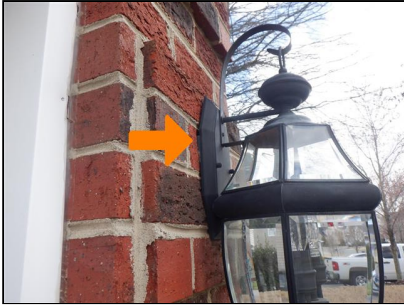
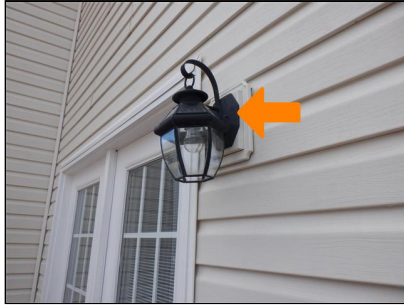
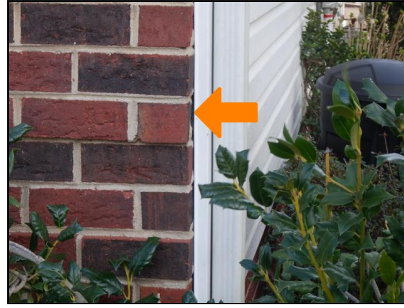
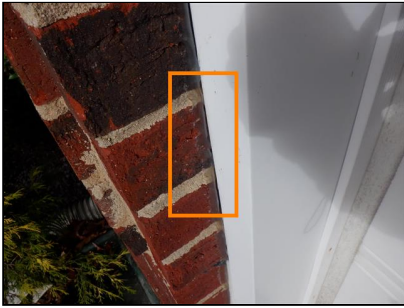
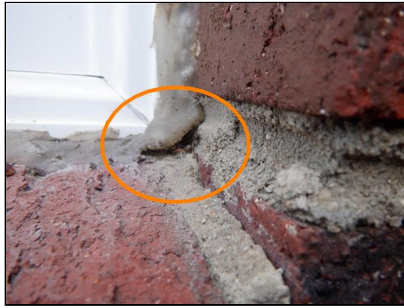
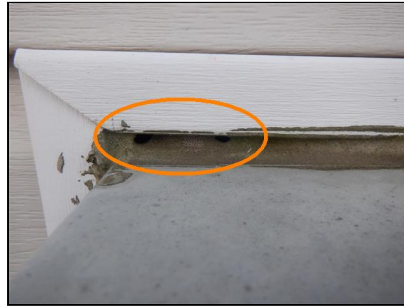
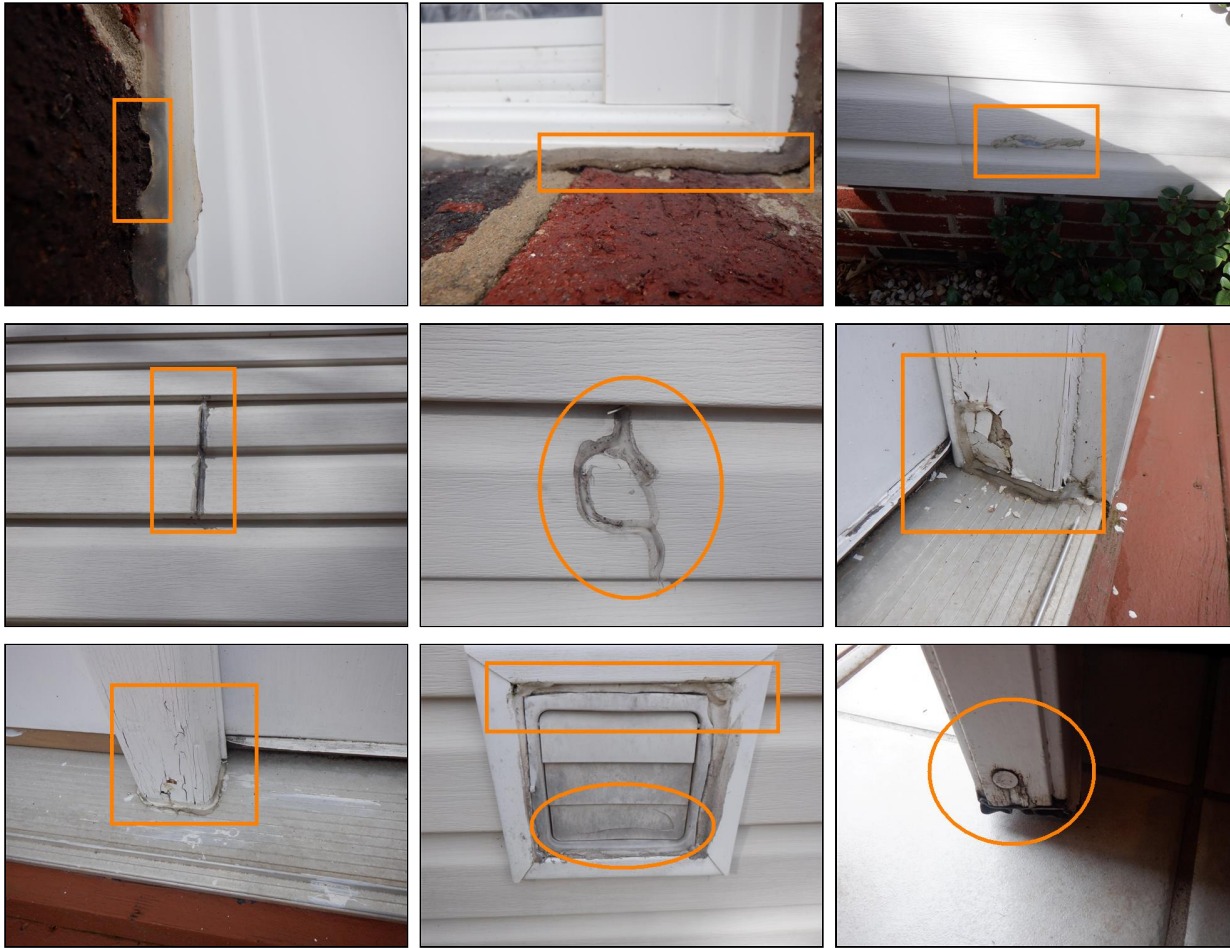
A. **Holes and/or cracks were noted in the vinyl siding and/or trim at or along the following elevations of the home, including but not limited to:**

B. The vinyl siding does not have proper clearance from the roof surface. The Vinyl Siding Institute (<http://www.vinylsiding.org>) recommends at least 1/2 inch clearance between the vinyl siding trim and roofing materials where walls meet the roof. This allows the flashing to be seen & the expansion / contraction of the siding and trim due to temperature changes. The shingles may also transmit enough heat to the channel holding the vinyl siding to distort the channel. NOTE: the current installation prevents the inspector from determining if the roof/wall intersection is properly flashed as it would be behind the vinyl siding.

C. The exterior light fixtures are not sealed where they meet the exterior walls. This can allow moisture penetration to occur. Contact a licensed qualified contractor to further evaluate and make the necessary repairs.

E. No weep holes were found above the windows and doors at the brick siding around the home. Weep holes are drilled hole, slots, or openings located around the foundation and above or below windows in brick veneer. The holes are used to permit moisture to drain that has gathered inside or behind a building component or allow water to escape that might otherwise accumulate in a window's sills and veneers.

F. Missing sealant or gaps in sealant were noted at the exterior siding, trim and/or door and window frames and thresholds. This can allow moisture penetration to occur.

G. Moisture damage was noted at the rear exterior door and door trim/frame. Further damage may occur if not corrected.

H. There is a section of vinyl siding does not properly overlap at the right side of the, Because of this there is a gap between 2 pieces of siding. The gap has been filled with sealed. This should be considered a temporary fix and proper repairs should be made to prevent moisture penetration.

I. There is a damaged vent at the right side of the home. Further damage and moisture penetration may occur if not corrected.

NOTE: multiple repairs were made to the vinyl siding using sealant. Sealant repairs require continual monitoring and repair to prevent moisture penetration.

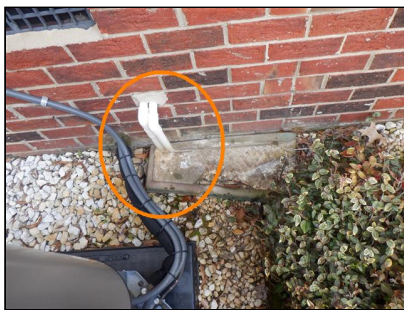
3. The condensate drains at the left elevation of the home terminate near the foundation, allowing them to deposit water near the foundation of the home. Water that is allowed to terminate near the foundation can cause and/or contribute to moisture and settlement related issues. Contact a licensed qualified contractor to further evaluate and make the necessary repairs.

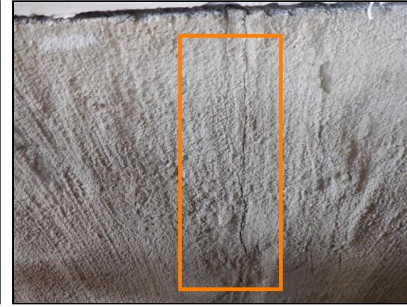
4. Cracking was noted to the foundation at the rear, left and right sides of the garage. Further cracking/movement may occur if not corrected. Contact a licensed qualified structural engineer to further evaluate and make the necessary repairs.

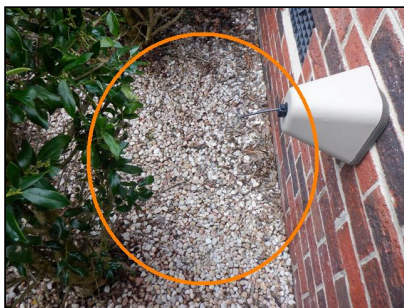
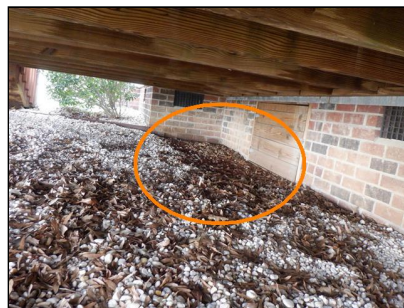
6. Areas of poor/negative grading were noted at the following elevations of the home, including but not limited to:

Poor/negative grading can allow water to terminate near the foundation which can cause and/or contribute to moisture and settlement related issues. Contact a licensed qualified contractor to further evaluate and make the necessary repairs.

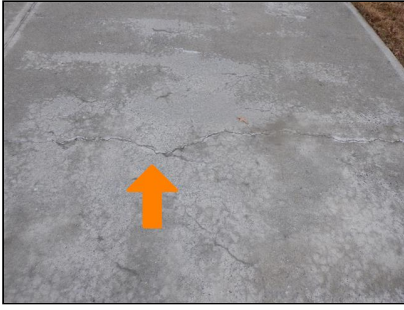
7. There are cracks noted at the driveway that need to be sealed and/or repaired properly to prevent water penetration and/or continual cracking. Contact a licensed qualified contractor to further evaluate and make the necessary repairs.

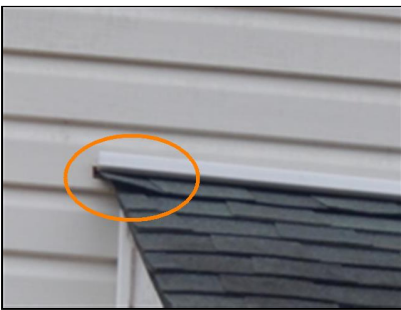
16. There is a lifted flashing or shingle noted at the roof/wall intersection over the fireplace bump out at the rear of the home. This can increase the potential for leakage. Contact a licensed qualified contractor to further evaluate and make the necessary repairs.

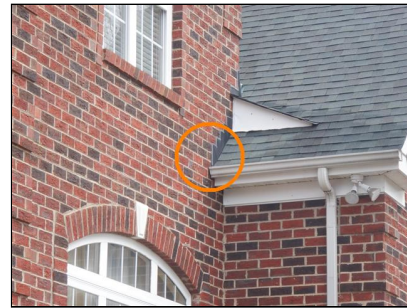
17. There is/are no visible kick out flashing(s) at the base of the roof/wall intersections of the home. Missing kick out flashings can allow water from roof run off to get behind the exterior wall covering which can result in moisture damage to the wall assembly. Unable to determine if hidden or concealed damage exist at the time of inspection. Contact a licensed qualified contractor to further evaluate and make the necessary repairs.

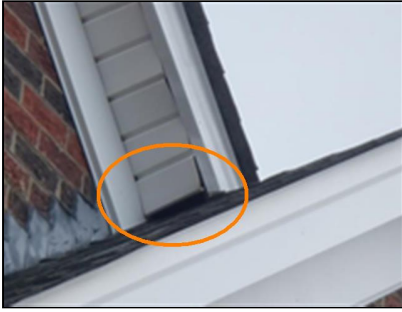
18. Gaps were noted in the soffit at the front of the home. This can allow moisture and pest intrusion to occur. Contact a licensed qualified contractor to further evaluate and make the necessary repairs.

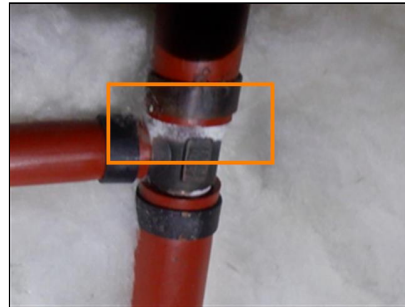
24. The visible plumbing lines in this home are plastic PEX with QPEX metal fittings manufactured by the Zurn Corporation. These plumbing fittings are the subject of a consumer class action lawsuit and settlement due to fitting failures related to dezincification. After years of consumer complaints, the Zurn Corporation has acknowledged that it has seen an increased number of premature failures and leaks in its QPEX fittings. Evidence of fitting deterioration was noted during the inspection in a few/several locations. A licensed plumbing contractor should be hired/consulted for a complete evaluation of the plumbing system to determine the general condition of the plumbing distribution and supply lines, the significance of this concern, and make all necessary and any additional repairs needed as deemed necessary. The client should visit the class action settlement website for more information, www.PlumbingFittingSettlement.com.

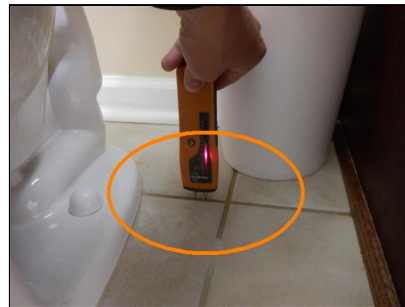
25. Discolored grout and elevated moisture levels were noted around the base of the toilets in the master, hall and 1/2 bathrooms. This may be evidence of leakage around the toilets. Further evaluation is needed to determine if leaks exist and if there is hidden or concealed damage. Contact a licensed qualified plumbing contractor to further evaluate and make the necessary repairs.

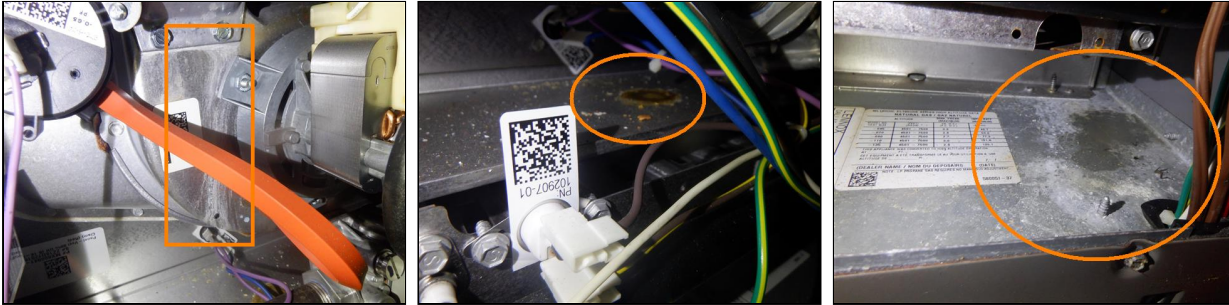
- 33. Rusting/corrosion was noted inside both of the furnace cabinets in the attic.** This is evidence of a leak at or within the units. Unable to determine the source of the leak or the extent of damage at the time of inspection. Further damage may occur if not corrected. Contact a licensed qualified HVAC contractor to further evaluate and make the necessary repairs.

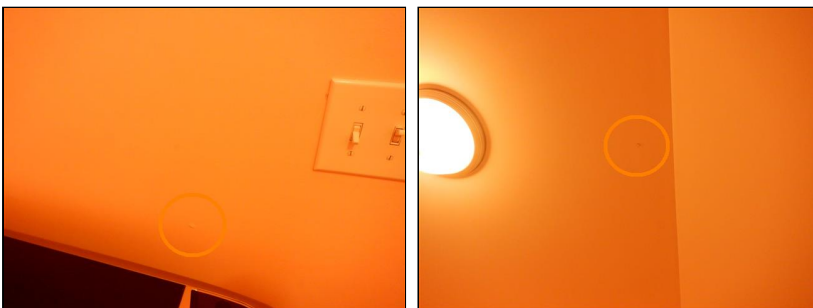
- 34. There are no carbon monoxide detectors installed or found on the 2nd floor of the home at the time of inspection.** Due to the gas fireplace/furnace/stove top/attached garage and/or gas appliances, a carbon monoxide detector(s) needs to be installed on each floor to ensure safety. Contact a licensed qualified contractor to further evaluate and make the necessary repairs.
- 35. Nail pops and/or some cracking noted in the ceiling and/or walls throughout the home.** The nail pop and/or cracking are signs of normal settlement and are typically considered cosmetic. Continue to monitor to ensure movement does not occur.

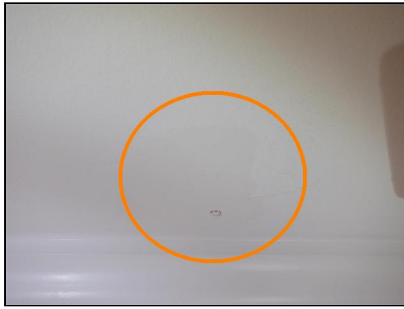
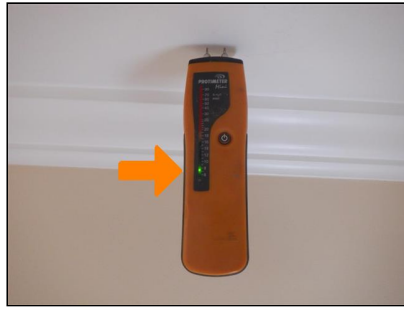
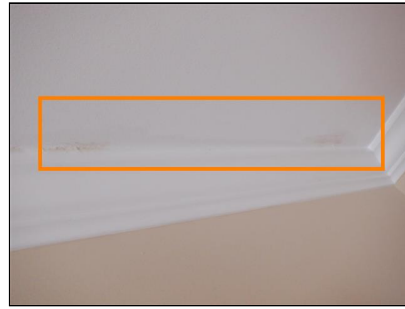
- 36. Repairs have been made at the ceiling in rear living room.** Unable to determine what the need for repair was. The inspector did use a moisture meter in these areas to, however the moisture levels in these areas were not elevated at the time of inspection. Ask the seller the history of the repairs and if the repairs made have corrected or repaired the cause or need for the repair. If the seller is unaware the further evaluation is needed by a qualified professional.

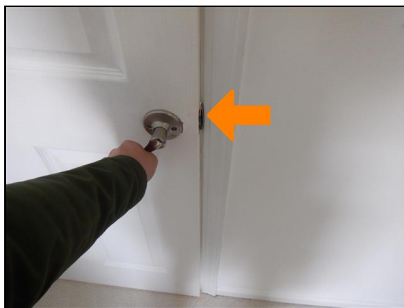
39. The rear left bedroom door rubs the door frame. Corrections are needed to allow proper function. Contact a licensed qualified contractor to further evaluate and make the necessary repairs.

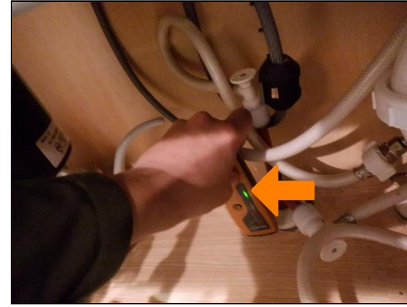
54. Evidence of a previous leak was noted under the kitchen sink. No active leakage was noted at the time of inspection and the moisture levels were not elevated in the cabinet under th sink when tested with a moisture meter. Ask the sellers the history of the stains and if repairs have been made to correct the leaks. If the sellers are unaware or no repairs were made the further evaluation is needed by a licensed plumbing contractor.

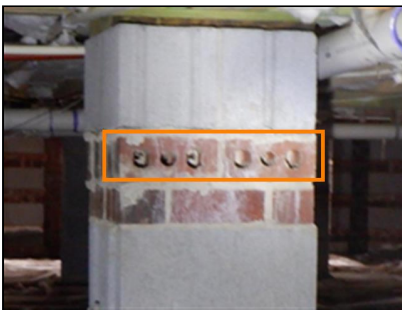
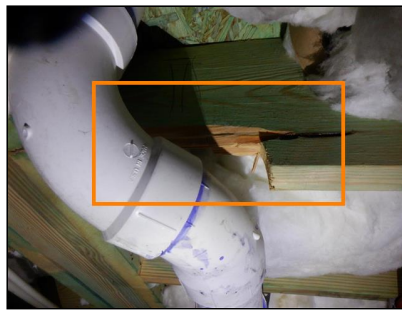
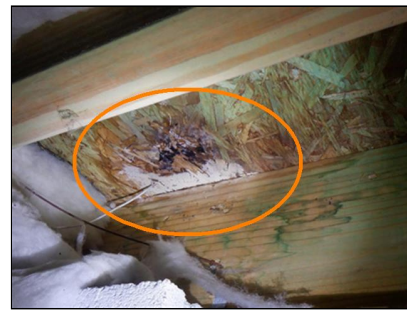
E. Single stack of solid or open cell, 8x8x16 CMUs were observed to be stacked higher than 36 inches, as measured from the top of the footer to the top of the last concrete block. Typically concrete blocks are allowed a maximum height is 36 inches; however, there may be an exception to the rule depending on different construction methods. Because of this, it is recommended that you consult with a qualified licensed engineer to evaluate further and determine if the current installation is installed to support the structure of the home properly.

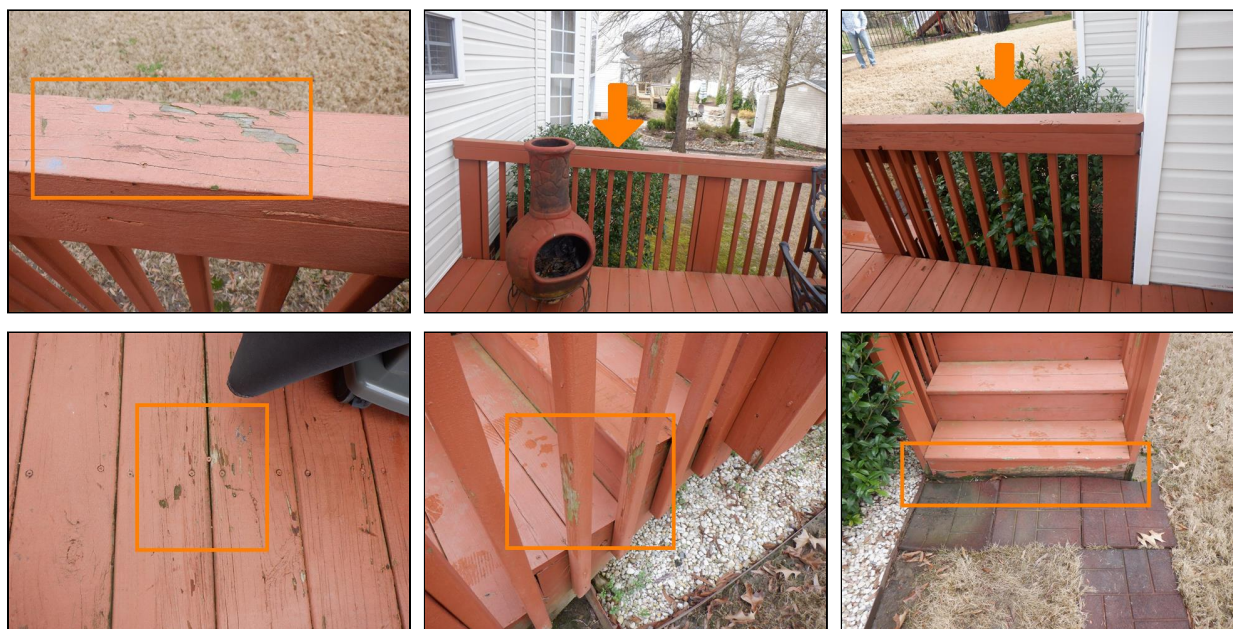
- A. Loose railing was noted at the rear deck. Corrections are needed to improve safety.
- B. The railing is supported with 2x6 boards instead of using posts. This can increase the potential for movement in the railing.
- C. Moisture damage was noted at the bottom of the stairs. Further damage may occur if not corrected.
- D. Missing or peeling paint was noted at the rear deck. Corrections are needed to protect the wood from moisture damage.

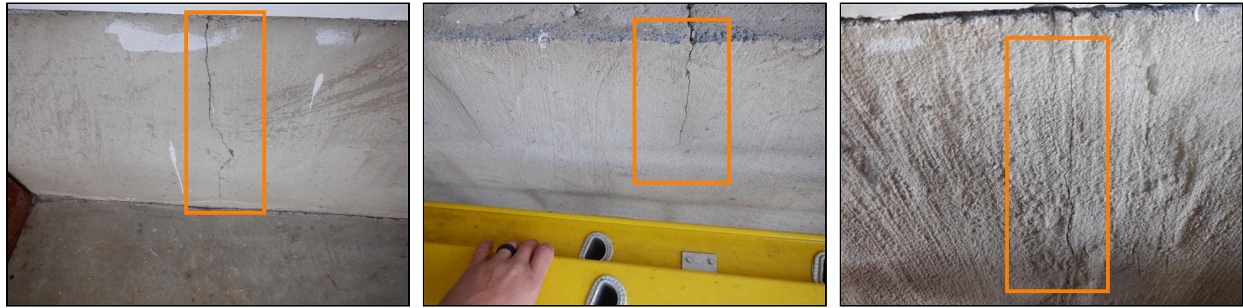
Cracking was noted to the foundation at the rear, left and right sides of the garage. Further cracking/movement may occur if not corrected. Contact a licensed qualified structural engineer to further evaluate and make the necessary repairs.

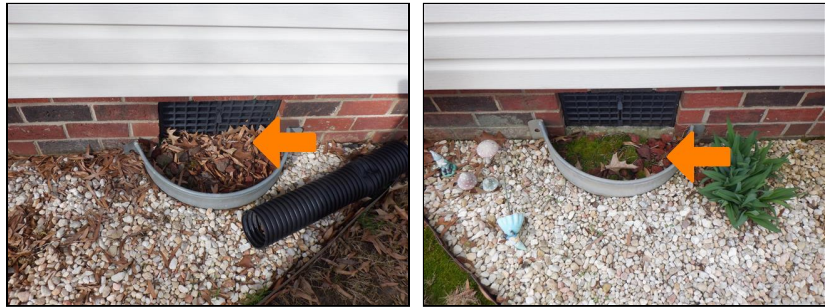
The foundation vent(s) wells need to be cleaned out around the home to allow for adequate airflow into and out of the crawl space. Contact a licensed qualified contractor to further evaluate and make the necessary repairs.

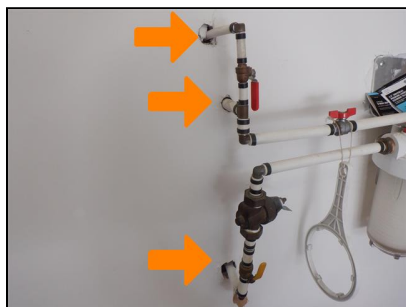
Holes and/or gaps were noted in the walls and/or ceiling within the garage. All holes and gaps, including around the water lines and any other wall or ceiling penetrations need to be properly sealed to maintain the proper fire rating between the home and garage and prevent possible carbon monoxide entry into the home. Contact a licensed qualified contractor to further evaluate and make the necessary repairs.

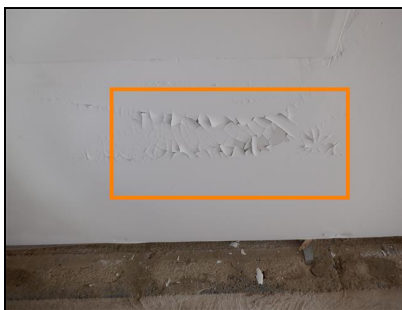
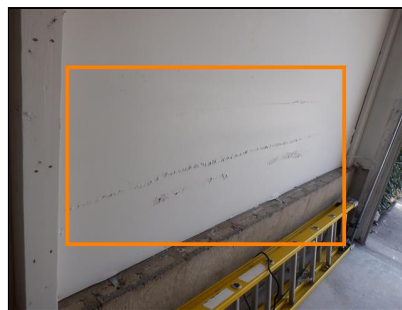
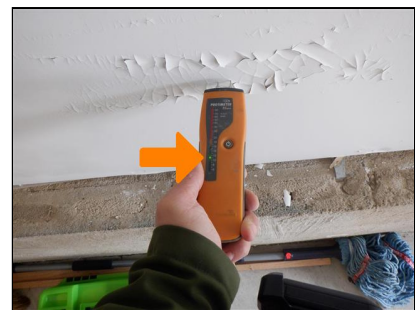
Peeling paint was noted at the garage walls. unable to determine the cause. Further evaluation is needed.

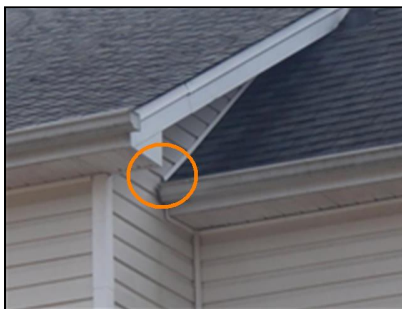
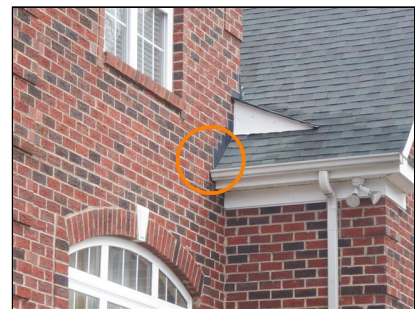
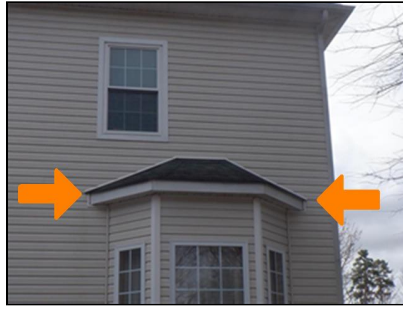
There is/are no visible kick out flashing(s) at the base of the roof/wall intersections of the home. Missing kick out flashings can allow water from roof run off to get behind the exterior wall covering which can result in moisture damage to the wall assembly. Unable to determine if hidden or concealed damage exist at the time of inspection. Contact a licensed qualified contractor to further evaluate and make the necessary repairs.

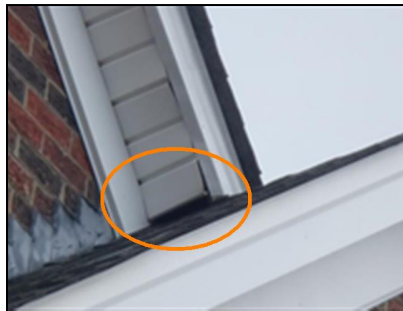
Gaps were noted in the soffit at the front of the home. This can allow moisture and pest intrusion to occur. Contact a licensed qualified contractor to further evaluate and make the necessary repairs.

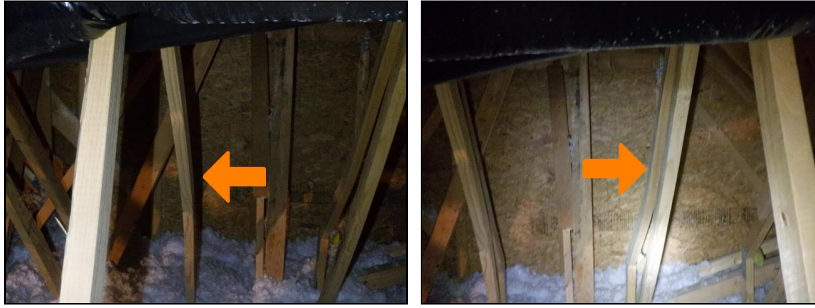
There are warped trusses noted in the front area of the attic. This could be a sign of stress on the trusses or they may have been warped before installation. Further evaluation by a structural engineer is needed to determine if corrections are needed.

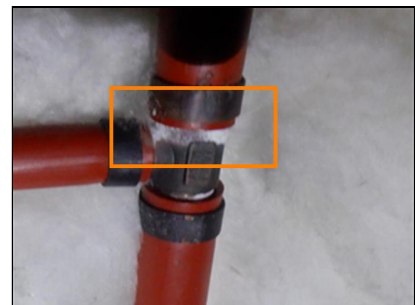
The visible plumbing lines in this home are plastic PEX with QPEX metal fittings manufactured by the Zurn Corporation. These plumbing fittings are the subject of a consumer class action lawsuit and settlement due to fitting failures related to dezincification. After years of consumer complaints, the Zurn Corporation has acknowledged that it has seen an increased number of premature failures and leaks in its QPEX fittings. Evidence of fitting deterioration was noted during the inspection in a few/several locations. A licensed plumbing contractor should be hired/consulted for a complete evaluation of the plumbing system to determine the general condition of the plumbing distribution and supply lines, the significance of this concern, and make all necessary and any additional repairs needed as deemed necessary. The client should visit the class action settlement website for more information, www.PlumbingFittingSettlement.com.

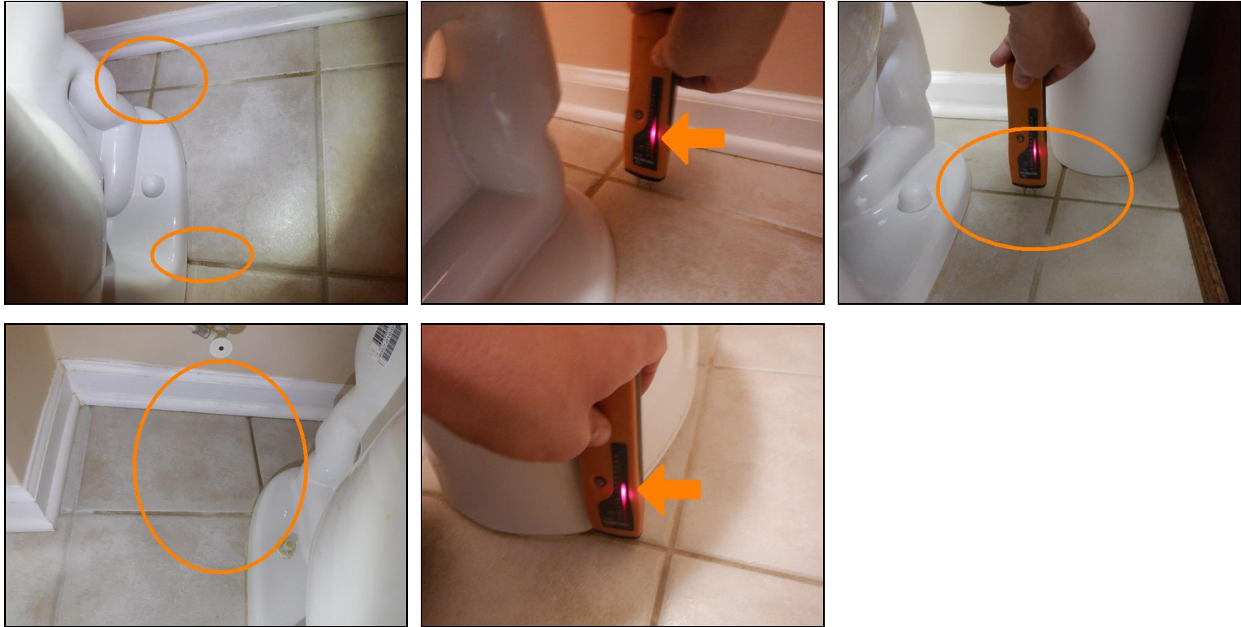
Discolored grout and elevated moisture levels were noted around the base of the toilets in the master, hall and 1/2 bathrooms. This may be evidence of leakage around the toilets. Further evaluation is needed to determine if leaks exist and if there is hidden or concealed damage. Contact a licensed qualified plumbing contractor to further evaluate and make the necessary repairs.

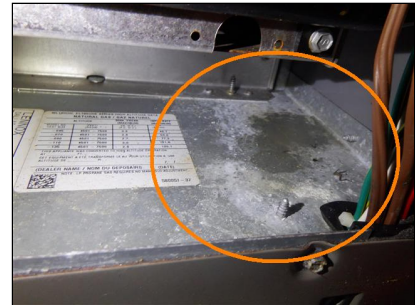
Rusting/corrosion was noted inside both of the furnace cabinets in the attic. This is evidence of a leak at or within the units. Unable to determine the source of the leak or the extent of damage at the time of inspection. Further damage may occur if not corrected. Contact a licensed qualified HVAC contractor to further evaluate and make the necessary repairs.

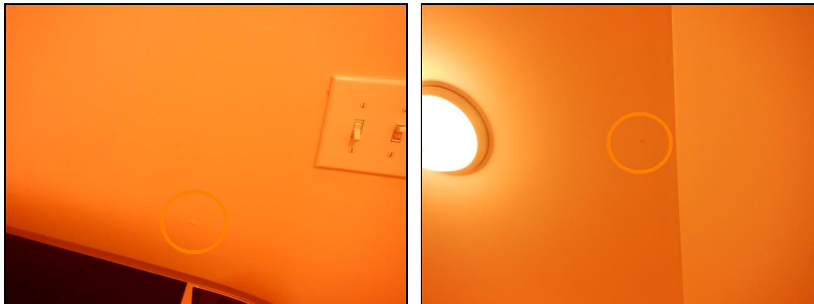
Nail pops and/or some cracking noted in the ceiling and/or walls throughout the home. The nail pop and/or cracking are signs of normal settlement and are typically considered cosmetic. Continue to monitor to ensure movement does not occur.

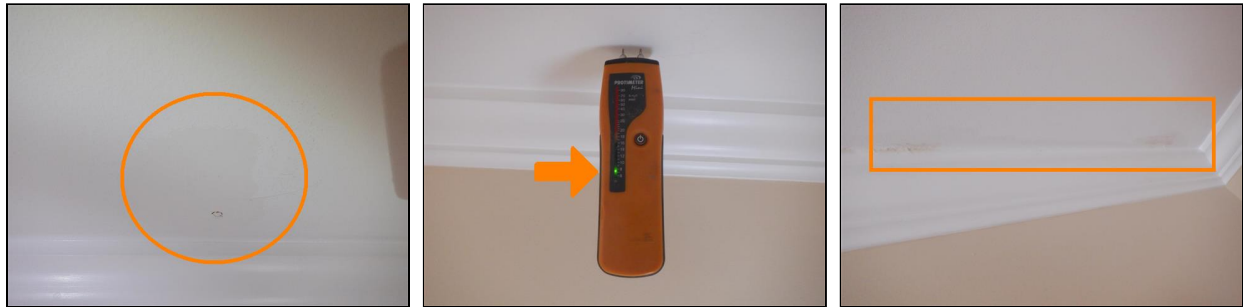
Repairs have been made at the ceiling in rear living room. Unable to determine what the need for repair was. The inspector did use a moisture meter in these areas to, however the moisture levels in these areas were not elevated at the time of inspection. Ask the seller the history of the repairs and if the repairs made have corrected or repaired the cause or need for the repair. If the seller is unaware the further evaluation is needed by a qualified professional.

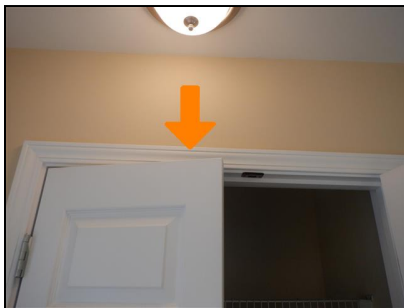
One of the hall closet doors does not latch closed on the 2nd floor. Corrections are needed to allow proper function. Contact a licensed qualified contractor to further evaluate and make the necessary repairs.

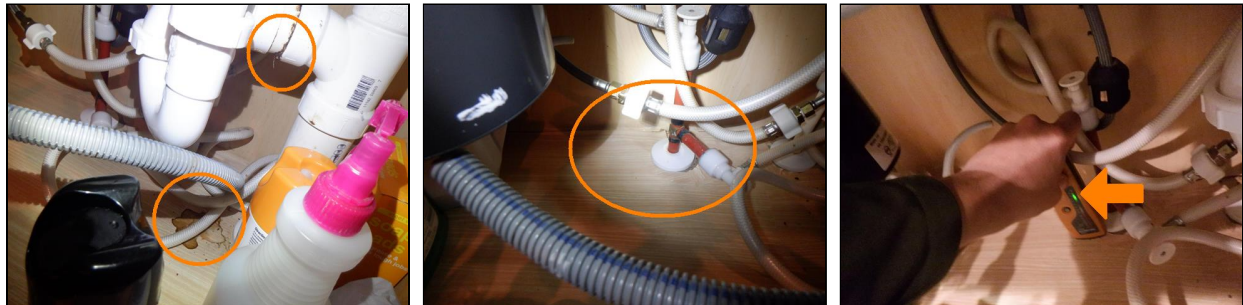
Evidence of a previous leak was noted under the kitchen sink. No active leakage was noted at the time of inspection and the moisture levels were not elevated in the cabinet under the sink when tested with a moisture meter. Ask the sellers the history of the stains and if repairs have been made to correct the leaks. If the sellers are unaware or no repairs were made the further evaluation is needed by a licensed plumbing contractor.

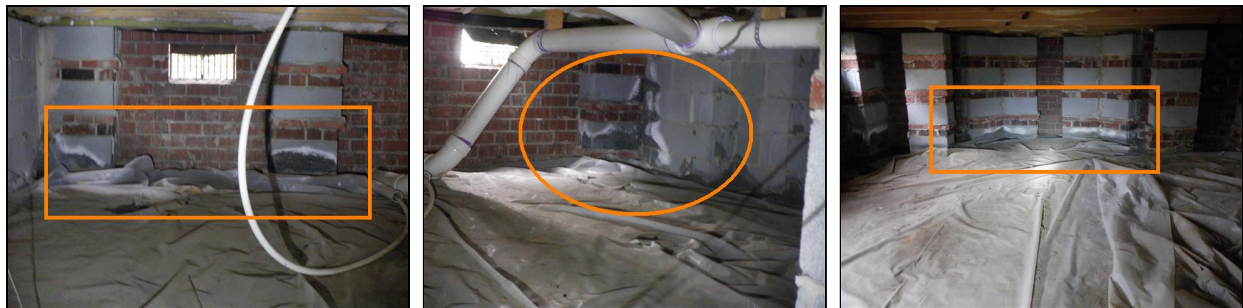
There are moisture stains noted along the back of the front, left and rear foundation walls in the crawl space. This is an indication that water is or has entered the crawl space at one point. Contact a licensed qualified contractor to further evaluate and determine if corrections are needed.
