Reliable Home Inspections

Property Inspection Report

123 Easy St, Pleasantville, TX 75555
Inspection prepared for: Joe Sample
Real Estate Agent: -

Date of Inspection: 5/27/2017 Time: 9:00 AM
Age of Home: 1984 Size: 2653
Weather: Cloudy 85 Degrees
Order ID:

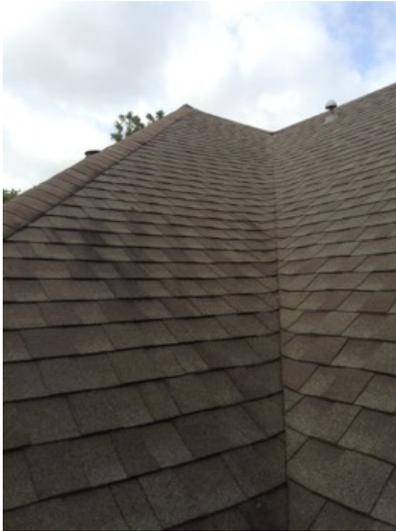
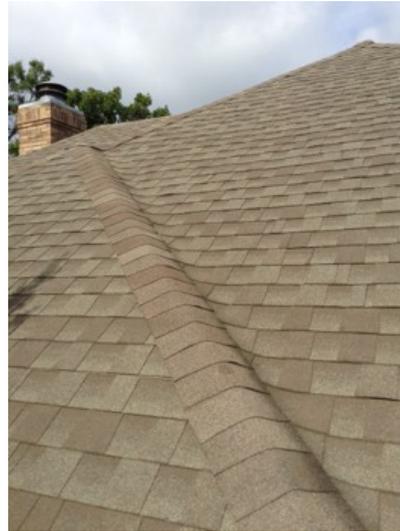
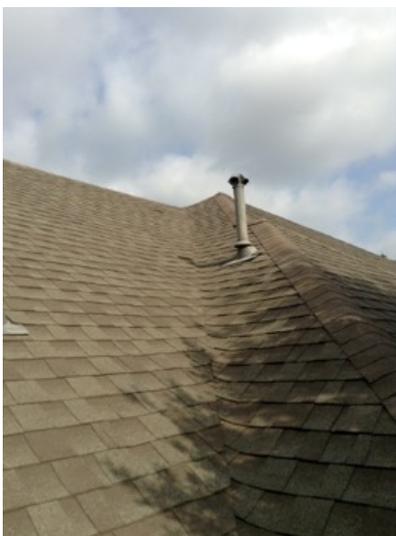
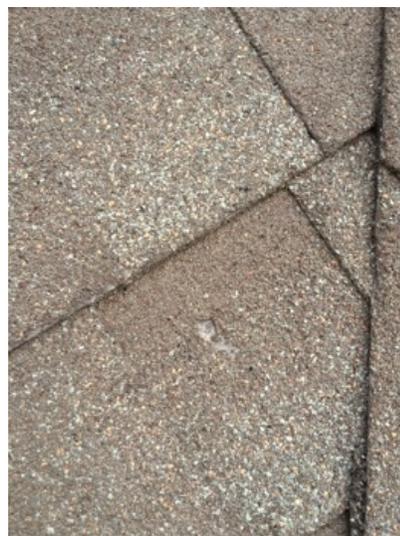
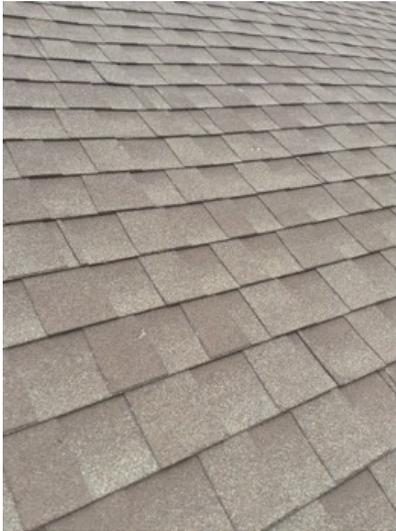
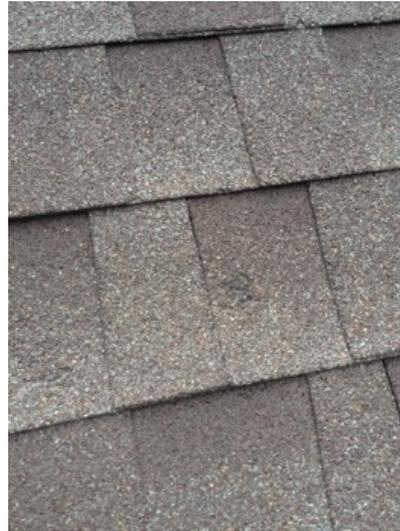
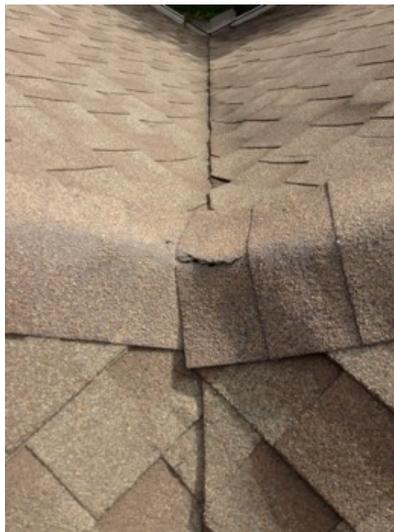
C.2. The roof has suffered hail damage. The roof needs to be further evaluated by a qualified roofing contractor or the insuring claim adjuster. The only one that can decide if the roof is insurable is the insuring company. Rear of roof

The roof has suffered hail damage. The roof needs to be further evaluated by a qualified roofing contractor or the insuring claim adjuster. The only one that can decide if the roof is insurable is the insuring company. Rear of roof

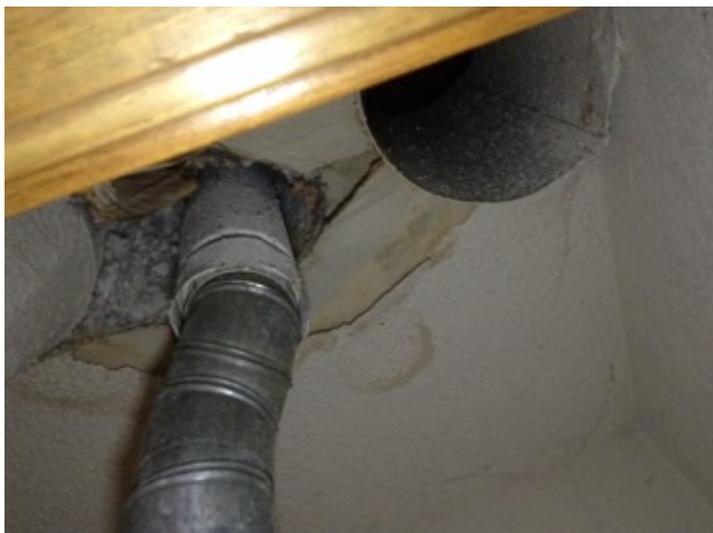
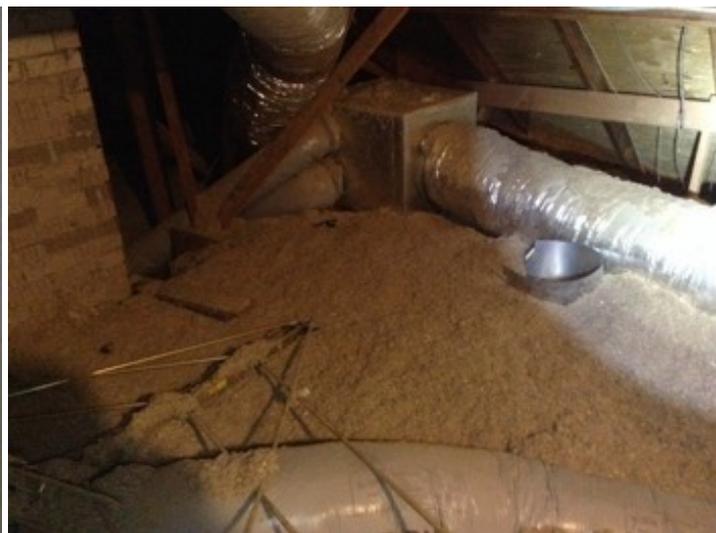
D.6. The heat shield is missing in the water heater closet. The ceiling is damaged and should be repaired.

The heat shield is missing in the water heater closet. The ceiling is damaged and should be repaired.

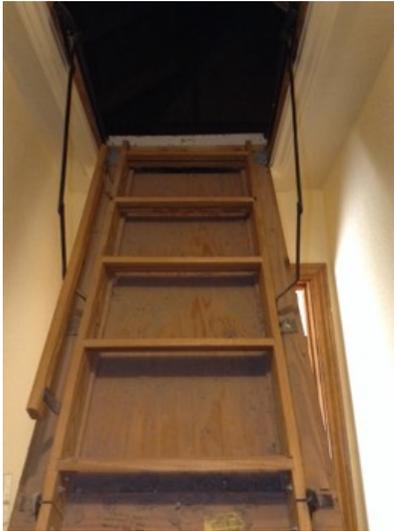
Ideally, the attic access hatch should be better insulated and weather stripped when inside the building envelope.

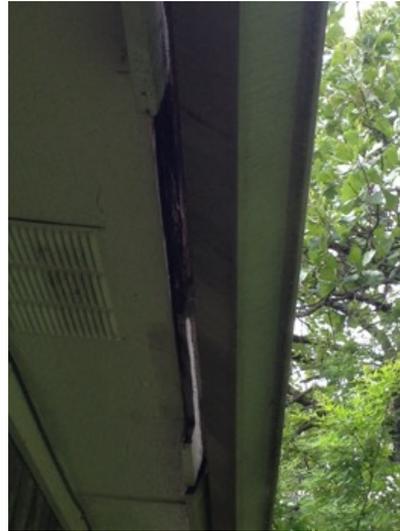
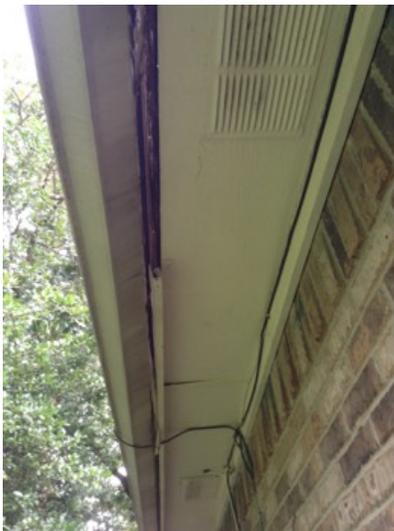
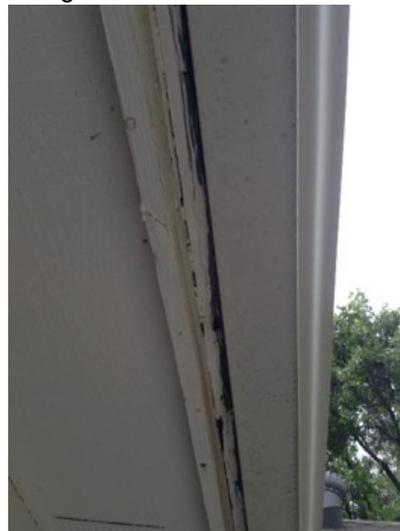
D.7. The fascia boards are water damaged on the rear side of the garage. All fascia board should be repaired and painted while the gutters are removed for re-roofing.

The fascia boards are water damaged on the rear side of the garage. All fascia board should be repaired and painted while the gutters are removed for re-roofing.

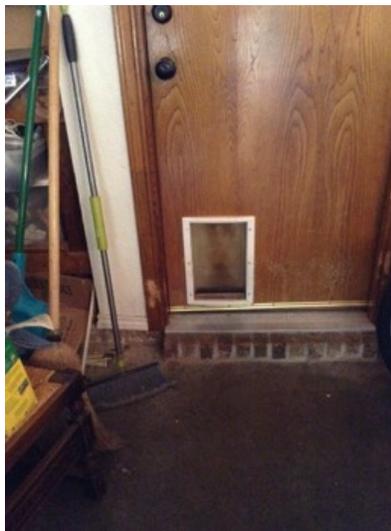
G.1. The garage to the interior door has a pet door. This is a fire code violation and the door should be replaced.

The garage to the interior door has a pet door. This is a fire code violation and the door should be replaced.

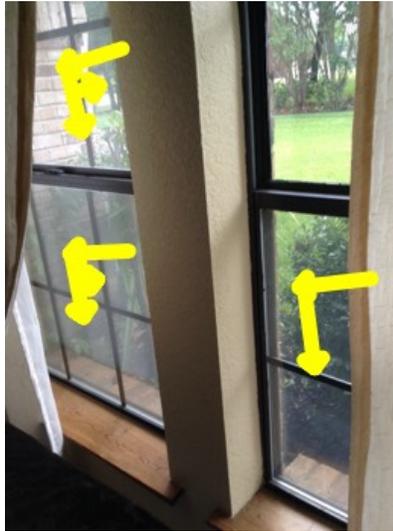
H.2. The window(s) have lost their seal. This has resulted in condensation developing between the panes of glass and can cause the glass to lose its insulating properties. The glass should be repaired or replaced.

The window(s) have lost their seal. This has resulted in condensation developing between the panes of glass and can cause the glass to lose its insulating properties. The glass should be repaired or replaced.

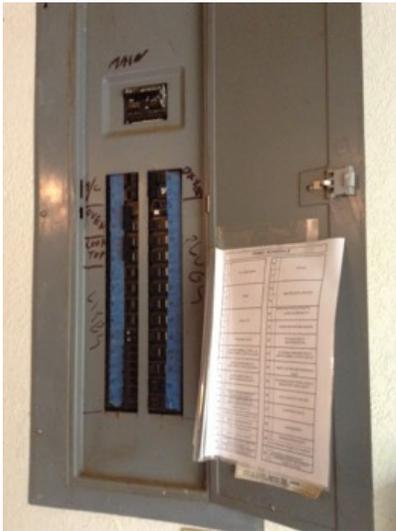
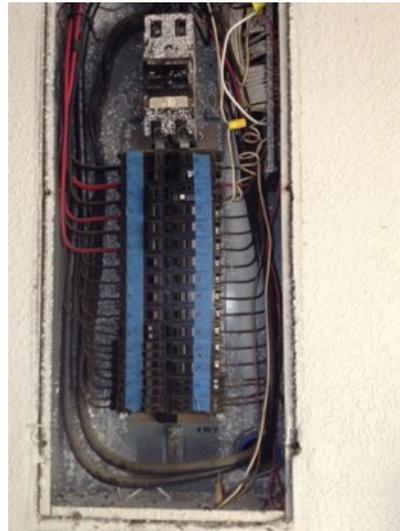
A.2. Panel screws need to be replaced where missing. Only machine screws should be installed in the panel.

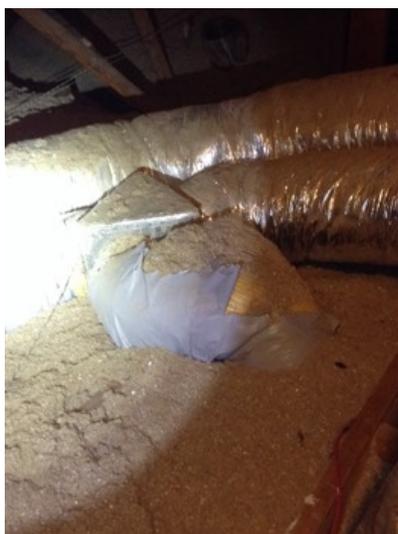
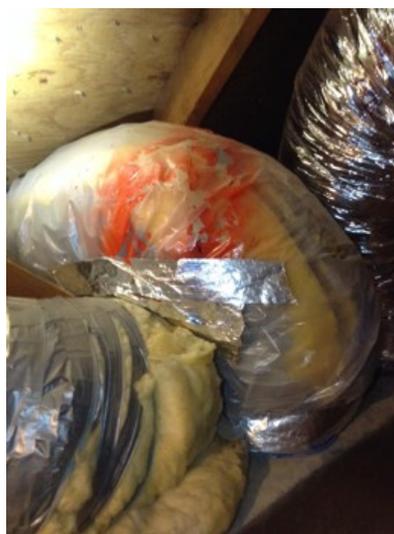
C.1. The HVAC grey flex duct was recalled due to the vapor barrier being easily damaged by UV light. Once the vapor barrier is damaged the insulation will open up. The duct has not been used since the late 1980's and should be replaced.

The HVAC grey flex duct was recalled due to the vapor barrier being easily damage by UV light. Once the vapor barrier is damaged the insulation will open up. The duct has not be used since the late 1980's and should be replaced.

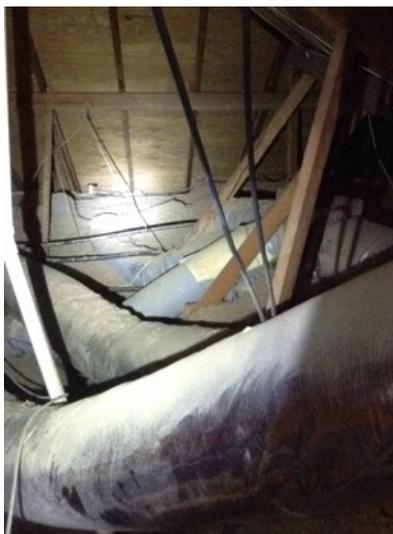
C.2. Flexible air flow ducts observed in contact with each other. Air flow ducts in contact with each other or other insulation material generate sweating to ceilings at the point of contact with each other or other building materials. Clearance or separation from contact with each other by strapping with HVAC nylon strapping material prevents sweating.

[ref: IRC M1601.2 factory made ducts; IMC 603.11 pg. 53; CABO 1901.2; SBCCI 606.2.1; "provisions shall be made to prevent the formation of condensation on the exterior of any duct"; TREC 535.230(d)(1).] Where ducts are separated by insulation blankets condensation moisture is generally increased (as the insulation traps hot air against the cooler ducts).

Flexible air flow ducts observed in contact with each other. Air flow ducts in contact with each other or other insulation material generate sweating to ceilings at the point of contact with each other or other building materials. Clearance or separation from contact with each other by strapping with HVAC nylon strapping material prevents sweating. [ref: IRC M1601.2 factory made ducts; IMC 603.11 pg. 53; CABO 1901.2; SBCCI 606.2.1; "provisions shall be made to prevent the formation of condensation on the exterior of any duct"; TREC 535.230(d)(1).] Where ducts are separated by insulation blankets condensation moisture is generally increased (as the insulation traps hot air against the cooler ducts).

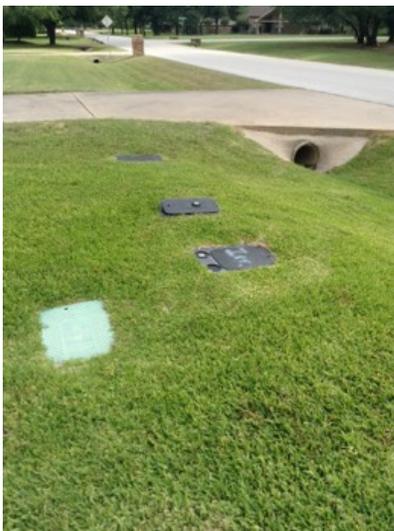
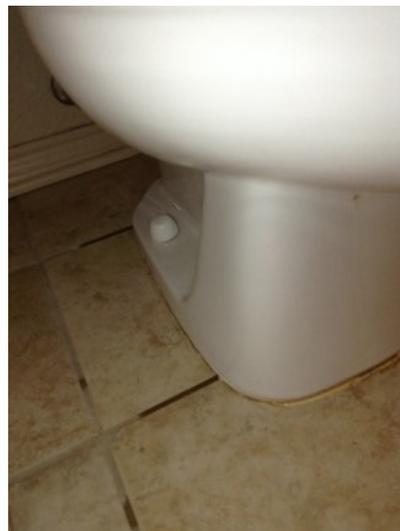
A.2. The toilet shows evidence of leakage at the base. Master bathroom. This should be repaired by a qualified plumbing contractor.

The toilet shows evidence of leakage at the base. Master bathroom. This should be repaired by a qualified plumbing contractor.

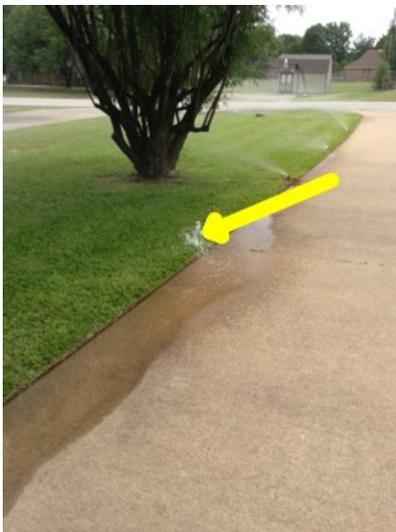
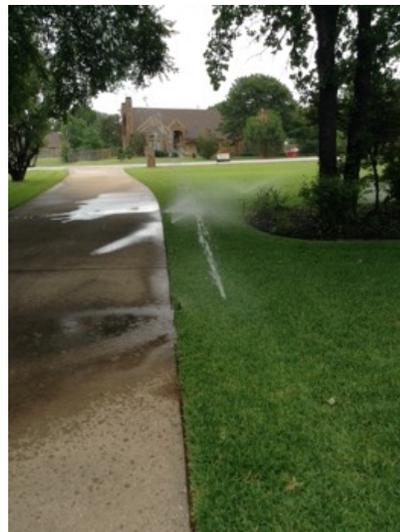
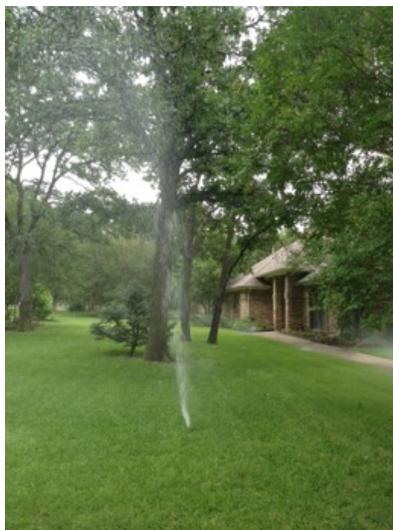
A.1. Broken and or missing sprinkler heads were noted. This condition should be remedied to ensure adequate spray coverage for the entire sprinkler system. Driveway zones and front yard. All lines need to be teed and repaired by a qualified irrigation contractor.

Broken and or missing sprinkler heads were noted. This condition should be remedied to ensure adequate spray coverage for the entire sprinkler system. Driveway zones and front yard. All lines need to be teed and repaired by a qualified irrigator.

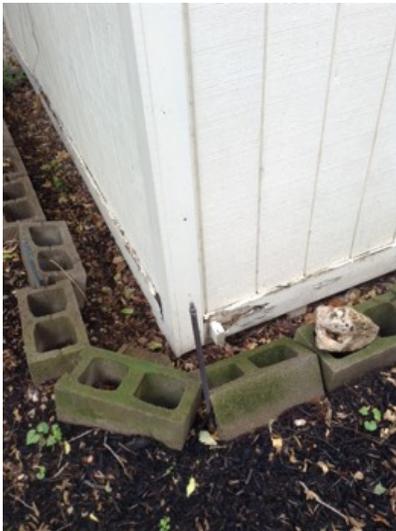
B.2. The damage wood siding on the detached building needs to be replaced.

The damage wood siding on the detached building needs to be replaced.

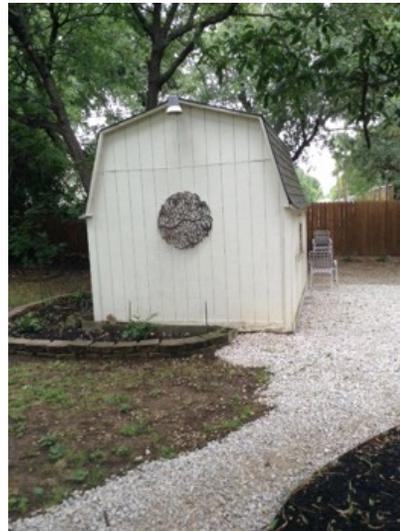
B.1. The outbuilding is not secured to a foundation. This is to prevent the building from being blown away during high winds and is required by most building codes. Suggest a permit be examined to meet local building codes.

The outbuilding is not secured to a foundation. This is to prevent the building from being blown away during high winds and is required by most building codes. Suggest a permit be examined to meet local building codes.

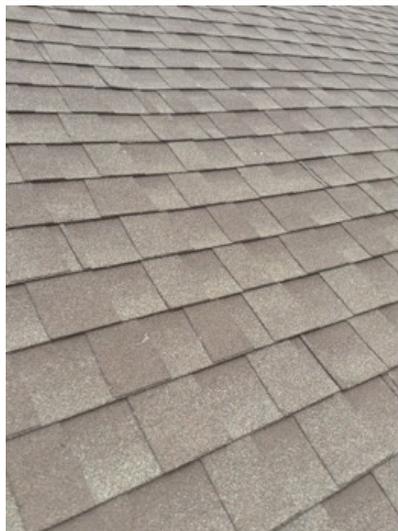
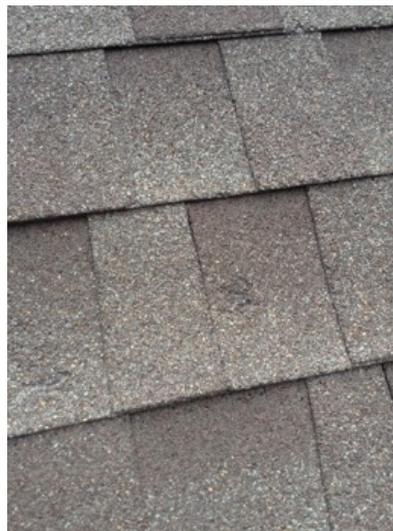
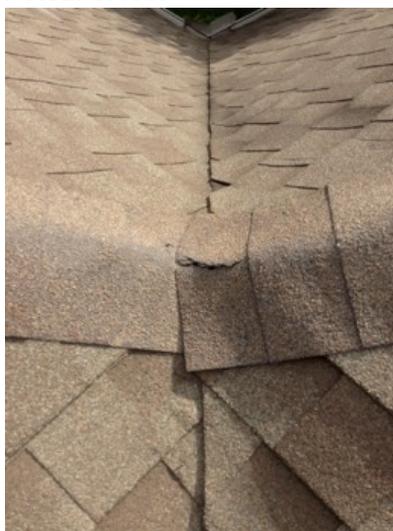
Page 3 Item: C	Roof Covering Materials	C.2. The roof has suffered hail damage. The roof needs to be further evaluated by a qualified roofing contractor or the insuring claim adjuster. The only one that can decide if the roof is insurable is the insuring company. Rear of roof
----------------	-------------------------	--

The roof has suffered hail damage. The roof needs to be further evaluated by a qualified roofing contractor or the insuring claim adjuster. The only one that can decide if the roof is insurable is the insuring company. Rear of roof

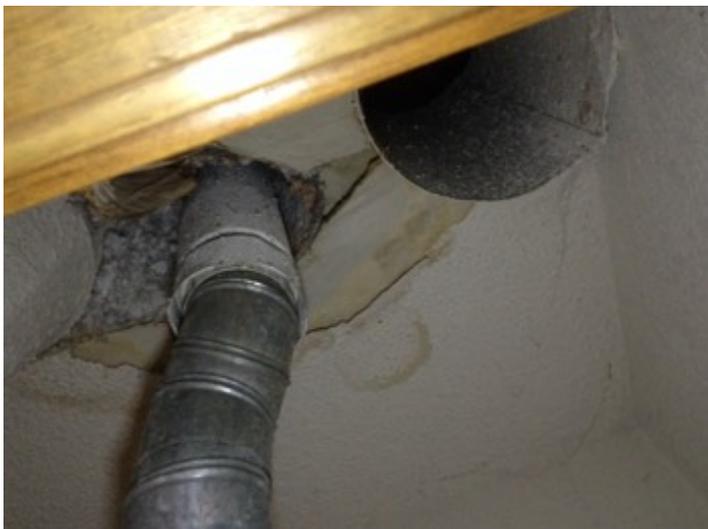
The heat shield is missing in the water heater closet. The ceiling is damaged and should be repaired.

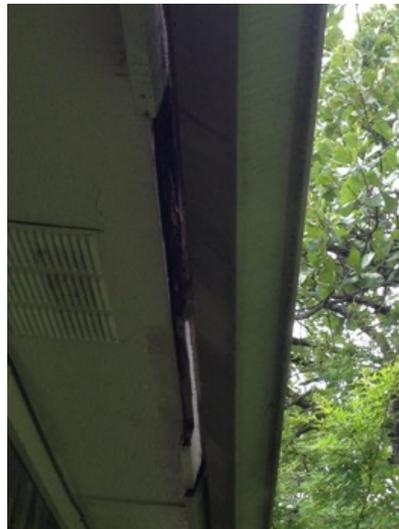
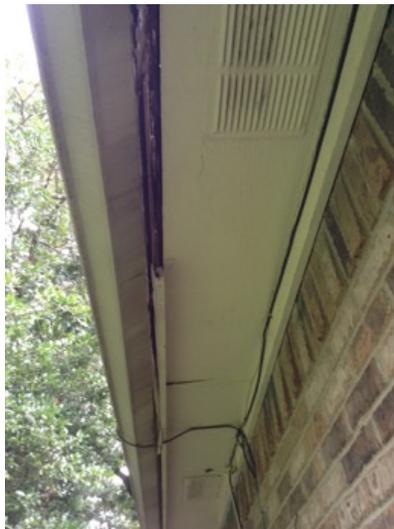
The fascia boards are water damaged on he rear side of the garage. All fascia broad should be repaired and painted while the gutters are removed for re-roofing.

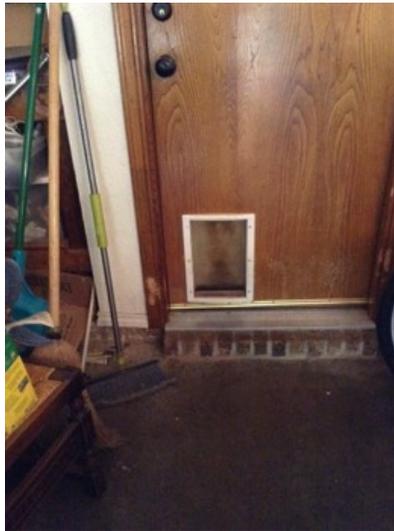
The garage to the interior door has a pet door. This is a fire code violation and the door should be replaced.

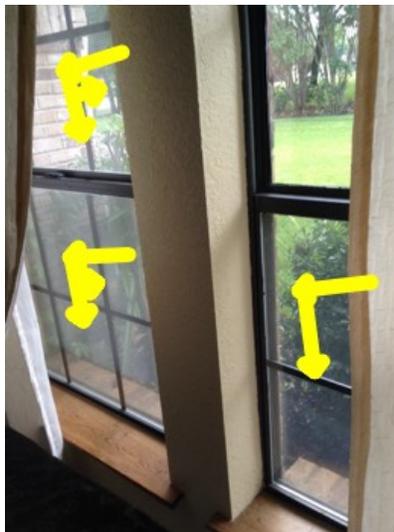
The window(s) have lost their seal. This has resulted in condensation developing between the panes of glass and can cause the glass to lose its insulating properties. The glass should be repaired or replaced.

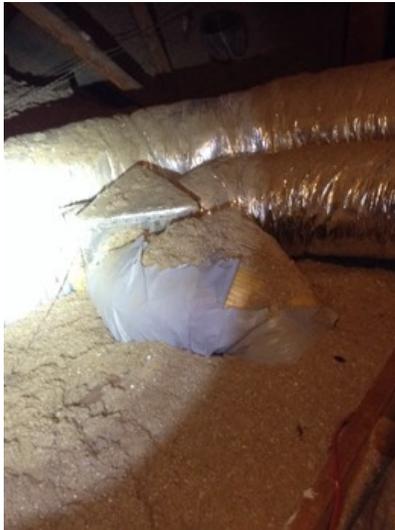
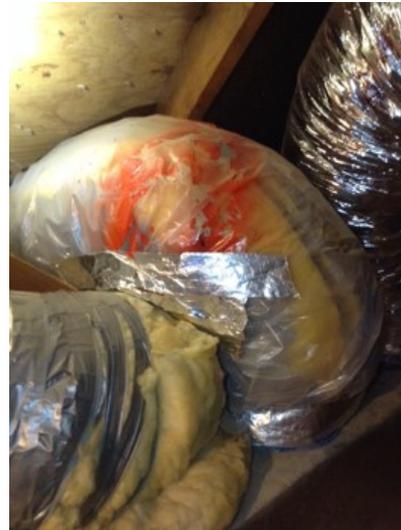
The HVAC grey flex duct was recalled due to the vapor barrier being easily damaged by UV light. Once the vapor barrier is damaged the insulation will open up. The duct has not been used since the late 1980's and should be replaced.

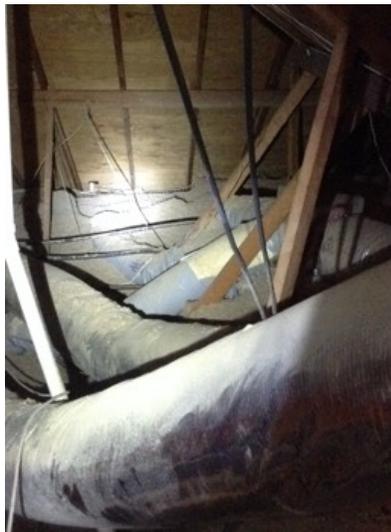
Flexible air flow ducts observed in contact with each other. Air flow ducts in contact with each other or other insulation material generate sweating to ceilings at the point of contact with each other or other building materials. Clearance or separation from contact with each other by strapping with HVAC nylon strapping material prevents sweating. [ref: IRC M1601.2 factory made ducts; IMC 603.11 pg. 53; CABO 1901.2; SBCCI 606.2.1; "provisions shall be made to prevent the formation of condensation on the exterior of any duct"; TREC 535.230(d)(1).] Where ducts are separated by insulation blankets condensation moisture is generally increased (as the insulation traps hot air against the cooler ducts).

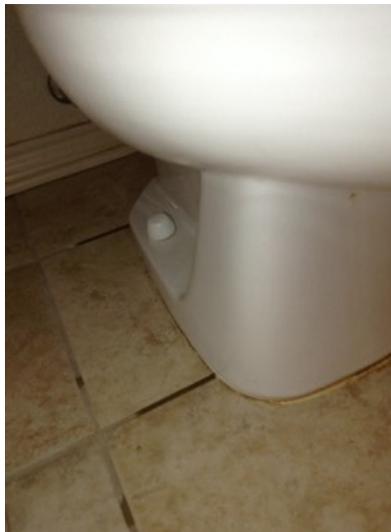
The toilet shows evidence of leakage at the base. Master bathroom. This should be repaired by a qualified plumbing contractor.

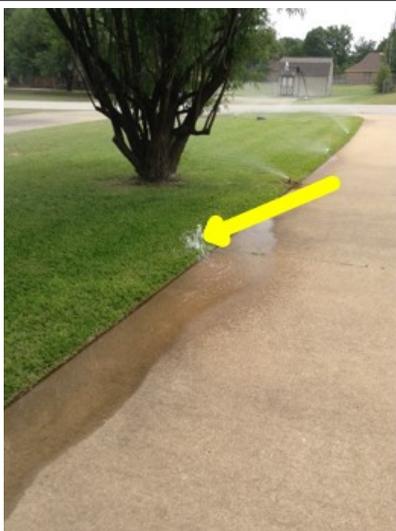
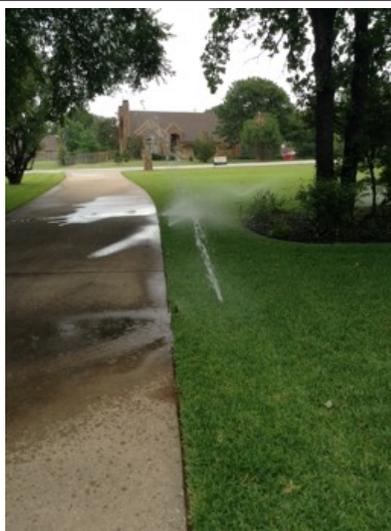
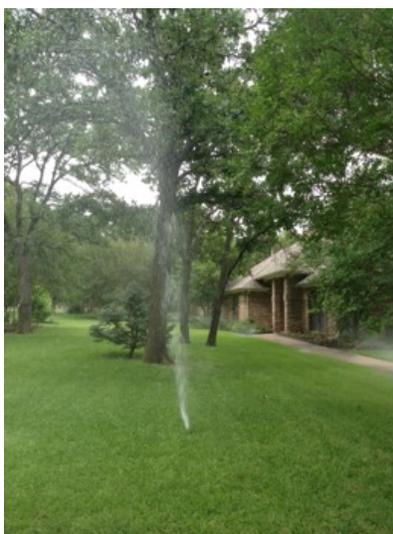
Broken and or missing sprinkler heads were noted. This condition should be remedied to ensure adequate spray coverage for the entire sprinkler system. Driveway zones and front yard. All lines need to be teed and repaired by a qualified irrigation contractor.

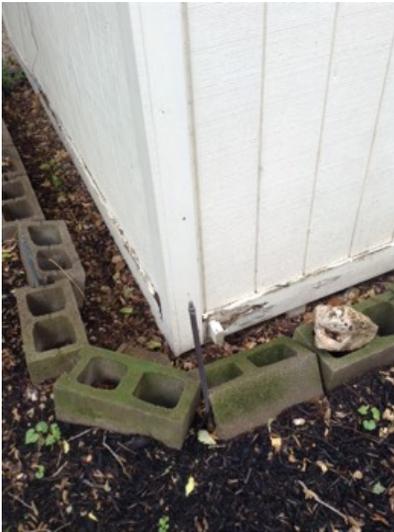
The damage wood siding on the detached building needs to be replaced.

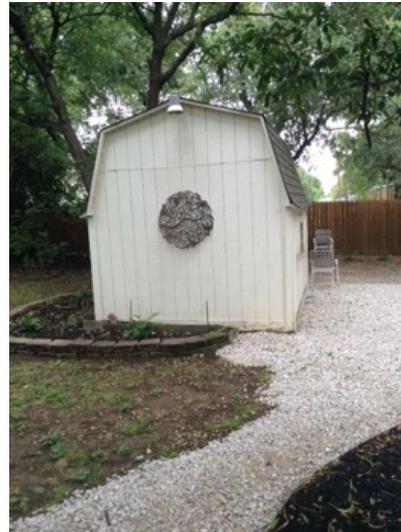
The outbuilding is not secured to a foundation. This is to prevent the building from being blown away during high winds and is required by most building codes. Suggest a permit be examined to meet local building codes.
