# Service Information

Category <b>S</b>	<b>Repair Guidance</b>	Ref. No. R017/16A	Page 1 of 6
Coverage Distributor only Please inform your dealers		Date Issued February 26, 2016	
Please convey this information to your Director General Manager Warranty Dept. Parts Dept. Training Dept. Field Rep.		Date Revised <b>March 29, 2016</b>	
Applicable Model  MX-5 (ND) with INNER CLOTH		Applicable Countries or Specifications  Worldwide

## Subject: Convertible Top-Inner Cloth coming off causing Poor Appearance and Obstructing view of Back Window

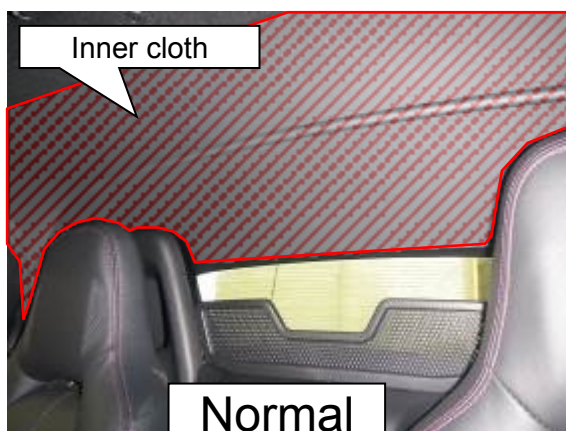
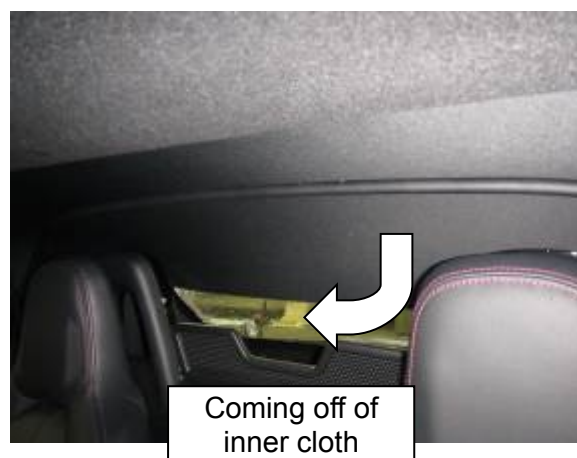
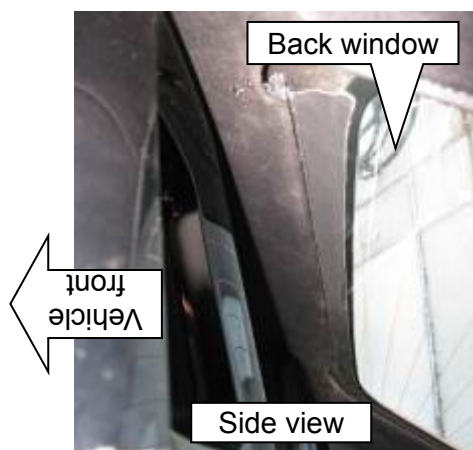
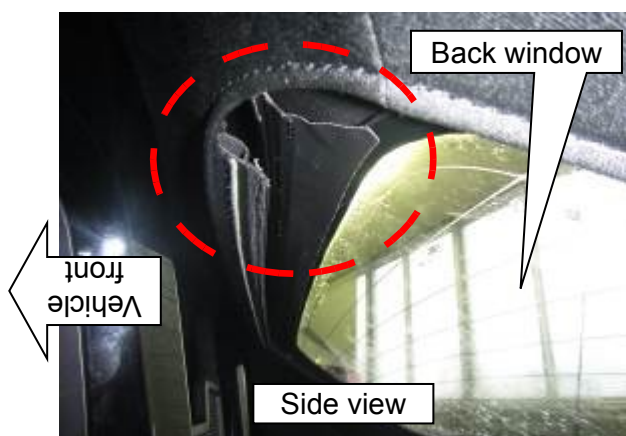
Some vehicles may exhibit a coming off of the inner cloth at the rear end causing poor appearance and obstructing view of the back window.

The coming off occurs when the convertible top is opening and/or closing or by vibration during vehicle driving.

The J-hook binding to hold the inner cloth becomes loose during opening/closing the convertible top or by heat influence.

Two top-protectors (clip) have been additionally installed to the both side edges of the J-hook to prevent opening/loosening of the J-hook.
