DSV Bibby Topaz Incident 18th Sept 2012

Agenda

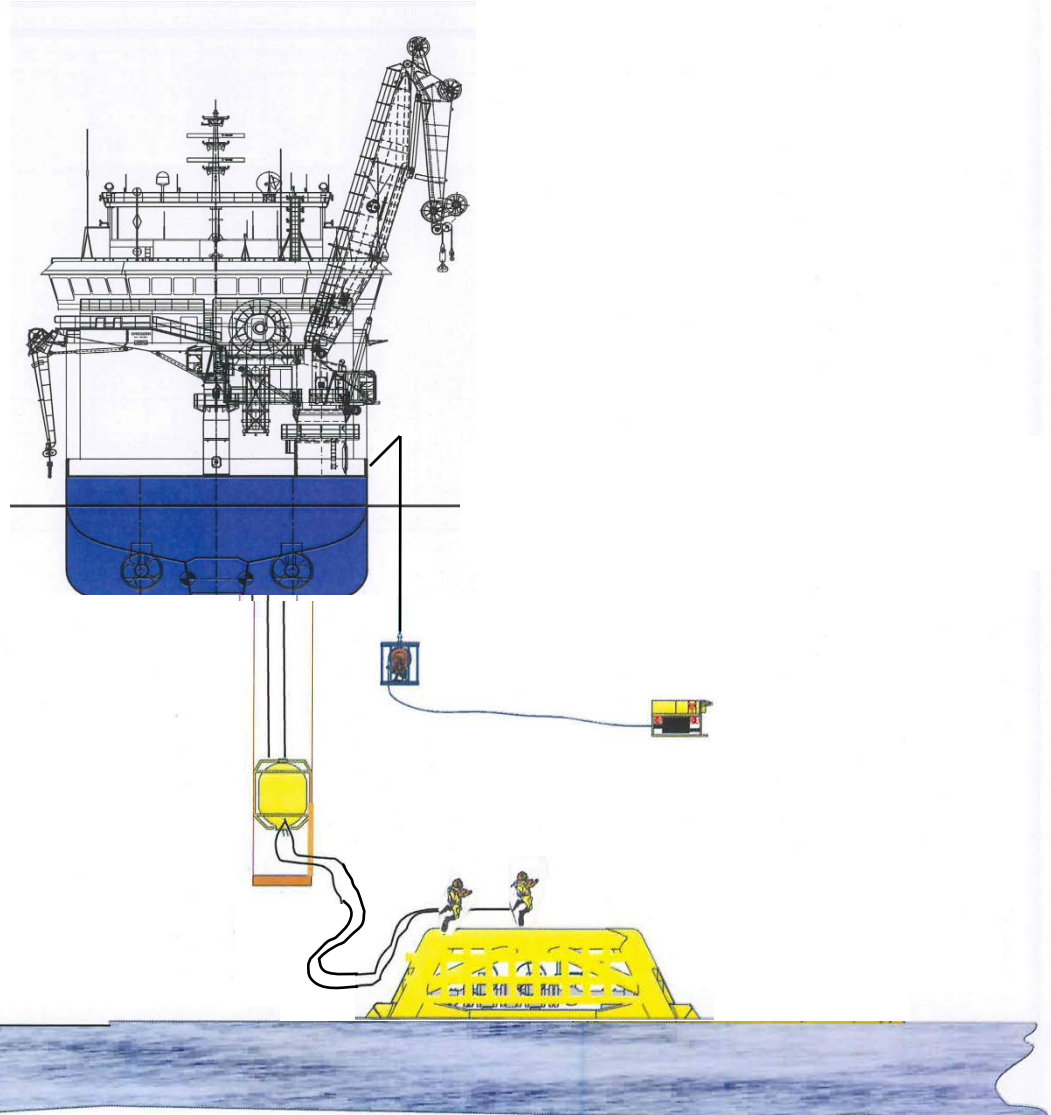
Time Line - 22.09

- Alarm for 'RBUS' activated
- DP amber alert activated
- Vessel starts to drift
- Master & Dive Control informed
- Dive Supervisor instructed divers to leave structure and locate to bell stage
- Attempts made to reselect thrusters into DP

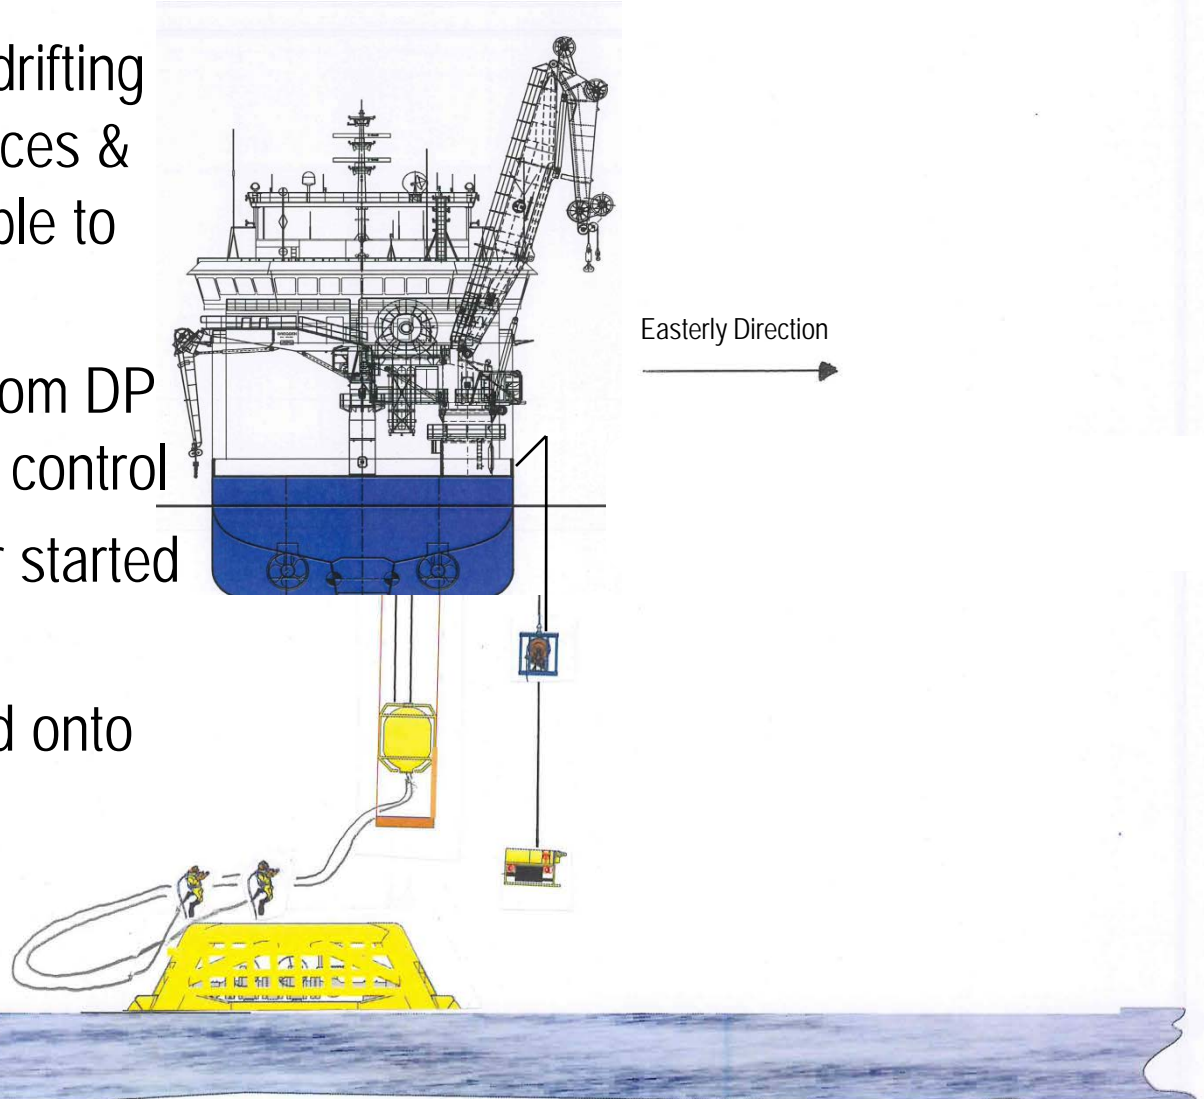
Time Line – 22.11

- DP Red alert activated
- Vessel continued drifting to East, all references & thrusters unavailable to DP
- Master switches from DP to manual thruster control
- Standby generator started with thruster 4
- Diver 1 & 2 located onto top of template

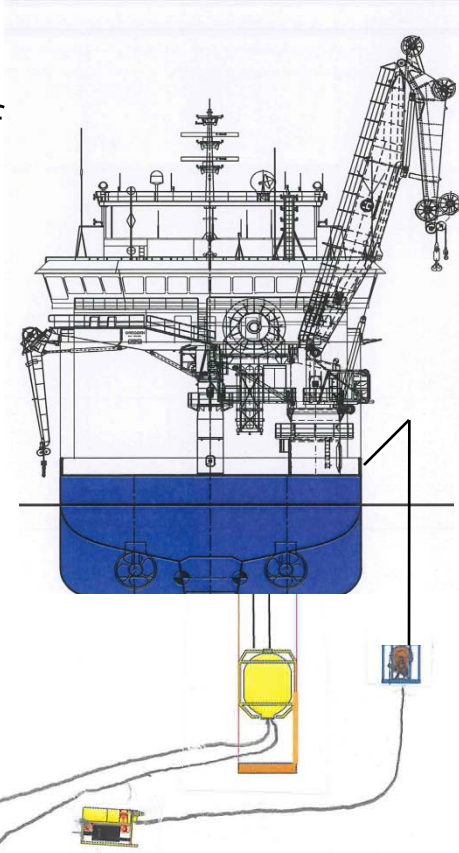
Time Line – 22.12

- Diver 2 umbilical snagged on transponder bucket located on side of structure
- Diver 1 pulled off template
- Momentary loss of comms to bell

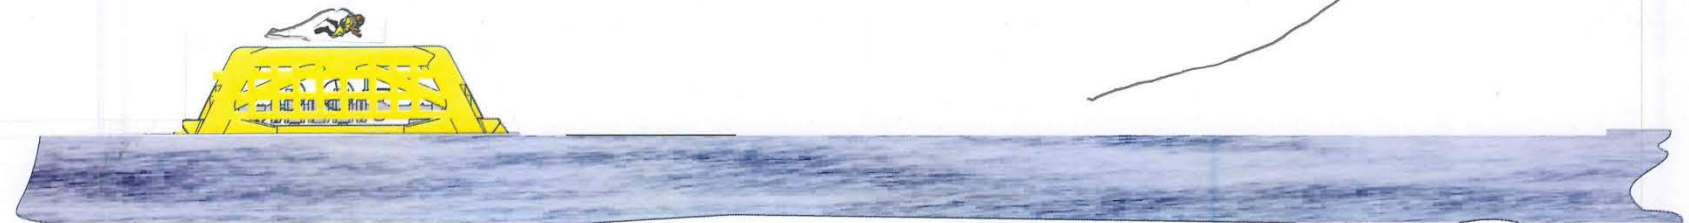
Time Line – 22.13 to 22.15

- Loss of comms / video to diver 2; umbilical severed
- Diver 1 made way back to bell stage
- OPM relocated from Dive Control to Bridge
- Port Taut Wire stowed (wire parted)
- Downline and tugger parted

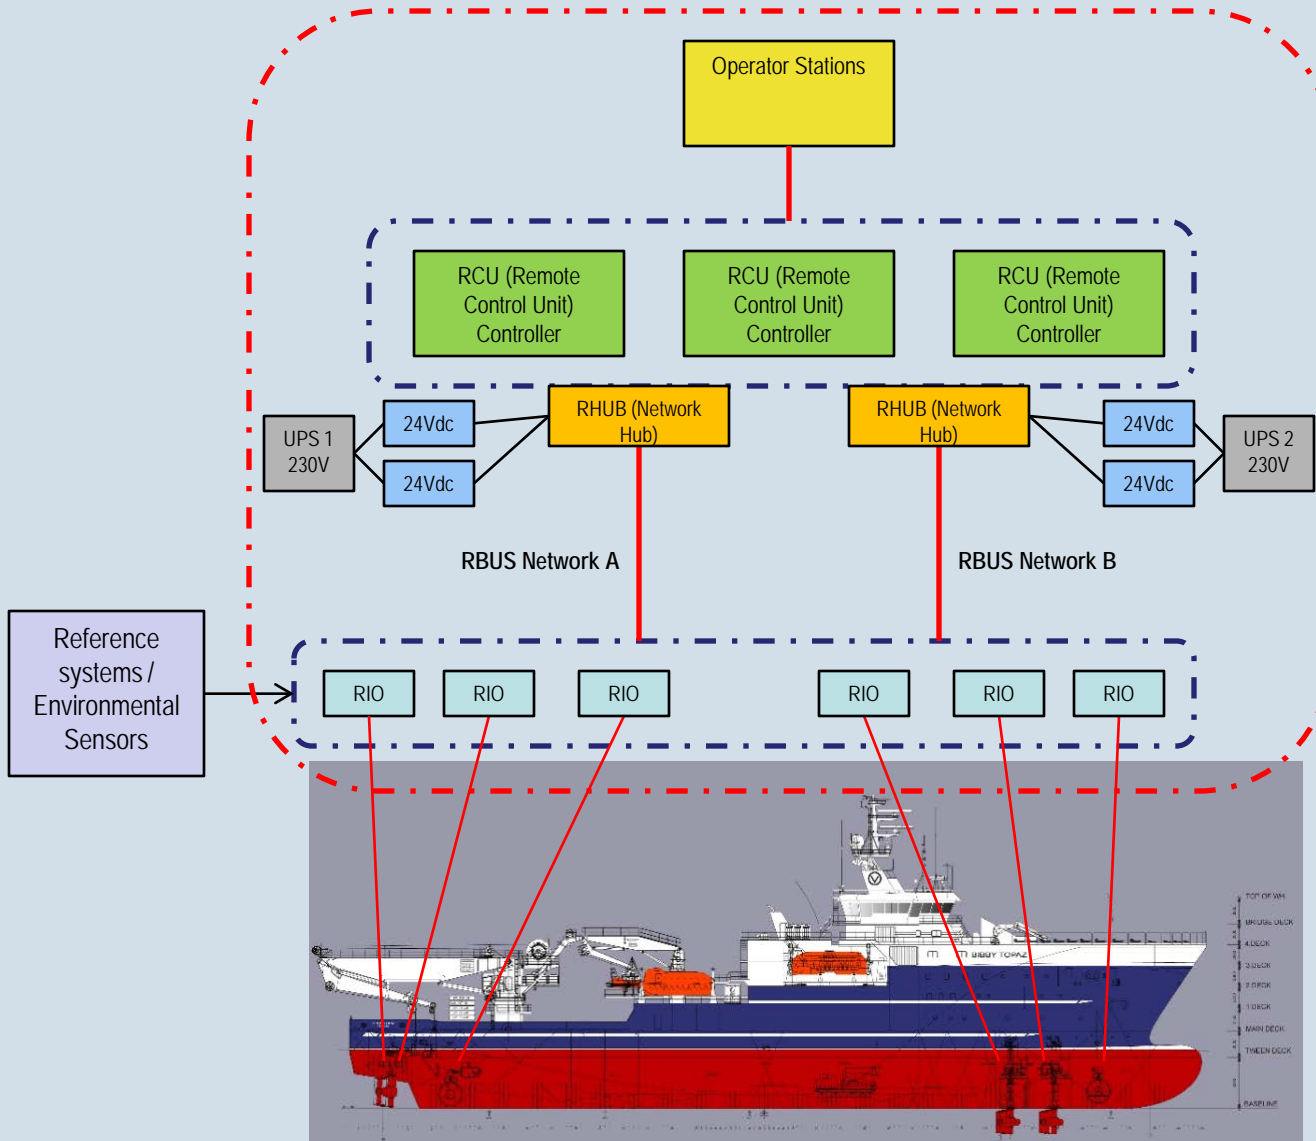
DP Control System

- Vessel conducted testing on the system to try to replicate the failure, in conjunction with the testing on the switchboards; in accordance with DNV approved trials schedule .
- Able to replicate the failure of the module to provide the various alarms that were seen on the 18th
- All options exhausted in terms of testing on the vessel; DNV agreement
- Power management system testing carried out
- DP hardware replaced & existing units taken off & sent back to Norway; DNV agreement
- Kongsberg disassembling module by module to fully substantiate root cause of the failure
- DP FMEA proving trials being conducted

Each of the RHUB (Network Hub) has two 24Vdc power supplies

Information from the RIO Units are conveyed to the controllers via 2 dedicated RBUS Networks; A & B

Remote Input Output (RIO) units. Take all feedback from the reference & environmental sensors along with command & feedback signals for the thrusters. Each Thruster has RIO unit
