TECHNICAL BULLETIN

LTB00768v2

SECTION: 303-00

3.0L TDV6 Valve Cover Split And/Or Cracked

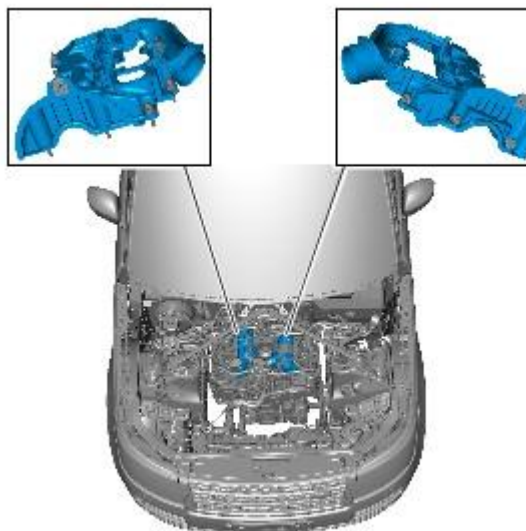
E186357

1The illustration shows the component location.

- 1Install a new engine valve cover left (see TOPIx Workshop Manual, Section 303-01 Engine - TDV6 3.0L Diesel - Valve Cover LH).
- 2Install a new engine valve cover right (see TOPIx Workshop Manual, Section 303-01 Engine - TDV6 3.0L Diesel - Valve Cover RH).
