# Hawker Hunter

## Airworthiness Certification

AIR-230 Airworthiness Certification Branch  
Federal Aviation Administration  
Washington, D.C.  
January 18, 2013

Subject: Hawker Hunter Airworthiness Certification

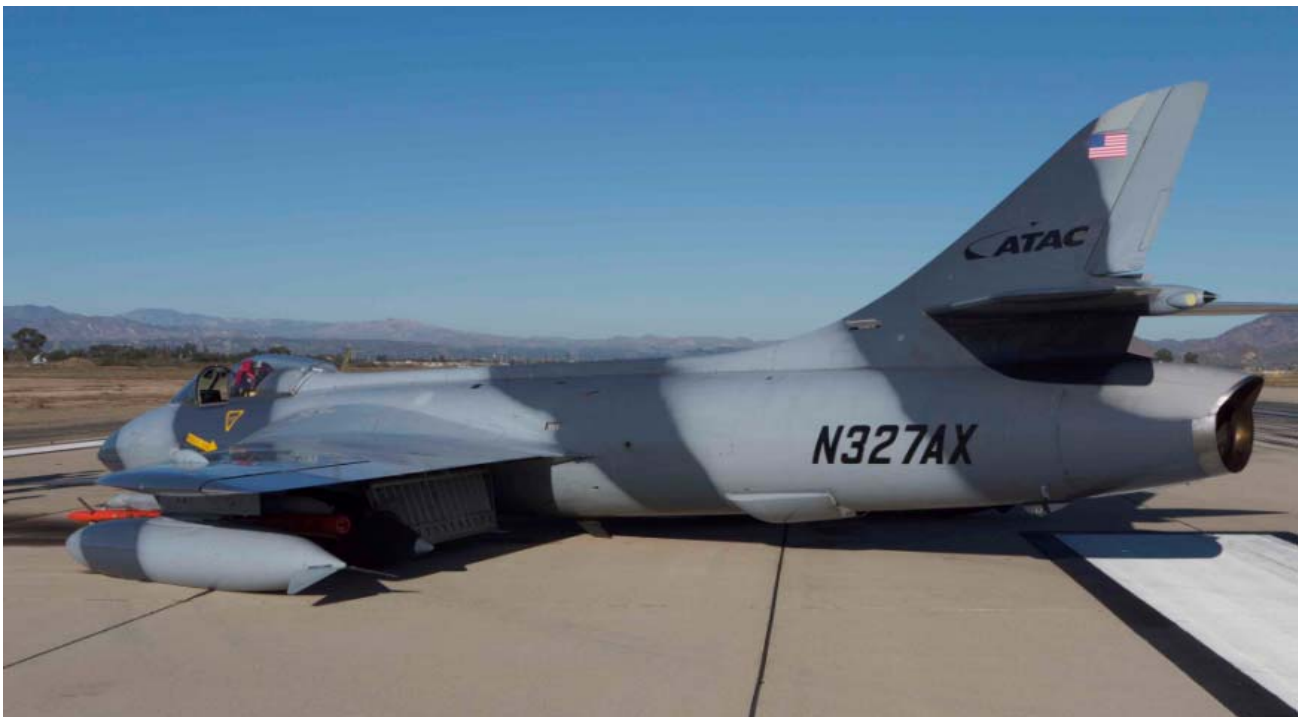
*Hunter Mk. 58 gear-up landing, Pt. Mugu, California, 2012. Source: NTSB.*

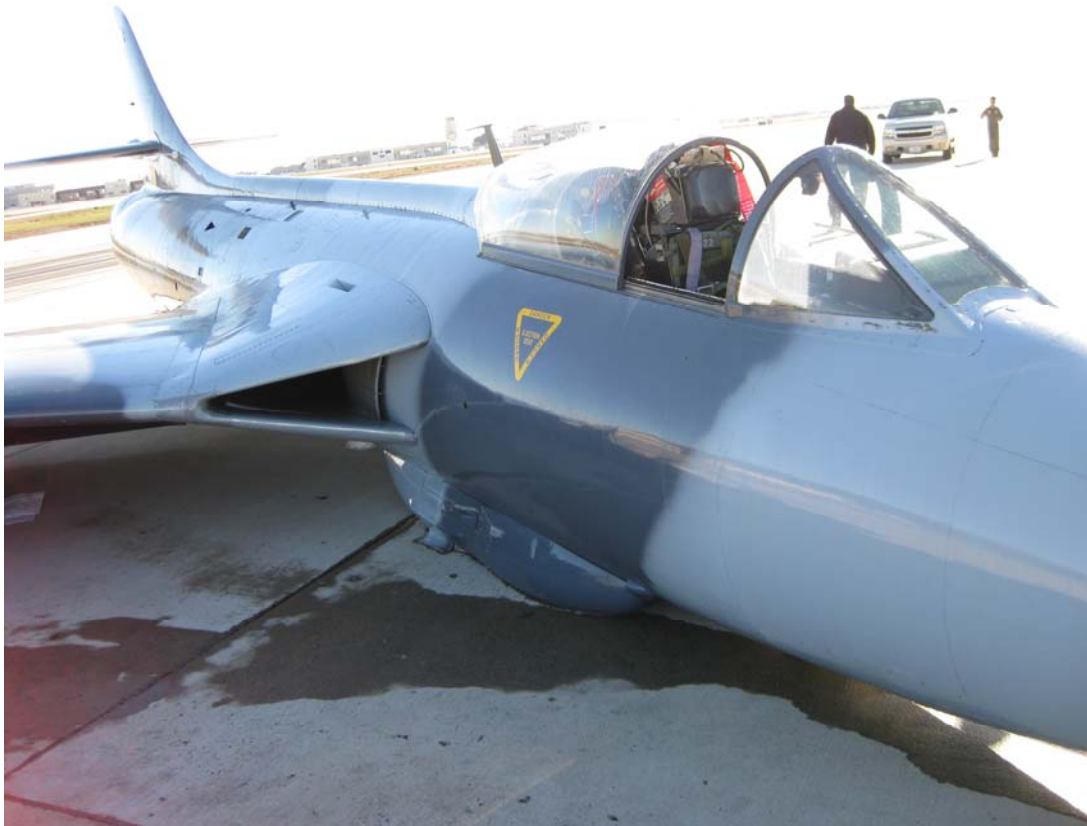
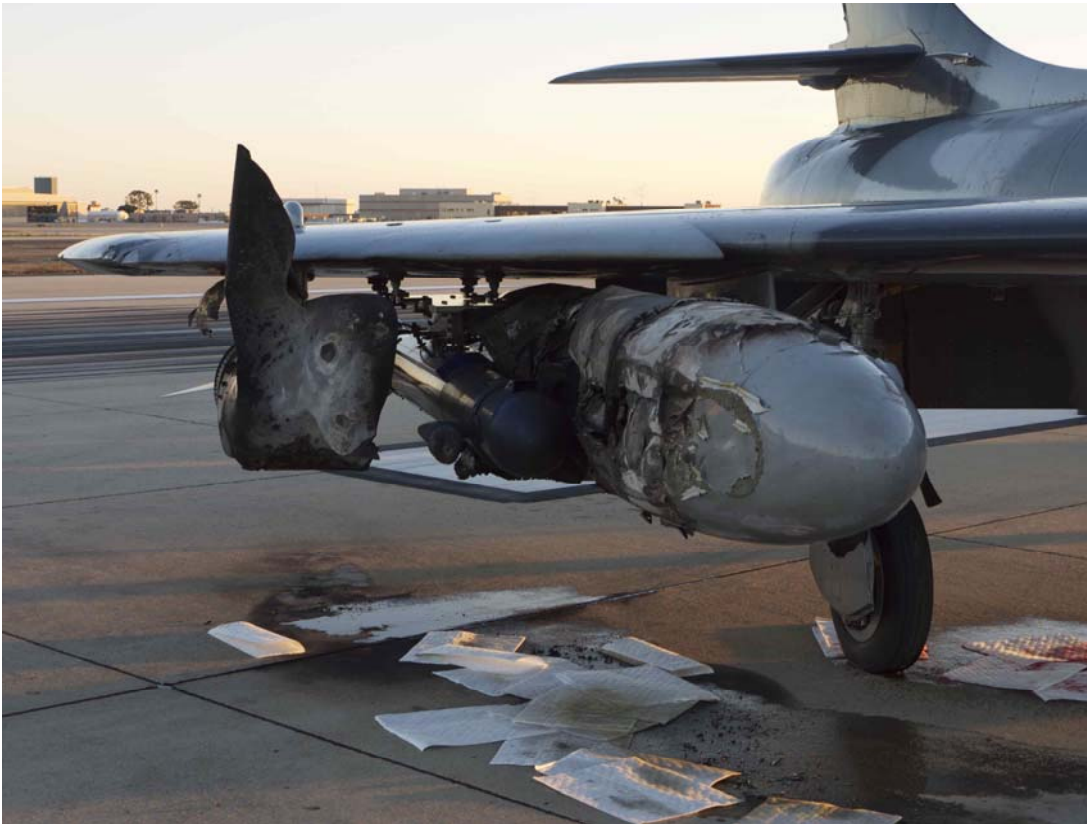
*Hunter Mk. 58 gear-up landing, Pt. Mugu, California, 2012. Source: NTSB & FAA.*

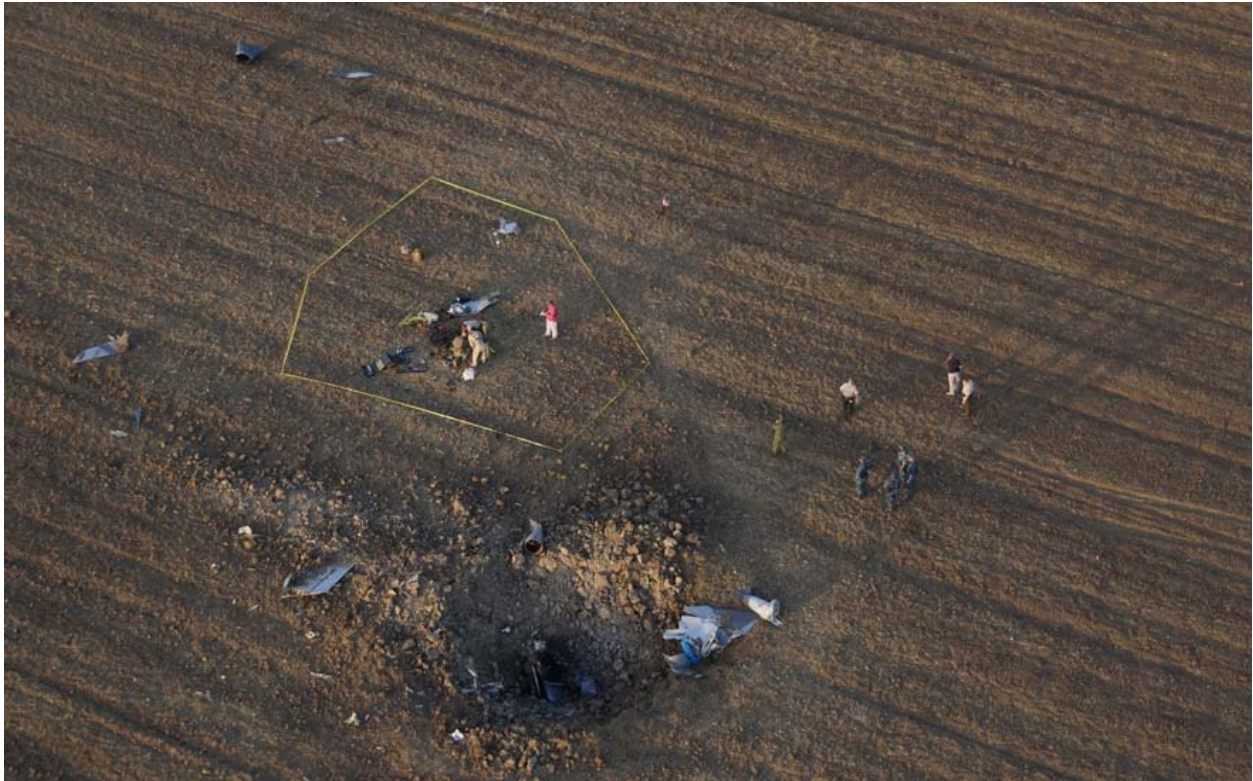
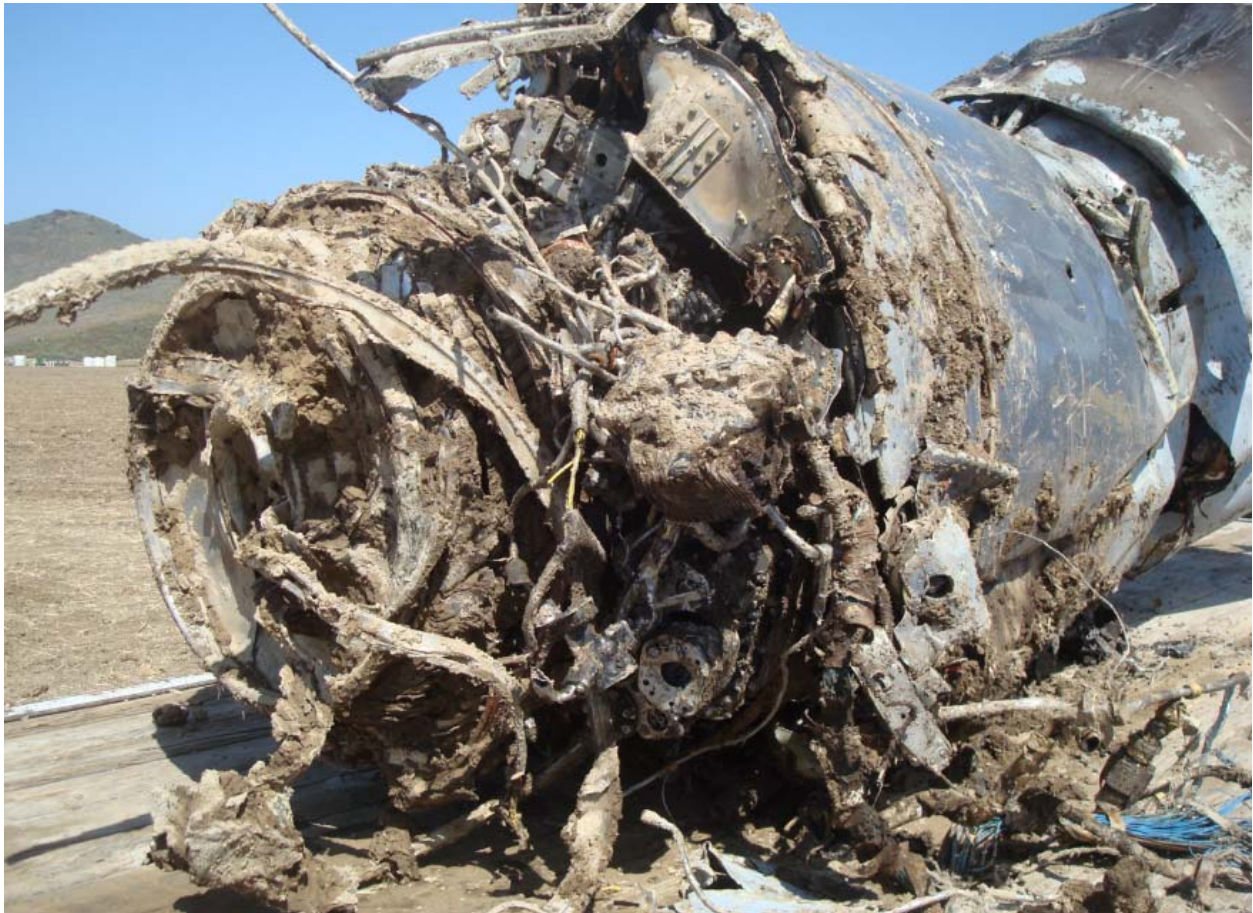
Two views of the aftermath of a fatal Hunter accident in 2012. Source: NTSB.

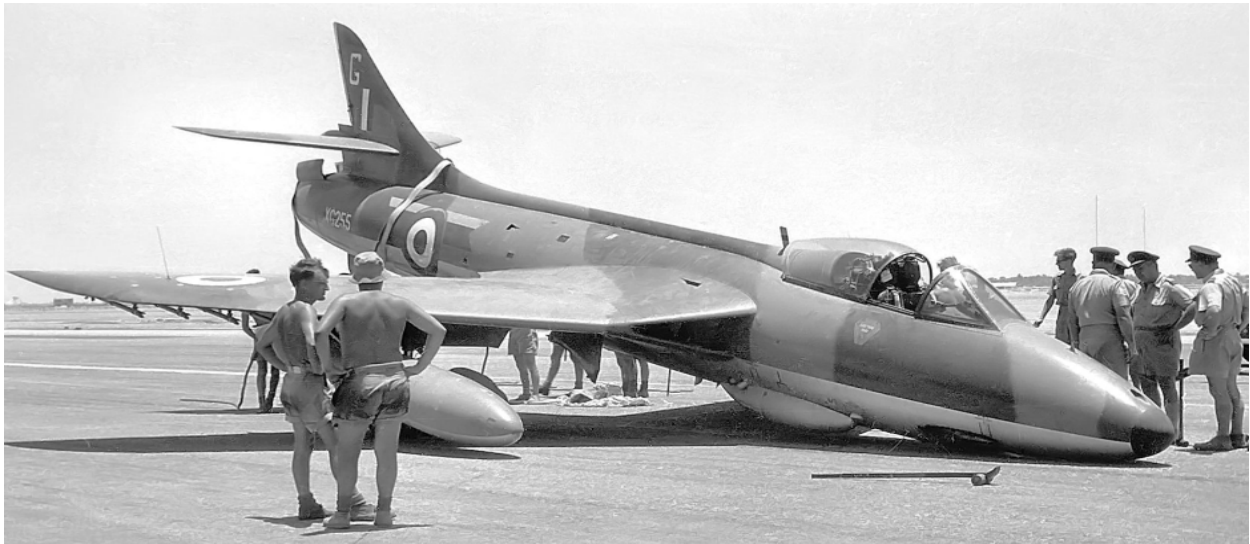
Typical Hunter accidents. Above, nose-gear failure. Below, external fuel tank separation. Source: Roger Wilkins via Ray Deacon. <http://www.radfanhunters.co.uk>.

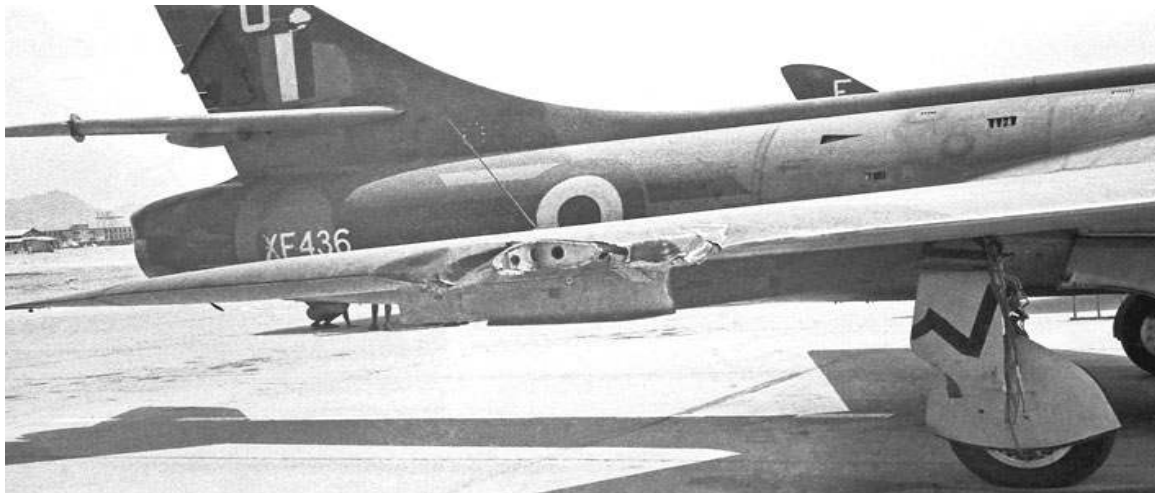
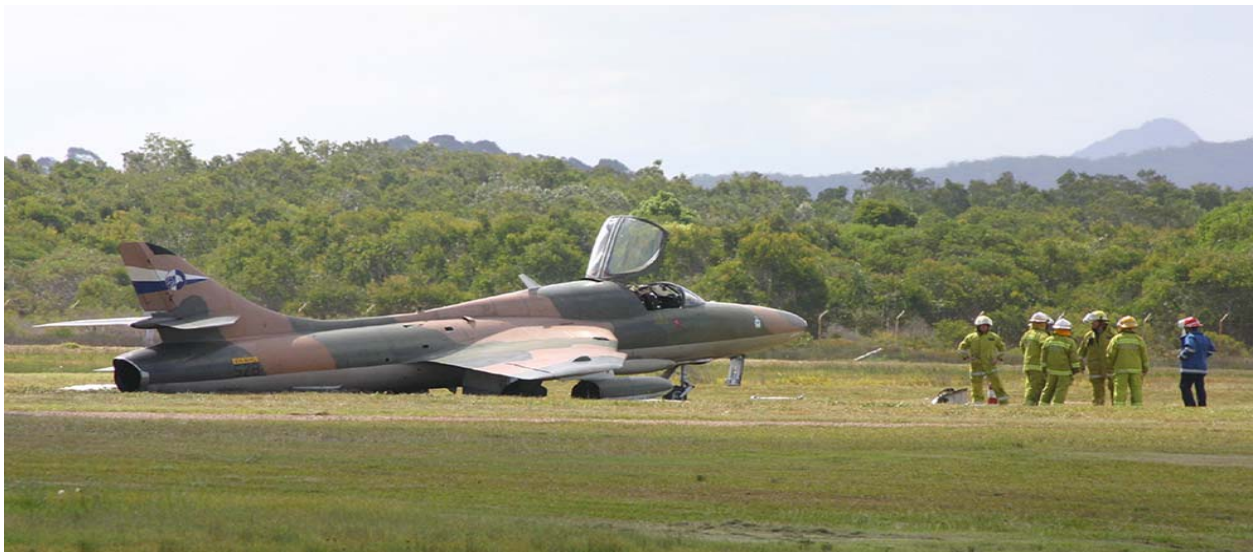
Hunter T75 accident (landing gear failure) in Australia in 2005. Source: Greg Weir. Copyright © 2006. [www.airliners.net](http://www.airliners.net).

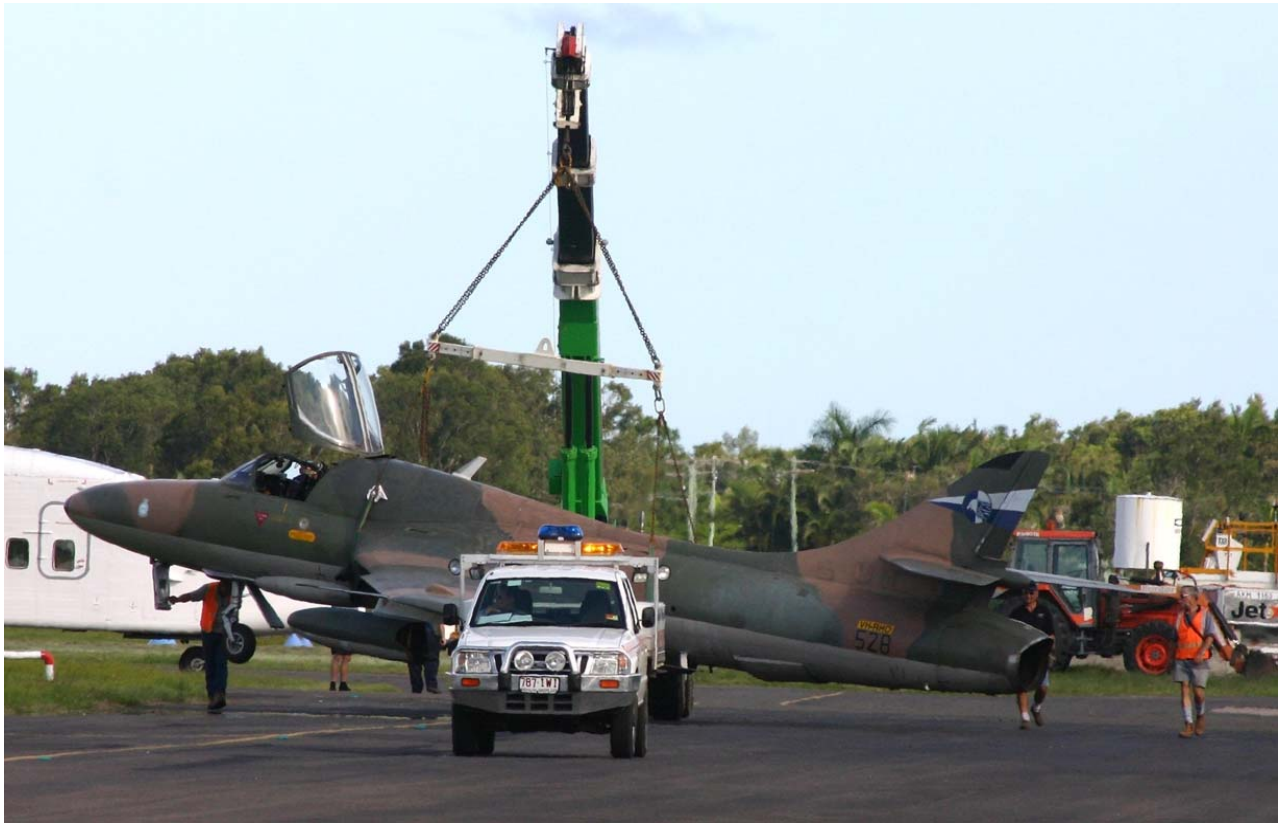
Aftermath of Hunter T75 landing gear accident in Australia. Source: Greg Weir. Copyright © 2006. [www.airliners.net](http://www.airliners.net).

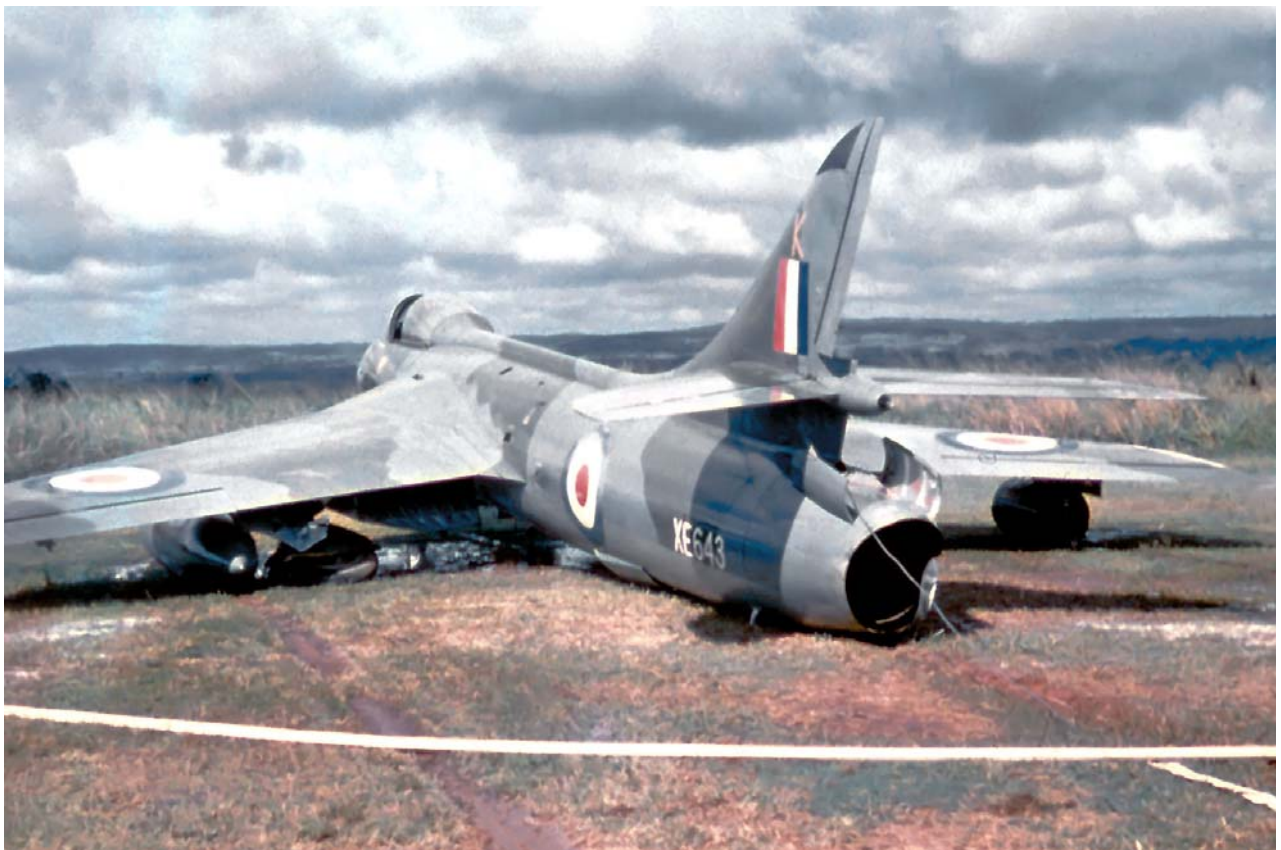
The outcome of a typical Hunter accident, a runway overrun. Source: Ray Deacon. <http://www.radfanhunters.co.uk>.

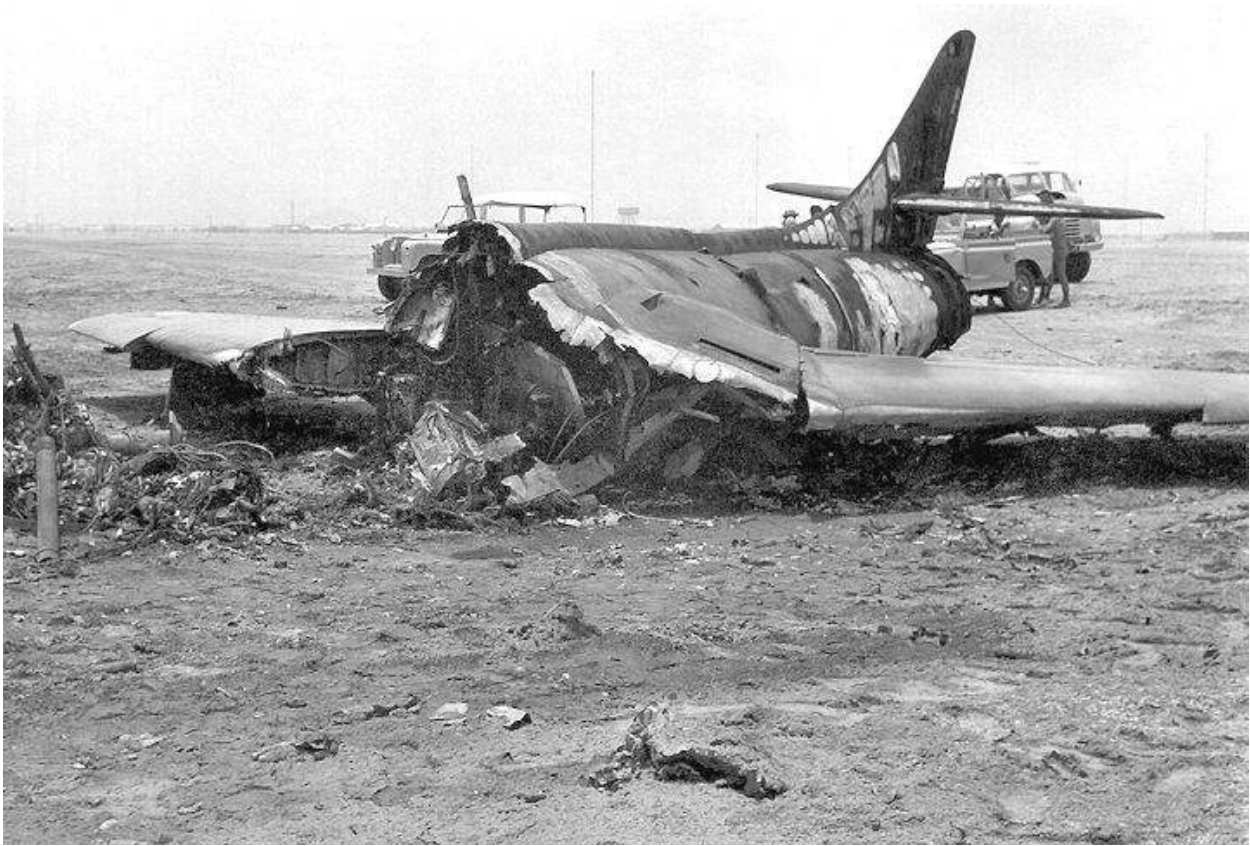
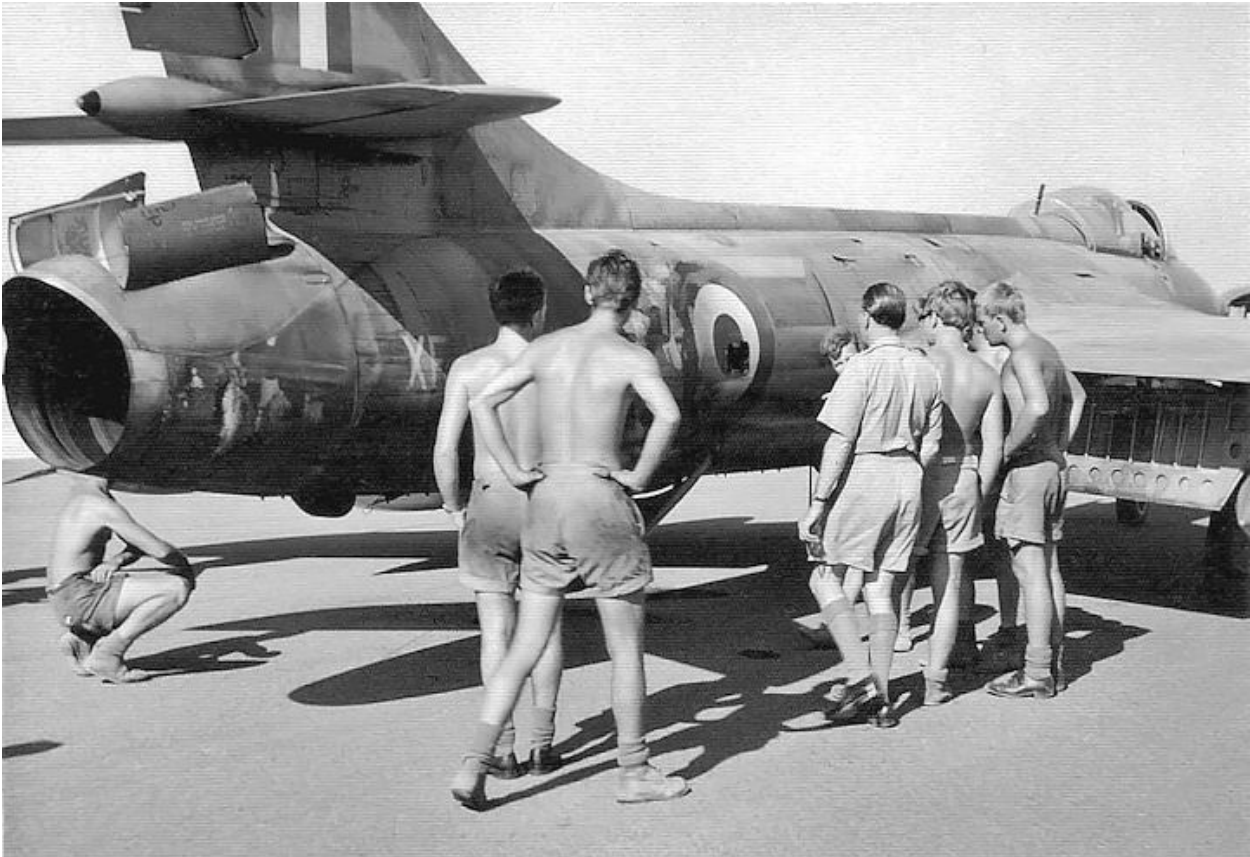
*Aftermath of two RAF Hunter engine failure accidents in the 1960s. Source: Roger Wilkins via Ray Deacon. <http://www.radfanhunters.co.uk>*

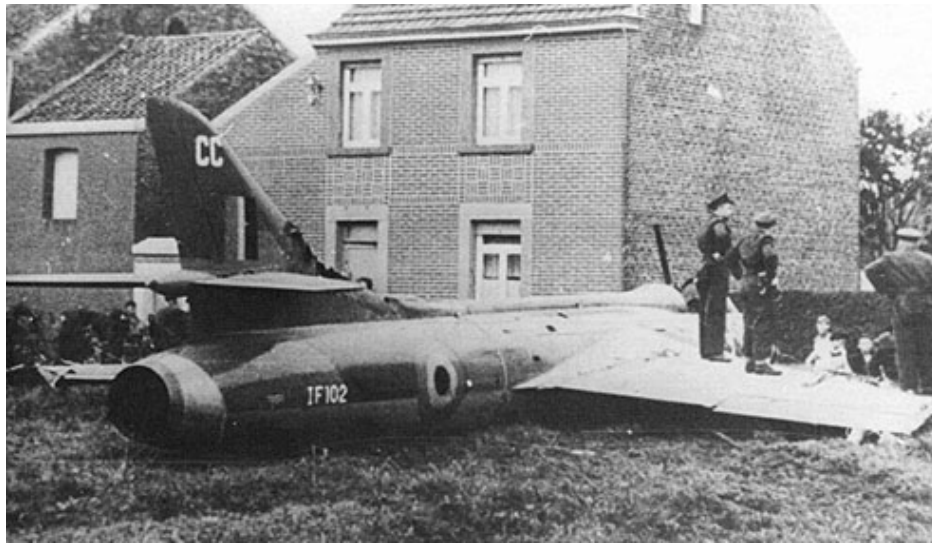
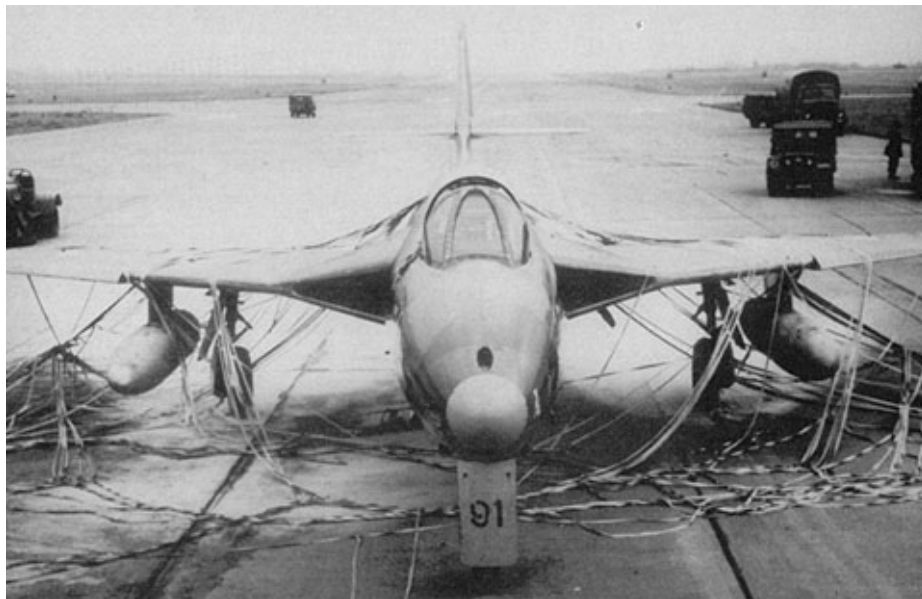
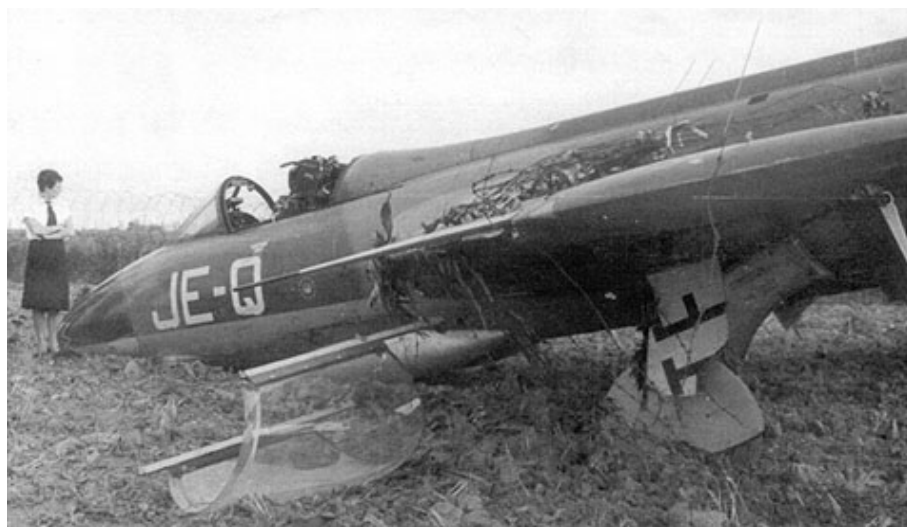
*Photos above: Belgian AF Hunter accidents 1958-1960. Source: Belgian AF.*

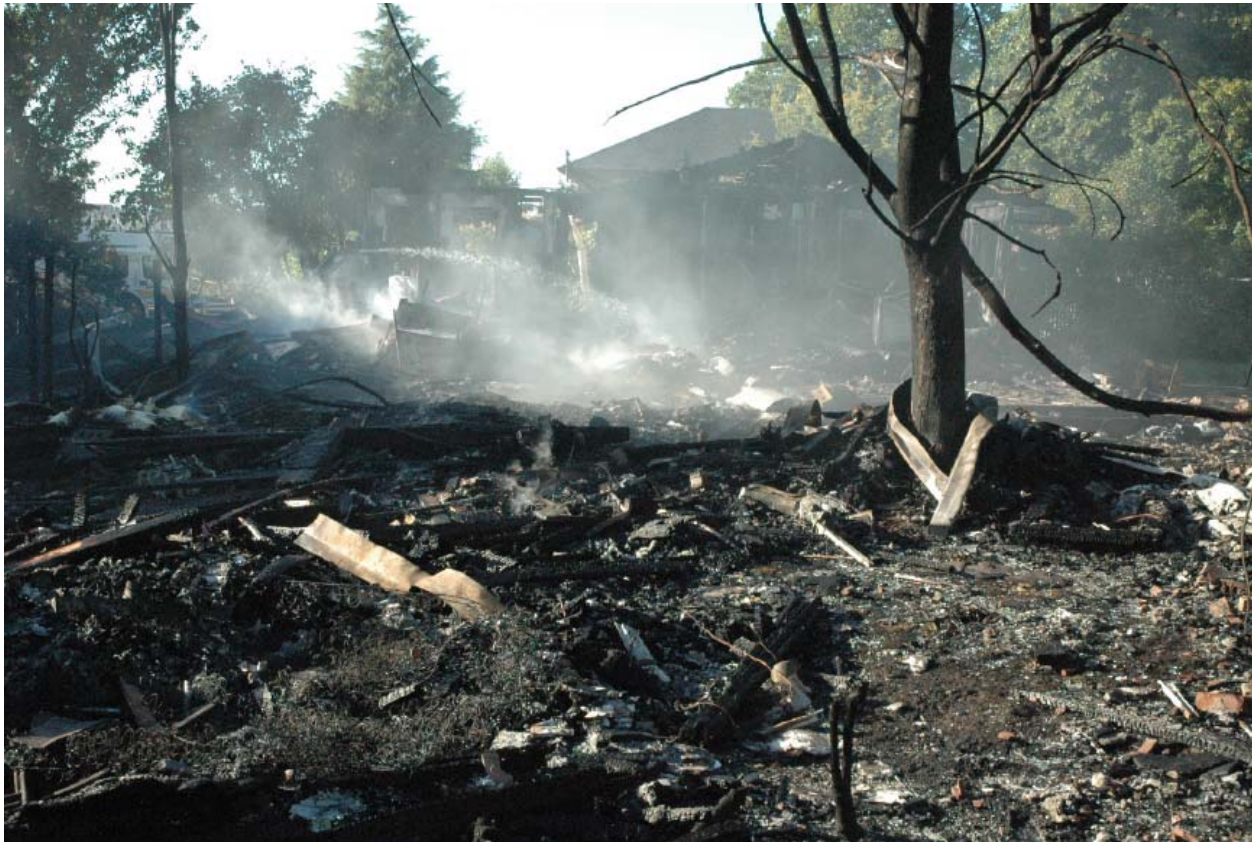
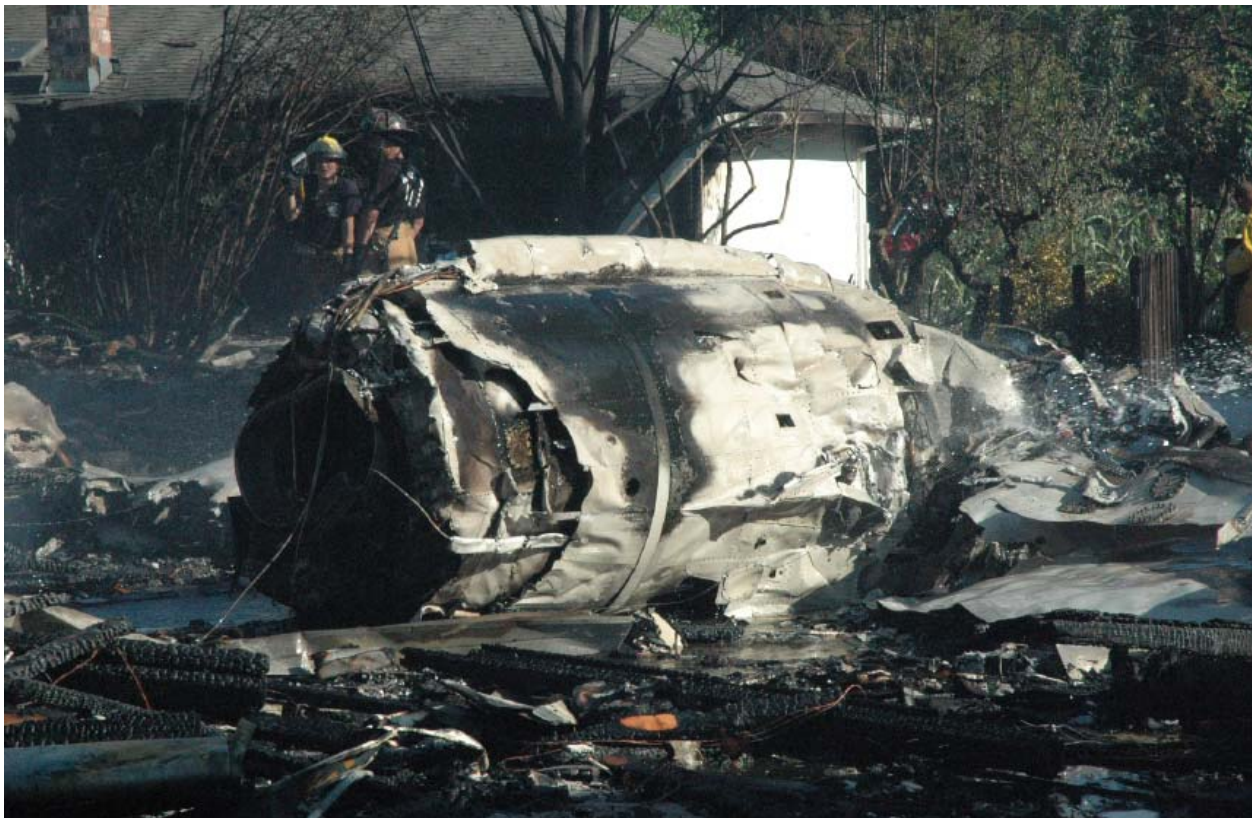
*Above and below, two photographs of the aftermath of the fatal July 2006 Hunter Mk. 58 crash (loss of engine power) in a residential area in Hillsboro, Oregon. Source: NTSB.*

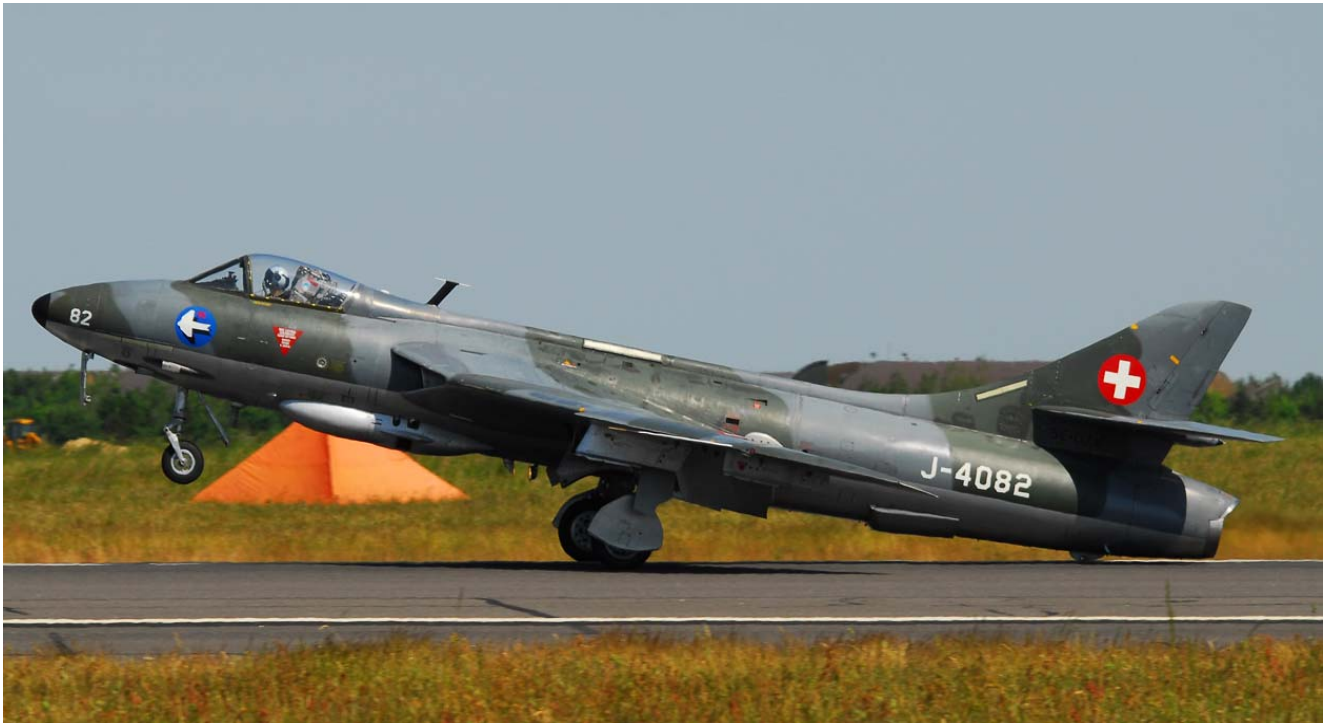
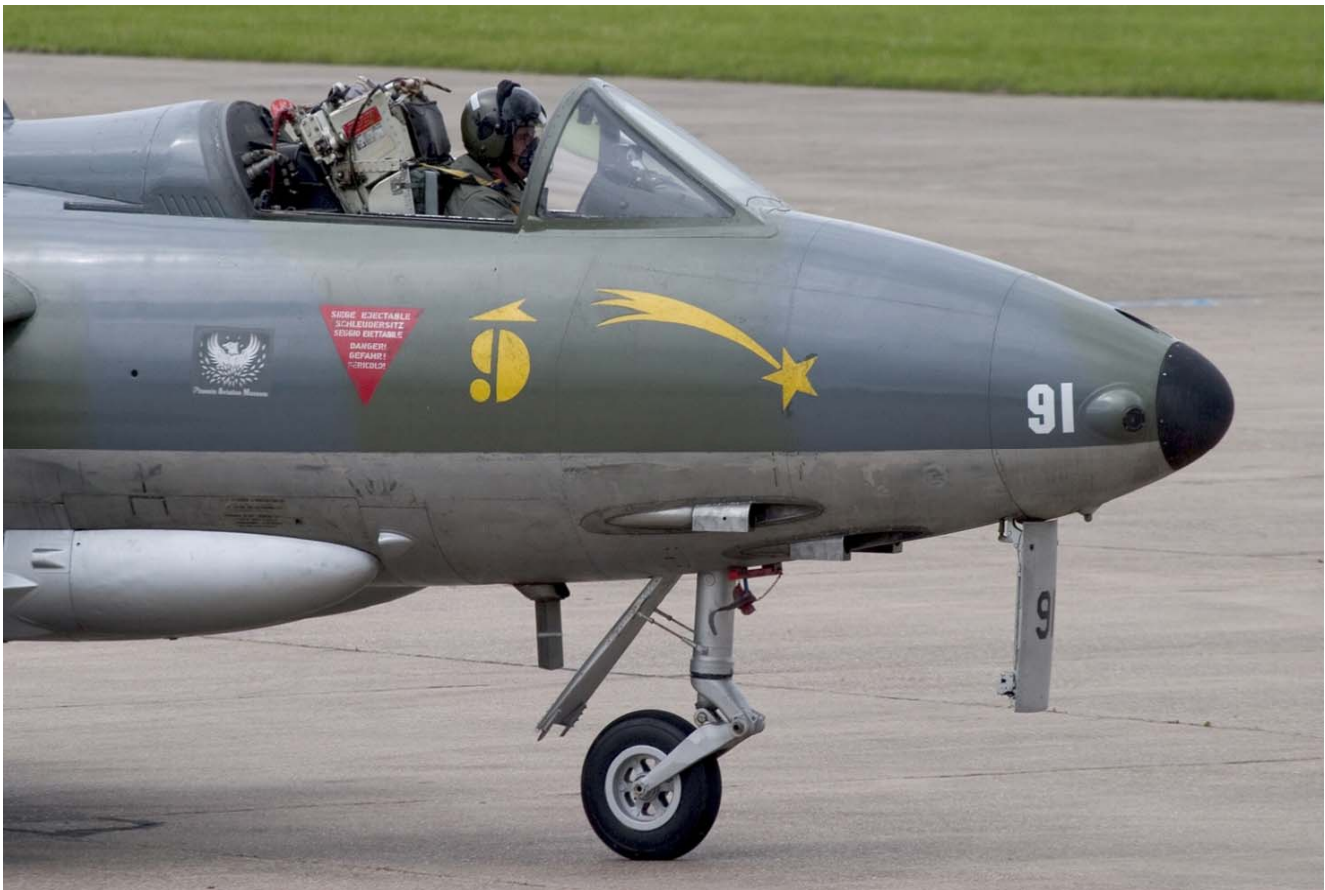
Above, Swedish-registered Hunter Mk.58 (SE-DXM) illustrating the Hunter's high potential for tail strikes during a landing in 2008. Source: Kurt Saxkjaer. Copyright © 2008. [www.airliners.net](http://www.airliners.net). Below, the result of an inadvertent pull, by an airshow spectator, on the Hunter's emergency canopy release system, UK, 2004. Source: Steve Petch. Copyright © 2008. [www.airliners.net](http://www.airliners.net).

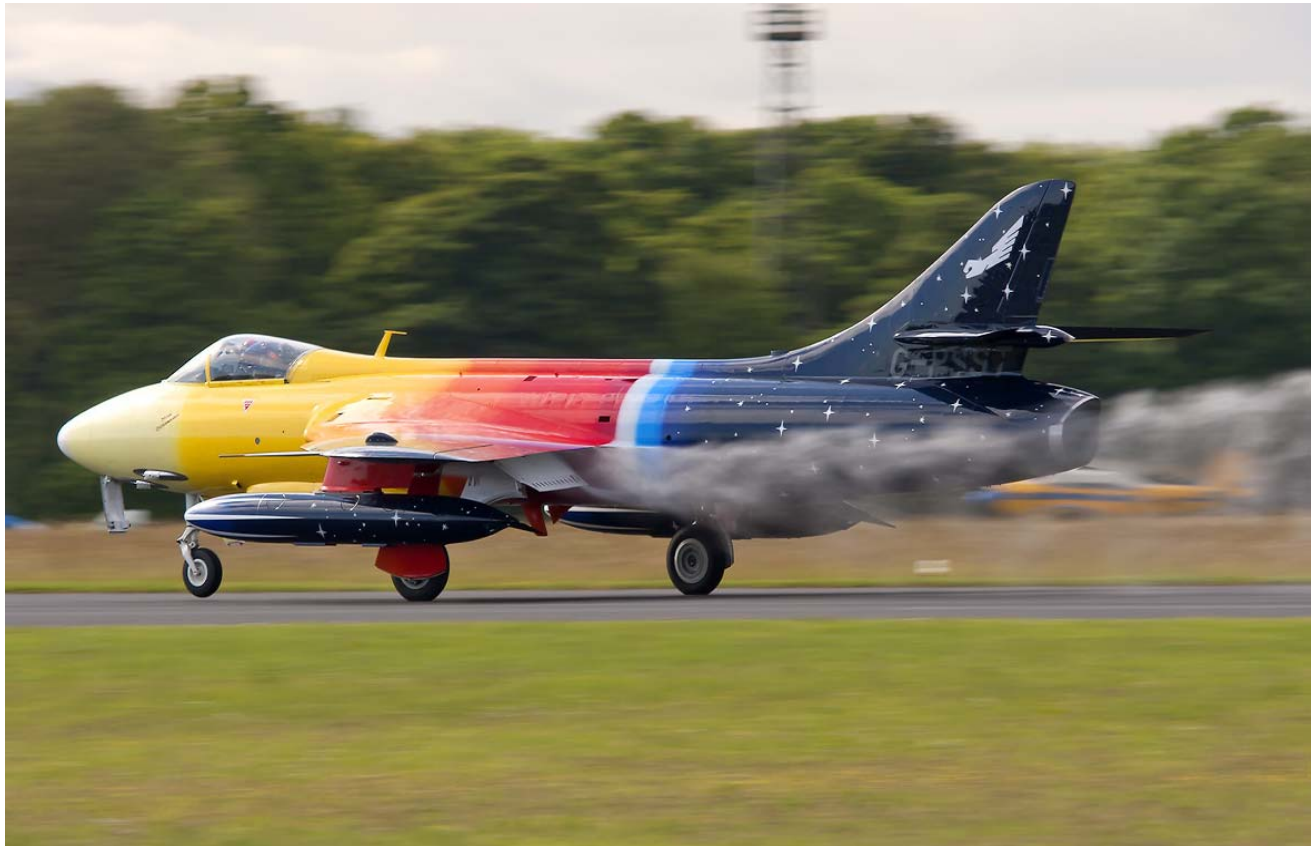
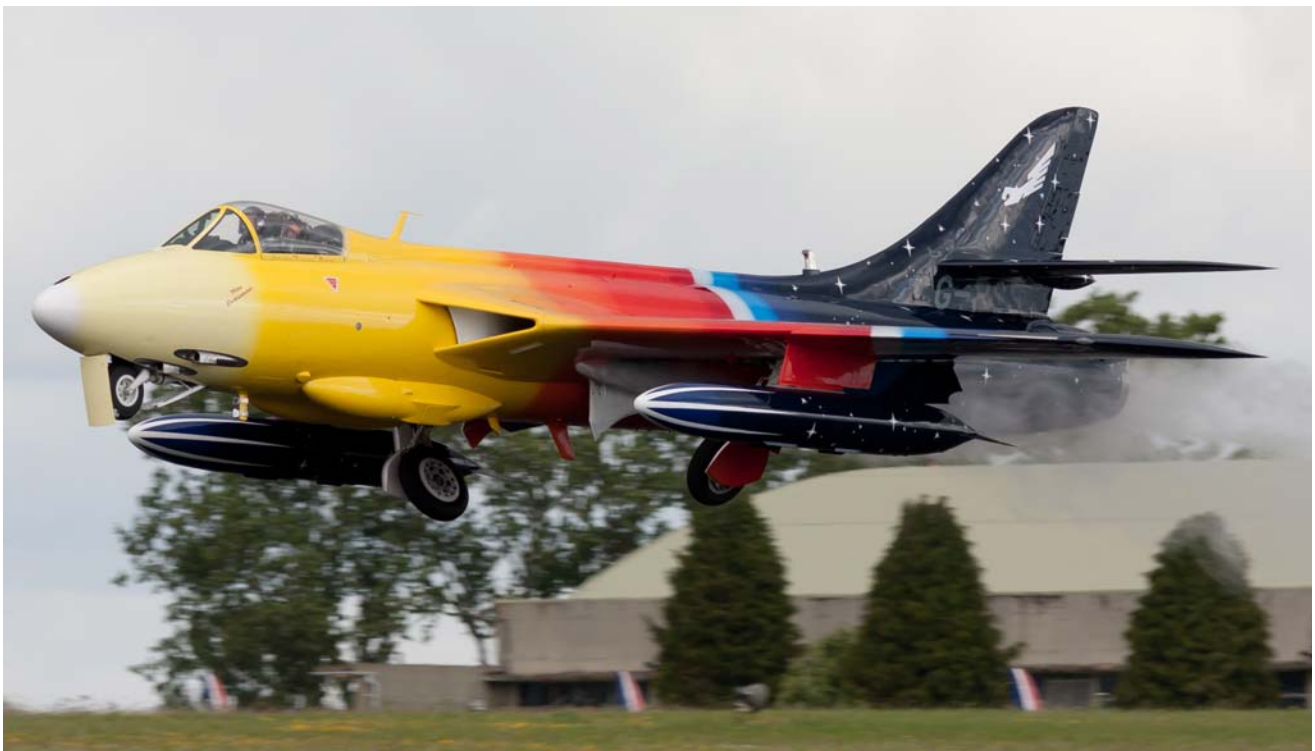
*Hunter Mk.58 G-PSST accelerating during take-off at Kemble (UK) in June 2011. A rather significant amount of fuel is leaking and seen streaming. It was the result of a sticking refueling pressure relief valve. Source: Michael Brazier-Aviation-Images. Copyright © 2011. [www.airliners.net](http://www.airliners.net). Below, another view of the incident a few instances later. Note the origin of the fuel leak forward of the white-painted fuselage gear door. Source: Max Hawkins. Copyright © 2011. [www.airliners.net](http://www.airliners.net).*

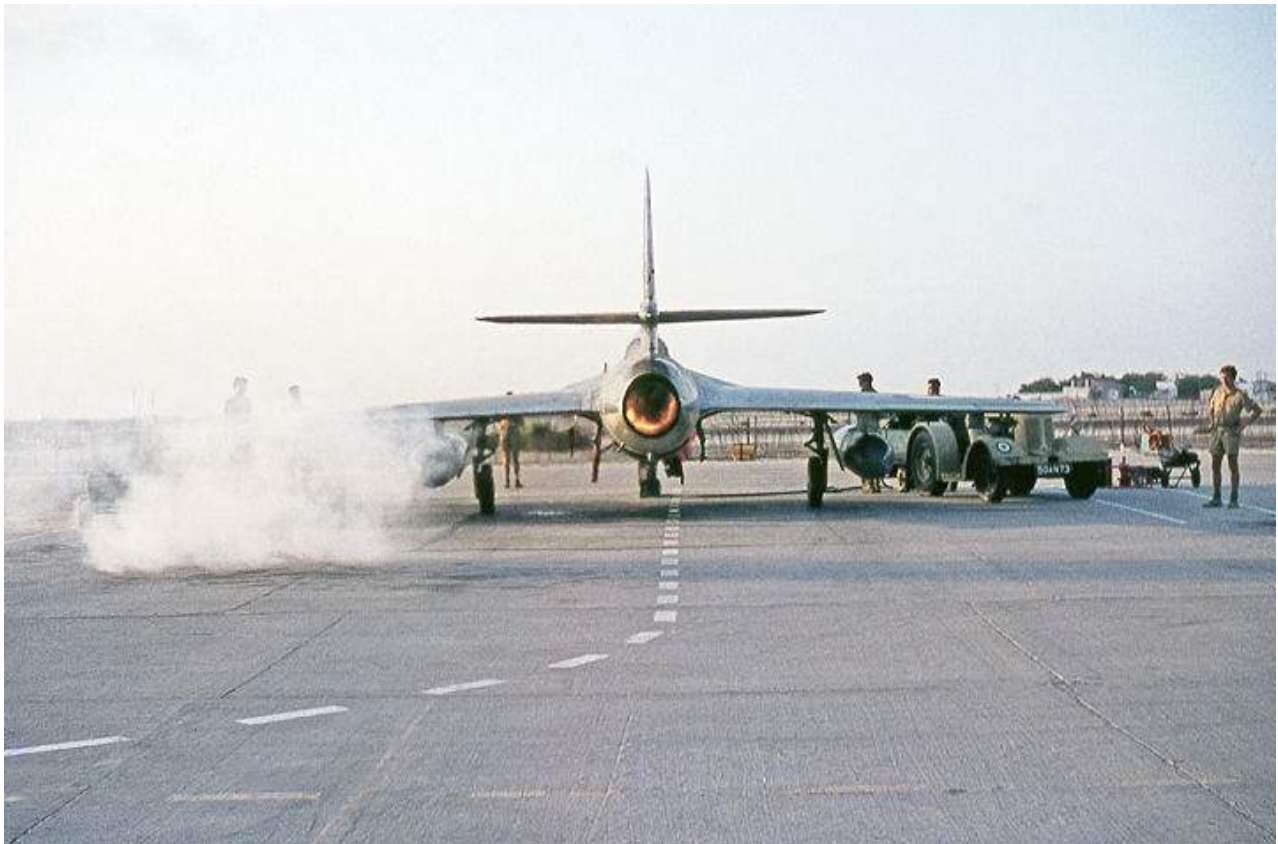
Above, a RAF Hunter FGA9 experiences the result of a second light-up attempt. Source: Ray Deacon. <http://www.radfanhunters.co.uk>. Below, a rather busy view of Royal Navy Hunters undergoing maintenance in the 1970s. Source: Mark Russell. Copyright ©2011. [www.fraduhunters.co.uk](http://www.fraduhunters.co.uk).
