SUBJECT: Counterbalance valve squeal

TO: Mike [REDACTED]
FROM: Howard [REDACTED]
DATE: August 31, 19[REDACTED]
SUBJECT: AT235 AND TA35 ARTICULATING ARM CYLINDER NOISE
COPIES: Dan [REDACTED], Daryl [REDACTED] LeRoy [REDACTED]

Subject: An evaluation of a returned No.S-502, 1/2 inch swage socket with magnetic particle indications below the eye section.

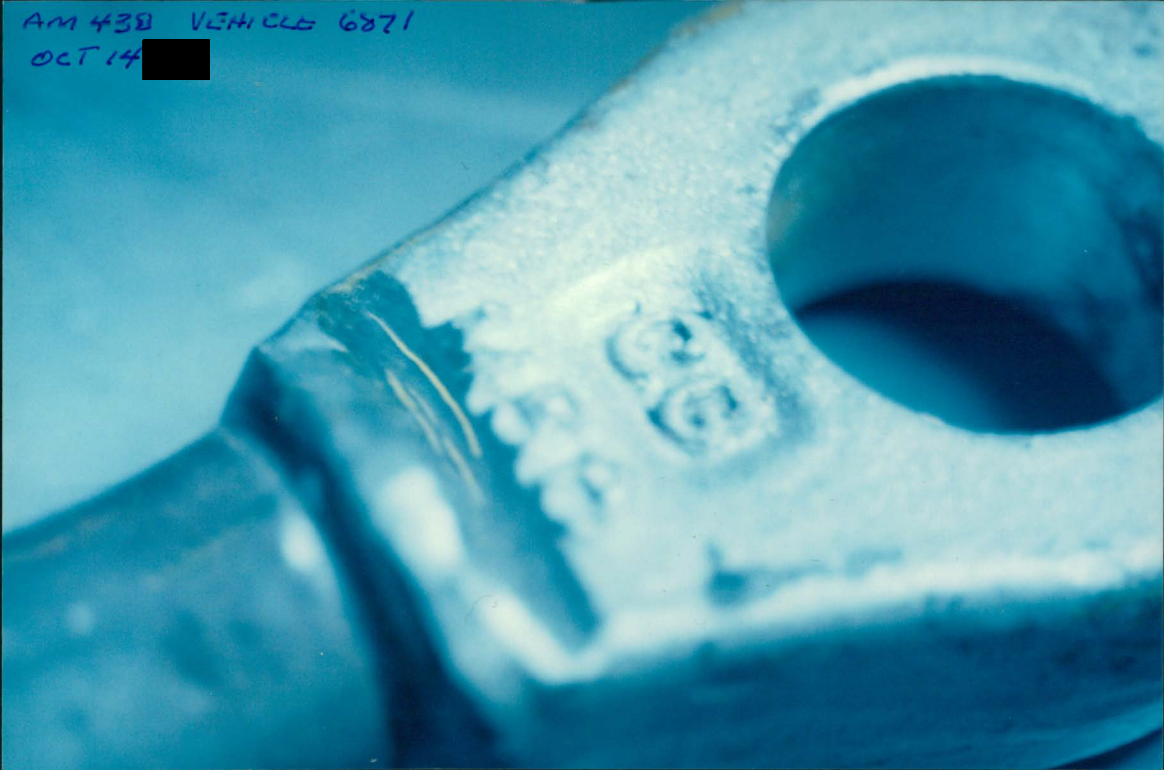
AM 438 VEHICLE 6871
OCT 14 [REDACTED]

Enclosed are [REDACTED] inspection people rejected this cable and a new one was ordered. We sourced the cable from our inventory from Kit 750-40013 shipped to us on P-ticket 24694, 02/25/94. The forged end is shaped differently.

1. What is our opinion of the cracks that are showing? Is this a manufacturers defect, a field stress problem, forge mark ??
2. At what point (date) did we change the design and or manufacturer of the forged end? If design change only, why was it changed?

~~the~~ Judging from the pictures, the ground line in the eyelet is a forge mark. ~~I would need to see~~ ^{Upon request,} we can have a lab evaluated the eyelet. ~~if required.~~

Paul to compare the two cables and for me the visual differences. Paul will send the cable in question to me so we can get it evaluated by Arvon Labs.
