# The Nantlle Tramway (Dorothea) Tunnel: a survey, before it collapses.

John Rowlands, March 2024.

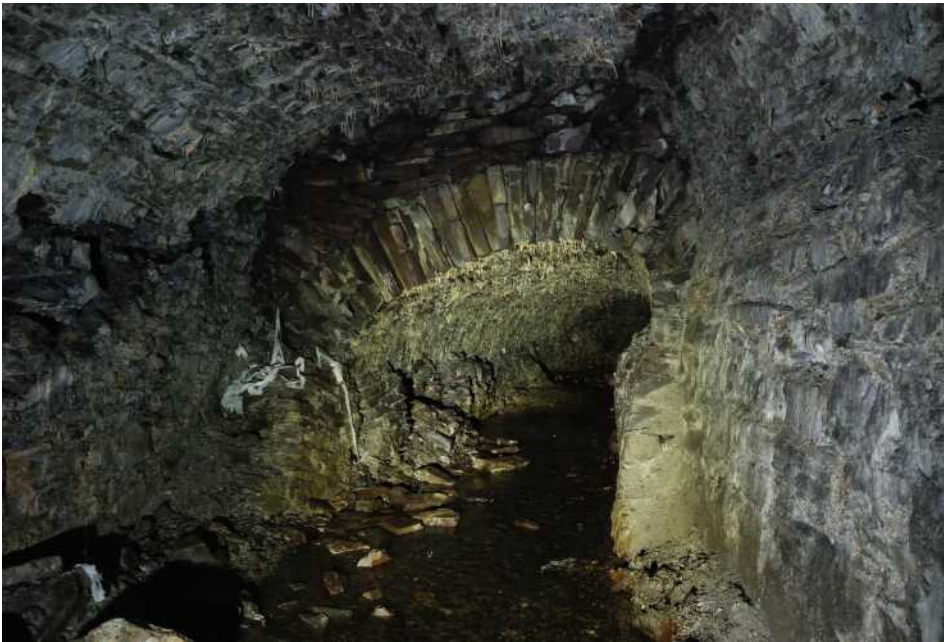
12. Looking back upstream in the tunnel (towards the eastern end) with a secondary reinforcing arch and packing above (camera at ~130m in). Low buttressing to ~1.2m up is seen along the northern (left) wall. The left face of the secondary arch and surroundings are missing blocks and slowly working their way to what would likely be a catastrophic collapse. There is room only for one track and only one was mapped as emerging in 1889. The white material at left is 'geocaching' decoration – the most ridiculous reason of all to place oneself at very high risk by being present anywhere near this section.

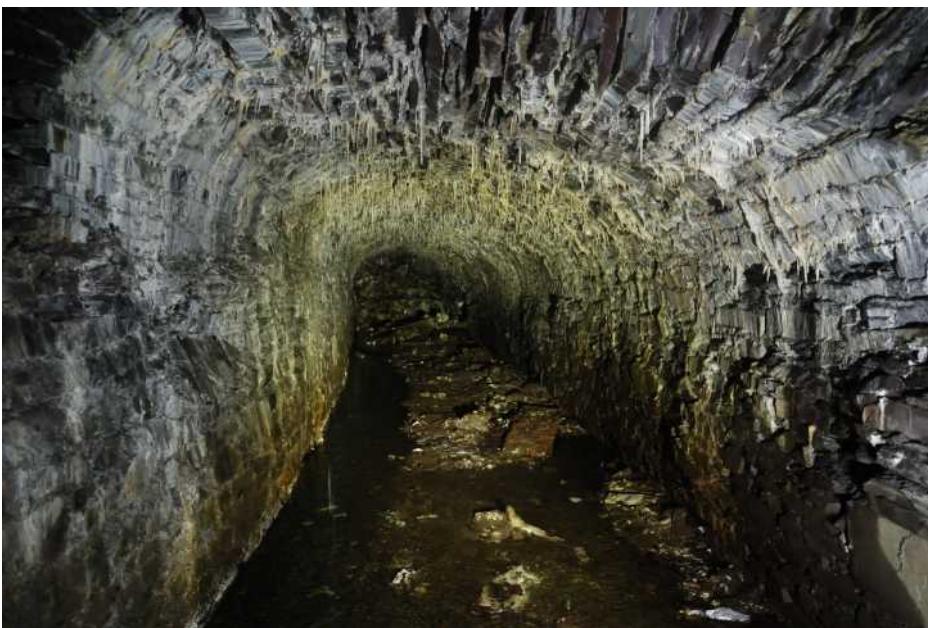
13. Western, blocked extremity of the tunnel, considered to be the natural built end, rather than a collapse. Slate blocks part way to the roof may have been deliberately set, but this is unclear. Waste within the tip is clearly visible as clean slate beyond. The tip edge and open air is probably only a few metres away. The culvert portal (see 14) emerges just in front of the blocking slate, on the right. The round rampant arch profile is very clear here.

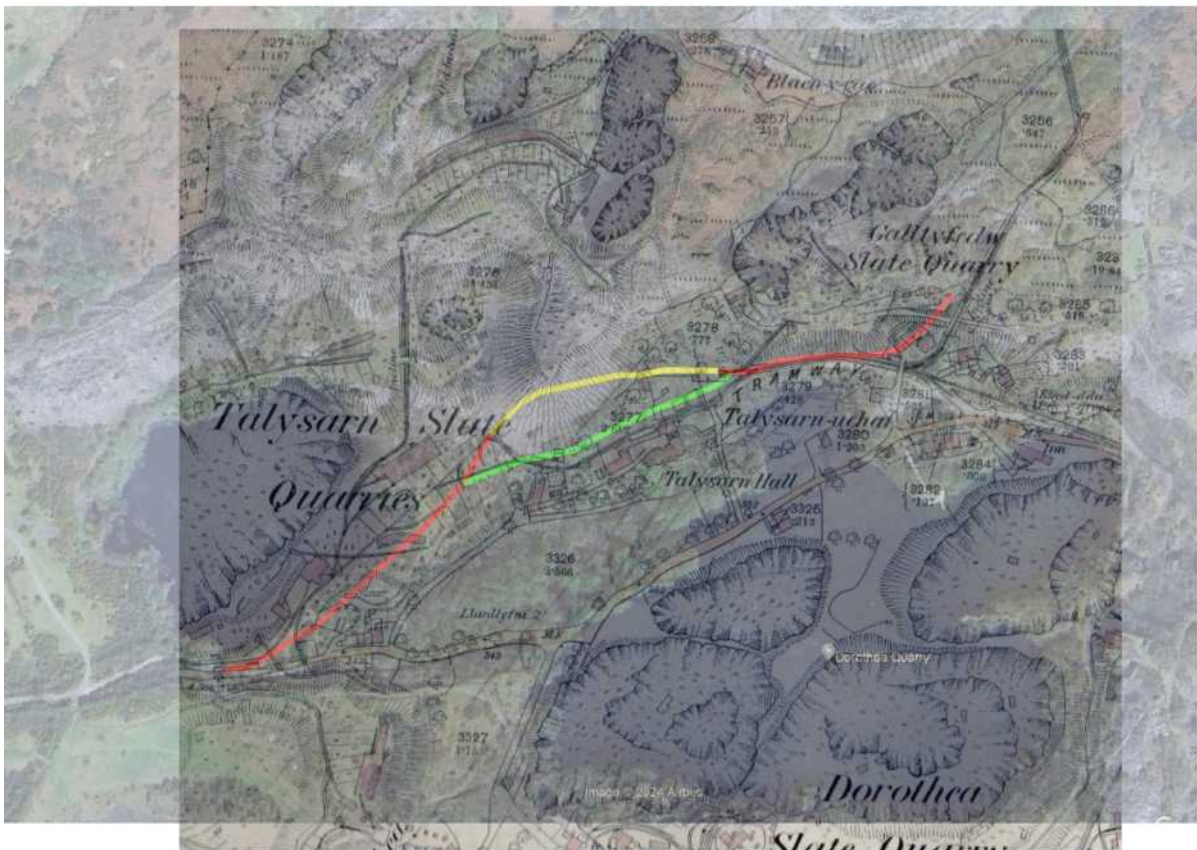
**16.** Overlay of 1889 First Edition OS map (Gwynedd Archives) and a modern satellite image with this work's surveyed tunnel route in yellow. The ends of the tunnel as surveyed align nearly perfectly with the tramway as mapped in 1889. The green, realigned route is not precisely aligned due to the difficulty of tracing the route on satellite imagery and dense tree cover. Red lines are also slightly misaligned for much the same reason and the absence of any indication of track at the western end. Crown Copyright; Google Copyright, 2024.

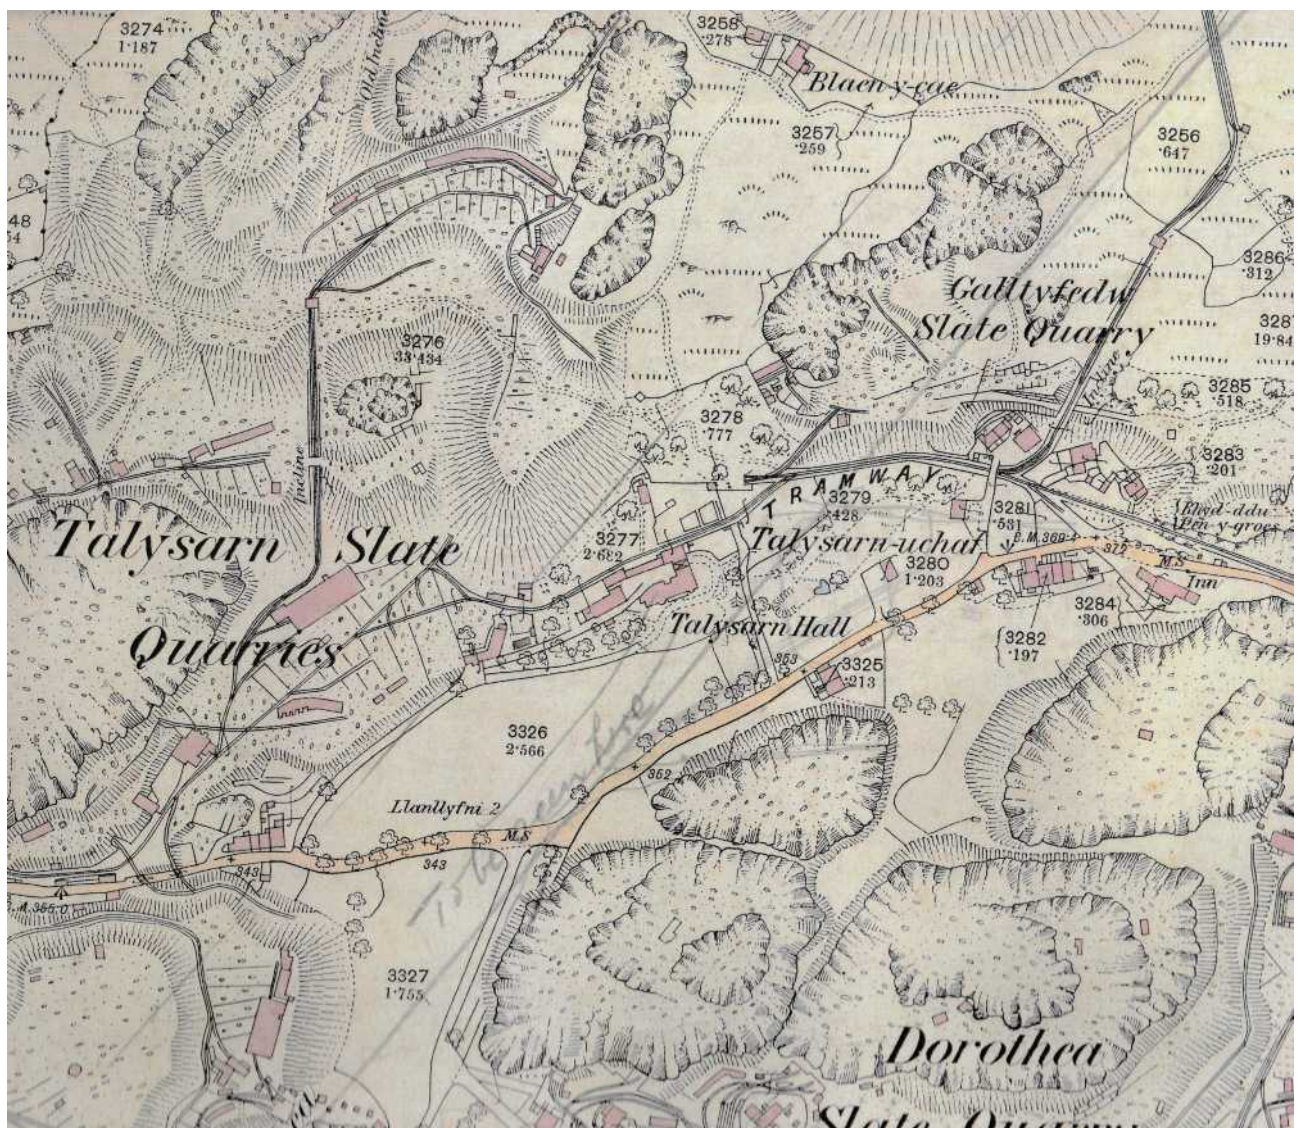
17. Extract from the 1889 First Edition OS map, clearly showing the portals of the tunnel (between the 't' and 'e' in 'Talysarn Slate...' and slightly above and to the left of 'T' in 'Tramway'. and the overlying tiptop centre left, to left of 3277. The bypass route is constructed at the time of this map, but the western portal is not yet smothered by waste, but does seem imminently threatened by further tipping or tip slippage. The tip did not grow appreciably, if at all, after this time. Gwynedd Archives: Dorothea 1538f XXI.9; Crown Copyright.

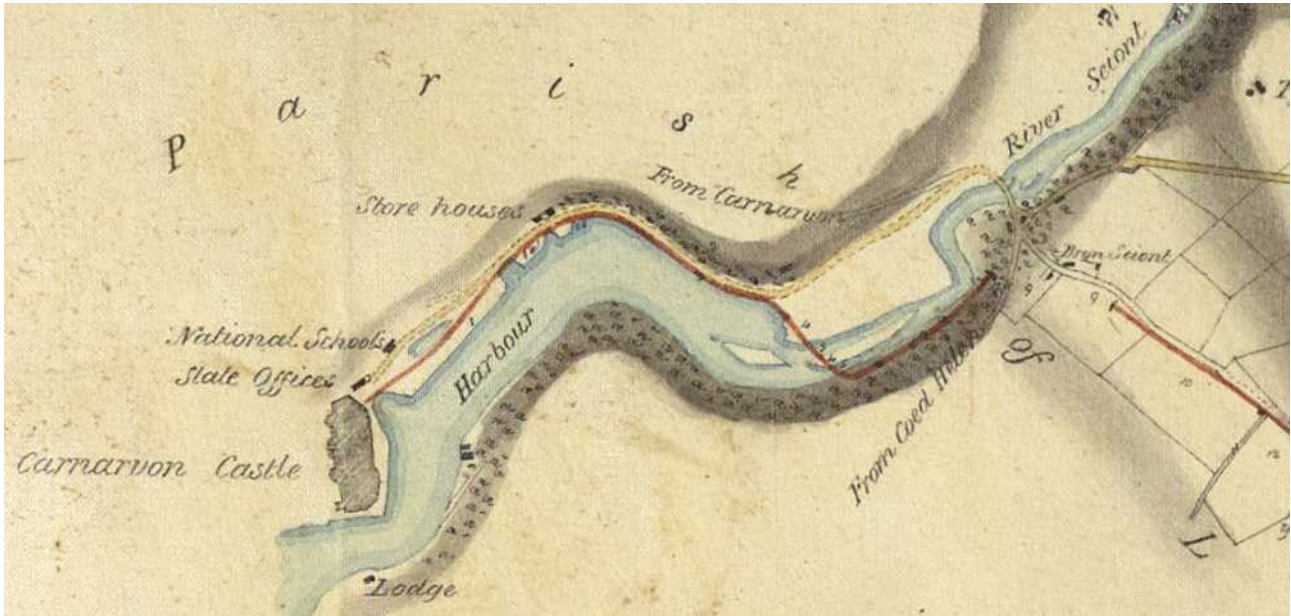
18. Extract from the plan attached to the 1825 Act (draughted November 1824) to create the Nantlle tramway, showing the Seiont estuary area at Caernarfon town. A tunnel is clearly depicted at centre right, near Bryn Seiont. Copyright, Parliamentary Archives.

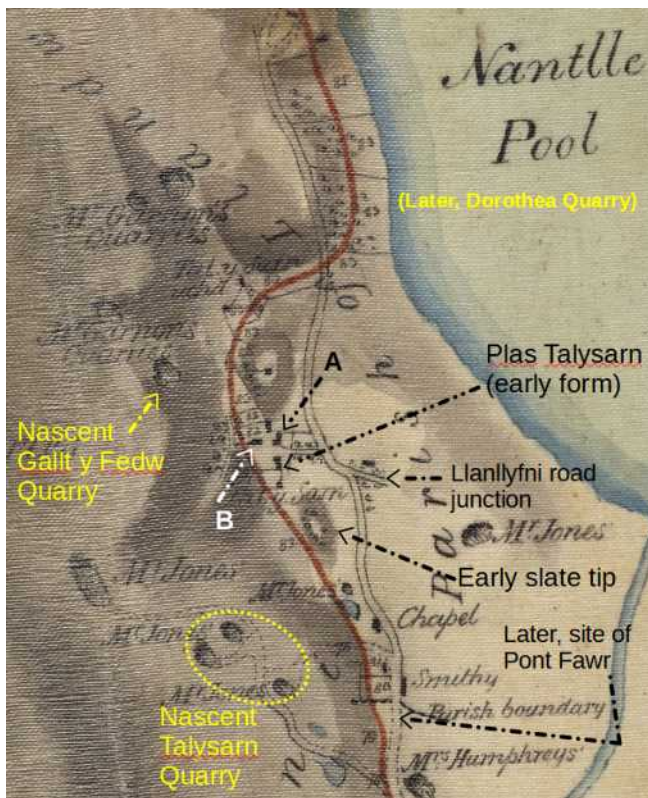
19. Plan attached to the 1825 Nantlle Tramway Act, draughted in November 1824. The red line indicates the intended tramway route. Buildings A and B remain readily-identifiable on the later, 1889 OS First Edition map (20) and allows location of the route around what is presumed to be the later arched-over, tunnel area to be established. No tunnel is indicated as being planned here at this time. No record of the indicated Chapel, later consumed by quarry development and presumably once serving Talysarn Uchaf, could be found in our archives searches. 19: Copyright, Parliamentary Archives. 20: Gwynedd Archives.

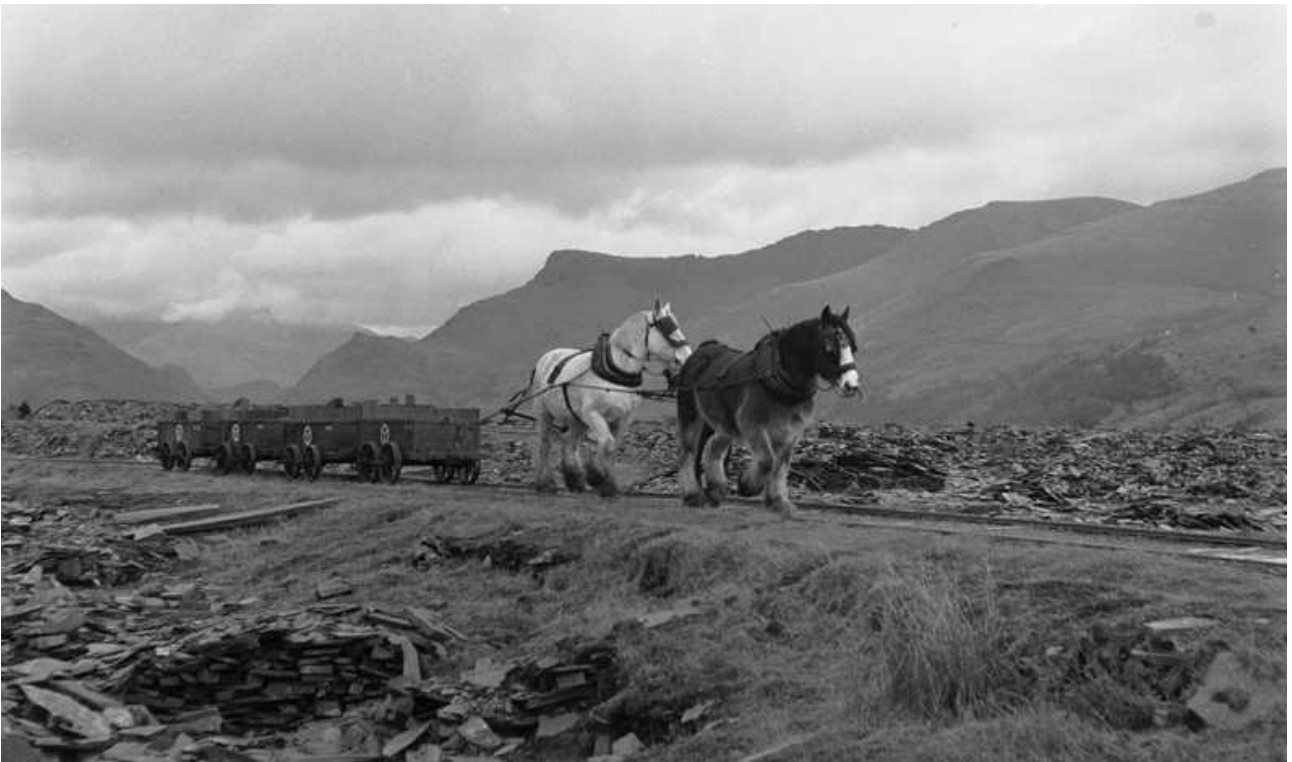
21. A pair of substantial shire horses - 'Prince' and 'Corwen' - pull wagons bearing the distinctive Blaen y Cae identifier in one of several staged photographs taken in 1959 as the line neared closure. National Library of Wales, gch18793, Geoff Charles collection released into the public domain under CC0 1.0.

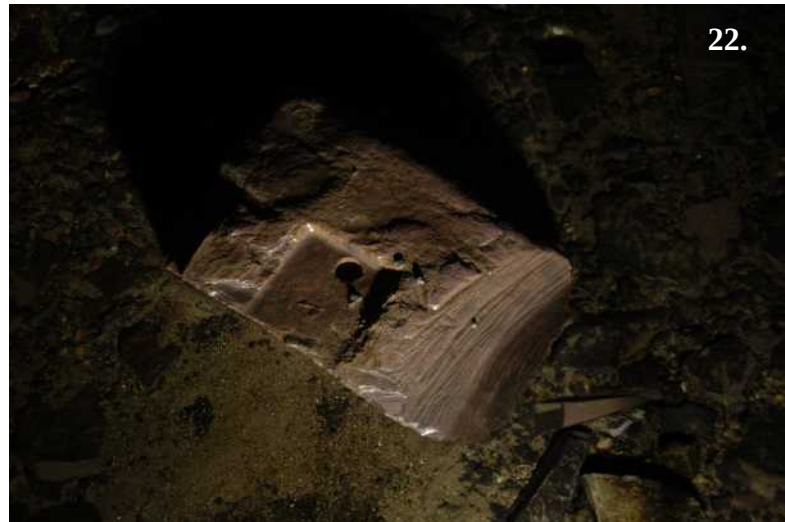
There is one rail embedded in the northern wall (23) which is in good condition, and another nearby which is in an extremely decayed state.

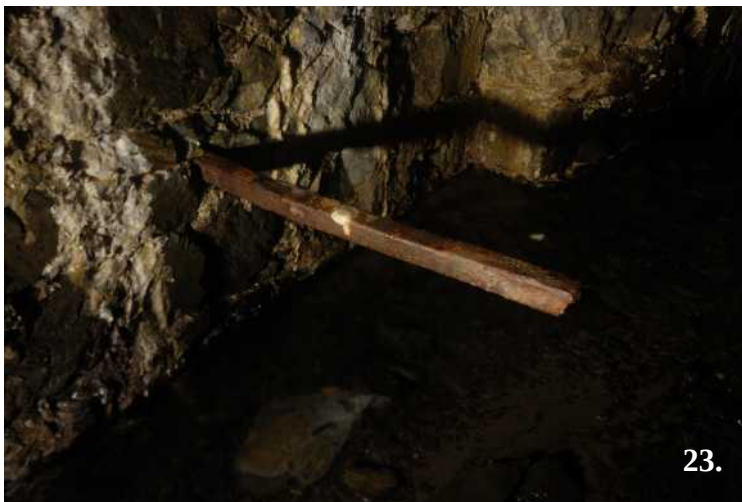
A half-round section of timber with iron bolts (24) still embedded is immersed in water immediately to the west of the first embedded rail, though what it was for is not clear. An iron bar of a flattened ellipsoid shape is found a few metres further in and again, its function is unknown.

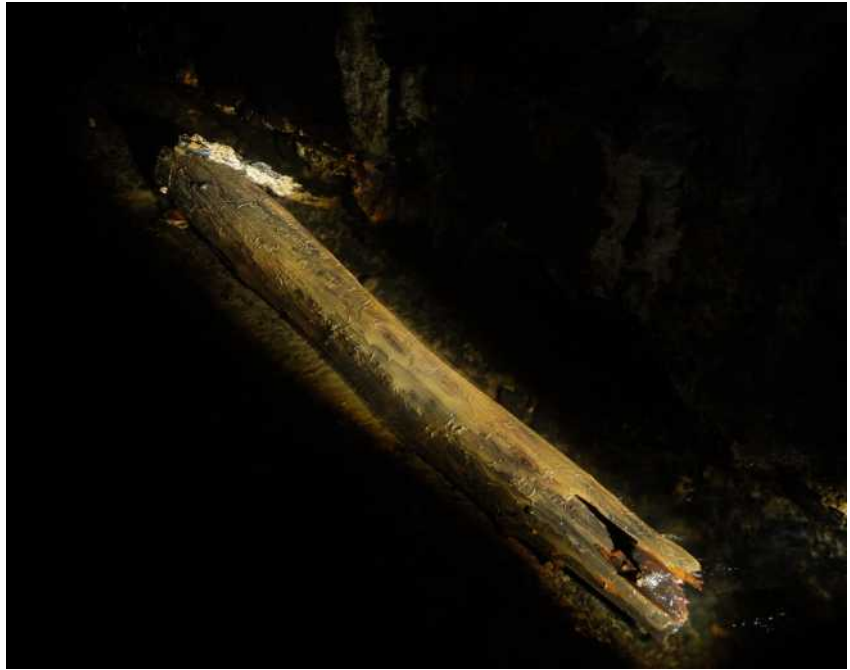
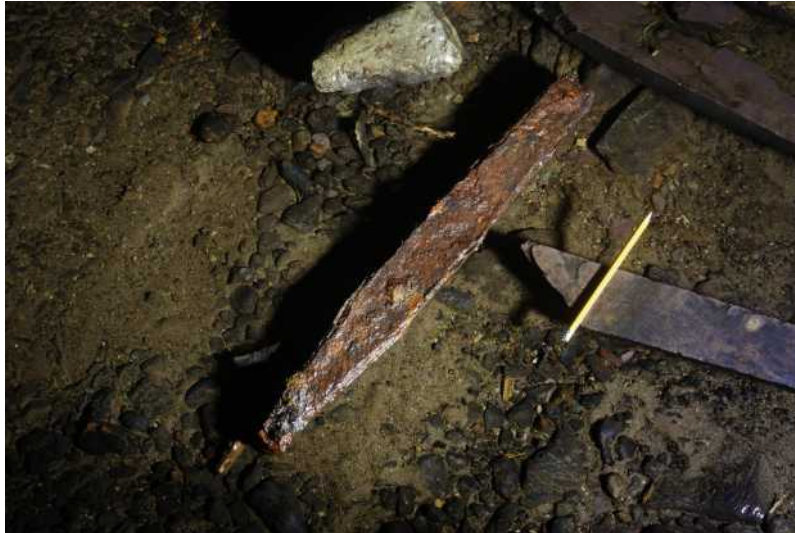
25. A currently unidentified iron artefact. Initial interpretation might be that it was related to the track system, perhaps a points mechanism.

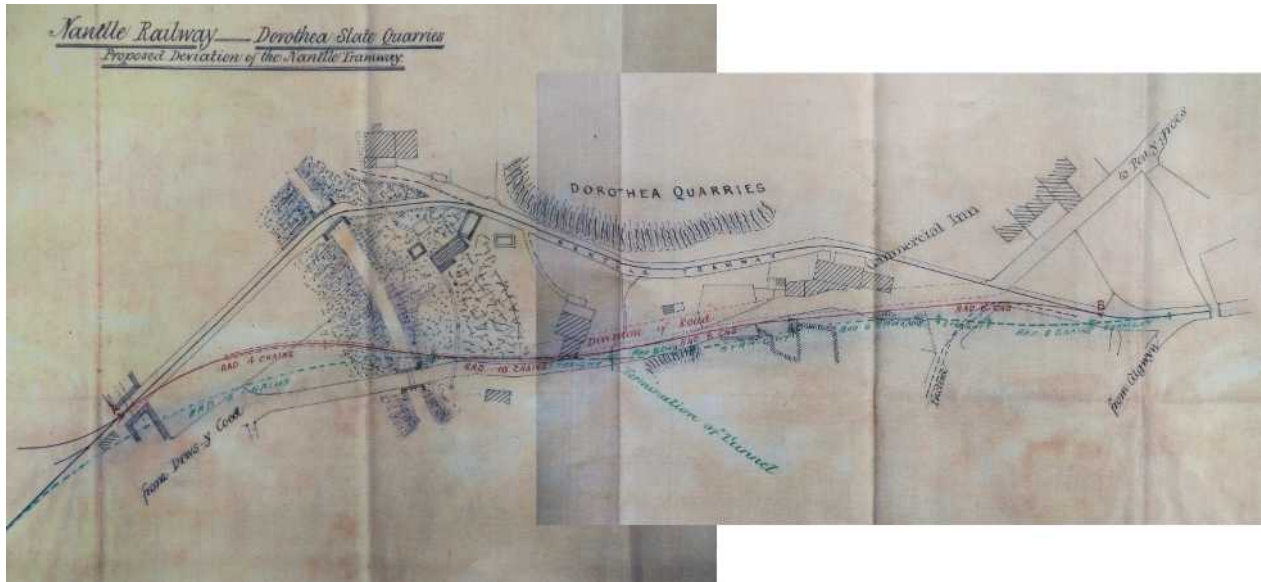
26, Above: Gwynedd Archives plan Dorothea 1560, North to bottom, showing intended diversion route. At centre is written "Termination of Tunnel" and its position. Boyd asserts the tunnel was built, with no specific reference, as usual. 27, Below : OS 1889 First Edition map capturing the area of the diversion map above. The Commercial Inn building provides a useful orientation point (noting the OS map is north to top).
