**MINISTRY OF TRANSPORTATION
AND INFRASTRUCTURE**

ISLAND RAIL CORRIDOR CONDITION ASSESSMENT

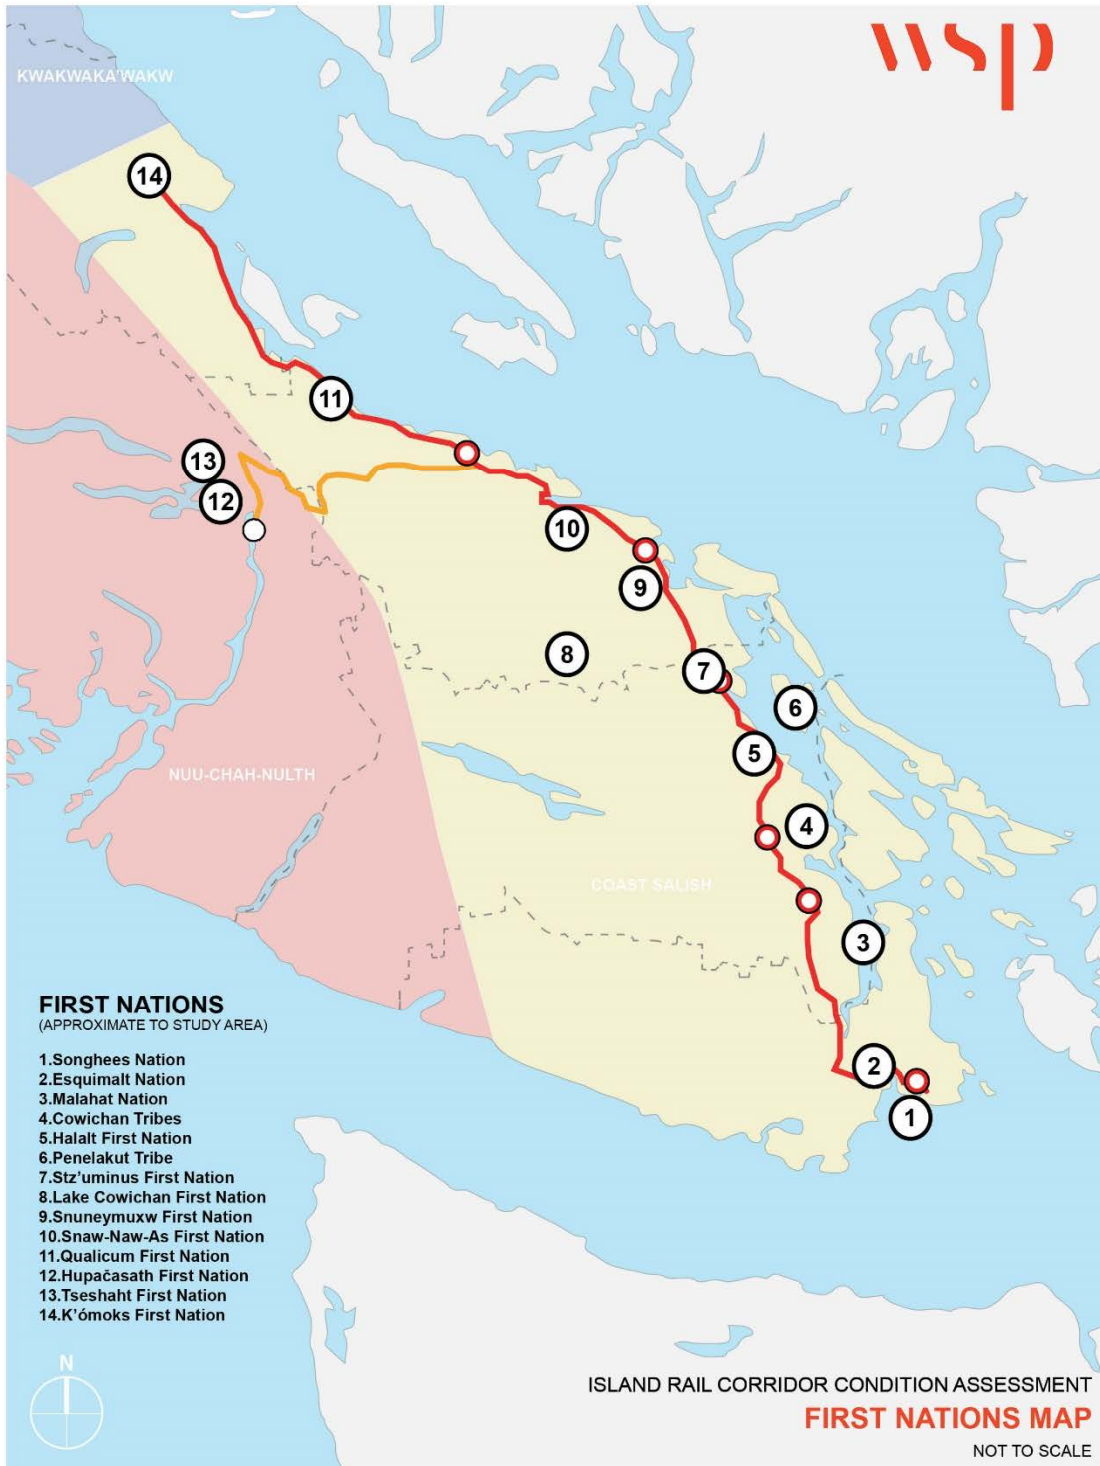
Figure 2: First Nations & Community Map

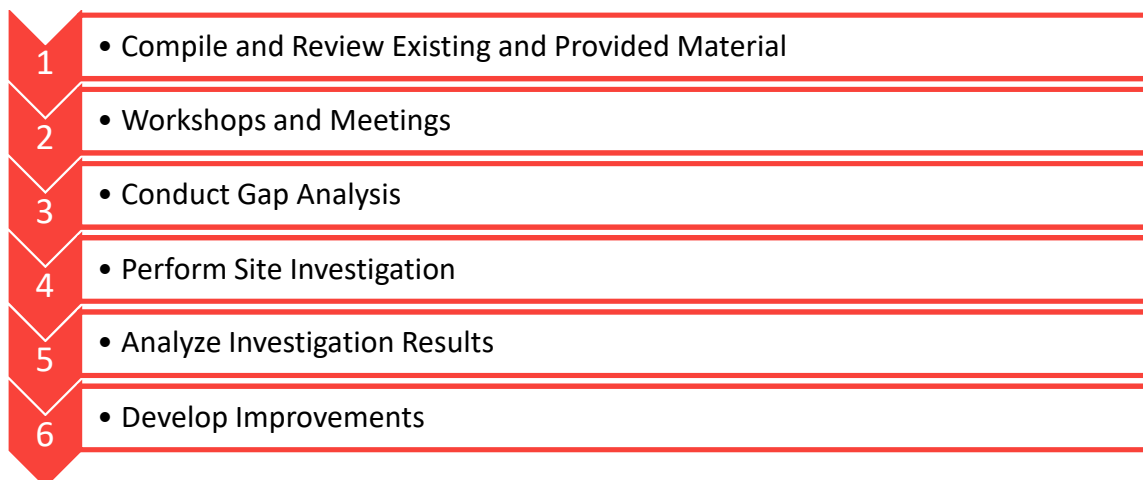
Step 1: Compile and Review Existing Information

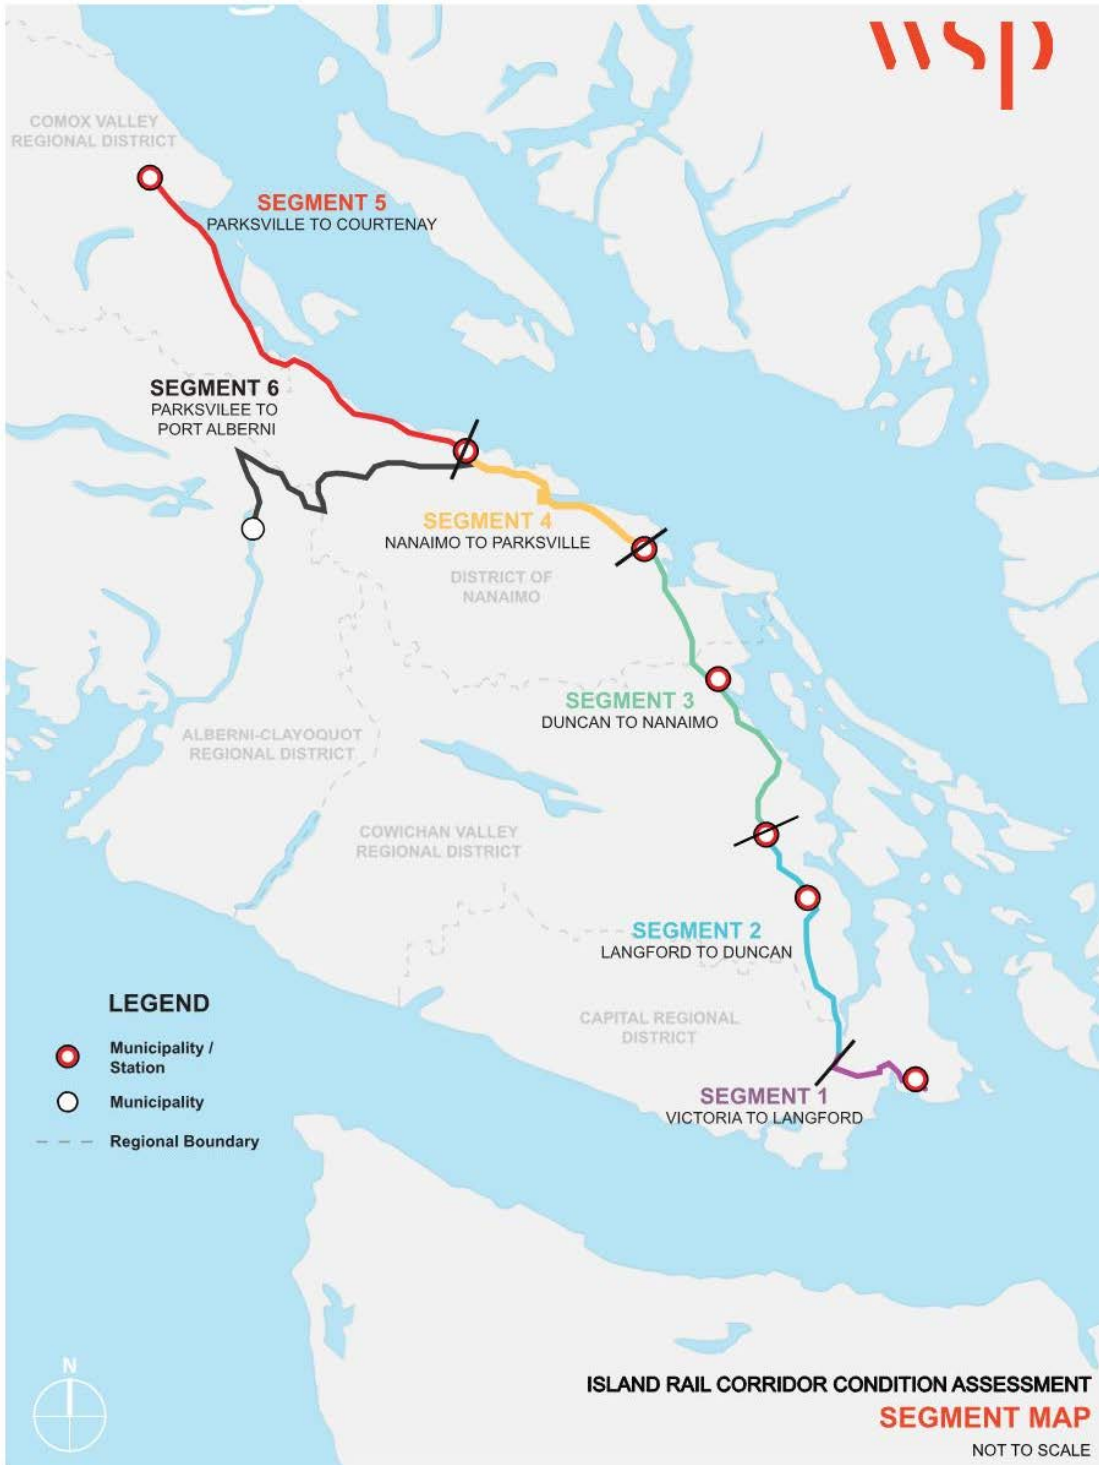
Figure 3: Segment Map

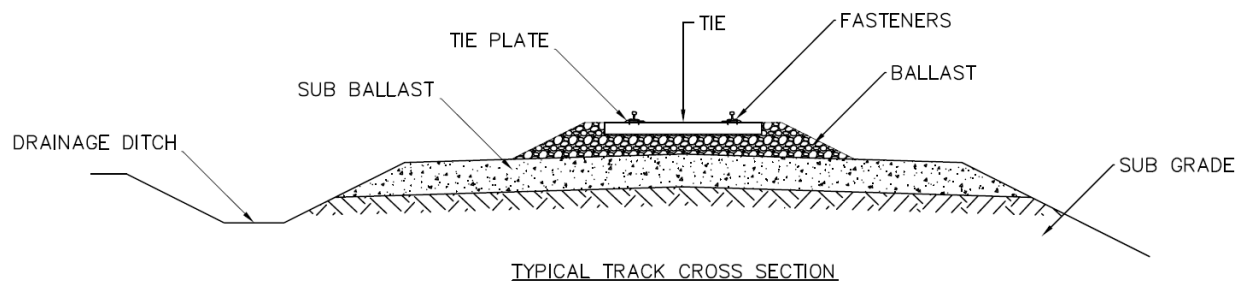
Figure 4: Typical Railway Track Cross Section

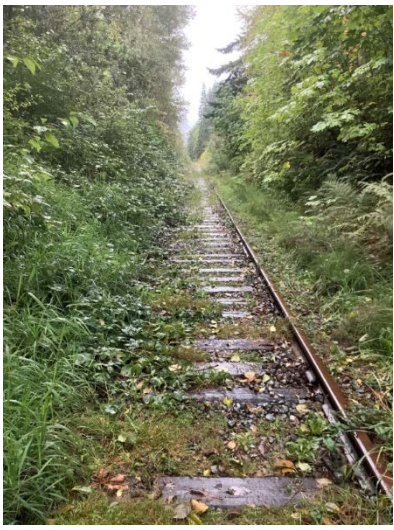
Typical "Good" Vegetation Condition	Typical "Fair" Vegetation Condition	Typical "Poor" Vegetation Condition

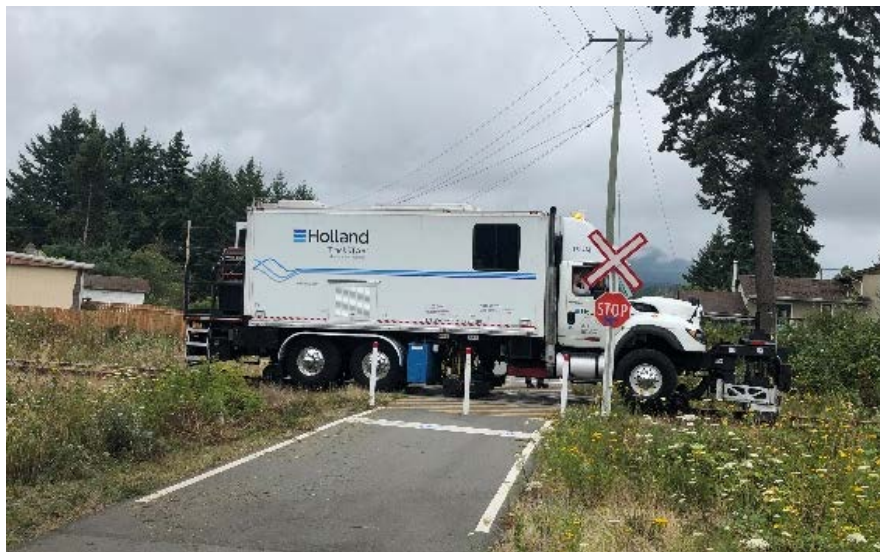
Figure 9: Holland TrackStar Vehicle observed in Nanaimo

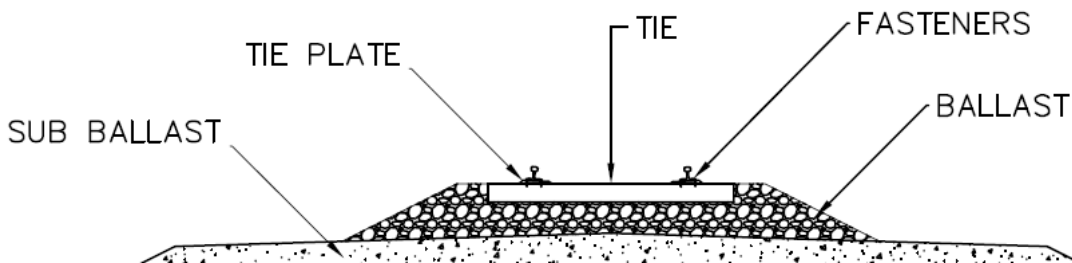
Figure 10: Typical Track Structure

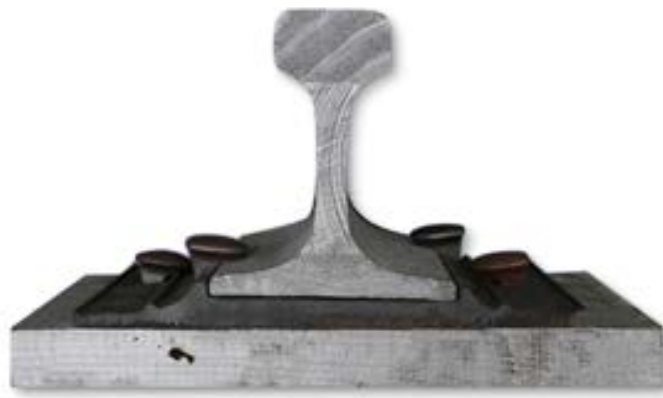
Figure 11: Rail Spike Fastening System

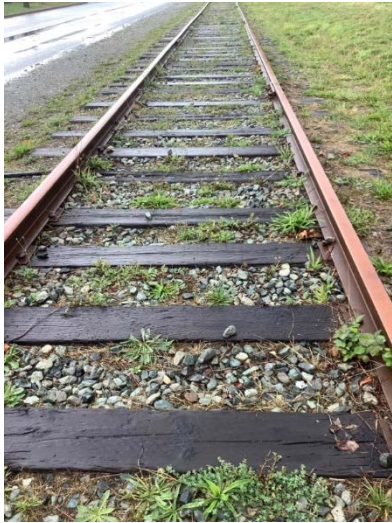
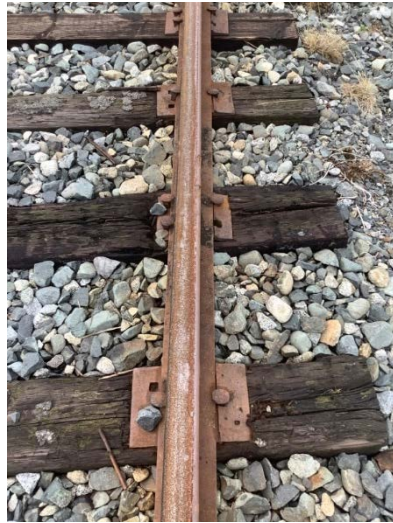
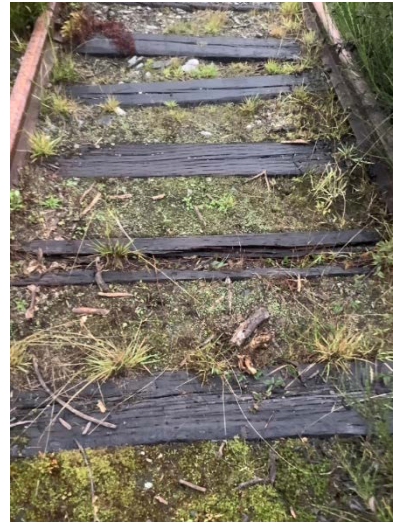
Typical "Good" Tie Condition	Typical "Fair" Tie Condition	Typical "Poor" Tie Condition

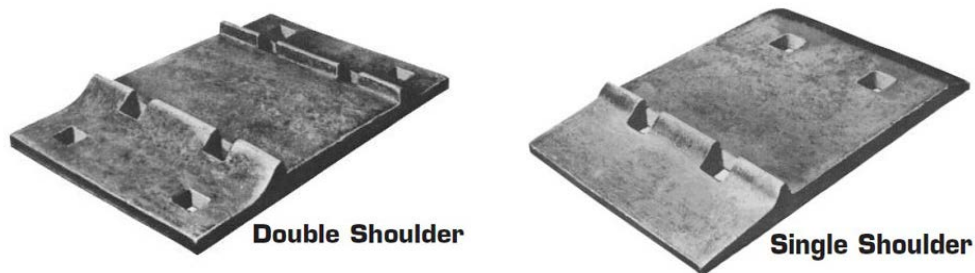
Figure 12: Types of Tie Plates

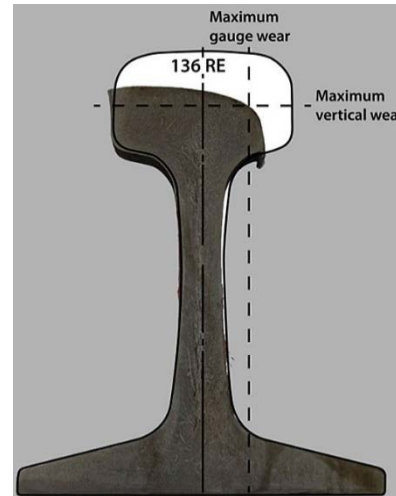
Figure 14: Head Loss (136lb rail)

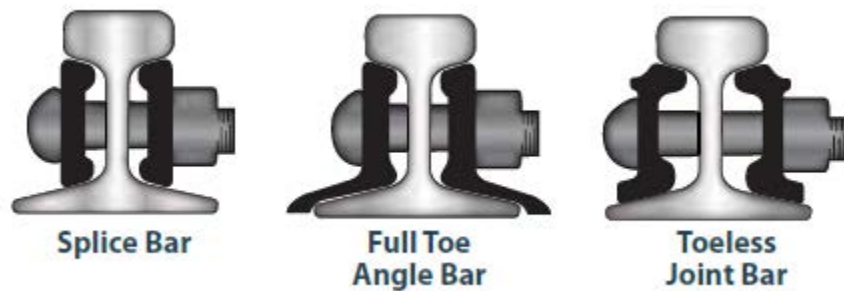
Figure 15: Joint Bar Types

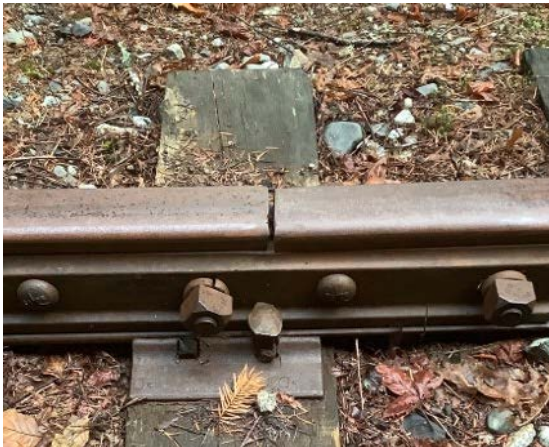
Figure 16: Standard Joint Bar

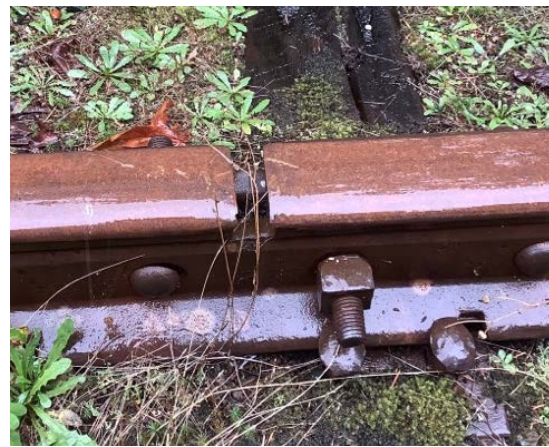
Figure 17: Angle Joint Bar

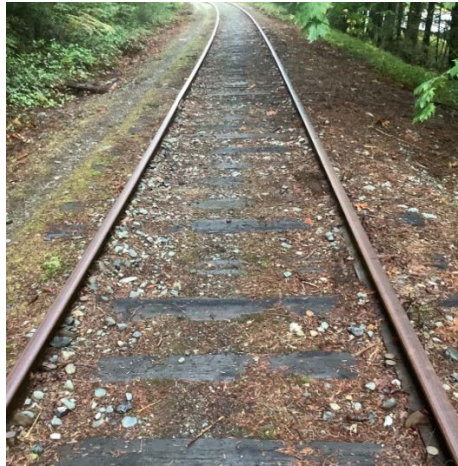
Figure 18: Typical Ballast Along the Corridor

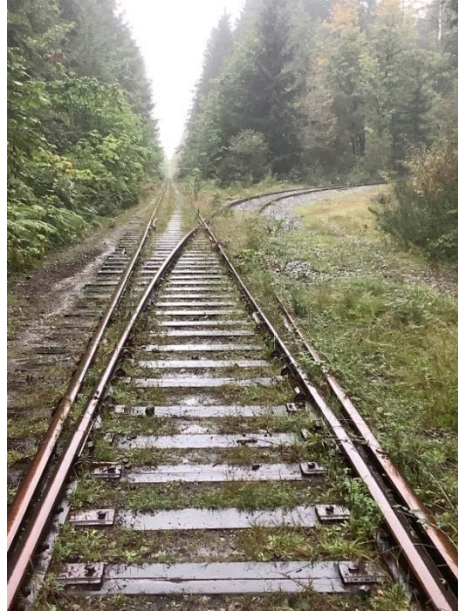
Figure 19: Typical Turnout within Corridor

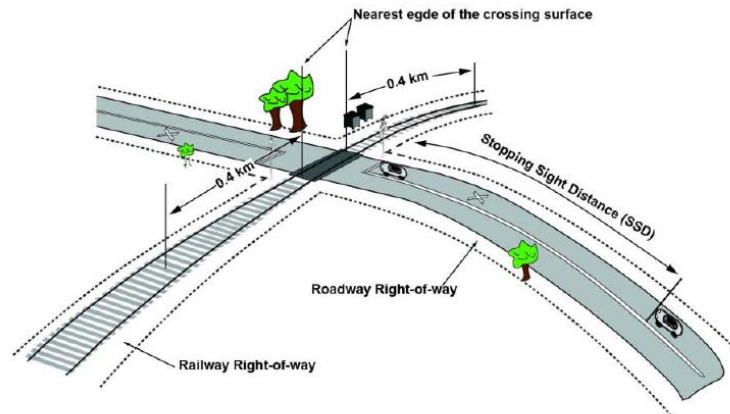
Figure 25: Typical Grade Crossing

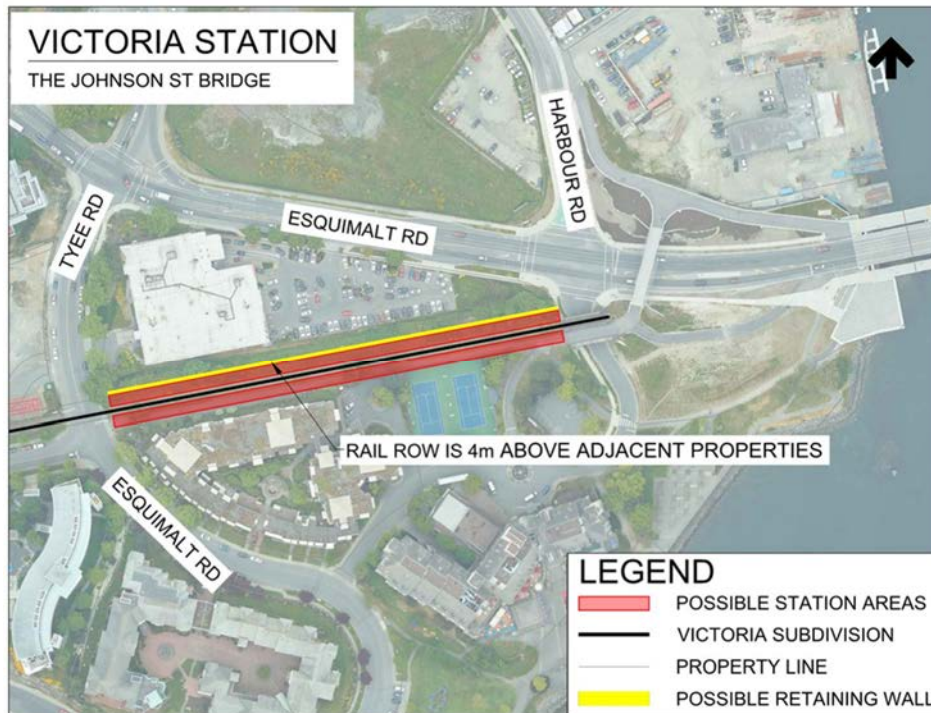
Figure 30: Victoria Station layout, context, options

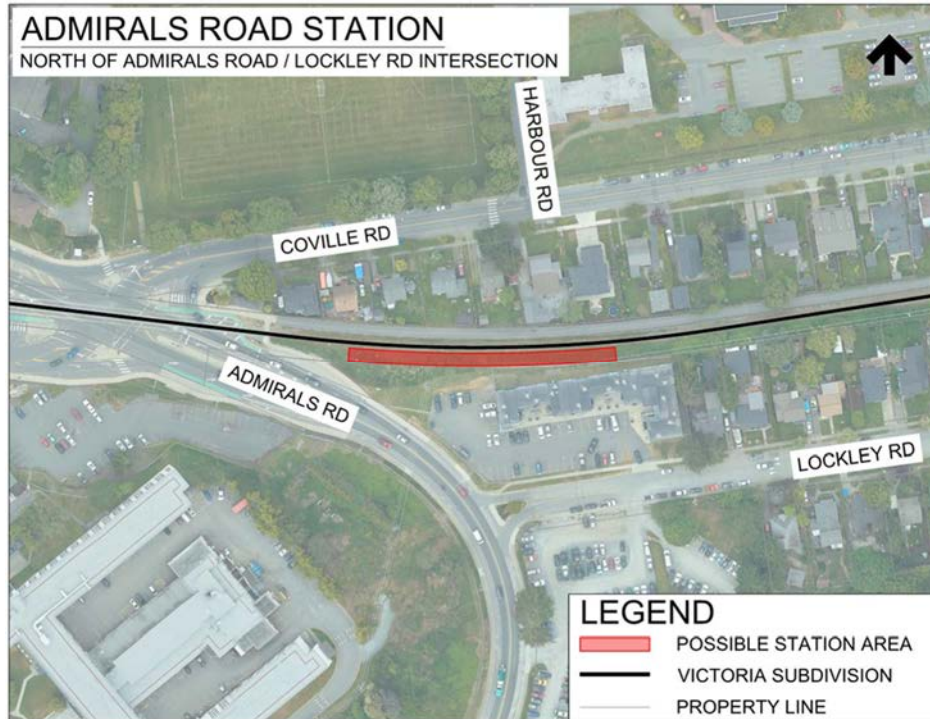
Figure 32: Esquimalt Station layout and context

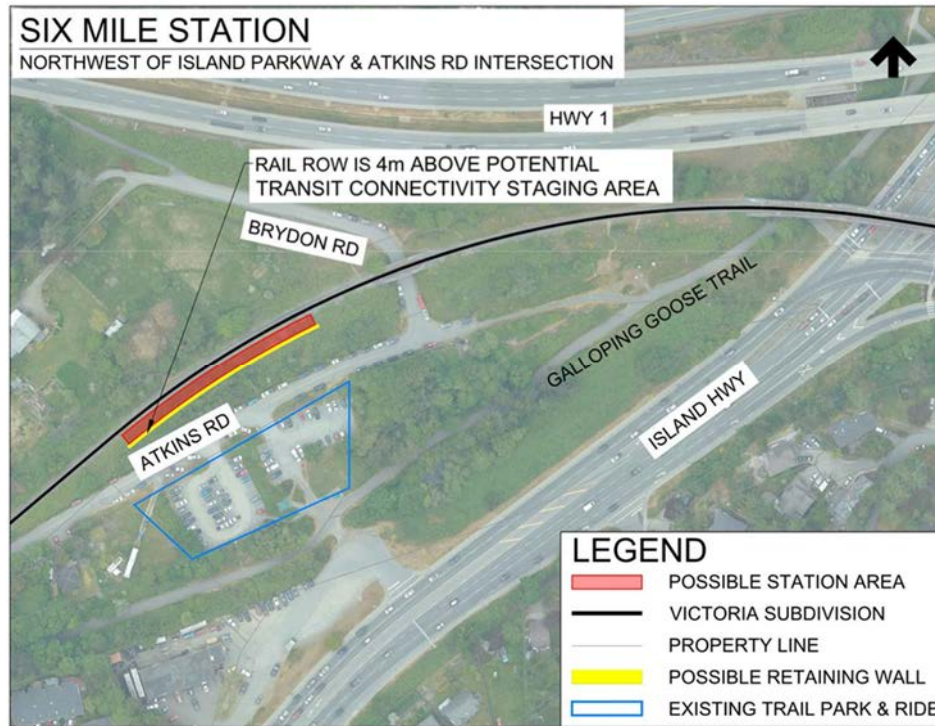
Figure 33: Six Mile Station layout, context, and options

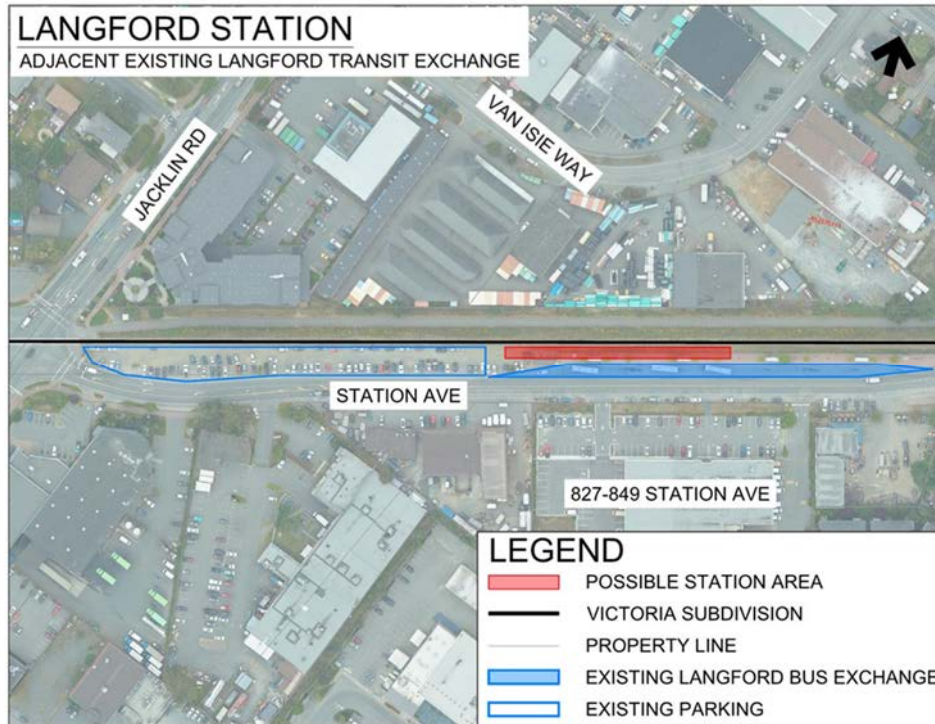
Figure 35: Langford Station layout and context

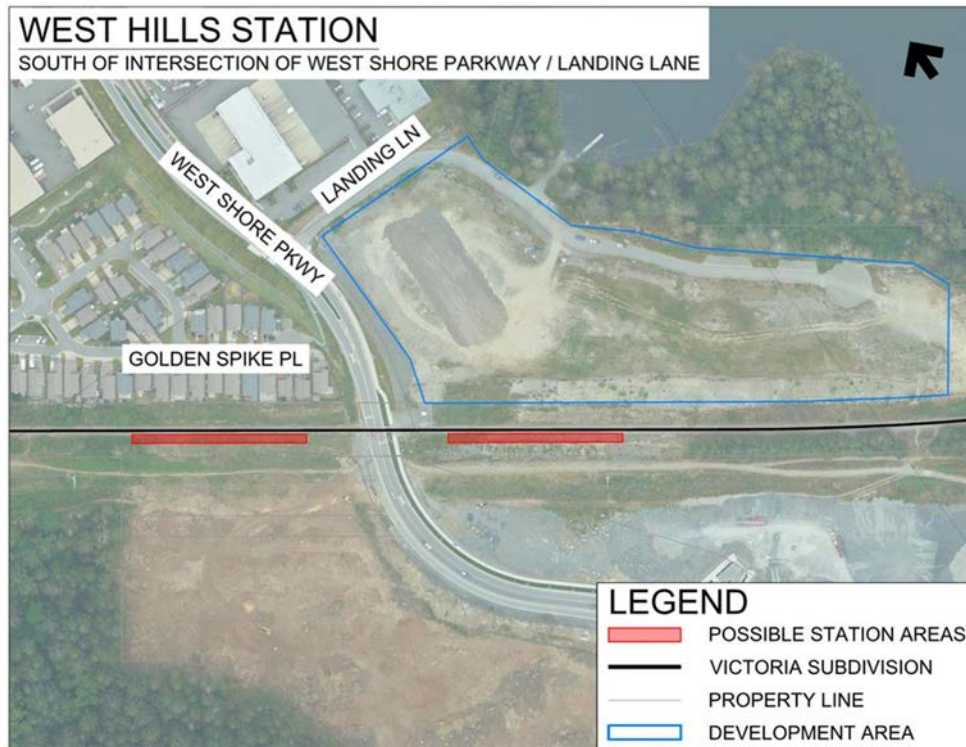
Figure 36: Westhills Station layout, context, and options
