Reliable Home Inspections Property Inspection Report

, TX 75150 Inspection prepared for: Date of Inspection: 12/28/2016 Size: 47000 Weather: Clear 50 Degrees

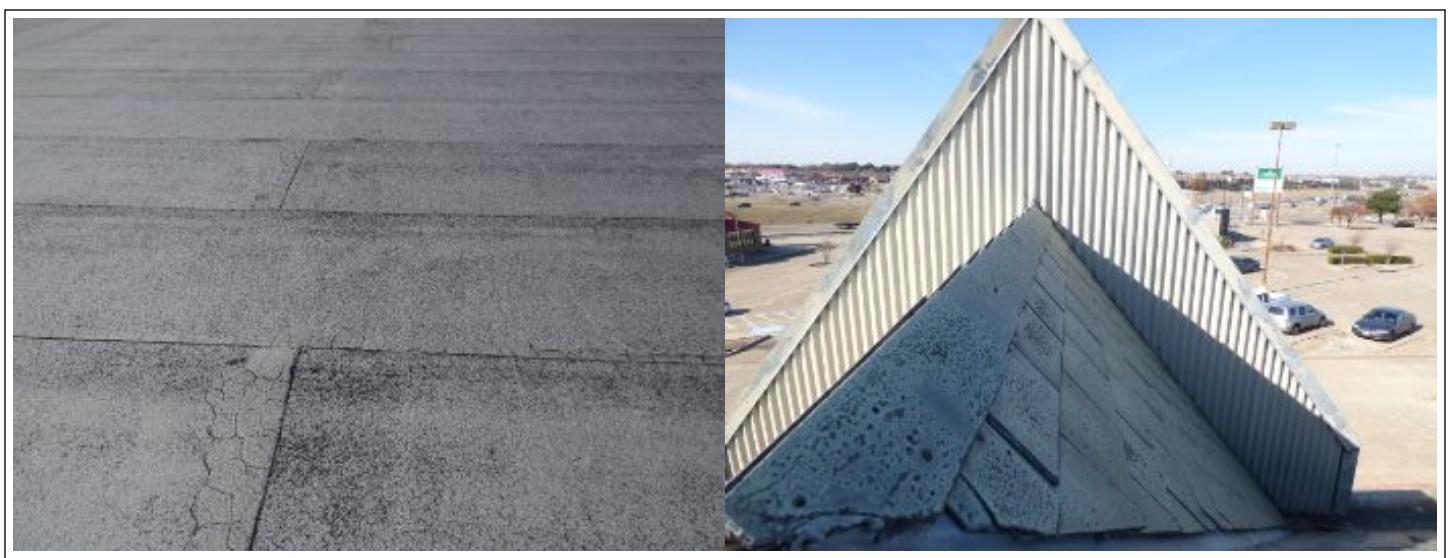
The Big Box roof is worn and has a short life expectancy. The roof does not appear to pond water and should be easy to recover.

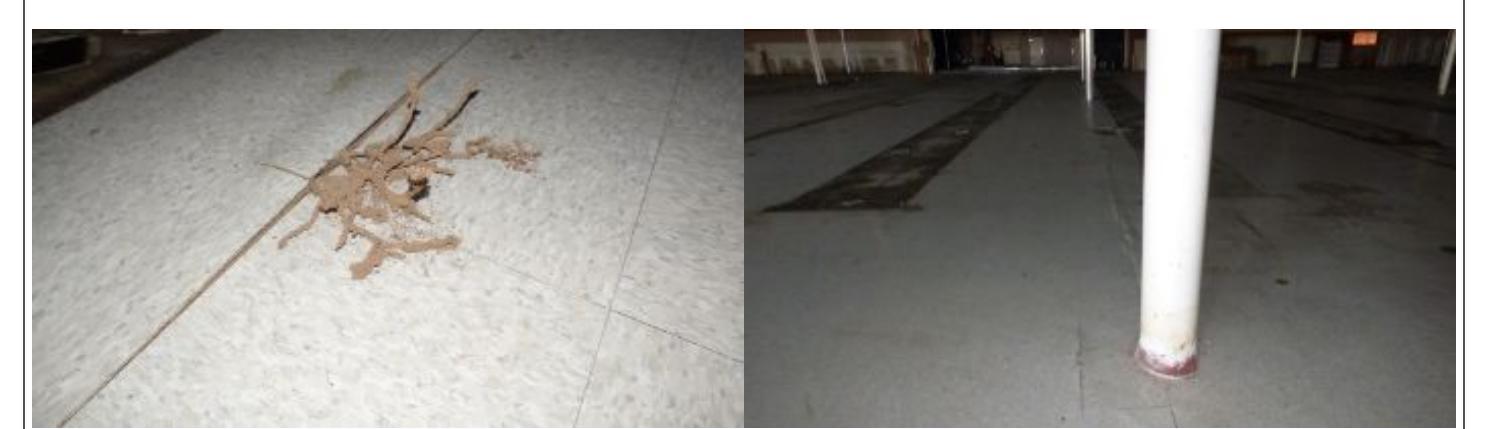
Termites in the slab crack. Big Box

The main slab in the Big Box has substantial slab cracking near the center of the building, from front to back. The crack has termite activity indicating it has moisture issues that need to be addressed. The plumbing systems may be an issue, but not water has been prior to or on at the time of this inspection. This needs to be examined further by a structural engineer and a plumbing contractor.

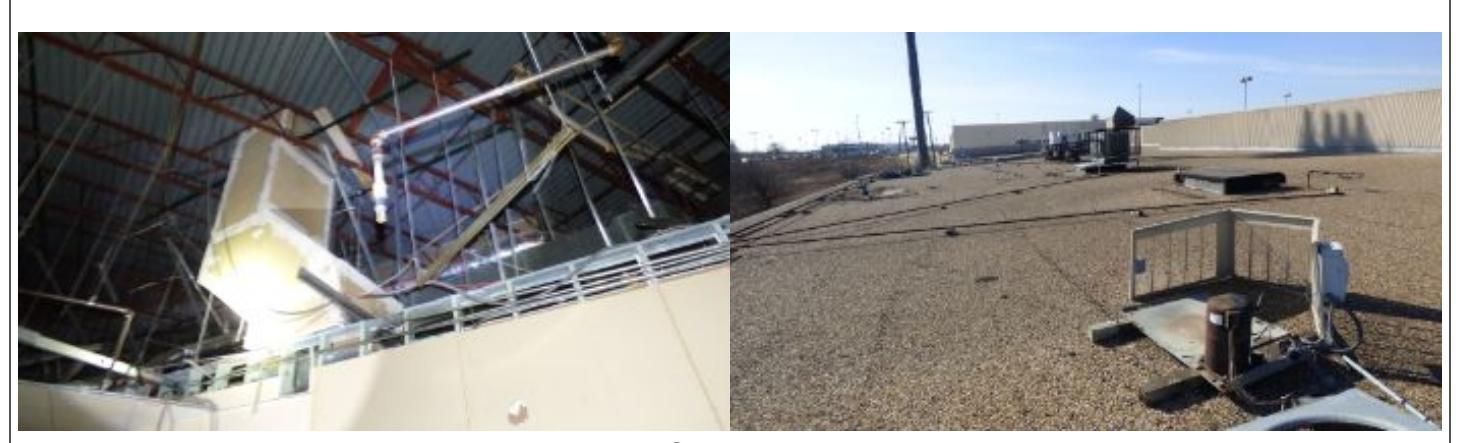
The Big Box does not have a working HVAC system. The current system has been discontinued and does not appear to be repairable. The new owner must consider replacement of the HVAC system and the removal of the old system. Removal will be a substantial expense and should be part of the new HVAC contractors bid. Roof mounted systems may be considered.

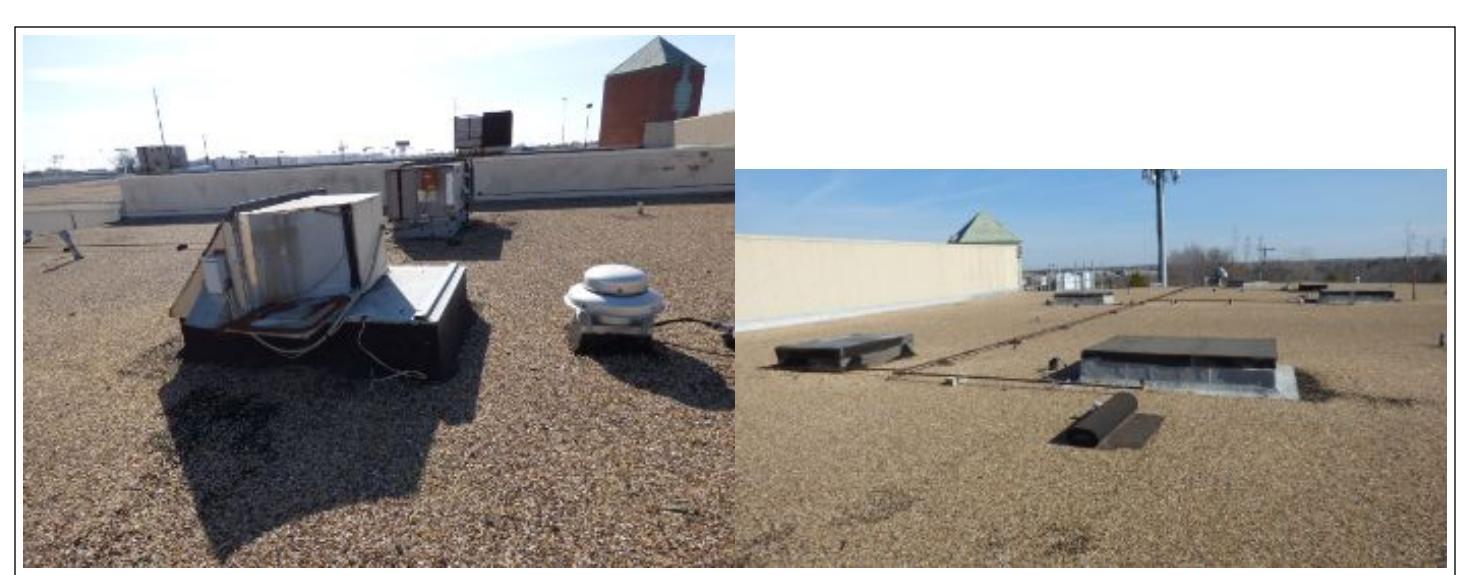
Removed Systems

Most of the vacant retail suites do not have exterior HVAC systems installed. The systems that were on the roof, have been striped for the condenser materials. Some of the suite do still have interior HVAC systems in the drop down ceilings, along with supply and return duct.

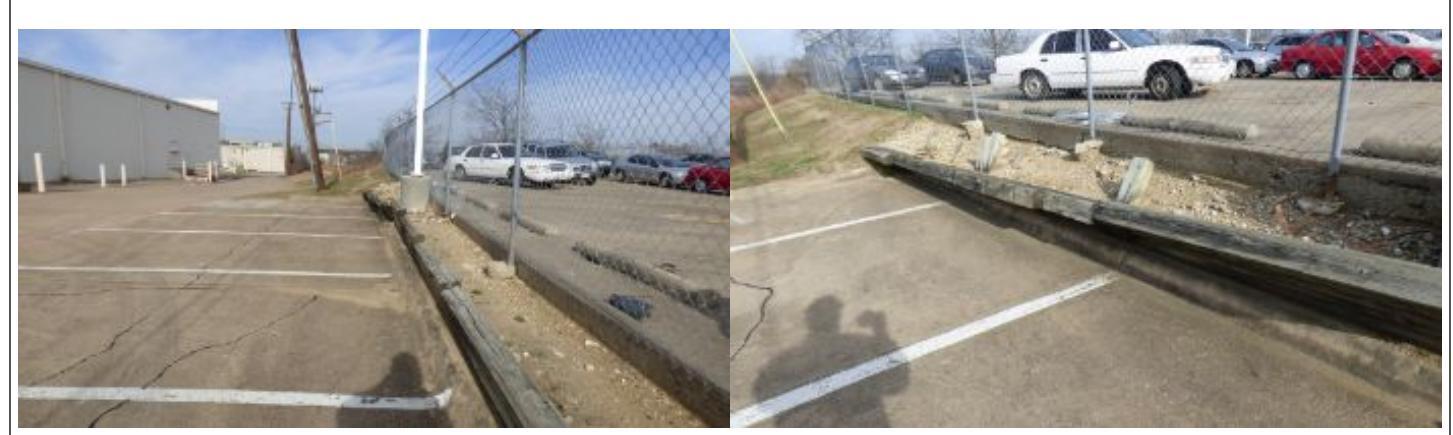
The retaining walls have failed on the back side of the building parking lot and delivery areas. These retaining walls need to be rebuilt to avoid further deterioration.

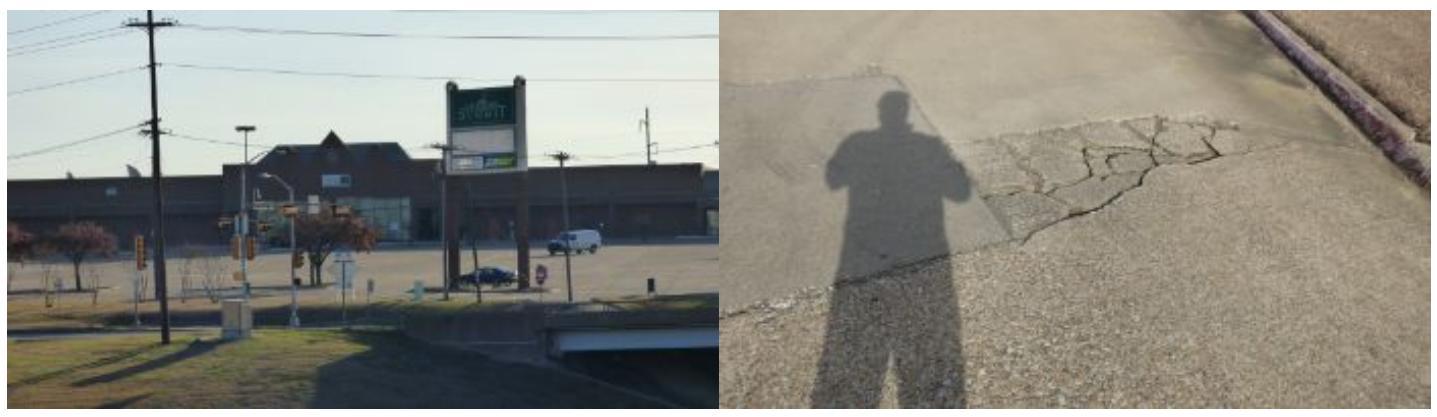
The parking lot lacks entry and exit signs, which are required at all entry and exit points. The arrows will need to be painted onto the lot surface as well.

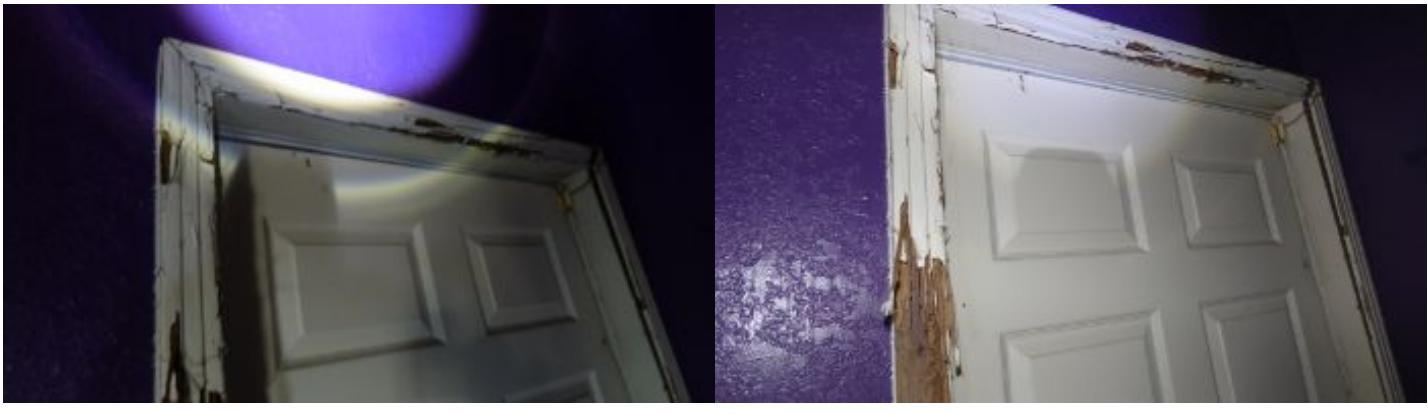
Several of the suites have suffered severe termite damage. Most at the the rear fire doors, and suite 140, the entire bathroom walls are termite damaged. Suites 115, 153, 140, 127, 155 need to be treated for termites along with the Big Box.

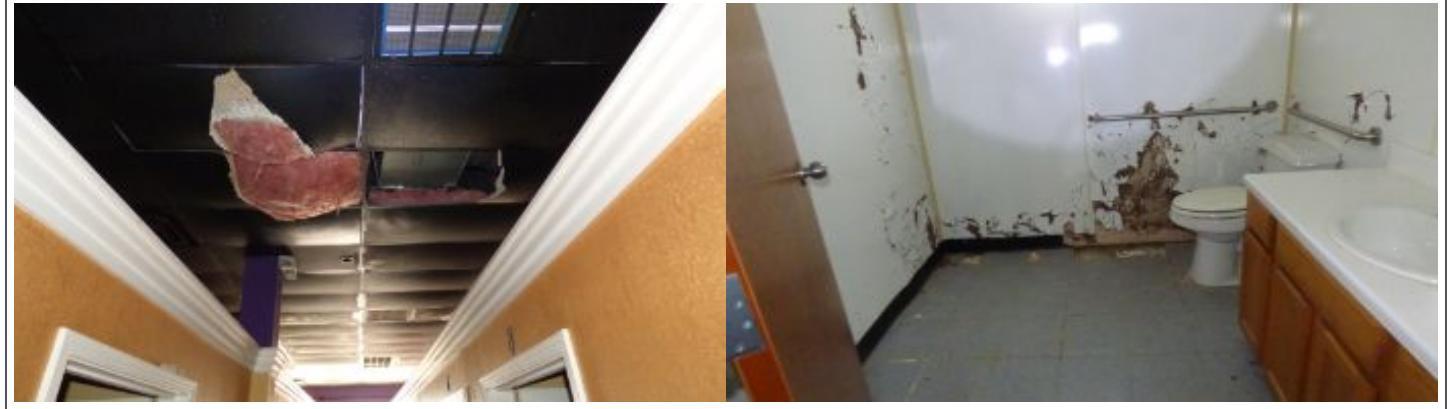
Several of the suites have suffered severe termite damage. Most at the the rear fire doors. Suite 140, the entire bathroom walls are termite damaged. Suites 115, 153, 140, 127, 155 need to be treated for termites along with the Big Box.

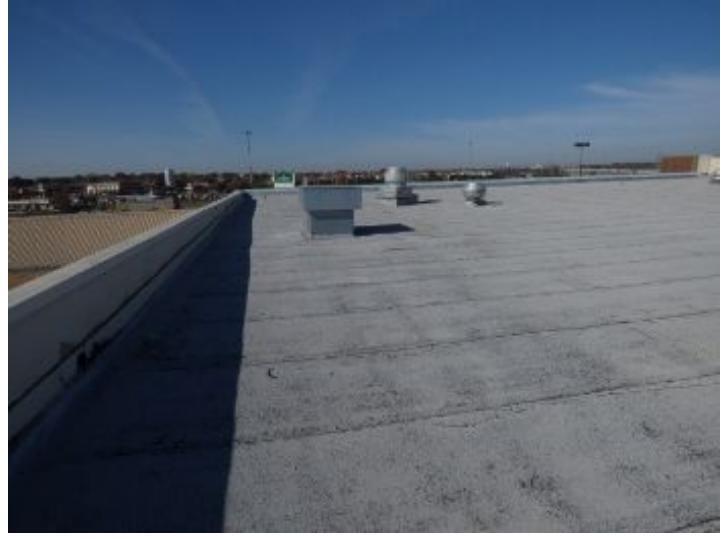
The Big Box roof is worn and has a short remaining life expectancy. The roof does not appear to pond water and should be easy to recover. This roof does not have UV protection. Other types of roofing material should be considered as a replacement.

The Big Box roof is worn and has a short life expectancy. The roof does not appear to pond water and should be easy to recover.

Replacement cost for the Big Box estimate (Roofing, Modified Bitumen, Smooth Surface \$4.25 per square foot) is \$200,000

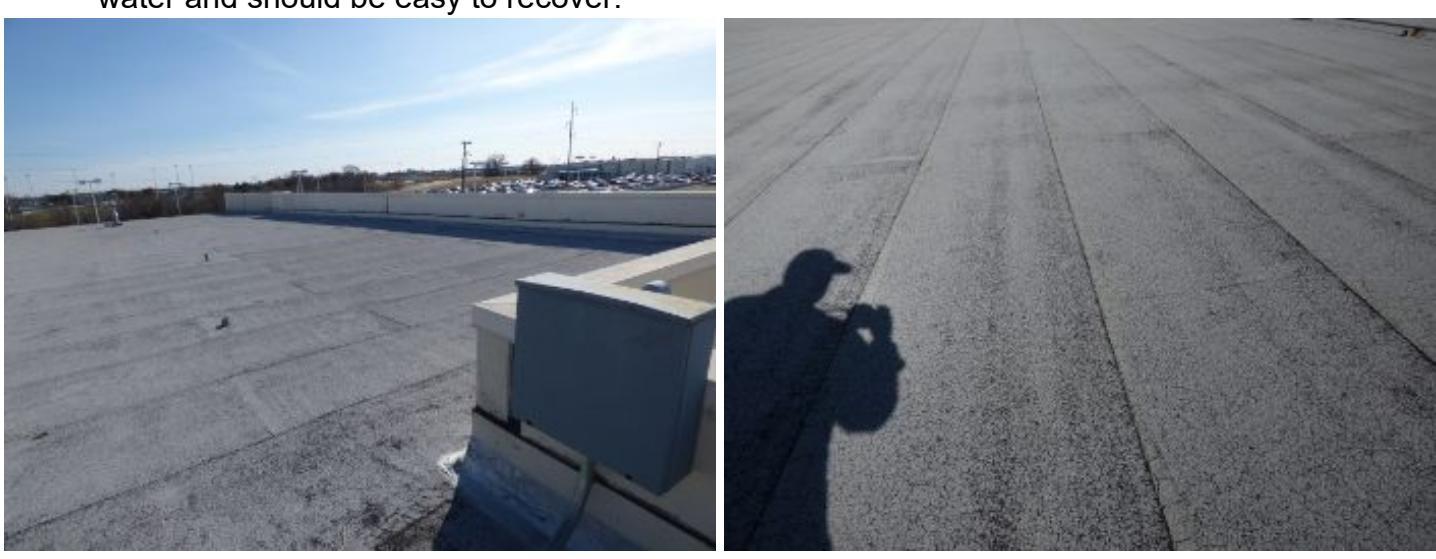
Worn surface

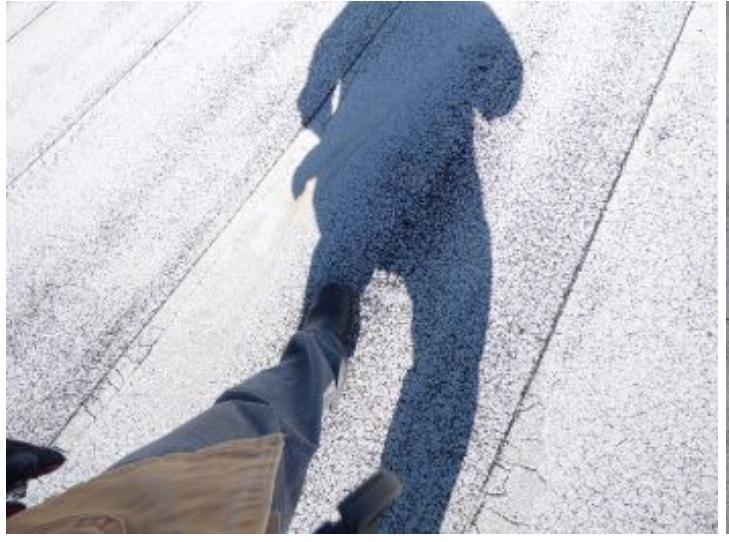
Worn surface Big Box

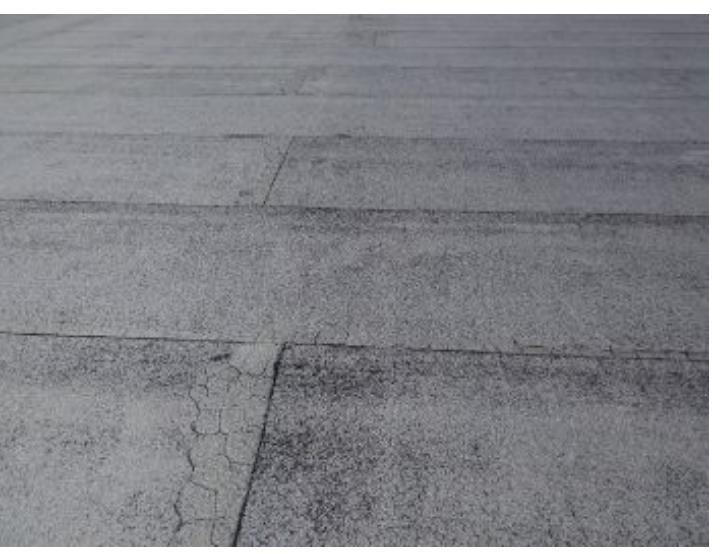
The Big Box roof is worn and has a short life expectancy. The roof does not appear to pond water and should be easy to recover.

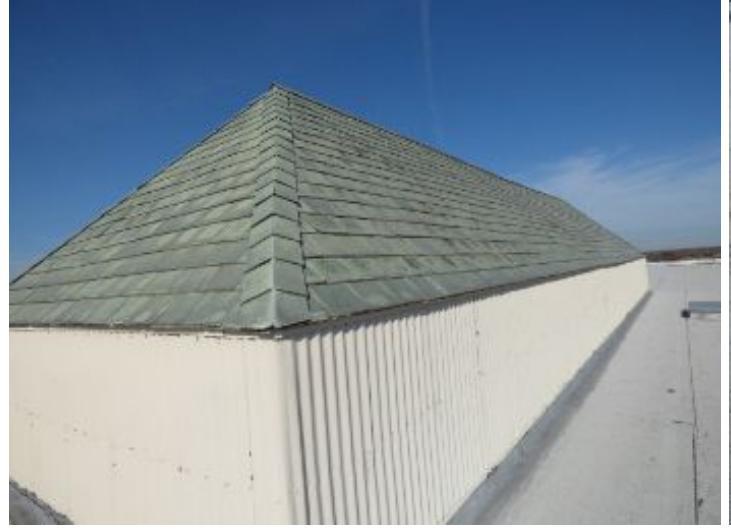
The roof system over the walkways and facade is leaking and worn beyond it life expectancy. This section may have hail damage but too worn to determine. The owner should have the roof system examined by a insurance adjuster. Replacement of roof system is needed.

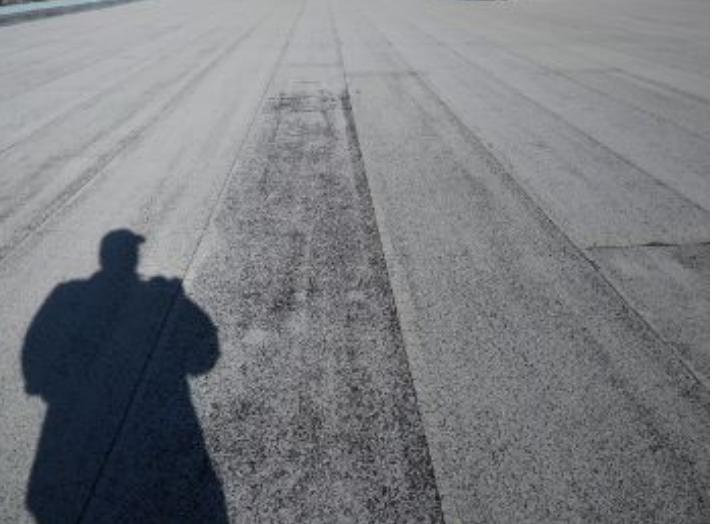
Worn surface Big Box

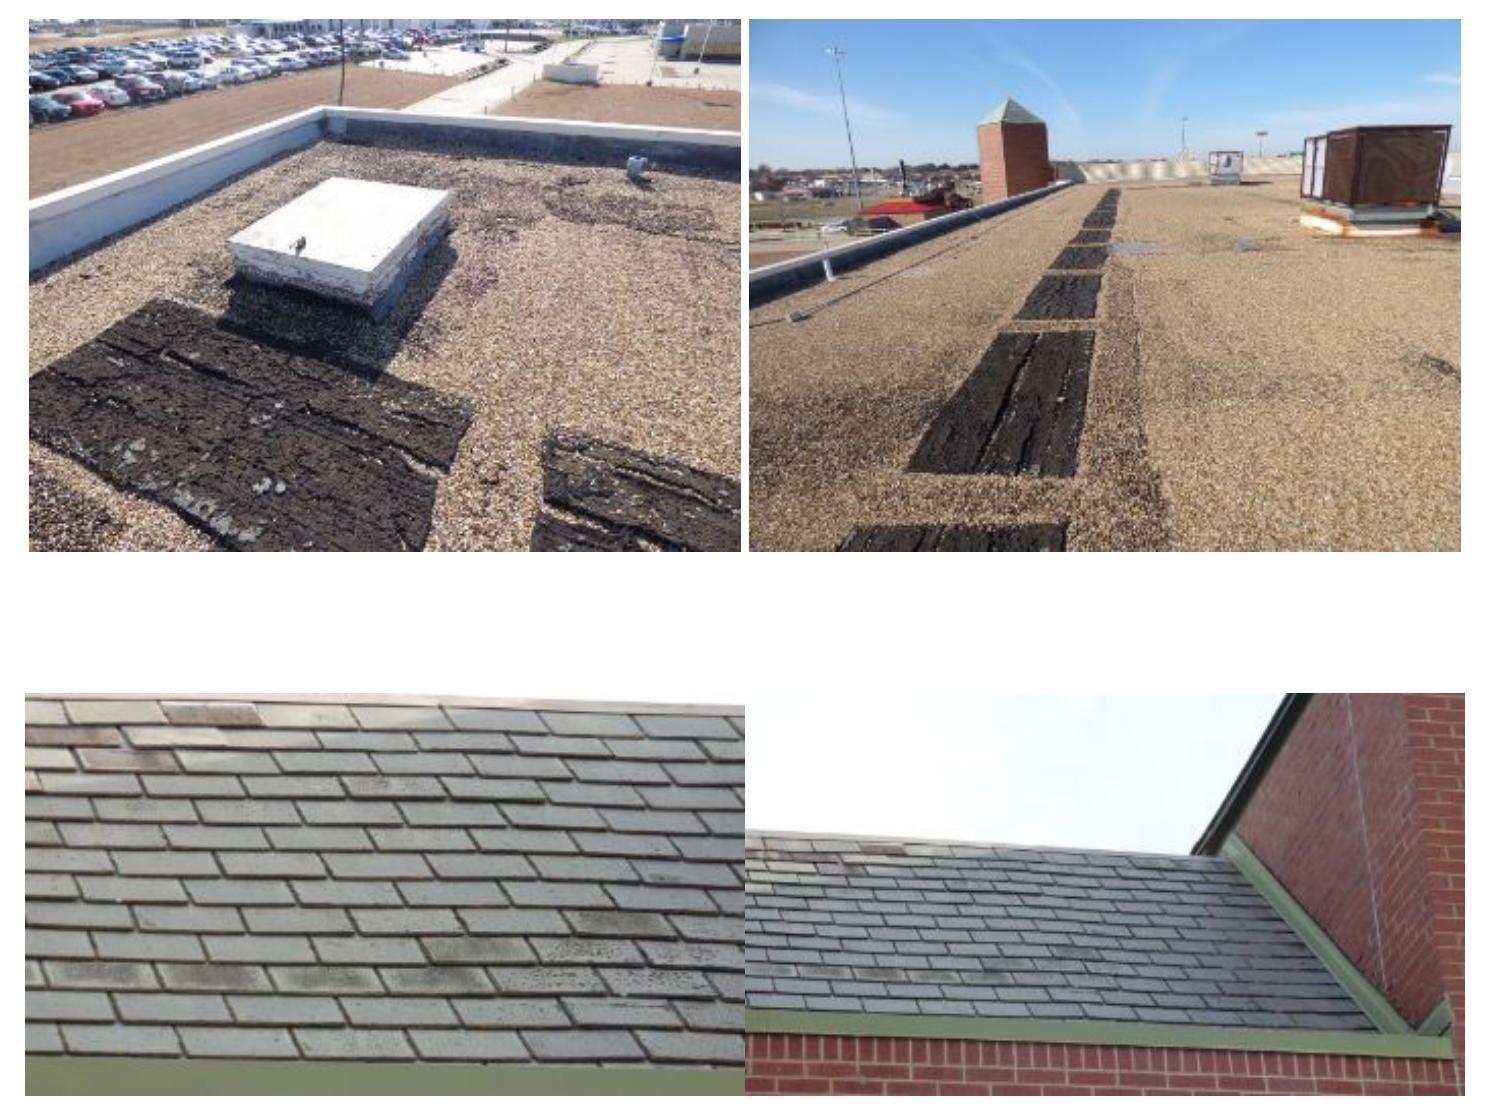
Slate roofing shingles are damaged and missing in many locations. The roof may have suffered previous hail damage. The roof material will need to be replaced and all underling damage repaired. (Slate replacement is \$10.00 per square foot @ 20,000 square feet). Total replacement cost \$200,000.

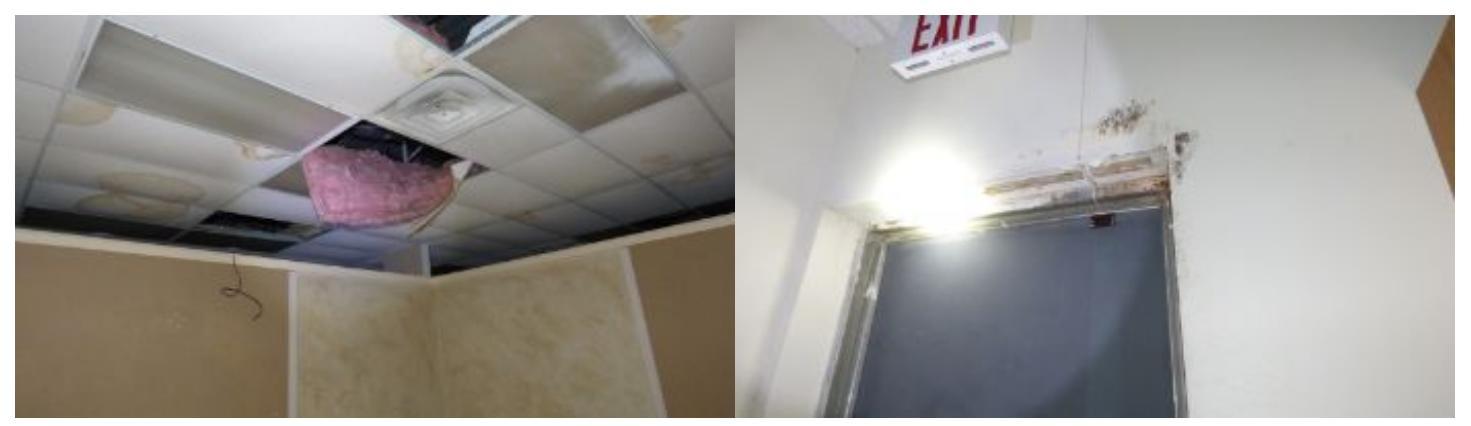
Water damage rear exit

These vacant suites have drop down ceiling tiles that have fallen from roof leakage and or HVAC condensate leakage. Interior walls are water damaged, and termite activity was noted. (Suites 153, 175, 151, 150,144,140,127,119) These suites will need substantial moisture remediation and repairs prior to occupancy.

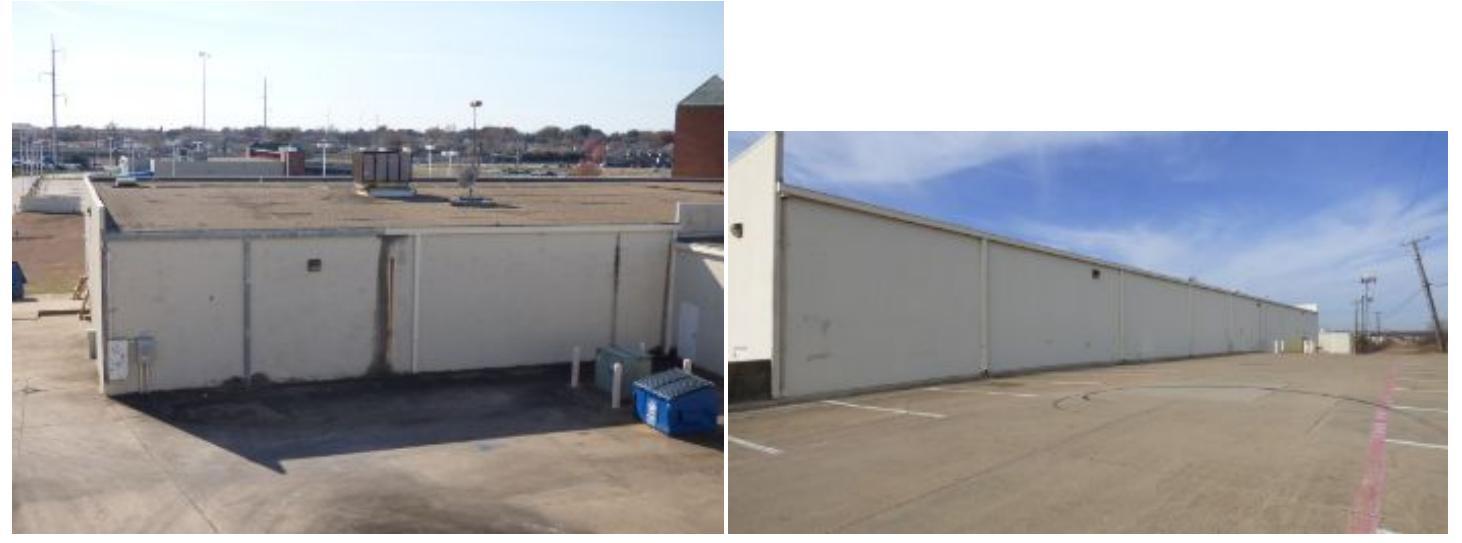
The gutters needs to be repaired or replaced where damaged. The leakage can damage the exterior finish and cause substantial drainage issues.

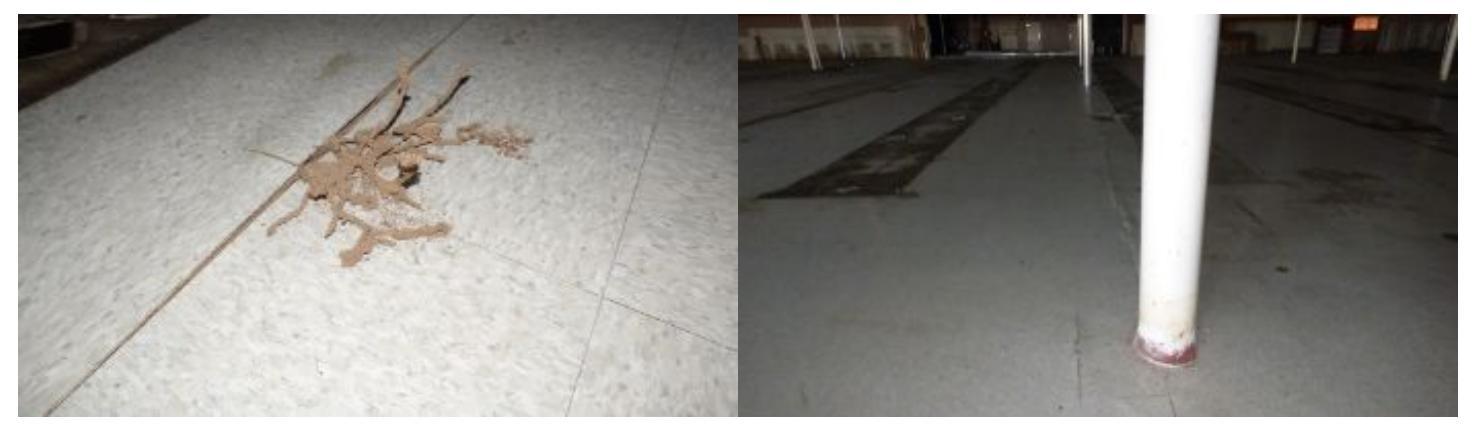
The main slab in the Big Box has substantial slab cracking near the center of the building, from front to back. The crack has termite activity indicating it has moisture issues that need to be addressed. The plumbing systems may be an issue, but not water has been prior to or on at the time of this inspection. This needs to be examined further by a structural engineer and a plumbing contractor.

Termites in the slab crack. Big Box

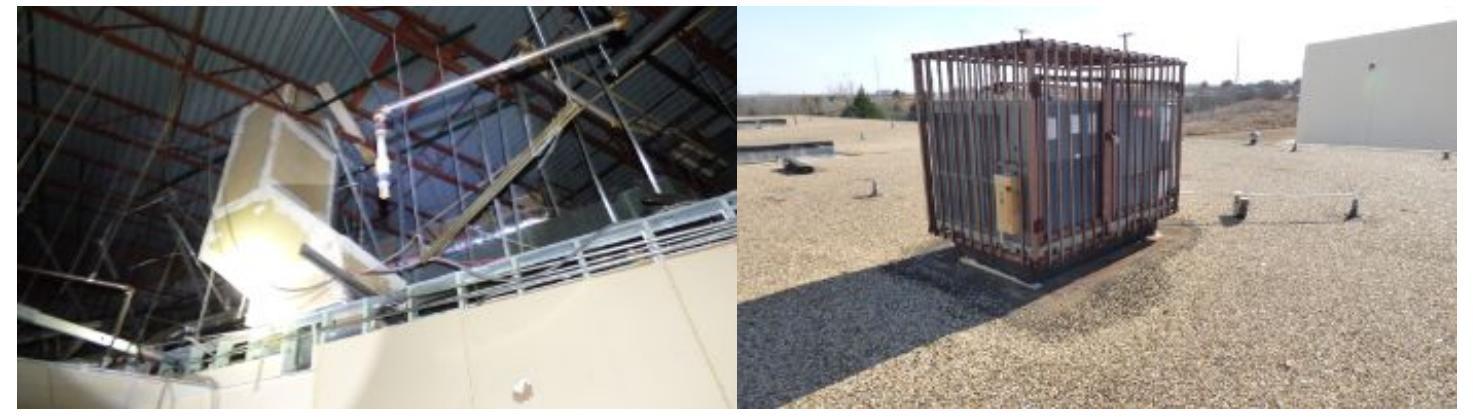
The Big Box does not have a working HVAC system. The current system has been discontinued and does not appear to be repairable. The new owner must consider replacement of the HVAC system and the removal of the old system. Removal will be a substantial expense and should be part of the new HVAC contractors bid. Roof mounted systems may be considered.

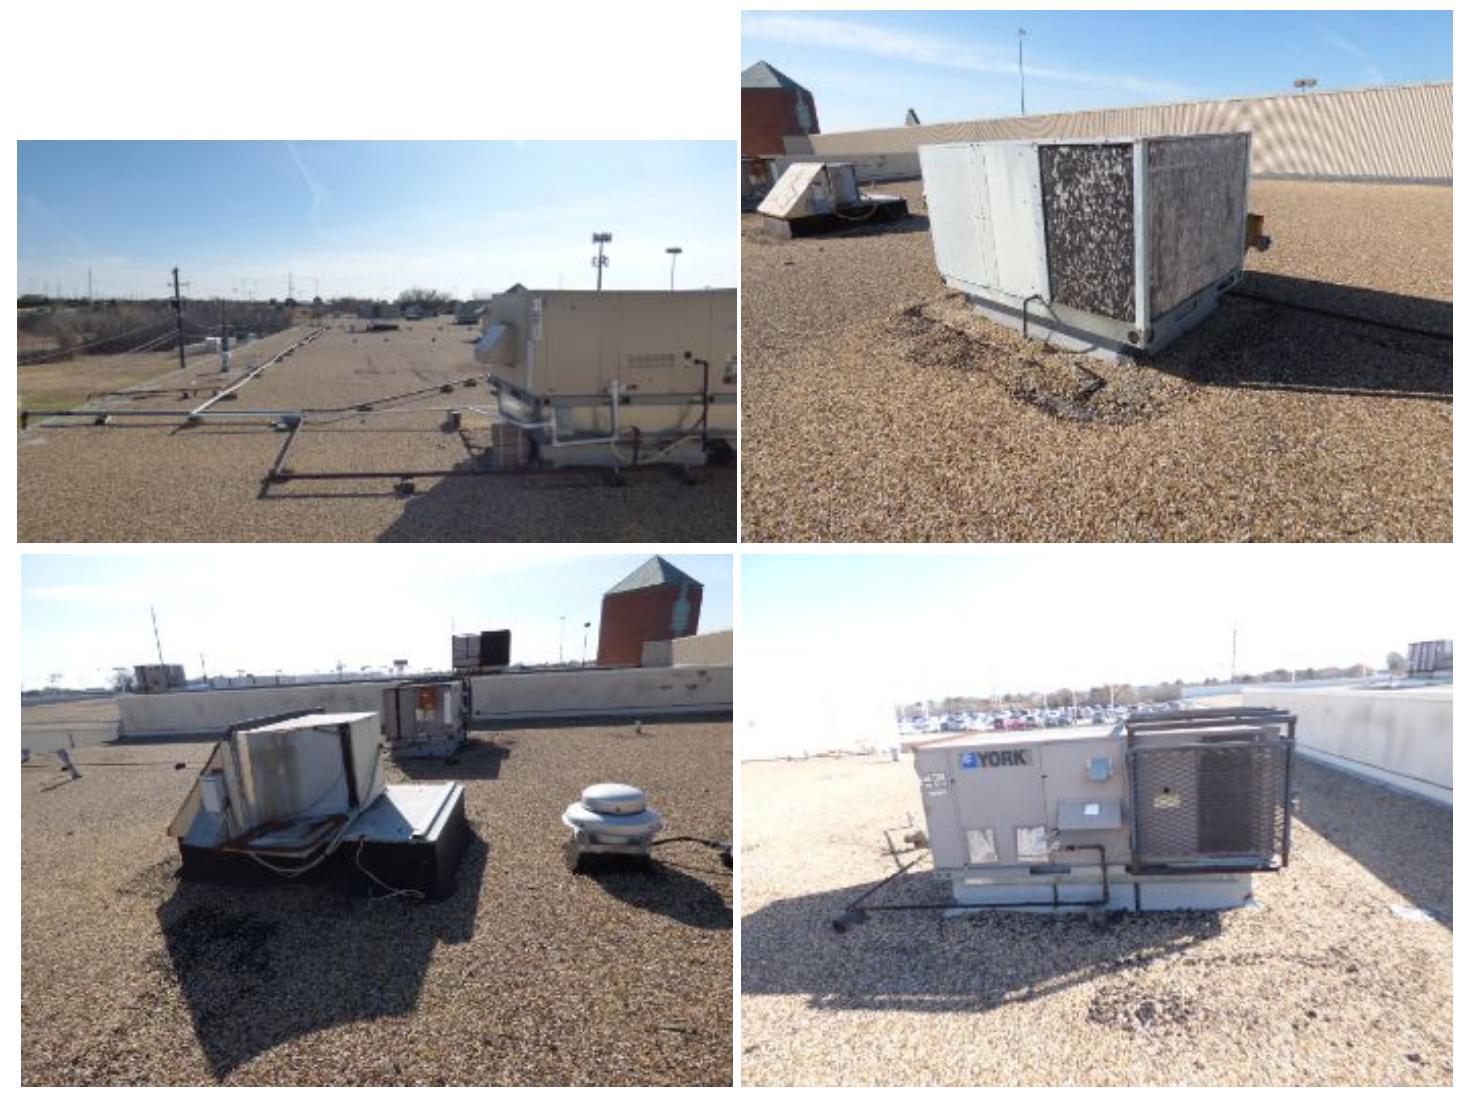
Most of the vacant retail suites do not have exterior HVAC systems installed. The systems that were on the roof, have been striped for the condenser materials. Some of the suite do still have interior HVAC systems in the drop down ceilings, along with supply and return duct.

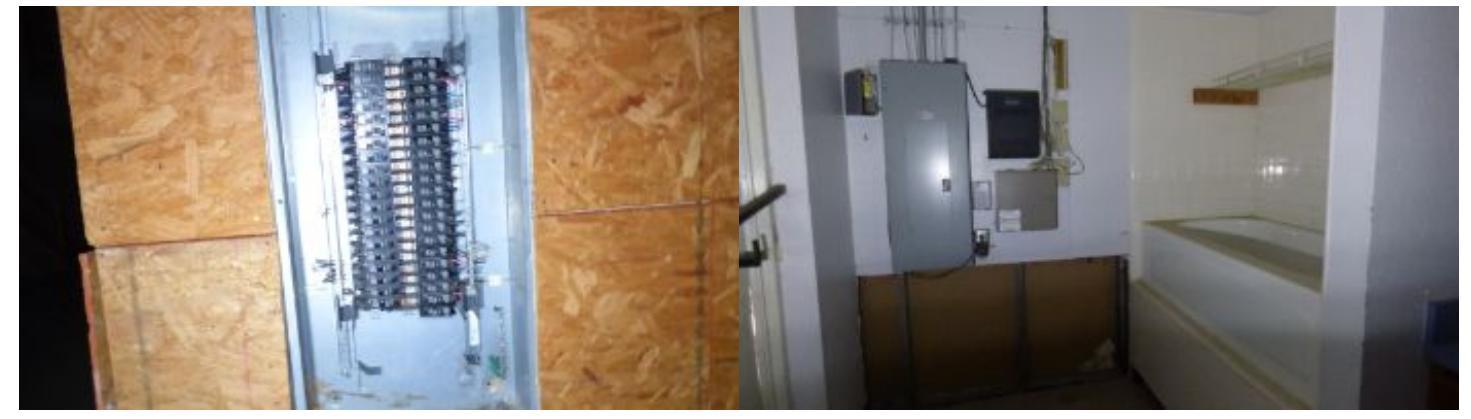
The Big Box electrical systems appear to be stripped of all electrical wiring. All electrical systems will have to be rebuilt.

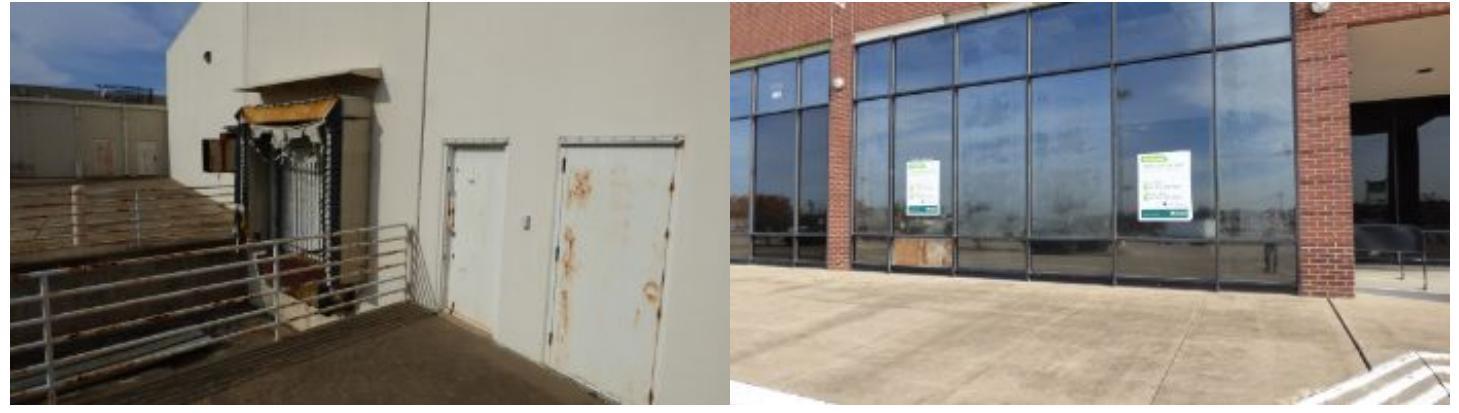
The loading dock doors and lift are in poor condition and need to be replaced. (Big Box)
