Report Date: August 07, 2018

Re: Warning Letter, Unauthorized Discharge, 1582 Bradner Road, Abbotsford BC, Refuse

Authorization: UA68121	Facility: 93 Land Company	15825 Bradner Road, Abbotsford BC
NRIS IR #:	Date: June 25, 2018

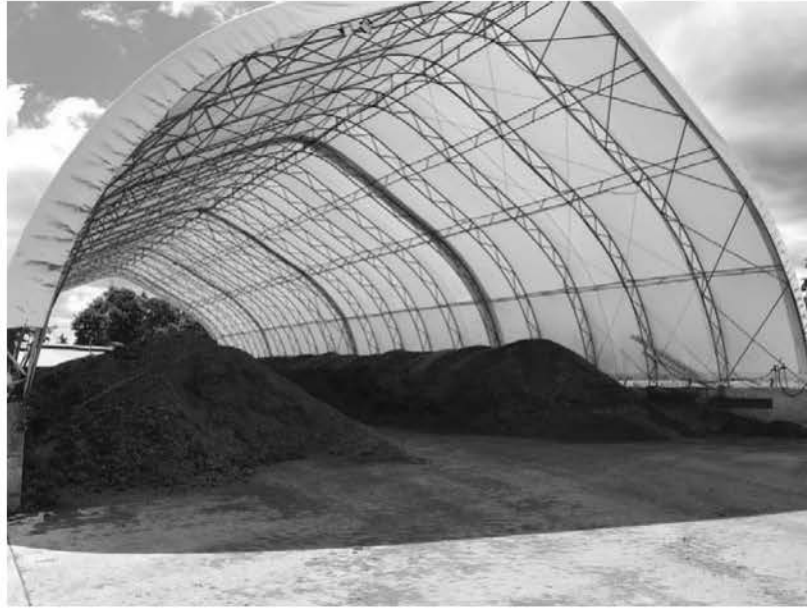
Photo 1

Agricultural waste being stored in one of two storage facilities at the business.

Photo taken facing south.

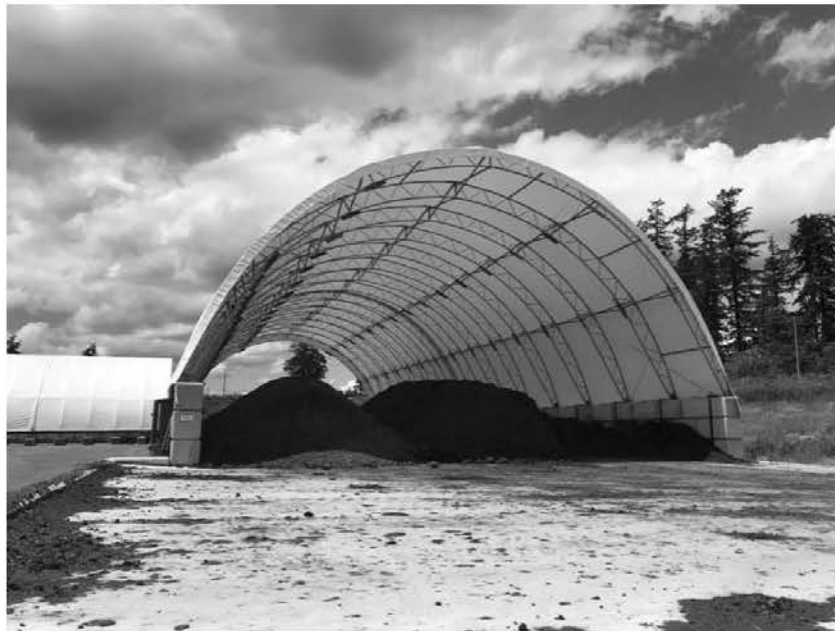
Photo 2

Agricultural waste being stored in the second of two storage facilities at the business.

Photo taken facing west.

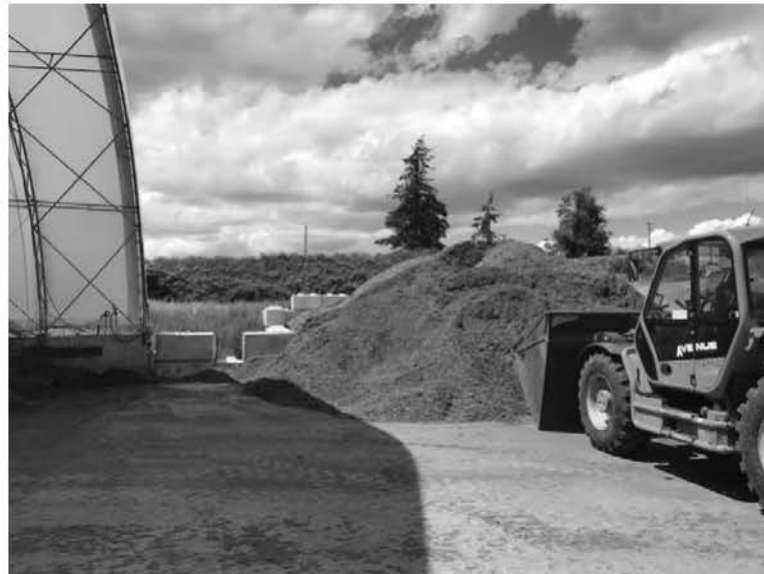
Photo 3

Agricultural waste stored outside the storage facility.

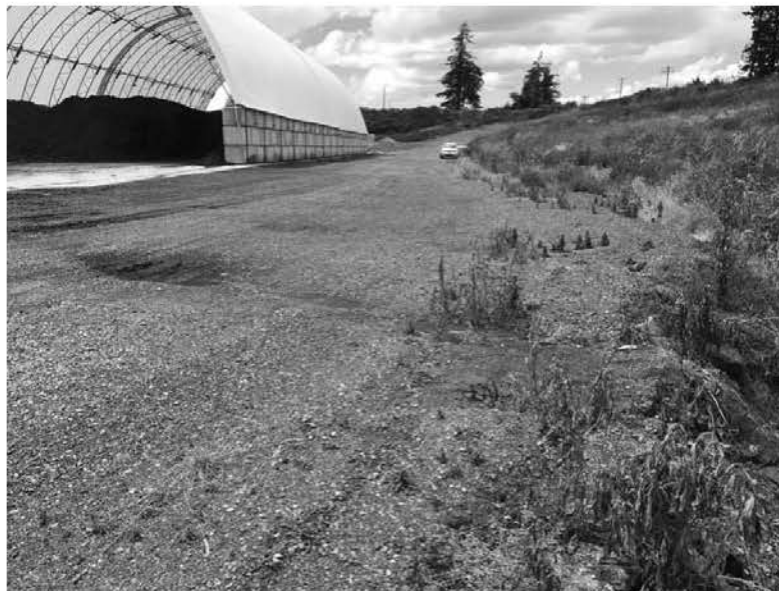
Photo 4

Dried manure debris observed off the cement pad of the east building, and off the gravel pad, entering the ditch. No flow of water during inspection.

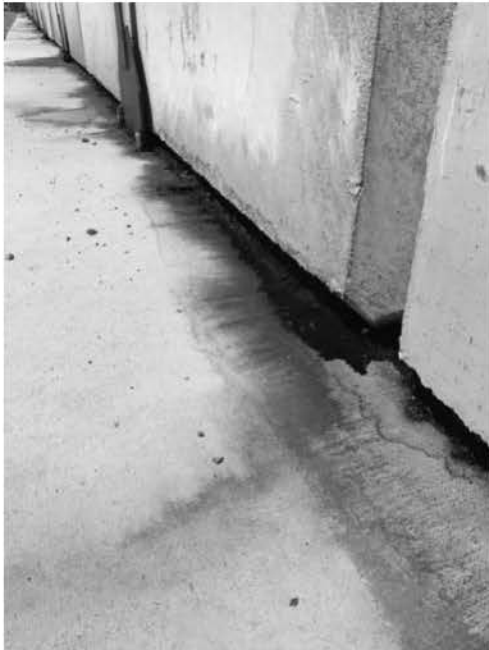
Details/Findings:	During the inspection on June 25, 2018, the storage facilities appeared to be constructed in a manner to prevent the escape of waste. Small amounts of leachate was observed escaping through the lock block walls of the east structure during the inspection (see photos attached). Neither storage structure was inspected from the inside because they were too full of material to allow safe entry. The west wall of the western storage structure was not observed from the outside due to vegetation growth.
Compliance:	Not Determined
Actions to be taken:	Ensure agricultural waste does not escape the storage facilities.

<p>Photo 5</p> <p>Leachate seeping under south lock block wall of the east building.</p>

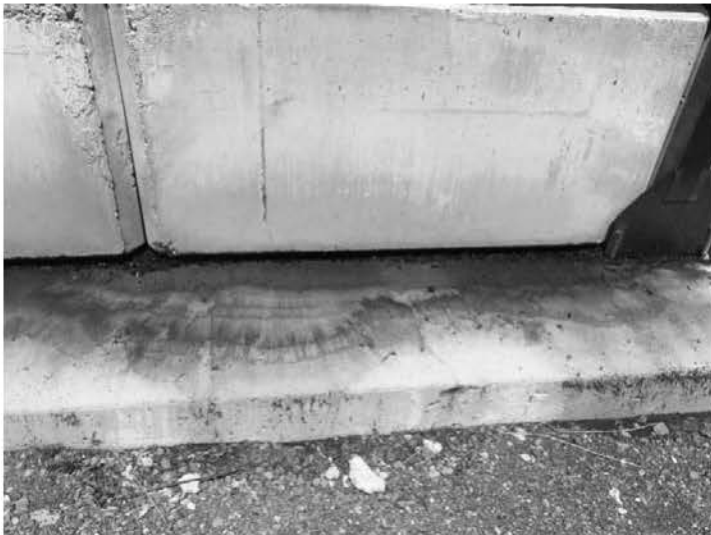
<p>Photo 6</p> <p>Leachate seeping under lock block of the east building and dried residue indicating leachate has left cement pad.</p>

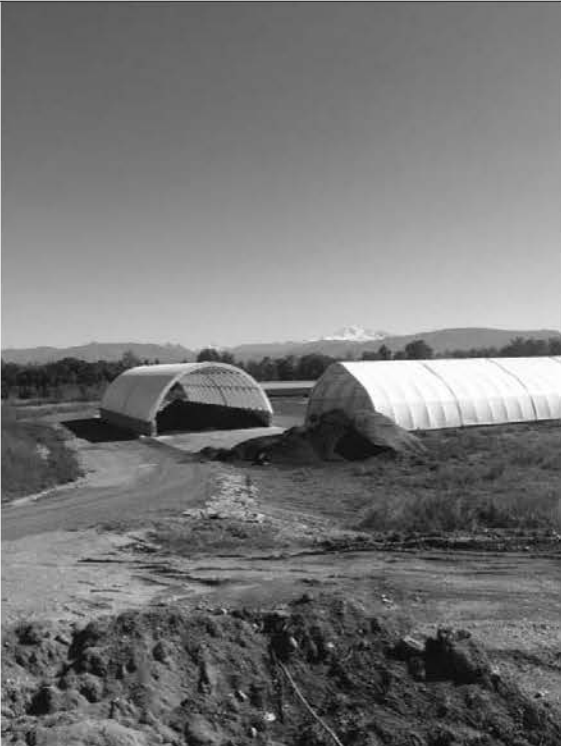
<p>Photo 1</p> <p>Two covered waste storage structures.</p> <p>Photo facing east.</p>

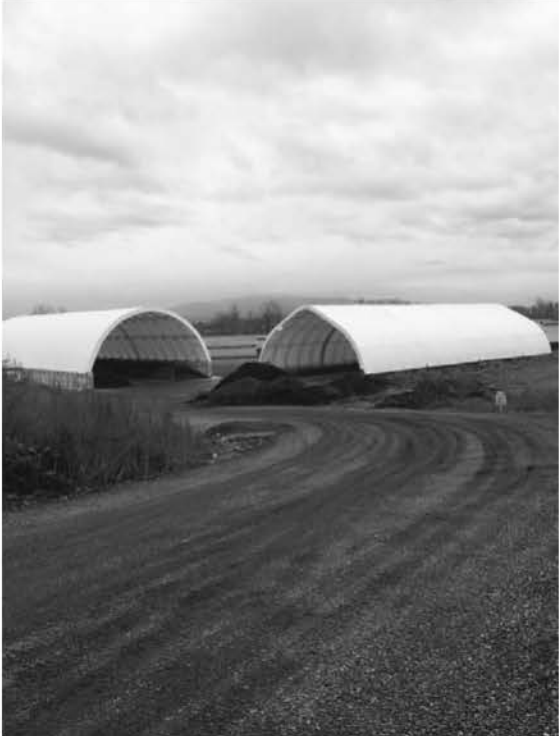
<p>Photo 1</p> <p>Piles of agricultural waste stored outside of the covered storage facility.</p> <p>Photo taken November 14, 2017</p> <p>Photo facing southeast.</p>

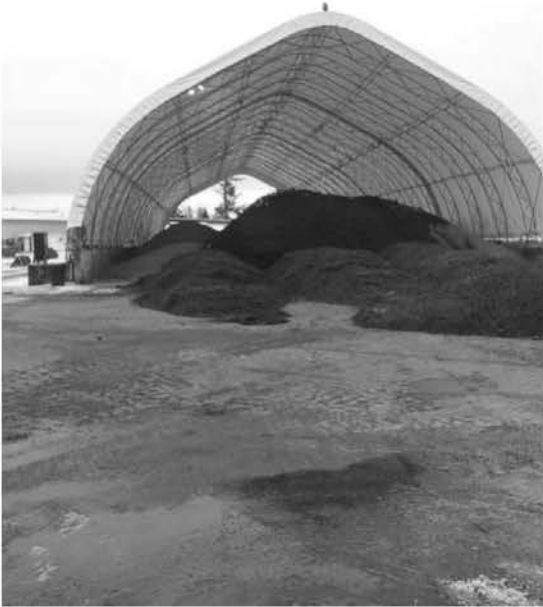
<p>Photo 2</p> <p>Piles of agricultural waste stored outside of the covered storage facility.</p> <p>Photo taken January 2, 2018</p> <p>Photo facing south.</p>

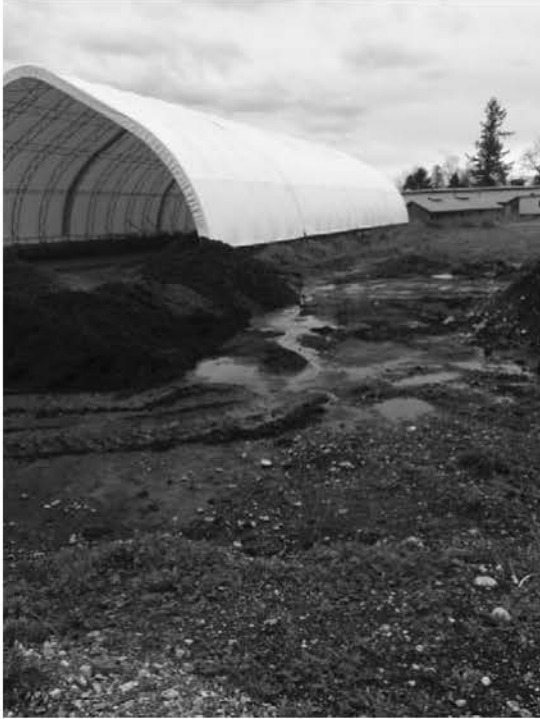
Requirement Description:	Environmental Management Act, Agricultural Waste Control Regulation (131/92) (EMA) 7 (1): A storage facility must be located at least 15 m from any watercourse and 30 m from any source of water for domestic purposes.
Details/Findings:	During the November 14, 2017 inspection, Officer Oldfield observed what appeared to be the early stages of construction of a stormwater management ditch as evidenced by the freshly exposed earth running along the western edge of the westernmost storage building to a freshly dug pit at the northwest corner of the storage facility building (see photos) and on to the ditch along the base of the slope at the northern property boundary where it flows eastwards. During the January 2, 2018 site inspection, Officer Oldfield observed imported rock which had been used to line the previously mentioned ditches and fill the pit. At this time, it has not been determined where this ditch leads to. Pepin Creek is located approximately 220m to the southeast from where the easternmost location of the ditch could be observed.

<p>Photo 3</p> <p>Fresh cut ditch observed running adjacent to the storage building</p> <p>Photo taken November 14, 2017</p> <p>Photo facing south.</p>

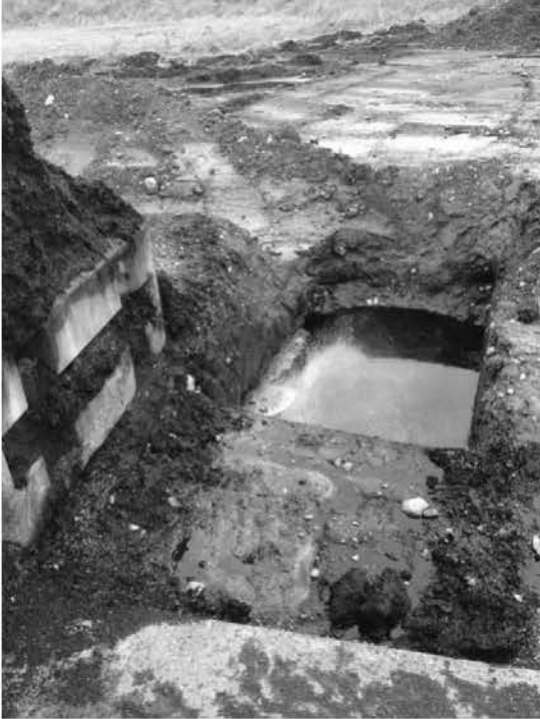
<p>Photo 4</p> <p>Fresh cut pit along the constructed storm water ditch located at the northwest corner of the westernmost storage building.</p> <p>Photo taken November 14, 2017</p> <p>Photo facing west.</p>

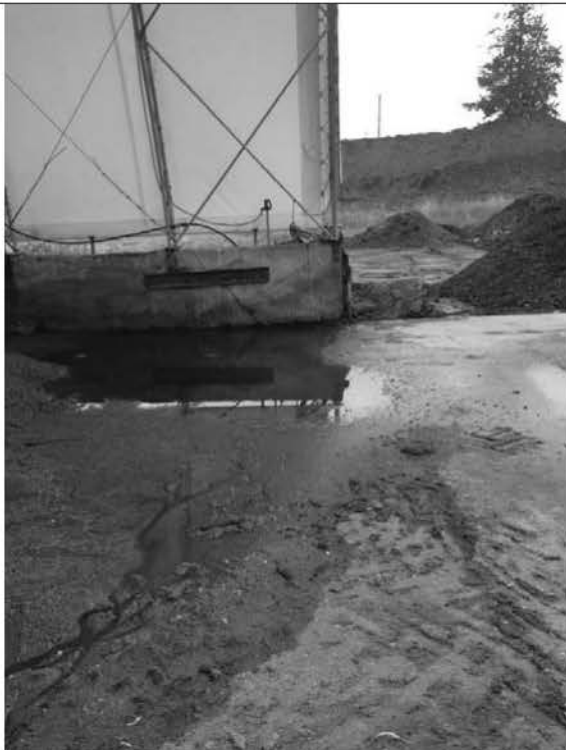
Requirement Description:	Environmental Management Act, Agricultural Waste Control Regulation (131/92) (EMA) 11: Agricultural waste must not be directly discharged into a watercourse or groundwater.
Details/Findings:	On November 14, 2017, Officer Oldfield observed pooled water which was in contact with agricultural waste leaving the storage facility and entering an unlined pit. This is a direct path for leachate to enter the local groundwater system.
Compliance:	Out
Actions to be taken:	Prevent any leachate generated at the storage facility from being discharged to watercourse or groundwater.

<p>Photo 5</p> <p>Pooled water inside the storage facility in direct contact with Agricultural waste and flowing into the freshly cut pit.</p> <p>Photo taken November 14, 2017</p> <p>Photo facing west.</p>

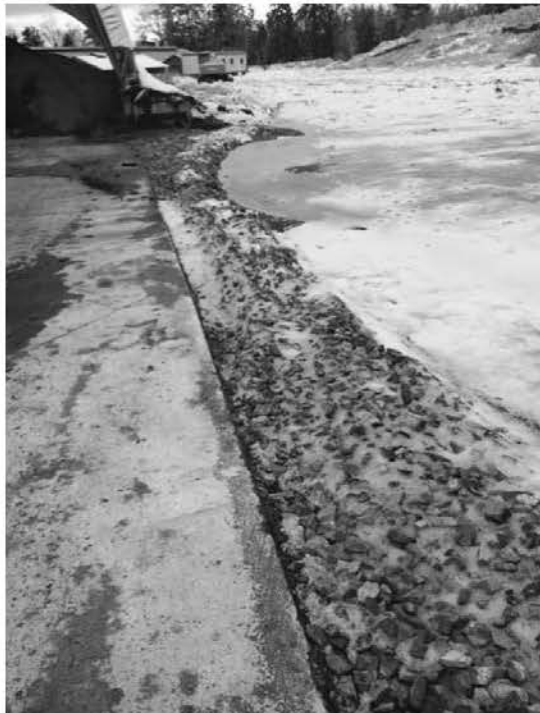
<p>Photo 6</p> <p>Storm water ditch and pit has now been backfilled with rock.</p> <p>Photo taken January 2, 2018</p> <p>Photo facing south.</p>

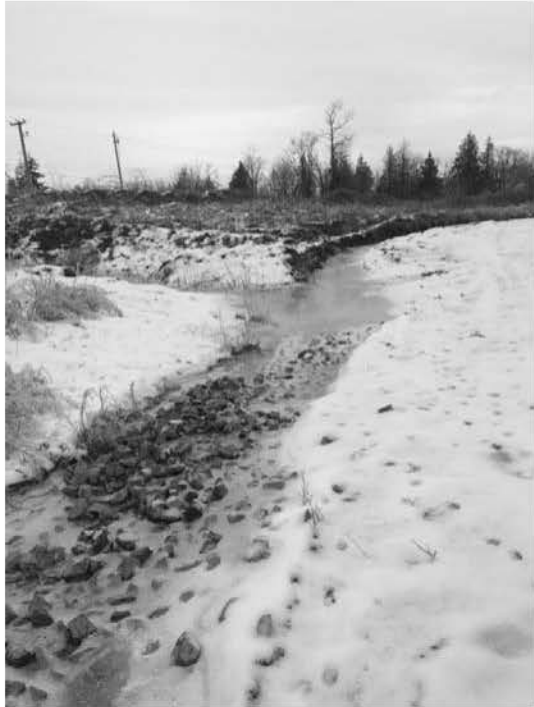
<p>Photo 7</p> <p>Storm water ditch along bottom of slope of northern property boundary. Water flows east at this point.</p> <p>Photo taken January 2, 2018</p> <p>Photo facing east.</p>

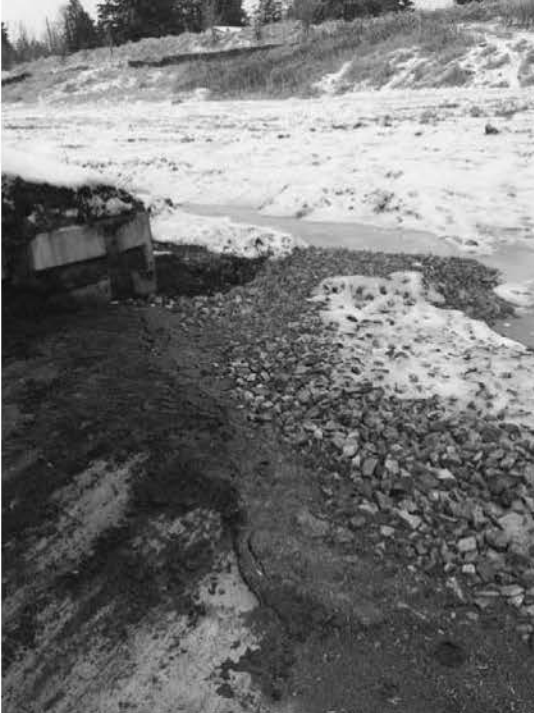
<p>Photo 8</p> <p>Backfilled pit location with agricultural waste lying on surface.</p> <p>Photo taken January 2, 2018</p> <p>Photo facing southwest.</p>

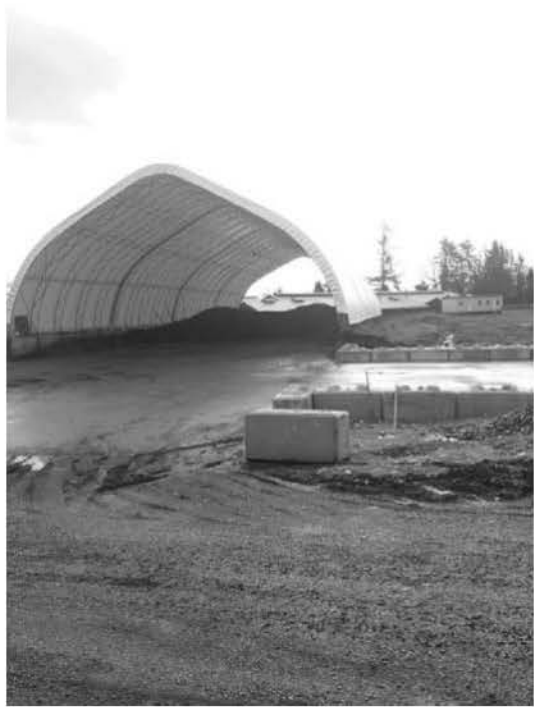
<p>Photo 9</p> <p>Storm water ditch has now been covered with an impermeable base at this location.</p> <p>Photo taken January 30, 2018</p> <p>Photo facing south.</p>
