TO WAR *in Stuart Tanks*

The 2/6th Australian Armoured Regiment in Papua

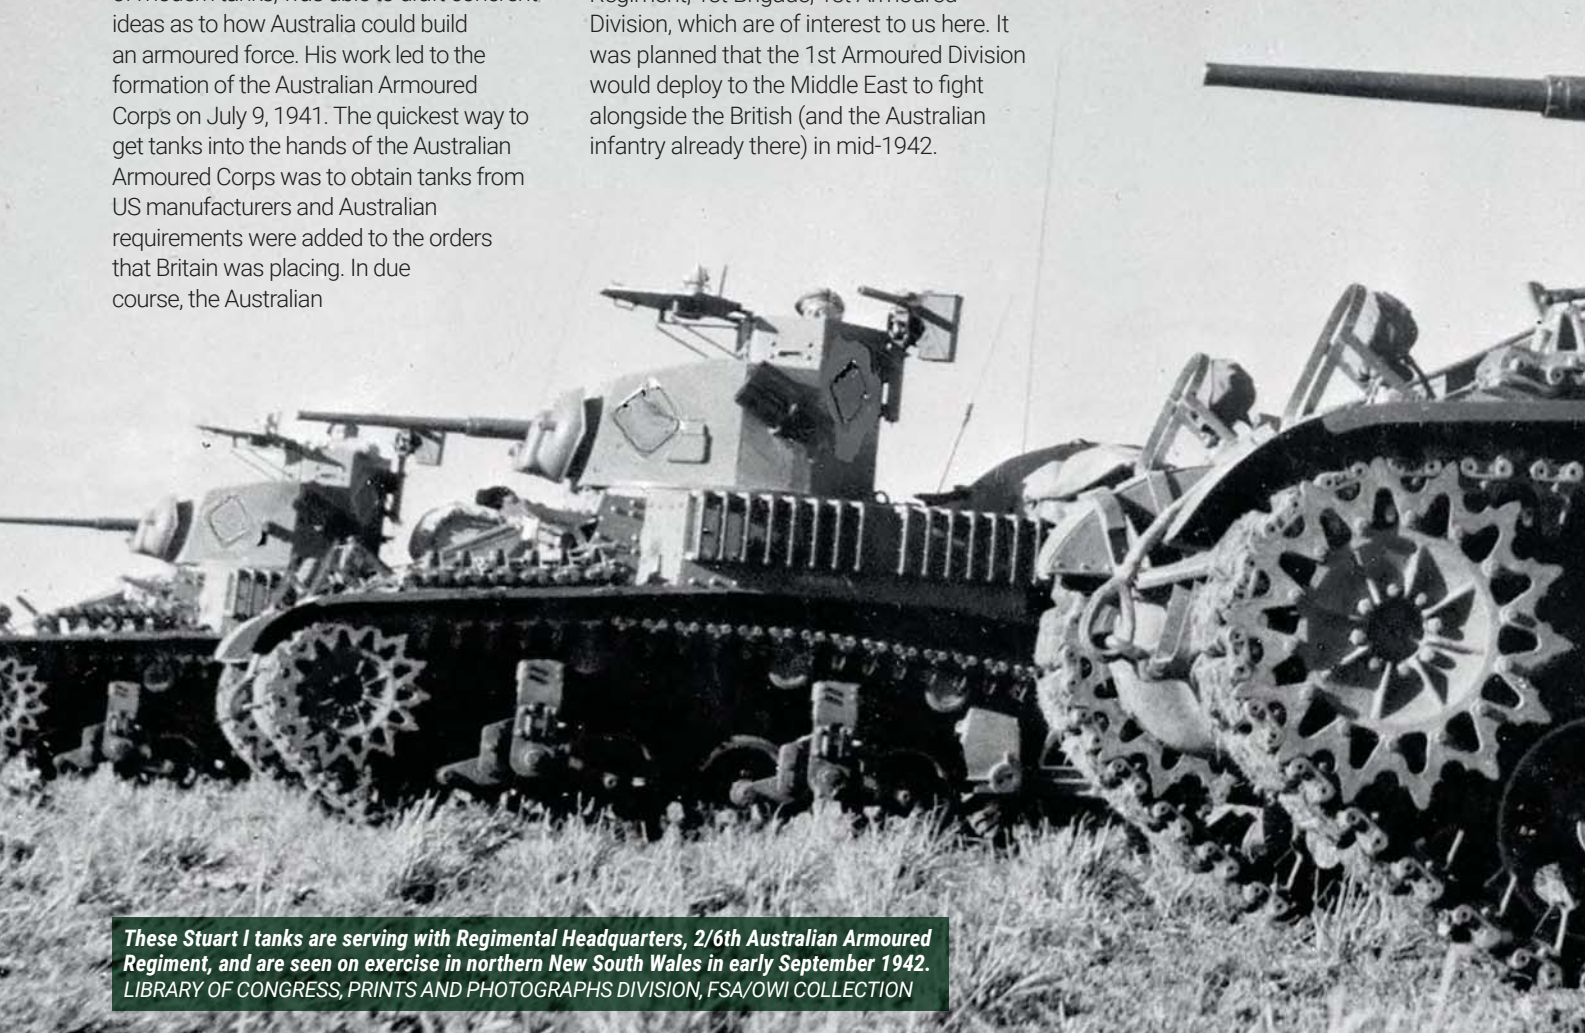
These Stuart I tanks are serving with Regimental Headquarters, 2/6th Australian Armoured Regiment, and are seen on exercise in northern New South Wales in early September 1942.
LIBRARY OF CONGRESS, PRINTS AND PHOTOGRAPHS DIVISION, FSA/OWI COLLECTION

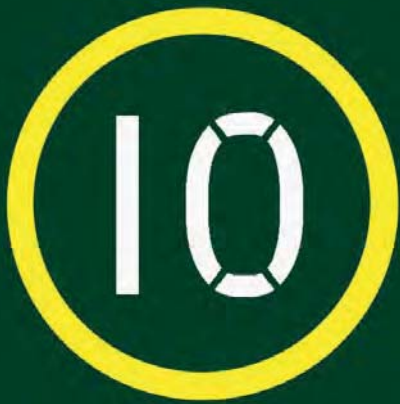
Australian wartime tactical marking of tanks broadly follows the system adopted by the British. This is a representation of the tactical mark carried by the tanks of 2/6th Armoured's C Squadron. The hollow circle is painted yellow; the circle identifies the regiment's C Squadron and the yellow paint indicates the second regiment in a brigade. A Squadron used a hollow triangle as a tactical mark, and B Squadron a hollow square. The 10, in white, indicates 10 Troop; troops were numbered consecutively through a regiment

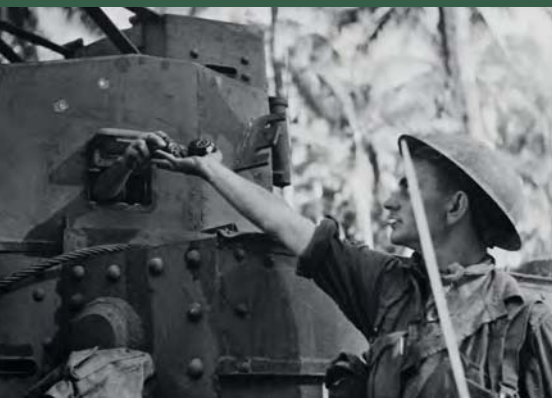
As well as using its tanks to provide fire support, 2/6th Armoured used them to re-supply the accompanying infantry on the battlefield as seen here. GEORGE SILK / LIBRARY OF CONGRESS, PRINTS AND PHOTOGRAPHS DIVISION, FSA/OWI COLLECTION

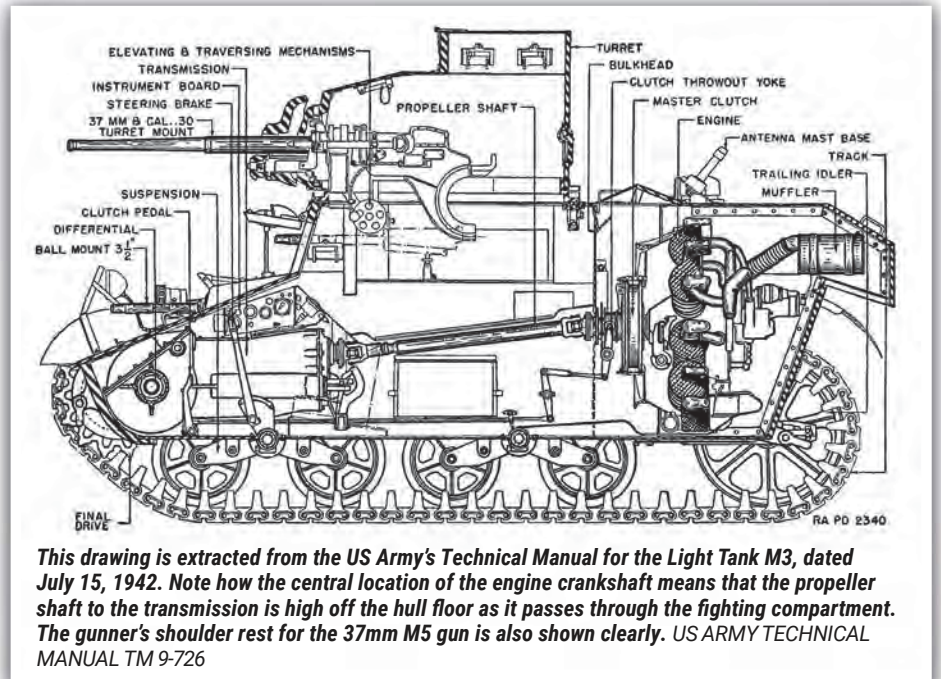
This drawing is extracted from the US Army's Technical Manual for the Light Tank M3, dated July 15, 1942. Note how the central location of the engine crankshaft means that the propeller shaft to the transmission is high off the hull floor as it passes through the fighting compartment. The gunner's shoulder rest for the 37mm M5 gun is also shown clearly. US ARMY TECHNICAL MANUAL TM 9-726

The crankshaft of the radial engine was in its centre, and thus located higher than it would have been in a Vee or in-line engine. This meant that the propeller shaft running forwards to the front- ▶

mounted transmission was located higher too, especially at the engine end. This made things awkward for the two-man turret crew.

In action the two crewmen stood on the hull floor, the gunner to the left of the gun and the loader / wireless operator to the right. If they traversed the turret, they had to watch their footing as they stepped over the cover enclosing the propeller shaft. It often proved easier simply to use the intercom (part of the No 19 wireless set as installed in British and Australian Stuarts) to instruct the driver to turn the entire tank. The turret traverse wheel was worked by the loader under the gunner's instructions (though in British and Australian service the wheel was often moved to the gunner's side of the gun). It was difficult to be precise with this arrangement, so the gun was in a mounting that allowed the gunner to use his shoulder to traverse it independently of the turret up to 10 degrees right and left. The gunner elevated the gun using a hand wheel.

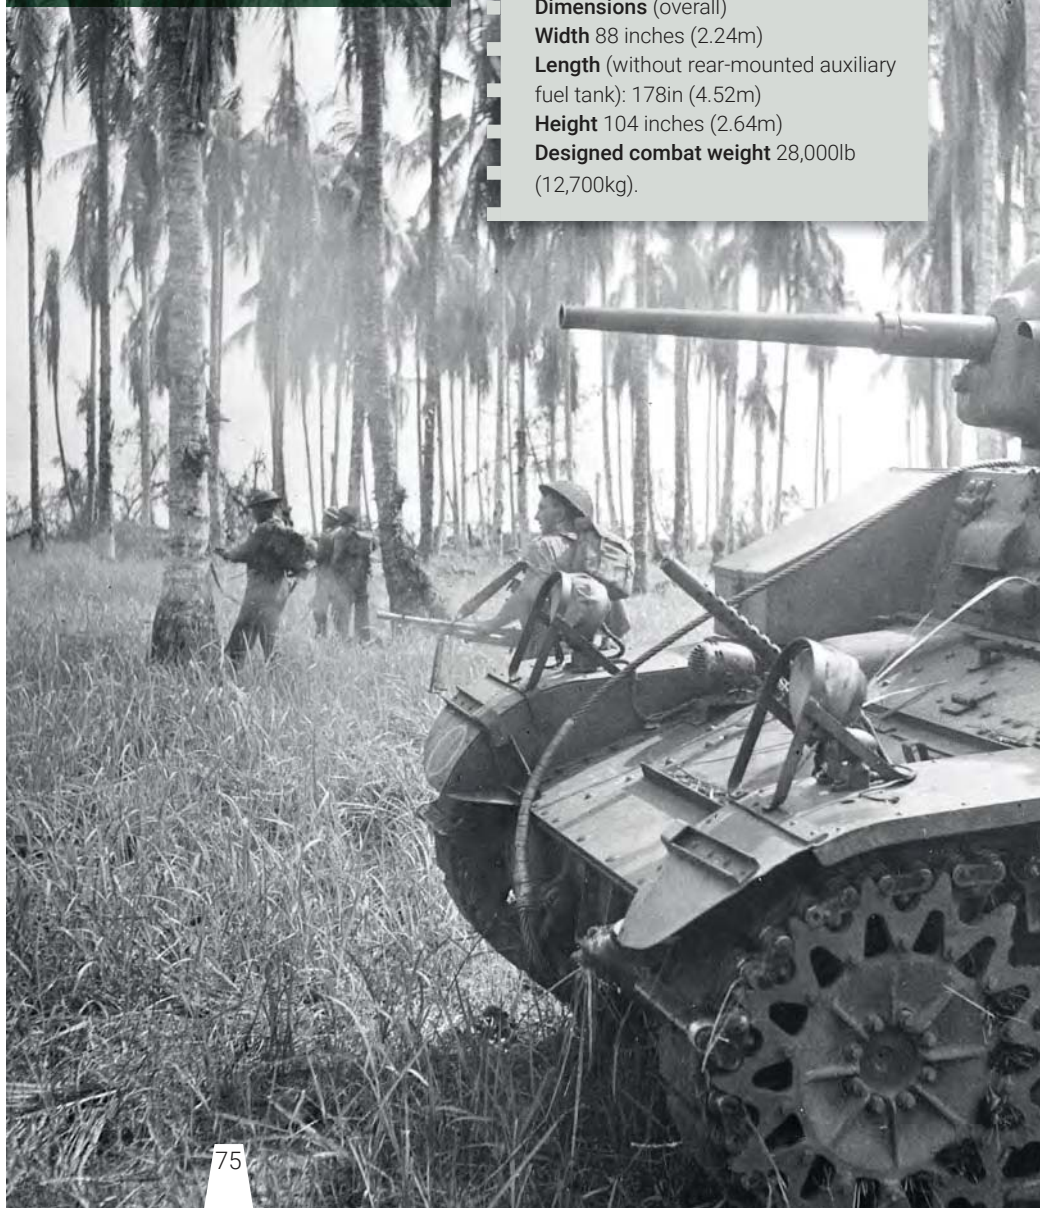
2/6th Armoured's Stuart I 'Binalong' in action at Giropa Point on New Year's Day, 1943. Note the hull machine gun at full elevation to engage snipers at the top of coconut palms. GEORGE SILK / LIBRARY OF CONGRESS, PRINTS AND PHOTOGRAPHS DIVISION, FSA/OWI COLLECTION

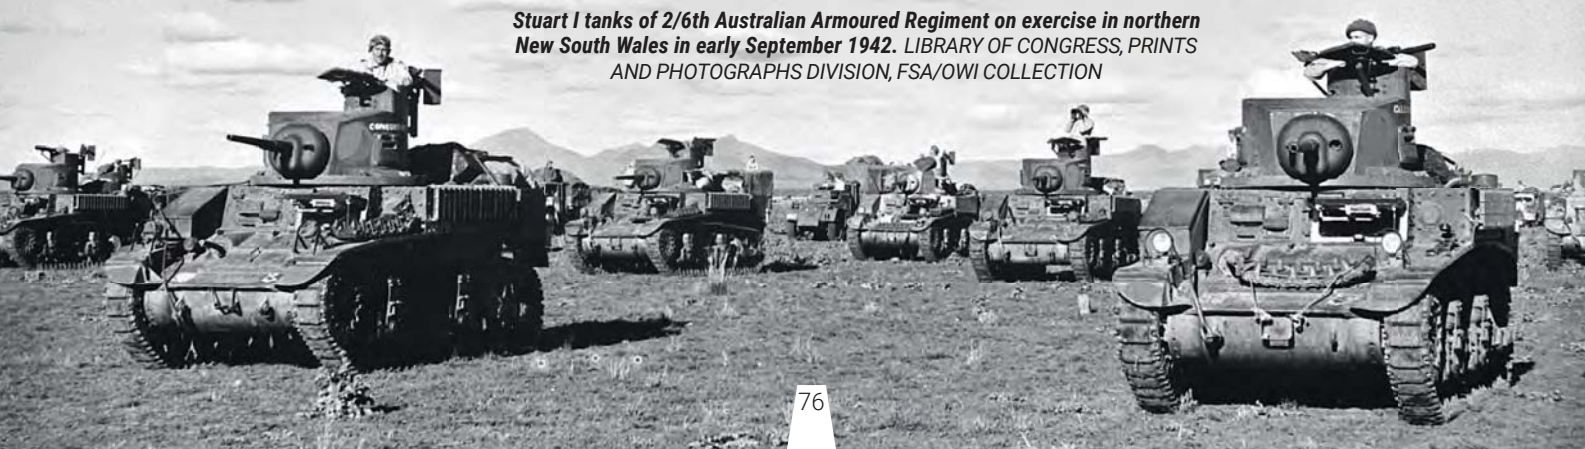
Stuart I tanks of 2/6th Australian Armoured Regiment on exercise in northern New South Wales in early September 1942. LIBRARY OF CONGRESS, PRINTS AND PHOTOGRAPHS DIVISION, FSA/OWI COLLECTION
