# Life-Saving Silicone Breast Implant After Firearm Injury: Case Report and Treatment Recommendations

Plastic Surgery Case Studies

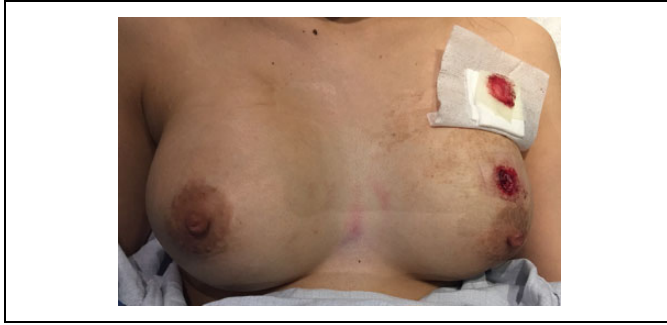
**Figure 1.** Anterior view of the chest showing bullet entrance wound in superior left breast.

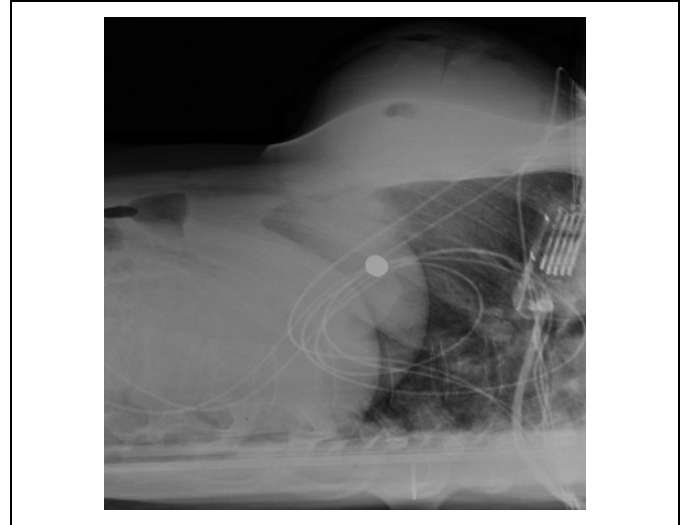
**Figure 3.** Anteroposterior (AP) and lateral chest radiographs. Note bullet in right lateral thoracic wall on AP chest X-ray. Note gas along bullet trajectory in lateral view.

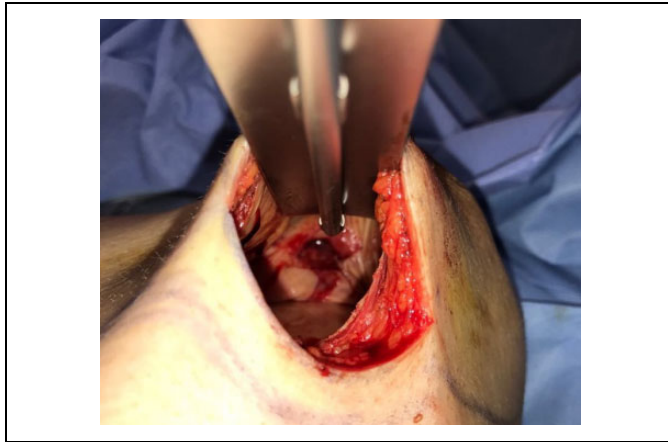
**Figure 4.** Intraoperative view of left breast capsule with implant removed showing bullet wound anteriorly.

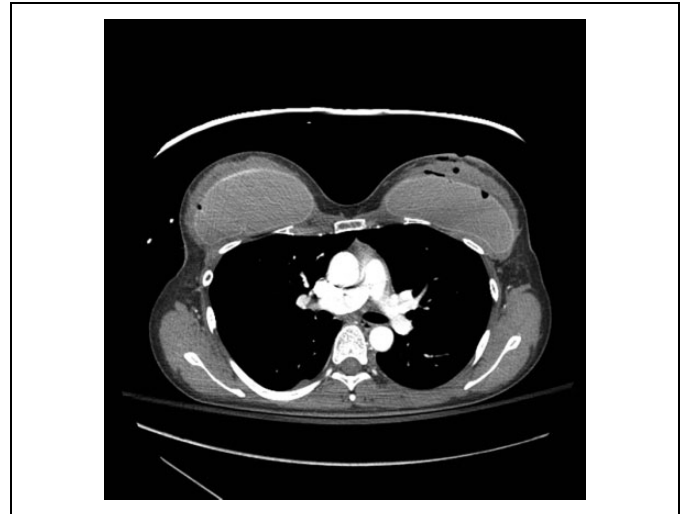
**Figure 7.** Axial computed tomography (CT) scan revealing entry wound to left breast with bullet tract into left breast implant, hematoma, and soft tissue damage.

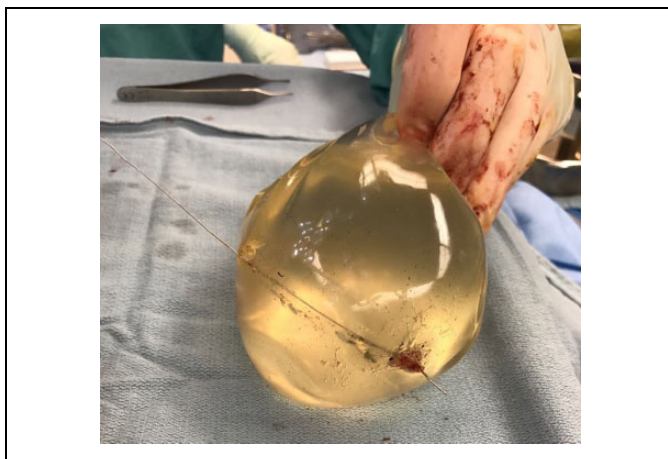
**Figure 5.** Intraoperative view of left breast implant showing bullet trajectory through implant.

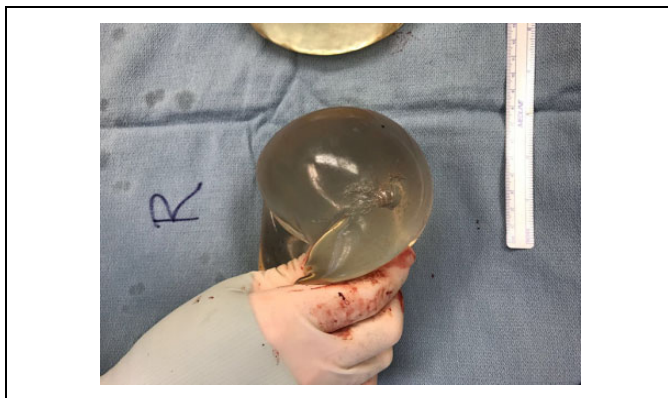
**Figure 6.** Intraoperative view of right breast implant with damage from bullet trajectory.

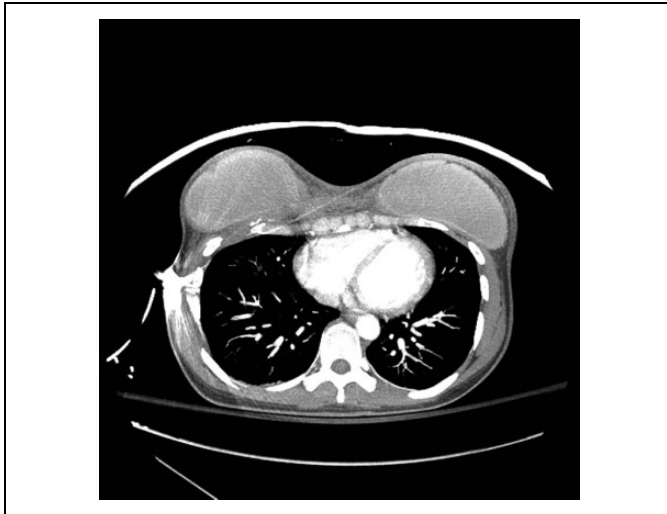
**Figure 9.** Axial computed tomography (CT) scan showing final bullet resting position with artifact and rib fracture on right side of chest.

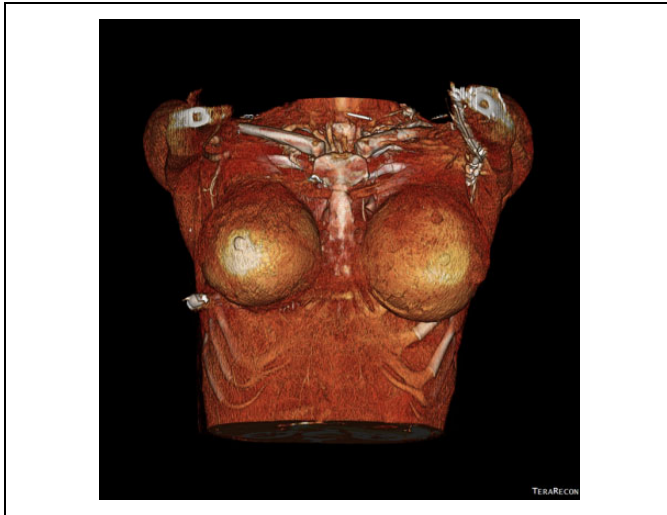
**Figure 10.** 3-dimensional (3D) reformatted volume-rendered image of chest with subcutaneous tissues removed (except nipples for anatomic reference).
