## 2008 VW Jetta GLI, 2.0L I4, Turbo 114,767 miles

Intake valves cleaned with  
No. 05319 *CRC GDI IVD® Intake Valve & Turbo Cleaner*

# VW JETTA GLI TEST RESULTS – INTAKE VALVES

# HYUNDAI SONATA TEST RESULTS — INTAKE VALVES

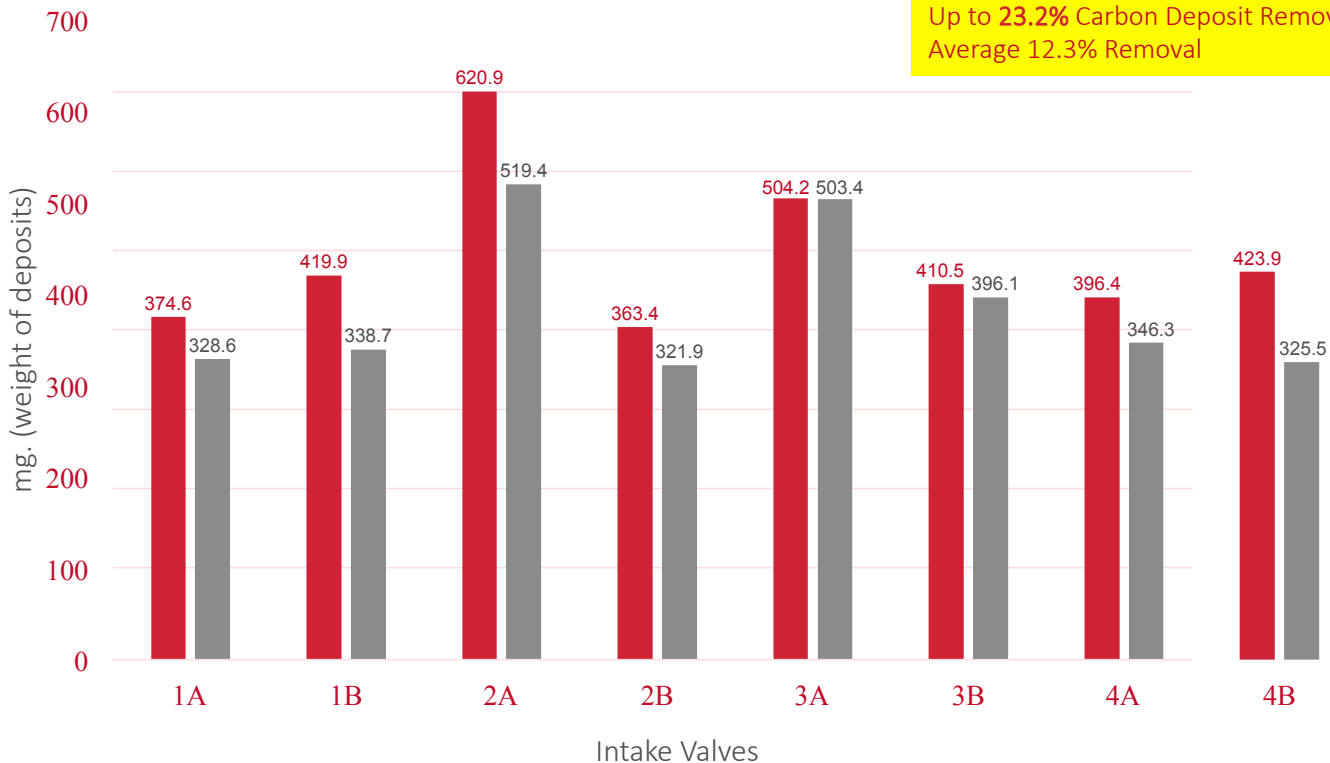
After First Hour:

Up to 23.2% Carbon Deposit Removal  
Average 12.3% Removal

■ Pre Cleanup (Dirty) ■ After Cleaning with 05319

**AVERAGE 12.3%  
Deposit Removal  
After First Hour!**

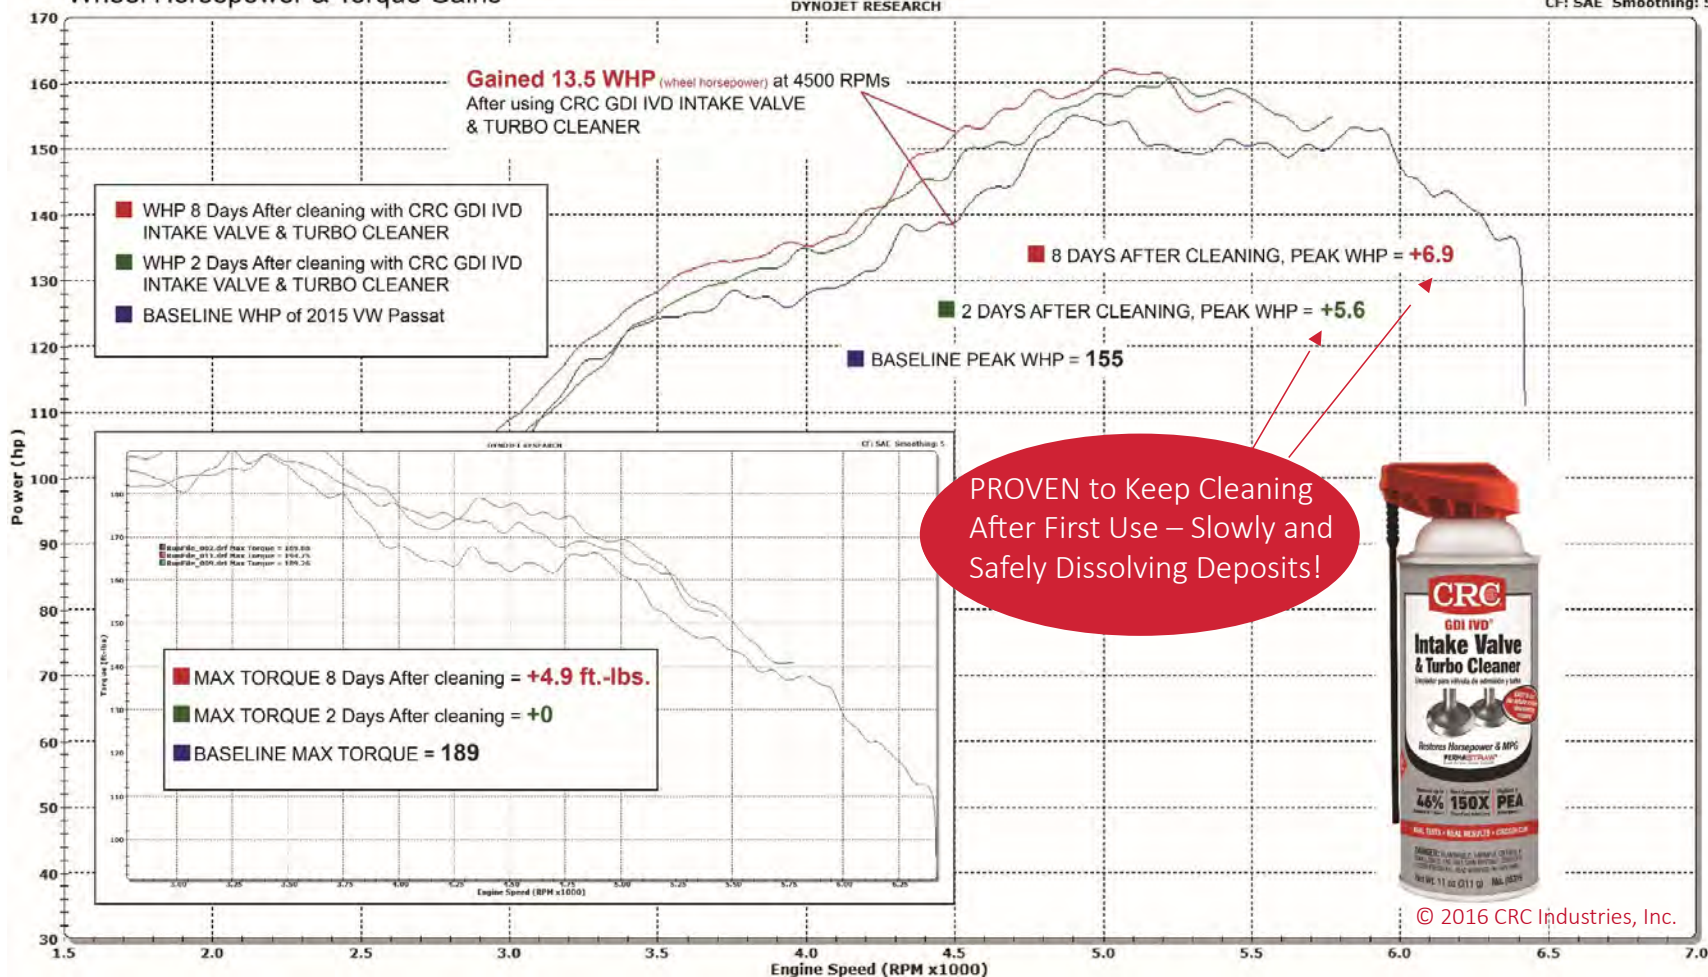
- Gained 13.5 horsepower & 4.9 ft.-lbs. of torque!
- Proven to keep cleaning even 8 days after application

2015 VW Passat 1.8L V4 Turbo · 25K Miles

Wheel Horsepower & Torque Gains

CF: SAE Smoothing: 5

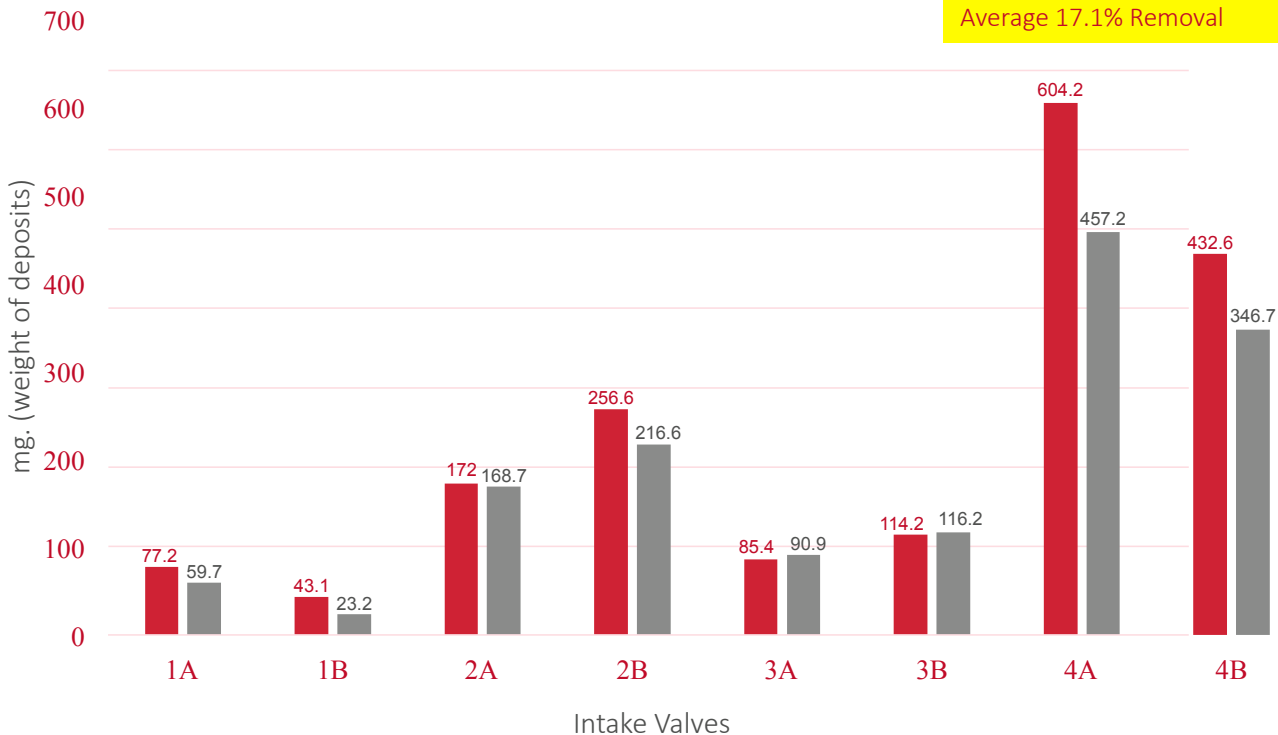
**After First Hour:**

Up to 46.2% Carbon Deposit Removal  
Average 17.1% Removal

■ Pre Cleanup ■ Post Cleanup

**AVERAGE 17.1%  
Deposit Removal  
After First Hour!**

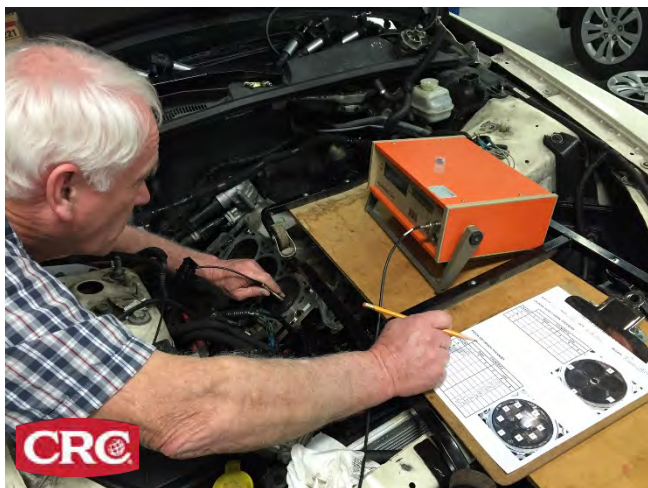
PISTON TOPS				CYLINDER HEADS			
<b>THICKNESS OF CARBON DEPOSIT BEFORE CLEANING (AVERAGE MILS)</b>							
CYL 1	CYL 2	CYL 3	CYL 4	CYL 1	CYL 2	CYL 3	CYL 4
4.23	3.84	4.37	4.59	11.55	10.55	10.01	9.89
<b>AFTER CLEANING with CRC GDI IVD INTAKE VALVE &amp; TURBO CLEANER</b>							
0.5	0.11	0.21	0.1	4.21	3.15	1.51	1.53
<b>CLEANUP RESULTS % AFTER 1 HOUR!</b>							
88.2%	97.1%	95.2%	97.8%	63.5%	70.1%	84.9%	84.5%

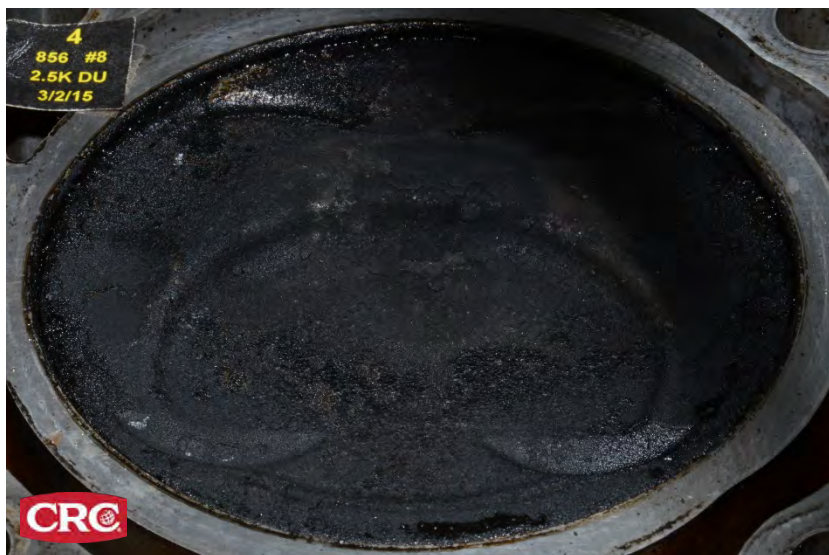
Piston Top (Dirty)  
Carbon Deposit Thickness in Mils = 4.59

Carbon Deposits Reduced  
by **98%** After First Hour!

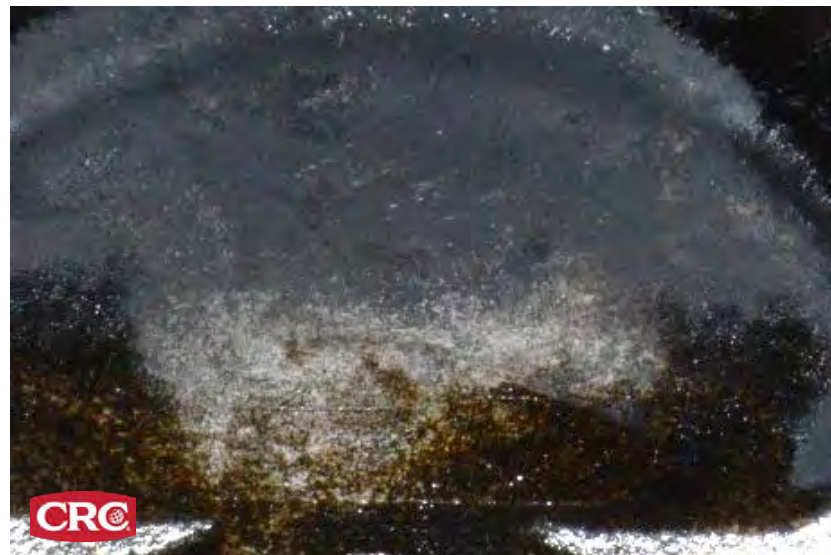
Piston Top After Cleaning with CRC 05319  
Carbon Deposit Thickness in Mils = 0.1

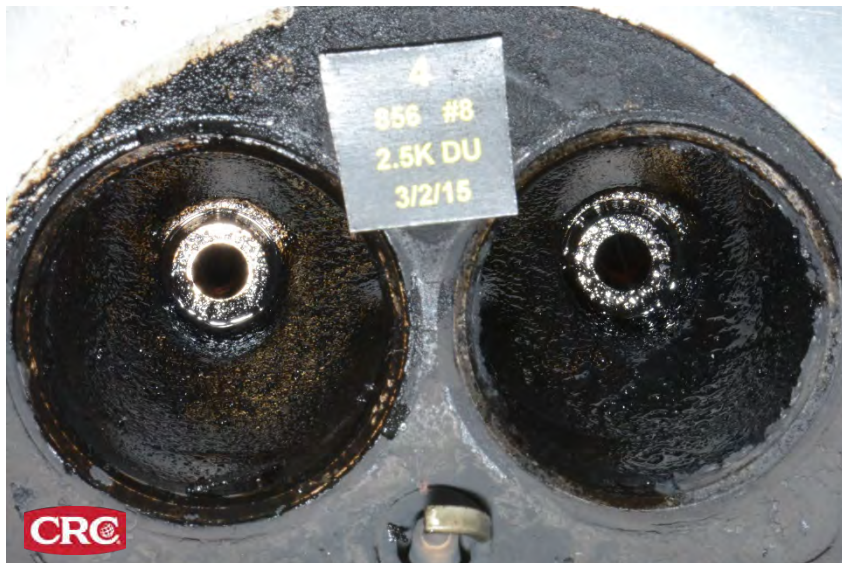
Cylinder Head (Dirty)  
Carbon Deposit Thickness in Mils = 9.89

Carbon Deposits Reduced  
by **85%** After First Hour!

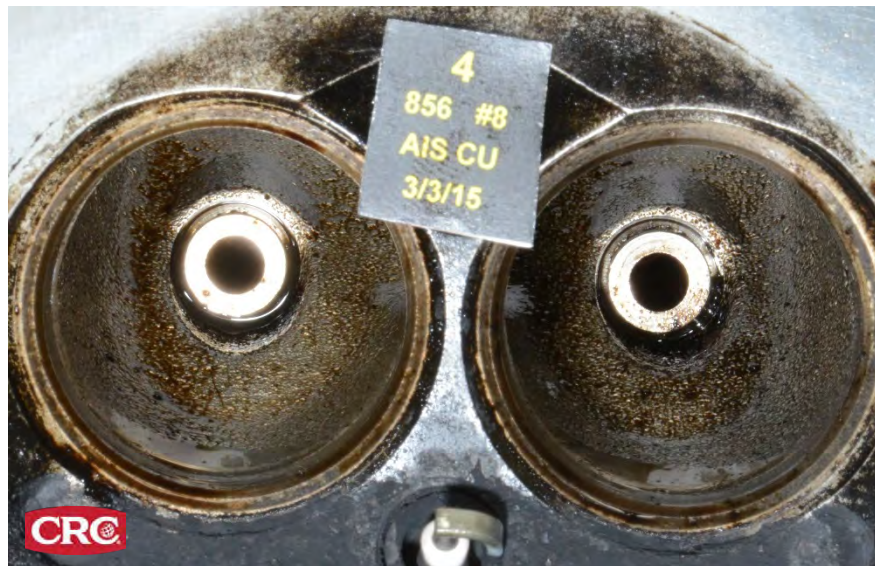
Cylinder Head After Cleaning with CRC 05319  
Carbon Deposit Thickness in Mils = 1.57

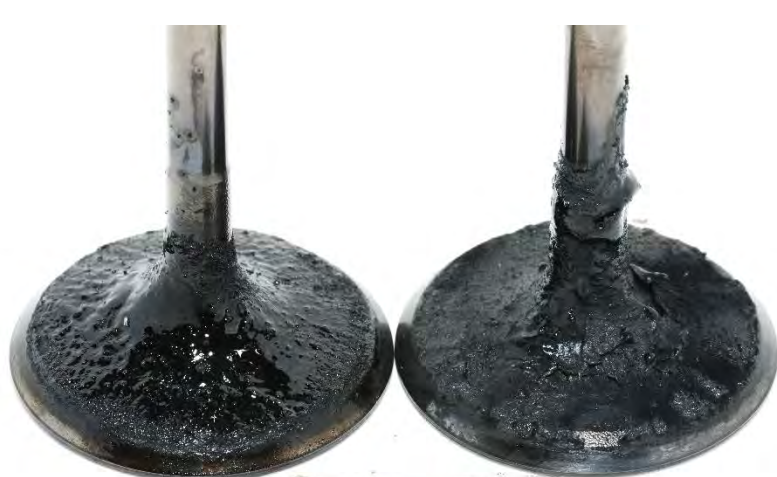
4  
856 #8  
2.5K DU  
3/2/15

Intake Valves (Dirty)

Deposit weight (mg) **604.2**

Intake Valve Carbon Deposits Reduced  
by 24.3% After First Hour!

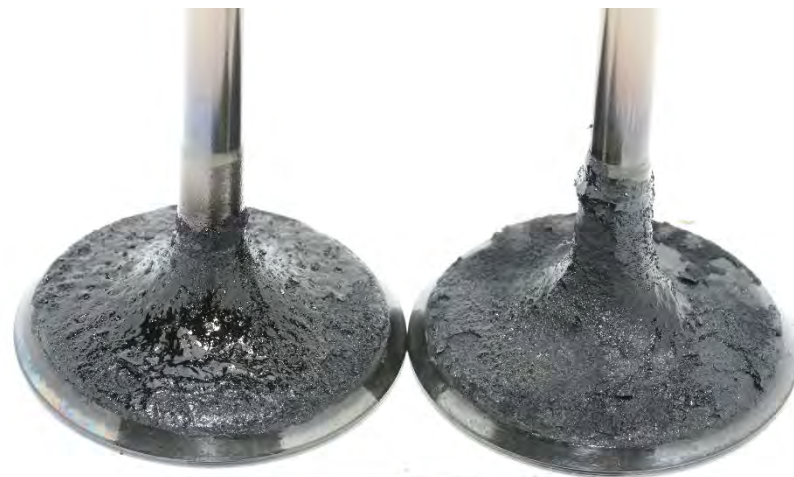
4  
856 #8  
AIS CU  
3/3/15

Intake Valves After Cleaning with CRC 05319

Deposit weight (mg) **457.2**

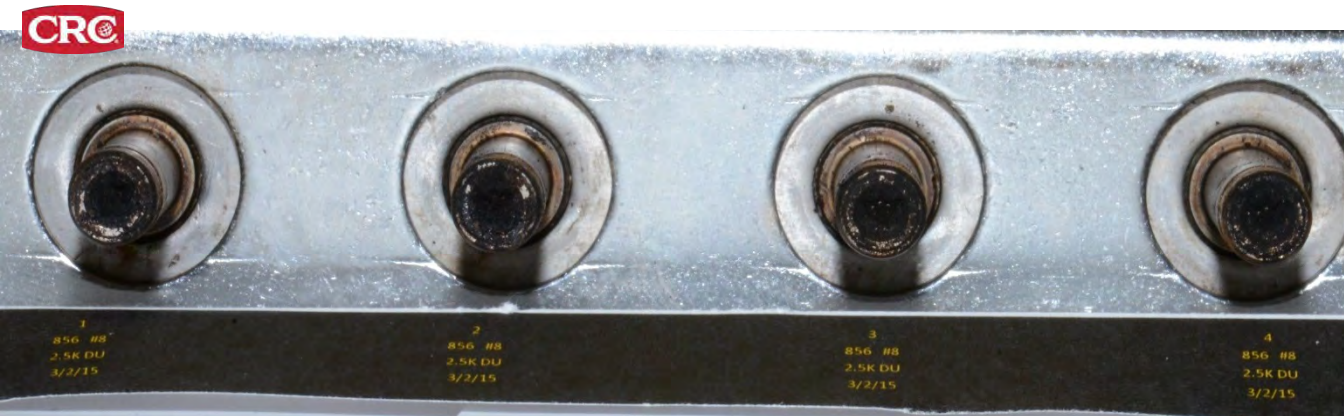
**Fuel Injectors  
Before Cleanup**

Injector Flow Data				
		Cleaned SOT	Pre CU	Post CU	Cleaned EOT	
		Data	2/5/2015 No CU required	3/2/2015	3/3/2015	3/6/2015
Injector ID	Flow #	Flow qty (gm.)	Flow qty (gm.)	Flow qty (gm.)	Flow qty (gm.)	
Injector 1	1	101.00	99.00	101.00	101.00	
	2	101.00	100.00	101.00	101.00	
	3	101.00	100.00	101.00	101.00	
	Average	101.00	99.67	101.00	101.00	
Injector 2	1	100.00	97.00	100.00	101.00	
	2	101.00	98.00	100.00	101.00	
	3	101.00	98.00	100.00	101.00	
	Average	100.67	97.67	100.00	101.00	
Injector 3	1	100.00	98.00	100.00	100.00	
	2	100.00	98.00	100.00	100.50	
	3	100.50	98.00	100.00	101.00	
	Average	100.17	98.00	100.00	100.50	
Injector 4	1	100.00	98.00	100.00	100.00	
	2	100.00	98.00	100.00	101.00	
	3	101.00	98.00	100.00	101.00	
	Average	100.33	98.00	100.00	100.67

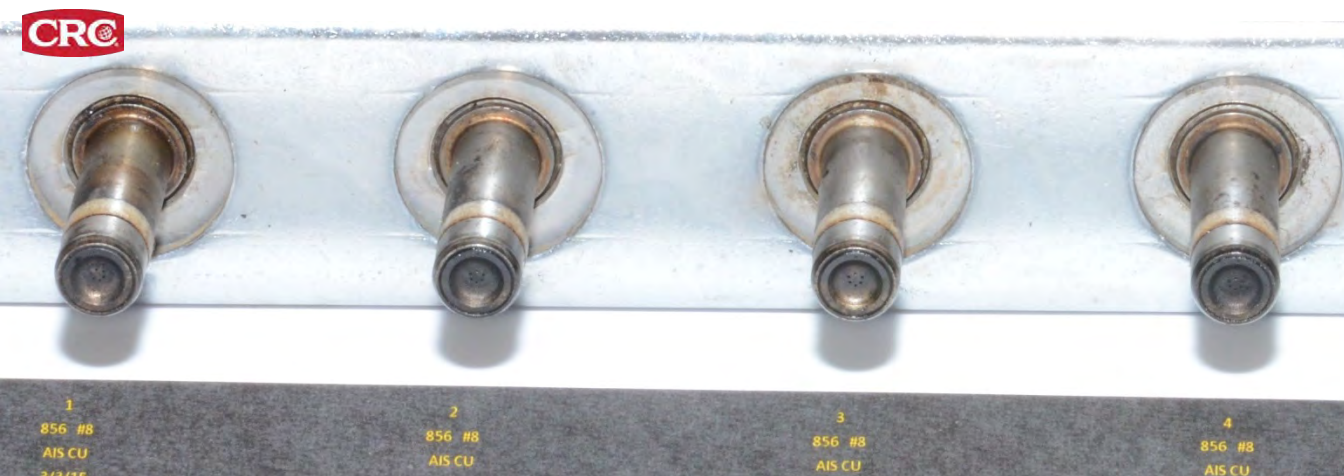
**Fuel Injectors  
100% Flow Restored  
After Cleaning with  
CRC 05319**

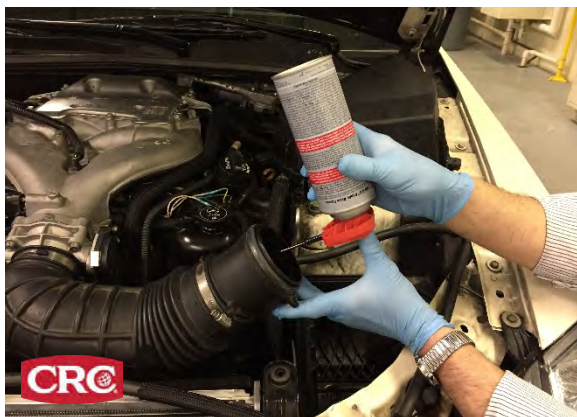
Spray CRC GDI IVD®  
Intake Valve & Turbo Cleaner  
past the MAF sensor...

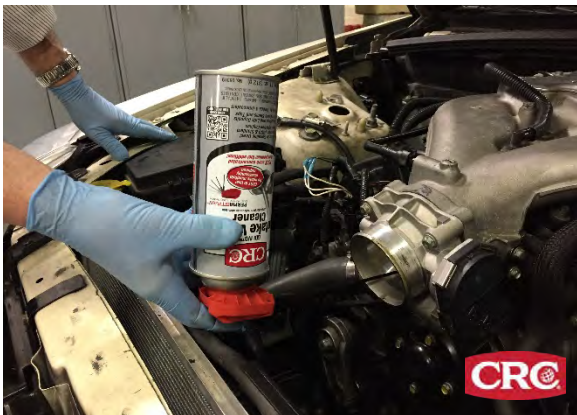
Directly into the throttle body...

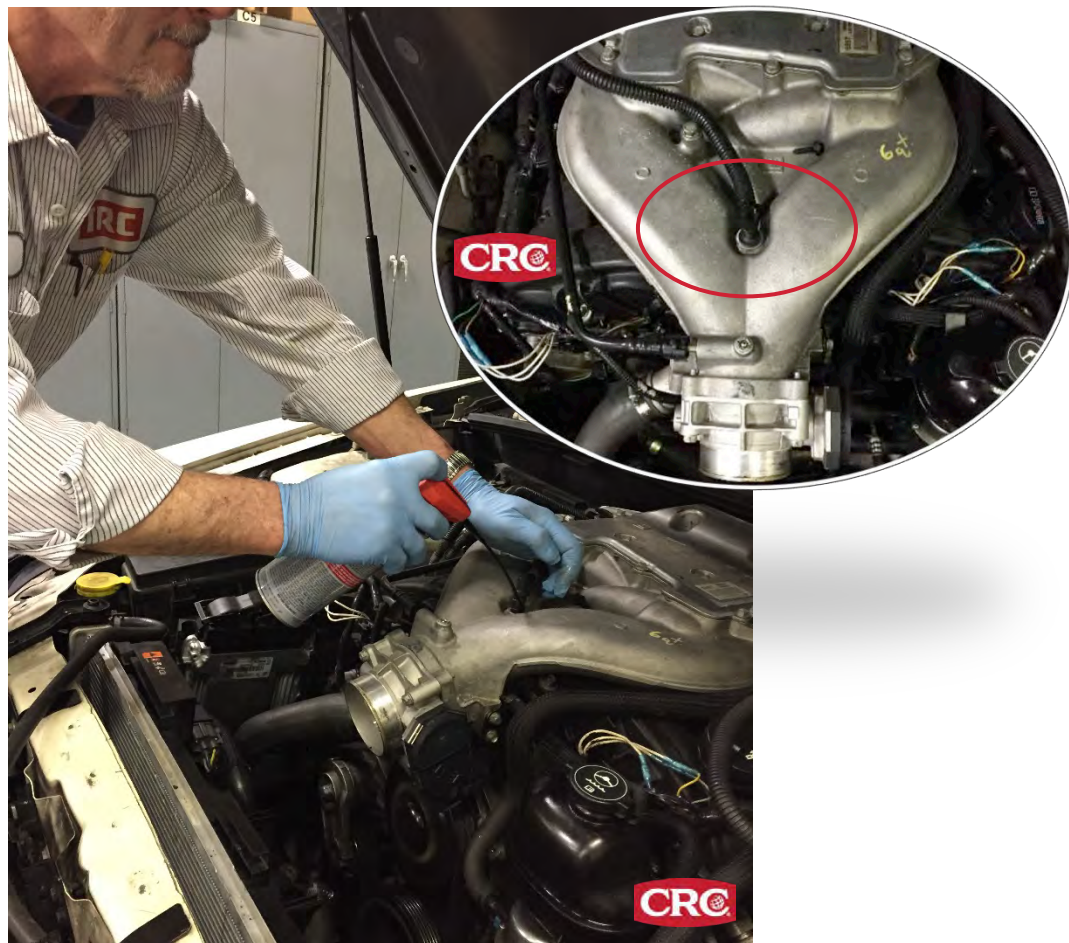
Or professionals can spray through a vacuum line  
connected to the intake manifold  
(i.e. brake booster vacuum line)

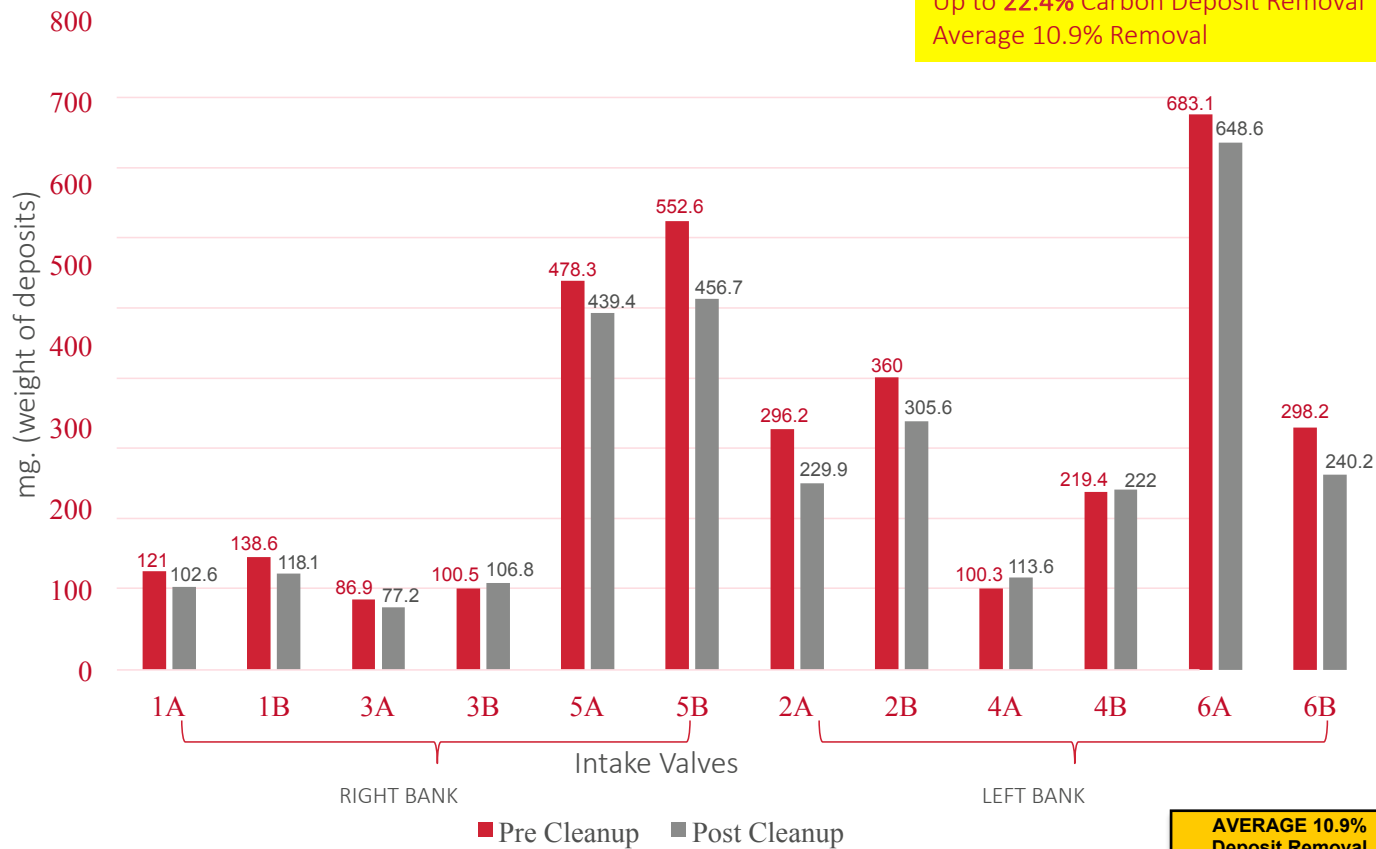
**After First Hour:**  
Up to 22.4% Carbon Deposit Removal  
Average 10.9% Removal

**AVERAGE 10.9% Deposit Removal After First Hour!**

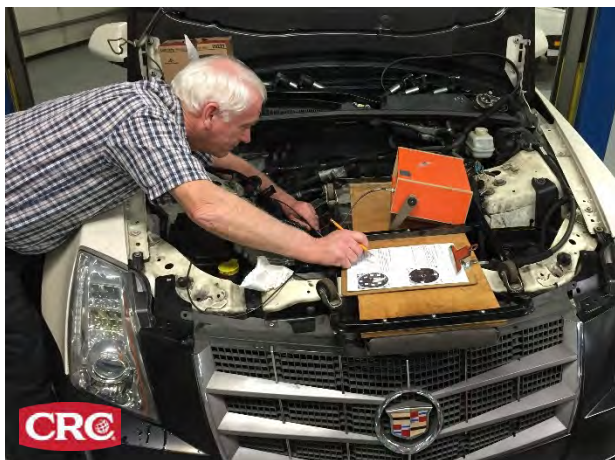
PISTON TOPS						COMBUSTION CHAMBERS					
THICKNESS OF CARBON DEPOSIT BEFORE CLEANING (AVERAGE MILS)											
CYL 1	CYL 2	CYL 3	CYL 4	CYL 5	CYL 6	CYL 1	CYL 2	CYL 3	CYL 4	CYL 5	CYL 6
6.76	7.32	6.65	8.5	6.75	8.59	9.52	10.15	10.54	12.38	12.07	11.88
AFTER CLEANING with CRC GDI IVD INTAKE VALVE & TURBO CLEANER											
2.59	3.4	3.18	4.04	3.49	2.77	3.45	4.43	5.35	6.73	6.71	4.88
CLEANUP RESULTS % AFTER FIRST HOUR!											
61.7%	53.6%	52.2%	52.5%	48.3%	67.8%	63.8%	56.4%	49.2%	45.6%	44.4%	58.9%

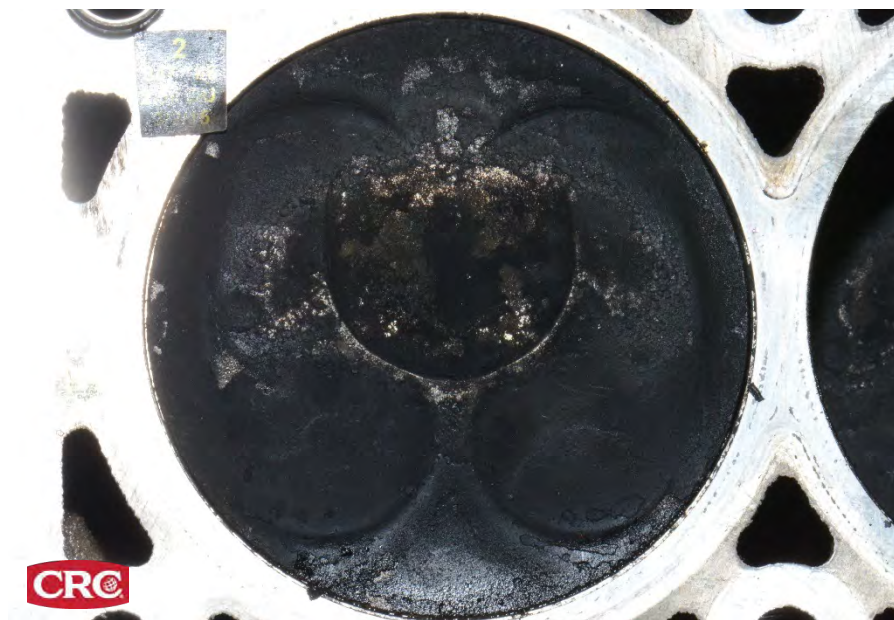
Piston Top (Dirty)

Carbon Deposit Thickness in Mils = 8.59

Carbon Deposits Reduced  
by **68%** After First Hour!

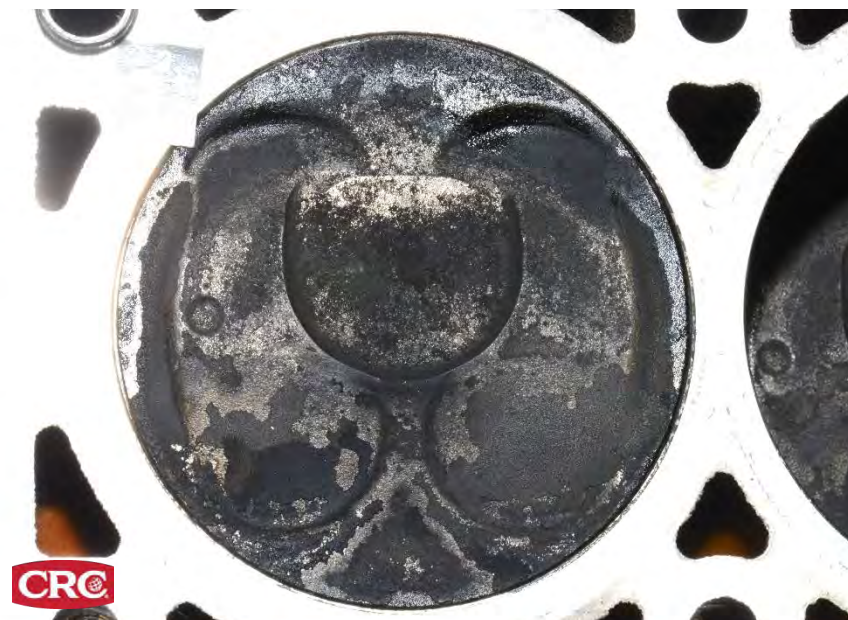
Piston Top After Cleaning with CRC 05319

Carbon Deposit Thickness in Mils = 2.77

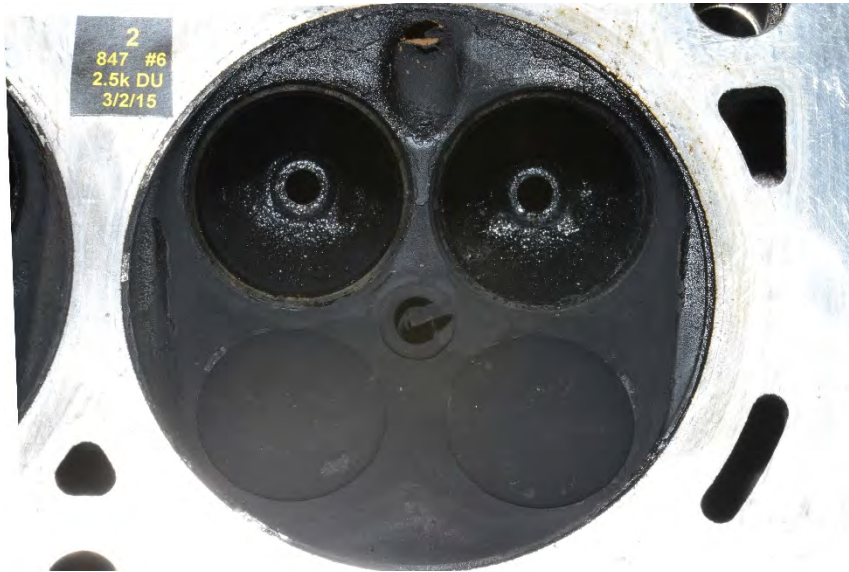
Cylinder Head (Dirty)

Carbon Deposit Thickness in Mils = 9.52

Carbon Deposits Reduced  
by 64% After First Hour!

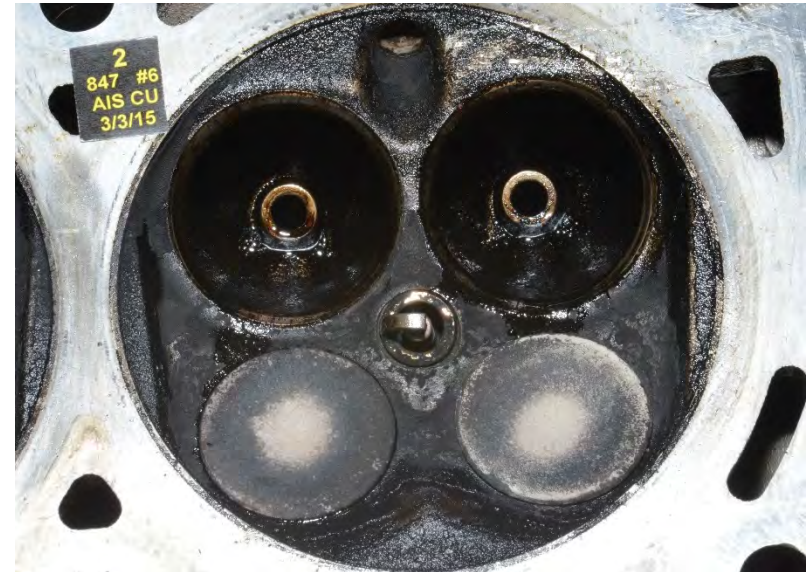
Cylinder Head After Cleaning with CRC 05319

Carbon Deposit Thickness in Mils = 3.45

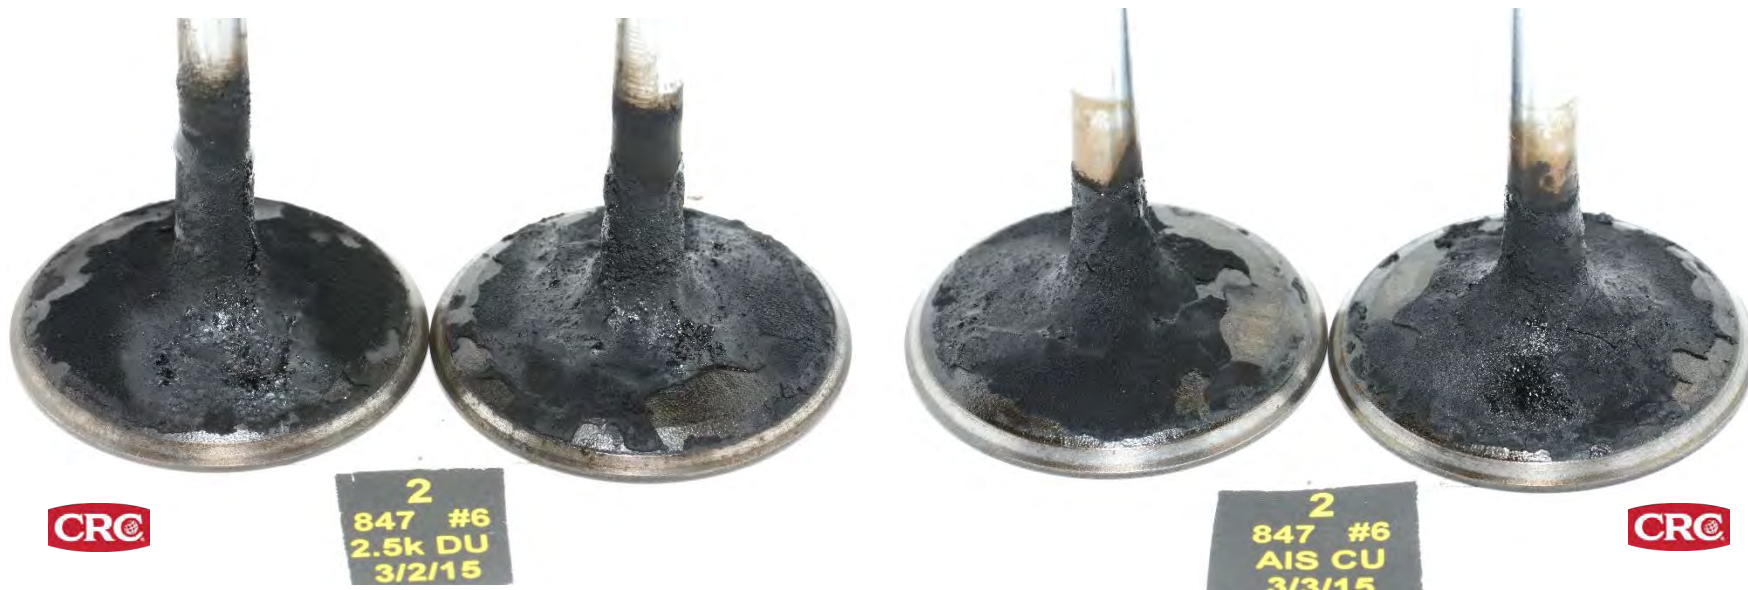
Intake Valves (Dirty)  
Deposit weight (mg) 296.2

Intake Valves After Cleaning with CRC 05319  
Deposit weight (mg) 229.9

Intake Valve Carbon Deposits Reduced  
by 23% After First Hour!

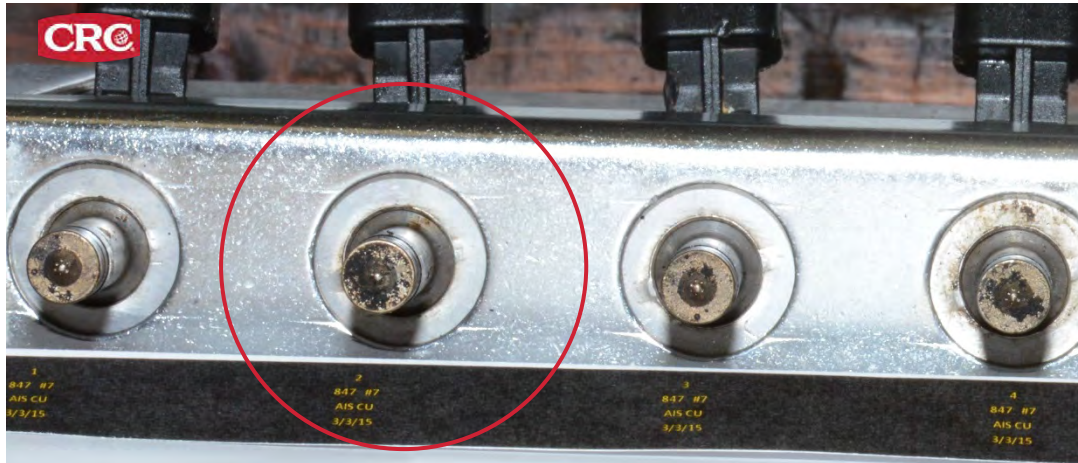
Fuel Injectors up to **91% Flow Restored**  
After the First Hour, Cleaning with CRC GDI IVD® Intake Valve & Turbo Cleaner

Cleaned SOT	Pre CU	Post CU	Cleaned EOT
Date		2/9/15	3/2/15	3/3/15	3/5/15
Injector ID	Flow #	Flow qty (gm.)	Flow qty (gm.)	Flow qty (gm.)	Flow qty (gm.)
Injector 1	1	91.00	90.00	90.00	91.000
	2	91.00	90.00	91.00	91.000
	3	91.00	90.00	91.00	91.000
	Average	91.00	90.00	90.67	91.00
Injector 2	1	88.50	88.00	89.00	88.000
	2	89.00	88.00	89.00	88.000
	3	89.00	88.00	89.00	89.000
	Average	88.83	88.00	89.00	88.33
Injector 3	1	89.00	88.00	89.00	89.000
	2	90.00	89.00	89.00	89.000
	3	90.00	89.00	89.00	89.000
	Average	89.67	88.67	89.00	89.00
Injector 4	1	90.00	89.00	90.00	89.000
	2	90.00	90.00	90.00	89.000
	3	90.00	90.00	90.00	89.000
	Average	90.00	89.67	90.00	89.00
Injector 5	1	91.00	91.00	92.00	90.500
	2	92.00	92.00	91.50	90.000
	3	92.00	92.00	92.00	90.000
	Average	91.67	91.67	91.83	90.17
Injector 6	1	89.00	89.00	90.00	88.000
	2	90.00	89.00	90.00	89.000
	3	90.00	89.00	90.00	89.000
	Average	89.67	89.00	90.00	88.67
Reference Injector	1	89.00	90.00	90.00	88.000

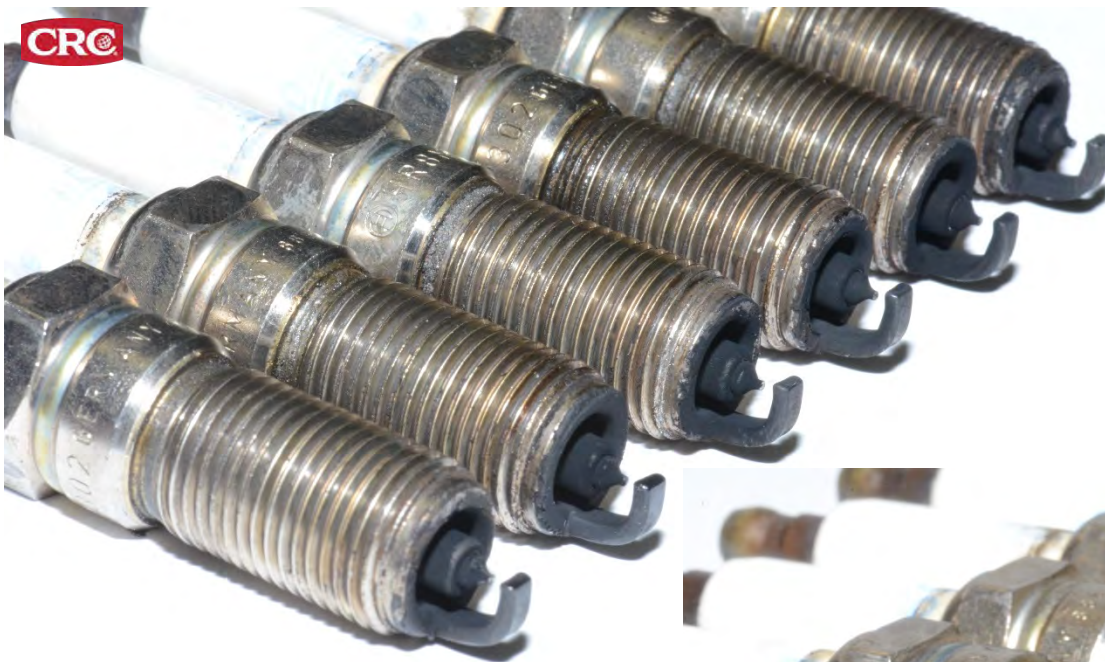
Spark Plugs (Dirty)

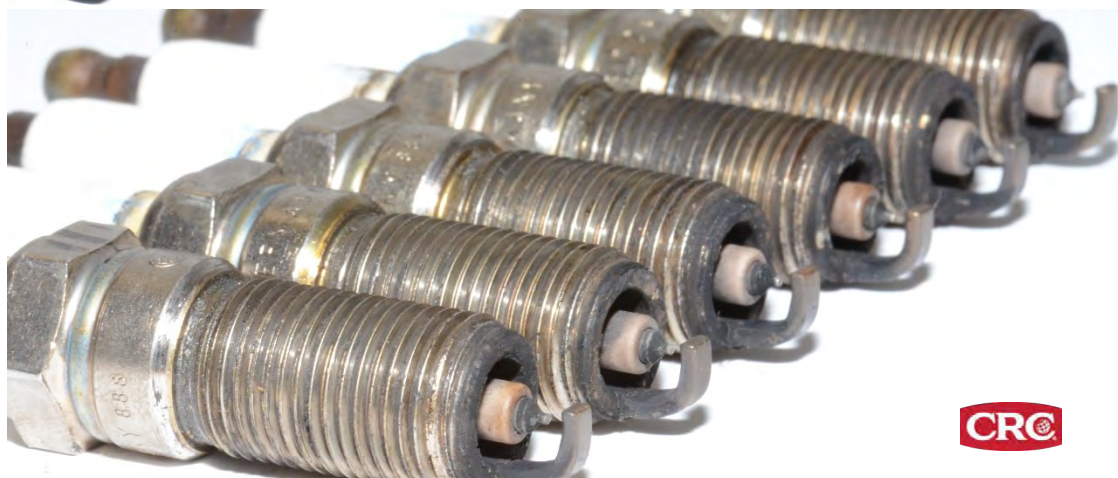
Spark Plugs After Cleaning with CRC 05319

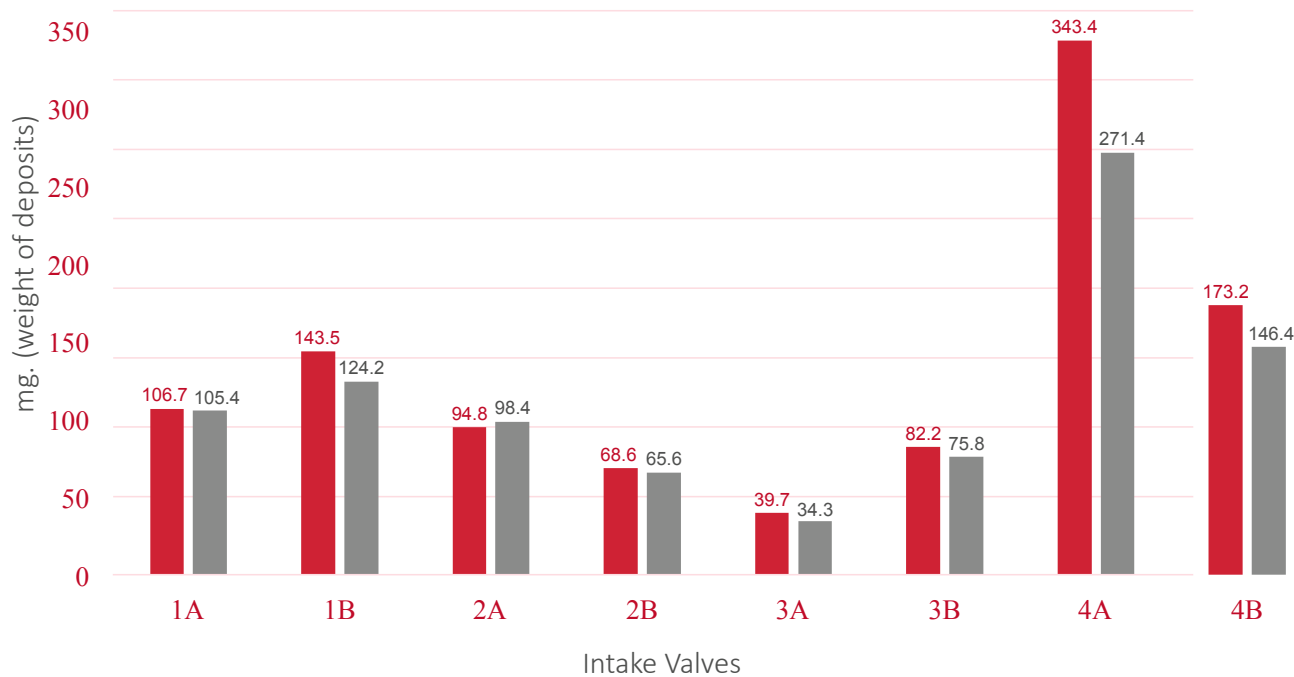
**After First Hour:**

Up to 21% Carbon Deposit Removal

Average 12.4% Removal

■ Pre Cleanup ■ Post Cleanup

**AVERAGE 12.4%  
Deposit Removal  
After First Hour!**

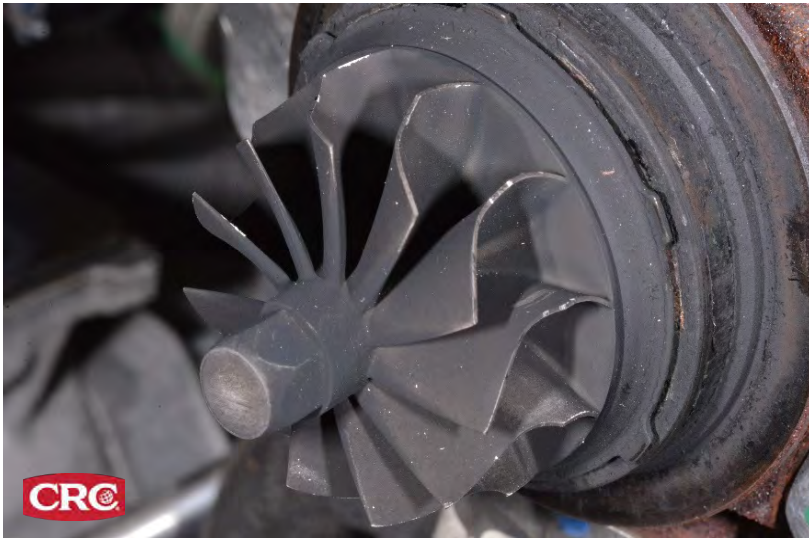
**Turbo Impeller**

**Before**

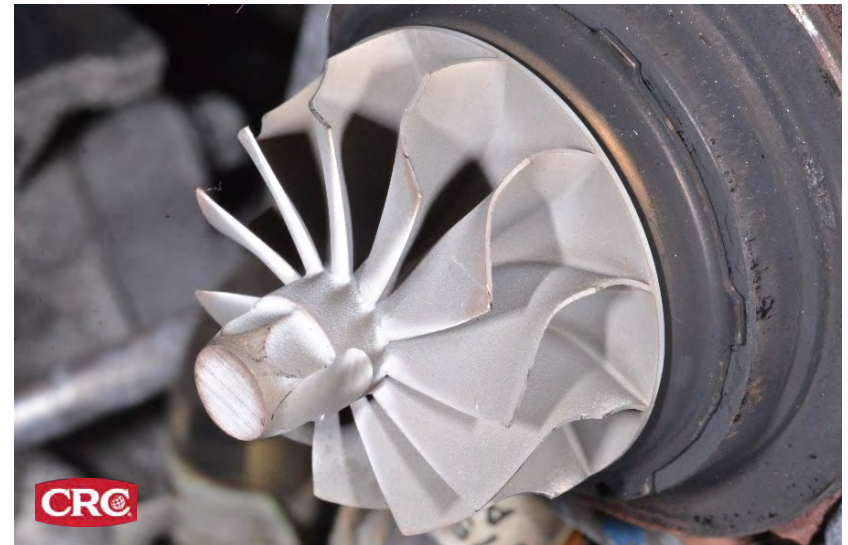
**After cleaning with  
CRC GDI IVD® INTAKE VALVE &  
TURBO CLEANER**
