## Suspicious Evidence

by Michael Kobs

### MH17 shot down by BUK missile: The definitive proof

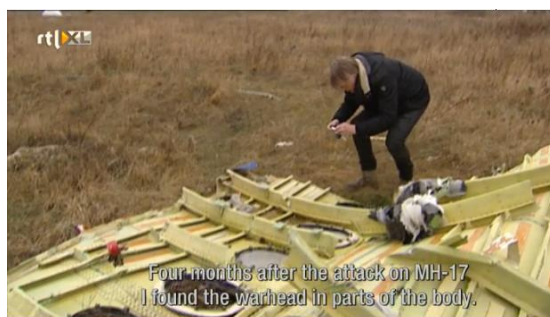
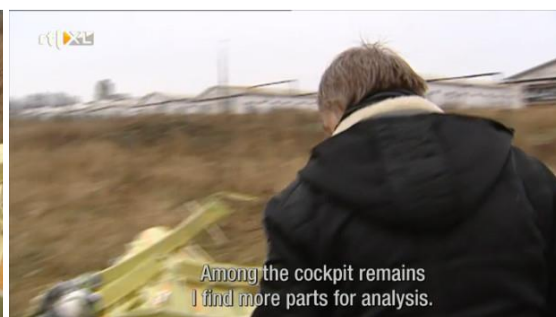
He obviously found that piece of evidence at the crash site close to the chicken farm (see right image below in the background) at 48.131829° 38.631337°.

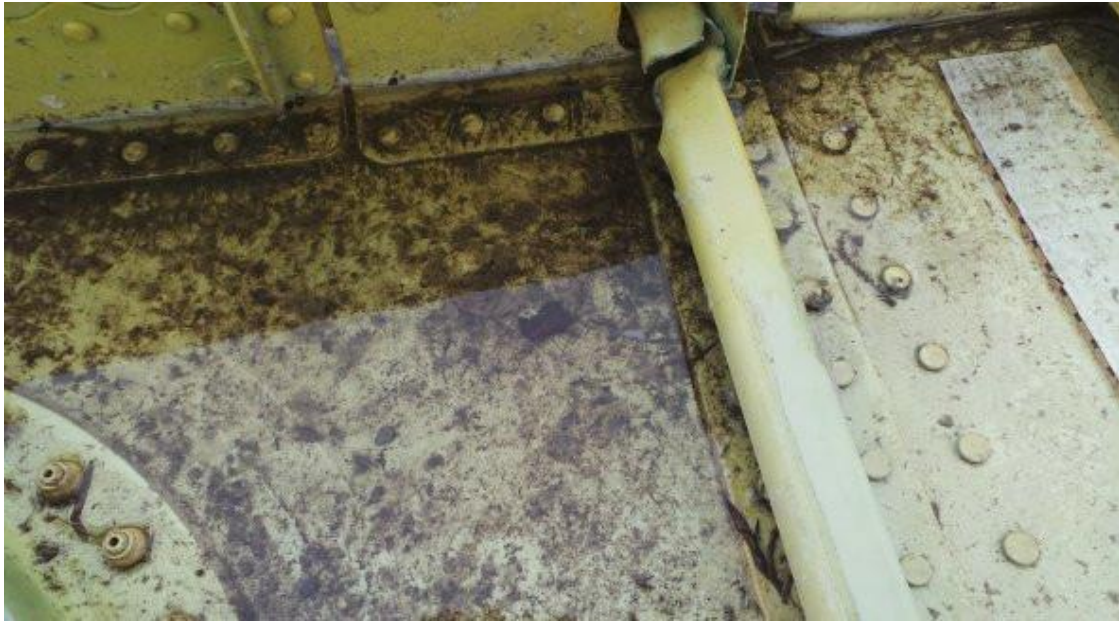
The allegedly original position of that bowtie is shown in the image below:

However, Marcel van den Berg pointed out that the piece of debris on which Akkerman allegedly found the bowtie was previously turned upside down. Earlier photographs of that piece of debris show the outside of the airplane pointing upwards.

Furthermore, that piece of debris is part of the left side of the tail and includes the last windows far behind the wings. It neither shows any damage due to submunition impacts nor would the bowtie be able to enter the airplane at that distance and angle.

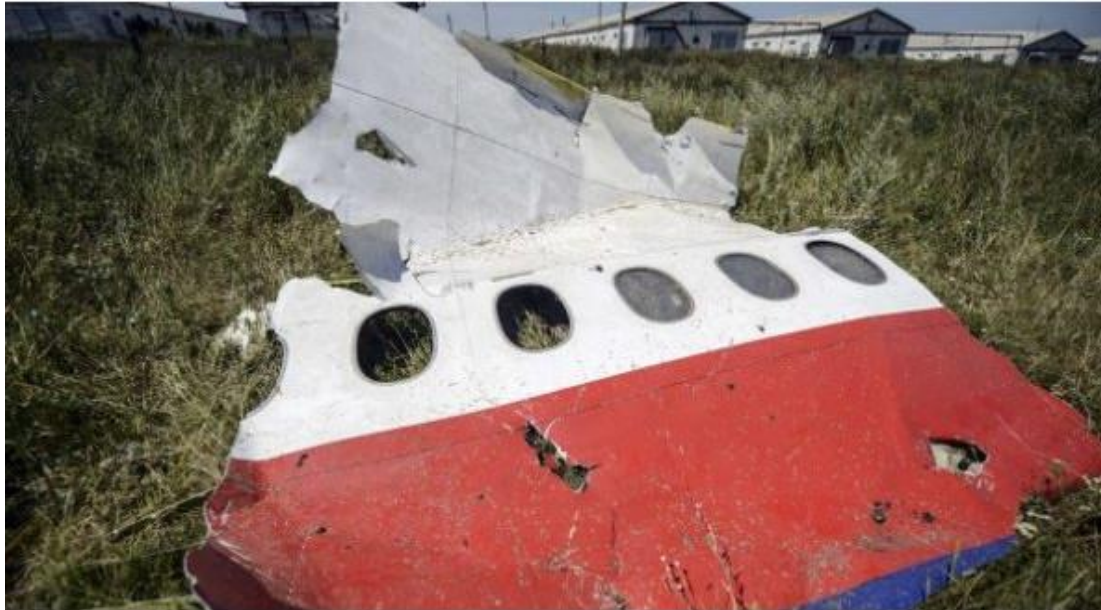
Google Earth images show that it was turned between August the 1<sup>st</sup> and 4<sup>th</sup> and disappeared between November the 1<sup>st</sup> and 20<sup>th</sup>. So Akkerman probably was the last one who had the chance to examine that piece at the crash site.

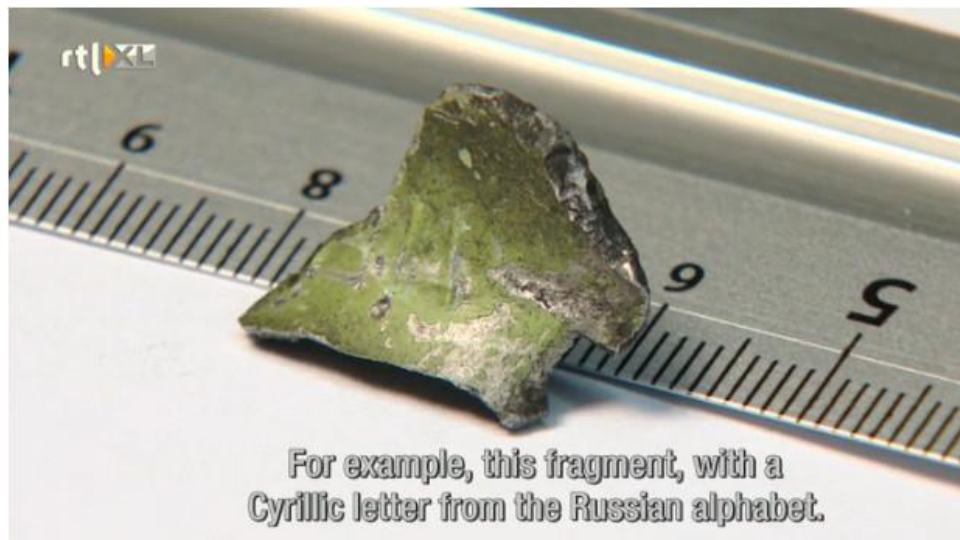
Nevertheless, Akkerman had more suspicious to show. He also found not only a piece of the missile but a piece of the serial number allegedly of the BUK missile:

The 2cm piece is bent in a radius much too small for the outer shell of a BUK missile but the main interest of the presentation was the number itself because it includes the Cyrillic letter "ц". Once again RTL Nieuws arrived at the same conclusion:

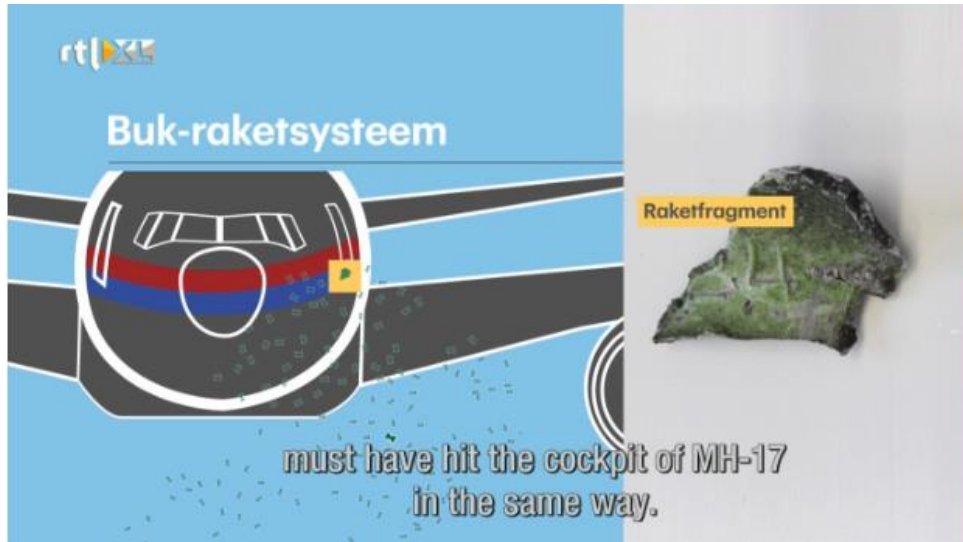
RTL Nieuws shows that piece of "evidence" from a slightly different perspective. Look at the Cyrillic letter "ц" again.

The Cyrillic letter ц is always written on the baseline. Hence, 2ц share the same baseline. Therefore, the piece of the serial number most likely says 24 using a font like Elite 12pt used by the [IBM Selectric advocate Typewriter](#) produced between 1975 and 1977:

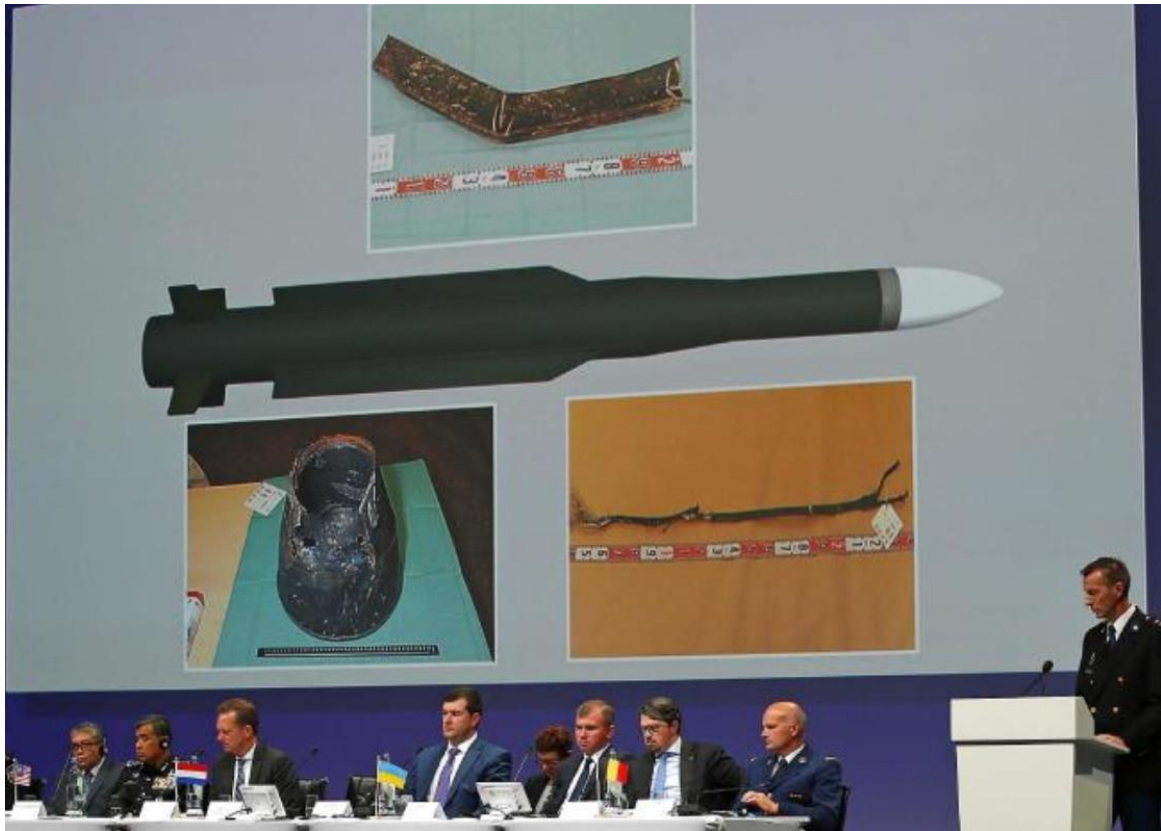
The most convincing part is a piece of the tail of the missile embedded in the window frame of the left side of the cockpit.

JIT: "A ball of twisted metal was found in the groove of one of the cockpit windows. This ball of twisted metal appears to be part of the missile of the 9M38 type. The shape, dimensions and milling traces on the metal match exactly the same part of the BUK missile that had been dismantled by the investigation team."

According to the image the red marked edge of the alleged missile part sticks below the undamaged edge of the window frame. The shadow below that folded piece of metal suggests that the impact at about 1000 m/s (without any additional force) didn't deform the shrapnel in a way that it matches (or embeds into) the surface of the groove along the window frame. Furthermore, there is no edge that possibly could have bent the lower edge of the shrapnel (bright blue) upwards. Therefore, the deformation appears not to be caused by the impact - or more precise by the impact to this window frame.

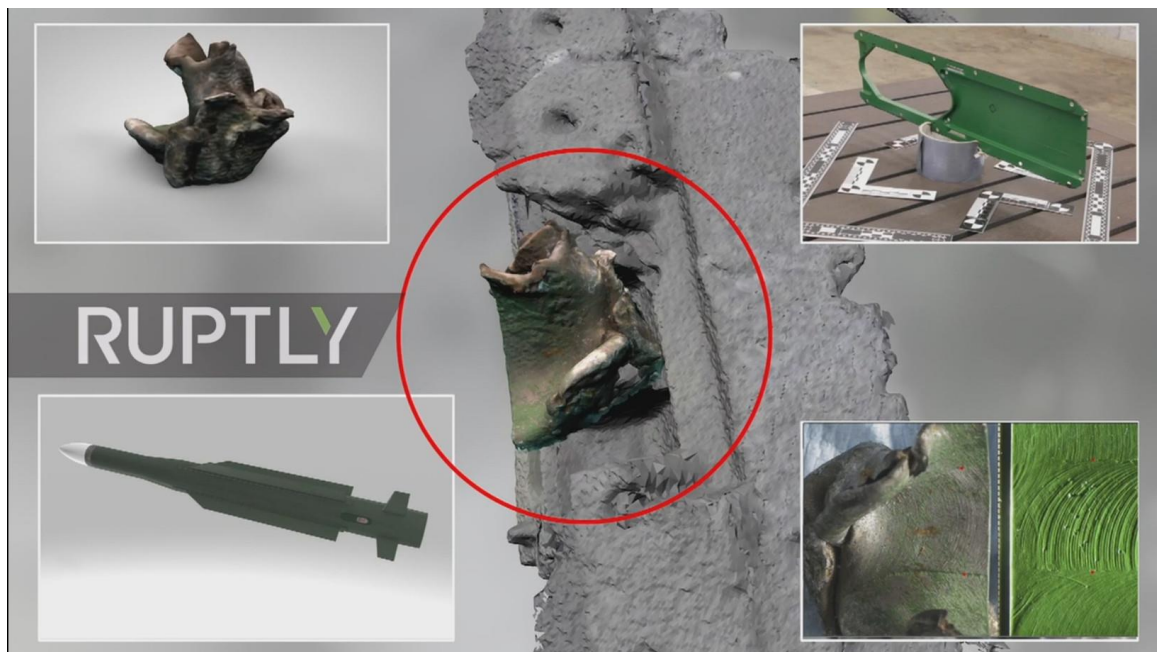
Obviously not the entire part of the missile body behind the warhead impacted the airplane. Such an almost frontal impact at  $730\text{m/s}$  (missile) +  $250\text{m/s}$  (plane) =  $1000\text{m/s}$  might have sliced through the airframe like a knife. Instead just some small shrapnel – seemingly a part of the lid in the upper right picture (picture in picture) – impacted the cockpit window frame.

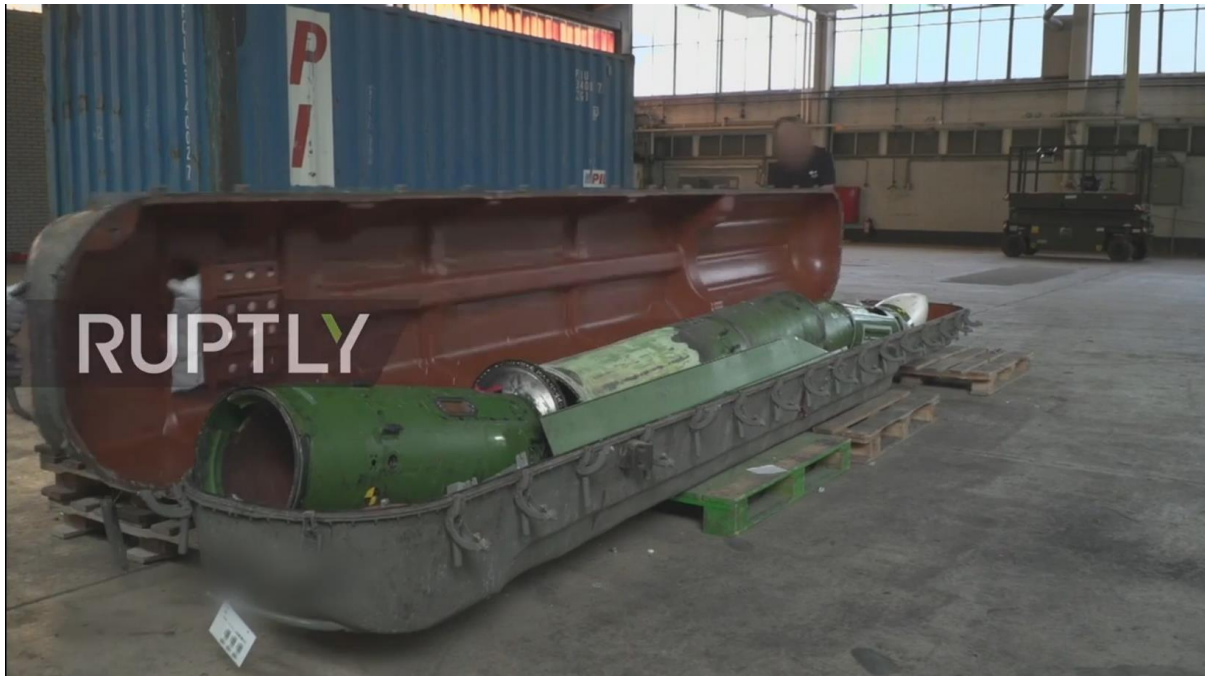
Notice that the lid is bolted to the last tail section of the missile:

So either the entire body of the missile disintegrated into small pieces or the last section of the body just lost the lid. Even if the body of the missile was never found, it seems to be unlikely that the entire body virtually vaporized due to the explosion of the warhead. The warhead is constructed in a way that directs most of the pressure almost perpendicular to the sides.

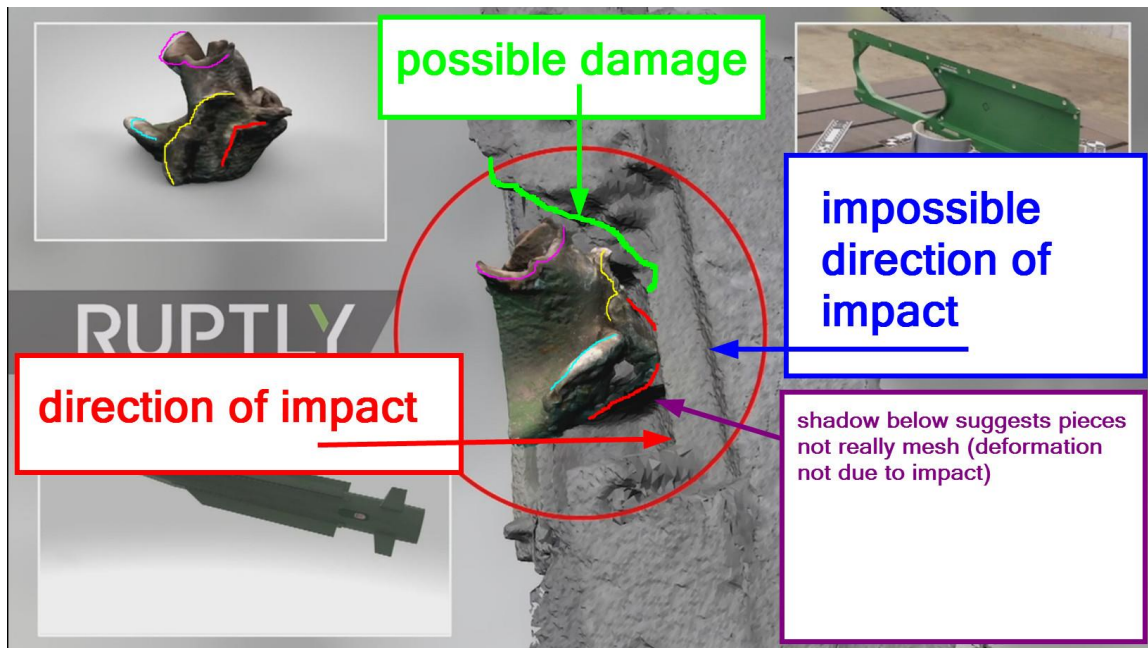
According to the JIT presentation (see below) that embedded piece of the lid apparently impacted from left to right (red arrow). Notice that the higher profile of the undamaged side of the window frame do not allow an impact from the right side (blue arrow).

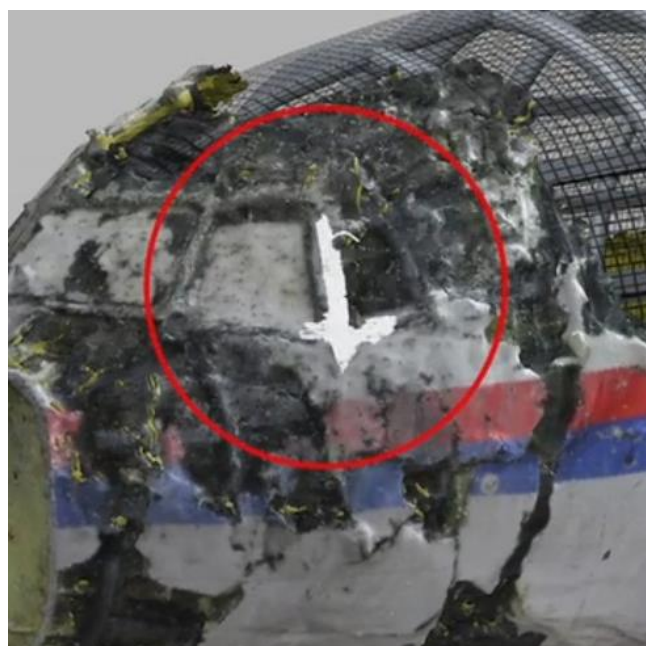
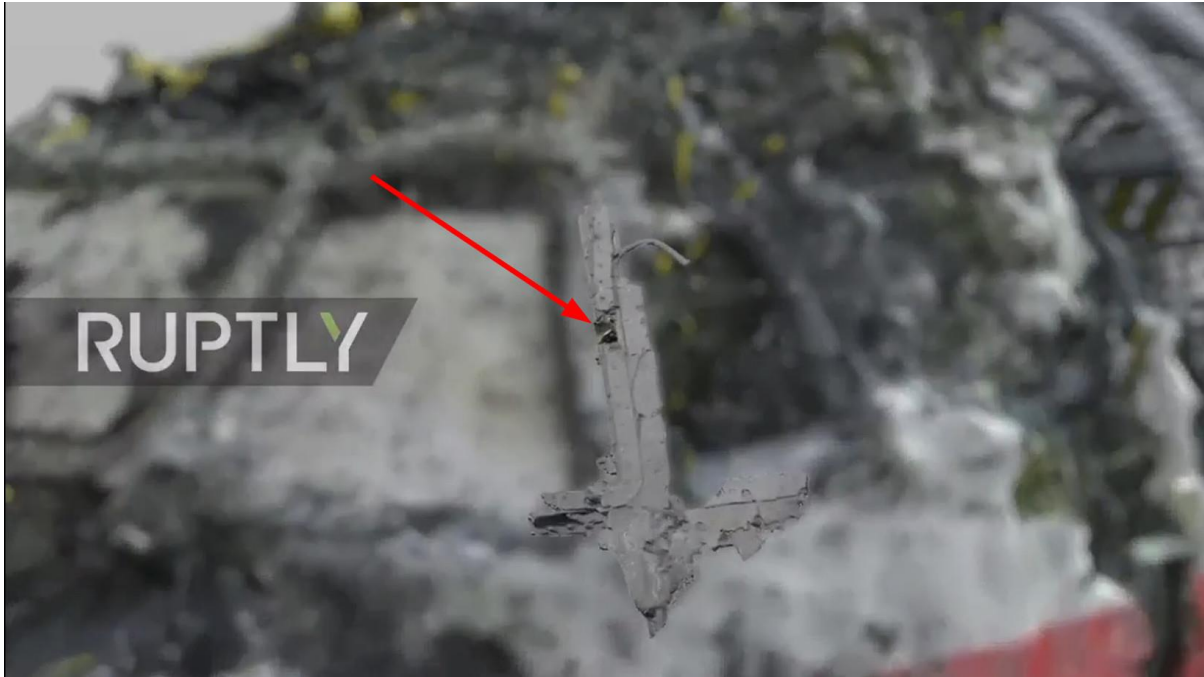
But there is a much bigger problem. The [JIT presentation](#) shows the location of the impacted window frame this way:

Notice that the debris of the window frame has the shape of a cross pointing downwards.

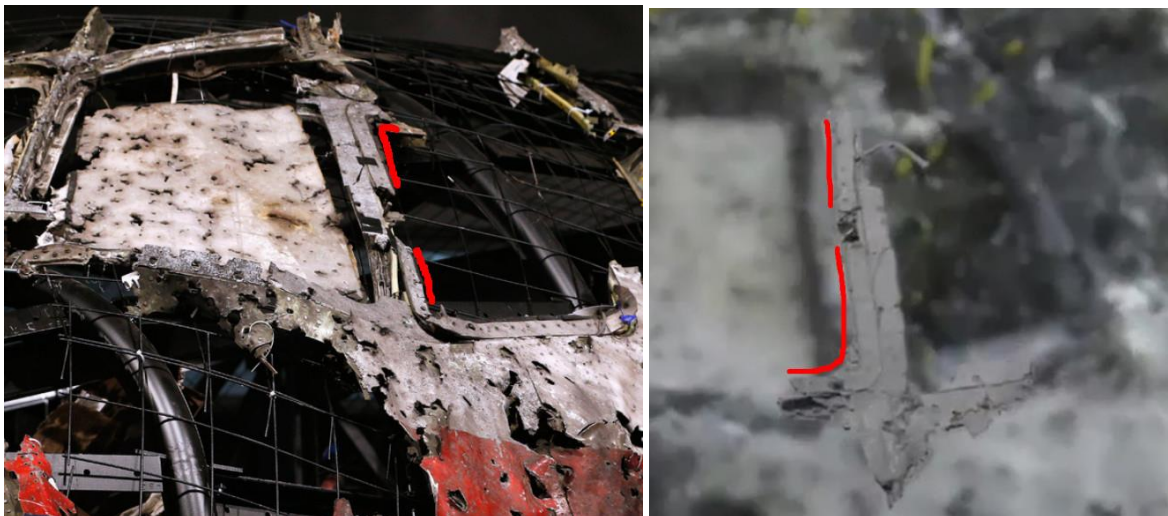
If we now compare the JIT presentation to the reconstructed airframe, then we realize the JIT turned that piece of the window frame upside down:

In other words, the embedded metal ball either impacted the window frame from behind the airplane or maybe slightly from the side and behind. An impact from the front of the airplane can be excluded. Therefore, the JIT illustration of the impact describes an impossible event that apparently became possible by a 180° rotation of that piece of the window frame.

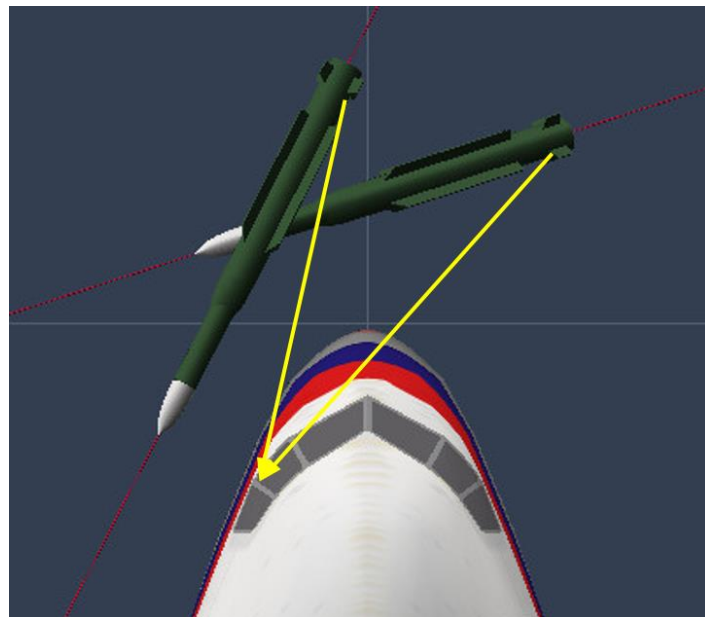
Keep in mind that the last tail section of the missile (either from Snizhne or from Zaroschenskoye) and the bolted lid is located some meters behind the warhead and was still in front of the cockpit when the warhead exploded.

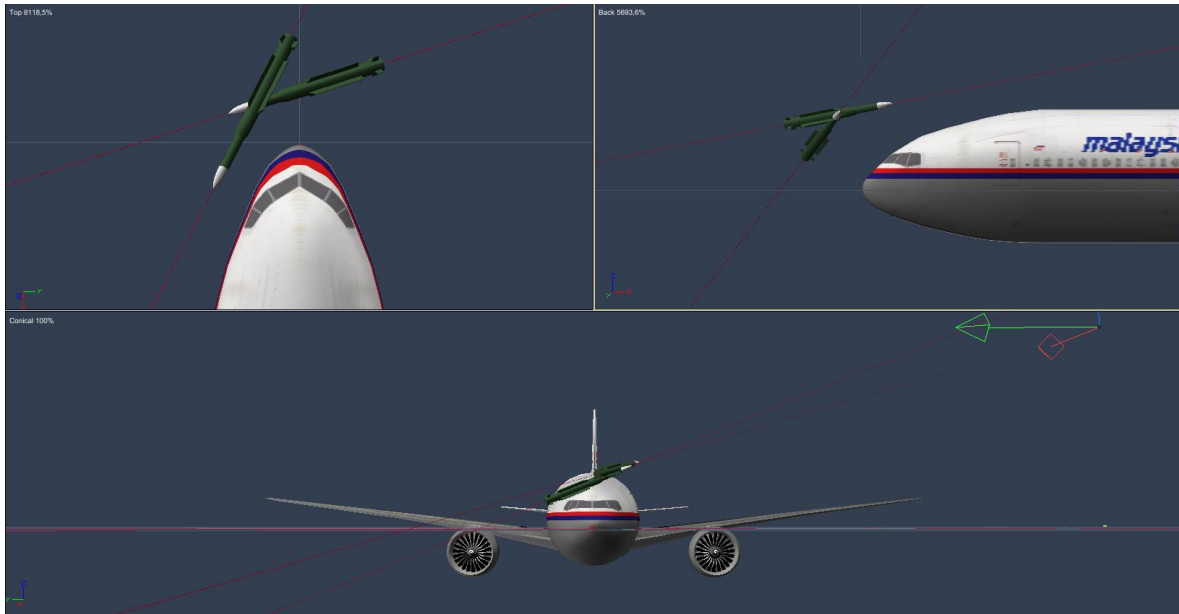
A disintegrated missile body or a shrapnel from that tail section must have entered the cockpit from the front.

Six milliseconds later the tail of a missile from the direction of Snizhne would pass the cockpit window but would be too high to embed a shrapnel from the side or from behind that window frame. Furthermore, some kind of post-explosion-explosion would have to accelerate that ball of twisted metal in the opposite direction. At minus 1000 m/s it just would reach the same speed like the window frame. So it needs some additional acceleration to finally embed that piece of metal deep enough in the groove to withstand the impact at the ground without being detached.

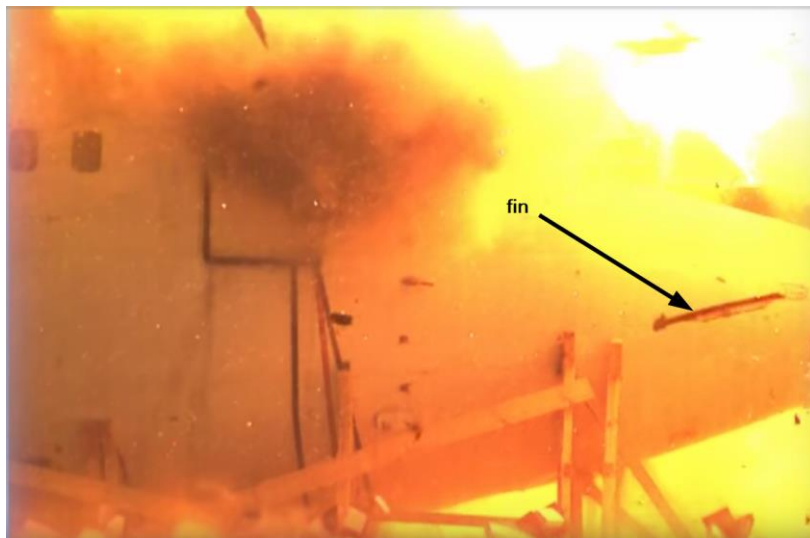
1) the slow motion of the explosion shows a piece that looks like a fin of the missile that was pushed over the cockpit and fell on the opposite side. Hence, the fin section appears to be disintegrated but the fin itself has hardly enough energy e.g. to deform into a ball due to an impact especially from behind the plane at a relative speed of  $-1000\text{m/s}$ .

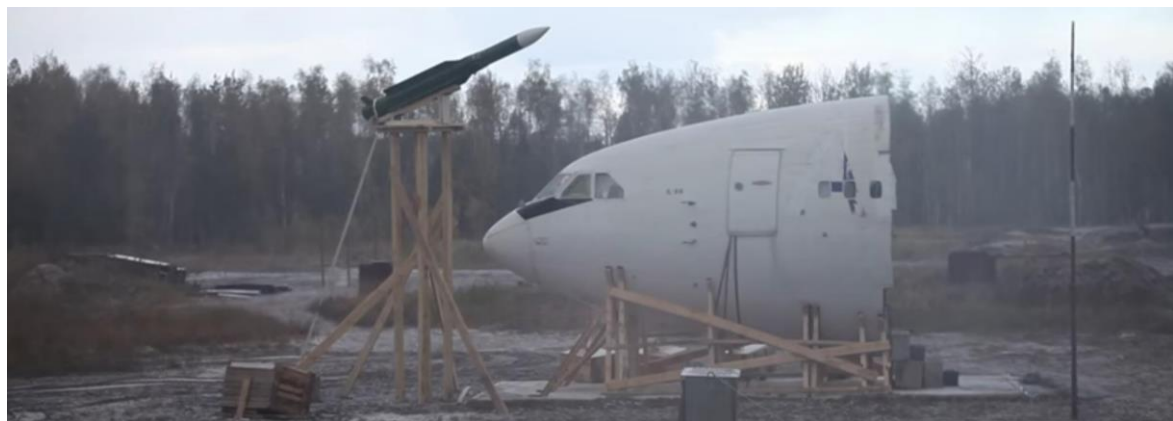
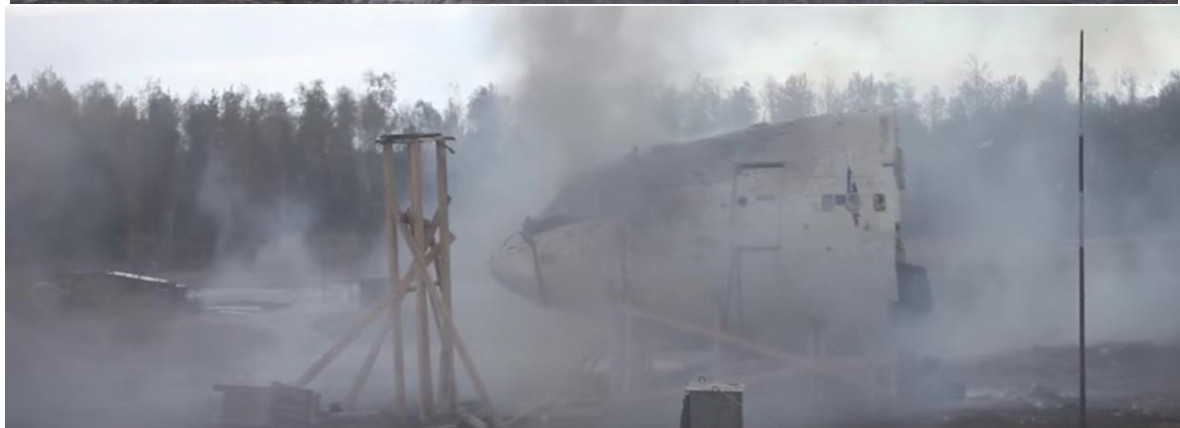
2) the wooden construction that carried the missile below the fin section survived the explosion virtually undamaged

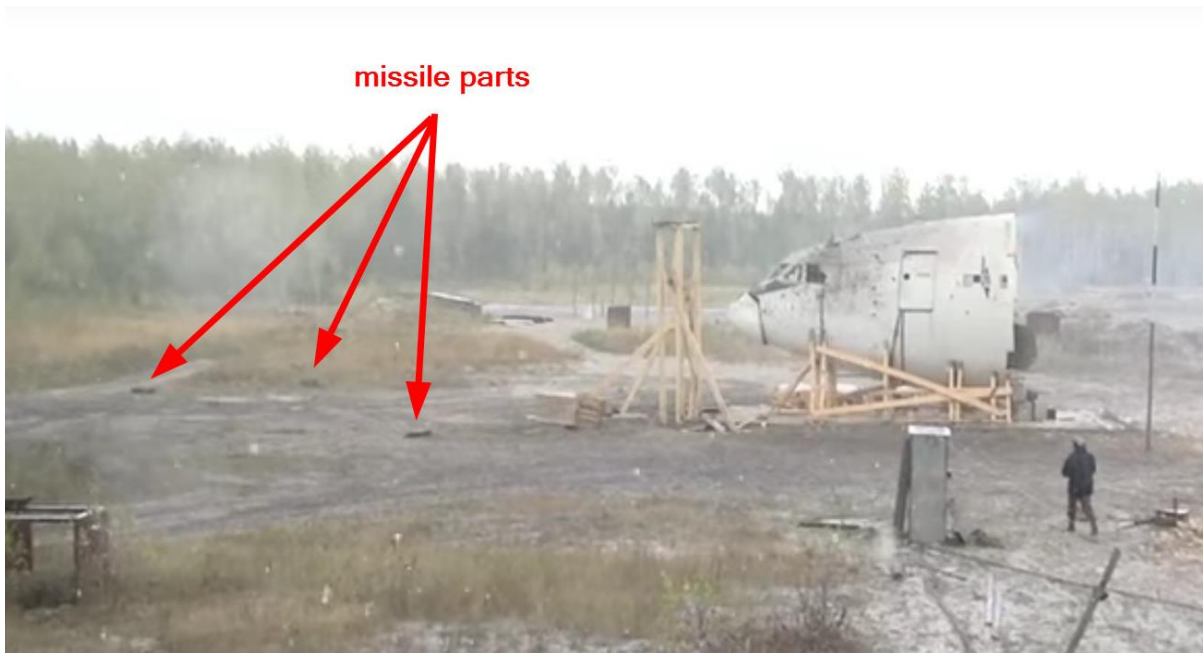
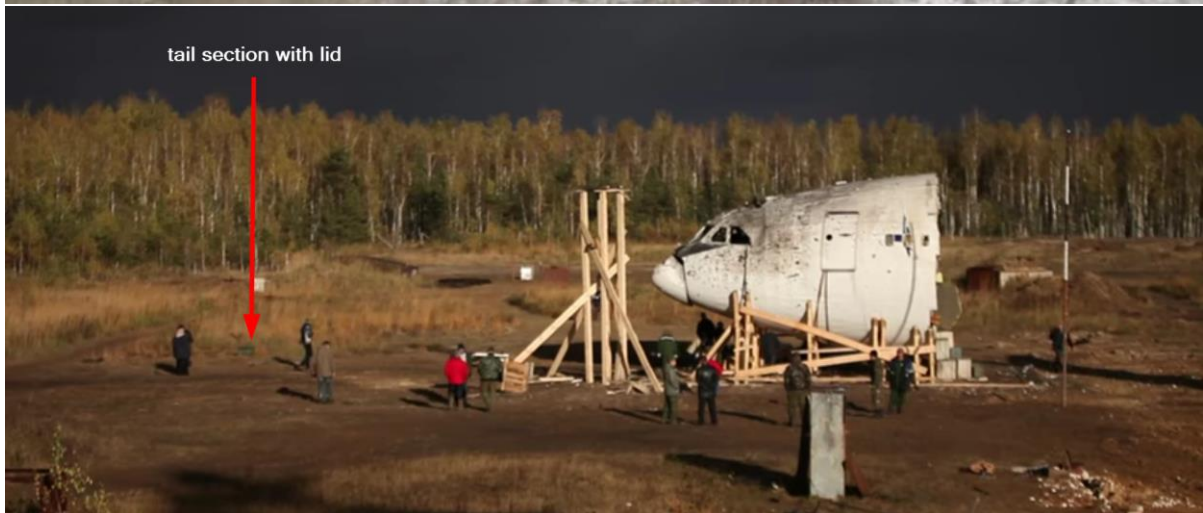
3) several missile parts dropped close to the wooden construction to the ground. The last section with the lid appears undamaged and pushed backwards.

The other two bigger pieces might be the fin section split in two parts. It seems RTL nieuws depicted at least this part of the story pretty accurate:

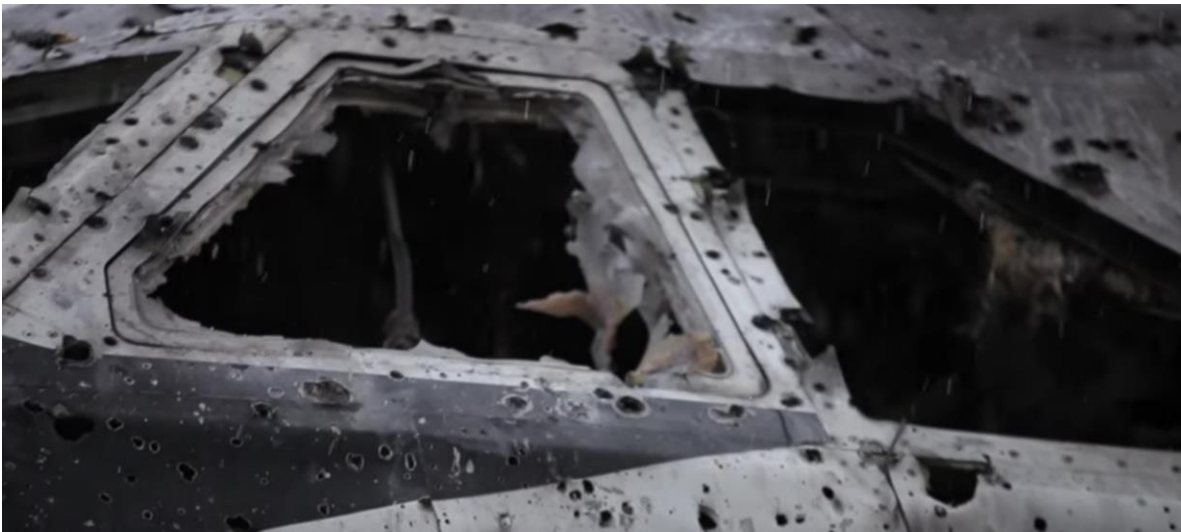
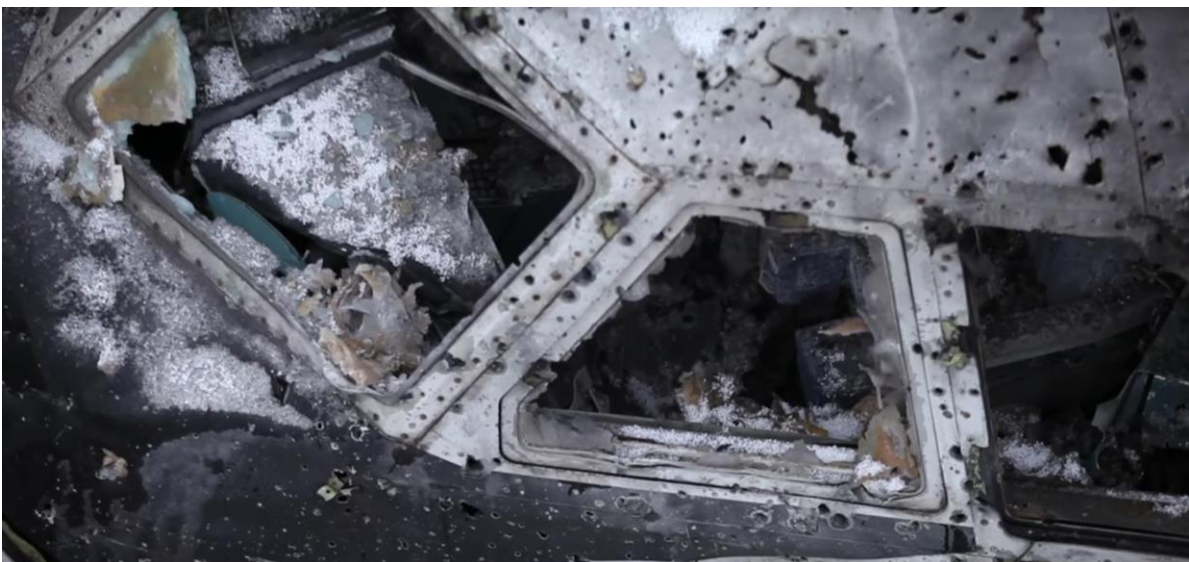
4) The IL-86 cockpit shows a very similar damage pattern along the windows frame.

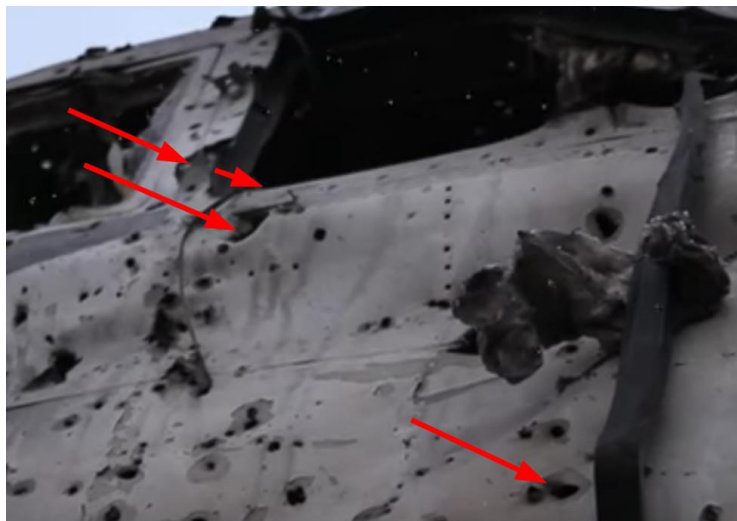
5) the edges of the damaged window frame are bowed outwards. This might be caused by a shrapnel that went through the aluminum skin and was deflected by the material (may be steel) below.

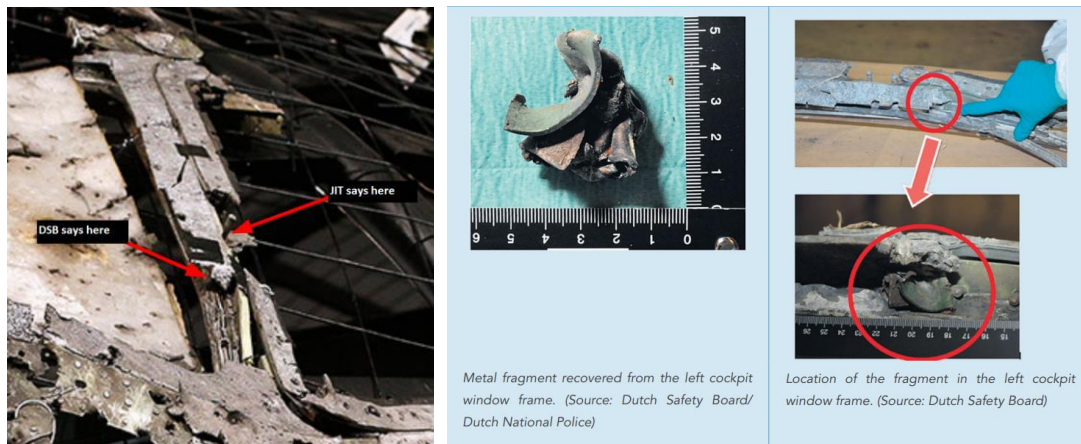
The DSB report Figure 40 provides a different location for the embedded metal ball in the front side of the same column.

Notice, that the window is punctured by the submunition but has no larger hole close to the DSB location. One possible sequence might be that first the submunition punctured the glass. Next the pressure pushed out the window and finally the lid slammed into the column of the frame.

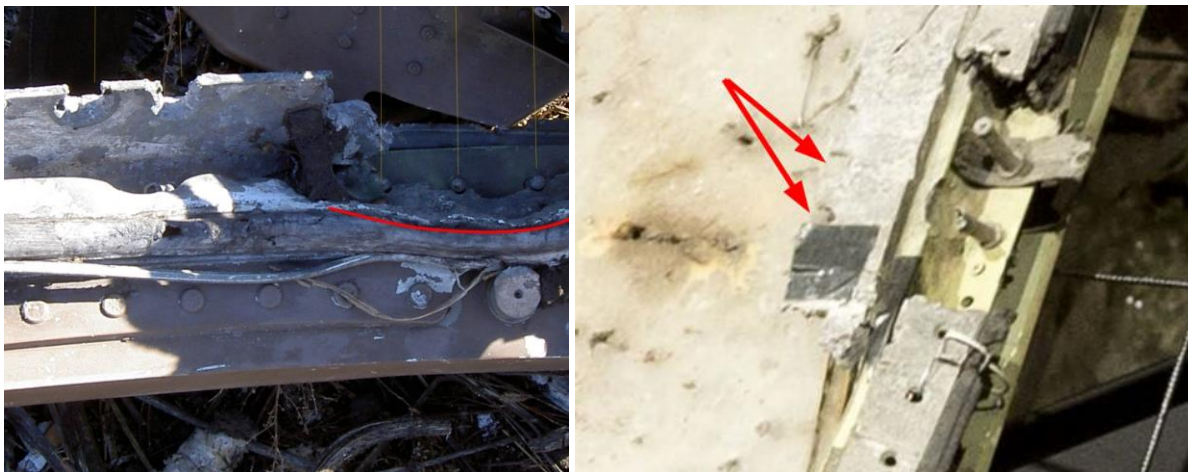
The following image shows the metal ball embedded behind some heavily corroded piece of metal sticking in the rubber. The rusty piece apparently neither belongs to the window frame nor is mentioned as part of the missile but fixes the missile part next to an extensive circular damage (red line) to the silver angle.

Possibly the lid from the tail of the missile slammed into column and broke that lost circular piece from the aluminum frame. Next to that damage are two holes looking like failed drill holes (red arrows). The top view reveals that both holes are obviously caused by high energy impacts at a different angle and therefore at a certain angle to the trajectory of the missile part.

A heavily corroded metal piece embedded in the rubber in front of the metal ball seemingly was neither investigated nor mentioned.

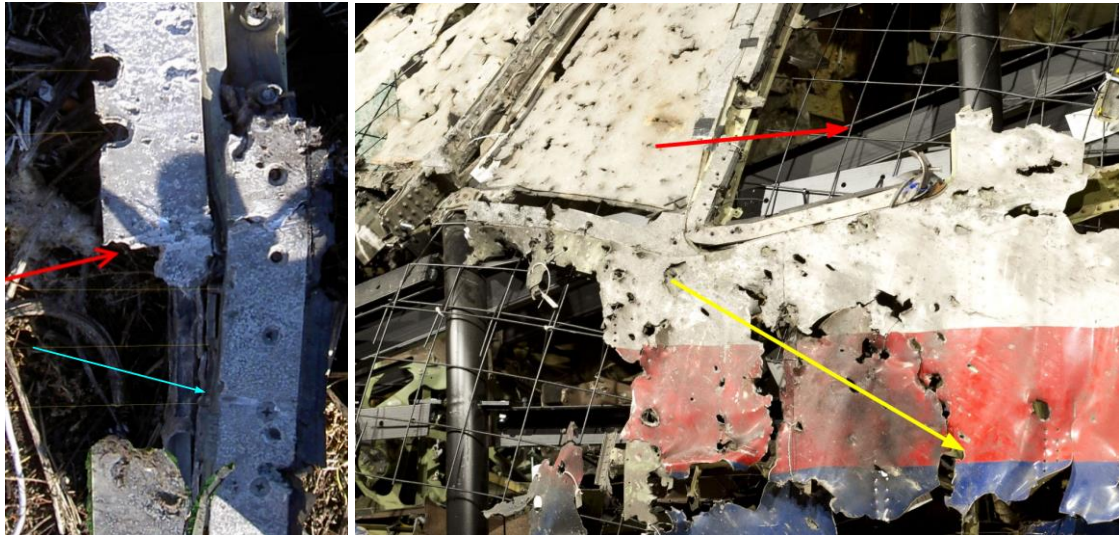
The collision of an object – presumably the lid - against the column left telling scratches on the outer surface. According to these scratches, the object must have been on an upward trajectory relative to the airplane.

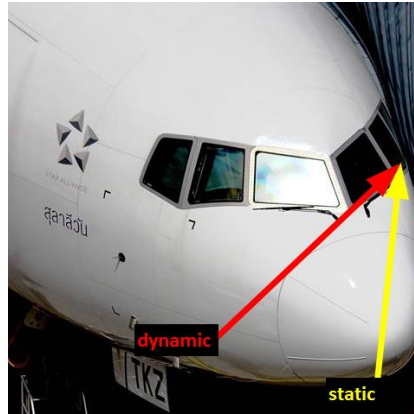
While the static case described in the presentations might appear somehow possible for both missile trajectories, the dynamics of this impact shortens the distance between both objects at about 1000m/s for the Snizhne launch spot and at about the half that speed for a launch spot south of Zaroschenskoye. The movement towards each other “squeezes” the space in the direction of the heading of the airplane and increases all involved angles that are not pointing exactly in that direction. The higher the relative speed the more that space will be “squeezed”.
