USS LEXINGTON CV-2 moored on, or possibly passing by the southwest side of Ford Island, Pearl Harbor Navy Yard, during late March 1942, for what was to be her last refit. Note the boat stowage was previously removed from the base of the funnel, which featured a small funnel cap on the leading uptake vent.

From: The Commandant, Navy Yard, Pearl Harbor, T. H.  
To: The Chief of the Bureau of Ships.  
Subject: USS LEXINGTON (CV2) - Removal of 8" Battery.  
Reference: (a) Opnav Conf. Despatch 201930 of February.  
Enclosure: (A) P. H. Photographs - USS LEXINGTON - Removal of 8" Battery. No's 419-42, 422-42, 424-42, 426-42, 427-42, 429-42, 431-42, 432-42, 434-42, 441-42, 446-42, 448-42.

Subject: U.S.S. LEXINGTON (CV2) - Installation of 20 MM and 1.1 A.A. Guns.

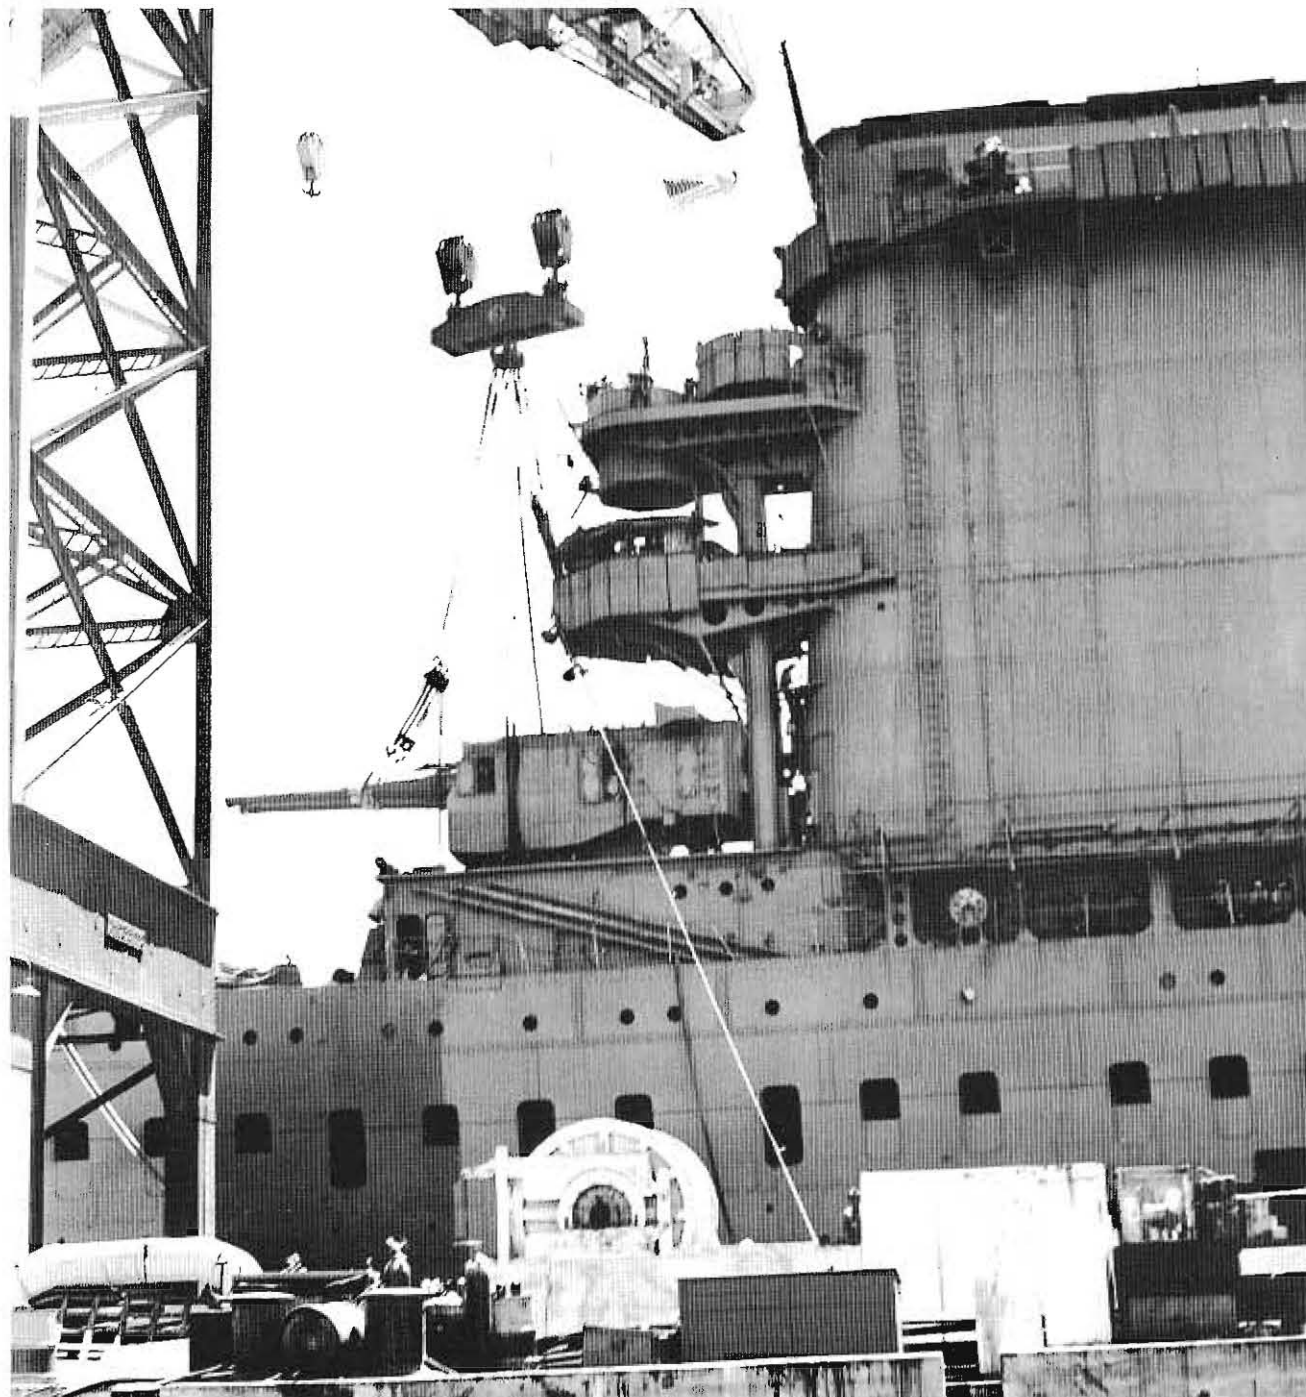
This close-up view of turret #3, as it was lifted into the air from the superstructure of LEXINGTON, shows the multitude of rivets used in the construction of this type of gun mount.

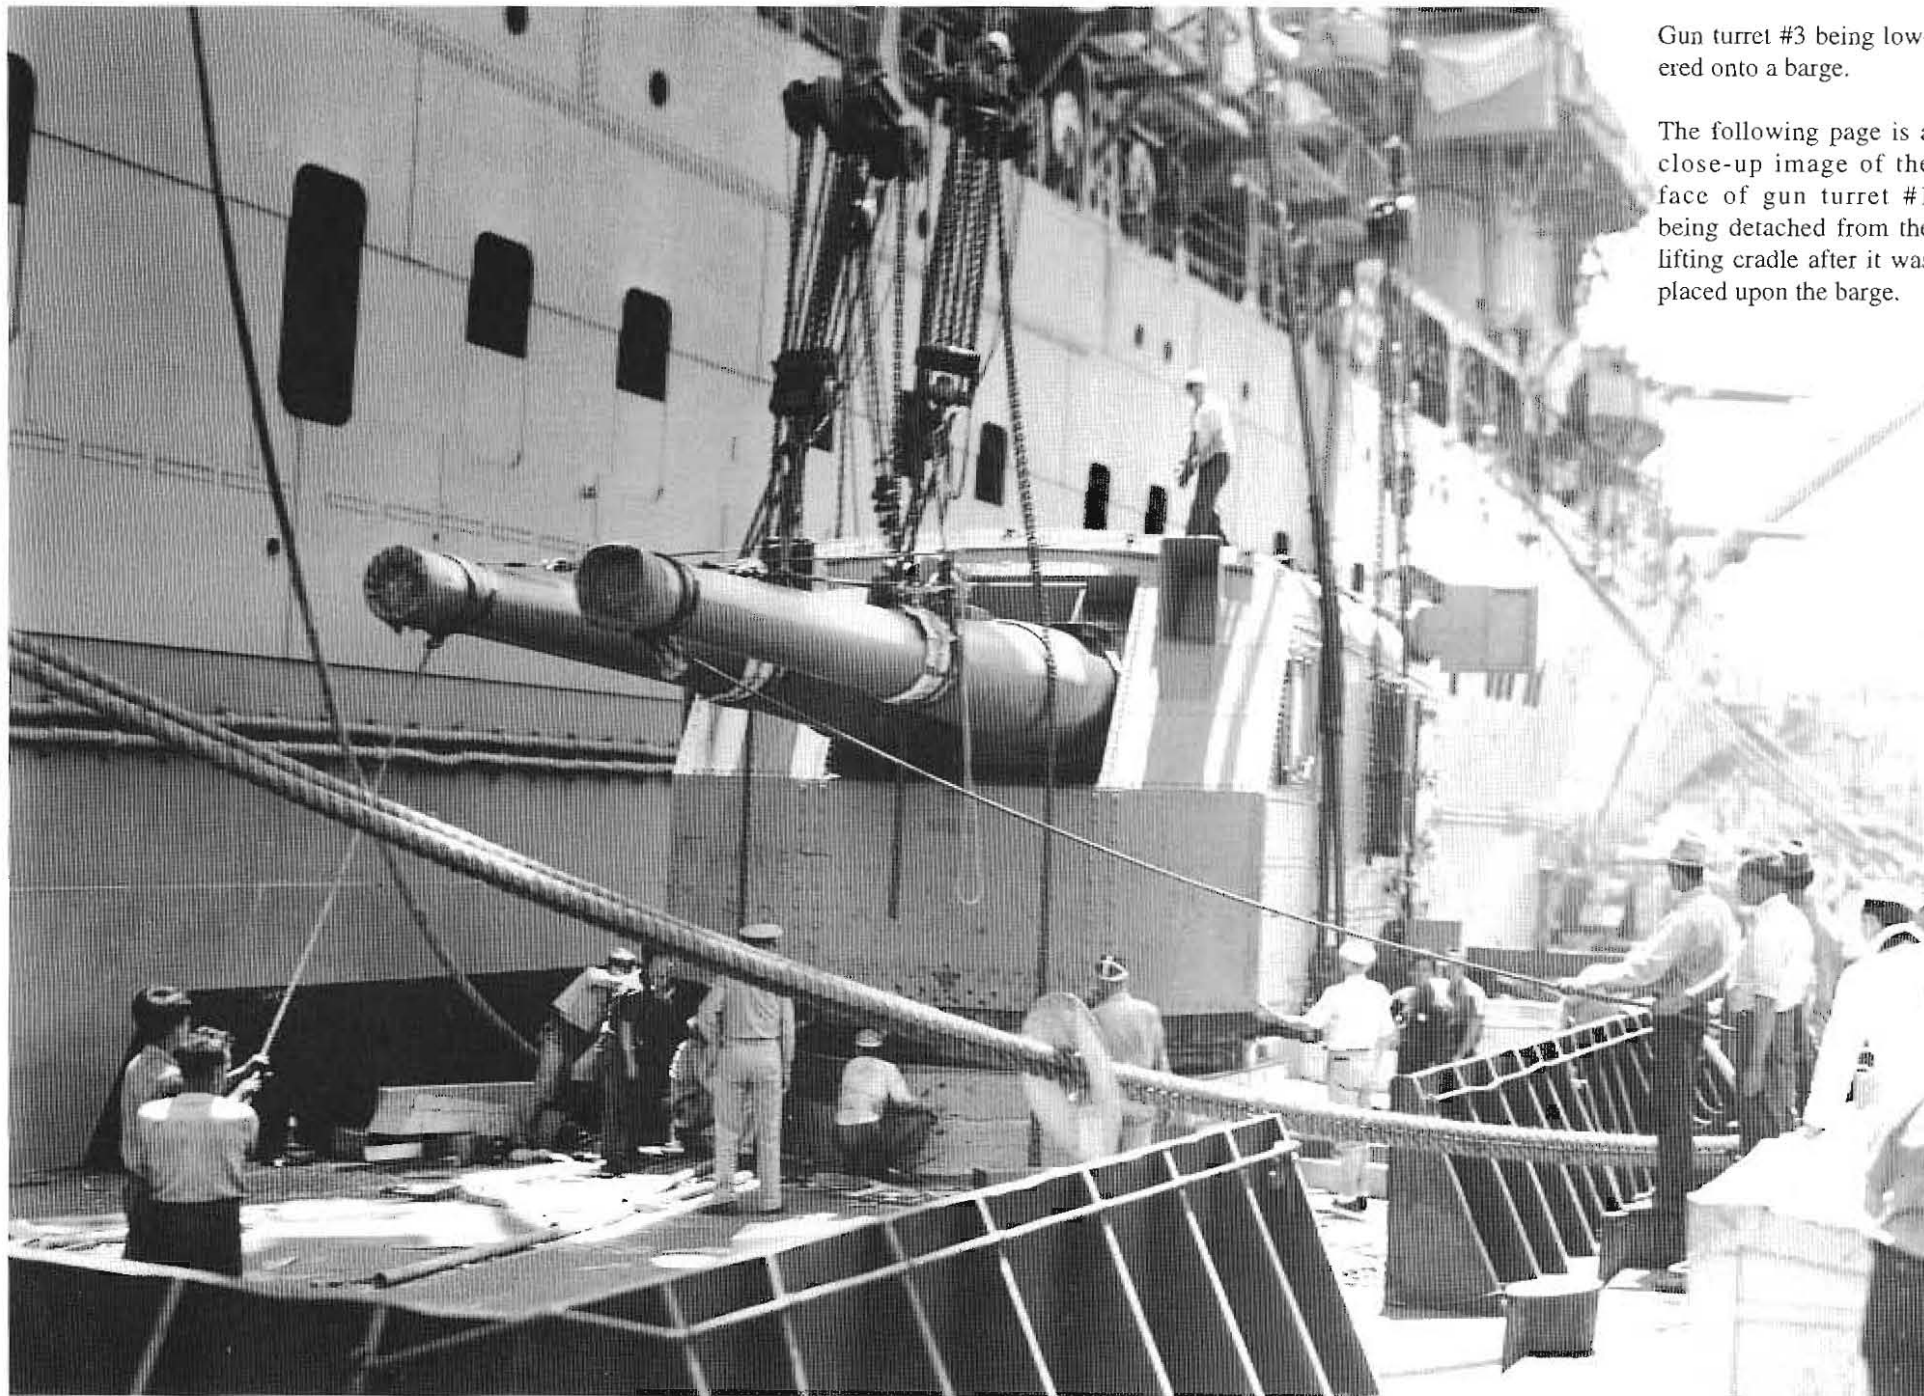
The following page is a close-up image of the face of gun turret #1 being detached from the lifting cradle after it was placed upon the barge.
