Firing on all *Cylinders*

Craig Moore chats to Gavin Barlow of Armoured Engineering to find out more about the Sherman V and a recent rebuild

The Sherman V rebuild project

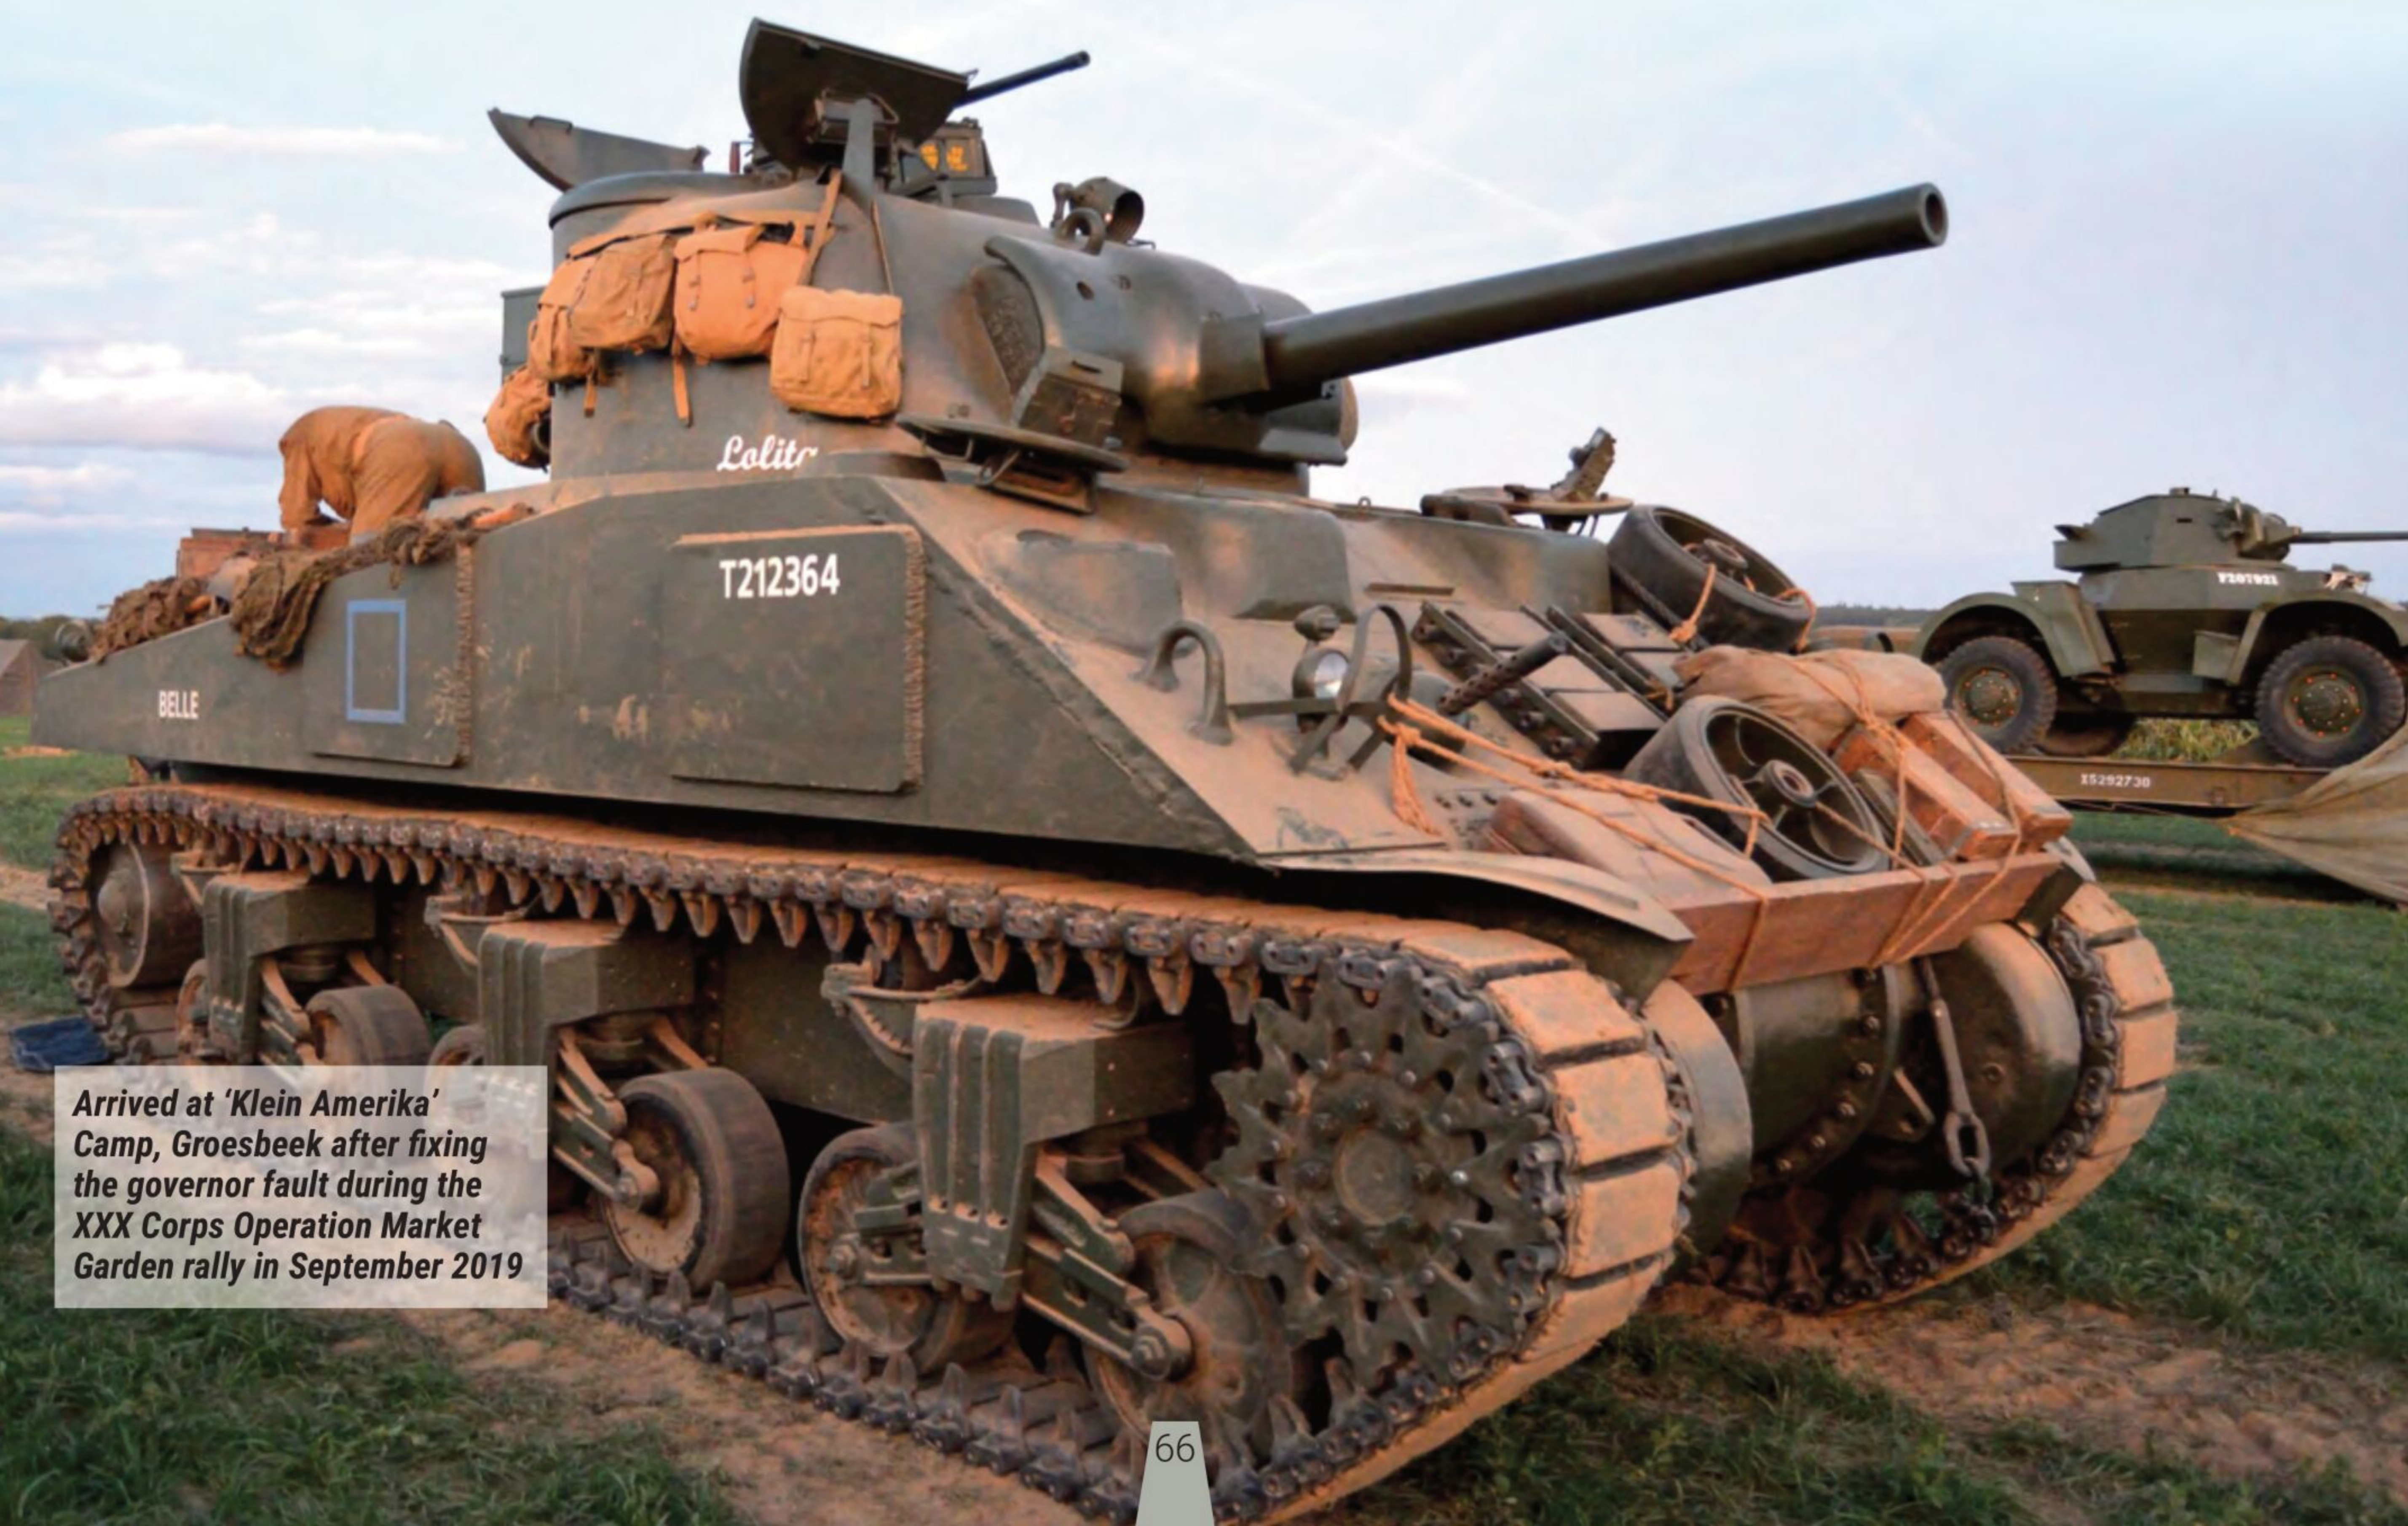
Arrived at 'Klein Amerika' Camp, Groesbeek after fixing the governor fault during the XXX Corps Operation Market Garden rally in September 2019

After further inspection, the crankshaft journals were damaged and had to be reground. During the XXX Corps rally, we encountered several issues. The first was a fuel leak from around the sender units. We only discovered the fault after filling the tanks, which made fixing the fault very tricky. The second fault was the main ignition cable detaching from the power unit causing it to cut out. This was repaired and running again in minutes. This was shortly followed by a governor linkage snapping which jammed open the throttle. We had to be recovered to the nearest staging post where we carried out an expedient repair enabling us to drive into camp at sunset under our own power.

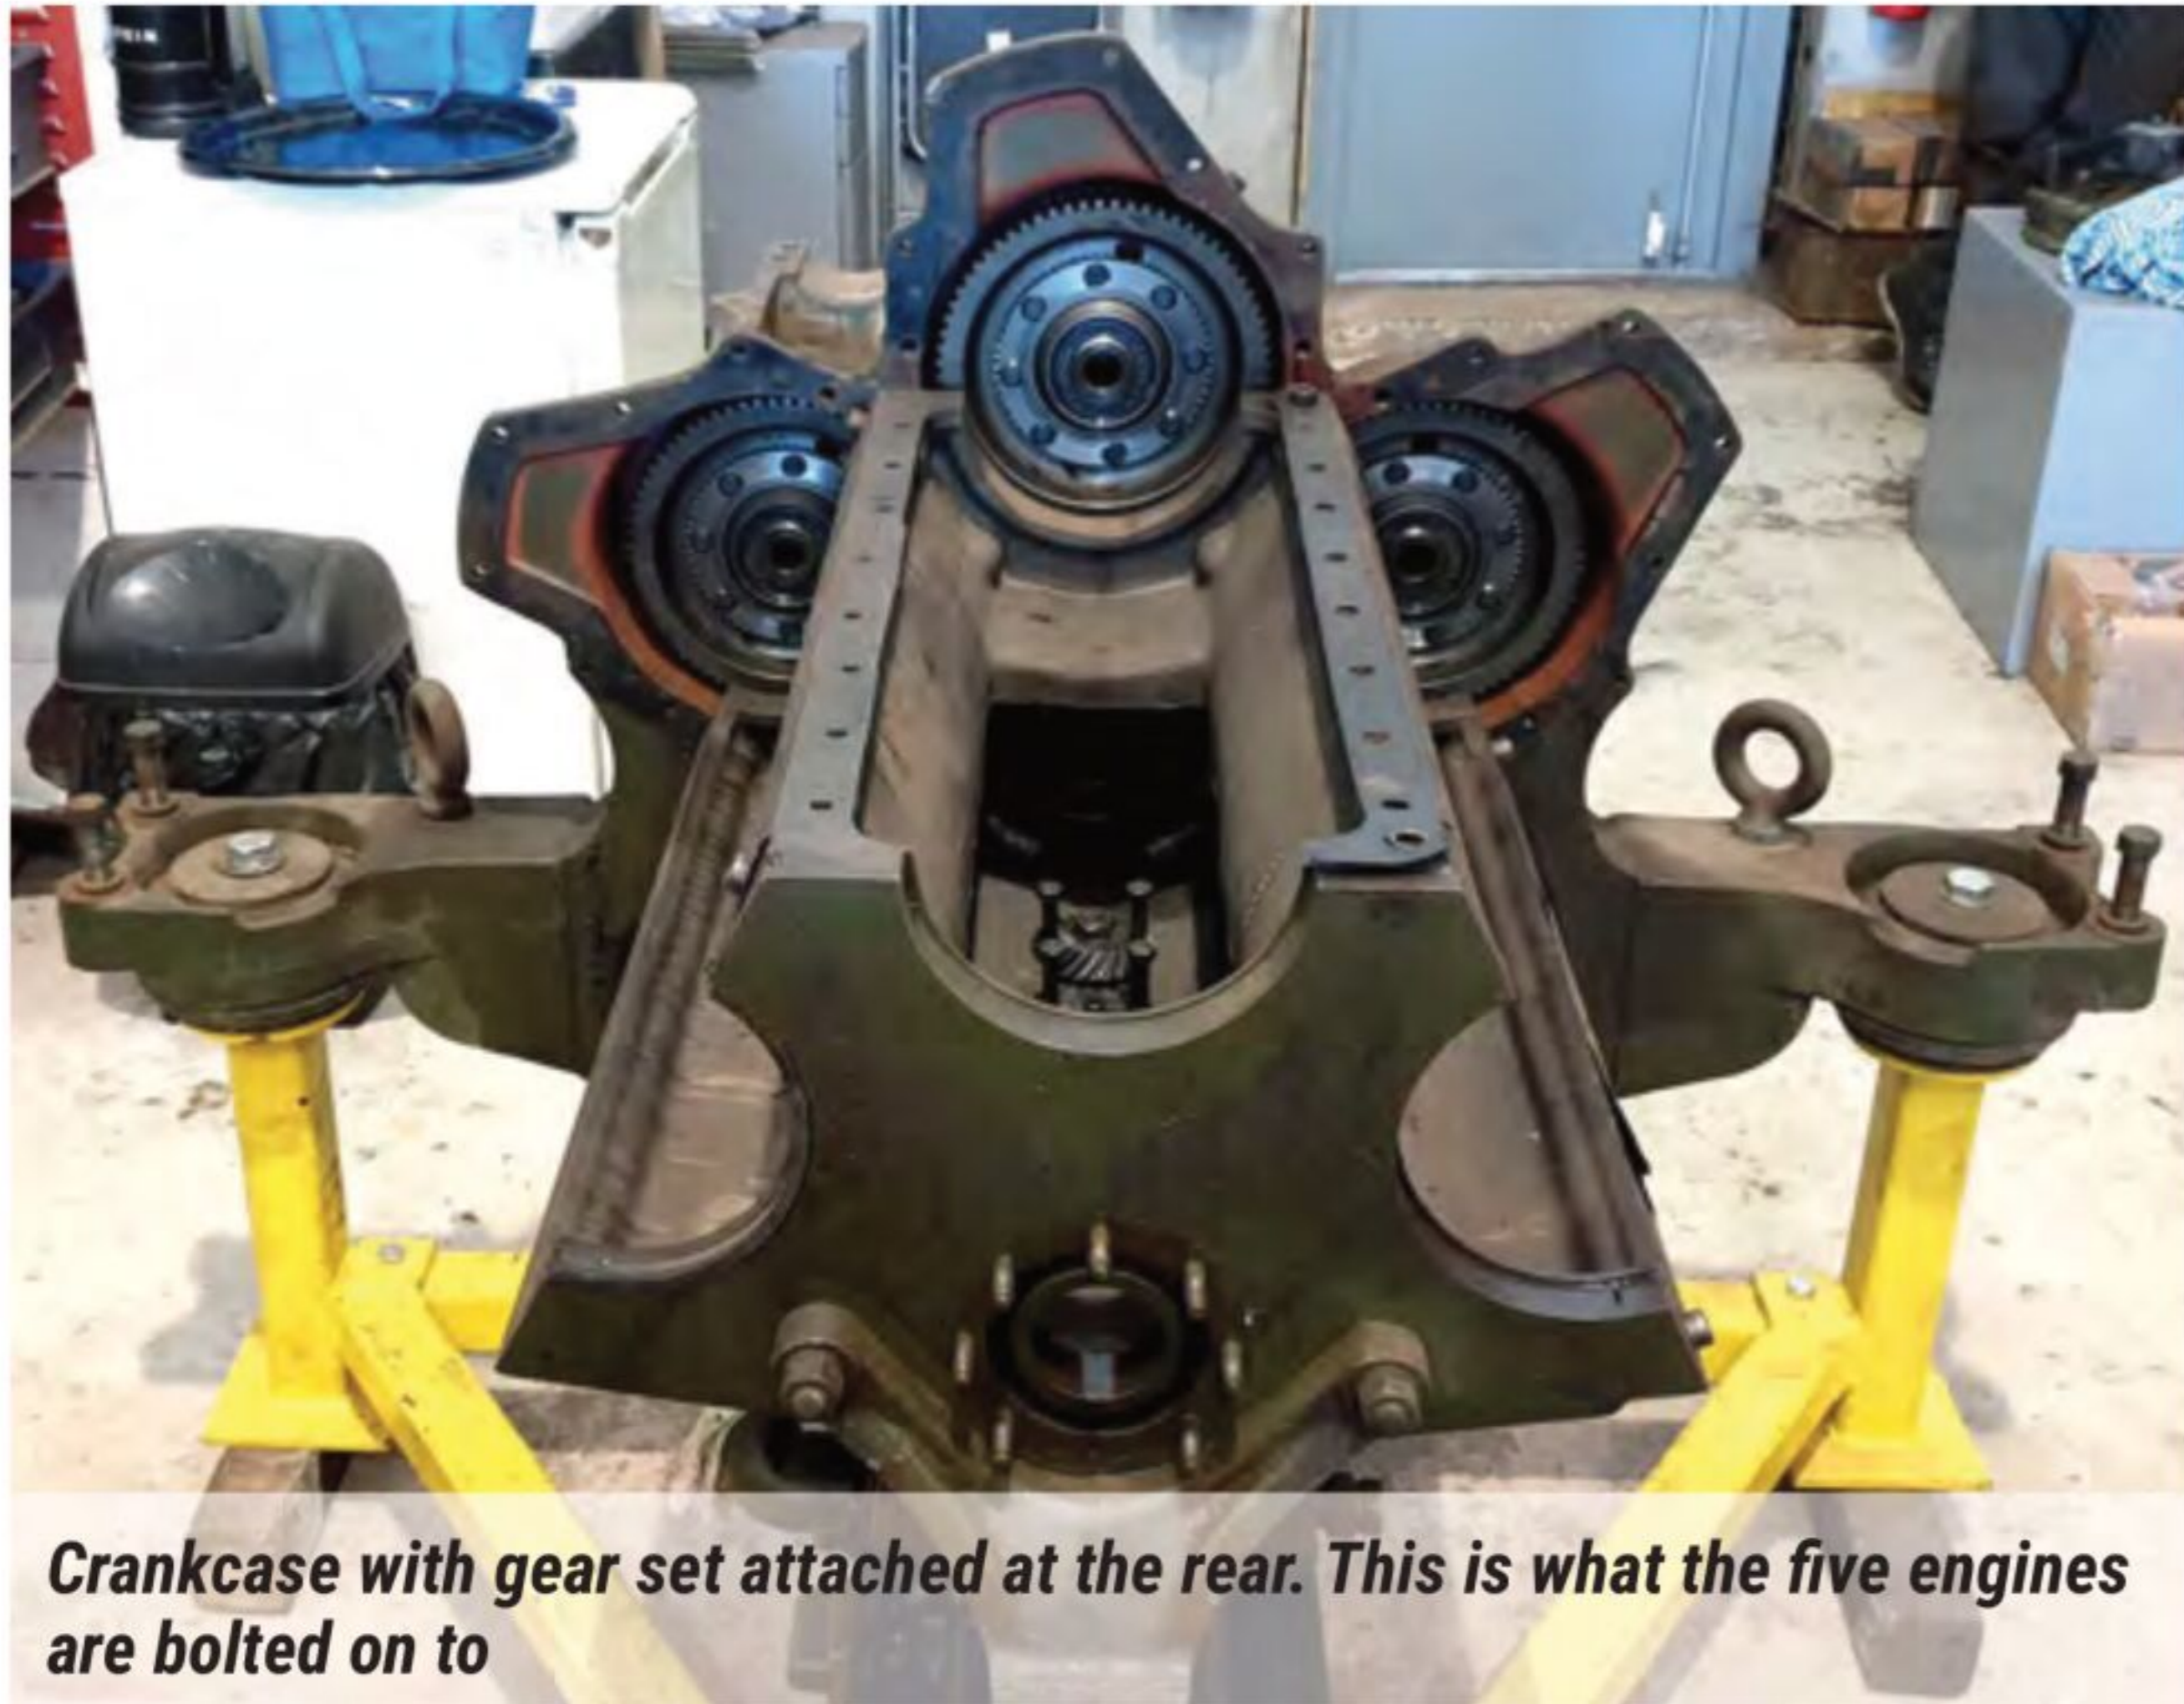
Crankcase with gear set attached at the rear. This is what the five engines are bolted on to

A. The five engines are meshed together using a large gearset at what should be the flywheel end of the crankshaft. These gears then drive one output shaft located in the centre of the gears which has a conventional flywheel/clutch assemble bolted to it, much the same as the radial engine. The power is then transmitted to the five-speed gearbox at the front of the vehicle using a long prop shaft. The drive is then turned through 90° using crown wheel pinion gears before utilising a differential, steering unit, and finally transmitting drive to the tracks via final drive units.

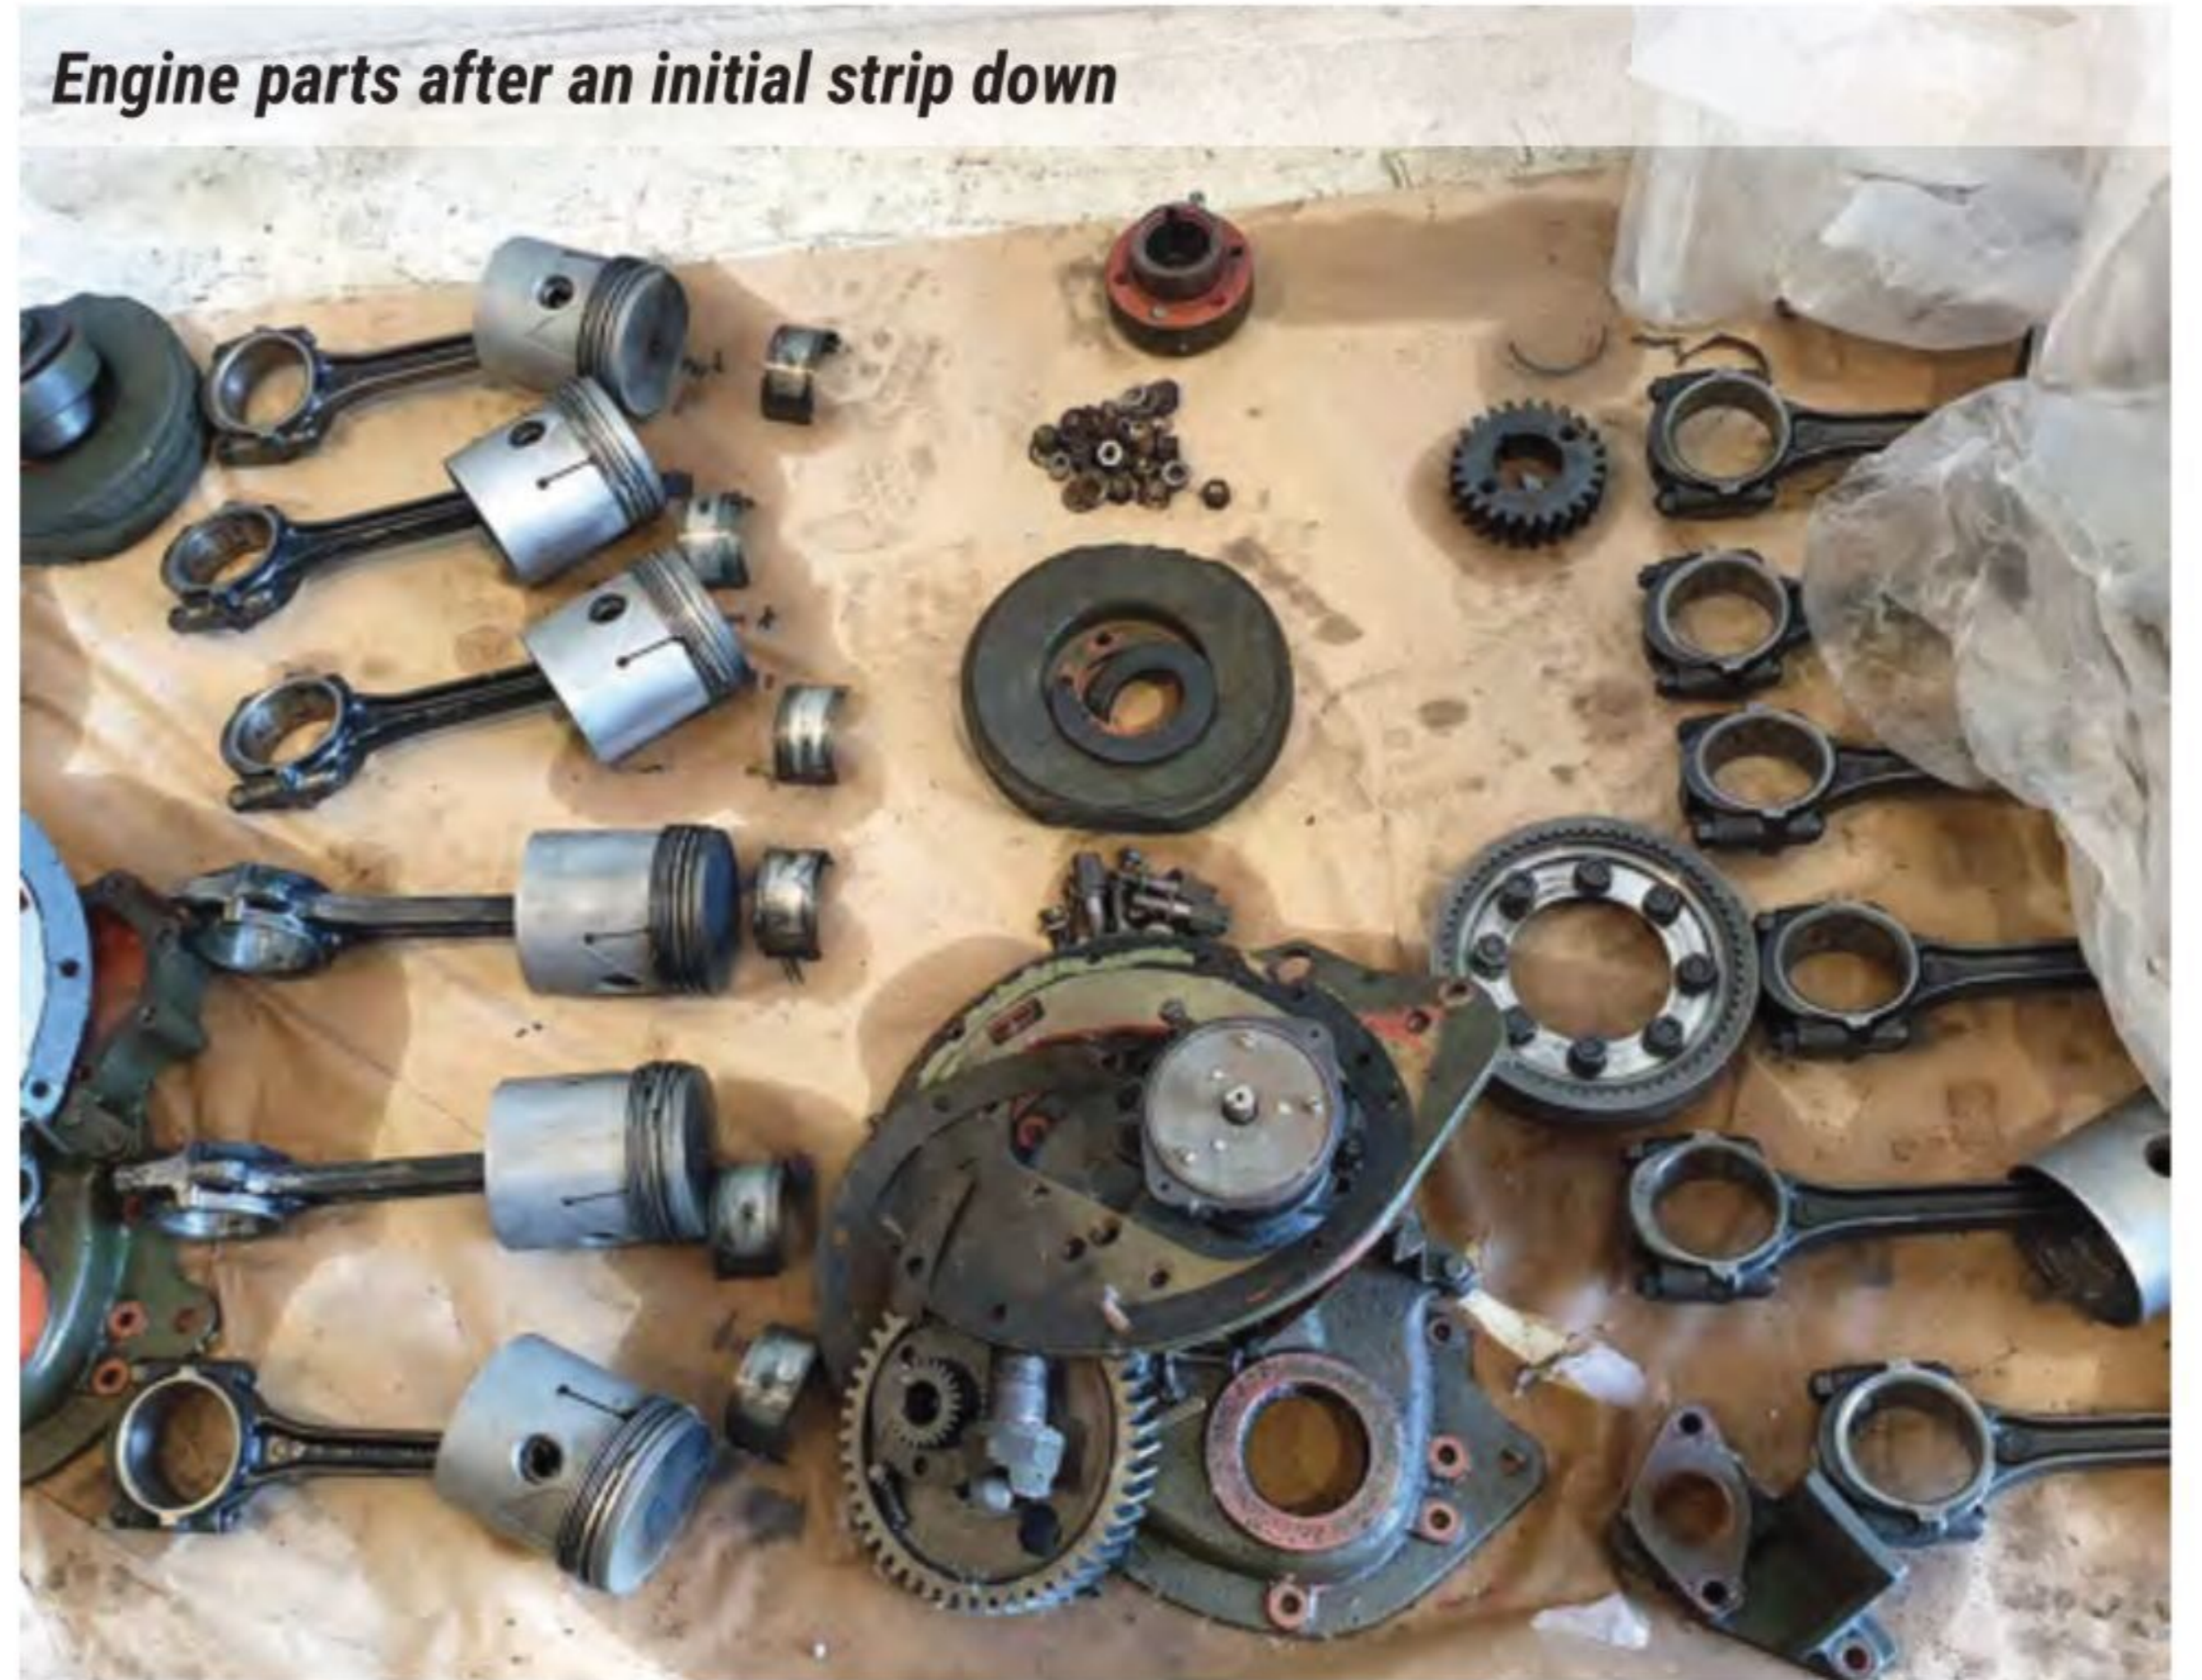
Engine parts after an initial strip down

A. When we received the vehicle from the Tank Museum the symptoms were a head gasket failure and a blown core plug. We opted to strip the engine fully, and luckily we did.

We found swarf laying under each crankshaft which points to an oil pressure failure and damaged crankshaft bearings. The actual cause was a ¼ inch unf bolt that had jammed the oil pump, which in turn snapped the drive shaft leading to complete failure of the crankshaft and camshaft bearings.

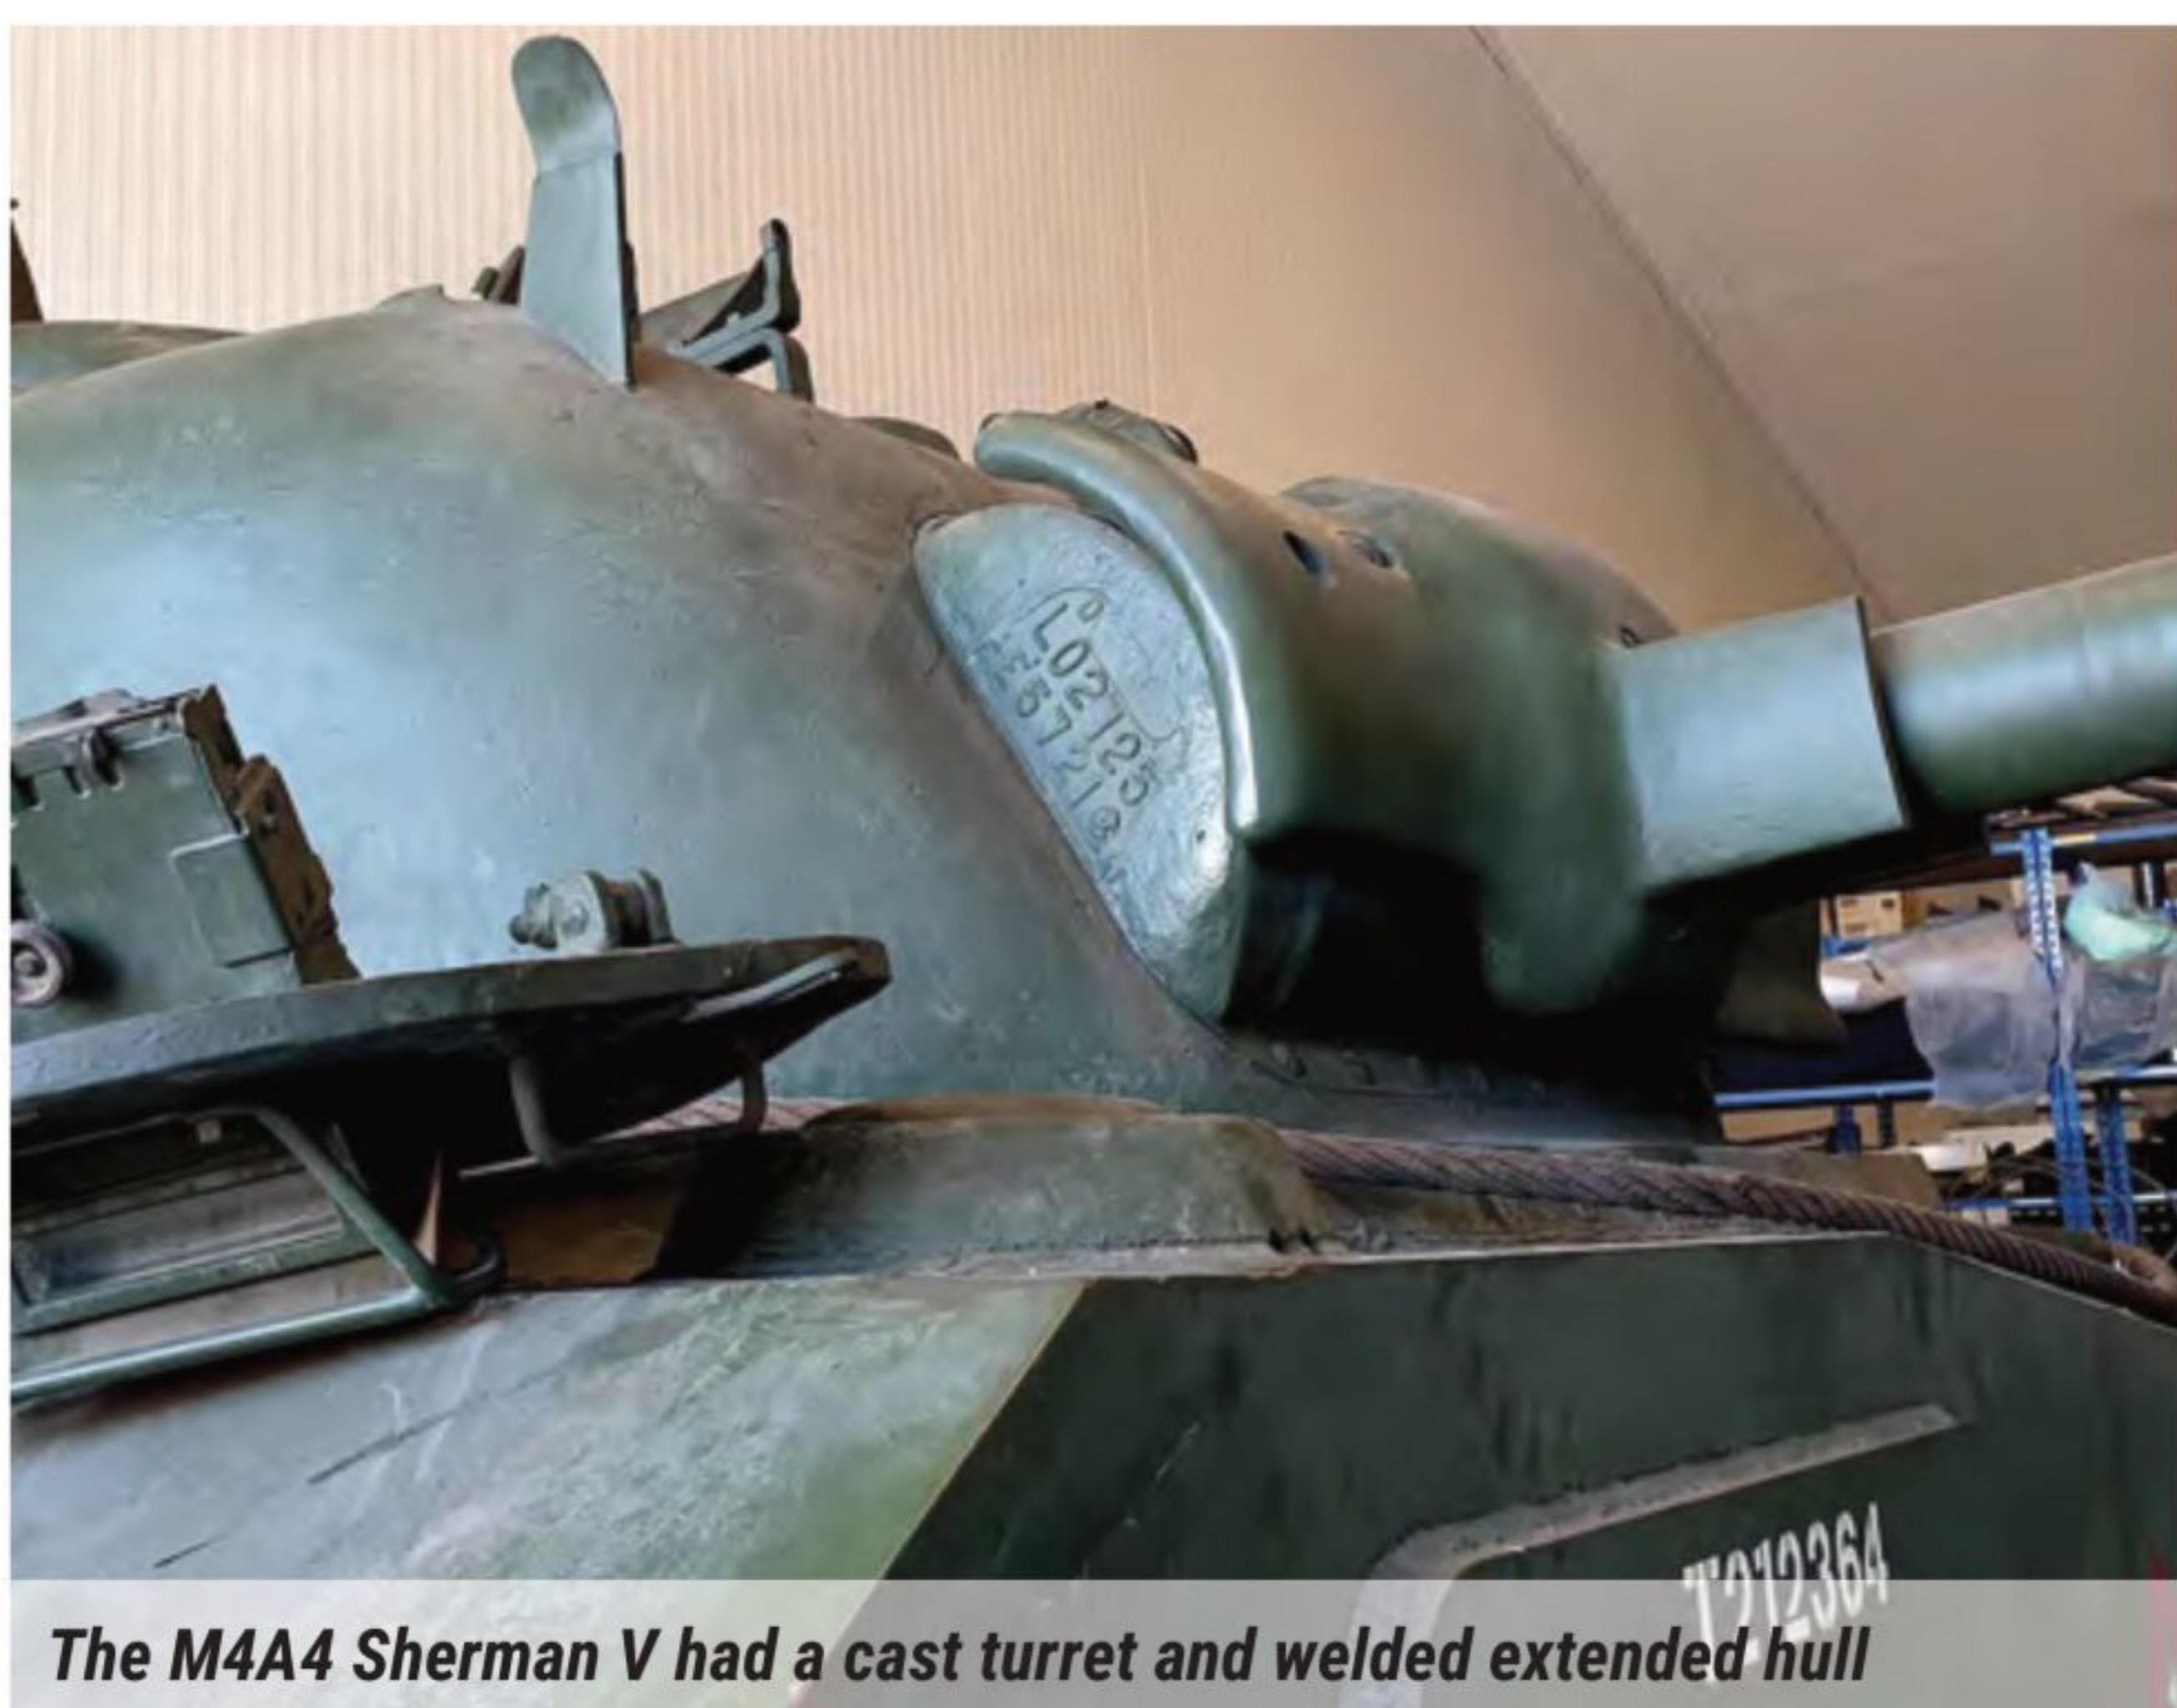
The M4A4 Sherman V had a cast turret and welded extended hull

Chrysler built 7,499 M4A4 Shermans. They had a lengthened welded rear hull with more widely spaced bogies to enable the Chrysler A57 multibank to fit in the engine compartment. There is a bulge in the engine deck immediately behind the turret to accommodate the large radiator. These are the main recognition features on the M4A4 tank.

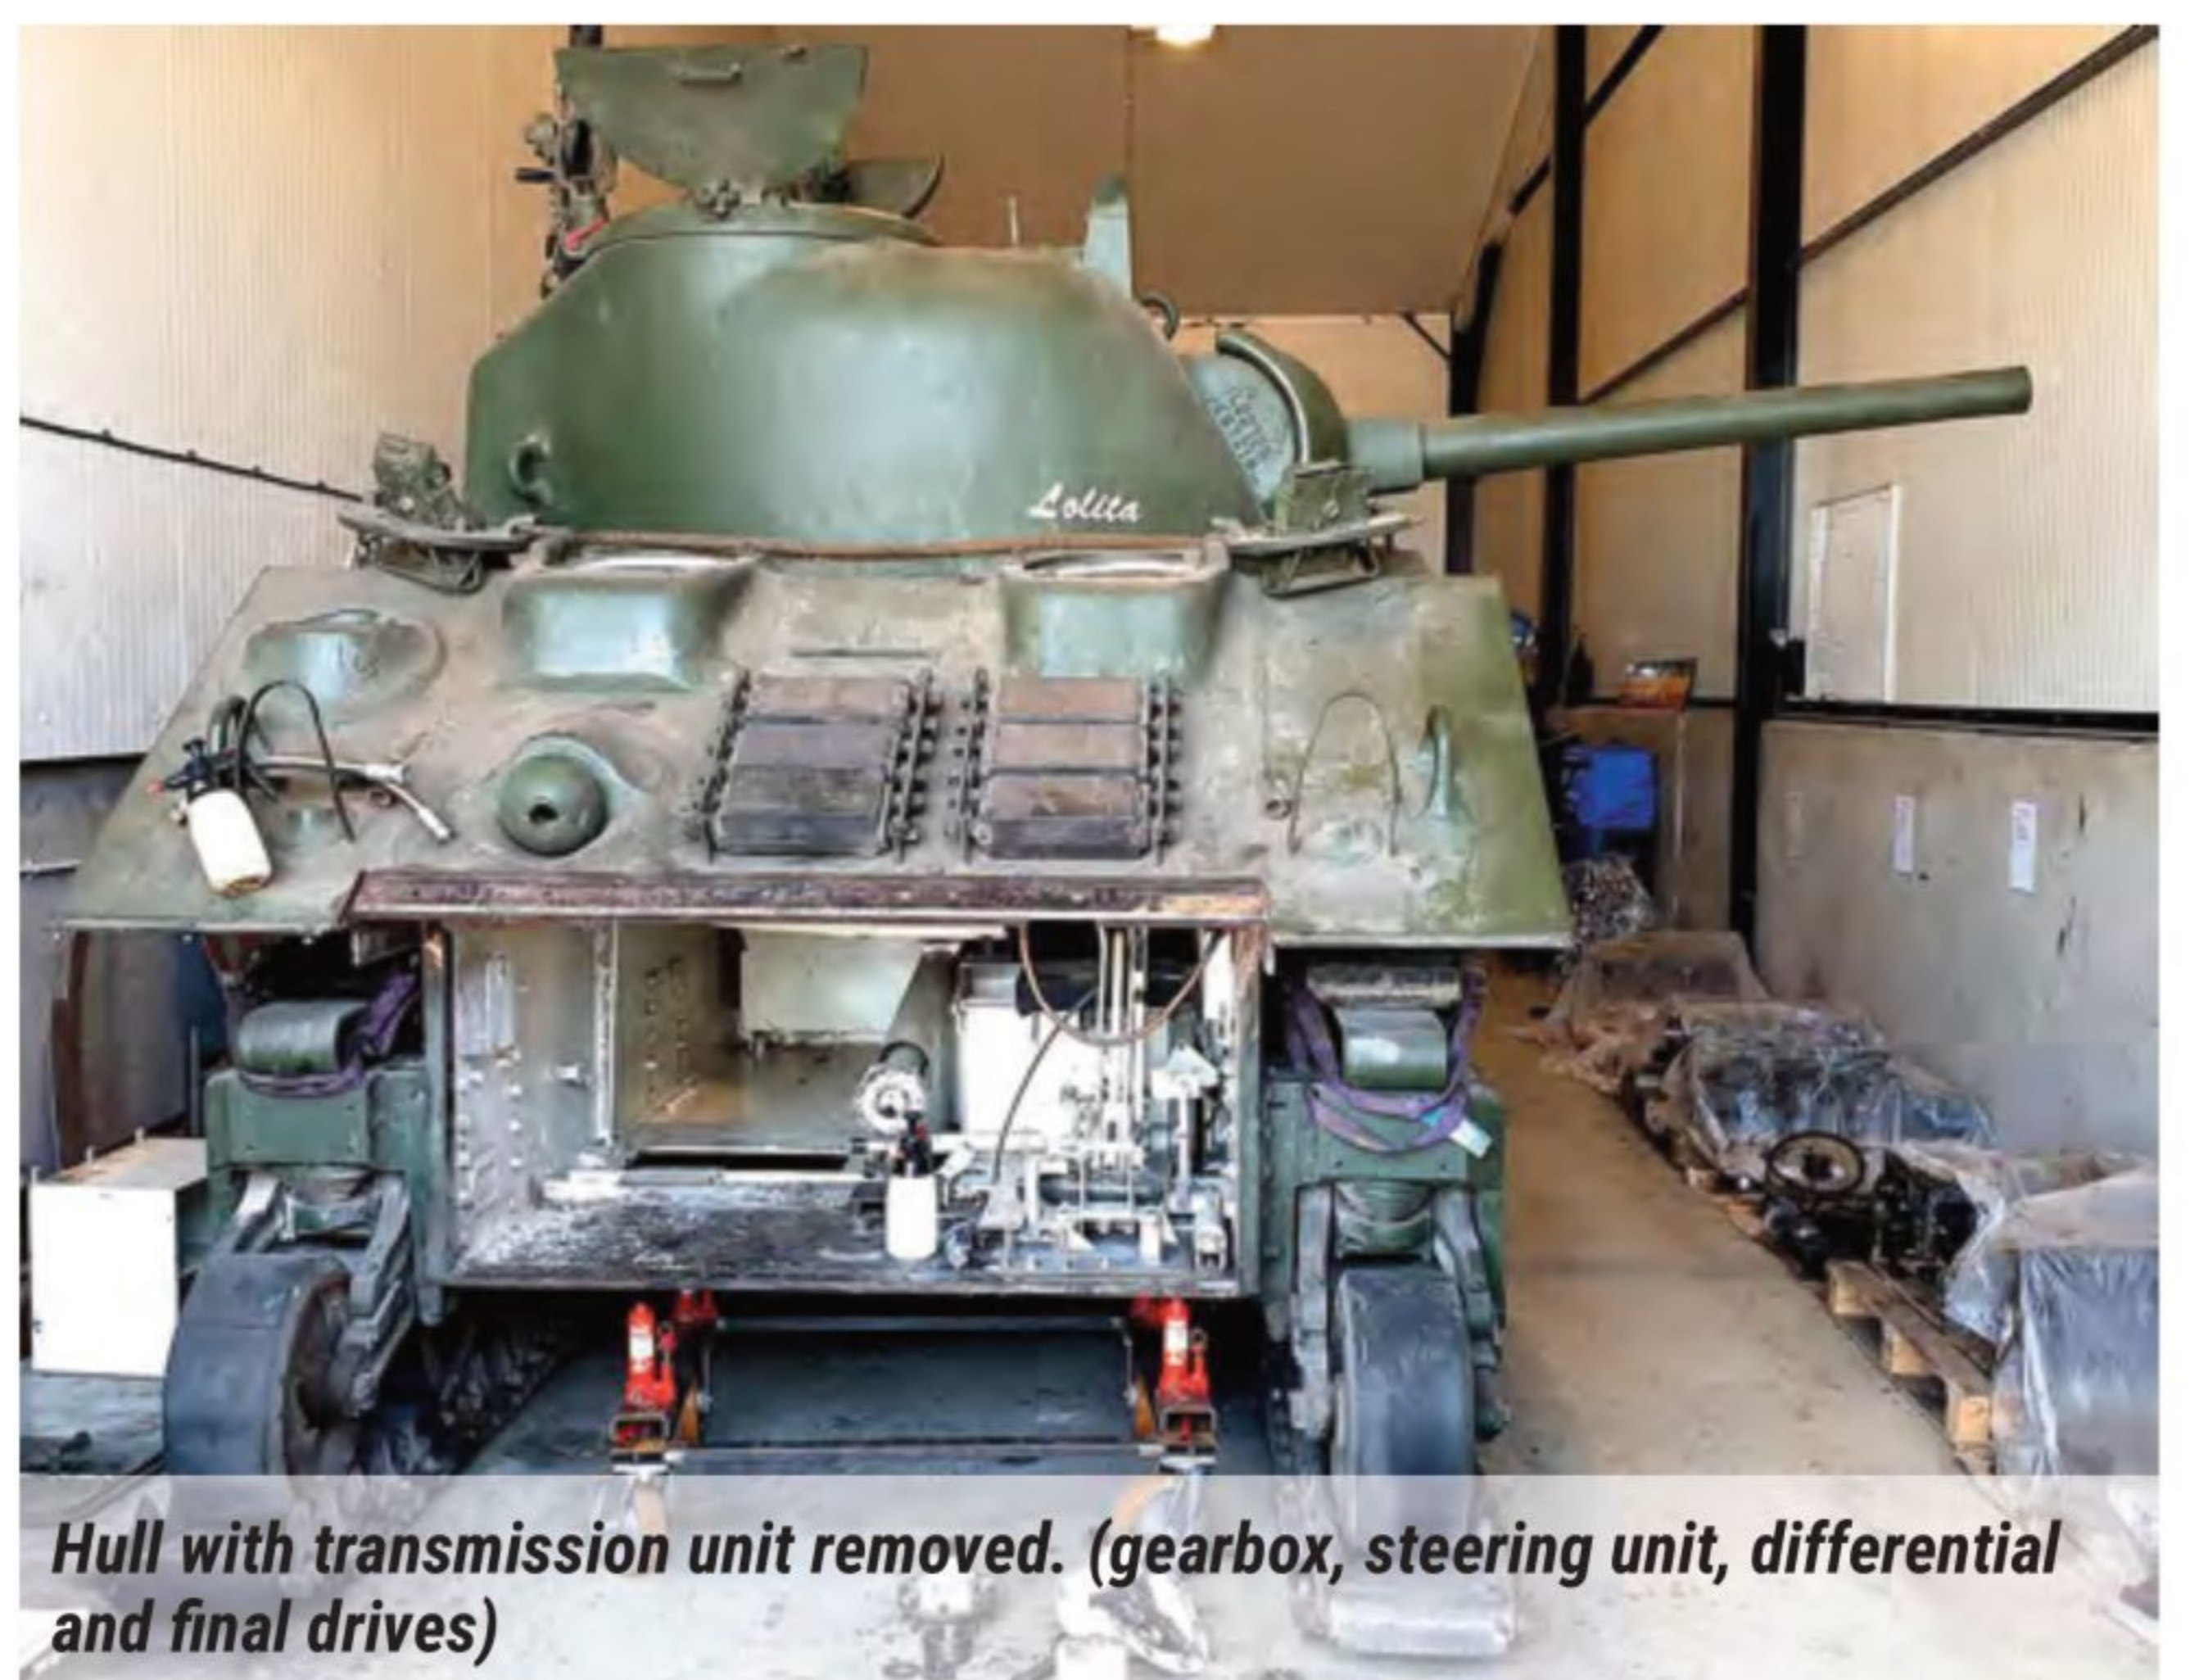
Hull with transmission unit removed. (gearbox, steering unit, differential and final drives)

The Sherman was designed to be easy to maintain. The final drives and transmission at the front of the tank could be accessed by unbolting the front lower hull curved armour plate and a
