Firing on all *Cylinders*

Craig Moore chats to Gavin Barlow of Armoured Engineering to find out more about the Sherman V and a recent rebuild

The Sherman V rebuild project

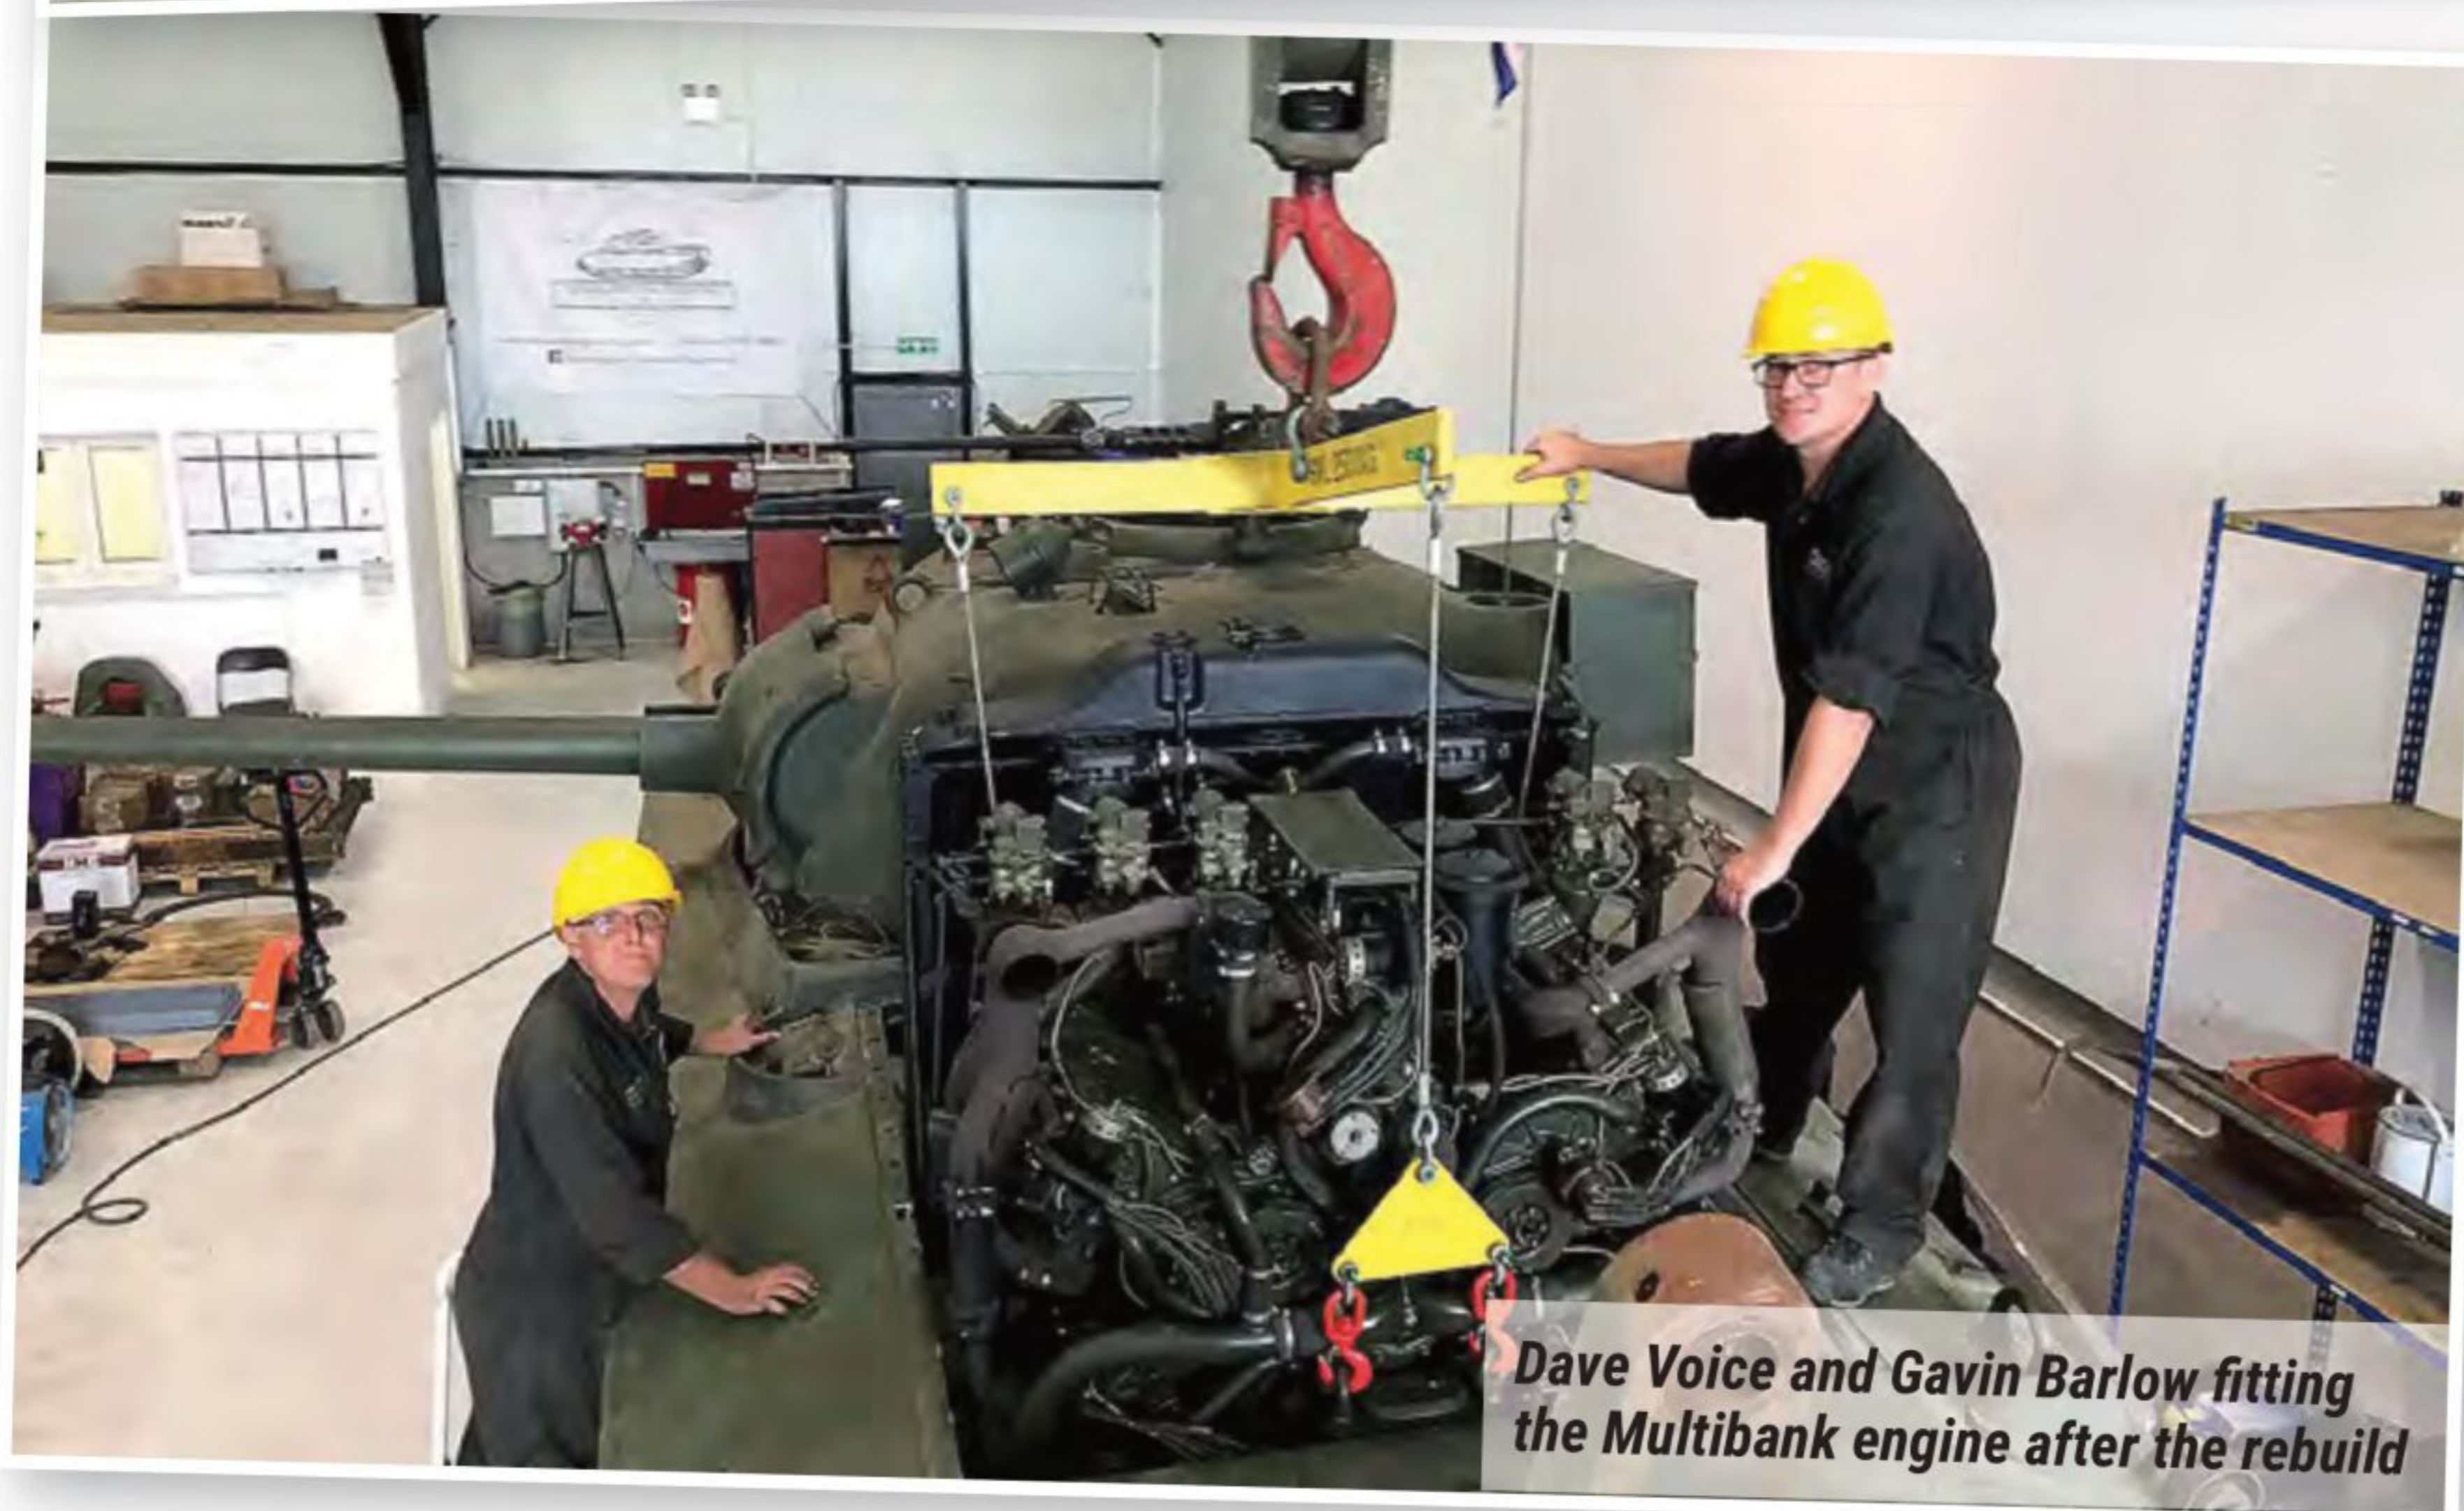
Dave Voice and Gavin Barlow fitting the Multibank engine after the rebuild

The M4A4 Shermans were powered by a Chrysler A57 multibank 30-cylinder four-cycle 'cloverleaf' water-cooled petrol engine. It was constructed using five car engines bolted together on a large metal frame. Its maximum net horsepower at 2,400rpm was 370hp, and it had a maximum gross horsepower rating at 2,850rpm of 425hp. It used 80 octane petrol and had a fuel capacity of 605.6 ltr. It had a maximum level road speed of 32km/h and for short bursts could reach up to 40km/h.
