**SERVICE BULLETIN**

**APPLICABILITY:** 2008~09MY Tribeca

**NUMBER:** 12-111-09

**SUBJECT:** Second Row Seat and Tailgate Rattles

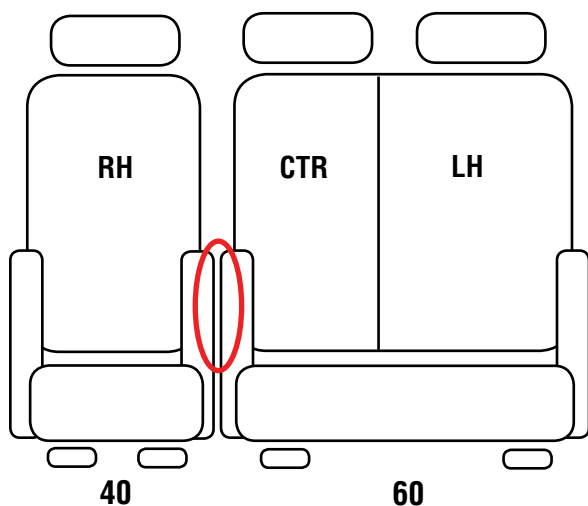
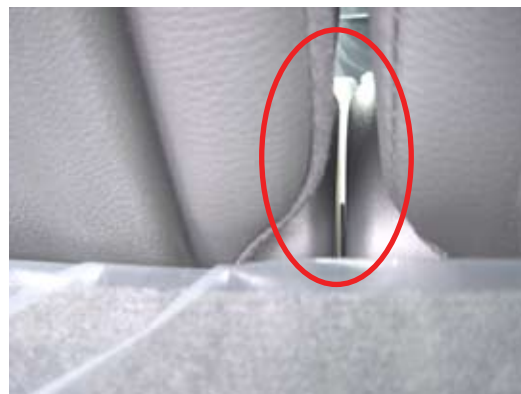
#### **(1) Seat Hinge Resin Covers**

Check to see if there is adequate clearance between the resin seat hinge covers located between the left/center and right hand seat. If the resin covers are just rubbing or have very little clearance, they could rattle. If they need to be replaced, hold off for now, they will be replaced later.
