Environmental Management Plan:  
Sprague Bay Dewatering and Marine Storage Site,  
Kinbasket Lake

Balcaen Consolidated Contracting Ltd.

**APPENDIX 1**  
**SITE VISIT PHOTOGRAPHS**

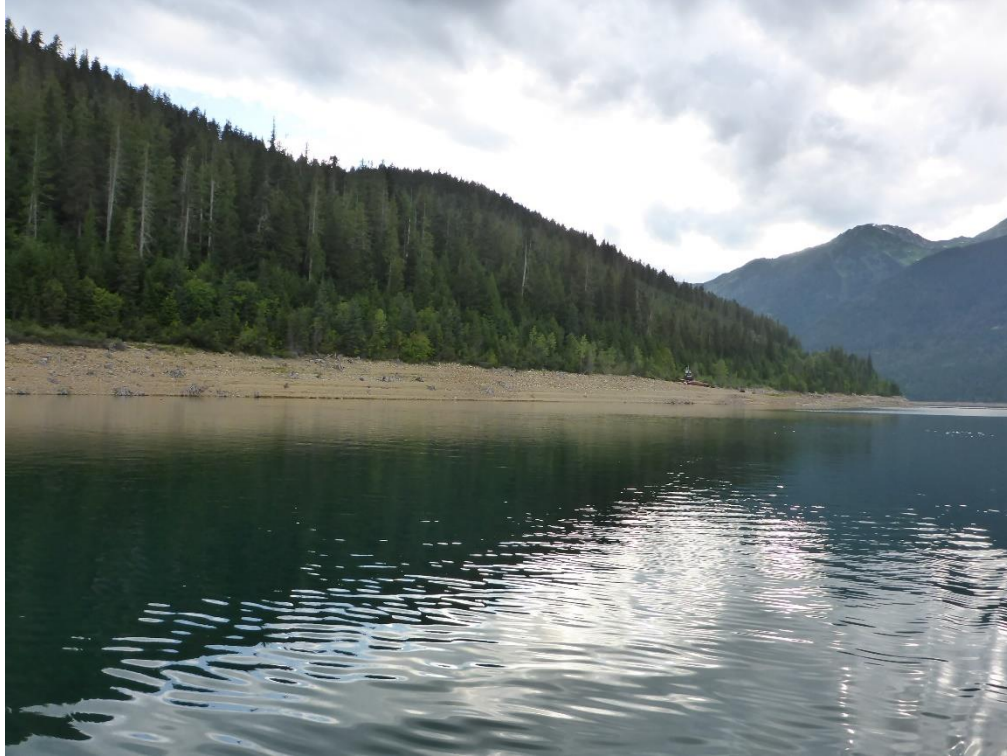
**Photo 3. View southwest from Kinbasket Lake at the log dewatering site from the east side of the site**

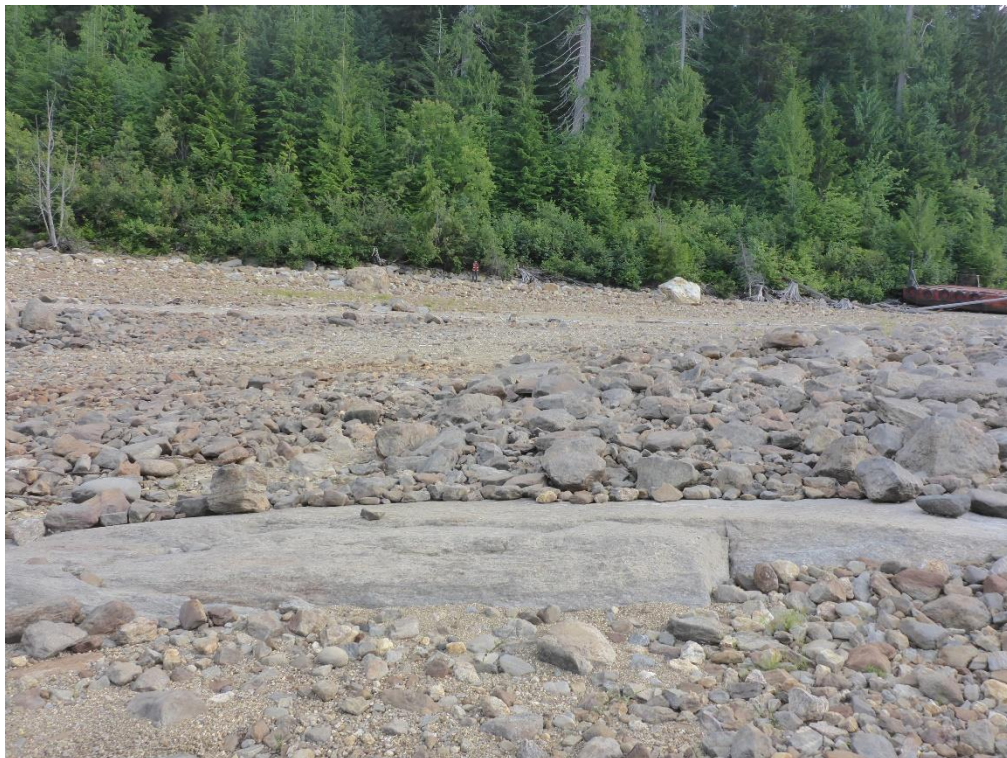
**Photo 4. View of general shoreline conditions at the log dewatering site**

A site assessment of the terrestrial and aquatic habitats in and around the dewatering and marine storage site was completed on July 25 and 26, 2019. The shoreline at the high-water mark (HWM) has a slope that varies from approximately 35 to 50% at the east end of the dewatering site and 10 to 15% to the west, where there is an historic boat launch area. Beach and shoreline substrates are mainly loose angular cobbles, and gravels with some sand. There is a rocky outcrop with angular boulders and bedrock present near the area where two old barges and a tugboat are located.

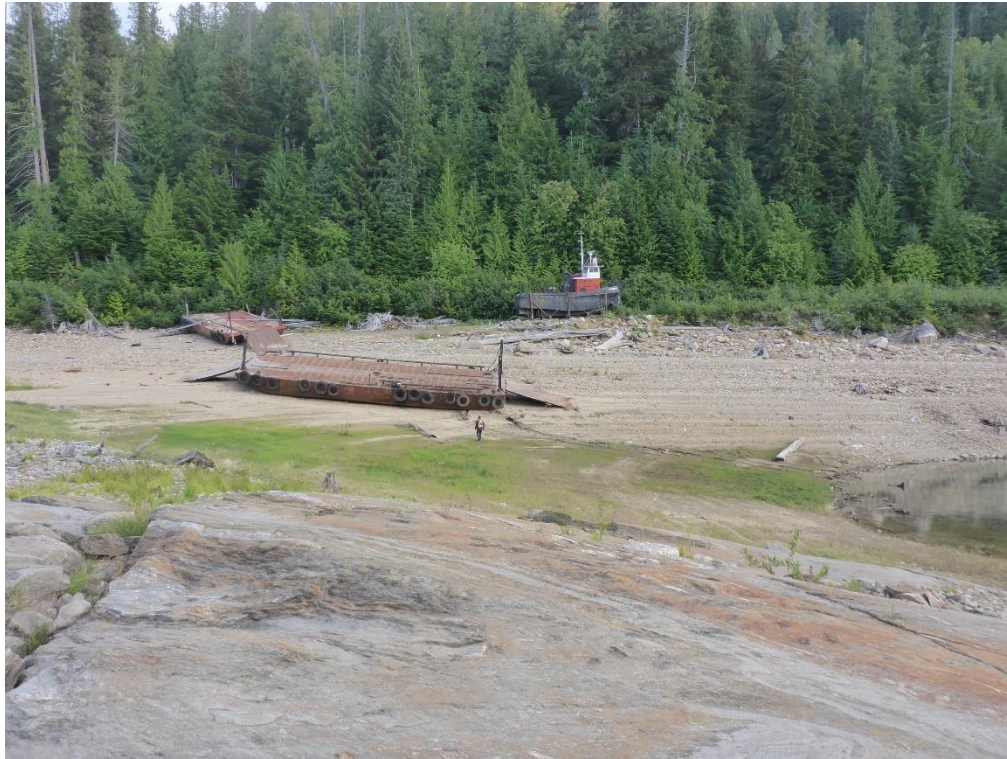
**Photo 5. View of existing equipment (tugboat and barges) located in the Project area**

Two old barges and a tugboat were observed on the dewatering site, along with old cables and miscellaneous metal debris from past logging operations.

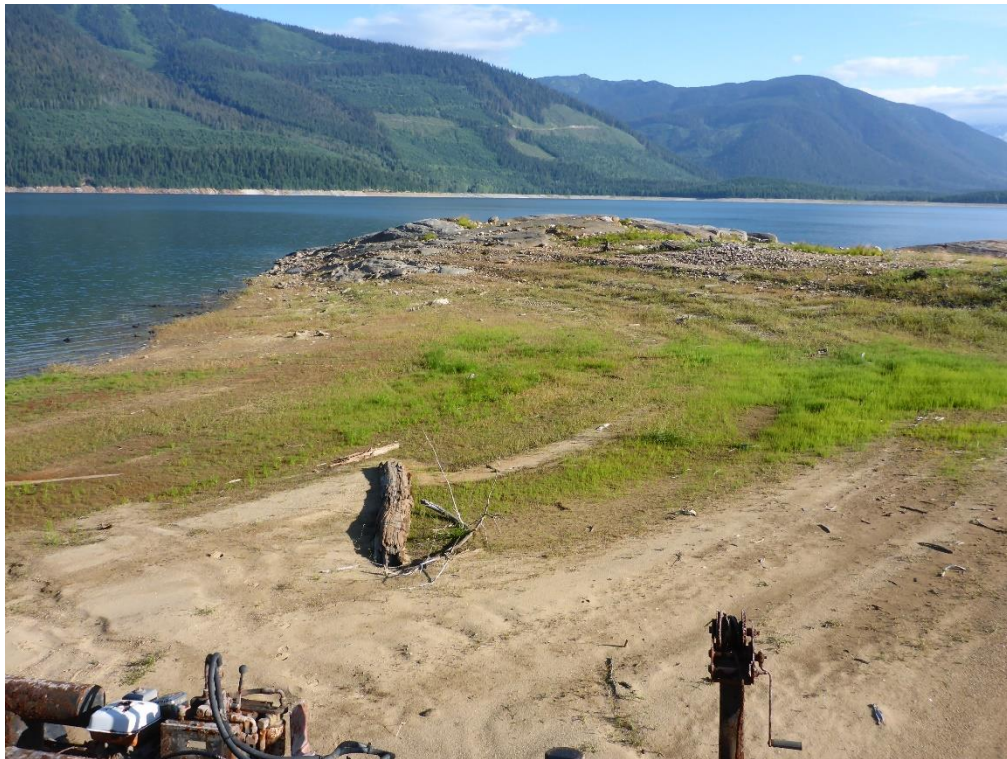
**Photo 6. View north at rock outcrop from where old barges are sitting along the shoreline**

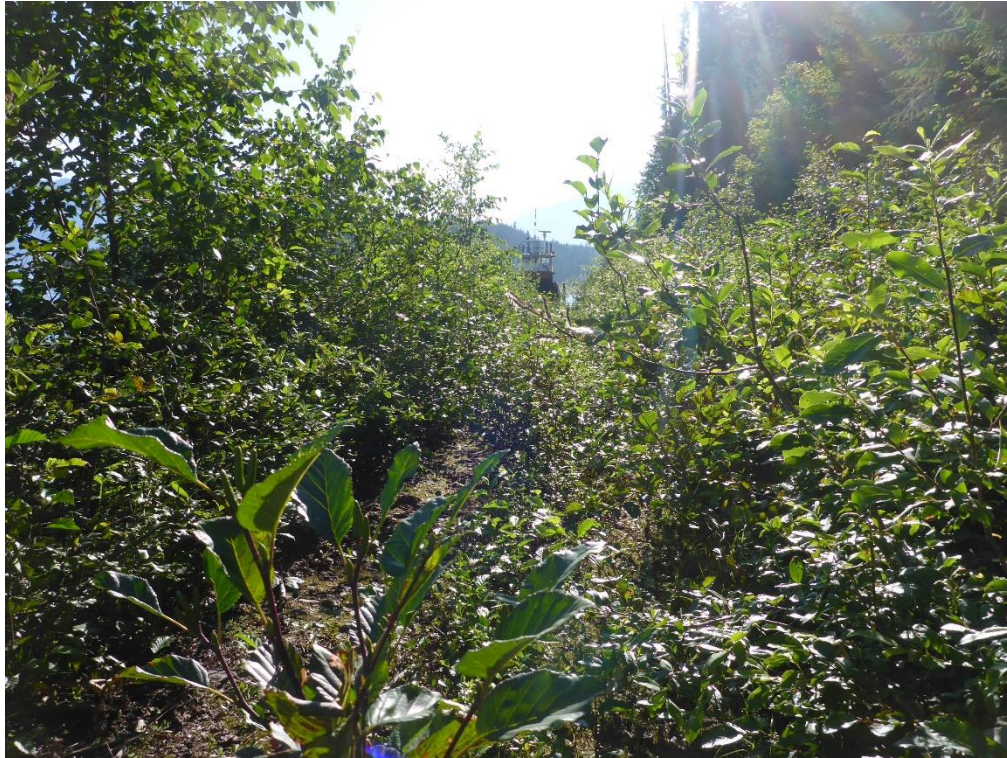
**Photo 7. View along overgrown road in upland area toward north to where tugboat is located**

There is an existing overgrown road from the upland area down to the beach where the tugboat and barges are located. Minor erosion and sloughing were present on the road. There is a small watercourse crossing along the access road (approximately 170 m upland from the beach) with an existing 600 mm culvert in place. The culvert is slightly overgrown; however, no blockages were observed. This watercourse enters Kinbasket Lake approximately 170 m west of the proposed dewatering site (where the tugboat and barges were located) but is still within the foreshore lease area.

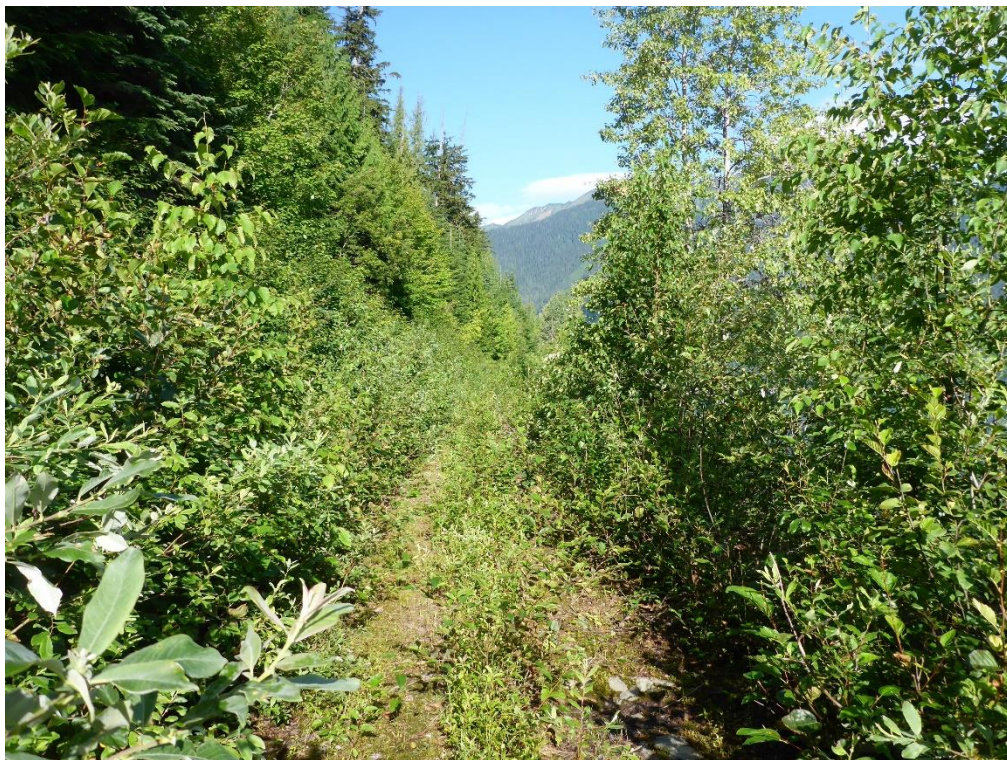
**Photo 8. View along overgrown road in upland area to the south from where the tugboat is located**

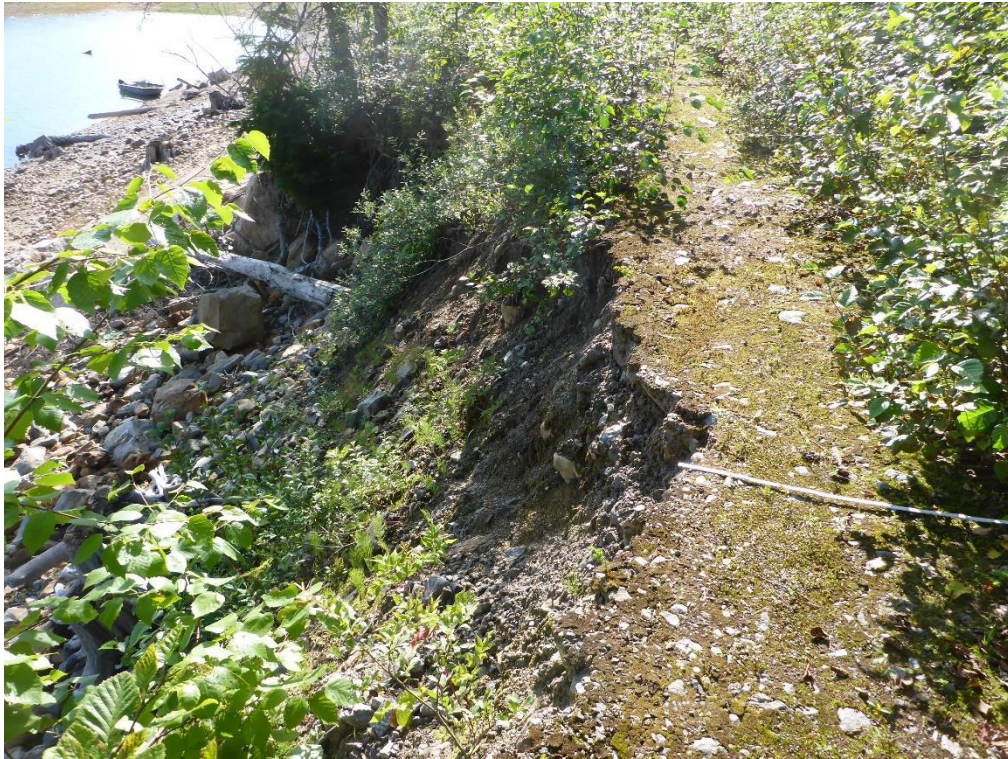
**Photo 9. View east along the existing access road where sloughing is present**

- High traffic areas may become muddy during rain events or rain-on-snow events. It is recommended to grade to redistribute gravels, or import gravels from nearby areas, to any areas with fine-textured soils where equipment operates.

- Retain existing vegetation wherever possible.
- Do not disturb existing embankments or embankment protection where possible.
- Provide, implement, inspect, and maintain temporary measures, which may include, but are not limited to, sand bags, silt fences, geotextiles, polyethylene sheeting, water pumps, spill kits, straw bales, drainage swales, ditches, drains, temporary drainage piping, sedimentation basins, vegetative cover, and other materials required to prevent erosion and migration of silt, mud, sediment, and other debris off-site or to other areas of the site where damage may result.

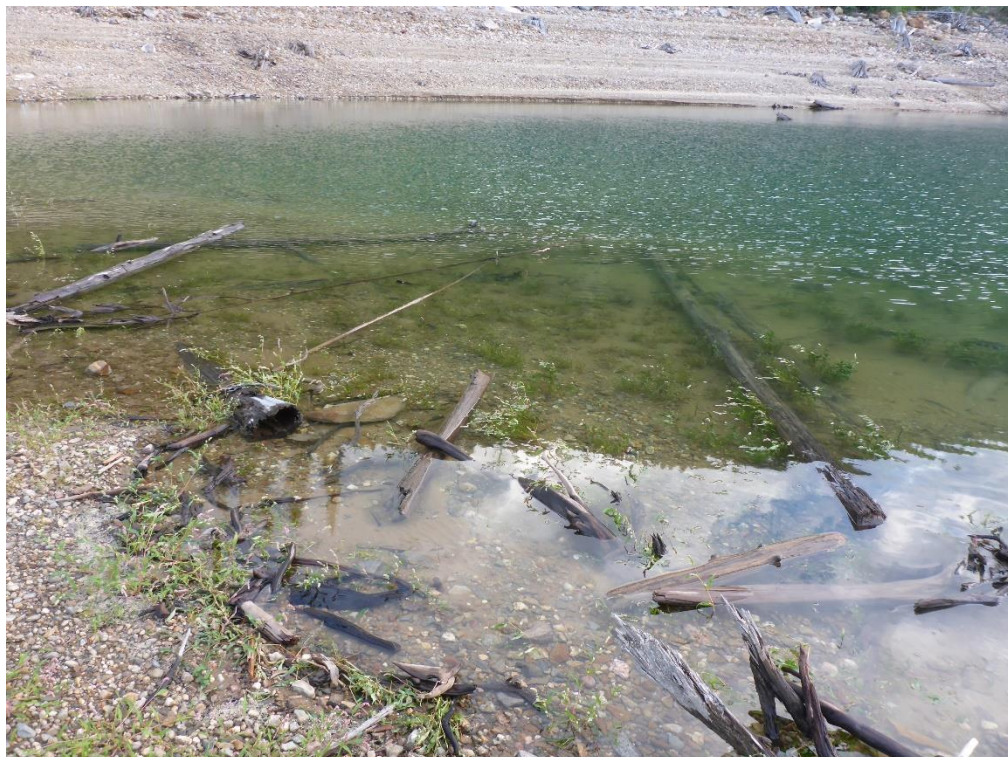
**Photo 10. View of water at shoreline; rocky with cobbles/boulders and limited aquatic vegetation**
