Newsletter of **Environmental, Disaster, and Crises Management Strategies**

Issue No.28 | October 2022

The October 15, 2022 Flash Flood in Agia Pelagia (Crete, southern Greece)

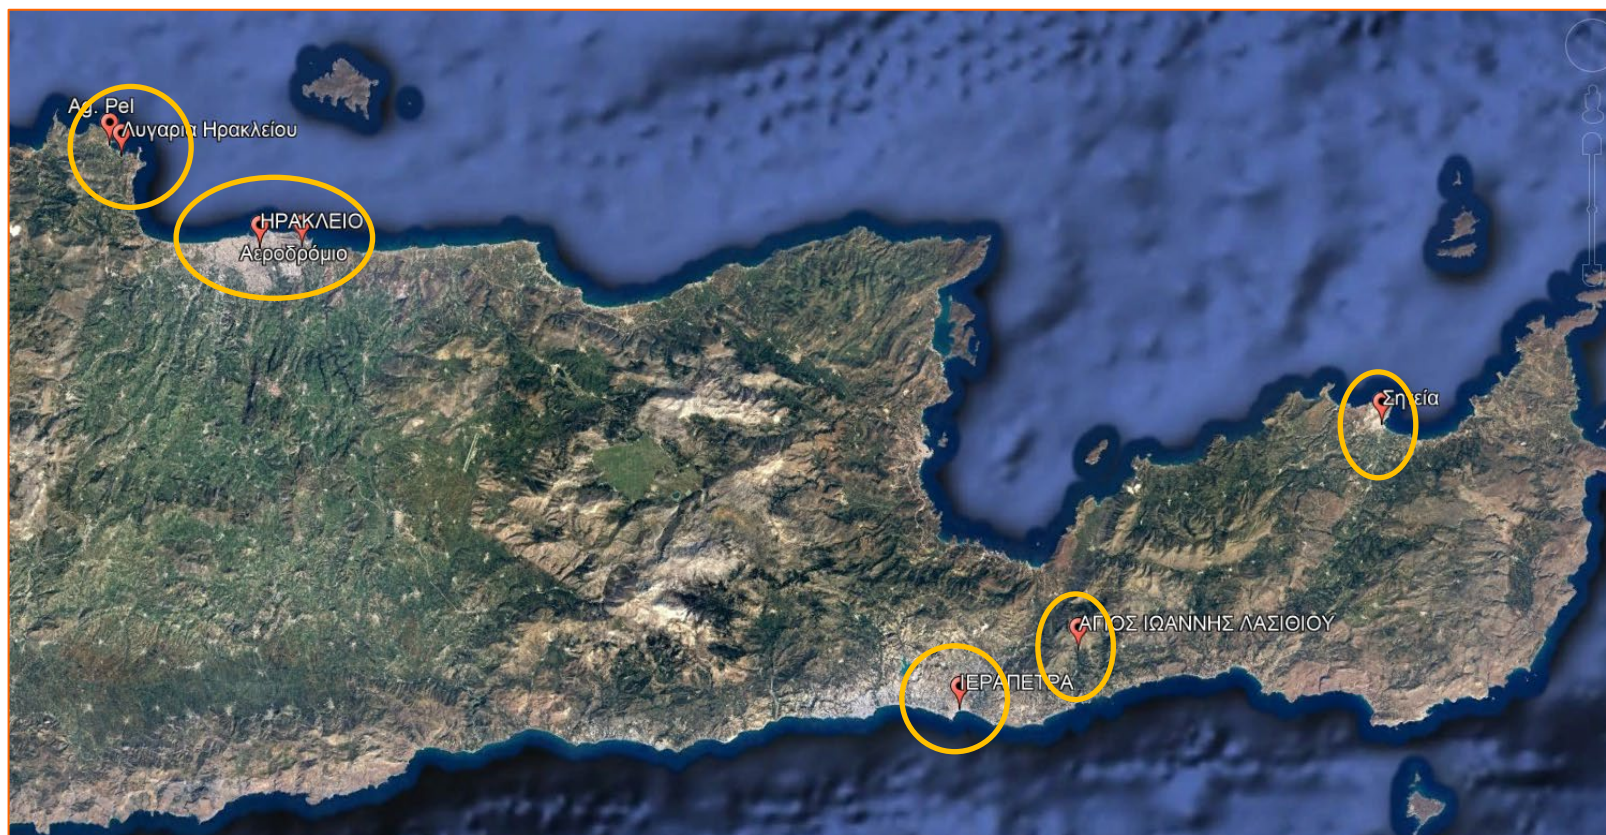
IMPACT ON SOUTHERN GREECE THE ISLAND OF CRETE

Significant impacts were observed in different locations around the island of Crete, mainly along the coast. Particular intensity occurred in Agia Pelagia and Lygaria villages in the Heraklion Region, as well as the towns of Sitia and Ierapetra, Agios Ioannis village and other locations to a lesser extent.

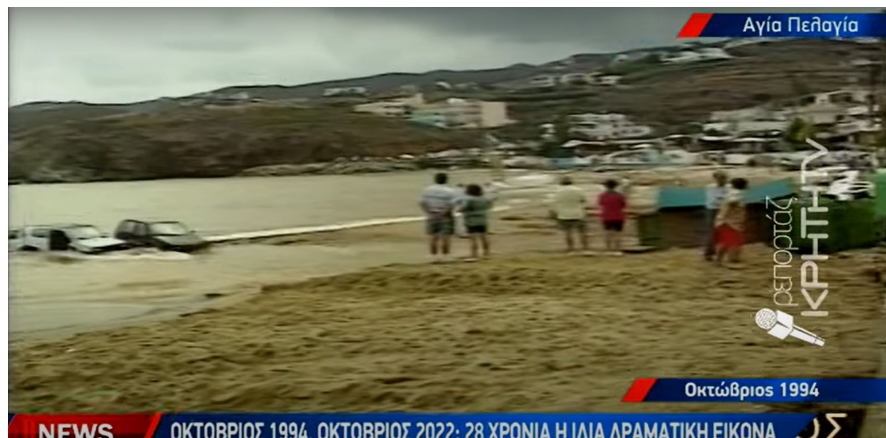
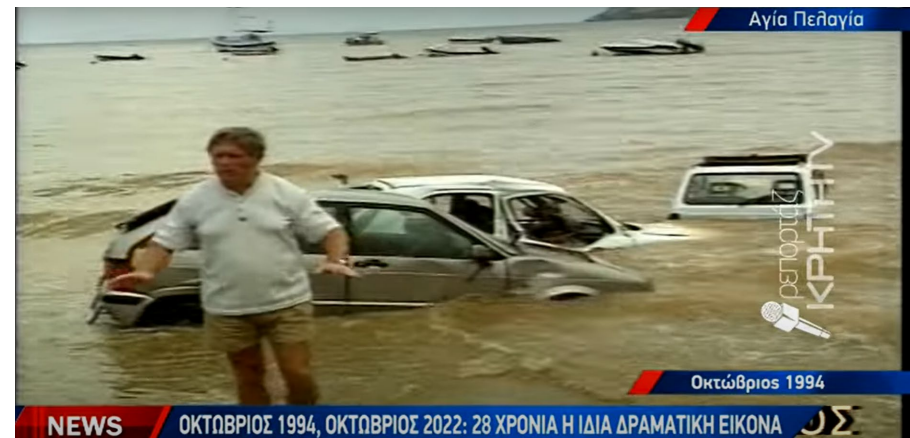
Agia Pelagia has a history of floods. The most important event, in the recent past, took place in 1994.

Image source: Crete TV (2022) - YouTube
October 1994 [left photo] – October 2022: 28 years after [right photo]

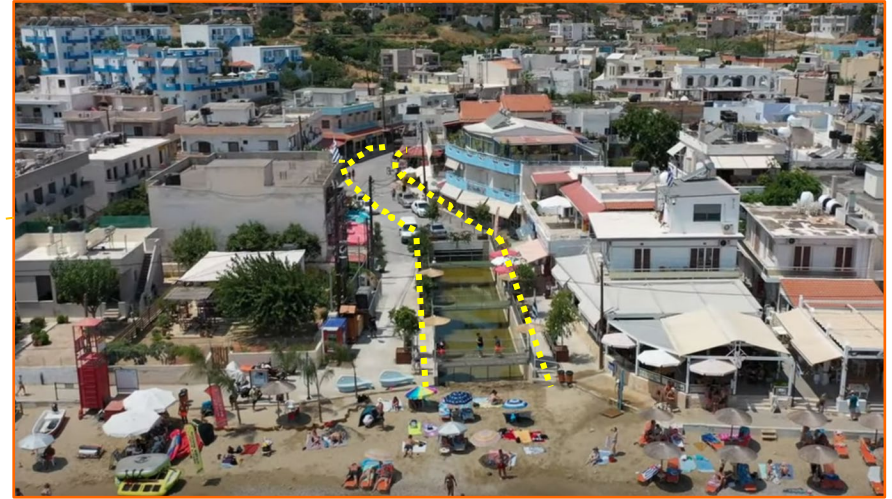
LOCAL DRAINAGE NETWORK IN AGIA PELAGIA TOWN

The local drainage network consists of small-sized catchments, with relatively high slopes especially in their upstream parts. These catchments due to their size and characteristics are particularly vulnerable to short duration high-intensity storms. In lower elevations, the torrents are heavily affected by development, with various obstructions situated within the floodplain. A portion of the drainage network has been converted into roads. At the outlet of the Agia Pelagia catchment, a rectangular concrete conduit has been constructed before a few years, to drain the basin and guide/lead storm waters to the sea.

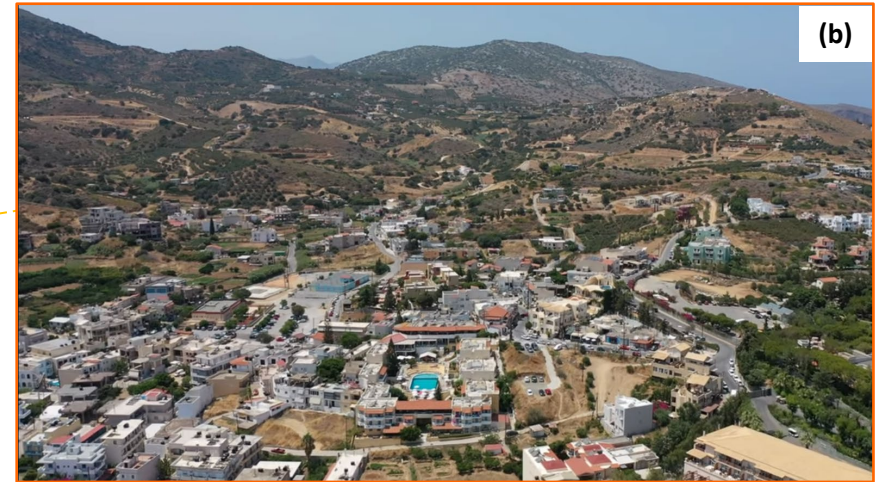
LOCAL DRAINAGE NETWORK IN AGIA PELAGIA TOWN

The upper parts of the small basin shown in map (a) present a relatively high inclination (b), (especially regarding the south slopes of the catchment).

The main two streams of the drainage network converge at lower elevations forming a narrow flood plain surrounding the main torrent of Agia Pelagia. A large part of the floodplain is nowadays converted into the urban fabric of the Agia Pelagia town.

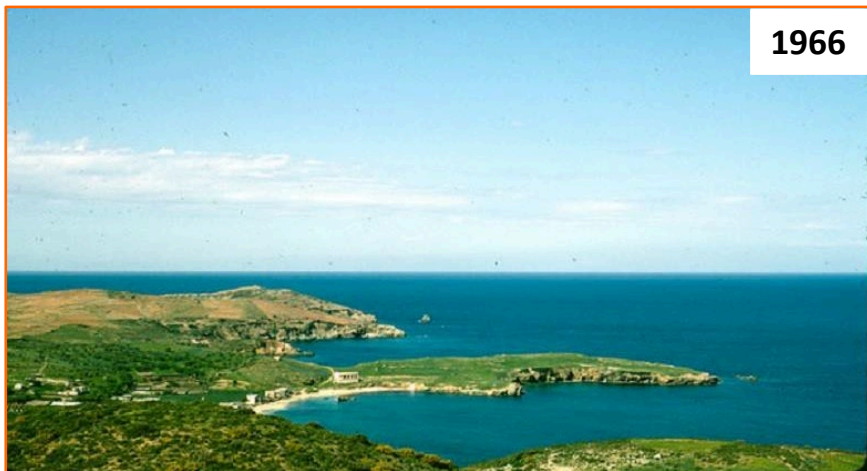
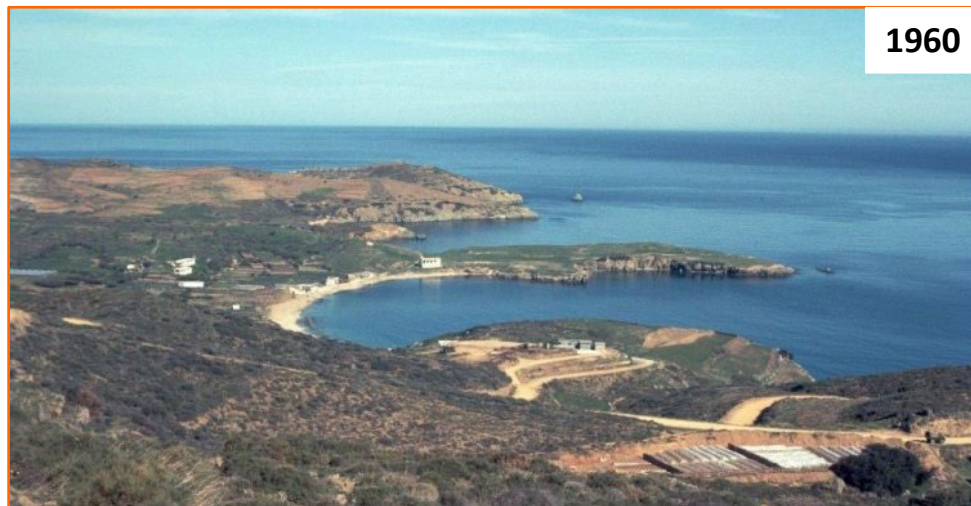
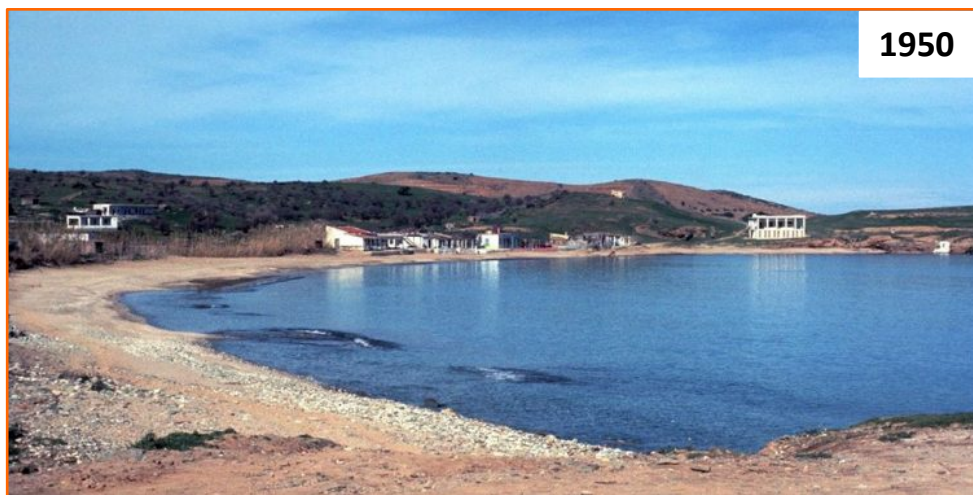
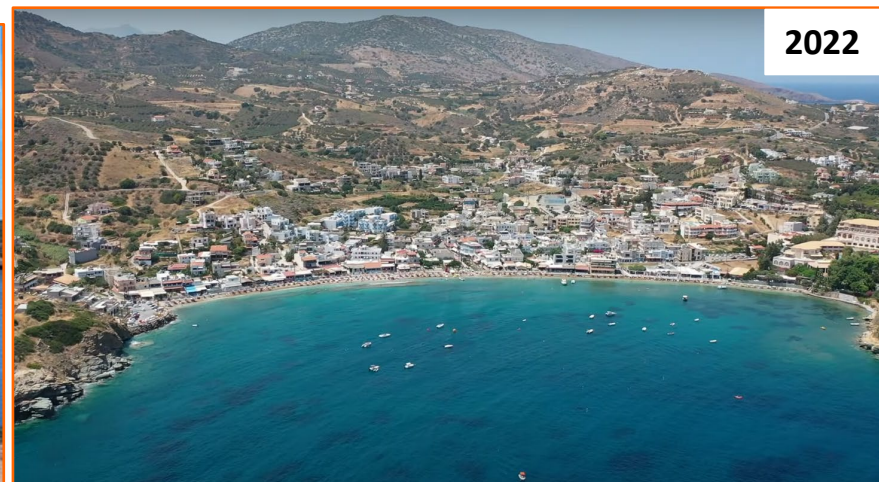
BUILT-UP OF THE AREA

Images show quite a different landscape in Agia Pelagia bay in previous decades

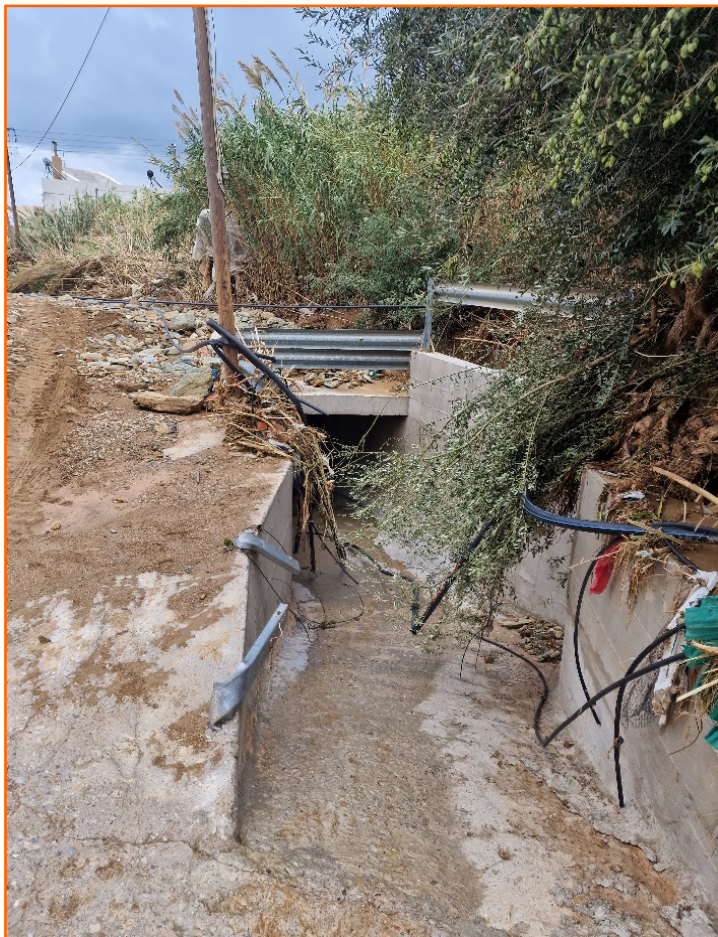
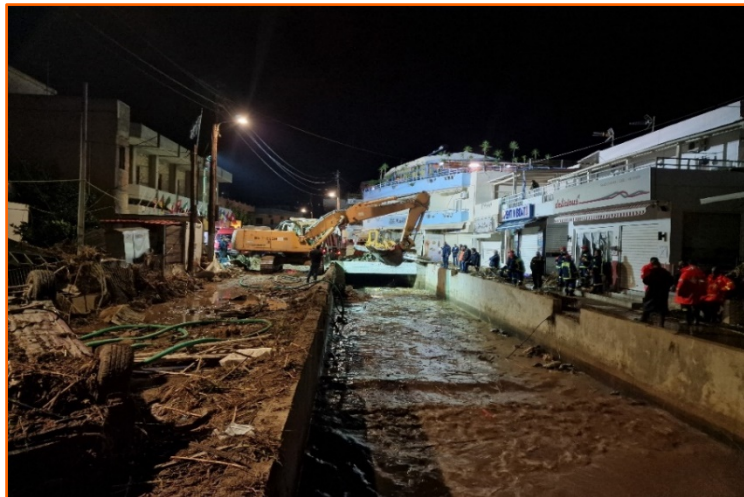
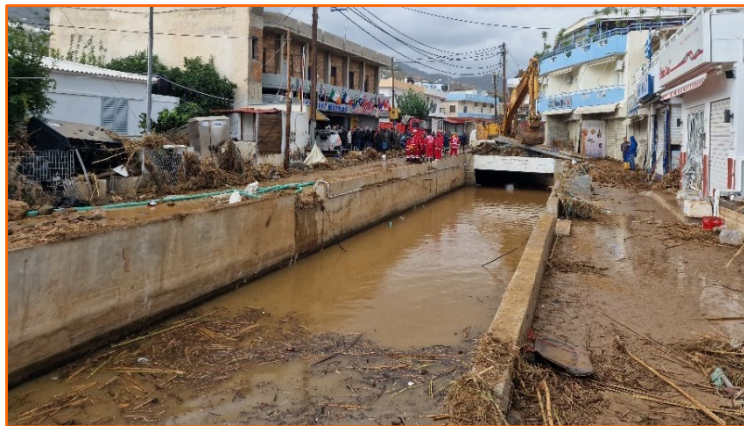
CONDUIT IN AGIA PELAGIA

The outlet of local drainage network uses a rectangular conduit under Agia Pelagia street that follows the course of the main channel. Evidence from the entrance and exit of the conduit indicate that, at locations, the debris deposited by the flood had reduced its capacity by blocking part of its cross sectional area.

7. Preliminary analysis indicates that the underground conduit on the main street of Agia Pelagia settlement, constructed along the main channel of the hydrographic network, was not sufficient to transport the total volume of water to the sea. For this case, previous research reveals that pipelines of this type are not sufficient during such phenomena, as the strong presence of transported materials can significantly contribute to cause failures due to clogging or a reduction in the hydraulic capacity (a phenomenon that has been recorded multiple times in other floods in the Greek area).

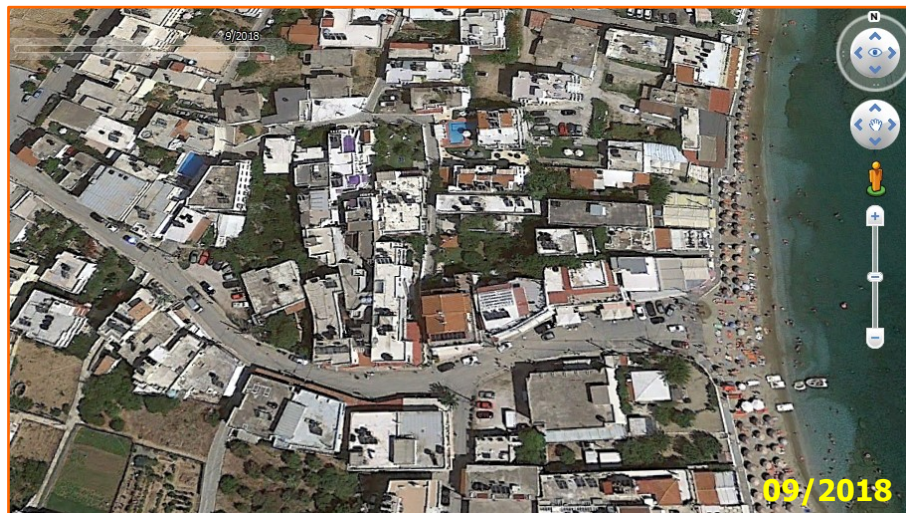
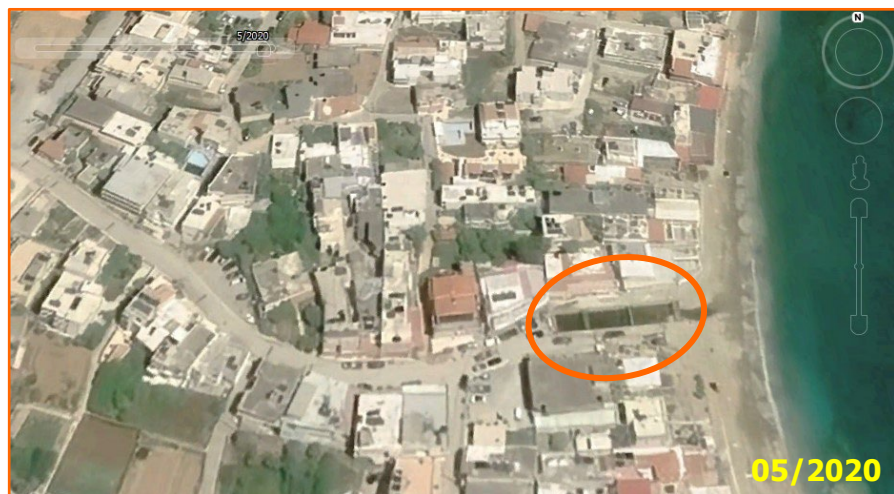
TILE-ROOFED CONDUIT AT THE DRAINAGE NETWORK OUTLET

The tile-roofed conduit was constructed during 2019. Until then, the stream followed its natural flow without any restriction, crossing the main road of the settlement.

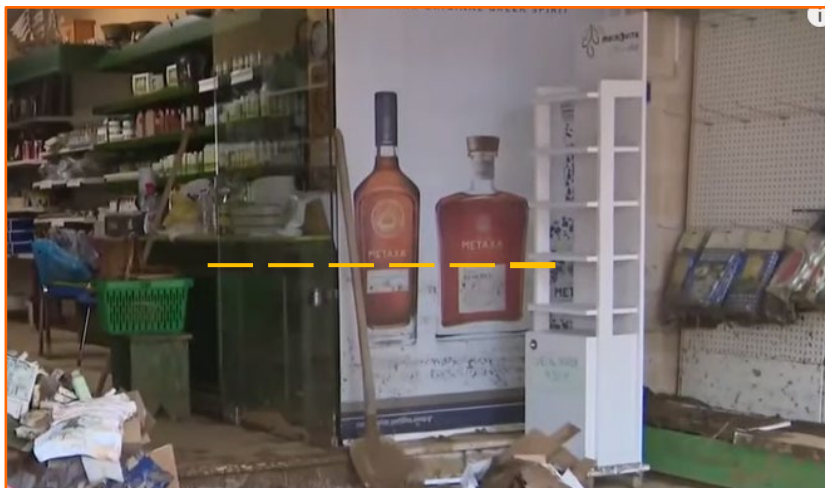
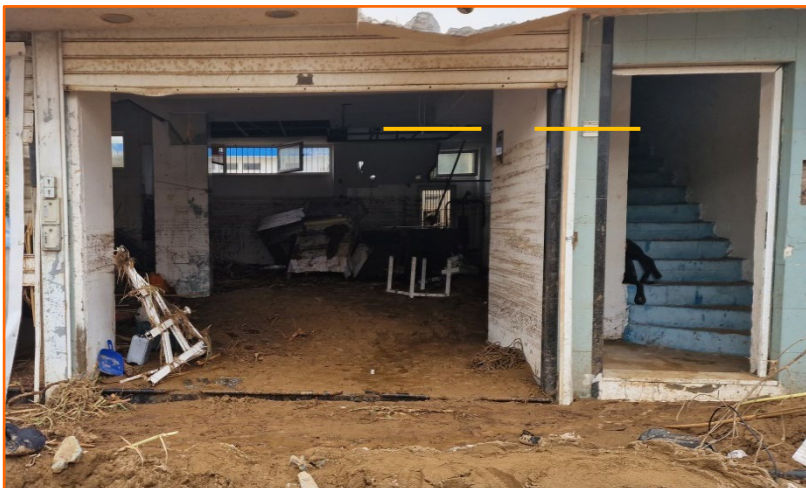
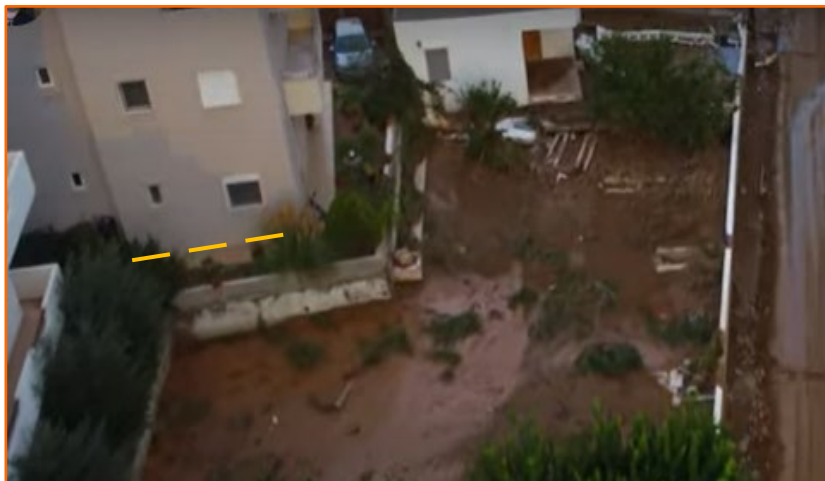
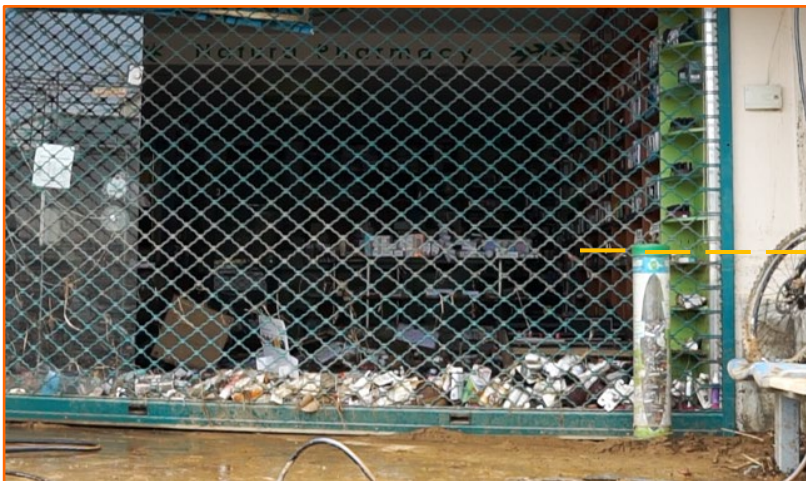
MAXIMUM WATER LEVEL FINDINGS

Water stage recorded at multiple locations around Agia Pelagia at 0,80m to 1,80m
(Photo credit by Prof. Dr. E. Lekkas)

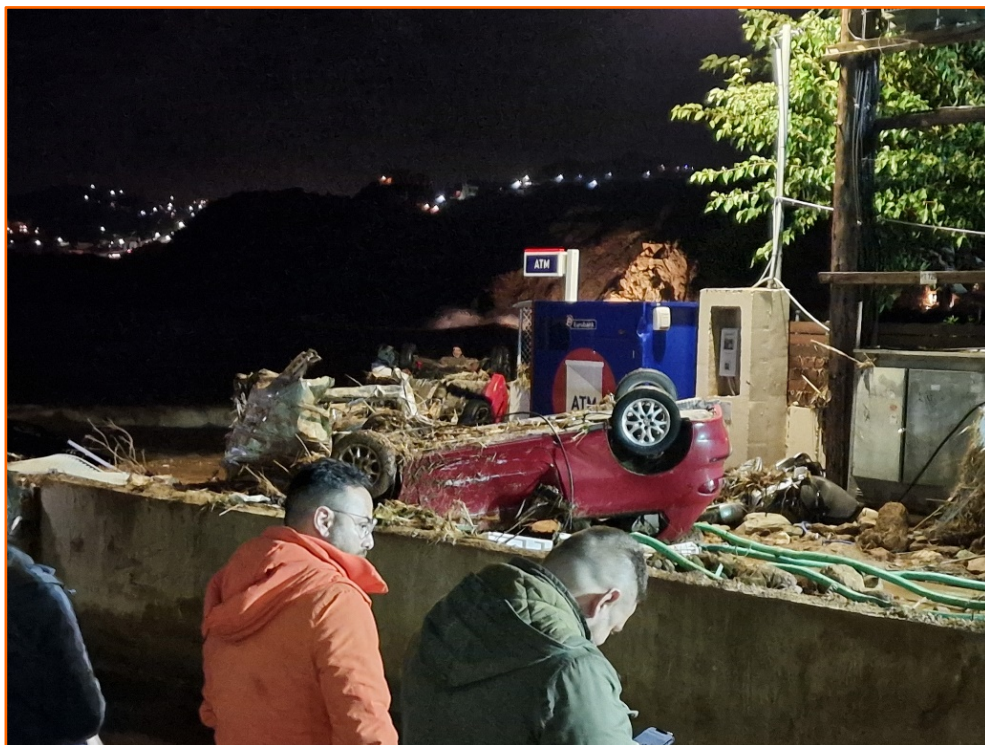
The car in which the two flood victims tried to leave their workplace when the flood struck Agia Pelagia (Photo credit by Prof. Dr. Efthymis Lekkas)

Two fatalities (male and female) were recorded due to the flash flood. Both were passengers of the same car, which was drifted by the water.

The 50-year-old driver lost his life while trapped inside his car. The 49-year-old passenger was swept into the sea, as she tried to abandon the car washed away by the flood.

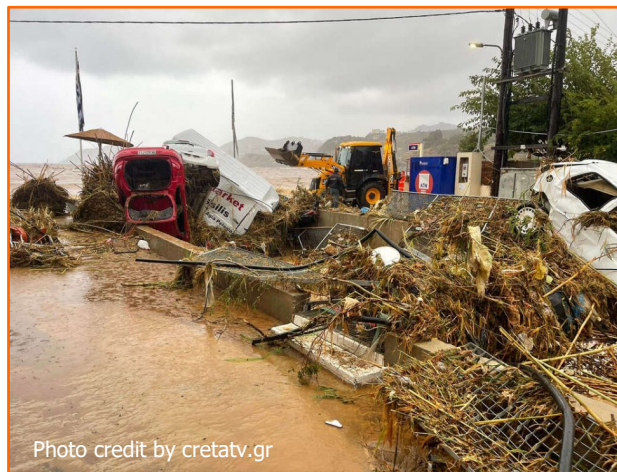
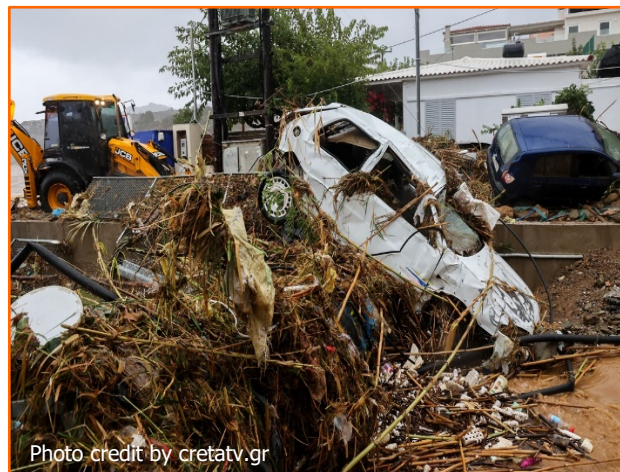
There are different impact severity classes on the environment. They include, mainly uprooting of riverine vegetation (reeds), small vegetation bending and uprooting, small uprooted trees [Denoting Class III & IV impacts in the Flash flood severity scale proposed by Diakakis et al. (2020) in *J. Hydrol.*]

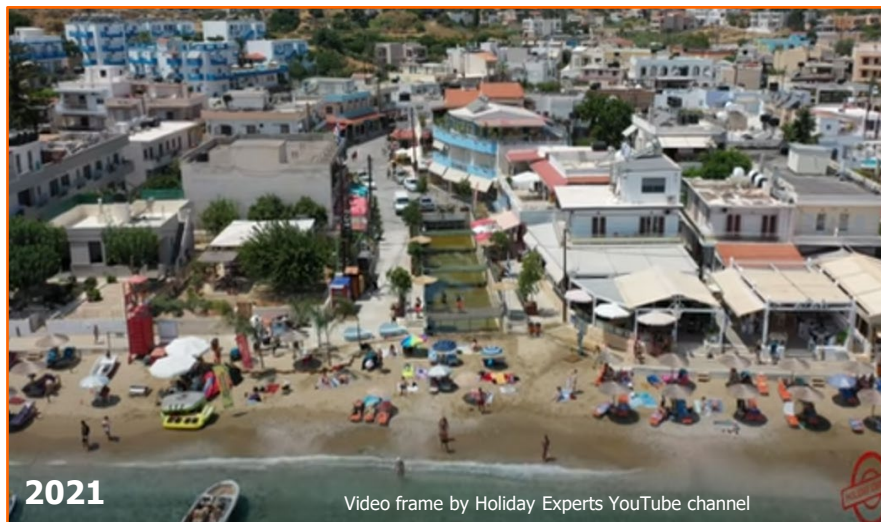
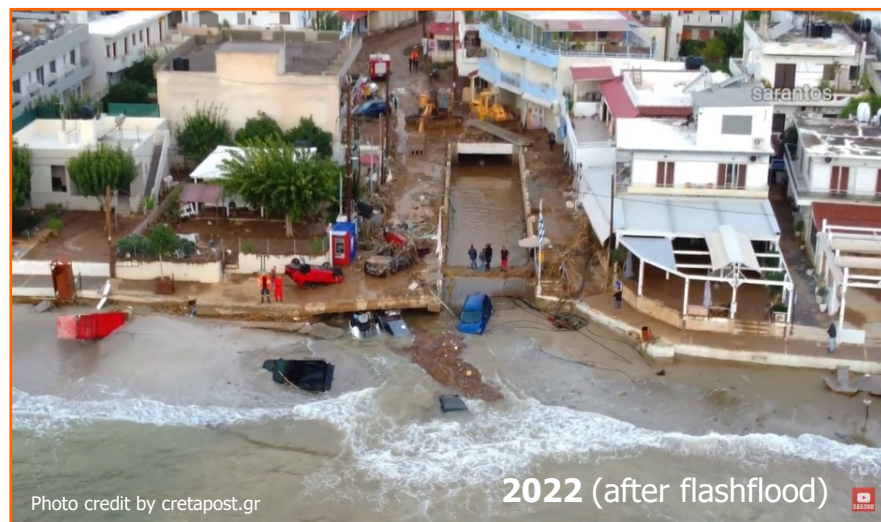
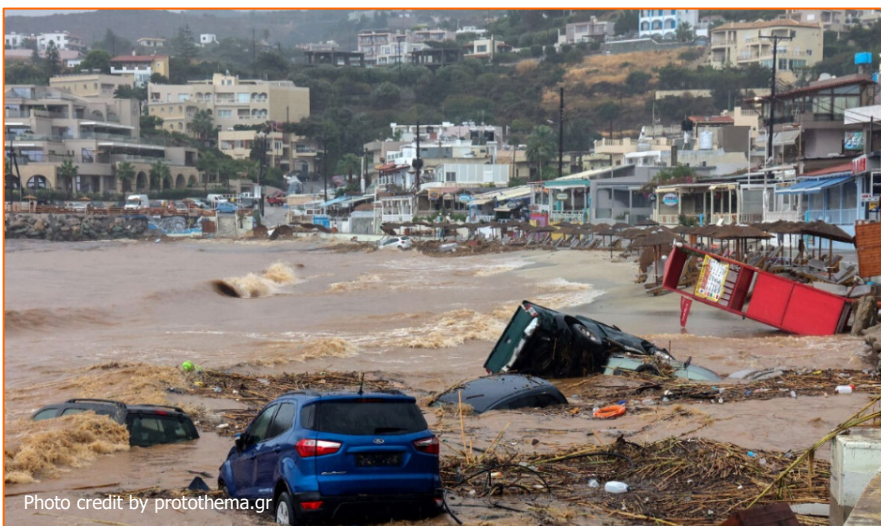
IMPACT ON ENVIRONMENT COASTLINE CHANGES

► Changes are observed due to the deposition of material on the shoreline. These changes will be temporary as deposition and erosion are strongly affected from oceanographic conditions, the character and load of the river sediment and the morphological features of the shelf.

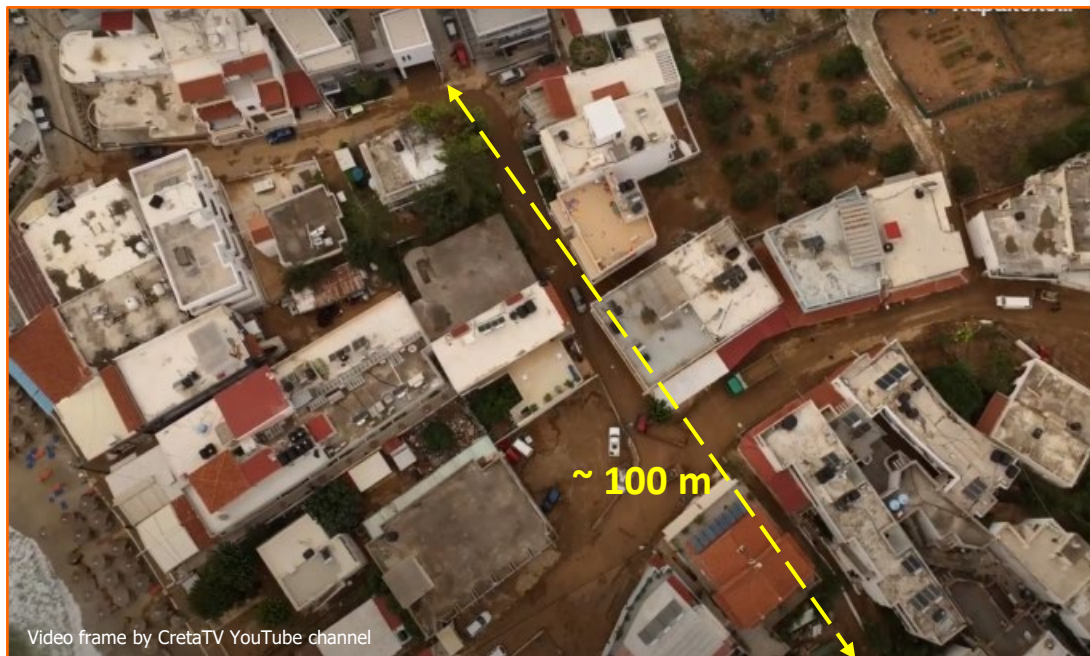
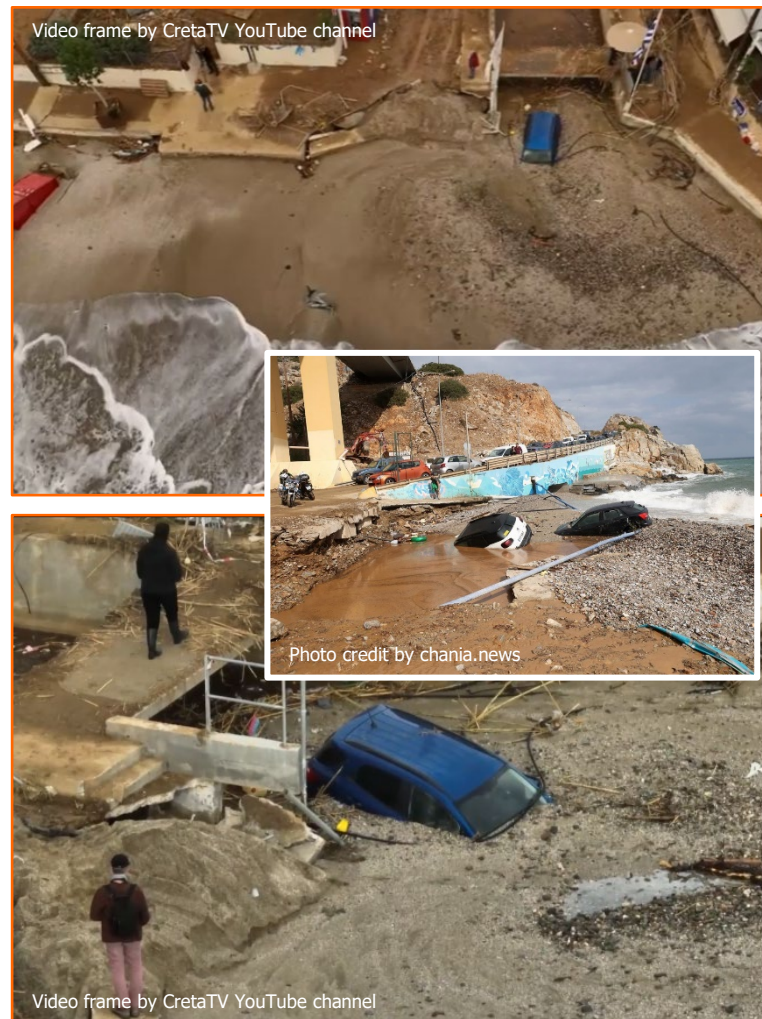
IMPACT ON ENVIRONMENT EFFECTS ON COASTLINE

▲ Deposition of fine-grained material in Agia Pelagia town

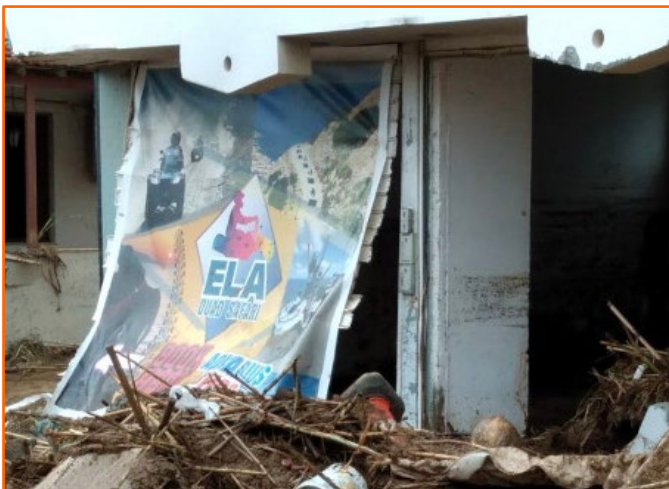
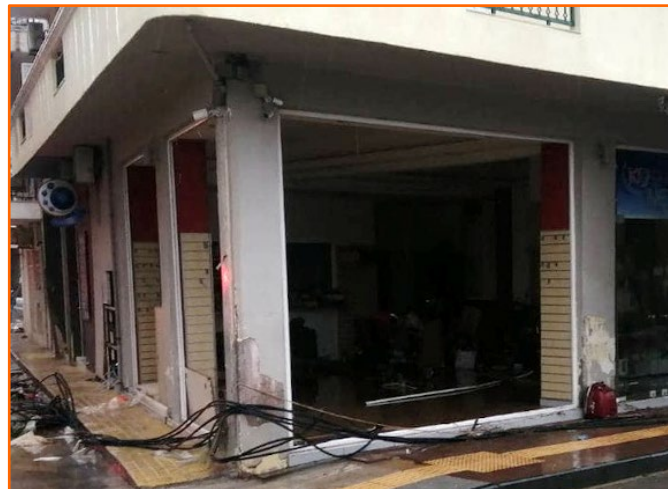
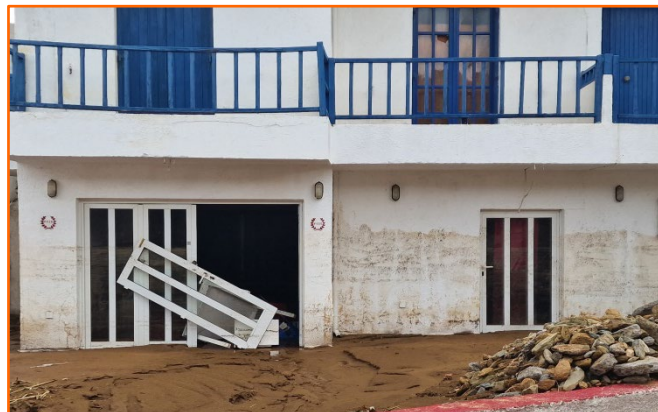
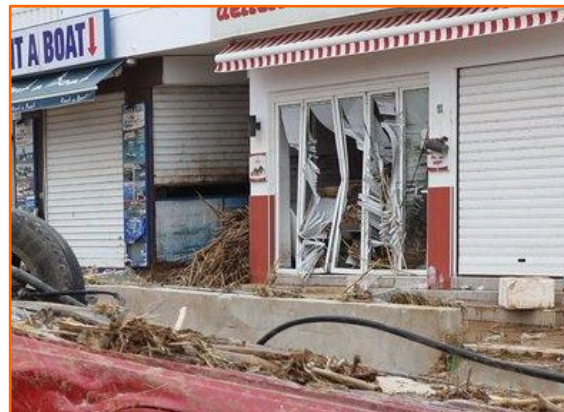
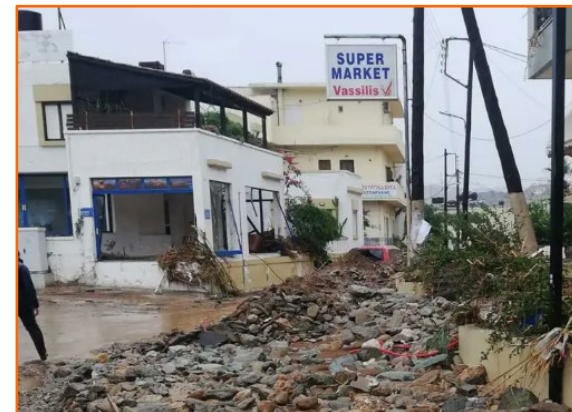
IMPACT ON THE BUILT ENVIRONMENT DAMAGE TO BUILDINGS

Non-structural damage to buildings with reinforced concrete frame with infill walls. Broken windows and destruction of window aluminum frames were recorded. Ground floor flooding affecting higher positioned equipment was also observed (Photos credit by Prof. Dr. E. Lekkas)

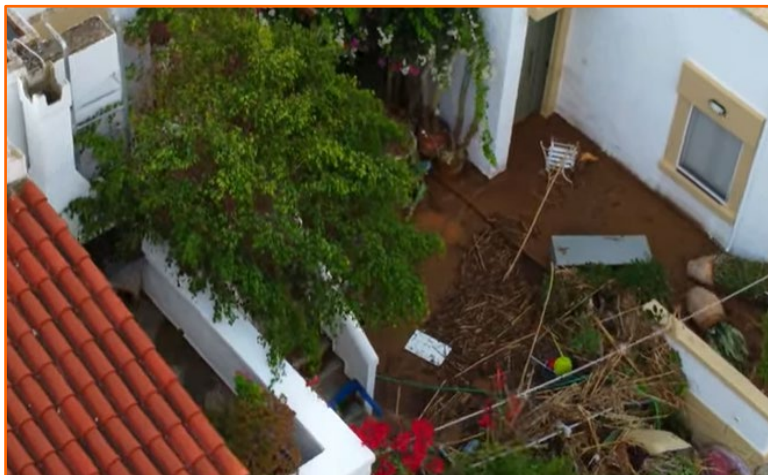
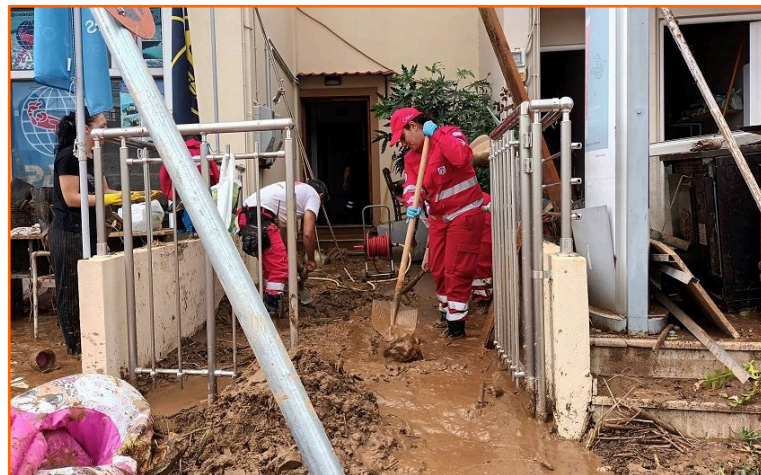
Yards and gardens suffer inundation

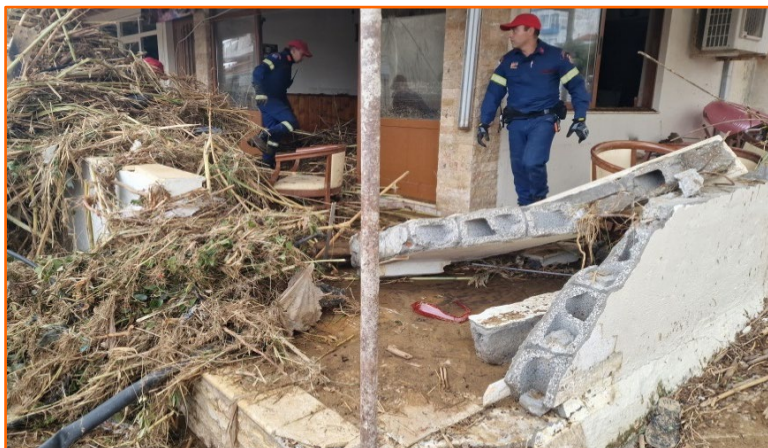
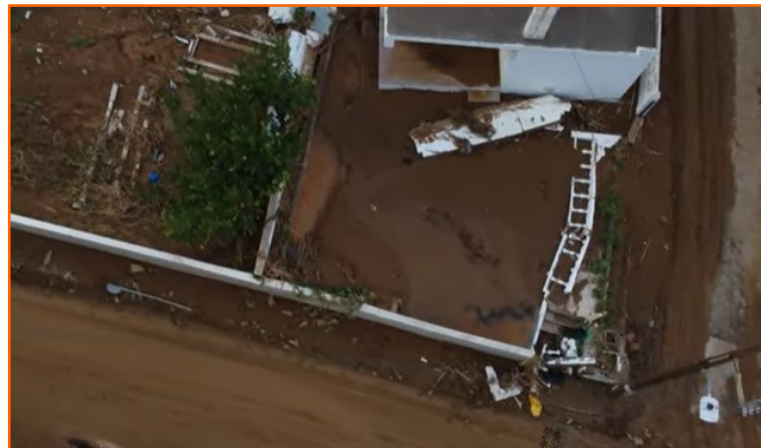
Yard walls and fences suffer structural damage
(Photo credit by Prof. Dr. E. Lekkas and skai.gr)

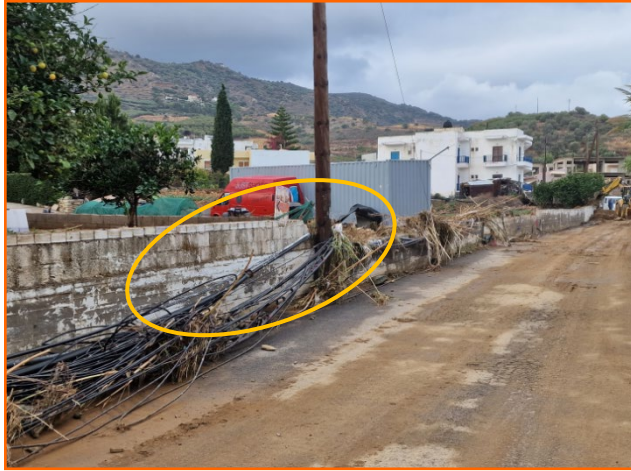
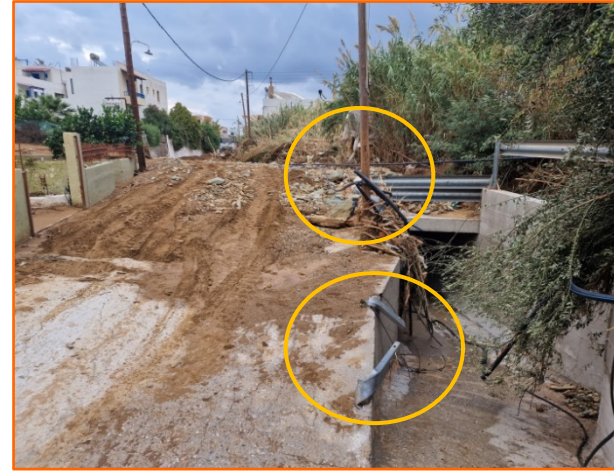
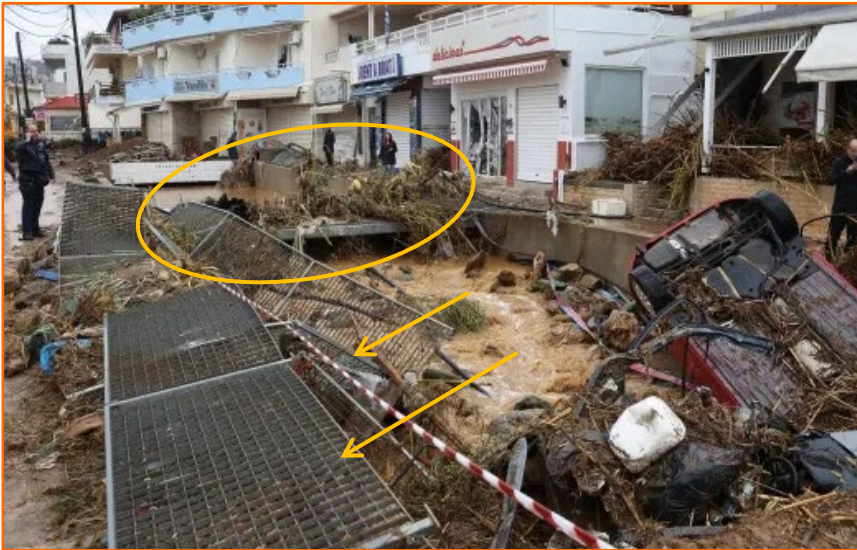
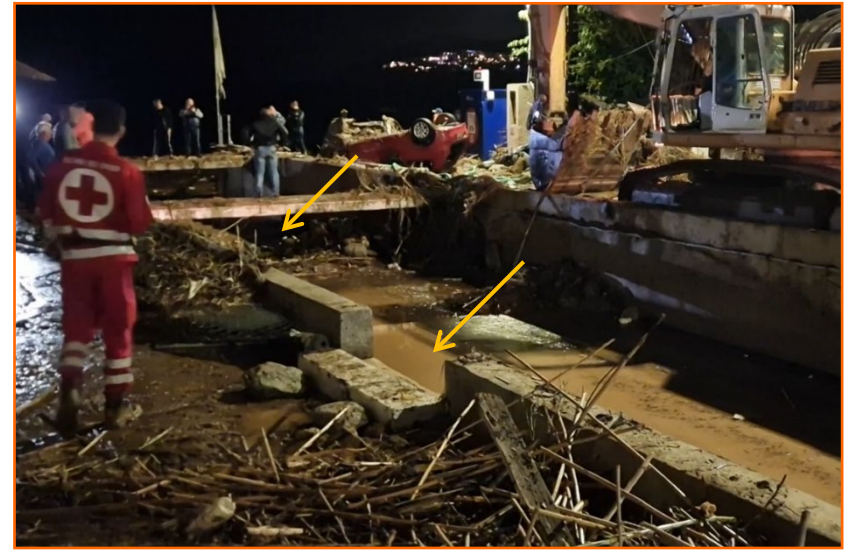
IMPACT ON BUILT ENVIRONMENT DAMAGE TO INFRASTRUCTURE

Damage to electricity and road networks (Photo credit by Prof. Dr. E. Lekkas)

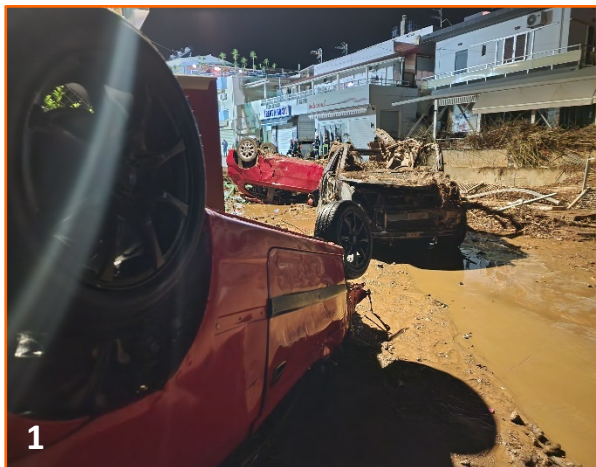
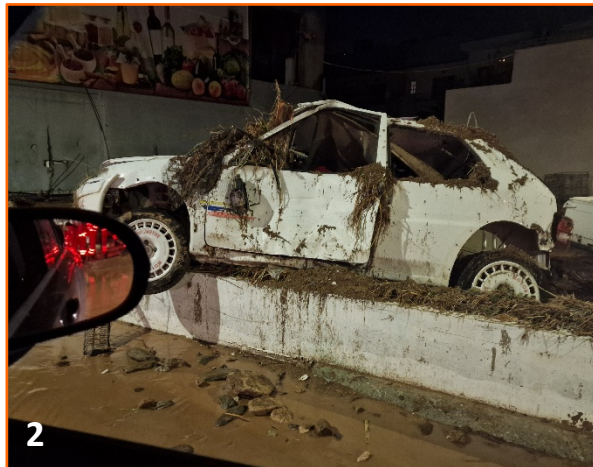
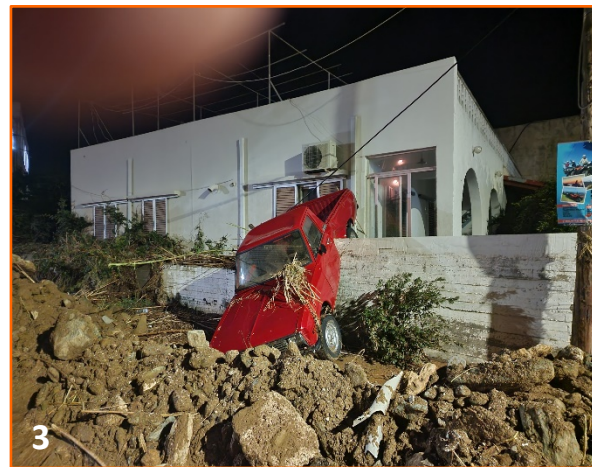
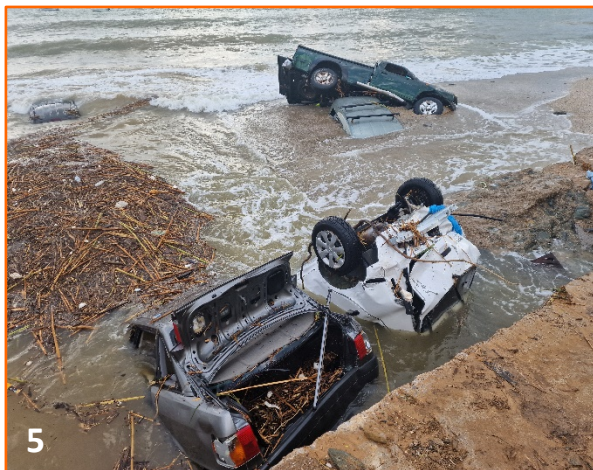
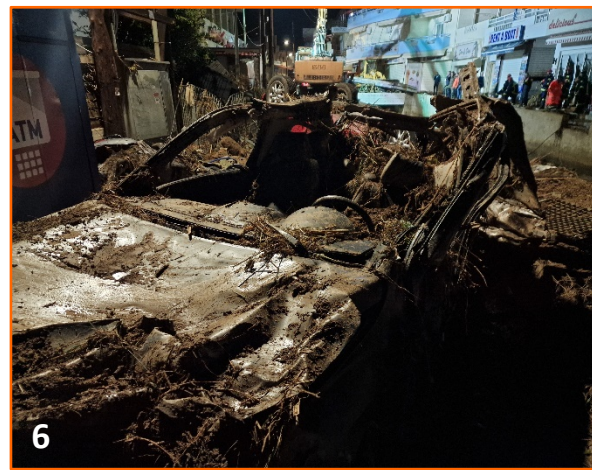
IMPACT ON MOBILE OBJECTS DAMAGE TO VEHICLES

Dozens of cars swept away by the water and suffered severe damage
(Photo credit by Prof. Dr. E. Lekkas)

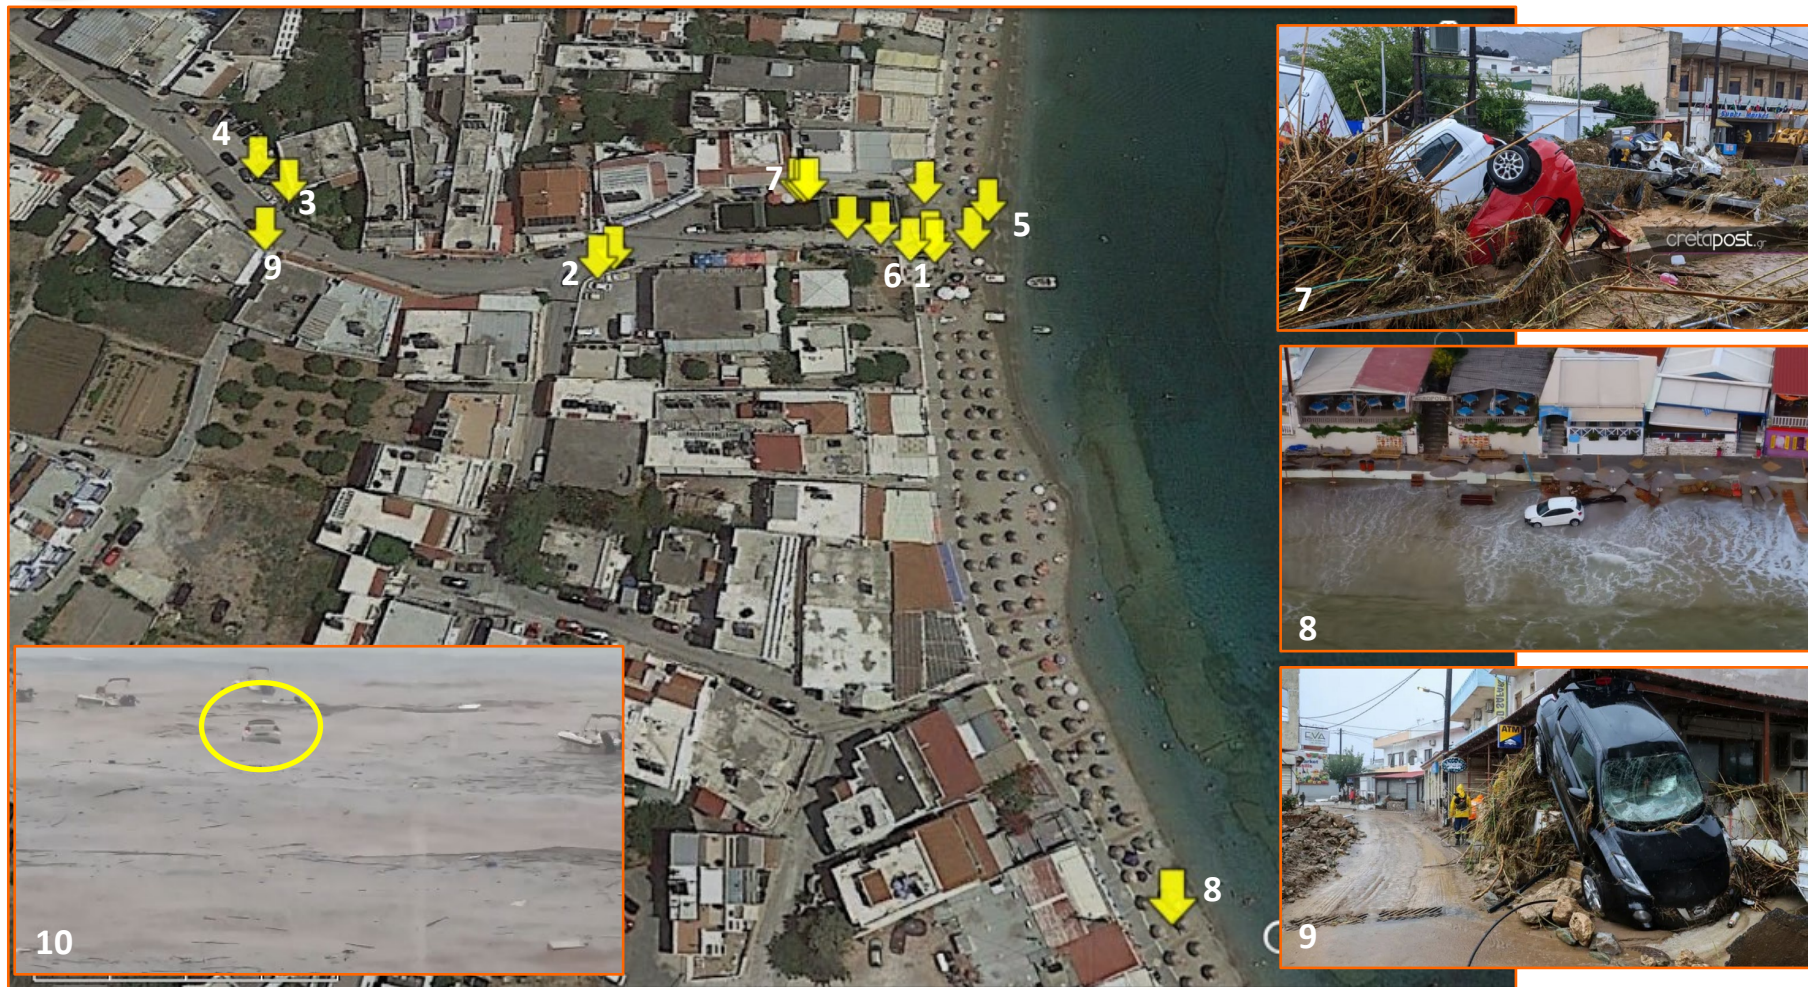
IMPACT ON MOBILE OBJECTS DAMAGE TO VEHICLES

17 cars were found after the flood [have been found] either on land or on the coastline. Many other cars drifted and sank into the sea [Photo credits by Nikos Sarantos YouTube video, cretapost.gr (7), bankingnews.gr (9), Leonidas Aretakis facebook video (10)]

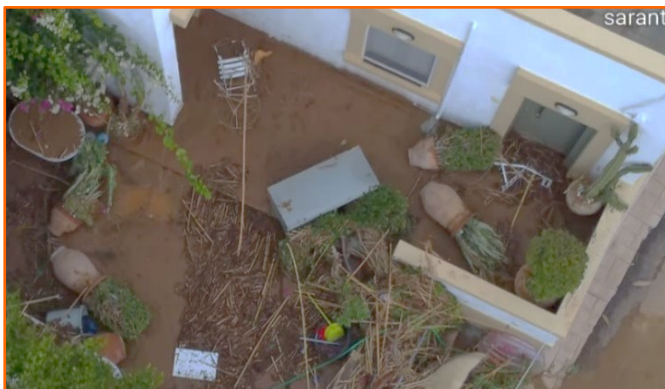
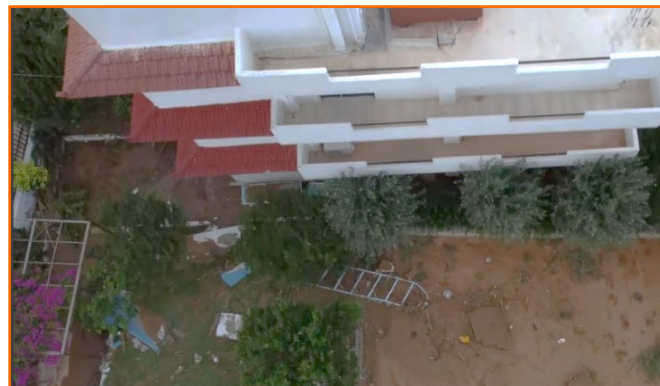
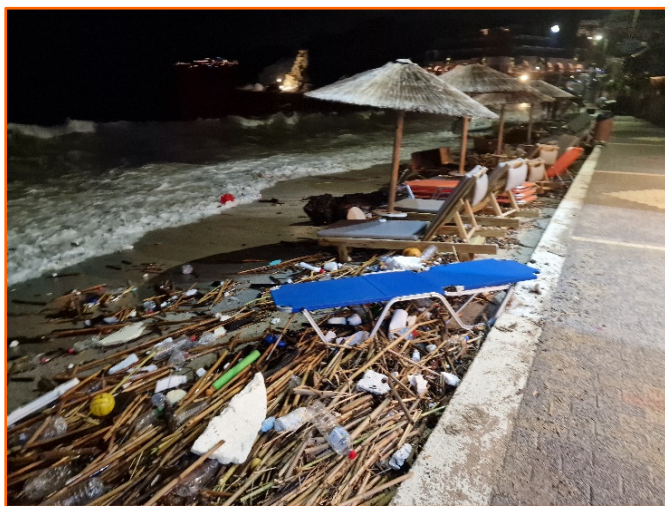
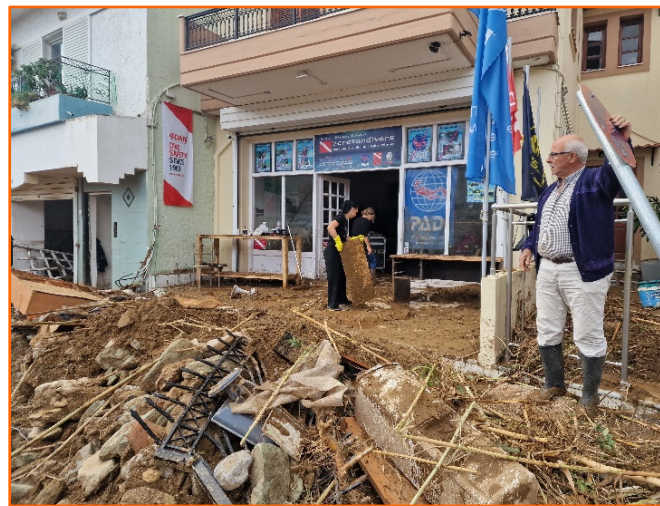
IMPACT ON MOBILE OBJECTS DAMAGE TO LIGHT OBJECTS

Lighter objects (beach umbrellas, sunbeds, light furniture and equipment, flower pots etc.) were swept away, sometimes forming debris gathered at some points (Photo credits by Prof. Dr. Efthymis Lekkas, Nikos Sarantos youtube video)
