MOUNTAIN GOAT-KLONDIKE HIGHWAY INTERACTIONS IN THE SOUTHERN YUKON

Report for WCS-Canada
Dr. Katarzyna Nowak
February 2019

Purpose of this report: To evaluate risks to mountain goats of a human transportation corridor intersecting goat range using data collected in the southern Yukon during summer 2018.

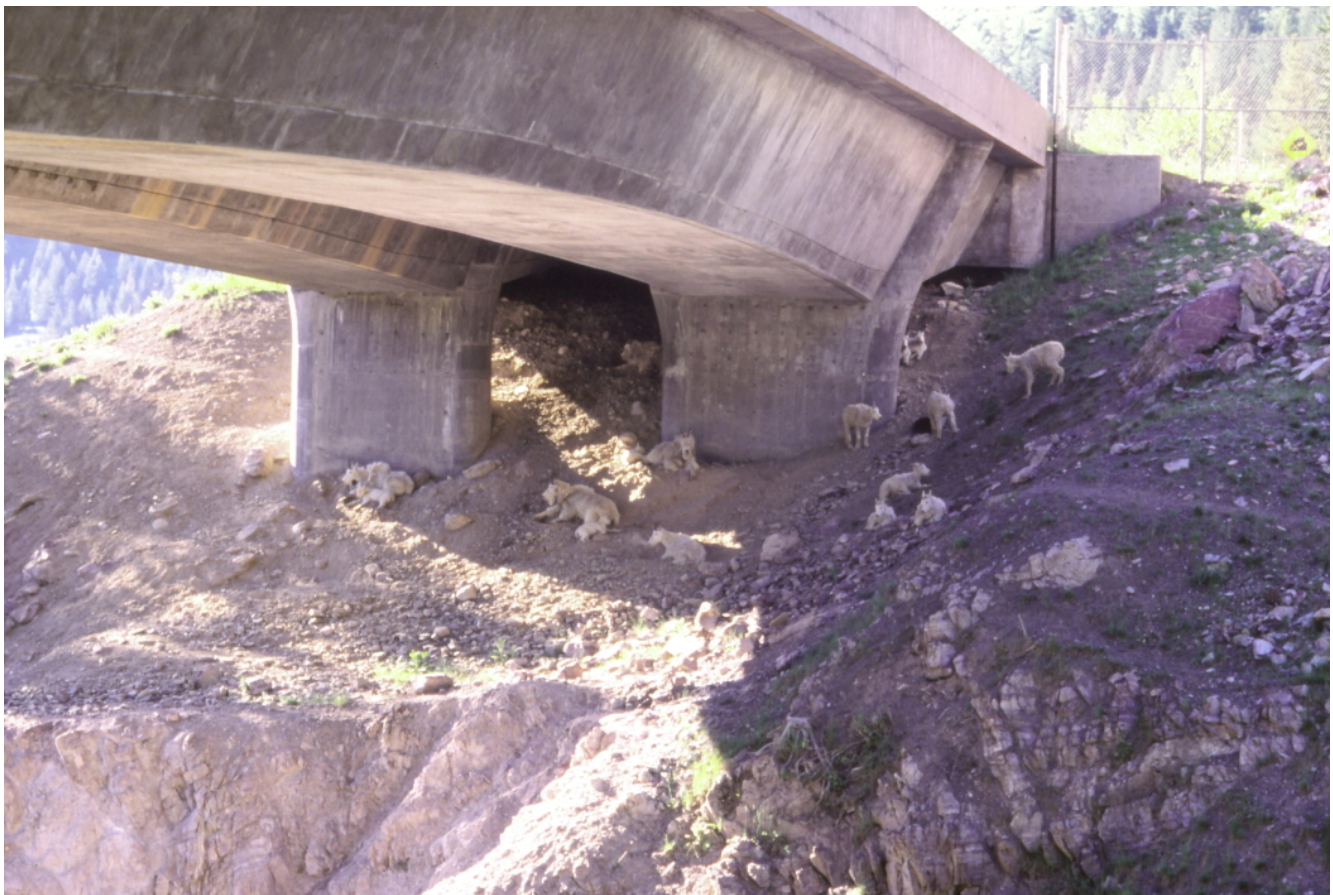
Figure 1 Mountain goats using the shade of an underpass at Glacier National Park, Montana.
Photo Credit: Sumio Harada

Thanks to Singer's work, a bridge permitting underpassage by mountain goats was constructed and mountain goats readily use it until today. There are now also several roadside viewing areas where visitors can observe the lick and goats. The "goat bridge" underpass is 3-8 m high and 23 m wide and accommodates the main goat highway crossing area (Singer, 1985); a second underpass accommodates another passage (3 m high x 3 m wide x 11 m) (Singer, 1985). During bridge construction, goat trails were obliterated and new trails dug leading to both bridge areas; in addition, a sheer wall downhill and a cyclone fence uphill restrict goats' movements funneling them in the direction of the underpasses (Singer, 1985). While Singer (1985) reports that initially, goats would run under bridges or show fear if stopping under bridges and hearing road traffic overhead, it appears that goats have habituated to traffic noise and now even rest underneath the bridges and use the underpassage areas for shade during summer (Sumio Harada, pers. comm., 2019; Fig. 1).

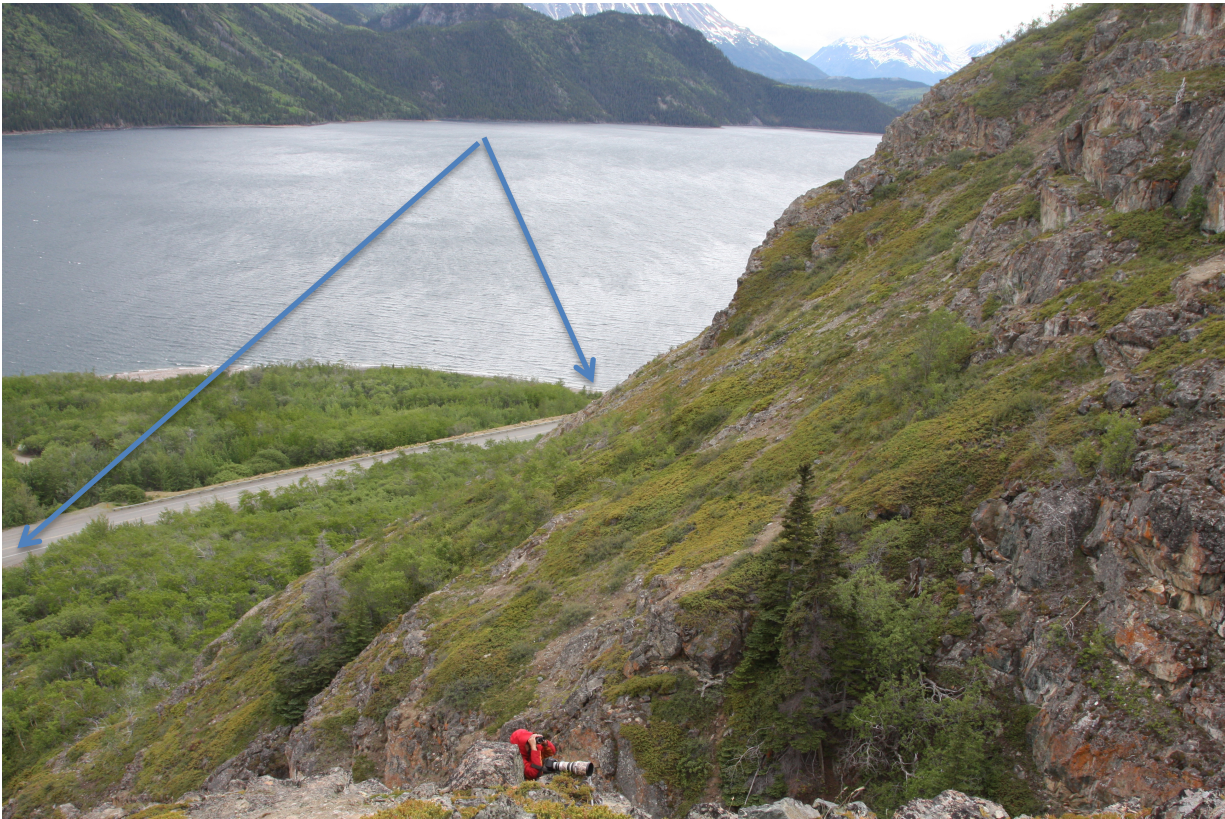
Figure 4 Crossing 1 area with Pooley Point in background and edge of Pooley Canyon in foreground. Arrows point to mountain goats' road access points.

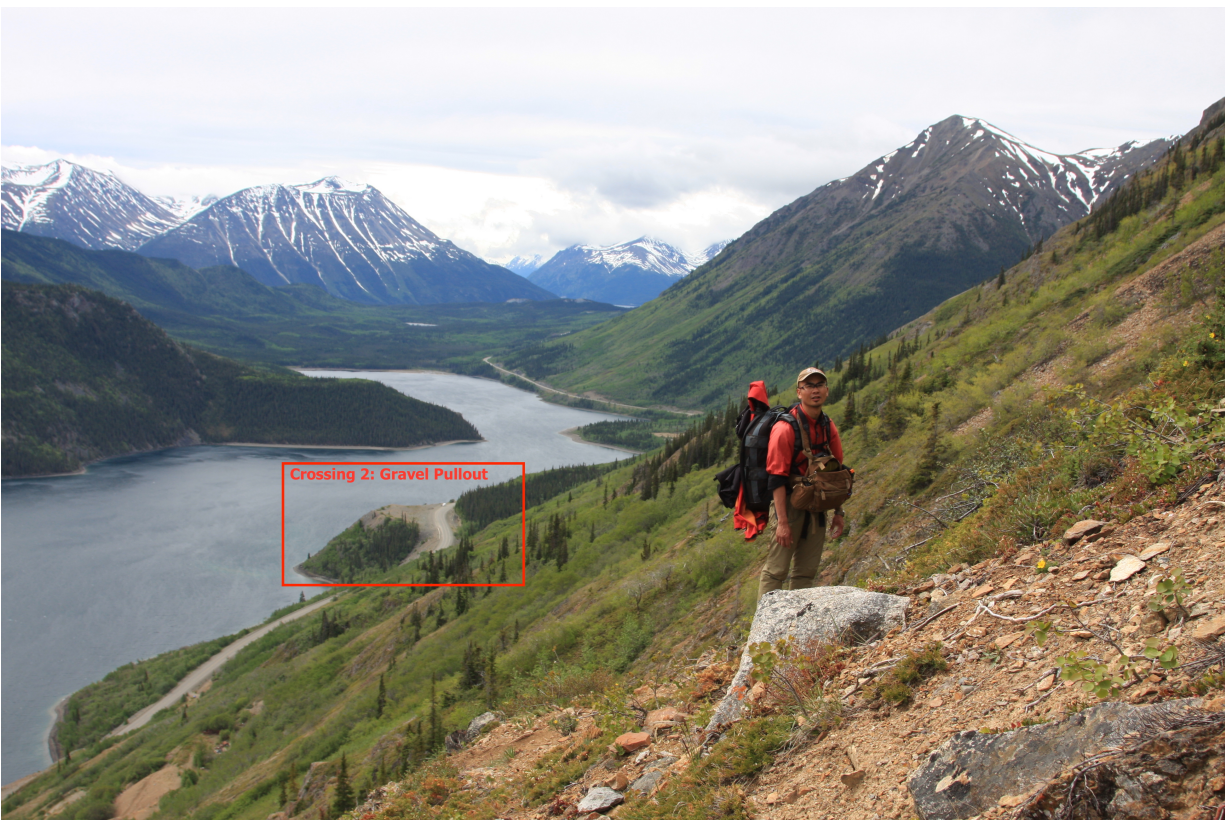
Figure 5 Crossing 2 area boxed in red in distance at gravel pullout.

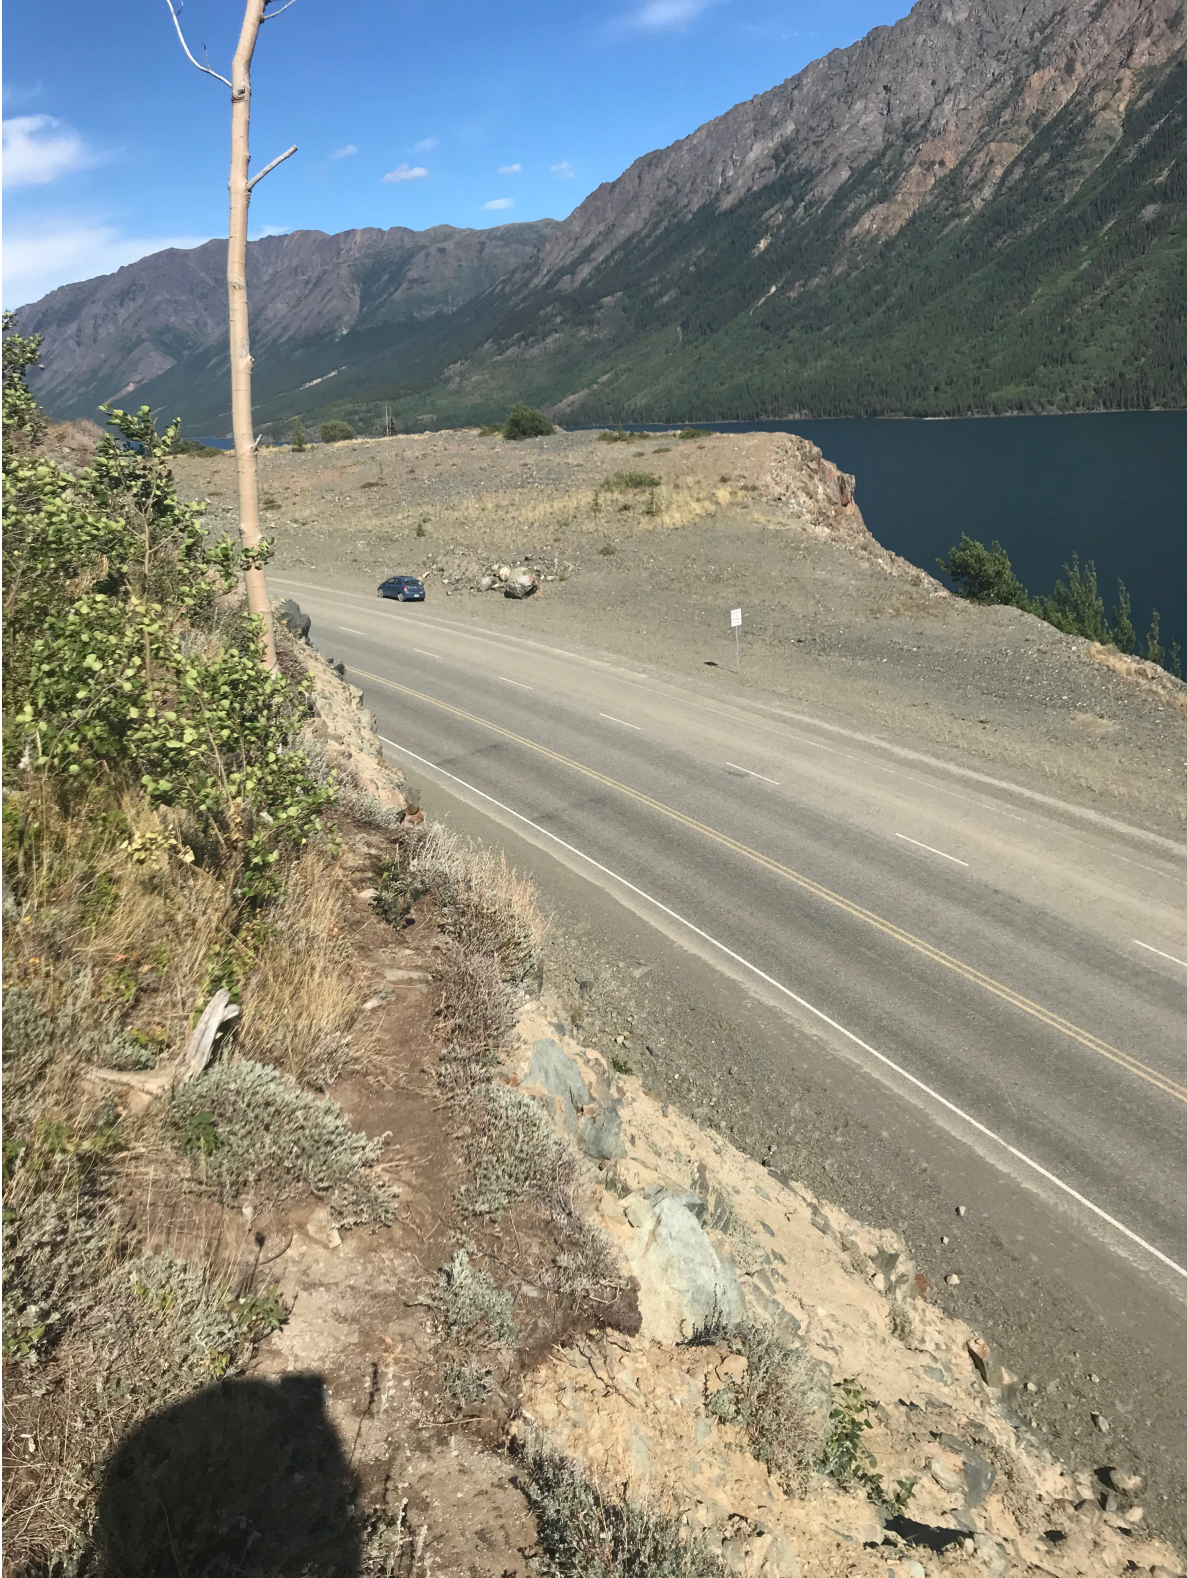
Figure 6 Gravel pullout at Crossing 2 as viewed from a mountain goat trail above the highway.

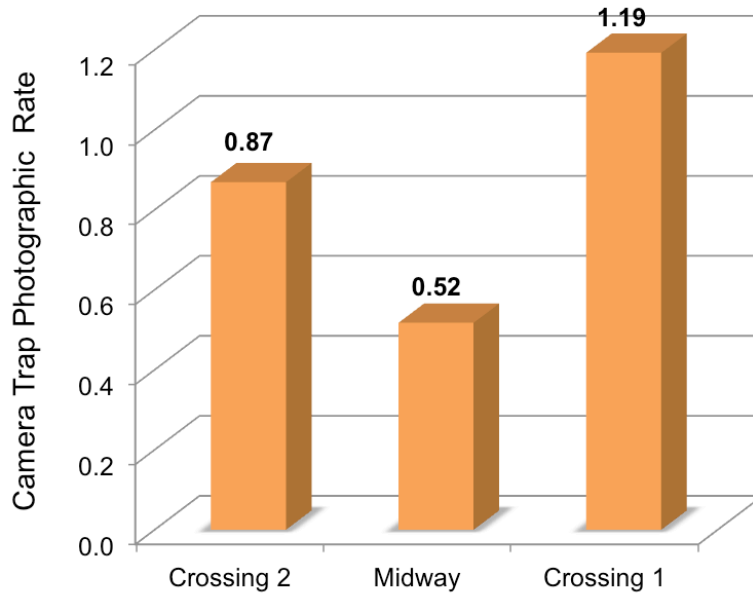
Figure 11 Camera trap photographic rates at and between crossings suggestive of relatively more mountain goat activity at Crossing 1 than Crossing 2. Figure is ordered by location on the highway from left to right indicating south (Crossing 2) to north (Crossing 1).

On the basis of camera trap (CT) photographic rates, Crossing 1 had more mountain goat activity than Crossing 2 (Fig. 11). More targeted study would ideally be conducted to confirm this by installing the same number of CTs that run uninterrupted from early May until early September in all three areas simultaneously (with the midway area acting as a kind of control for comparison).

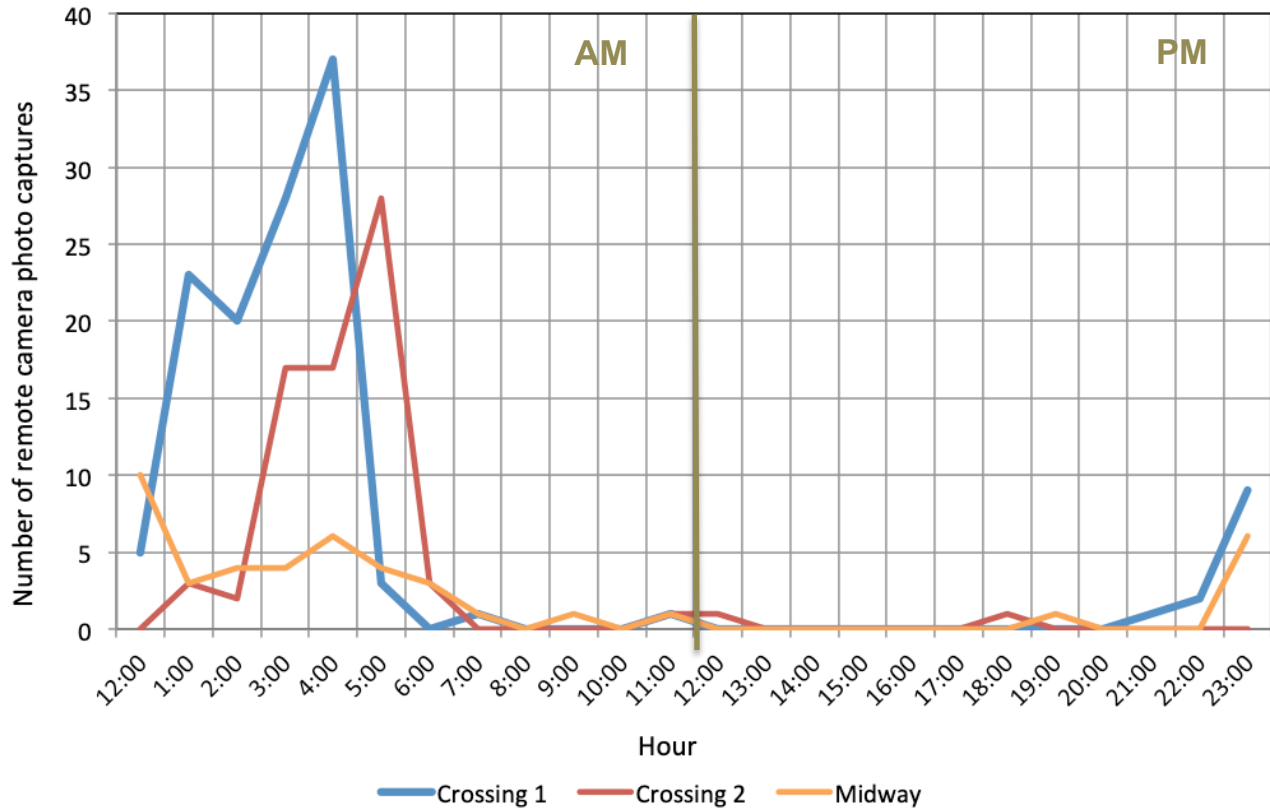
Figure 13 Number and times of day that mountain goats were captured by CTs at the two crossings and midway. Peak movement times were between midnight and 6 AM.

According to our CT data (and consistent with our opportunistic observations), mountain goats were moving between 11 PM and 6 AM (Fig. 13), thus avoiding high traffic volumes when crossing the road (as do wildlife elsewhere for example in West Glacier, Montana; Roesch, 2010; Waller & Servheen, 2005).

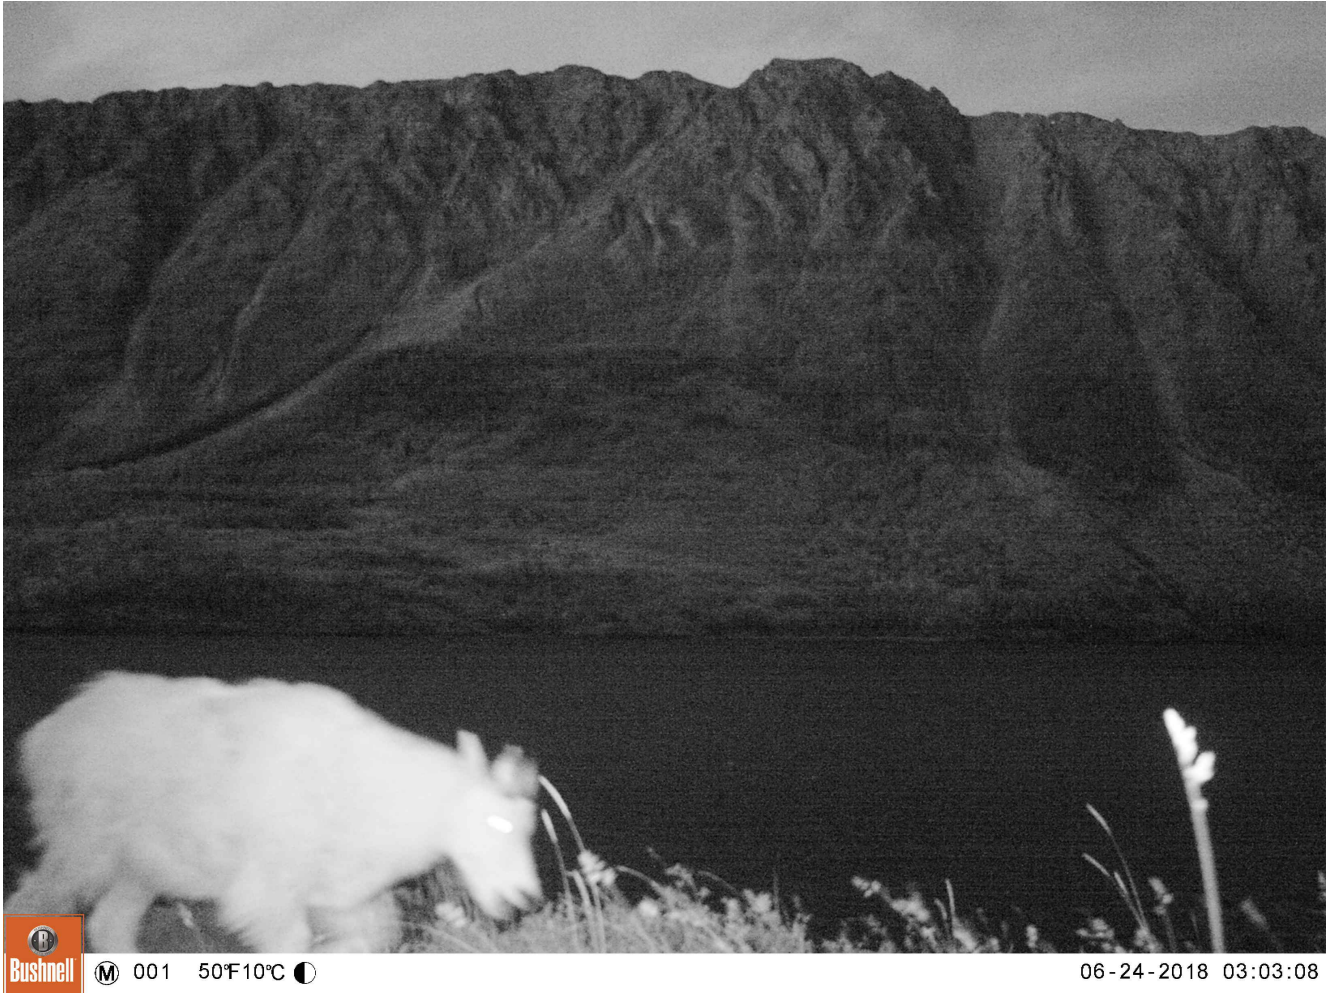
Figure 14 Mountain goat captured at 3 AM on June 24, 2018 by a remote camera tied to the highway barrier near Crossing 1 above the beach at Pooly Point. This individual had already crossed the highway and moved through the highway barrier break point, then swung right and moved alongside the outside of the barrier above the lake.

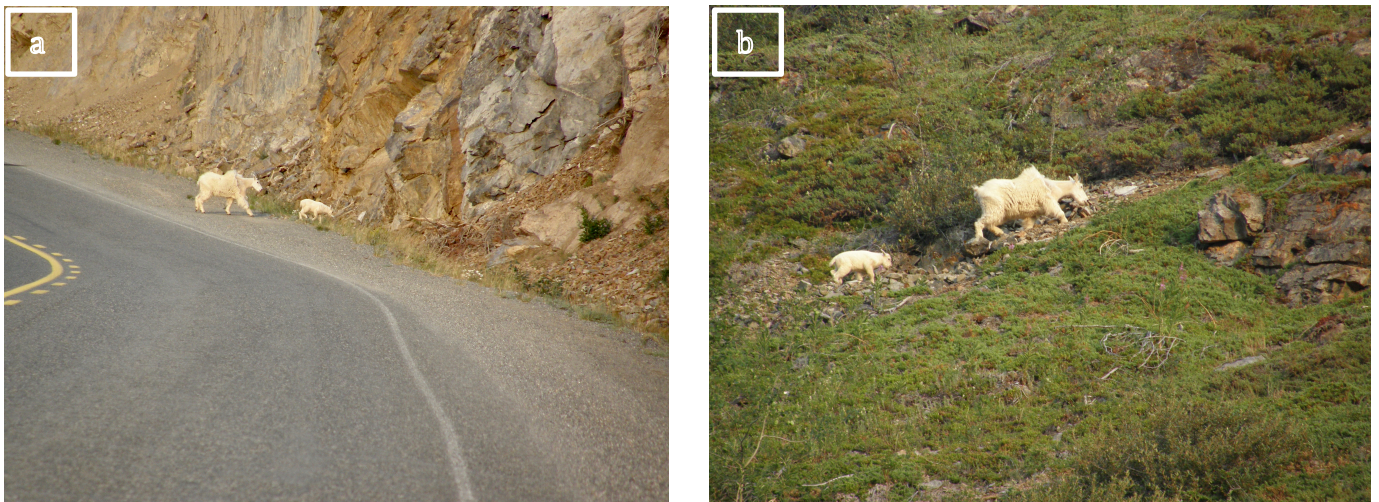
Figure 22 a-b A nanny and kid along the Klondike Highway (a) scamper quickly upslope (b) at the sight of a vehicle. Photo Credit: Jacqueline St. Jacques

Another local person, Jacqueline St. Jacques, convinced highway authorities to leave the barrier open where mountain goats cross the highway near the Pooly property. She also asked a trucker friend if he has noticed any changes in habits of the mountain goats since the highway was first built and he said no. "The goats still come down for water in the evenings, and early mornings, never during the day. I have had to go up the road twice this week at 5-5:30 AM and have seen goats both times...to the north and south of the Pooly property driveway. As soon as they hear/see your vehicle they go running across the highway and up the mountain" (Fig. 22a-b shows escape response to vehicle).

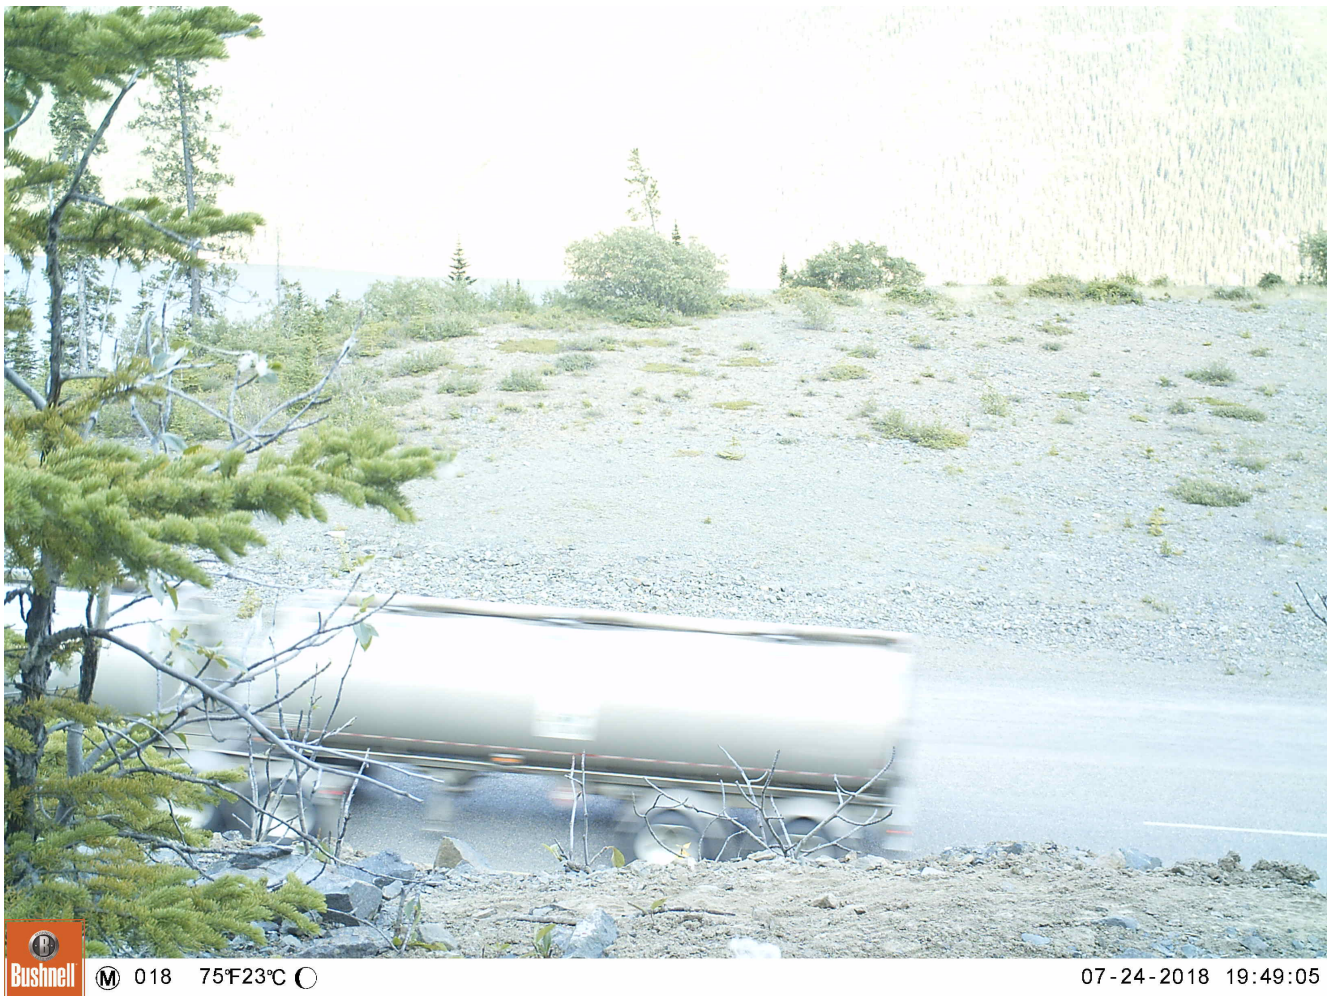
Figure 23 Large truck caught on our camera trap opposite the gravel pullout at Crossing 2.

Two hazards that characterize this stretch of road are blind spots and large trucks (Figs. 23-24).

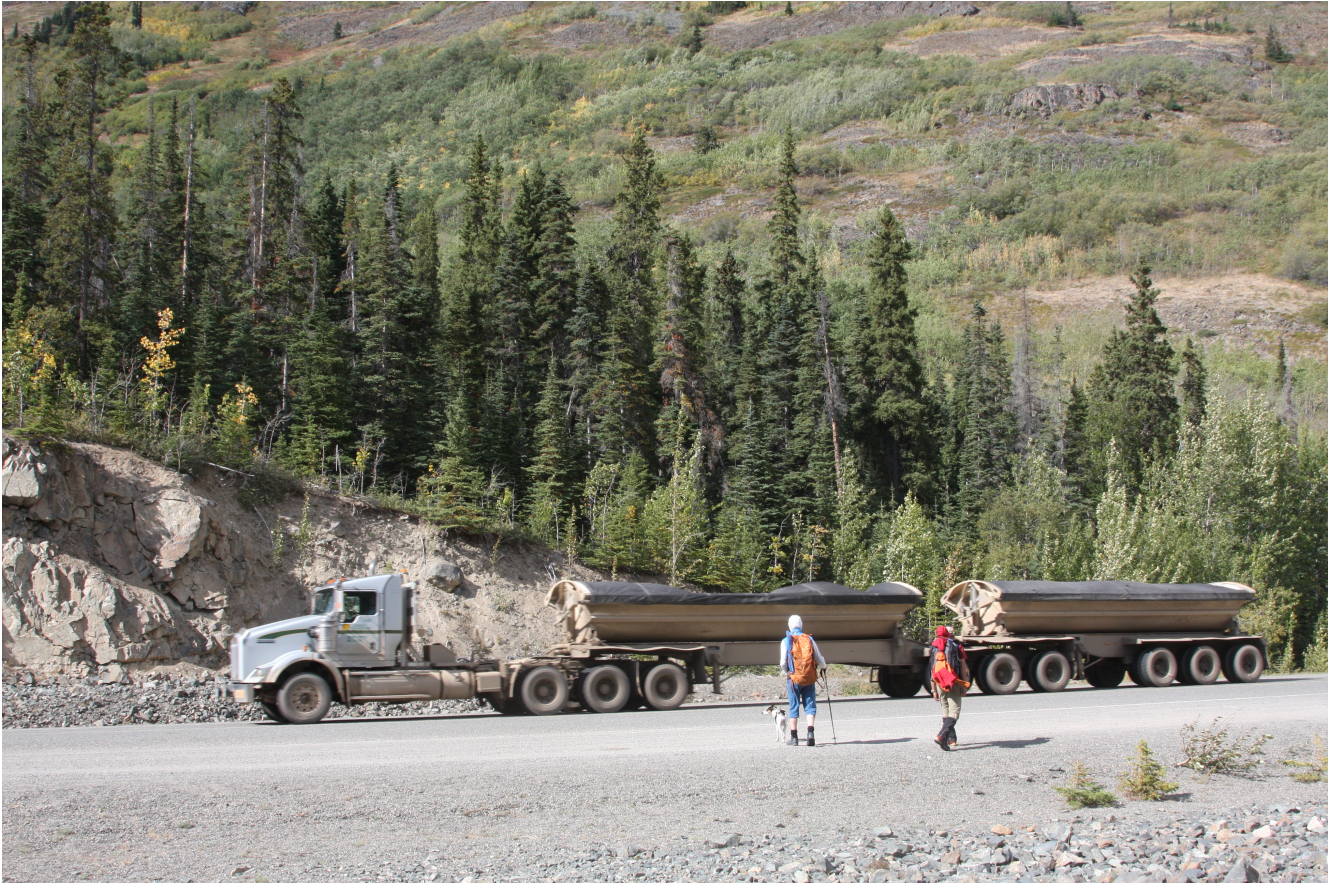
Figure 24 Truck at Crossing 2 in late August.
