**Jackson Zoological Society, Jackson Mississippi – 2015 Master Plan**  
Building & Facility Assessment

**ENTRANCE GATE**

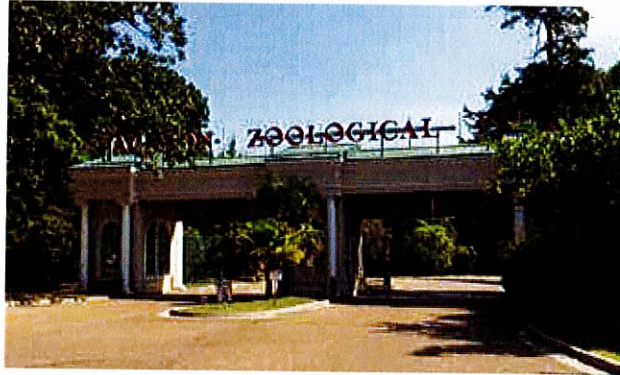
Key Plan Locator: **1**

**LOCATION:** West  
**CURRENT USE:** Park Entry  
**ORIGINAL USE:** Park Entry / Ticketing  
**ORIGINAL CONSTRUCTION DATE:** 2004  
**BUILDING AREA:**  
**CONSTRUCTION:** Metal Studs/ EIFS,  
Metal Roof

- Two Ticketing Offices (100 sf each)
- Electrical Room
- Gated
- Offices currently not being used – Gates are locked at night

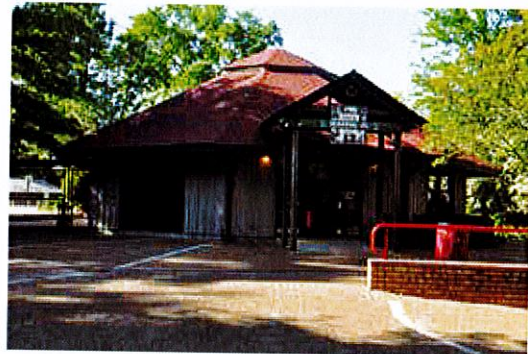
Key Plan Locator: **2**

<b>LOCATION:</b>	North
<b>CURRENT USE:</b>	Visitor Entrance & Services
<b>ORIGINAL USE:</b>	Concessions
<b>ORIGINAL CONSTRUCTION DATE:</b>	1980's
<b>BUILDING AREA:</b>	2000 sf
<b>CONSTRUCTION:</b>	Wood Frame, Asphalt Roof Shingles, Open Structure in the Gift Shop
<b>HVAC SYSTEM:</b>	Split System

- Lighting is not adequate
- Dated interior finishes
- Need more space for gift shop and storage
- Desire for gift shop and admissions to be separated

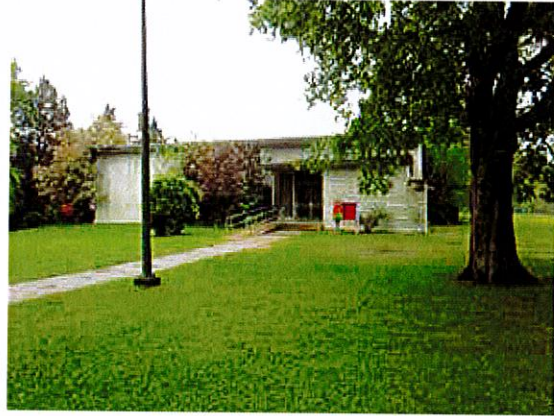
Key Plan Locator: **3**

**CONSTRUCTION:** Wood Frame with brick and stone veneer  
Wood Frame single slope roof structure with built-up roof  
Acoustical Tile Ceiling

- Needs new roof
- Finishes are old and need replacing
- Restrooms need to be upgraded

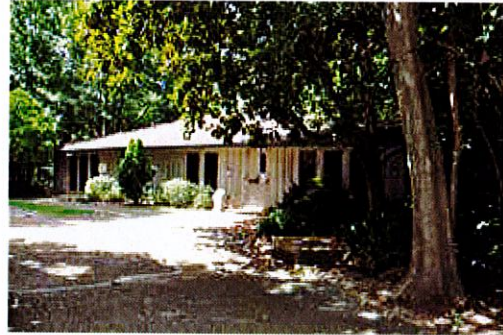
Key Plan Locator: **4**

**CONSTRUCTION:** Wood Frame with CMU walls at animal holding areas  
Wood Frame roof with asphalt shingles  
Board and Batten siding

- Roof needs replacing, including wood fascia boards
- Addition is separating from original building causing possible rodent intrusion
- HVAC is not working adequately, staining around vents and possible rats nest at diffusers
- Return Air vent is in storage room
- Continuing problem with doors rusting at holding area
- Antiquated electrical panel and system
- Quarantine needs to be stand alone structure

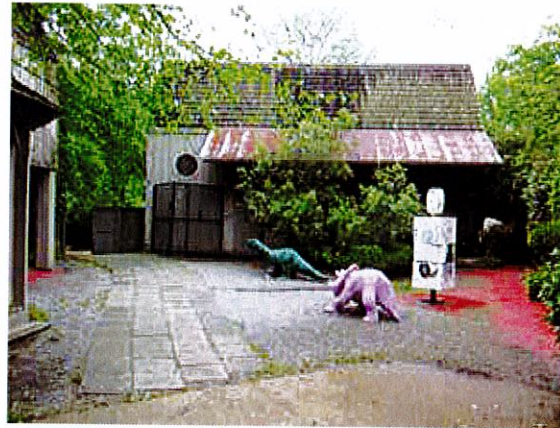
Key Plan Locator: **6**

**CONSTRUCTION:** Heavy timber post system with structural tongue and groove roof decking with wood shingle roof Board and batten siding

- Roof needs replacing immediately, roof is actively leaking
- Board and batten siding is experiencing dry rot and decaying in areas most vulnerable to exposure to the elements
- Despite water damage, building is in good structural condition
- Where addition meets main building, building siding and roof have serious wood decay

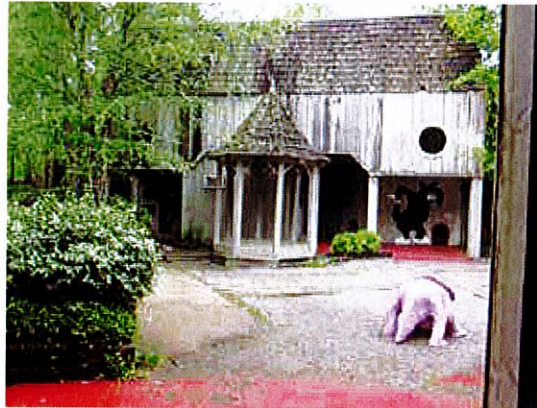
Key Plan Locator: **7**

**CONSTRUCTION:** Heavy timber post system with structural tongue and groove roof decking with wood shingle roof  
Board and batten siding

- Roof needs replacing immediately, roof is actively leaking
- Board and batten siding is experiencing dry rot and decaying in areas most vulnerable to exposure to the elements
- Despite water damage, building is in good structural condition

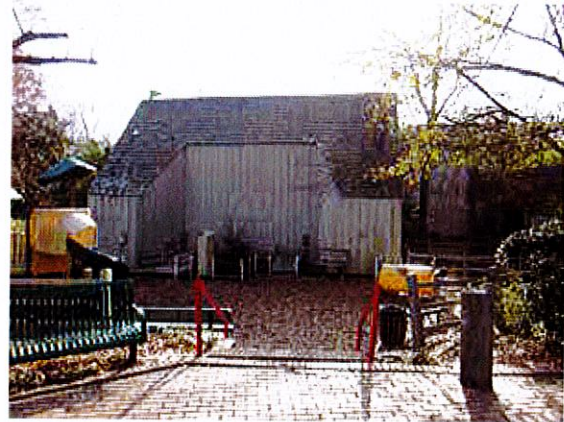
Key Plan Locator: **8**

**CONSTRUCTION:** Heavy timber post system with structural tongue and groove roof decking with wood shingle roof  
Board and batten siding

- Roof needs replacing immediately, roof is actively leaking
- Board and batten siding is experiencing dry rot and decaying in areas most vulnerable to exposure to the elements
- Despite water damage, building is in good structural condition

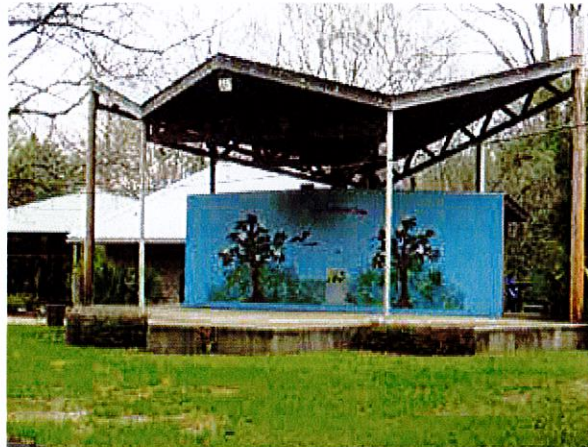
Key Plan Locator: **9**

**CONSTRUCTION:** Wood and steel columns with wood roof trusses, metal roof

- Staining at exterior wood siding at storage area and concrete stage wall

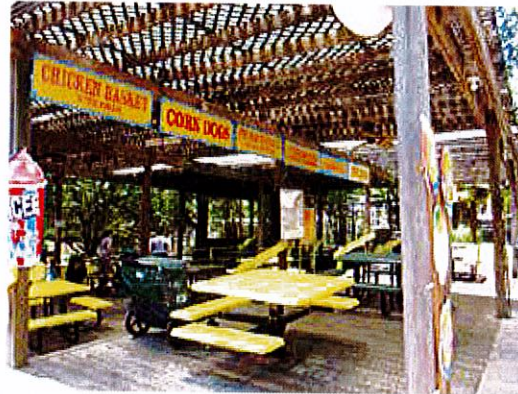
Key Plan Locator: **11**

LOCATION:	Central
CURRENT USE:	Eating Pavilion
ORIGINAL USE:	Eating Pavilion
ORIGINAL CONSTRUCTION DATE:	1990's
BUILDING AREA:	
CONSTRUCTION:	Wood
HVAC SYSTEM:	None

- Needs maintenance and general improvements
- Dated structure

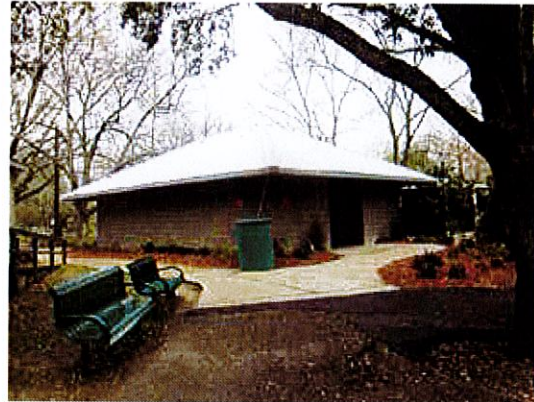
Key Plan Locator: **12**

**LOCATION:** Central  
**CURRENT USE:** Restrooms  
**ORIGINAL USE:** Restrooms  
**ORIGINAL CONSTRUCTION DATE:** 2011  
**BUILDING AREA:** 850 sf  
**CONSTRUCTION:** Concrete block walls with wood framed roof structure with metal roof  
**HVAC SYSTEM:** Exhaust

- Poor lighting

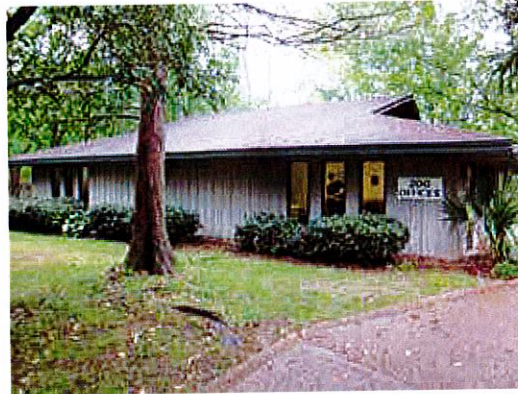
Key Plan Locator: **14**

**CONSTRUCTION:** Wood framed with board and batten siding and asphalt shingle roof

- Antiquated electrical system
- Office space is maxed
- Finishes are outdated
- Roof is wearing

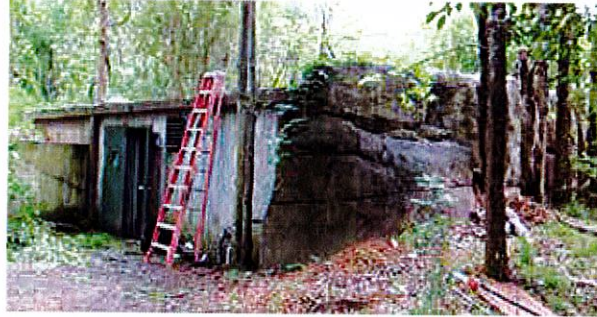
Key Plan Locator: **16**

**CONSTRUCTION:** Poured in place concrete with rockwork at exterior, membrane roof

- Membrane Roof needs replacing
- Waterfall does not work
- Skylights are broken
- Lighting is poor
- Hard to get in and out of exhibit
- Needs continual loop (currently there are two ways to exhibit opening)
- Poor drainage
- No easy way to accommodate big enrichment into exhibit
- There is no outdoor holding
- Building shifts (possible soil conditions) and doors are continually stuck
- Use Fan for cooling – not adequate

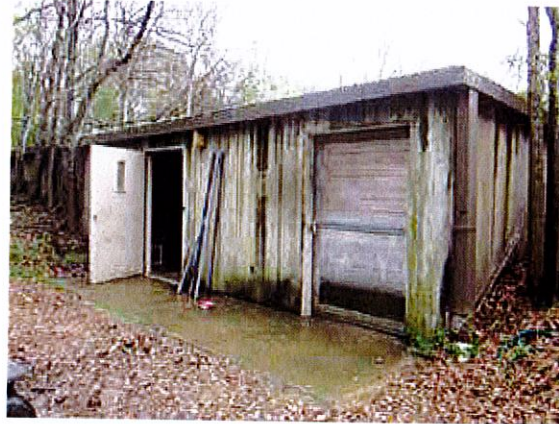
Key Plan Locator: **17**

**CONSTRUCTION:** Poured in place concrete with rockwork at exterior, membrane roof

- Ceiling is low for Rhino
- Lighting is low
- Membrane roof needs to be replaced

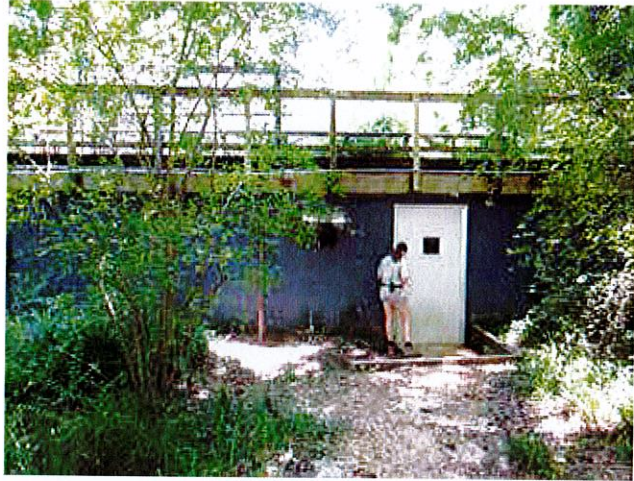
Key Plan Locator: **19**

**CONSTRUCTION:** Concrete Block walls  
with wood framed  
with membrane

- Concrete block is broken at bolts
- Shifting, doors do not operate properly
- Loud, due to visitors walking above at boardwalk
- Standing water at roof – needs new roof – hard to replace due to boardwalk
- Difficult to get large enrichment into exhibit
- Rat problem – holes in ceiling

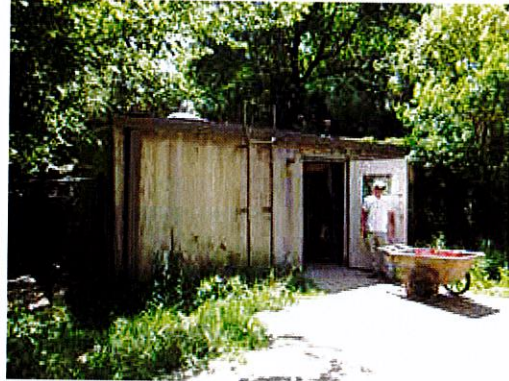
Key Plan Locator: **20**

**CONSTRUCTION:** Concrete walls with concrete roof with membrane

- Pools have drainage problems
- Problems with electrical doors
- Humidity problem

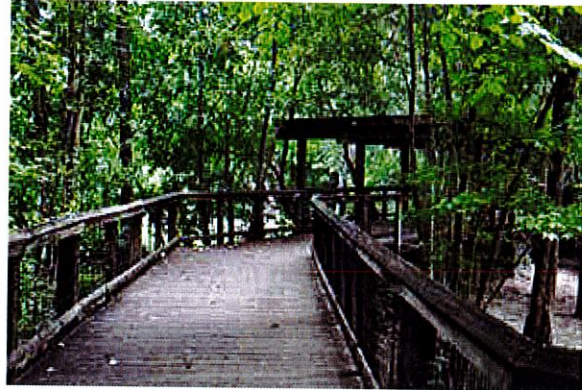
Key Plan Locator: **21**

**CONSTRUCTION:** Wood

- Deteriorated / damaged boards and railing need replacing
- General maintenance needed

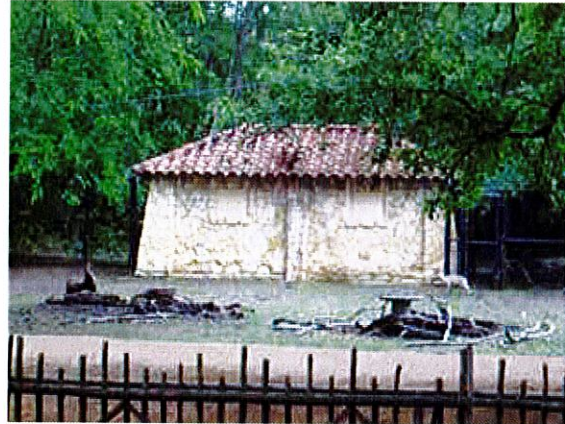
Key Plan Locator: **22**

**LOCATION:** South – Africa Savannah  
**CURRENT USE:** Animal Holding  
**ORIGINAL USE:** Animal Holding  
**ORIGINAL CONSTRUCTION DATE:** 1940's  
**BUILDING AREA:** 500 sf  
**CONSTRUCTION:** Tishamingo Stone Walls  
with wood rafters and  
clay tile roof  
**HVAC SYSTEM:** None

- \*Historic Importance
- No floor drains, concrete slab slopes to drain to exterior

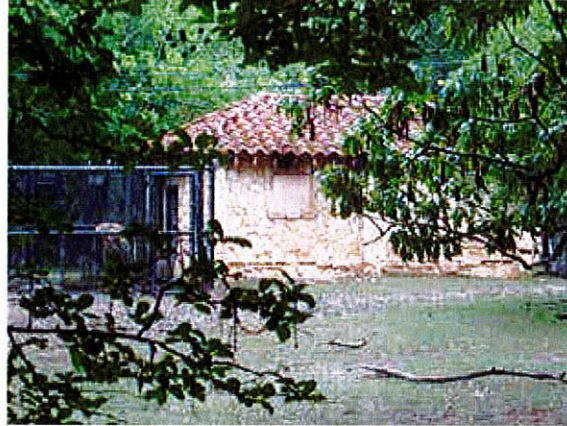
Key Plan Locator: **23**

**LOCATION:** South – Africa Savannah  
**CURRENT USE:** Animal Holding  
**ORIGINAL USE:** Animal Holding  
**ORIGINAL CONSTRUCTION DATE:** 1940's  
**BUILDING AREA:** 500 sf  
**CONSTRUCTION:** Tishamingo Stone Walls  
with wood rafters and  
clay tile roof  
**HVAC SYSTEM:** None

- \*Historic Importance
- No floor drains, concrete slab slopes to drain to exterior

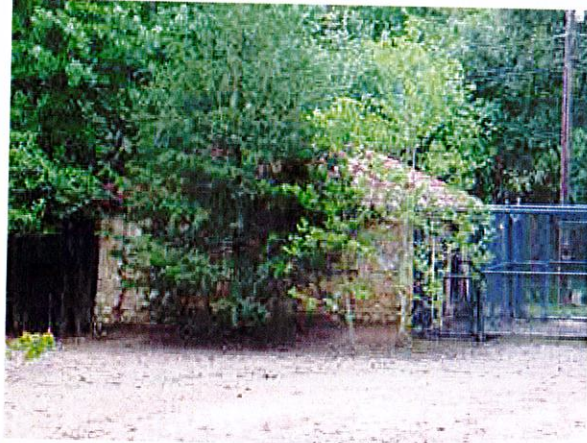
Key Plan Locator: **24**

**LOCATION:** South – Africa Savannah  
**CURRENT USE:** Animal Holding  
**ORIGINAL USE:** Animal Holding  
**ORIGINAL CONSTRUCTION DATE:** 1940's  
**BUILDING AREA:** 500 sf  
**CONSTRUCTION:** Tishamingo Stone Walls with wood rafters and clay tile roof  
**HVAC SYSTEM:** None

- \*Historic Importance
- No floor drains, concrete slab slopes to drain to exterior

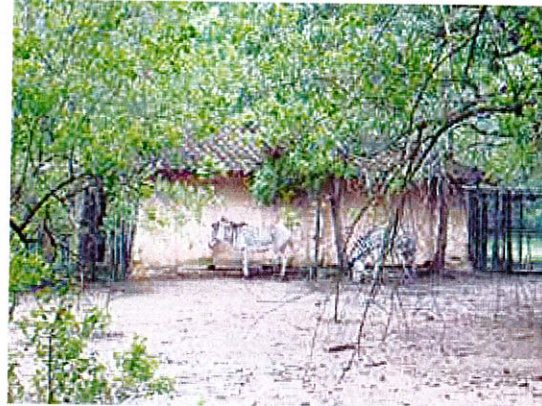
**CONSTRUCTION:** Tishamingo Stone Walls  
with wood rafters and clay  
tile roof

- No floor drains, concrete slab slopes to drain to exterior
- Shifting is inadequate for zebra
- Minor cracking in mortar joints
- Plaster enclosure walls are deteriorating from the bottom

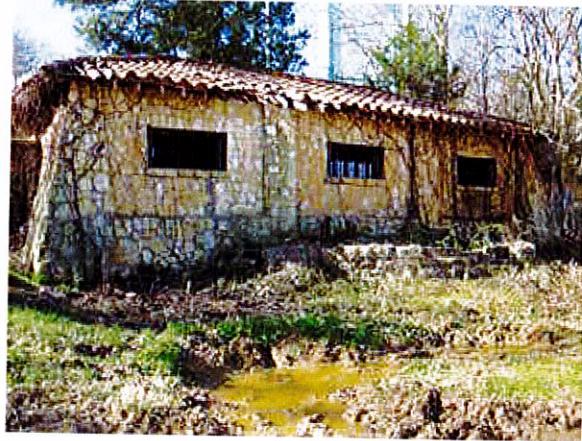
Key Plan Locator: **26**

<b>LOCATION:</b>	South – Africa
<b>CURRENT USE:</b>	Empty
<b>ORIGINAL USE:</b>	Elephant Holding
<b>ORIGINAL CONSTRUCTION DATE:</b>	1940's
<b>BUILDING AREA:</b>	1000 sf
<b>CONSTRUCTION:</b>	Tishamingo Stone Walls with wood rafters and clay tile roof
<b>HVAC SYSTEM:</b>	None

- \*Designated as Mississippi Landmark
- Currently in design phase for renovation
- Structurally in good condition

- Roof is heavily damage from vine intrusion
- Wood roof structure needs replacement in limited areas
- Stone is showing signs of previous shifting
- Drainage between buildings needs improvement
- Needs new electrical

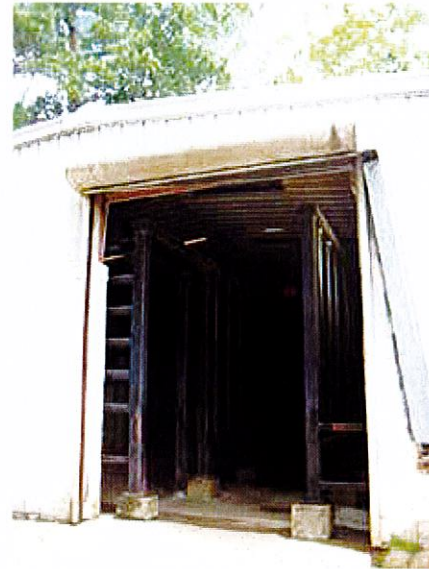
Key Plan Locator: **27**

**LOCATION:** South – Africa  
**CURRENT USE:** Rhino Holding  
**ORIGINAL USE:** Elephant Holding  
**ORIGINAL CONSTRUCTION DATE:** 1940's  
**BUILDING AREA:** 1639 sf  
**CONSTRUCTION:** Metal Building with concrete block wainscot  
**HVAC SYSTEM:** Radiant heating

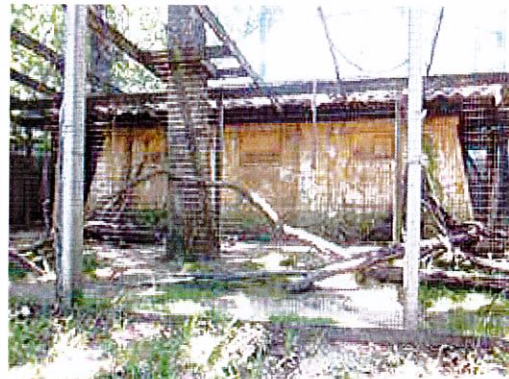
Key Plan Locator: **32**

**LOCATION:** South  
**CURRENT USE:** Lemur Holding  
**ORIGINAL USE:** Restrooms  
**ORIGINAL CONSTRUCTION DATE:** 1940's  
**BUILDING AREA:** 450 sf  
**CONSTRUCTION:** Tishamingo Stone Walls with wood rafters and clay tile roof

- Roof needs repair
- Wood roof rafters and framing need repair and paint
- Interior floor drains do not work
- Poor exterior drainage

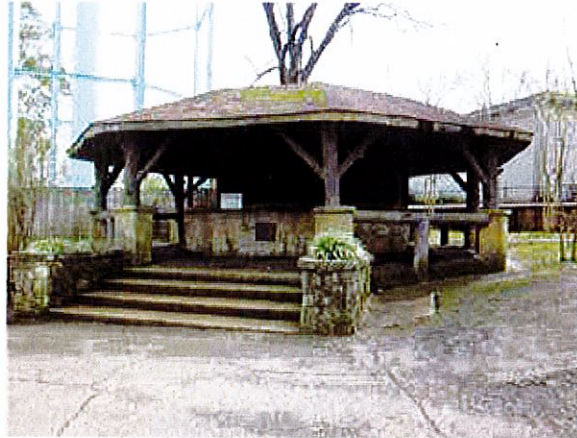
**CONSTRUCTION:** Concrete and Steel covered in gunite, asphalt roof

- Needs new roof
- No drainage system
- Skylight is broken
- Needs new caging
- Fascia Boards needs repair/replacement

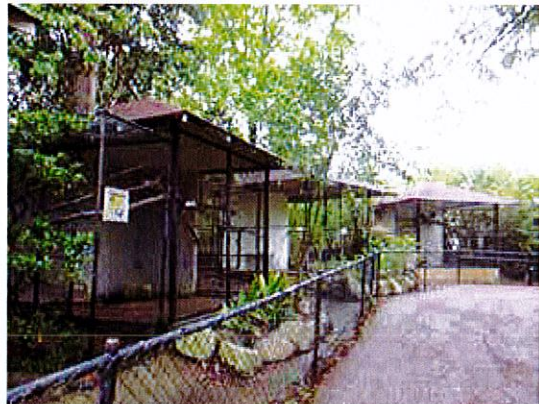
Key Plan Locator: **34**

**LOCATION:** West  
**CURRENT USE:** Bird Exhibit  
**ORIGINAL USE:** Bird Exhibit  
**ORIGINAL CONSTRUCTION DATE:** 1964  
**BUILDING AREA:**  
**CONSTRUCTION:** Gunite and Chainlink

- No holding for sick birds
- No drainage
- No pools
- Difficult to bring in large enrichment / limbs due to no access

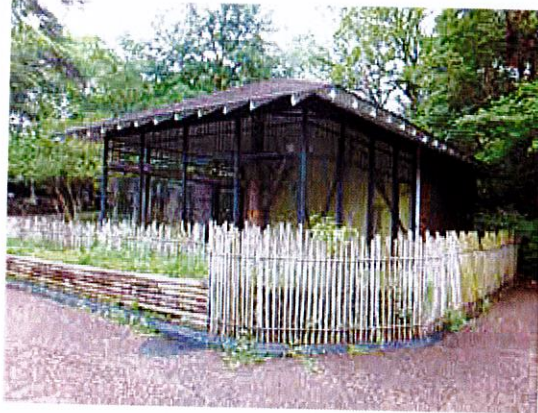
**CONSTRUCTION:** Concrete Block with Skim coat, Wood Framed Roof, asphalt shingles, chain link

- No Water System
- Roof is wearing

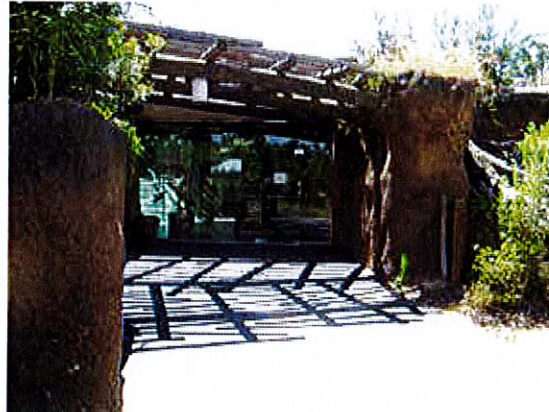
Key Plan Locator: **36**

**LOCATION:** West – Mississippi  
**CURRENT USE:** Holding and Exhibits  
**ORIGINAL USE:** Holding and Exhibits  
**ORIGINAL CONSTRUCTION DATE:** 2004  
**BUILDING AREA:**  
**CONSTRUCTION:** Concrete Block with concrete roof with membrane

- Drainage system for exhibits is difficult
- Many places for spider webs and dust – difficult to maintain
- Beaver viewing bubble leak
- HVAC is hard to adjust

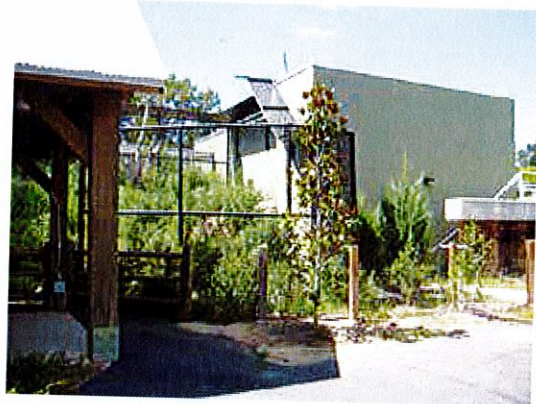
Key Plan Locator: **37**

**LOCATION:** West – Mississippi  
**CURRENT USE:** Bear Holding  
**ORIGINAL USE:** Bear Holding  
**ORIGINAL CONSTRUCTION DATE:** 2004  
**BUILDING AREA:** 1140 sf  
**CONSTRUCTION:** Concrete Block with concrete roof with membrane  
**HVAC SYSTEM:** split system

- 3 bedrooms including 1 large bedroom
- Outdoor holding

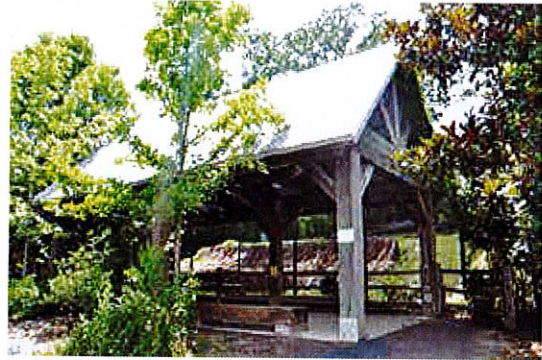
Key Plan Locator: **38**

**LOCATION:** West – Mississippi  
**CURRENT USE:** Bear Viewing  
**ORIGINAL USE:** Bear Viewing  
**ORIGINAL CONSTRUCTION DATE:** 2004  
**BUILDING AREA:** 512 sf  
**CONSTRUCTION:** Heavy Timber, Metal Roof  
**HVAC SYSTEM:**

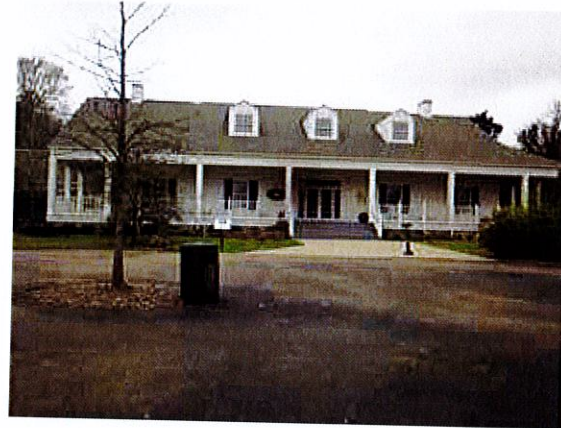
**CONSTRUCTION:** 2 story Wood Framed ,  
asphalt shingle and metal  
roof

- 3 Offices
- Conference Room
- Mechanical Room
- 2 Storage Rooms (1 could be office)
- Classroom
- Small Classroom
- Kitchen
- Security
- Old Docent Office
- Exhibit Hall

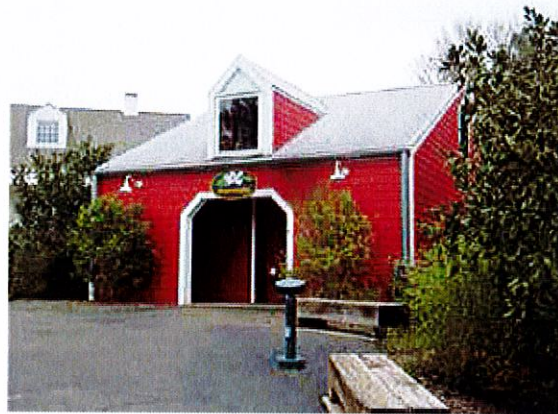
**BUILDING AREA:** 950 sf

**CONSTRUCTION:** Concrete block , wood framed roof with metal roof

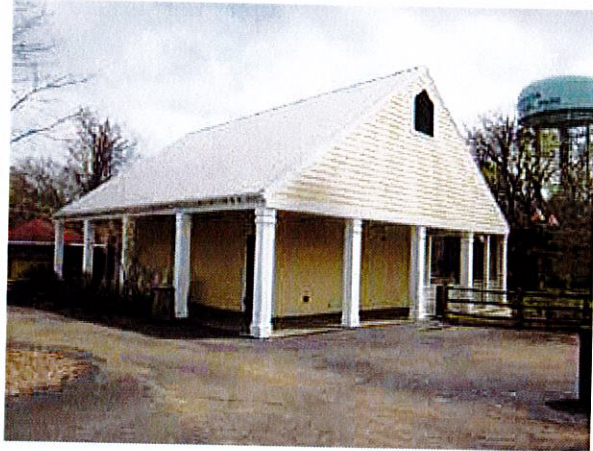
Key Plan Locator: **43**

**LOCATION:** West - Mississippi  
**CURRENT USE:** Small Habitat Holding and Exhibits  
**ORIGINAL USE:** Small Habitat Holding and Exhibits  
**ORIGINAL CONSTRUCTION DATE:** 2004  
**BUILDING AREA:** 1200 sf  
**CONSTRUCTION:** Wood framed with metal roof  
**HVAC SYSTEM:** Split system

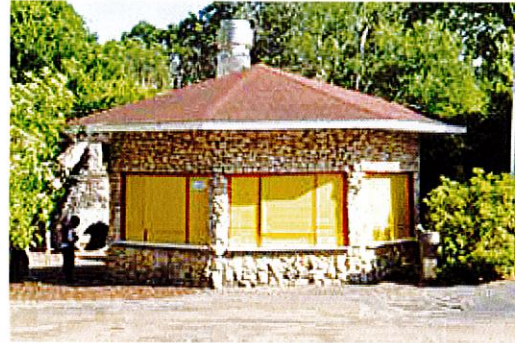
Key Plan Locator: **44**

**LOCATION:** West - Mississippi  
**CURRENT USE:** Food Service  
**ORIGINAL USE:** Concessions  
**ORIGINAL CONSTRUCTION DATE:**  
**BUILDING AREA:** 300 sf  
**CONSTRUCTION:** Wood post with stone veneer and wood framed roof with asphalt shingles  
**HVAC SYSTEM:** Window unit

- Roof is wearing
- Waterline to service building needs work
- Small electrical

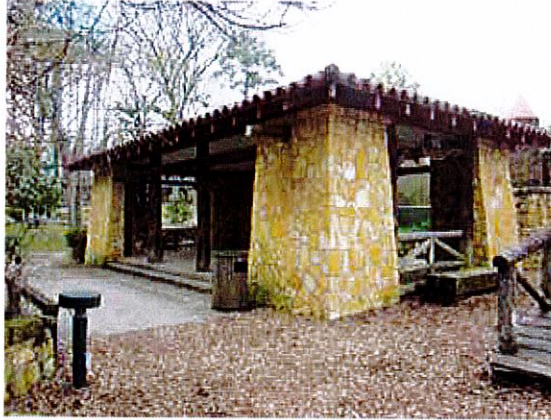
**CONSTRUCTION:** Tishamingo Stone  
Structure with wood post,  
wood framed roof and  
clay tile roof

- Heavy Termite Damage too wood post and beams (not structural)
- Lighting needs replacement
- Stone needs cleaning – general maintenance
- Roof needs cleaning – general maintenance

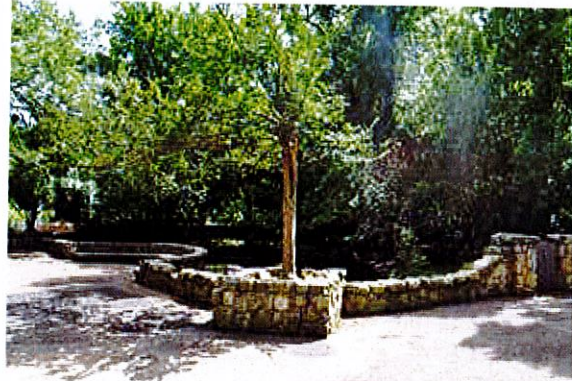
Key Plan Locator: **47**

**LOCATION:** West Central  
**CURRENT USE:** Surrounding Flamingoes and Ducks  
**ORIGINAL USE:**  
**ORIGINAL CONSTRUCTION DATE:** 1940's  
**BUILDING AREA:** 600 lf  
**CONSTRUCTION:** Stone Structure  
**HVAC SYSTEM:** None

- Damaged in some areas
- Needs cleaning and maintenance

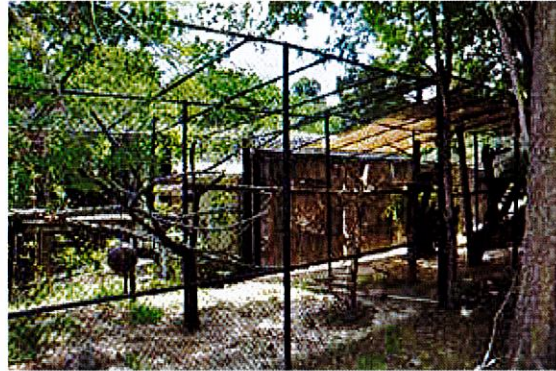
Key Plan Locator: **48**

**LOCATION:** Central - Asia  
**CURRENT USE:** Leopard Holding  
**ORIGINAL USE:** Leopard Holding  
**ORIGINAL CONSTRUCTION DATE:** 2013  
**BUILDING AREA:** 670 sf  
**CONSTRUCTION:** Concrete block, fully grouted with concrete roof with membrane

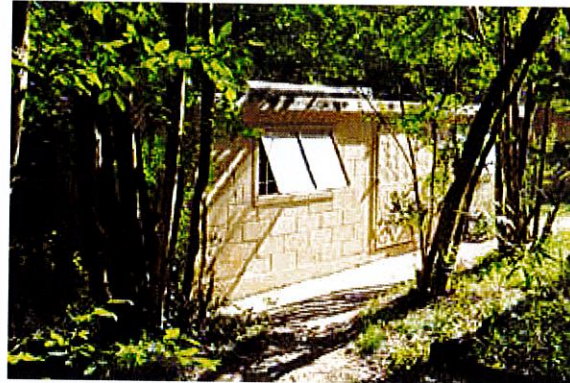
Key Plan Locator: **50**

**LOCATION:** Central – Asia  
**CURRENT USE:** Fishing Cat Holding  
**ORIGINAL USE:**  
**ORIGINAL CONSTRUCTION DATE:** Renovations in 2013  
**BUILDING AREA:** 260 sf  
**CONSTRUCTION:** Concrete block with concrete roof

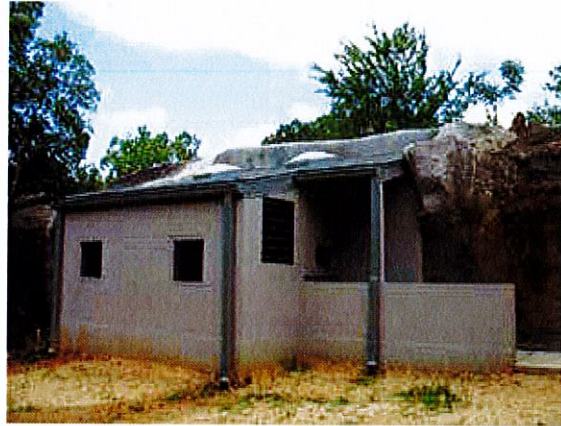
Key Plan Locator: **52**

**LOCATION:** Central – Asia  
**CURRENT USE:** Orangutan Holding  
**ORIGINAL USE:** Animal Holding  
**ORIGINAL CONSTRUCTION DATE:** 1960's with  
keeper addition in 2008  
**BUILDING AREA:**  
**CONSTRUCTION:** Gunitite / addition is  
Concrete block with metal  
roof  
**HVAC SYSTEM:** Gas Furnace – forced air

- Inadequate for shifting orangutans and breeding process
- Dark
- Gunitite work is brittle
- Does not meet current standards
- Floor is too slippery
- Too Hot in summer
