# *Reliable Home Inspections*

## Property Inspection Report

Inspection prepared for:  
Date of Inspection: 6/17/2016

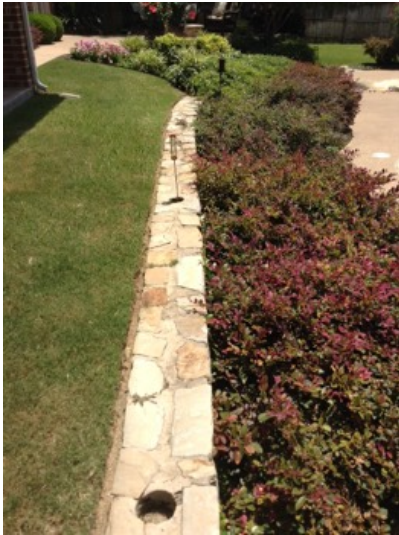
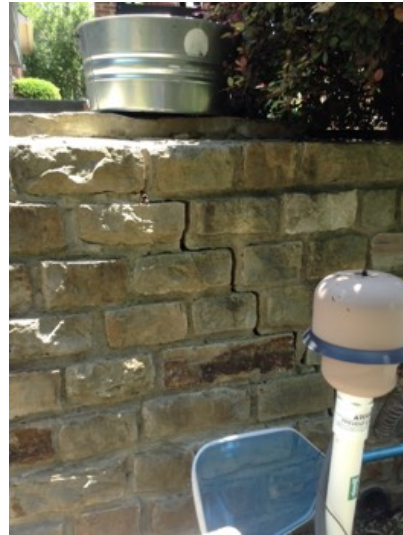
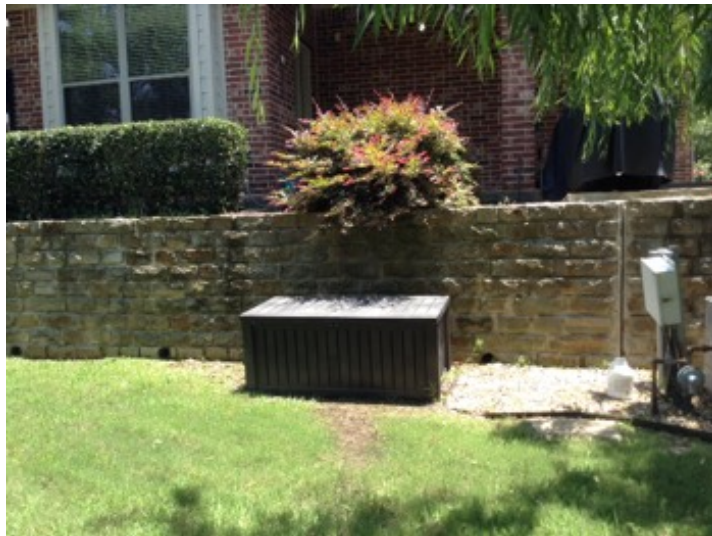
B.3. The retaining wall has a large crack near the pool equipment. This should be repaired by a qualified contractor.

B.4. Due to the height of the retaining wall a fence should be installed for safety concerns.

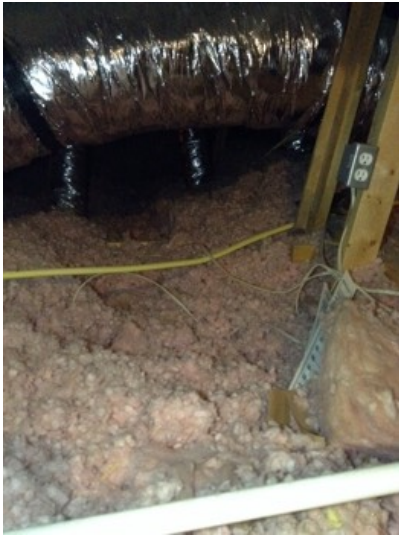
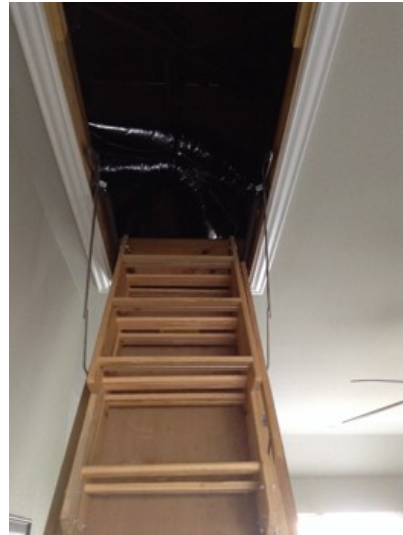
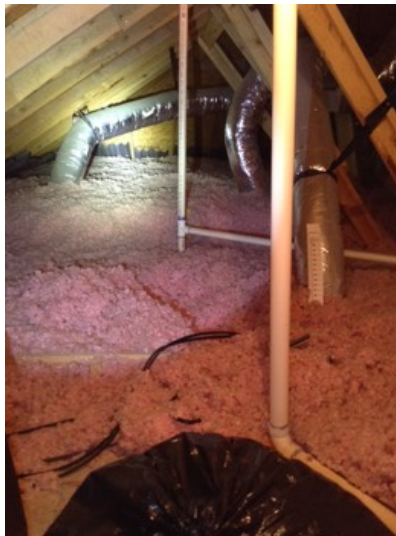
D.3. Ideally, the attic access hatch should be better insulated and weather stripped when inside the building envelope. The ladder is not cut to fit properly. This s a safety concern.

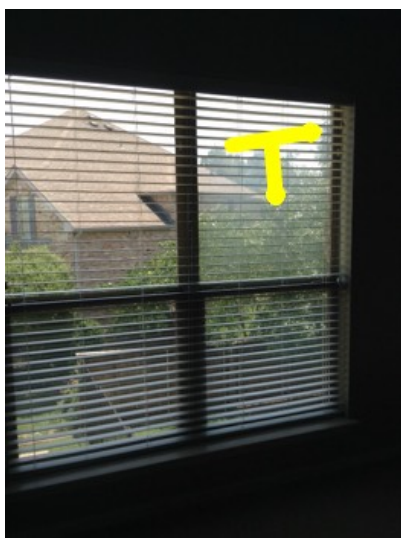
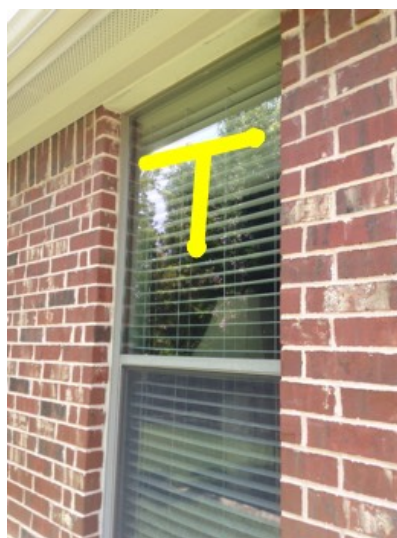
E.2. Windows have tint that has failed. The window pane will have to be replaced.

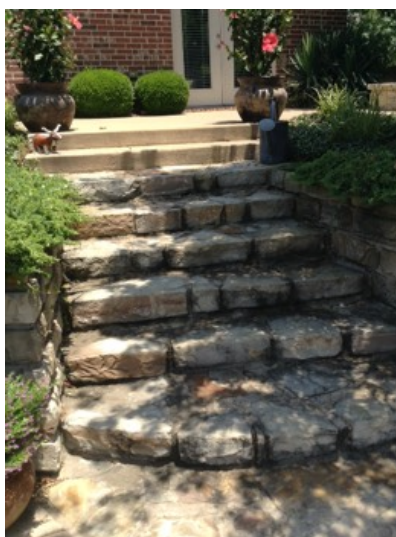
F.2. For improved safety, it is recommended that a railing be provided for the steps.

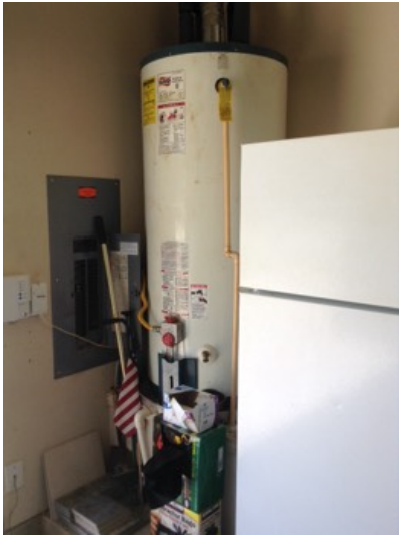
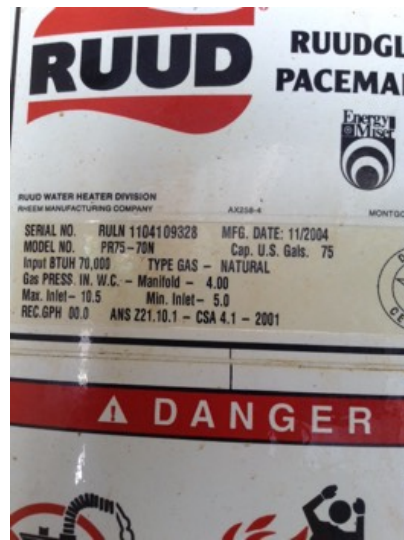
Unit is 75 gallons 2004

C.2. Water heaters have a typical life expectancy of 7 to 12 years. The existing unit is approaching this age range. One cannot predict with certainty when replacement will become necessary.

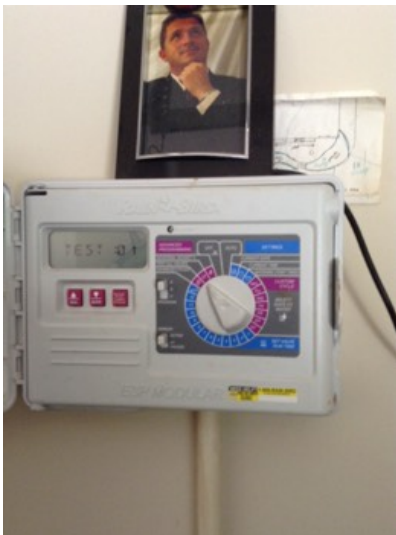
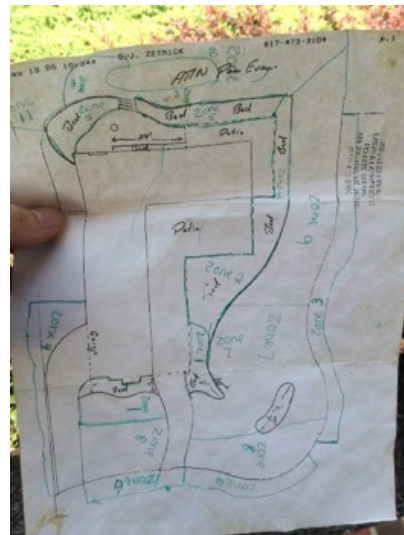
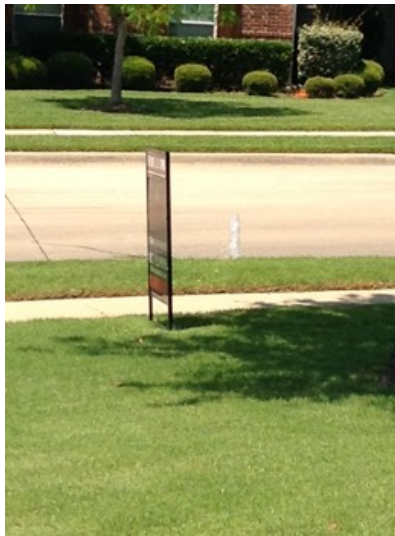
A.1. Missing sprinkler heads were noted. This condition should be remedied to ensure adequate spray coverage for the entire sprinkler system. Zone 3

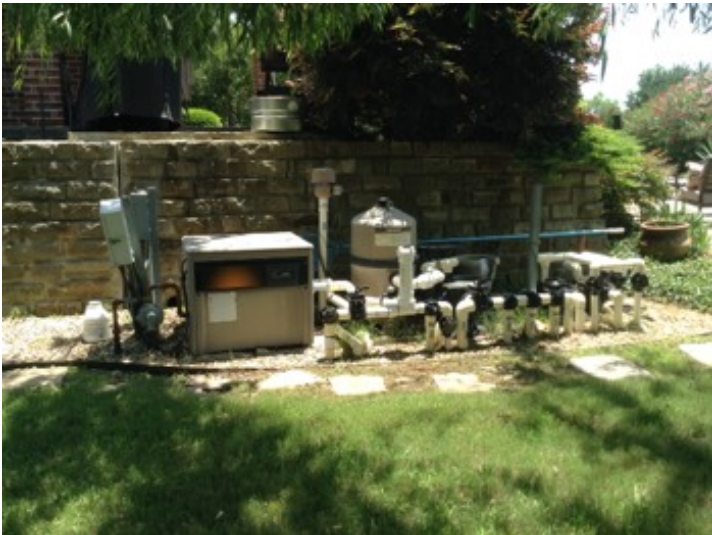
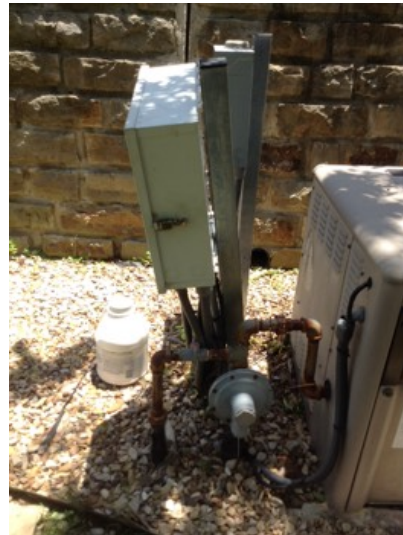
B.2. The seller stated that repairs to the pool are being scheduled. The pool heater, pool lights, support post for the control panel and the gas fire pit are part of these repairs.

B.3. The fence gate needs to be self closing and self latching.

B.4. All exterior doors to the pool require alarms that can only be turned off manually.
