7. Cleanup of Radioactive Floating Refuse at Vromos Bay

This chapter presents a case study of how Vromos Bay was restored. It describes conditions before restoration, initial restoration attempts, a major restoration project, and its results.

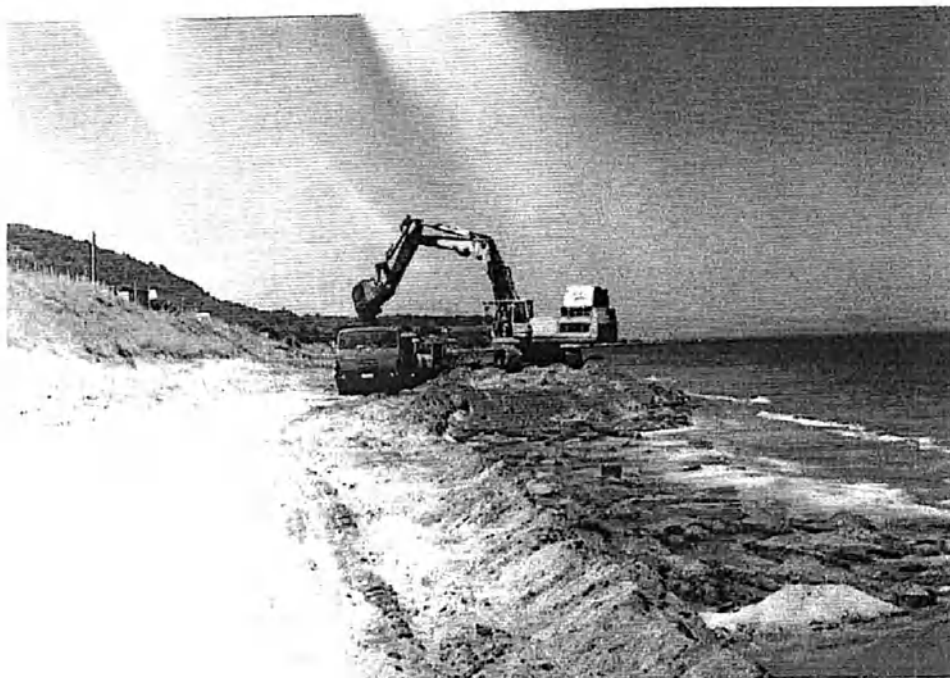
Figure 7.5 Cleaning of the beach at Vromos Bay, 1998

Cleanup of the Vromos Bay beach area started as early as September 1997 in compliance with the techniques in the project plans. The radioactive flotation tailings were collected by bulldozers, loaded onto dump trucks by front loaders and excavators (Figure 7.5), and then disposed either to the R-4 tailing dump or the Rossen Flotation Mill (see Figure 7.3). To speed the process, sand was excavated at three or four points simultaneously. This arrangement required 30 to 40 dump trucks of 14- to 16-ton capacity to be simultaneously operating.
