Date	19/05/2016
Number	0682
Pages	8

### TECHNICAL INFORMATION

MODEL	MT09 / MT09A / FZ09 / MT09TRA / FJ09
SUBJECT	CAM CHAIN TENSIONER (CCT) NOISE

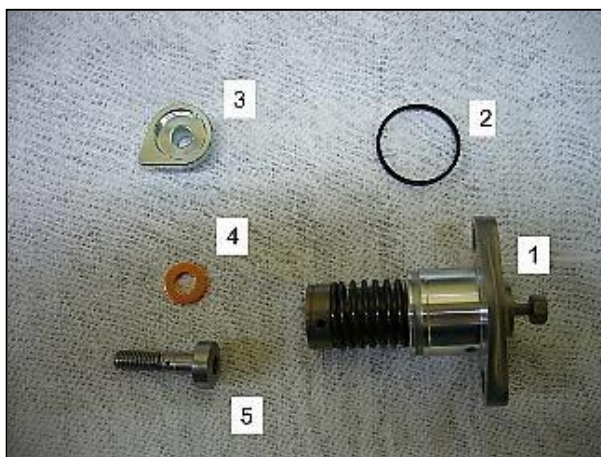
No.	Description	Code	Quantity
1	TENSIONER ASSY	1RC-12210-09	1
2	RING	1RC-14633-09	1
3	COLLAR	1RC-11478-09	1
4	GASKET	90430-006166	1
5	BOLT	1RC-12157-09	1

In case of a problem, replace the tensioner and place all the parts of improved kit.

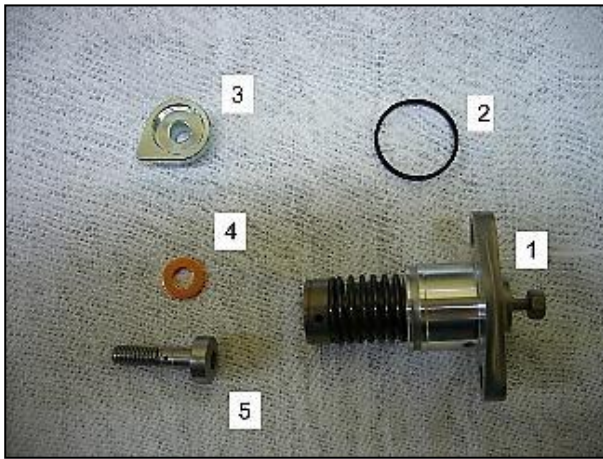
**IMPROVEMENT TENSIONER KIT 2 (P/N: 90891-10274)**

No.	Description	Code	Quantity
1	TENSIONER ASSY	1RC-12210-08	1
2	COLLAR	1RC-11478-09	1
3	GASKET	90430-06166	1
4	BOLT	1RC-12157-09	1
