YUYO PROJECT IMPLEMENTATION STAGE 1 / 3, HK 3610 TROMMEL START UP AT TAILINGS (No jig)

REF: YUYO PROJECT
10-DAY START UP OPERATIONS

FEBRUARY 8TH, 2023

FIELD REPORT

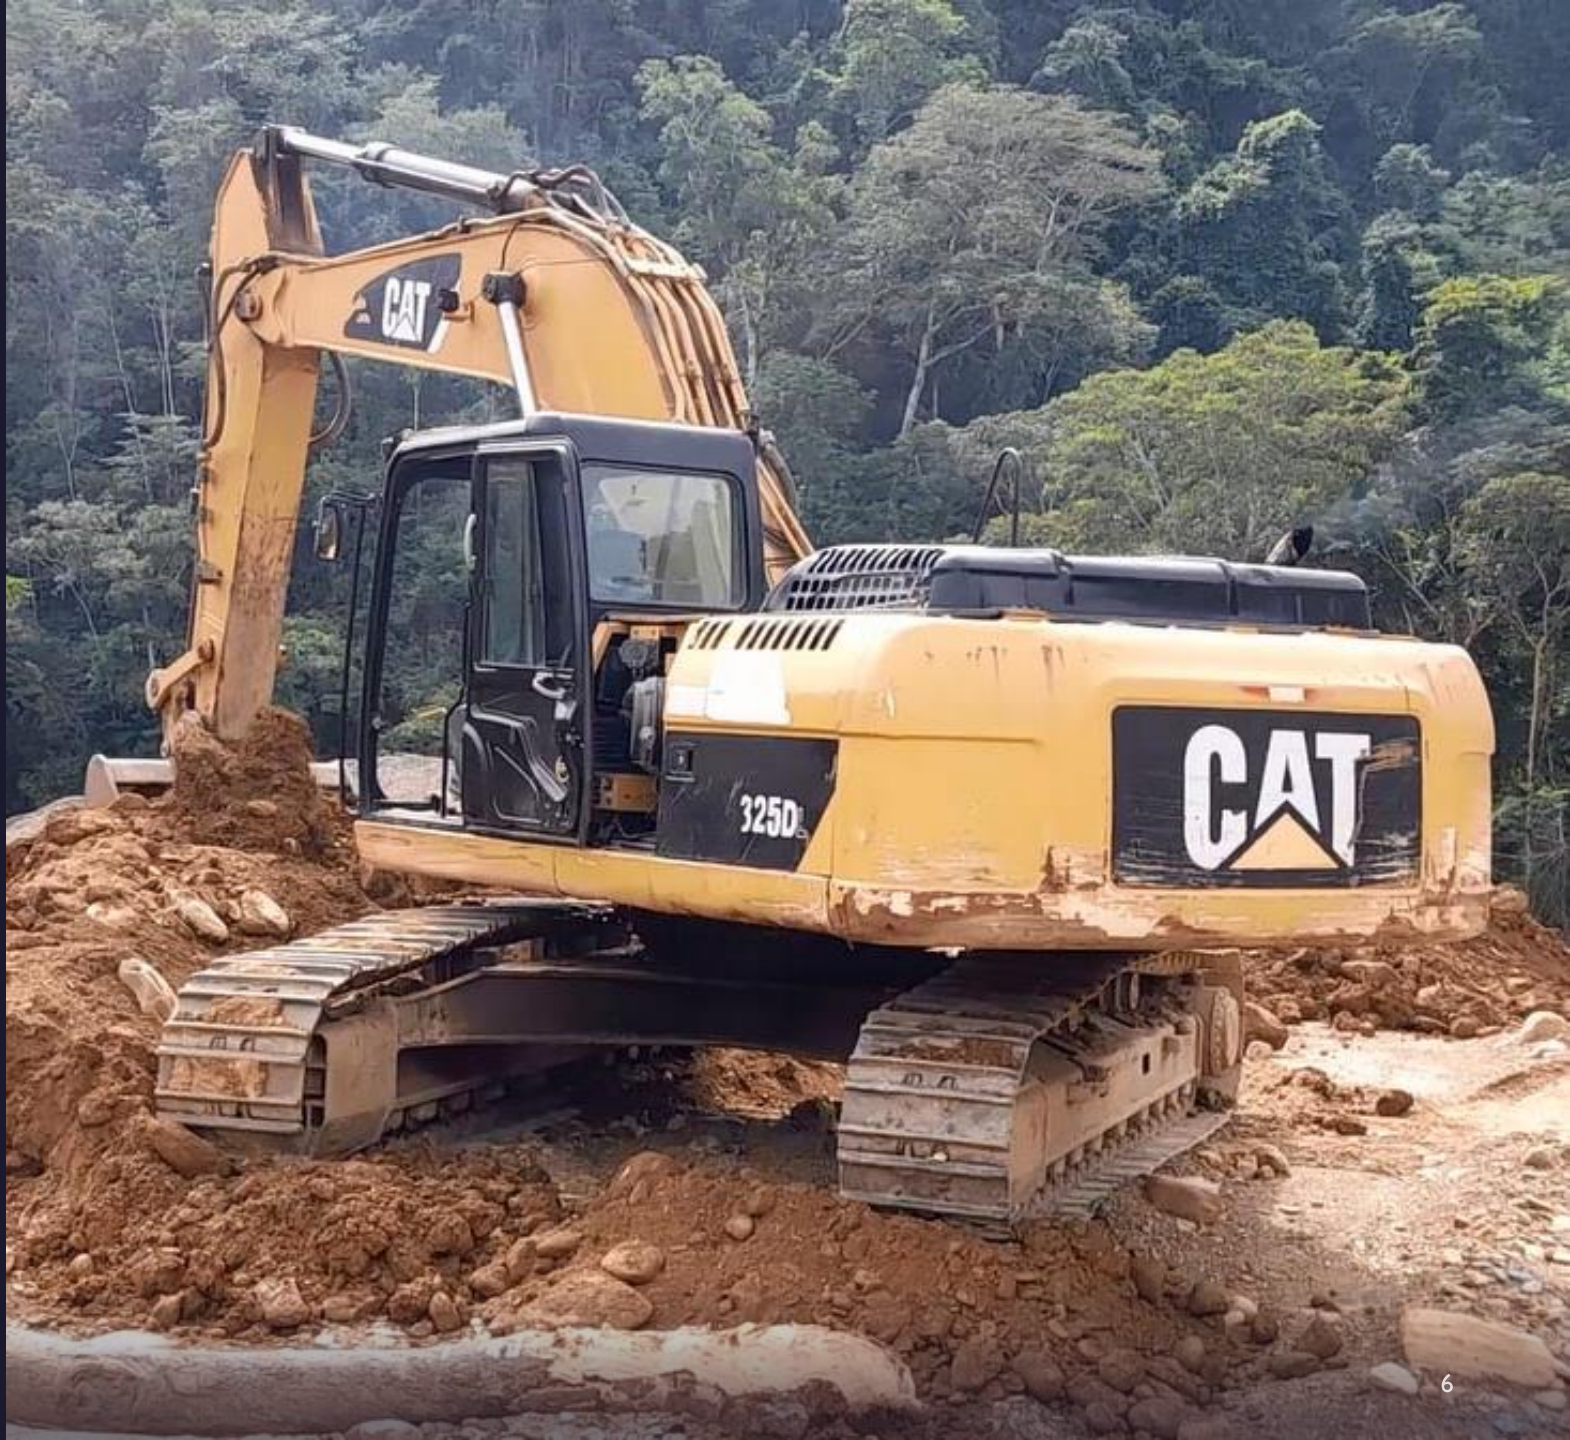
AREA SETUP

On January 29th, we only started around 8 am, due to the excavator requiring some minor repairs, mainly in one of its tracks. Once it was sorted, we finalized preparations on the working area, by constructing a water channel and a direct access ramp to the generator platform. During these two first days, the excavator also gathered tailings material into a big mound close to the trommel, in order to avoid it from moving long distances.

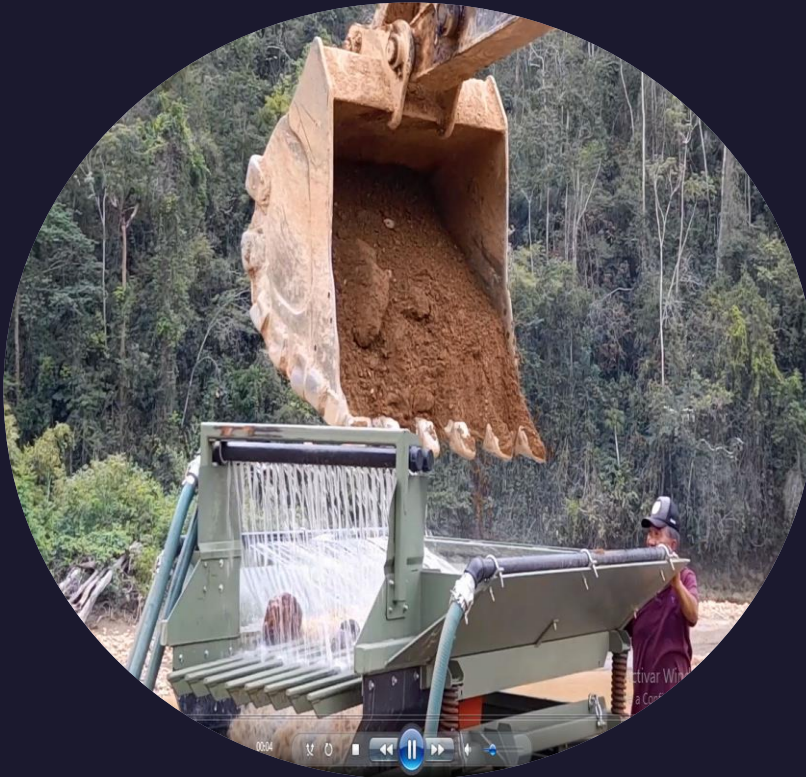
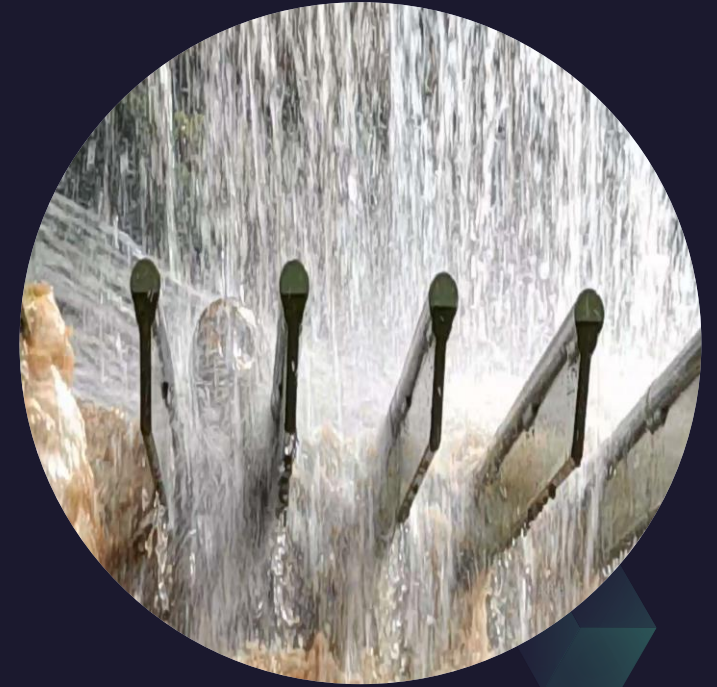
In the afternoon, we started processing material. It was only around 5 pm that we finally found the correct angles and ratios to let us process between 20 and 25 cubic meters per hour (roughly equal in tons), without having any material or water loss, and attempting to wash as best as possible, by avoiding clogging in the loading tray. We continue processing until day light left us.

On January 30th, after a few minor tweaks, we proceeded with processing throughout the day with a 1-hour lunch break. Around 5 pm we started washing the carpets and padding the resulting concentrate. In this exercise we recovered 1 gram approx.

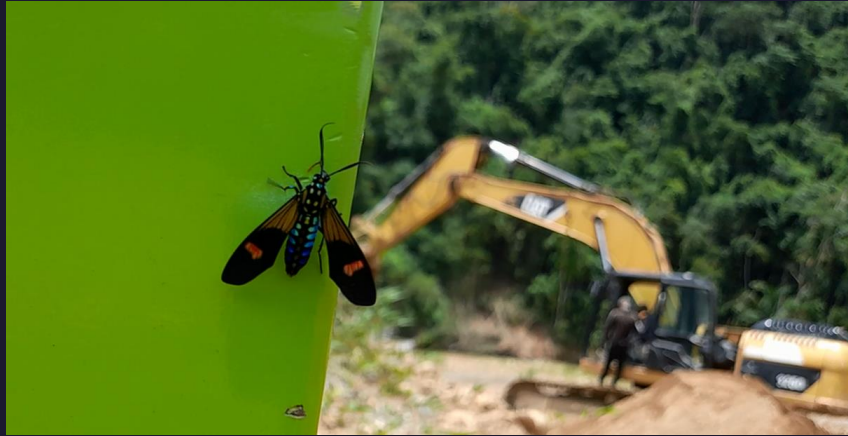
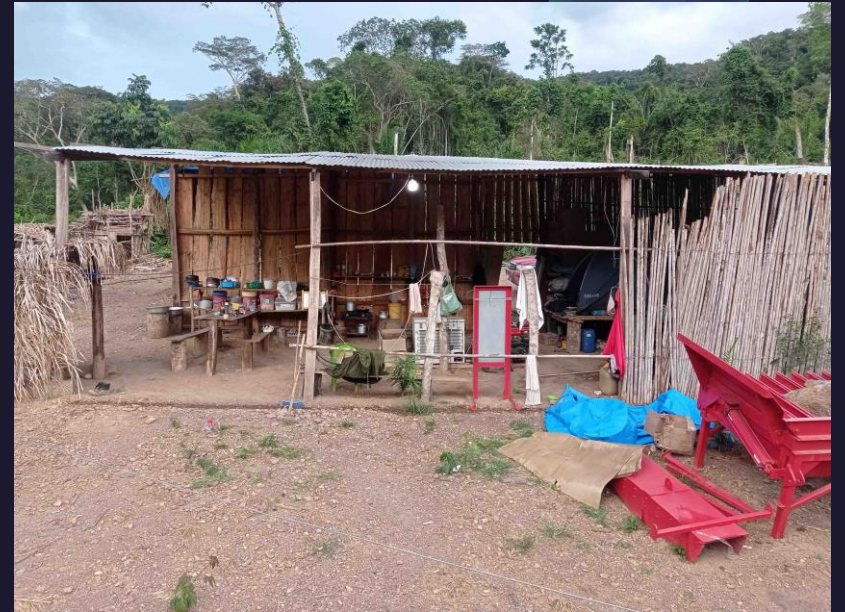
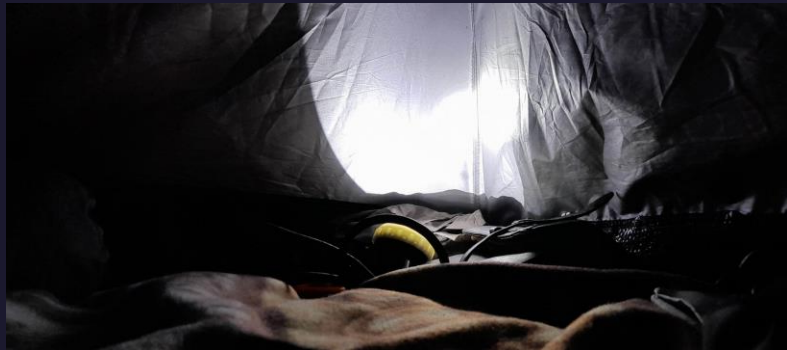
HK 3610 GREEN TROMMEL OBSERVATIONS CONDITIONS AND CURRENT CAPABILITIES

- The pump provided by the fabricant is barely sufficient, and it needs to be replaced immediately by a water source in order to work. Even then, water flow is just under par, generating issues with mud clogging at the loading tray and irregular and insufficient washing in the barrel.
- The excavator used, the only one we could find in the area, is larger than the typical 320 or 323 Cat or equivalents. It is an older model, stronger, but a little slower, and has a large 2.5 cubic meter bucket. Therefore loading was a little rougher than it could have been. Despite this, and as stated before, we did manage to increase from 10 tons per hour (as per the last time we processed) to 24 / 25 tons per hour.
- The loading tray and barrel inclination match those recommended by the plant's fabricant.

We tried speed setting for the loading tray and the barrel, first on equal ratios, starting from the slowest position of vibration and rotation, respectively on each of the parts (loading tray and barrel) and went up on increments of 10 Hz attempting to get to the point of achieving no water loss in the back of the plant and no sand loss on the barrel. Once we have achieved a close to perfect solution, we proceeded to zeroing within that range from 30 to 60 Hz in 5Hz increments, and to make variations in loading tray vibration speed and trommel barrel rotation speed. Finally arriving to 35.9 Hz on the loading tray, and 52.9 Hz on the barrel speed. Once the point was set, some minor adjustments were made in the trommel inclination and in better securing its placement.

- We then proceeded to check the water, sand and gravel flow on the sluice channels, making sure at this point that all the material came into contact with the mesh and carpet. This was done manually covering the whole length of the sluice channel. This time the material was flowing correctly through the system.
- The dump expelled by the trommel's barrel required two personnel constantly shoveling in order to be barely manageable. This being one of the tasks that either a front-end loader or a medium size backhoe is usually assigned to.
