Lehigh Valley International Airport (ABE)

Airside Pavement Management Plan

Final Working Report – February, 2018

Prepared by
Airport Design Consultants Inc.

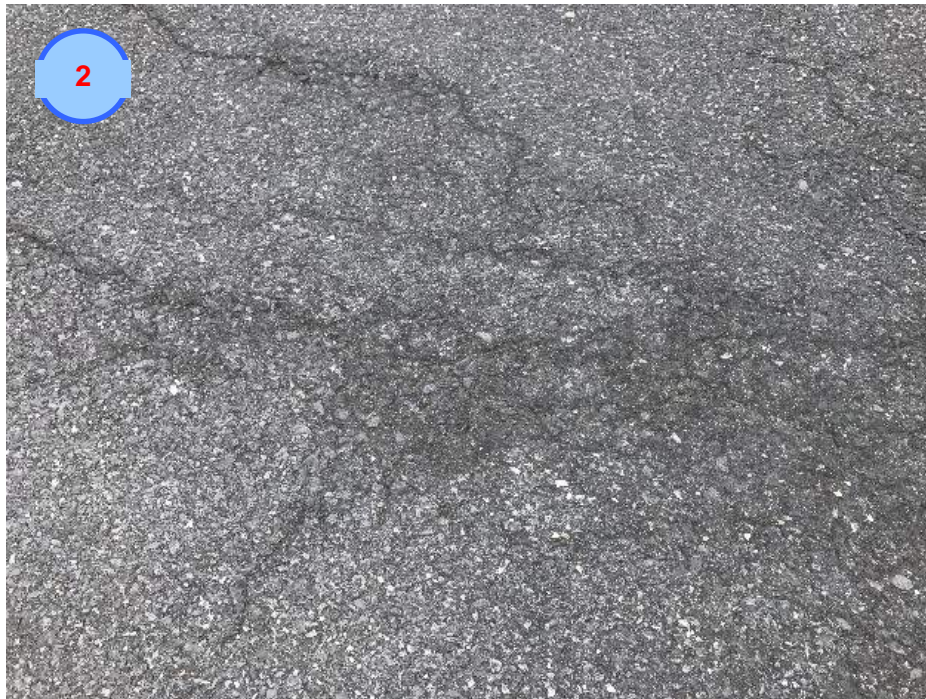
Low Severity Longitudinal Cracking, Weathering, and Raveling

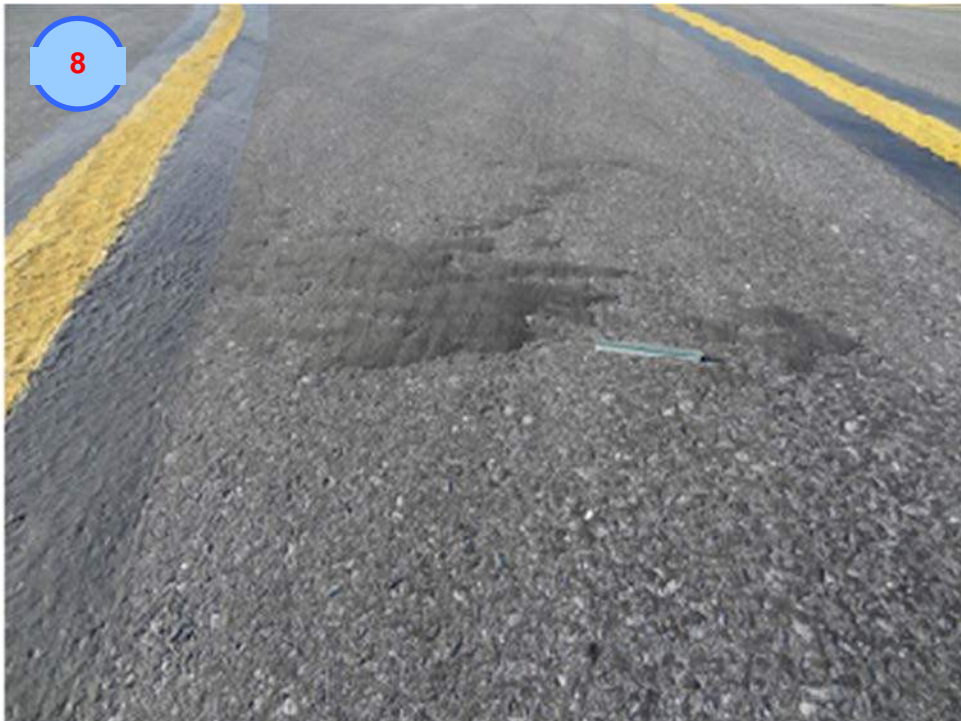
Weathering and Bleeding Taxiway A

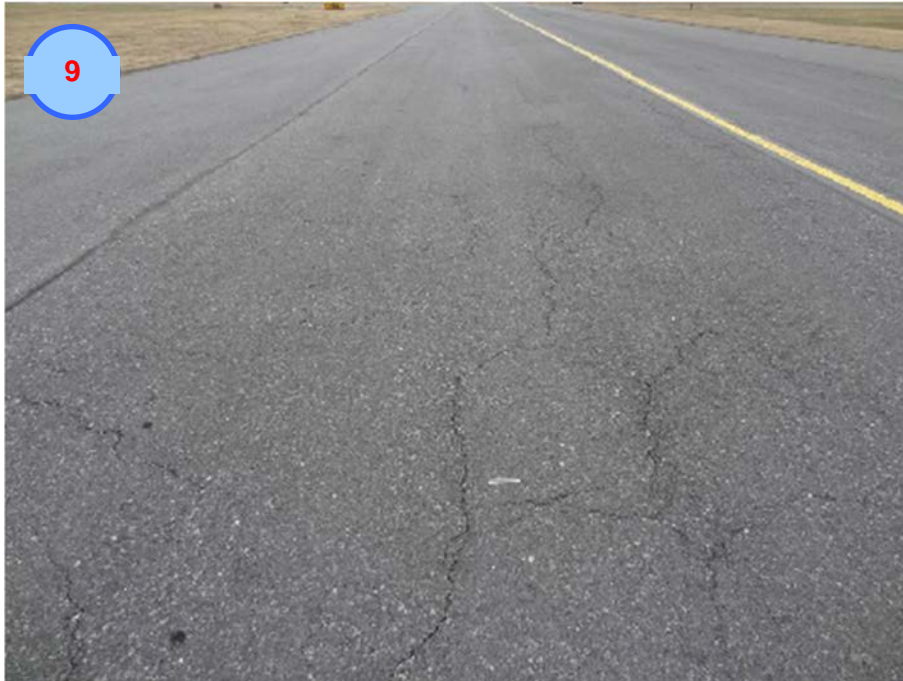
Low severity Longitudinal Cracking Western Portion

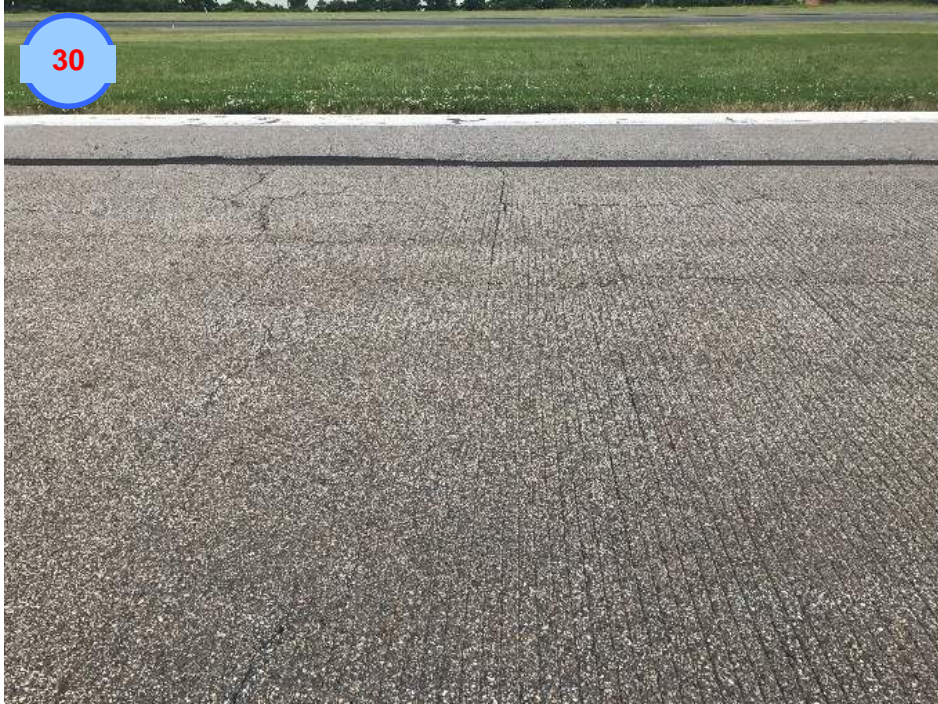
Alligator Cracking, Weathering, and Longitudinal Cracking

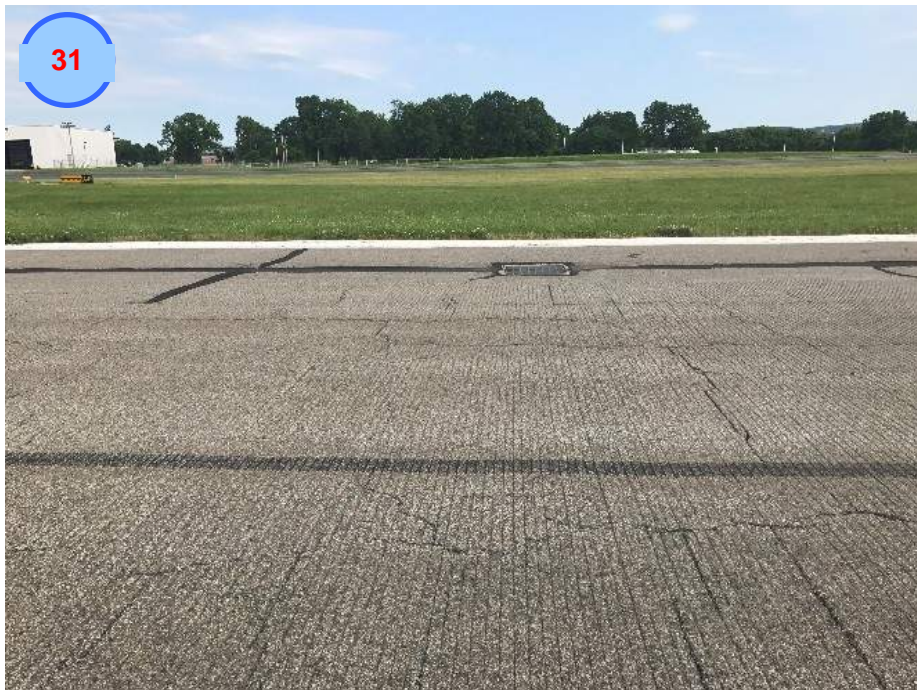
Medium Severity Block Cracking, Alligator Cracking, and Weathering

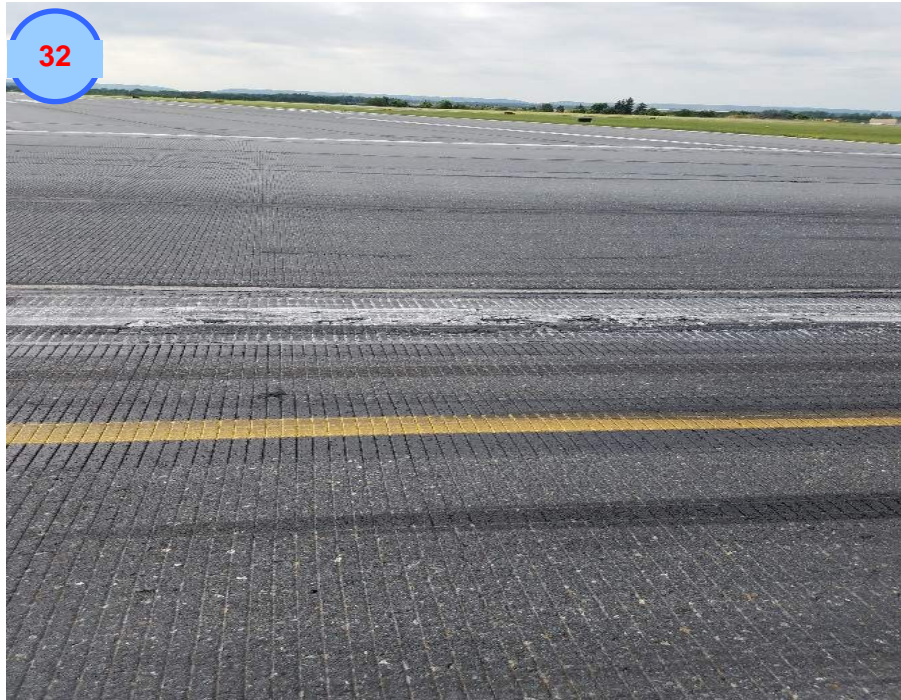
Weathering and Raveling

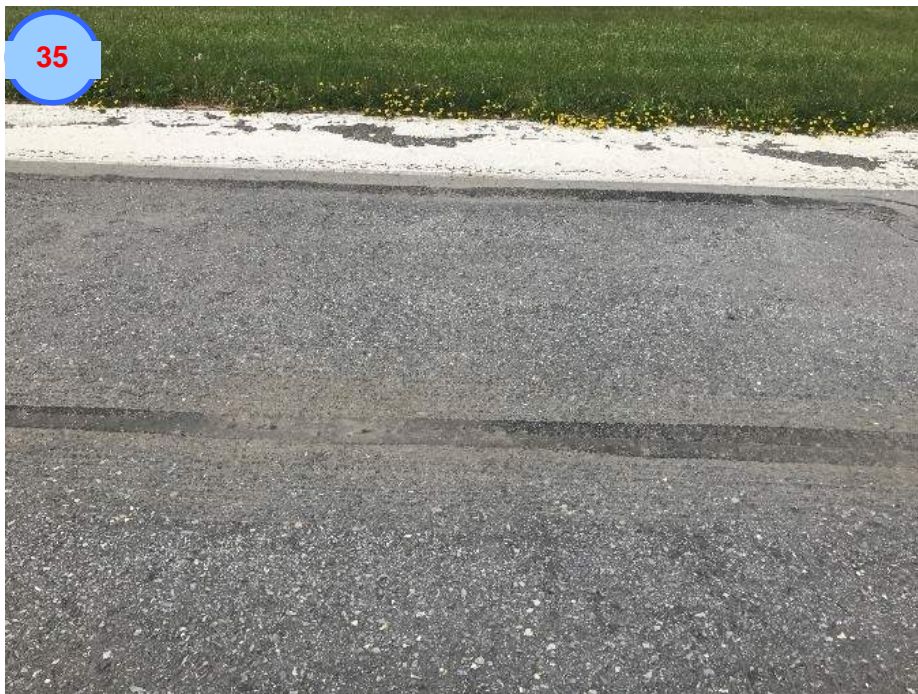
Low Severity Weathering and Longitudinal Cracking

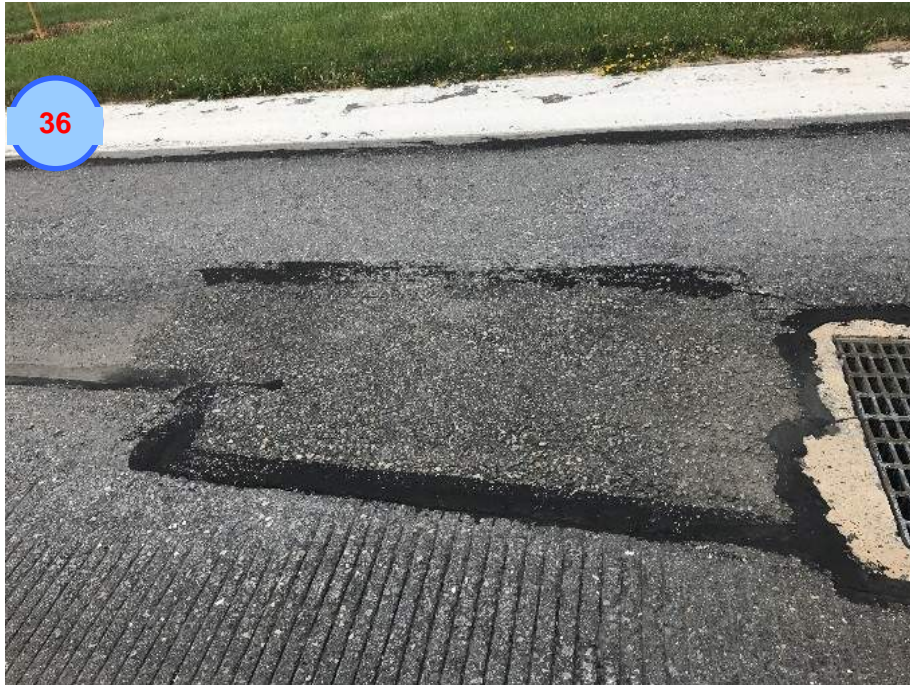
Patching, Weathering, and Raveling

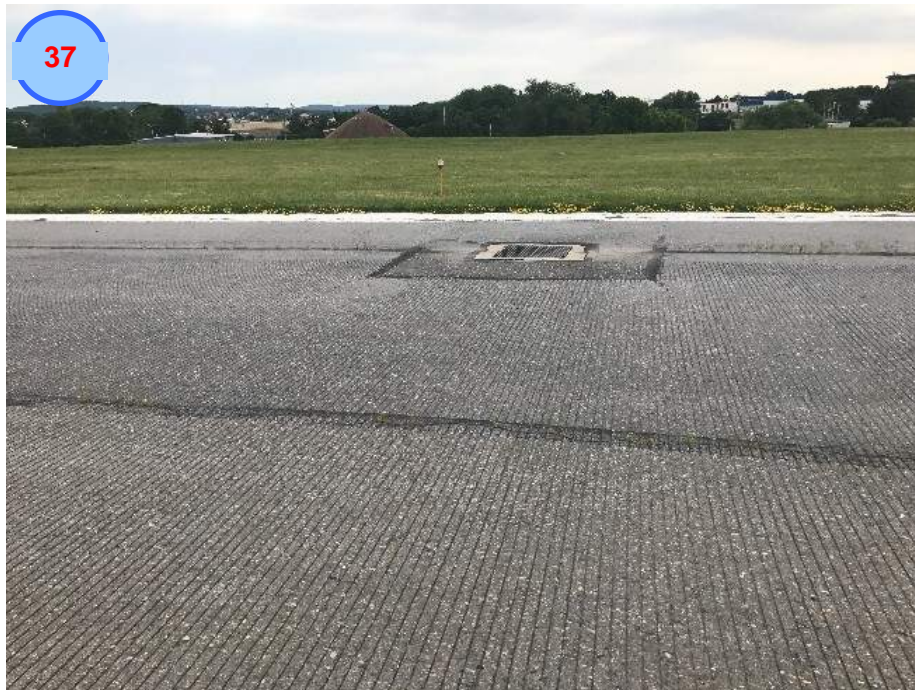
Patching, Weathering, and Longitudinal Cracking

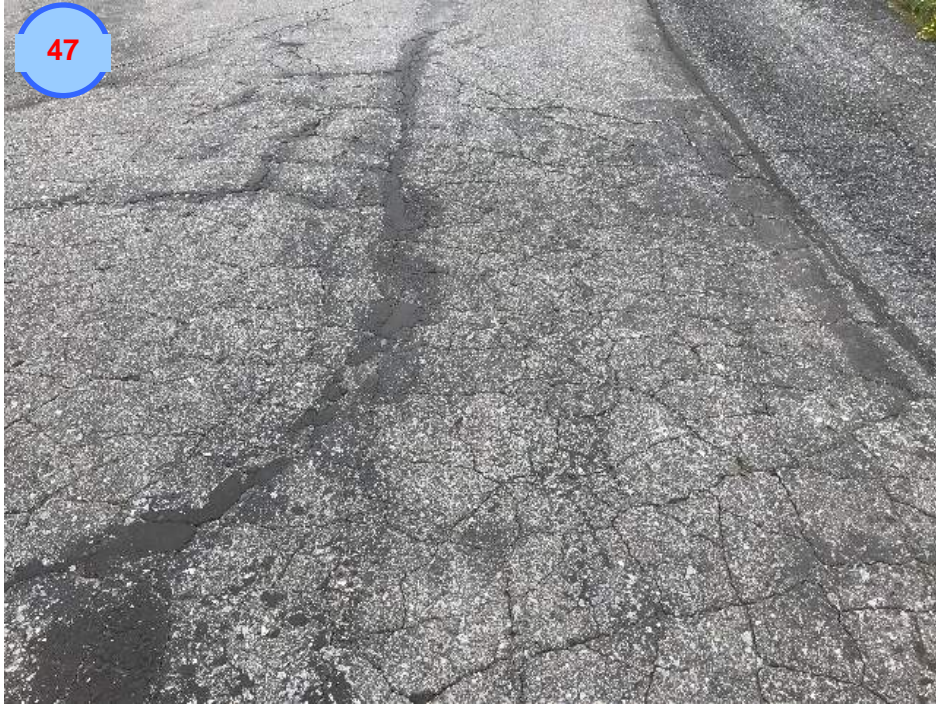
Medium Severity Alligator Cracking, Bleeding, and Weathering

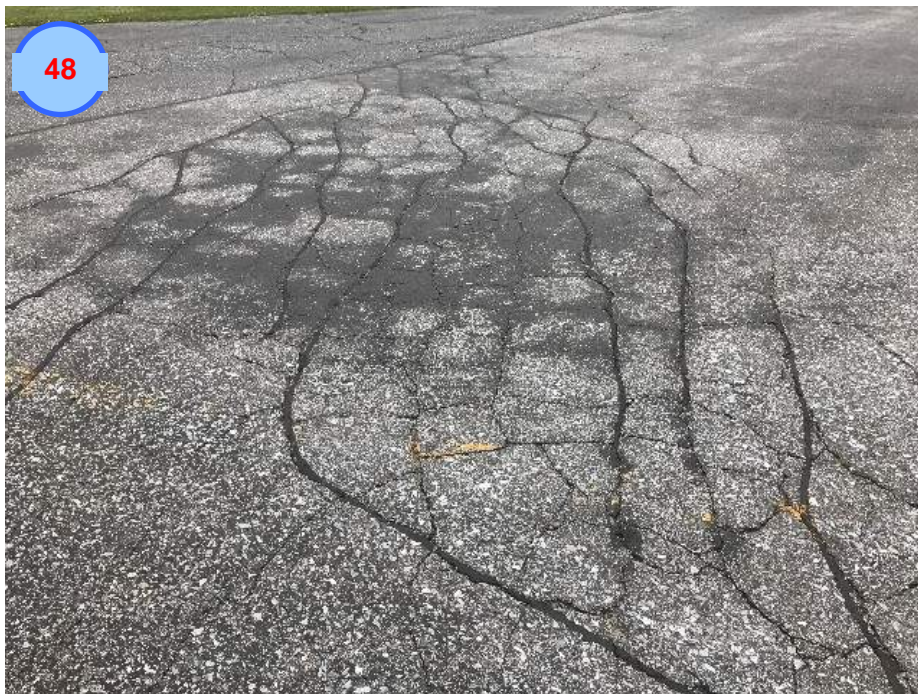
Medium Severity Alligator Cracking, Bleeding, Weathering, and Slippage Cracking

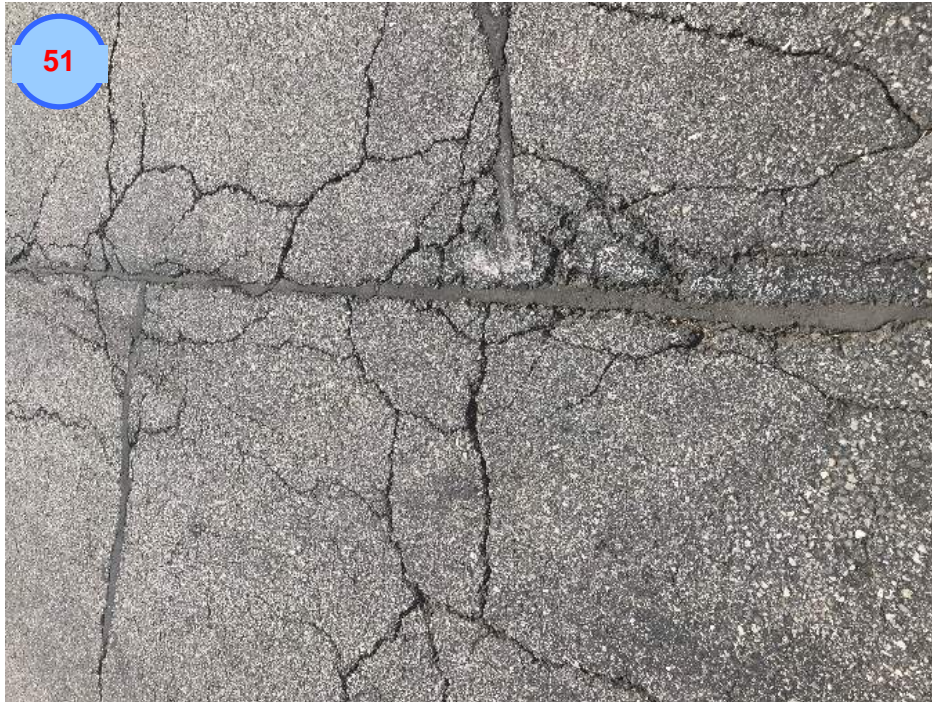
Medium Severity Alligator Cracking

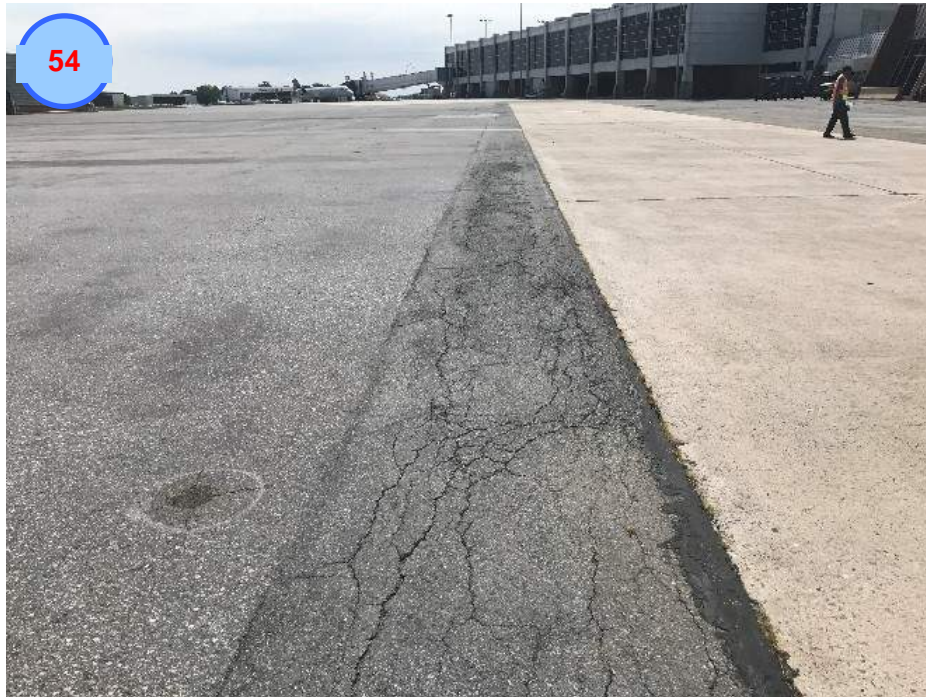
Alligator Cracking and Raveling at AC/PCC Transitional Pavement

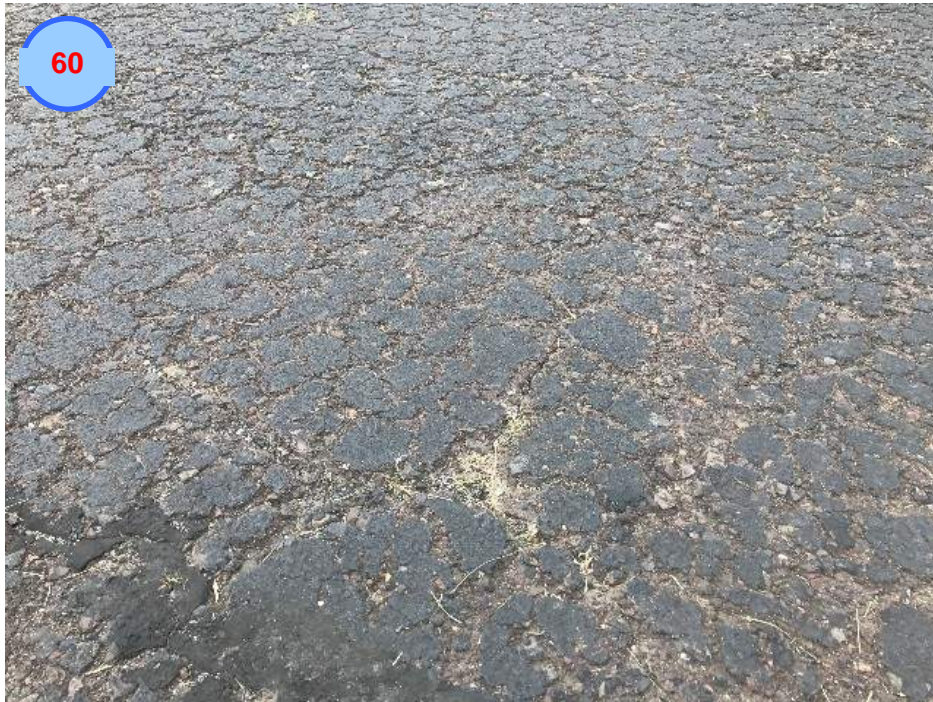
High Severity Weathering and Raveling
