Home Inspection Report

Home Inspection Summary

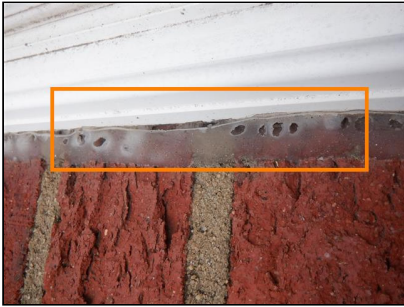
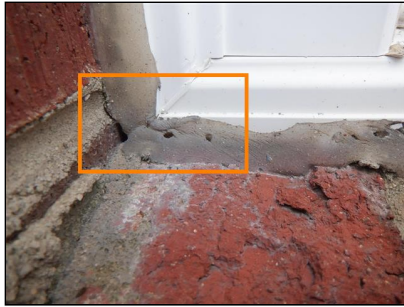
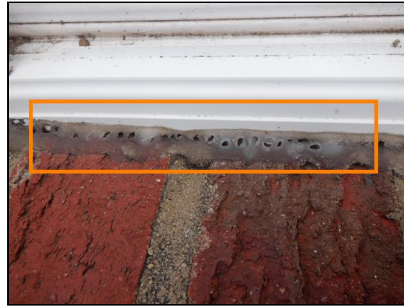
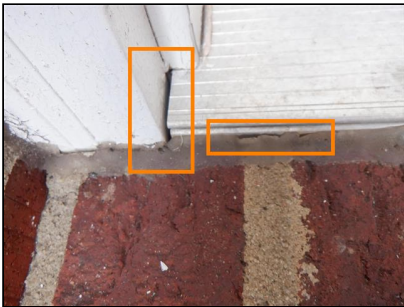
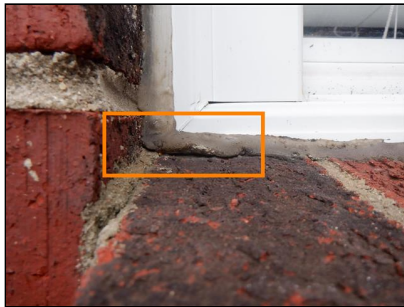
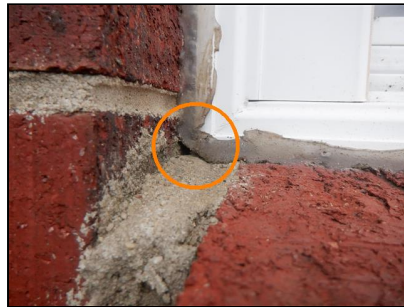
A. **Holes and/or cracks were noted in the vinyl siding and/or trim at or along the following elevations of the home, including but not limited to:**

This can allow moisture penetration to occur.

B. The vinyl siding does not have proper clearance from the roof surface. The Vinyl Siding Institute (<http://www.vinylsiding.org>) recommends at least 1/2 inch clearance between the vinyl siding trim and roofing materials where walls meet the roof. This allows the flashing to be seen & the expansion / contraction of the siding and trim due to temperature changes. The shingles may also transmit enough heat to the channel holding the vinyl siding to distort the channel. NOTE: the current installation prevents the inspector from determining if the roof/wall intersection is properly flashed as it would be behind the vinyl siding.

C. The exterior light fixtures are not sealed where they meet the exterior walls. This can allow moisture penetration to occur. Contact a licensed qualified contractor to further evaluate and make the necessary repairs.

E. No weep holes were found above the windows and doors at the brick siding around the home. Weep holes are drilled hole, slots, or openings located around the foundation and above or below windows in brick veneer. The holes are used to permit moisture to drain that has gathered inside or behind a building component or allow water to escape that might otherwise accumulate in a window's sills and veneers.

F. Missing sealant or gaps in sealant were noted at the exterior siding, trim and/or door and window frames and thresholds. This can allow moisture penetration to occur.

G. Moisture damage was noted at the rear exterior door and door trim/frame. Further damage may occur if not corrected.

H. There is a section of vinyl siding does not properly overlap at the right side of the, Because of this there is a gap between 2 pieces of siding. The gap has been filled with sealed. This should be considered a temporary fix and proper repairs should be made to prevent moisture penetration.

I. There is a damaged vent at the right side of the home. Further damage and moisture penetration may occur if not corrected.

NOTE: multiple repairs were made to the vinyl siding using sealant. Sealant repairs require continual monitoring and repair to prevent moisture penetration.

2. Due to the following but not limited to, a qualified licensed contractor should be consulted to further evaluate the entire exterior of the home, as there may be hidden or concealed damage that was unseen or could not be viewed at the time of inspection. Further evaluation is recommended before closing of escrow to completely understand the extent of any damage or repairs required or deemed necessary:

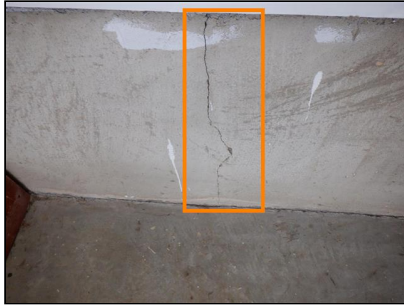
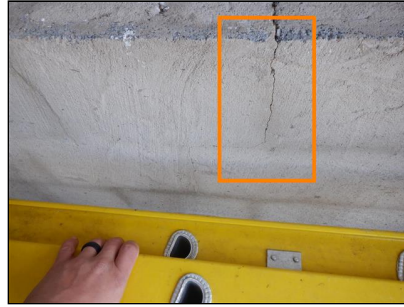
4. Cracking was noted to the foundation at the rear, left and right sides of the garage. Further cracking/movement may occur if not corrected. Contact a licensed qualified structural engineer to further evaluate and make the necessary repairs.

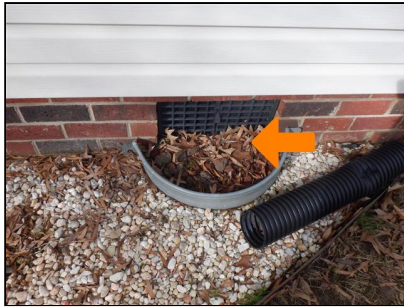
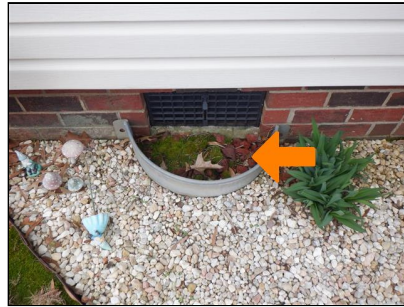
5. The foundation vent(s) wells need to be cleaned out around the home to allow for adequate airflow into and out of the crawl space. Contact a licensed qualified contractor to further evaluate and make the necessary repairs.

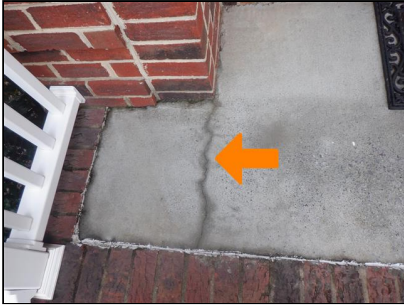
8. There are cracks noted at the front porch that need to be sealed and/or repaired properly to prevent water penetration and/or continual cracking. Contact a licensed qualified contractor to further evaluate and make the necessary repairs.

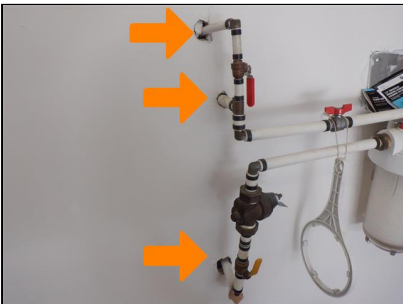
9. Holes and/or gaps were noted in the walls and/or ceiling within the garage. All holes and gaps, including around the water lines and any other wall or ceiling penetrations need to be properly sealed to maintain the proper fire rating between the home and garage and prevent possible carbon monoxide entry into the home. Contact a licensed qualified contractor to further evaluate and make the necessary repairs.

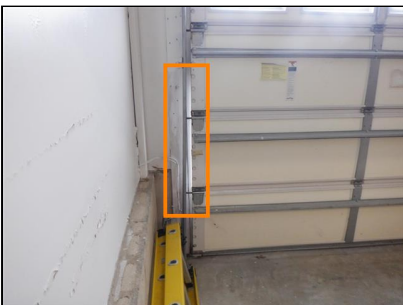
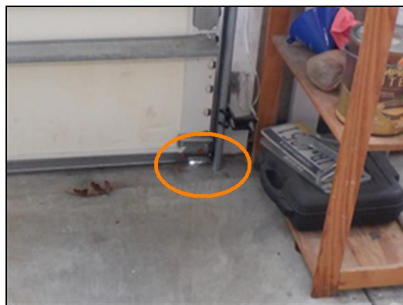
10. Daylight is visible around the garage door when it is closed. This can allow moisture and pest intrusion to occur. Contact a licensed qualified contractor to further evaluate and make the necessary repairs.

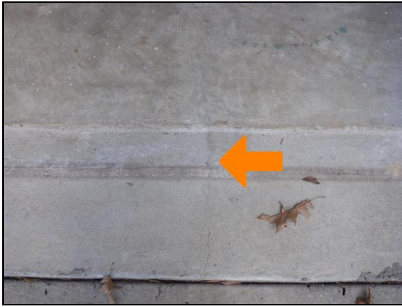
11. There are cracks noted at the garage floor that need to be sealed and/or repaired properly to prevent water penetration and/or continual cracking. Contact a licensed qualified contractor to further evaluate and make the necessary repairs.

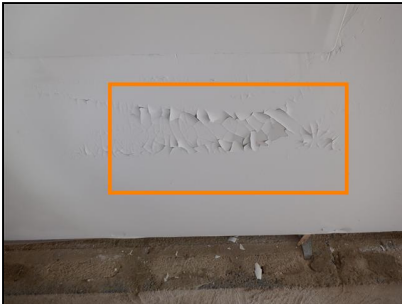
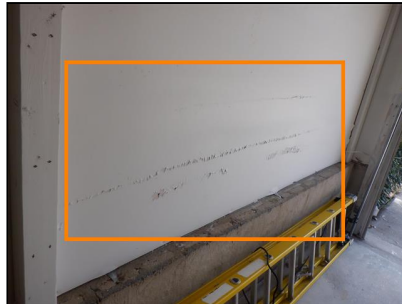
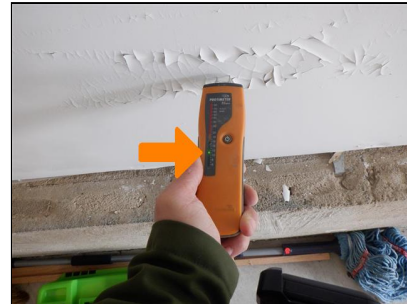
12. Peeling paint was noted at the garage walls. unable to determine the cause. Further evaluation is needed.

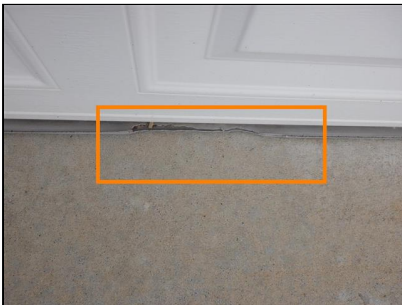
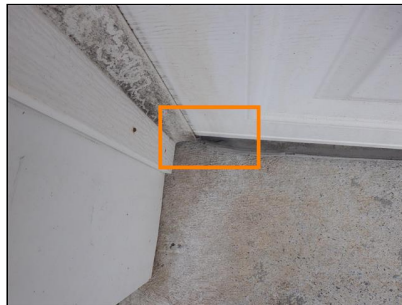
13. Damaged or loose weather stripping was noted at the garage doors. This can allow moisture and pest intrusion to occur. Contact a licensed qualified contractor to further evaluate and make the necessary repairs.

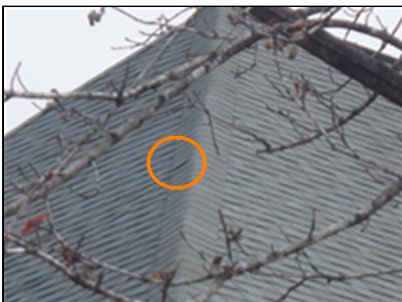
14. There is a nail protruding from the roof surface (nail pop). Corrections needed to prevent the nail from damaging the shingle and or allowing possible wind damage on **the front left corner of the home**. Contact a licensed qualified contractor to further evaluate and make the necessary repairs.

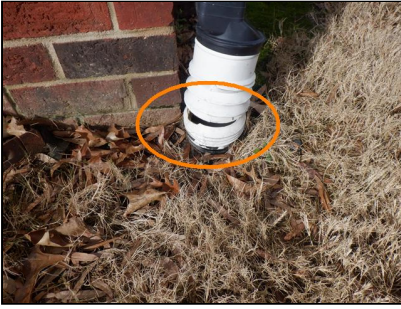
15. The gutter drain is damaged at the rear right corner of the home. This can allow leakage to occur. Contact a licensed qualified contractor to further evaluate and make the necessary repairs.

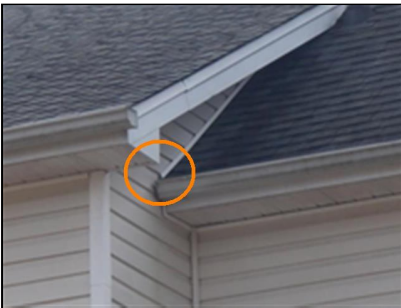
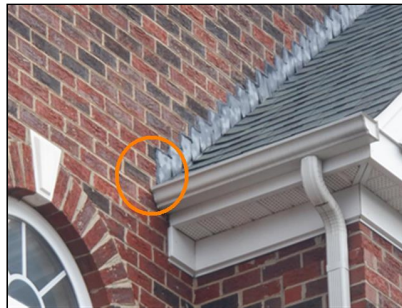
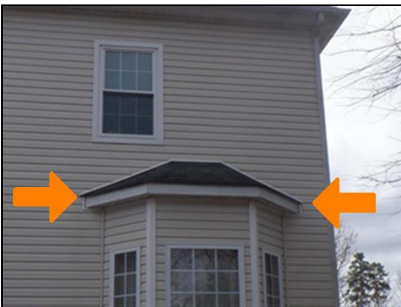
17. There is/are no visible kick out flashing(s) at the base of the roof/wall intersections of the home. Missing kick out flashings can allow water from roof run off to get behind the exterior wall covering which can result in moisture damage to the wall assembly. Unable to determine if hidden or concealed damage exist at the time of inspection. Contact a licensed qualified contractor to further evaluate and make the necessary repairs.

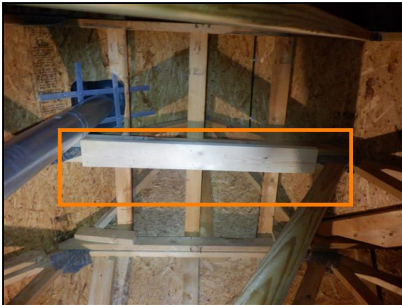
19. Repairs were noted to the truss system in the attic. There was no structural engineers letter attached to the repairs as required. When a truss system is repaired or modified a structural engineers letter is required. Ask the sellers if they have a letter from a structural engineer for the repairs, if they do not then further evaluation by a structural engineer is needed.

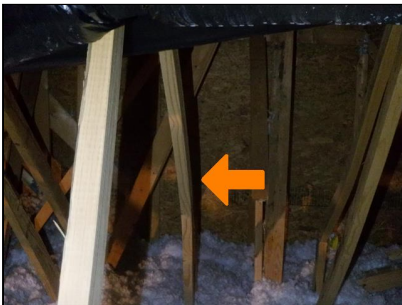
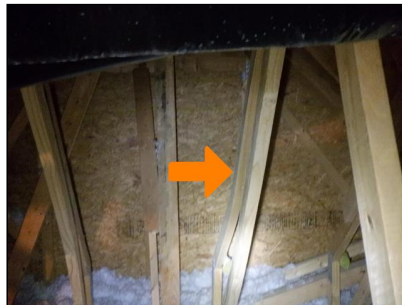
20. There are warped trusses noted in the front area of the attic. This could be a sign of stress on the trusses or they may have been warped before installation. Further evaluation by a structural engineer is needed to determine if corrections are needed.

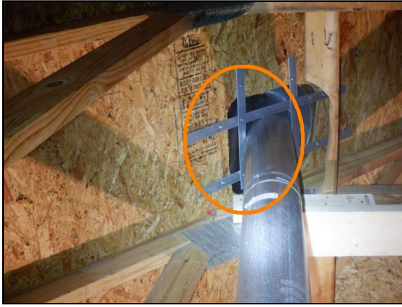
21. The furnace exhaust flue does not have proper clearance from combustible materials where it exits the attic. Corrections are needed to prevent a possible fire hazard. Contact a licensed qualified contractor to further evaluate and make the necessary repairs.

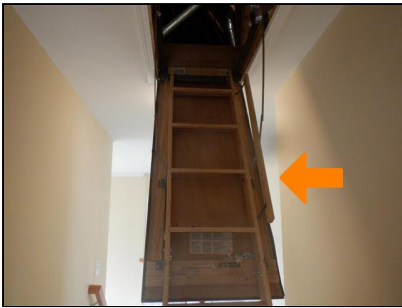
22. **There is no insulation installed on the back of the attic stairs.** This can result in a large source of heating and air loss, installation of insulation and weather stripping is needed to prevent heating and air loss. **The ???? exhaust flue does not have proper clearance from combustible materials where it exits the attic.** Corrections are needed to prevent a possible fire hazard. Contact a licensed qualified contractor to further evaluate and make the necessary repairs.

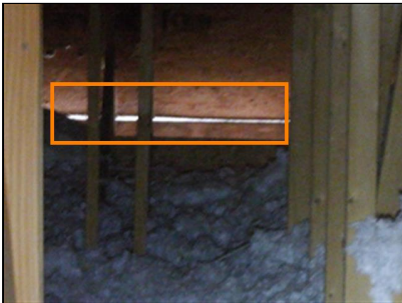
23. Daylight is visible between the roof sheathing and the fascia in the attic. This can allow moisture and pest intrusion to occur.

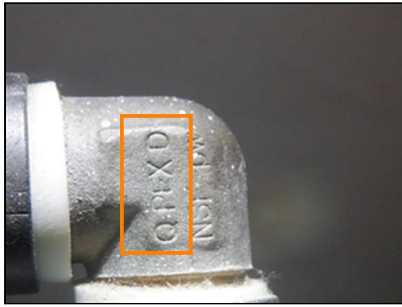
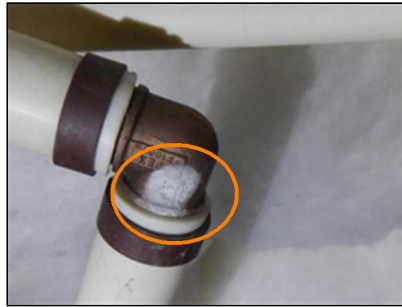
24. The visible plumbing lines in this home are plastic PEX with QPEX metal fittings manufactured by the Zurn Corporation. These plumbing fittings are the subject of a consumer class action lawsuit and settlement due to fitting failures related to dezincification. After years of consumer complaints, the Zurn Corporation has acknowledged that it has seen an increased number of premature failures and leaks in its QPEX fittings. Evidence of fitting deterioration was noted during the inspection in a few/several locations. A licensed plumbing contractor should be hired/consulted for a complete evaluation of the plumbing system to determine the general condition of the plumbing distribution and supply lines, the significance of this concern, and make all necessary and any additional repairs needed as deemed necessary. The client should visit the class action settlement website for more information, www.PlumbingFittingSettlement.com.

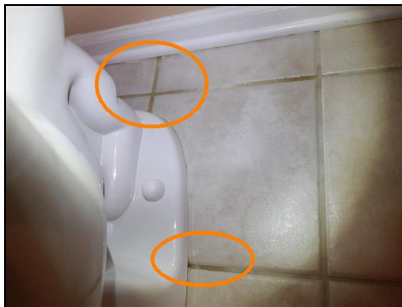
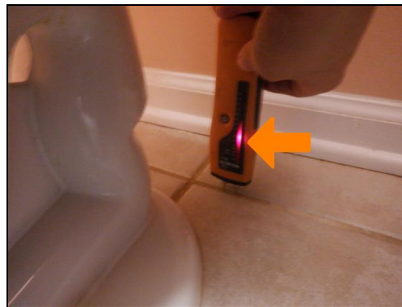
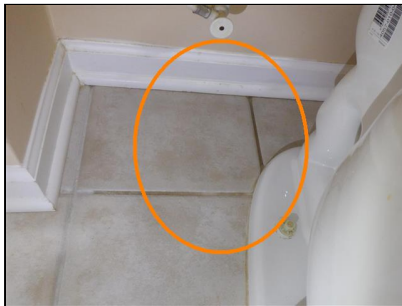
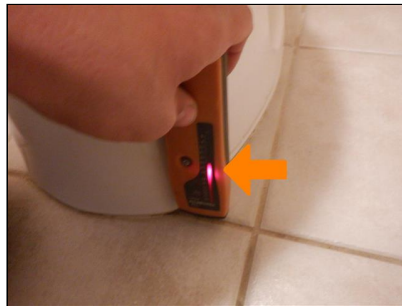
25. Discolored grout and elevated moisture levels were noted around the base of the toilets in the master, hall and 1/2 bathrooms. This may be evidence of leakage around the toilets. Further evaluation is needed to determine if leaks exist and if there is hidden or concealed damage. Contact a licensed qualified plumbing contractor to further evaluate and make the necessary repairs.

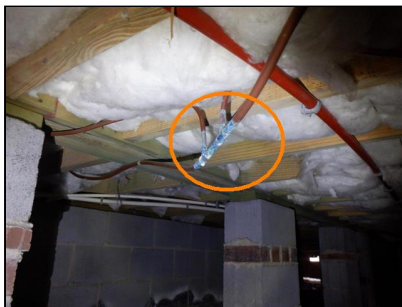
26. Corrosion was noted at connections and/or fitting at the copper gas lines. Have these areas further evaluated to ensure there is no risk of leakage.

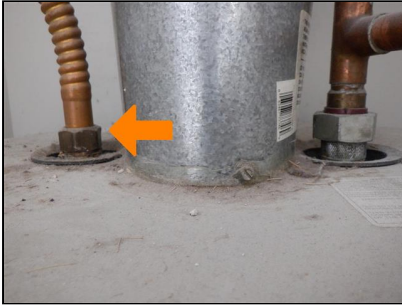
27. The water heater is missing a dielectric connection at the top of the tank where the hot and cold plumbing nipples connect to the supply lines. When two different types of metal connect together, it may cause corrosion and/or leakage to occur. A dielectric connection is recommended by the manufacturer and/or the home warranty companies to have the proper connections installed. Note: The manufacturer and/or home warranty companies may deny any repairs to the water heater if the supply lines are not properly installed. Contact a licensed qualified contractor to further evaluate and make the necessary repairs.

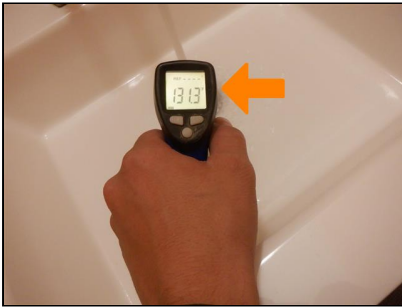
28. The hot water temperature at the time of inspection was 131 degrees. Water temperatures at or above 125 degrees can burn or scald. This is a safety hazard. The hot water temperature needs to be adjusted to below the current setting. Contact a licensed qualified contractor to further evaluate and make the necessary repairs.

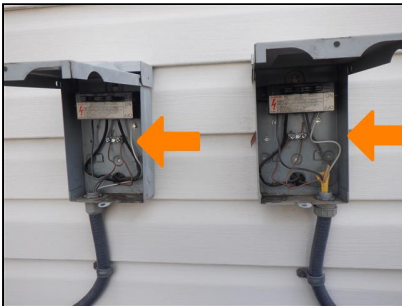
29. The electrical panels behind the exterior HVAC units are missing internal covers. This can be dangerous as there is no protection from live electrical wiring when the outer cover is open/unlocked. An interior panel cover should be installed for safety reasons. Contact a licensed qualified contractor to further evaluate and make the necessary repairs.

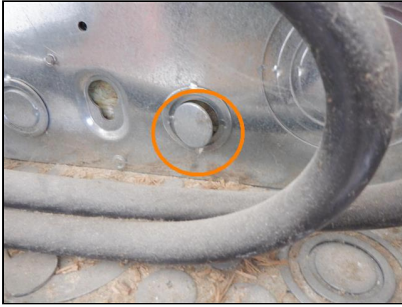
30. There is a nail protruding through the back of the main electrical panel. This should be blunted, capped off or removed to prevent possible damage to electrical components within the panel. Contact a licensed qualified contractor to further evaluate and make the necessary repairs.

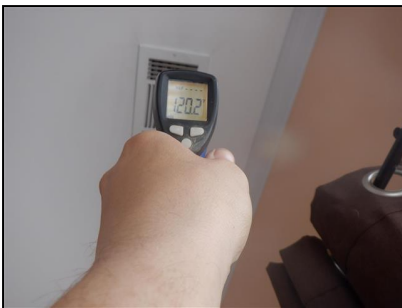
1st floor

31. Uneven temperature distribution and/or air flow was noted at the supply air registers when testing the HVAC system. Because of this some areas of the home may be noticeably warmer or cooler than the rest of the home. Some variation is to be expected between different air registers, however these variations should not be more than a few degrees difference between air registers located on the same floor. Contact a licensed qualified HVAC contractor to further evaluate and make the necessary repairs.

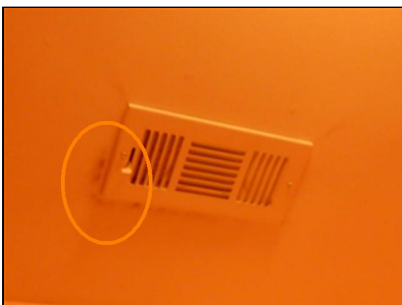
32. Discoloration was noted on the ceiling around the ducts. This may be an indication that the ducts are in need of cleaning. Contact a licensed qualified contractor to further evaluate and make the necessary repairs.

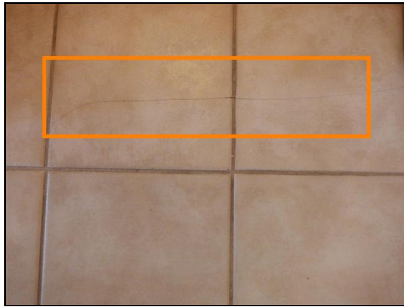
37. Cracking was noted at the floor tiles between the laundry room and the kitchen/hall areas. Further cracking may occur if not corrected. Contact a licensed qualified contractor to further evaluate and make the necessary repairs.

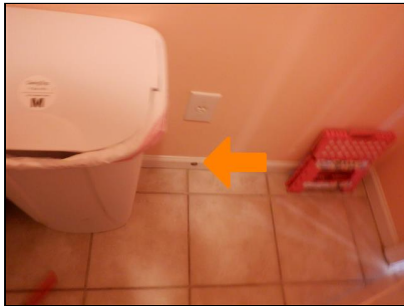
38. There are door stops missing/damaged behind doors in areas throughout the home; replacement needed to prevent possible damage to the walls behind the doors.

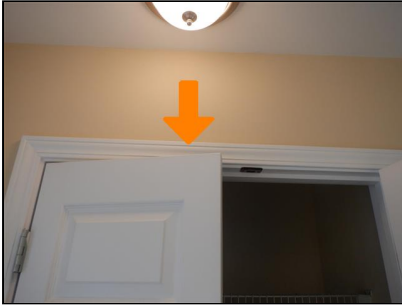
40. One of the hall closet doors does not latch closed on the 2nd floor. Corrections are needed to allow proper function. Contact a licensed qualified contractor to further evaluate and make the necessary repairs.

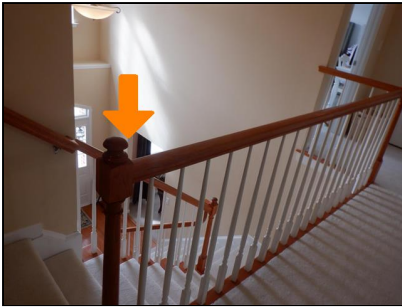
41. **The banister is loose at the top of the stairs that needs to be secured properly to ensure safety.** Contact a licensed qualified contractor to further evaluate and make the necessary repairs.

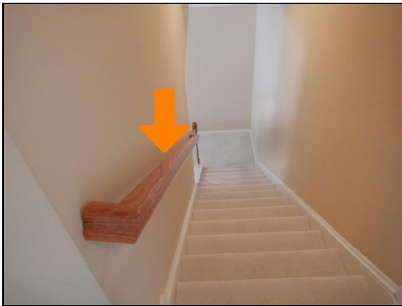
42. **The handrail is loose at the interior stairways and needs to be secured properly to prevent it from coming loose and to ensure safety.** Contact a licensed qualified contractor to further evaluate and make the necessary repairs.

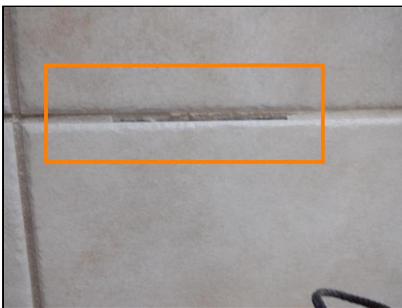
43. Loose grout and/or tiles were noted at the floor in the master bathroom. **Corrections are needed.** Contact a licensed qualified contractor to further evaluate and make the necessary repairs.

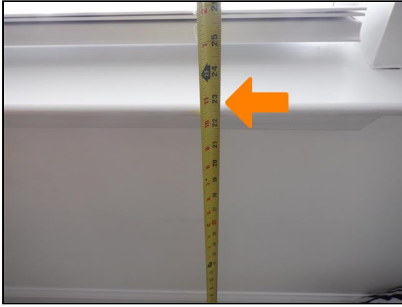
44. **There are no child safety latches installed on some or all of the windows within the home that have a window sill that is less than 24" from the floor.** This poses a fall safety hazard at the window(s) especially for children. Child safety latches are required on all windows that are more than 72" above the exterior grade when the window sill is less than 24" from the interior floor (or 36" above the floor in some jurisdictions). Have a qualified licensed contractor further evaluate and make any additional repairs as needed or deemed necessary.

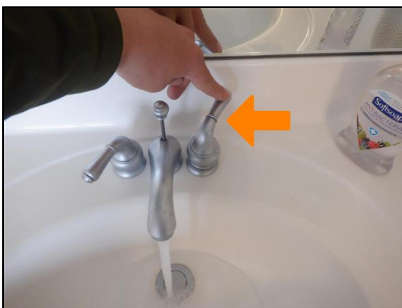
46. The master bathroom faucet handles nearest the closet are stripped (spin all the way around). If the handles are not placed in the exact location the water will continue to drip, repair and or replacement needed. Contact a licensed qualified contractor to further evaluate and make the necessary repairs.

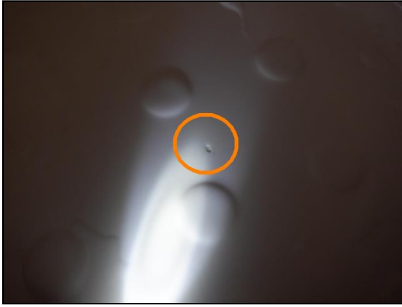
47. There is a chip in the master bath tub. Further damage and possible leakage may occur if not corrected. Contact a licensed qualified contractor to further evaluate and make the necessary repairs.

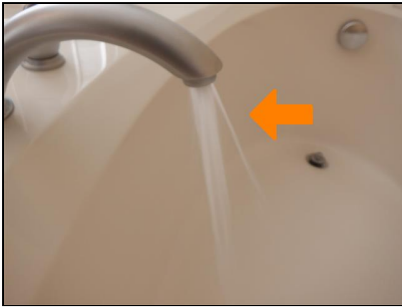
48. The master bath tub faucet has over spray when in use. Corrections are needed to allow proper function. Contact a licensed qualified contractor to further evaluate and make the necessary repairs.

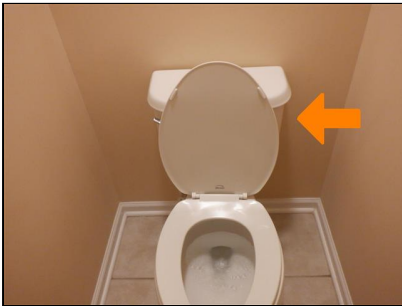
49. The toilet valve makes unusual noises when operating. Repair or replacement may be needed to ensure proper function. Contact a licensed qualified contractor to further evaluate and make the necessary repairs.

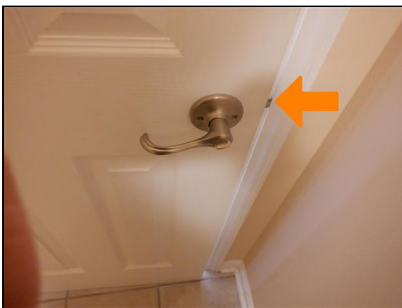
50. The water closet door in the master bathroom does not latch closed. Corrections are needed to allow proper function. Contact a licensed qualified contractor to further evaluate and make the necessary repairs.

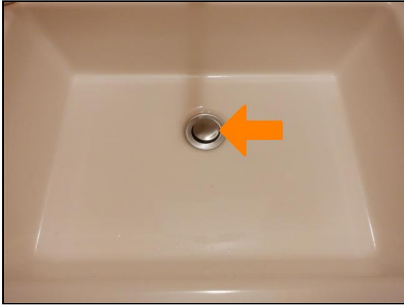
51. **The sink stopper did not function properly** at the time of inspection. When fully engaged water still drains. Contact a licensed qualified contractor to further evaluate and make the necessary repairs.

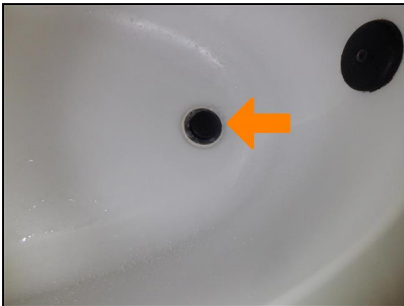
52. The tub drain stopper did not function properly or respond to the lever when testing at the time of inspection and needs repair or corrections. Contact a licensed qualified contractor to further evaluate and make the necessary repairs.

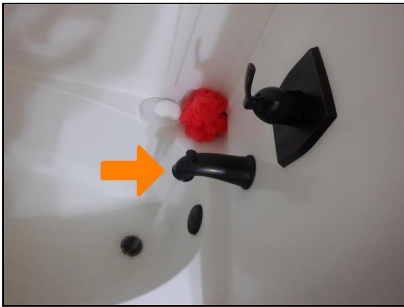
53. The faucet handle and or tub faucet are loose in the wall and need to be secured properly to prevent movement and possible leakage. Contact a licensed qualified contractor to further evaluate and make the necessary repairs.

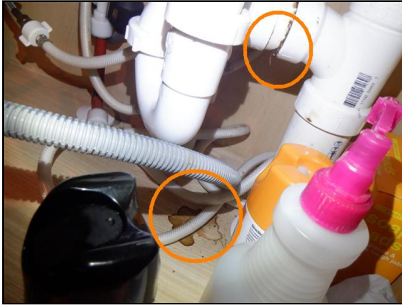
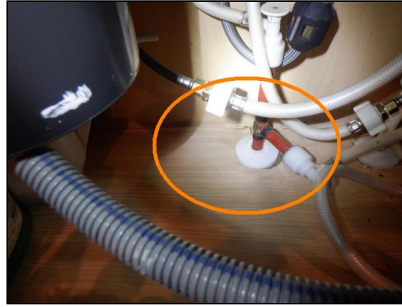
54. Evidence of a previous leak was noted under the kitchen sink. No active leakage was noted at the time of inspection and the moisture levels were not elevated in the cabinet under th sink when tested with a moisture meter. Ask the sellers the history of the stains and if repairs have been made to correct the leaks. If the sellers are unaware or no repairs were made the further evaluation is needed by a licensed plumbing contractor.

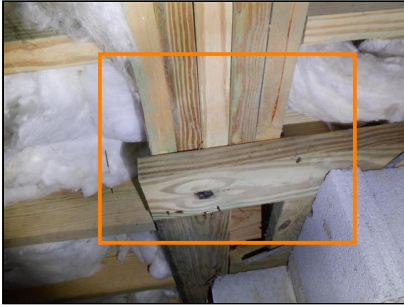
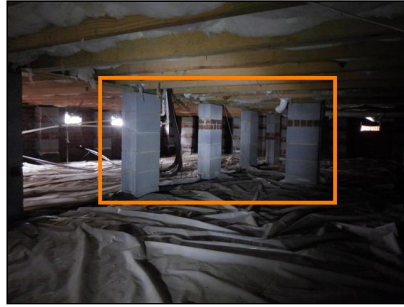
E. Single stack of solid or open cell, 8x8x16 CMUs were observed to be stacked higher than 36 inches, as measured from the top of the footer to the top of the last concrete block. Typically concrete blocks are allowed a maximum height is 36 inches; however, there may be an exception to the rule depending on different construction methods. Because of this, it is recommended that you consult with a qualified licensed engineer to evaluate further and determine if the current installation is installed to support the structure of the home properly.

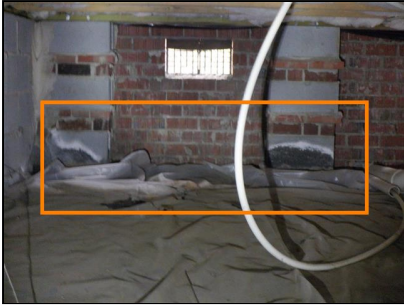
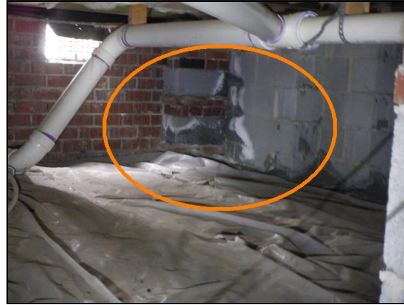
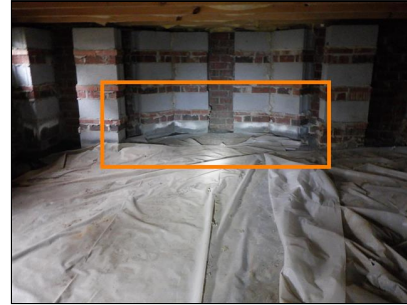
56. There are moisture stains noted along the back of the front, left and rear foundation walls in the crawl space. This is an indication that water is or has entered the crawl space at one point. Contact a licensed qualified contractor to further evaluate and determine if corrections are needed.

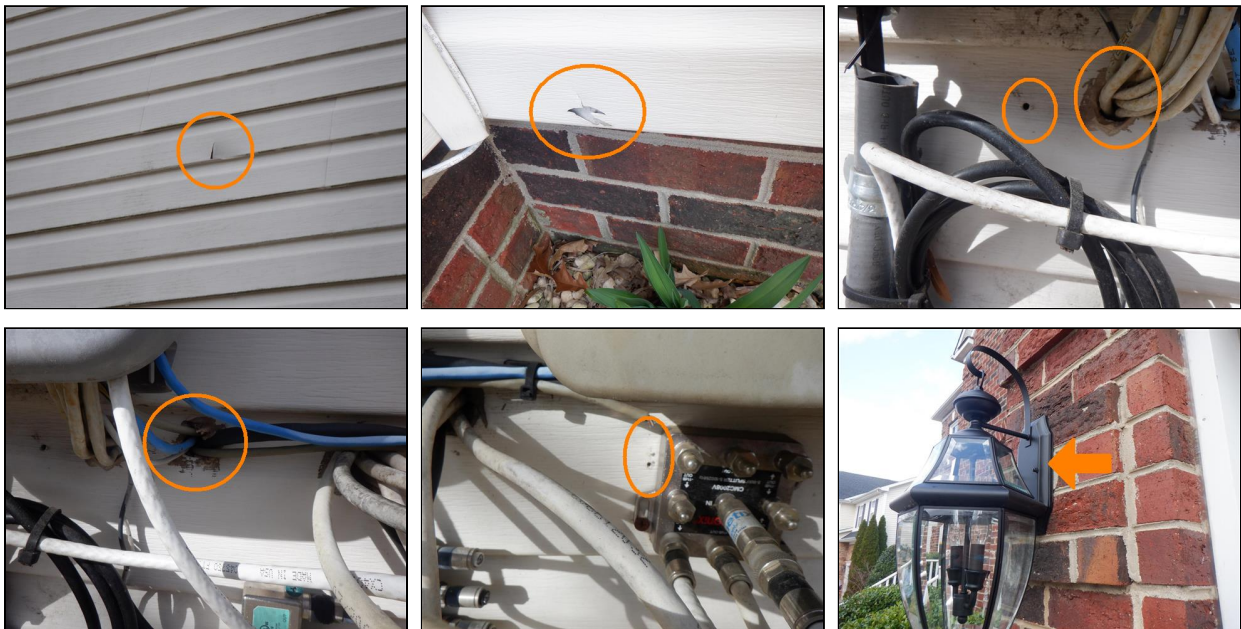
NOTE: multiple repairs were made to the vinyl siding using sealant. Sealant repairs require continual monitoring and repair to prevent moisture penetration.

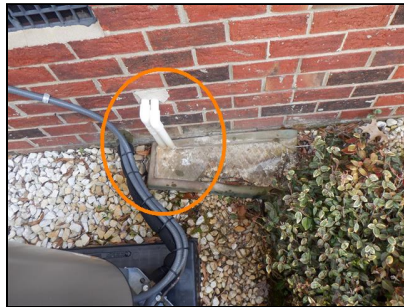
The condensate drains at the left elevation of the home terminate near the foundation, allowing them to deposit water near the foundation of the home. Water that is allowed to terminate near the foundation can cause and/or contribute to moisture and settlement related issues. Contact a licensed qualified contractor to further evaluate and make the necessary repairs.

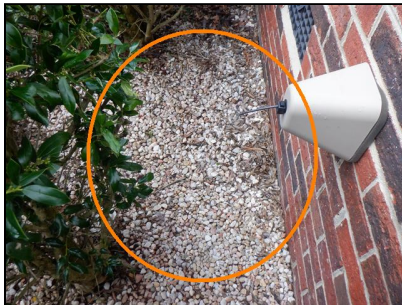
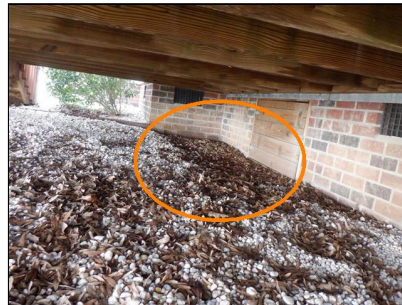
Areas of poor/negative grading were noted at the following elevations of the home, including but not limited to:

-rear

Poor/negative grading can allow water to terminate near the foundation which can cause and/or contribute to moisture and settlement related issues. Contact a licensed qualified contractor to further evaluate and make the necessary repairs.

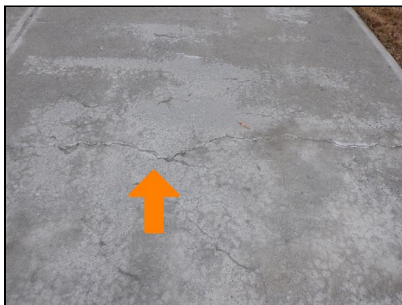
There are cracks noted at the driveway that need to be sealed and/or repaired properly to prevent water penetration and/or continual cracking. Contact a licensed qualified contractor to further evaluate and make the necessary repairs.

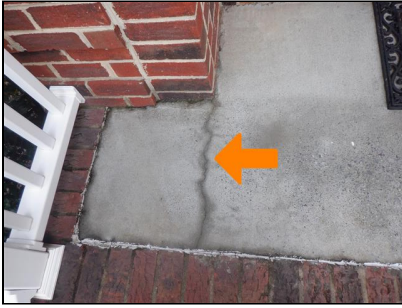
There are cracks noted at the front porch that need to be sealed and/or repaired properly to prevent water penetration and/or continual cracking. Contact a licensed qualified contractor to further evaluate and make the necessary repairs.

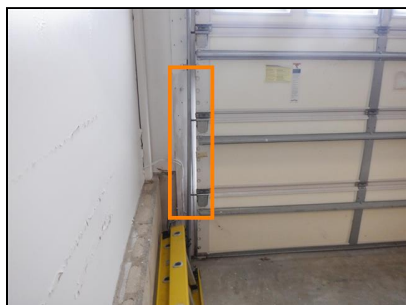
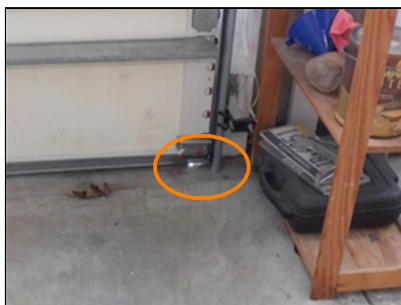
Daylight is visible around the garage door when it is closed. This can allow moisture and pest intrusion to occur. Contact a licensed qualified contractor to further evaluate and make the necessary repairs.

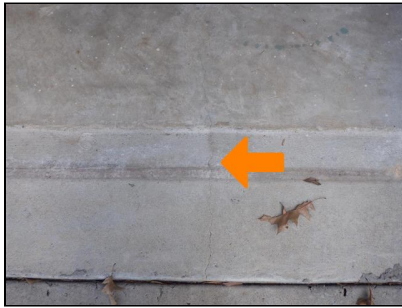
There are cracks noted at the garage floor that need to be sealed and/or repaired properly to prevent water penetration and/or continual cracking. Contact a licensed qualified contractor to further evaluate and make the necessary repairs.

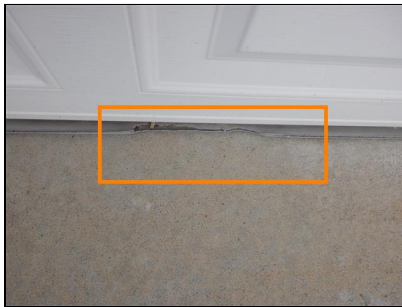
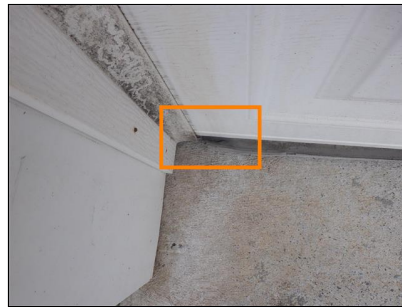
Damaged or loose weather stripping was noted at the garage doors. This can allow moisture and pest intrusion to occur. Contact a licensed qualified contractor to further evaluate and make the necessary repairs.

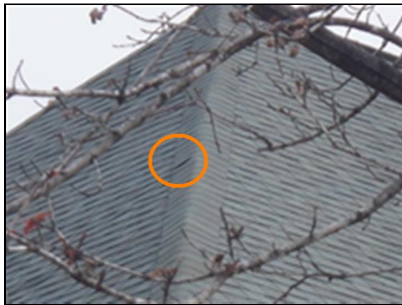
There is a nail protruding from the roof surface (nail pop). Corrections needed to prevent the nail from damaging the shingle and or allowing possible wind damage on **the front left corner of the home**. Contact a licensed qualified contractor to further evaluate and make the necessary repairs.

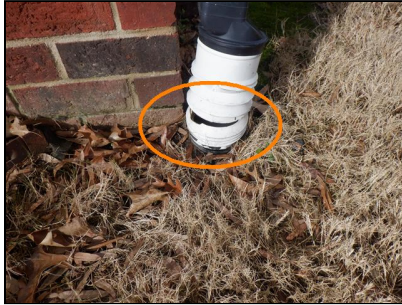
The gutter drain is damaged at the rear right corner of the home. This can allow leakage to occur. Contact a licensed qualified contractor to further evaluate and make the necessary repairs.

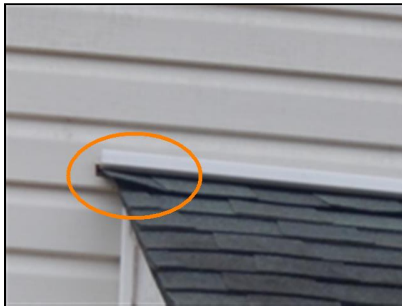
There is a lifted flashing or shingle noted at the roof/wall intersection over the fireplace bump out at the rear of the home. This can increase the potential for leakage. Contact a licensed qualified contractor to further evaluate and make the necessary repairs.

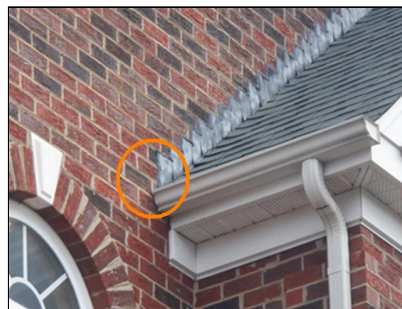
There is/are no visible kick out flashing(s) at the base of the roof/wall intersections of the home. Missing kick out flashings can allow water from roof run off to get behind the exterior wall covering which can result in moisture damage to the wall assembly. Unable to determine if hidden or concealed damage exist at the time of inspection. Contact a licensed qualified contractor to further evaluate and make the necessary repairs.

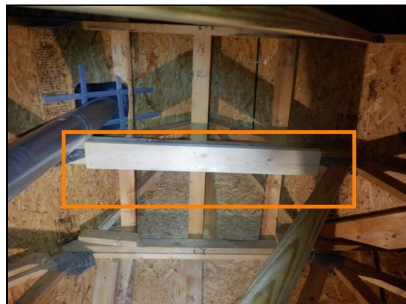
Repairs were noted to the truss system in the attic. There was no structural engineers letter attached to the repairs as required. When a truss system is is repaired or modified a structural engineers letter is required. Ask the sellers if they have a letter from a structural engineer for the repairs, if they do not then further evaluation by a structural engineer is needed.

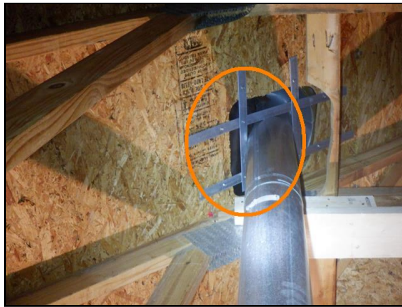
The furnace exhaust flue does not have proper clearance from combustible materials where it exits the attic. Corrections are needed to prevent a possible fire hazard. Contact a licensed qualified contractor to further evaluate and make the necessary repairs.

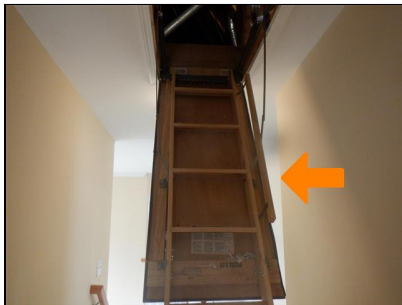
There is no insulation installed on the back of the attic stairs. This can result in a large source of heating and air loss, installation of insulation and weather stripping is needed to prevent heating and air loss. **The ???? exhaust flue does not have proper clearance from combustible materials where it exits the attic.** Corrections are needed to prevent a possible fire hazard. Contact a licensed qualified contractor to further evaluate and make the necessary repairs.

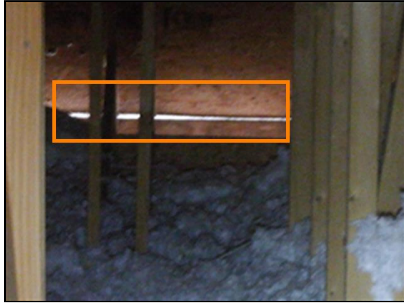
Daylight is visible between the roof sheathing and the fascia in the attic. This can allow moisture and pest intrusion to occur.

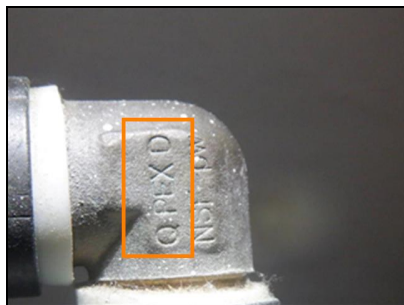
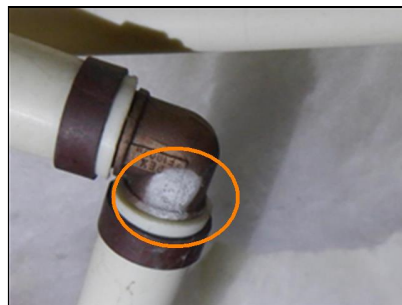
The visible plumbing lines in this home are plastic PEX with QPEX metal fittings manufactured by the Zurn Corporation. These plumbing fittings are the subject of a consumer class action lawsuit and settlement due to fitting failures related to dezincification. After years of consumer complaints, the Zurn Corporation has acknowledged that it has seen an increased number of premature failures and leaks in its QPEX fittings. Evidence of fitting deterioration was noted during the inspection in a few/several locations. A licensed plumbing contractor should be hired/consulted for a complete evaluation of the plumbing system to determine the general condition of the plumbing distribution and supply lines, the significance of this concern, and make all necessary and any additional repairs needed as deemed necessary. The client should visit the class action settlement website for more information, www.PlumbingFittingSettlement.com.

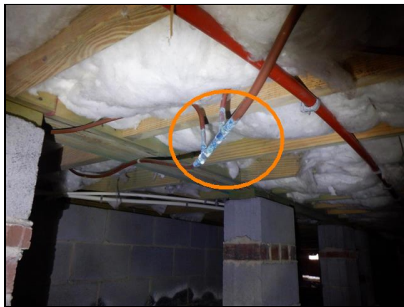
Corrosion was noted at connections and/or fitting at the copper gas lines. Have these areas further evaluated to ensure there is no risk of leakage.

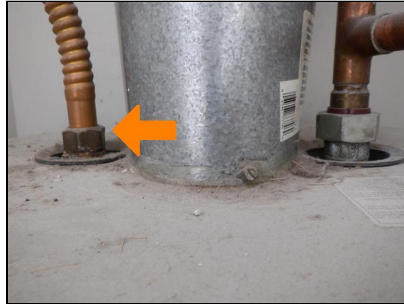
The water heater is missing a dielectric connection at the top of the tank where the hot and cold plumbing nipples connect to the supply lines. When two different types of metal connect together, it may cause corrosion and/or leakage to occur. A dielectric connection is recommended by the manufacturer and/or the home warranty companies to have the proper connections installed. Note: The manufacturer and/or home warranty companies may deny any repairs to the water heater if the supply lines are not properly installed. Contact a licensed qualified contractor to further evaluate and make the necessary repairs.

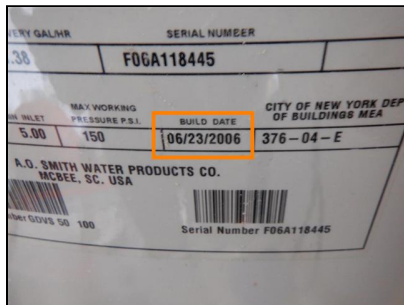
The water heater appears to be above ten years of age. The lifespan of a typical water heater is noted to be 10-15 years for an electric water heater and 15-18 years for a gas water heater. The lifespan can depend on several things: the condition of the water; if the water heater is maintained properly; the location of the water heater (crawl space, interior closet, garage, etc.); and several other factors. Due to additional factors, it is impossible to determine the lifespan of the water heater(s) currently installed and/or the additional years left for the water heater.

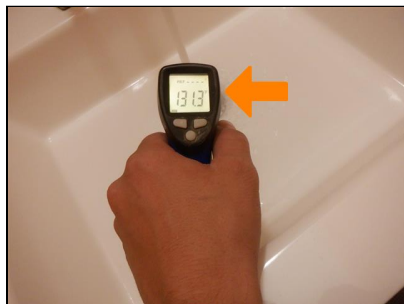
The hot water temperature at the time of inspection was 131 degrees. Water temperatures at or above 125 degrees can burn or scald. This is a safety hazard. The hot water temperature needs to be adjusted to below the current setting. Contact a licensed qualified contractor to further evaluate and make the necessary repairs.

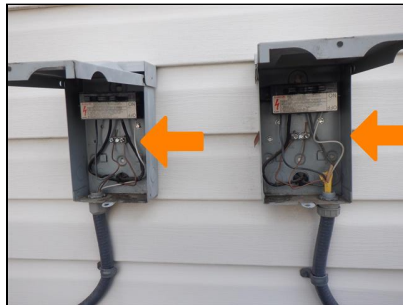
The electrical panels behind the exterior HVAC units are missing internal covers. This can be dangerous as there is no protection from live electrical wiring when the outer cover is open/unlocked. An interior panel cover should be installed for safety reasons. Contact a licensed qualified contractor to further evaluate and make the necessary repairs.

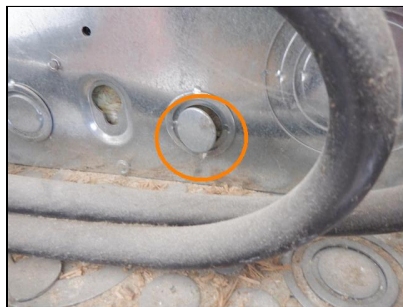
There is a nail protruding through the back of the main electrical panel. This should be blunted, capped off or removed to prevent possible damage to electrical components within the panel. Contact a licensed qualified contractor to further evaluate and make the necessary repairs.

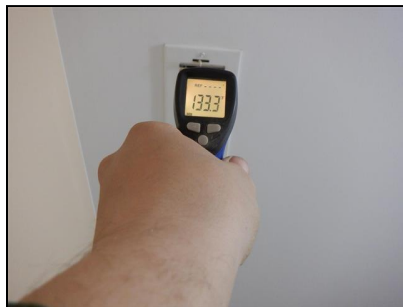
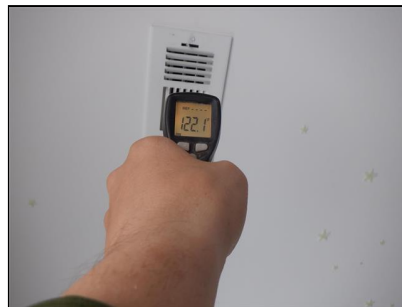
Second Floor Heat - 133-122 Degrees.

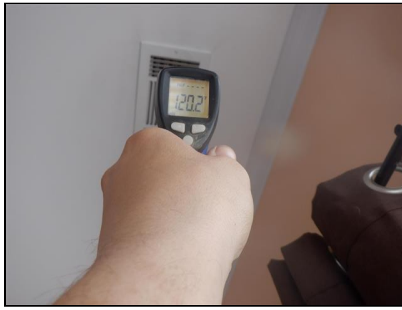
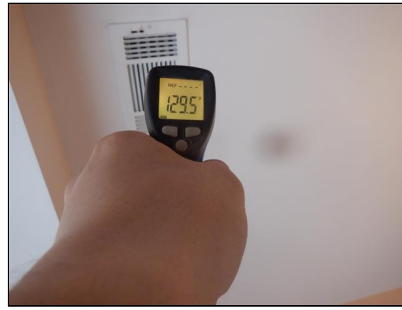
Primary Heat - 120-129 Degrees.

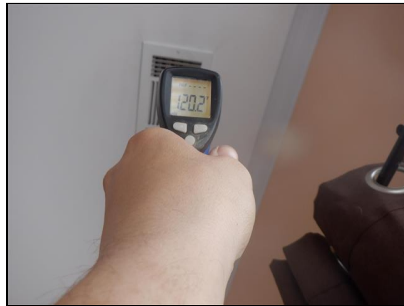
1st floor

Uneven temperature distribution and/or air flow was noted at the supply air registers when testing the HVAC system. Because of this some areas of the home may be noticeably warmer or cooler than the rest of the home. Some variation is to be expected between different air registers, however these variations should not be more than a few degrees difference between air registers located on the same floor. Contact a licensed qualified HVAC contractor to further evaluate and make the necessary repairs.

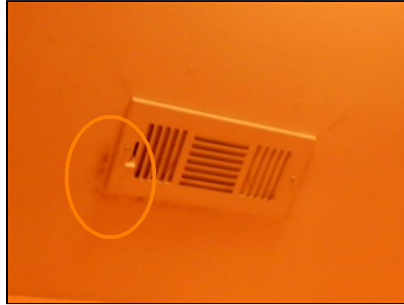
Discoloration was noted on the ceiling around the ducts. This may be an indication that the ducts are in need of cleaning. Contact a licensed qualified contractor to further evaluate and make the necessary repairs.

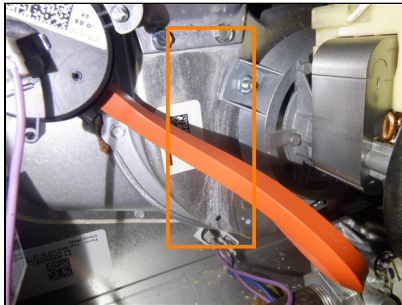
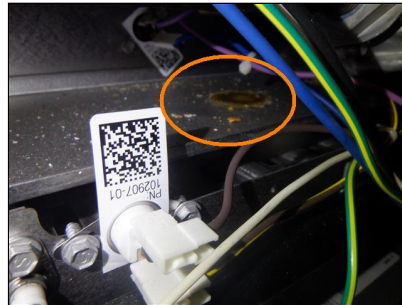
Rusting/corrosion was noted inside both of the furnace cabinets in the attic. This is evidence of a leak at or within the units. Unable to determine the source of the leak or the extent of damage at the time of inspection. Further damage may occur if not corrected. Contact a licensed qualified HVAC contractor to further evaluate and make the necessary repairs.

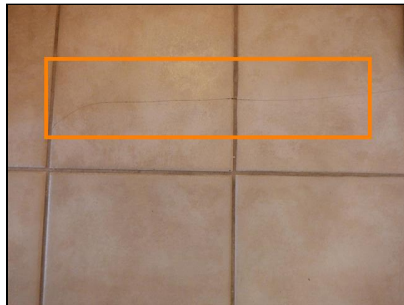
Cracking was noted at the floor tiles between the laundry room and the kitchen/hall areas. Further cracking may occur if not corrected. Contact a licensed qualified contractor to further evaluate and make the necessary repairs.

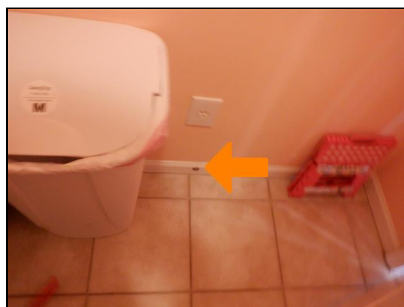
There are door stops missing/damaged behind doors in areas throughout the home; replacement needed to prevent possible damage to the walls behind the doors.

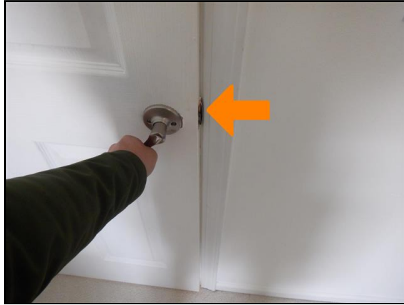
The rear left bedroom door rubs the door frame. Corrections are needed to allow proper function. Contact a licensed qualified contractor to further evaluate and make the necessary repairs.

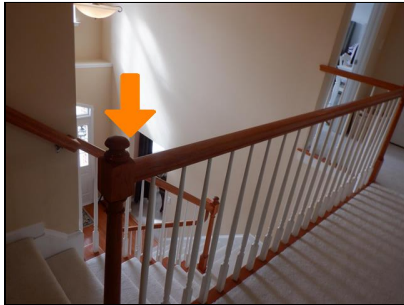
The banister is loose at the top of the stairs that needs to be secured properly to ensure safety. Contact a licensed qualified contractor to further evaluate and make the necessary repairs.

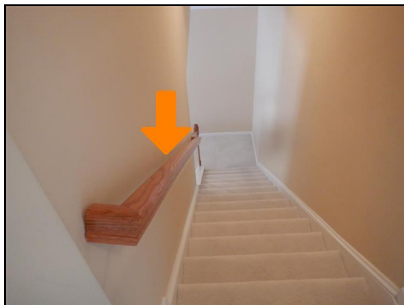
The handrail is loose at the interior stairways and needs to be secured properly to prevent it from coming loose and to ensure safety. Contact a licensed qualified contractor to further evaluate and make the necessary repairs.

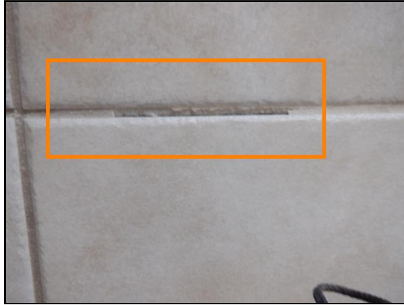
Loose grout and/or tiles were noted at the floor in the master bathroom. **Corrections are needed.** Contact a licensed qualified contractor to further evaluate and make the necessary repairs.

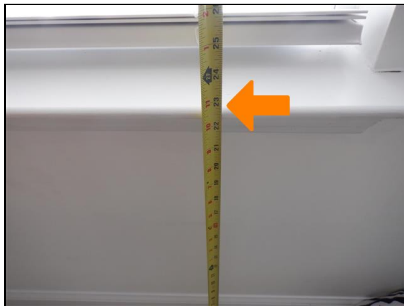
There are no child safety latches installed on some or all of the windows within the home that have a window sill that is less than 24" from the floor. This poses a fall safety hazard at the window(s) especially for children. Child safety latches are required on all windows that are more than 72' above the exterior grade when the window sill is less than 24' from the interior floor (or 36" above the floor in some jurisdictions). Have a qualified licensed contractor further evaluate and make any additional repairs as needed or deemed necessary.

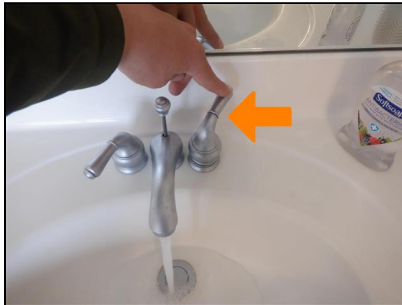
The master bathroom faucet handles nearest the closet are stripped (spin all the way around). If the handles are not placed in the exact location the water will continue to drip, repair and or replacement needed. Contact a licensed qualified contractor to further evaluate and make the necessary repairs.

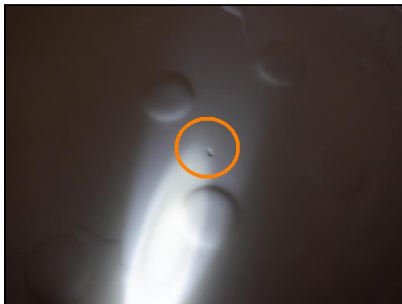
There is a chip in the master bath tub. Further damage and possible leakage may occur if not corrected. Contact a licensed qualified contractor to further evaluate and make the necessary repairs.

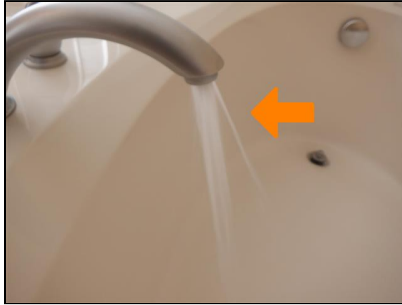
The master bath tub faucet has over spray when in use. Corrections are needed to allow proper function. Contact a licensed qualified contractor to further evaluate and make the necessary repairs.

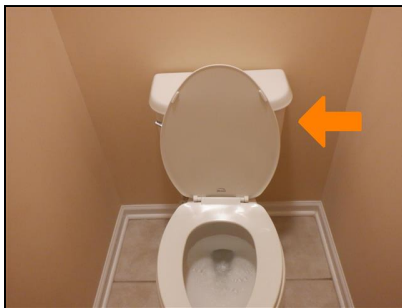
The toilet valve makes unusual noises when operating. Repair or replacement may be needed to ensure proper function. Contact a licensed qualified contractor to further evaluate and make the necessary repairs.

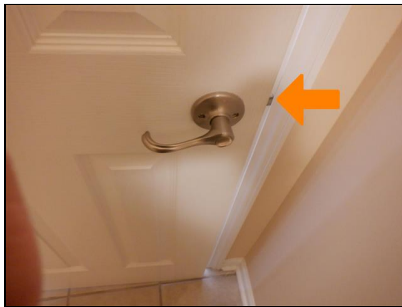
The water closet door in the master bathroom does not latch closed. Corrections are needed to allow proper function. Contact a licensed qualified contractor to further evaluate and make the necessary repairs.

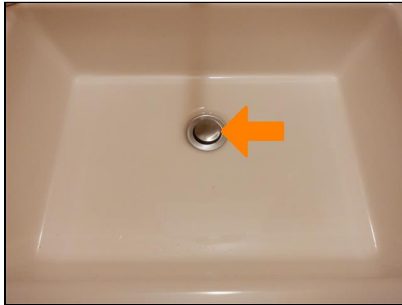
The sink stopper did not function properly at the time of inspection. When fully engaged water still drains. Contact a licensed qualified contractor to further evaluate and make the necessary repairs.
