Home Inspection Report

Home Inspection Summary

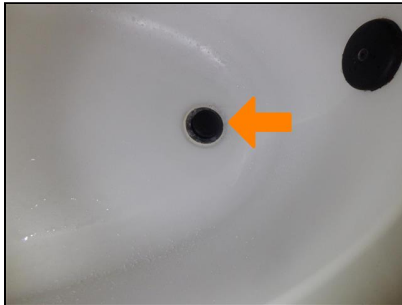
The tub drain stopper did not function properly or respond to the lever when testing at the time of inspection and needs repair or corrections. Contact a licensed qualified contractor to further evaluate and make the necessary repairs.

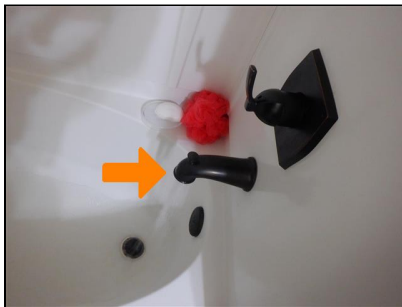
The faucet handle and or tub faucet are loose in the wall and need to be secured properly to prevent movement and possible leakage. Contact a licensed qualified contractor to further evaluate and make the necessary repairs.

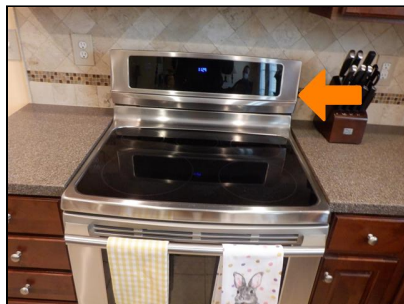
Though not required by code, the stove does not have an anti-tip device which you may want to install after closing. This is a bracket that attaches behind the oven at the wall/floor and the rear "foot" of the stove locks into it. Should you happen to have a child in the house learning to walk and they decide to pull-up on the oven handle it will prevent the stove from tipping forward and spilling hot items on top of the stove onto the child.

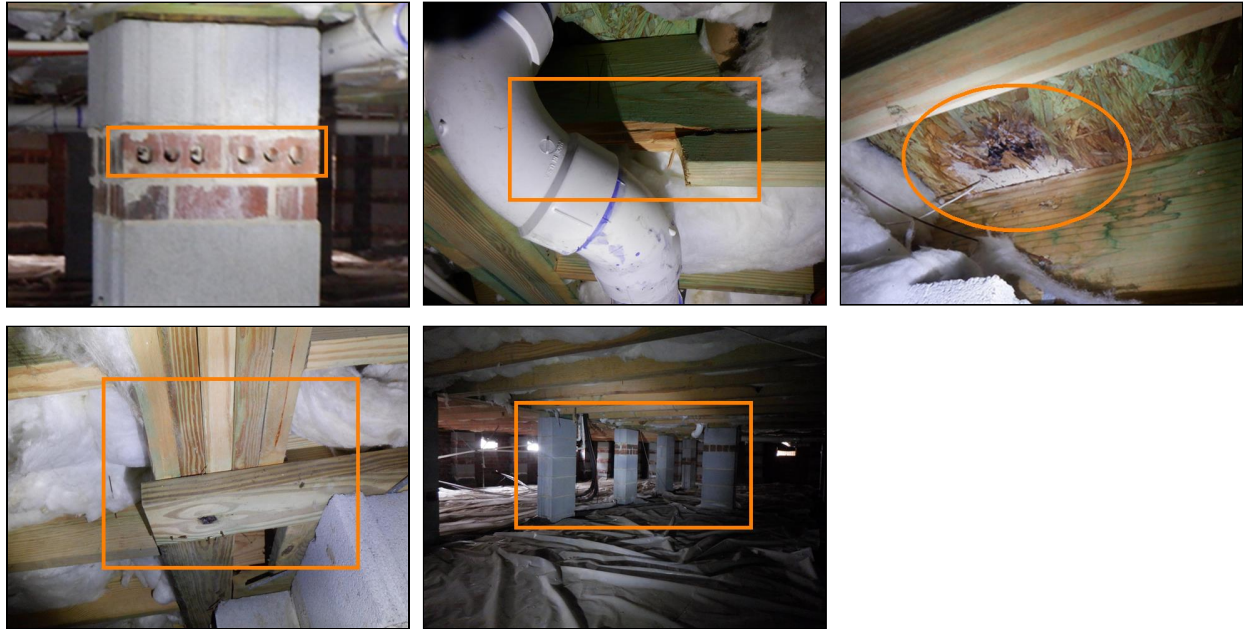
E. Single stack of solid or open cell, 8x8x16 CMUs were observed to be stacked higher than 36 inches, as measured from the top of the footer to the top of the last concrete block. Typically concrete blocks are allowed

a maximum height is 36 inches; however, there may be an exception to the rule depending on different construction methods. Because of this, it is recommended that you consult with a qualified licensed engineer to evaluate further and determine if the current installation is installed to support the structure of the home properly.
