# Service Information

Category <b>S</b>	<b>Repair Guidance</b>	Ref. No. R017/16A	Page 1 of 6
Coverage Distributor only Please inform your dealers		Date Issued February 26, 2016	
Please convey this information to your Director General Manager Warranty Dept. Parts Dept. Training Dept. Field Rep.		Date Revised <b>March 29, 2016</b>	
Applicable Model  MX-5 (ND) with INNER CLOTH		Applicable Countries or Specifications  Worldwide

## Subject: Convertible Top-Inner Cloth coming off causing Poor Appearance and Obstructing view of Back Window

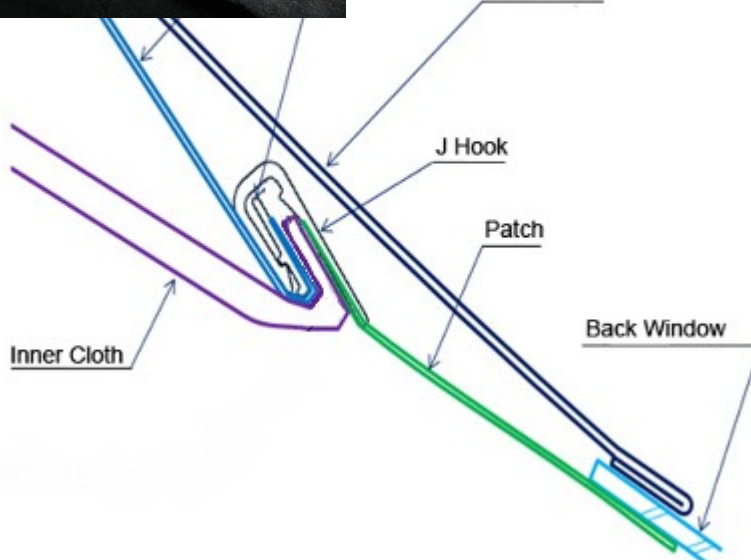
-Cross  
Tension  
Inner  
how they  
in J-Hook-

view of  
Cloth and  
cloth to show  
are installed

4). Lightly pull the inner cloth and verify that the inner cloth does not come off easily.

**2. Install the top-protectors onto both edges of the J-hook.**
