DSV Bibby Topaz Incident 18th Sept 2012

Agenda

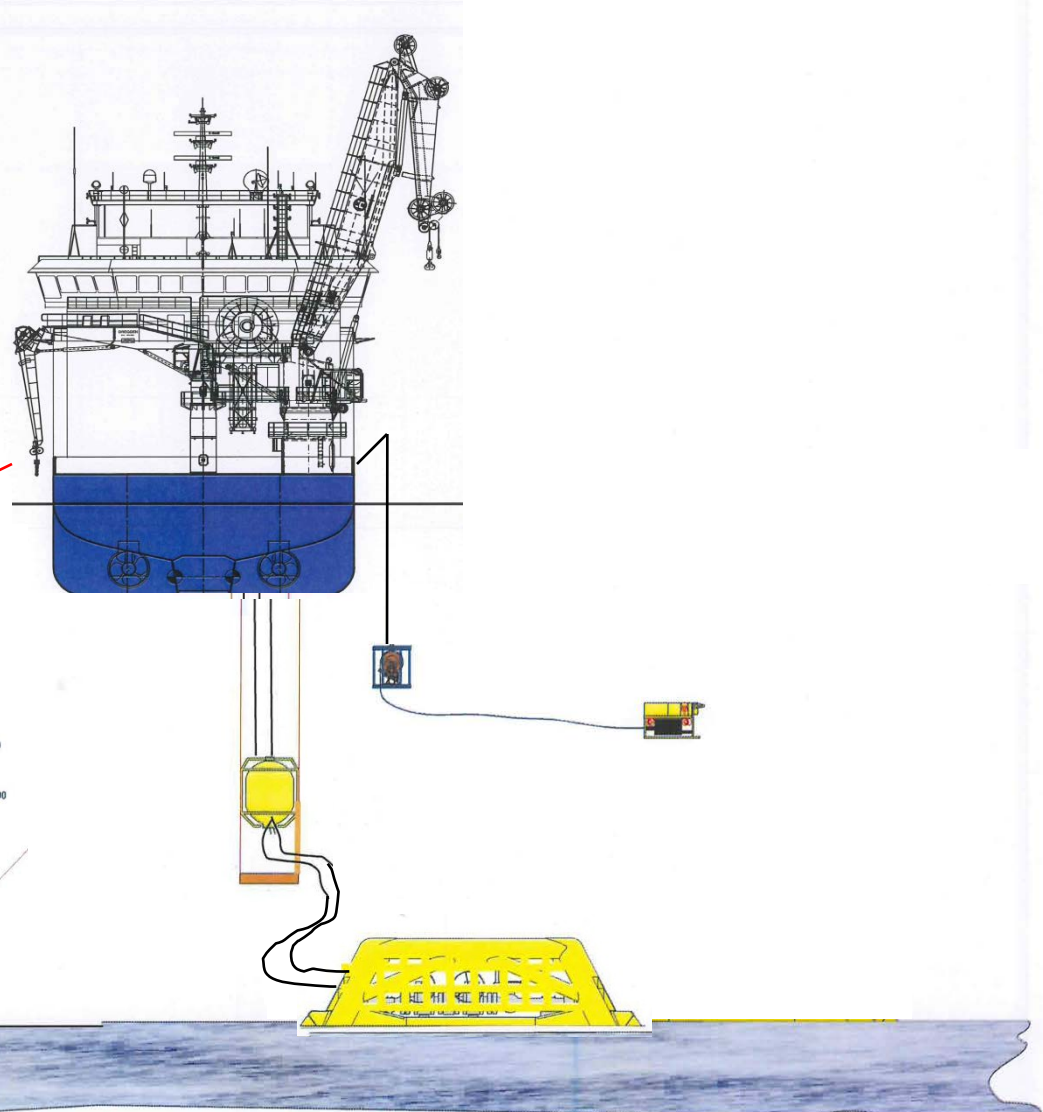
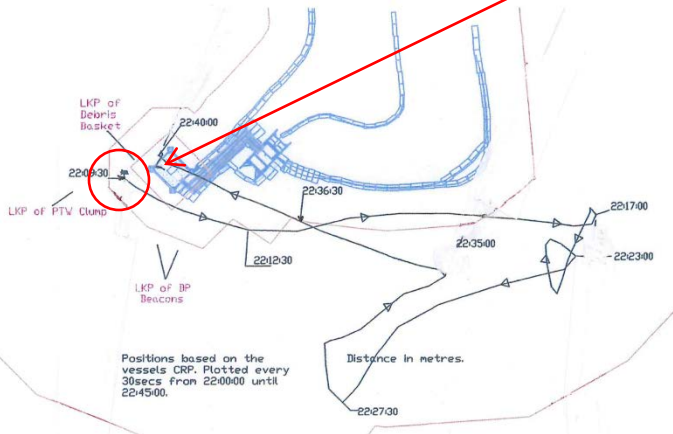
Time Line – 20.49 to 22.09

- Diver 1 & 2 located inside drilling template structure carrying out barrier testing activities
- ROV monitoring

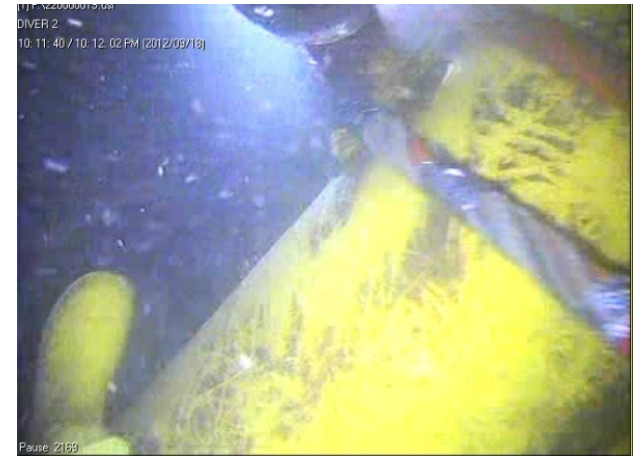
Easterly Direction

- Diver 2 umbilical snagged on transponder bucket located on side of structure
- Diver 1 pulled off template
- Momentary loss of comms to bell

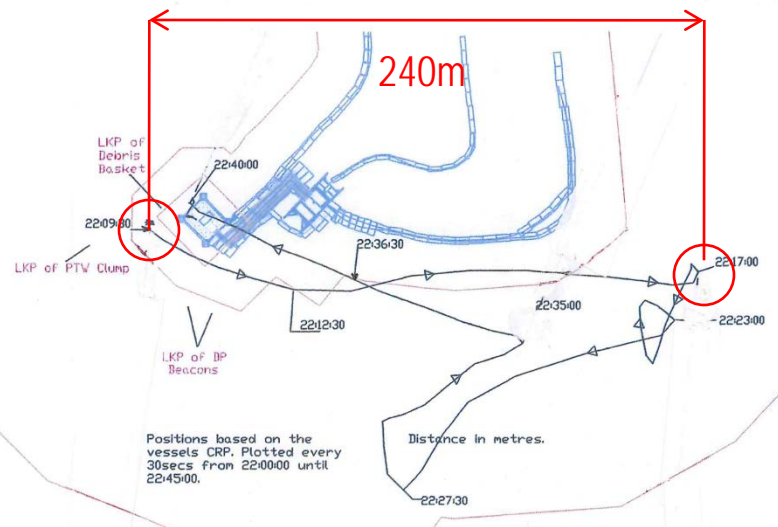
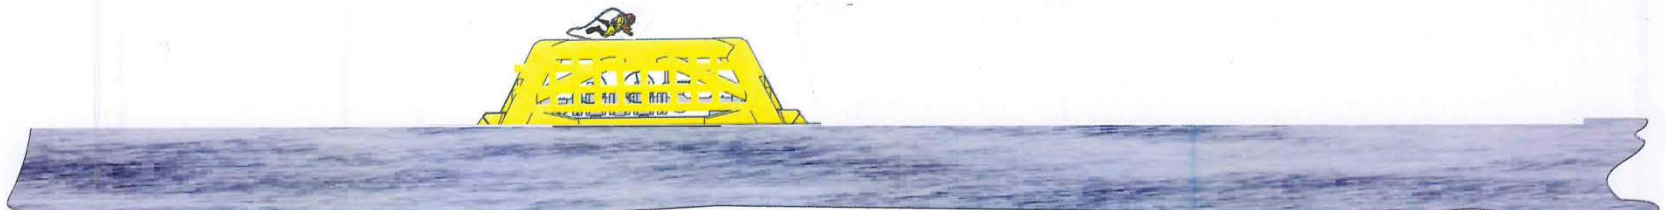
Time Line – 22.17

- Vessel position 240m East of Drilling Template
- Vessel being manually driven using forward and aft azimuths
- Chief Officer on thrusters 2 & 3, Master on main propulsion thrusters 5 & 6
- Diver 2 locator beacon identified to be at template

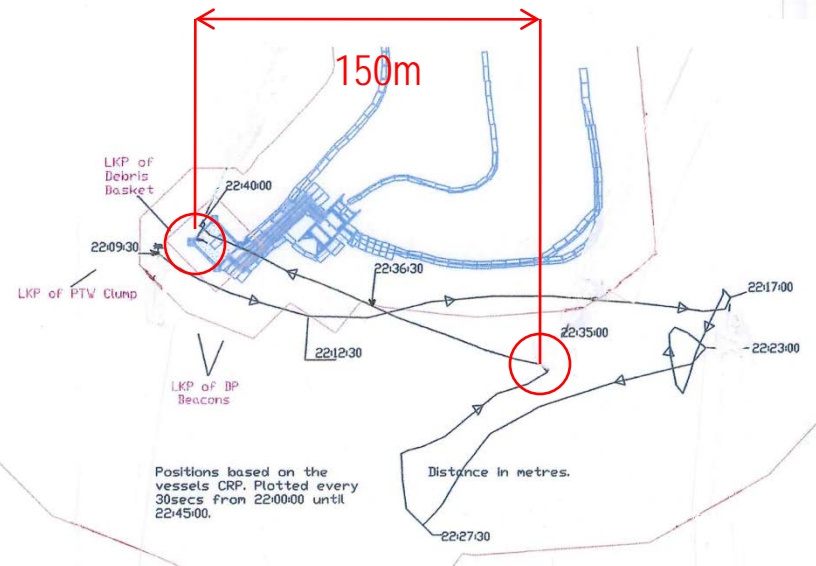
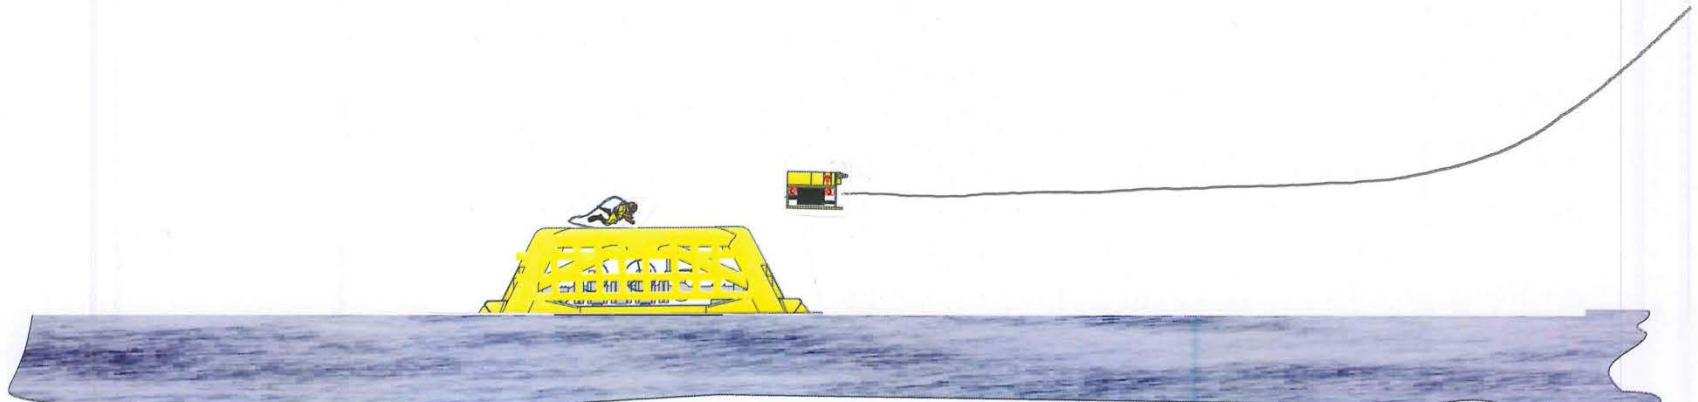
Time Line - 22.29 – 22.34

- ROV back at Drilling Template
- Diver 2 located on top of template
- DP controllers power recycled
- Vessel back on full auto DP

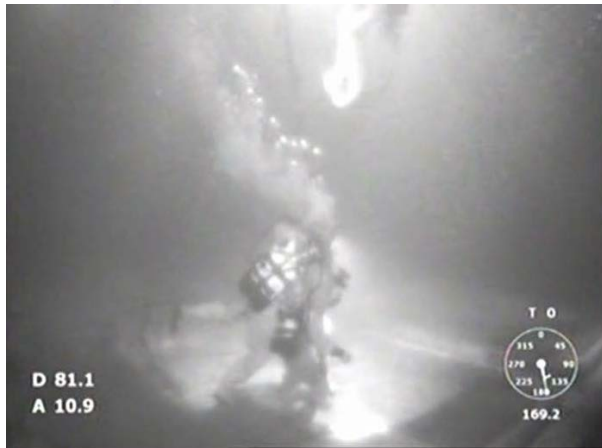
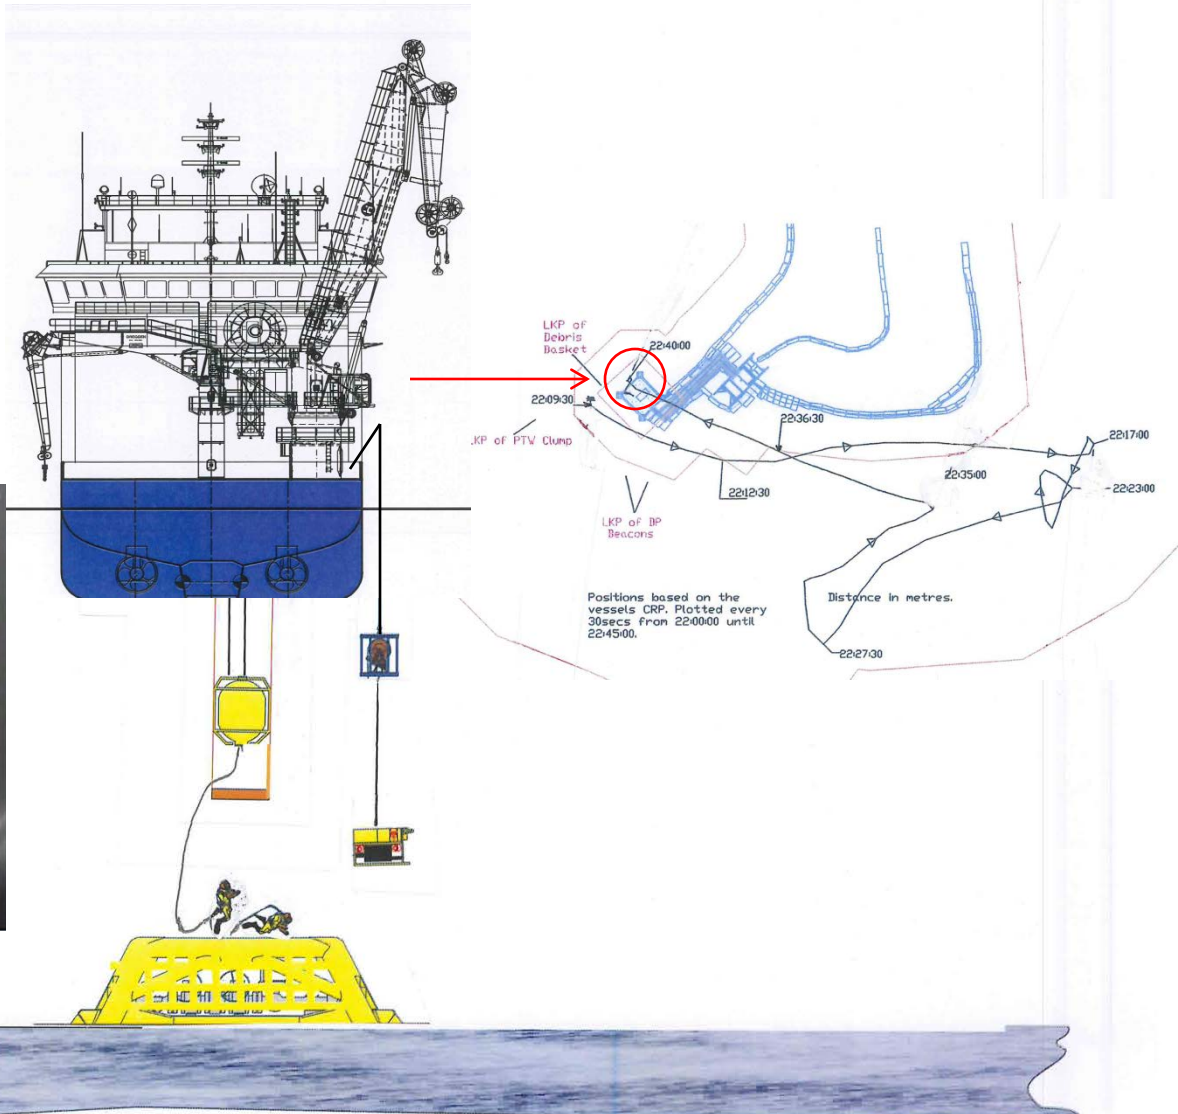
Time Line – 22.40

- Vessel back at Drilling Template
- Diver 1 left stage, bell 18m from template
- Recovery of Diver 2 commenced

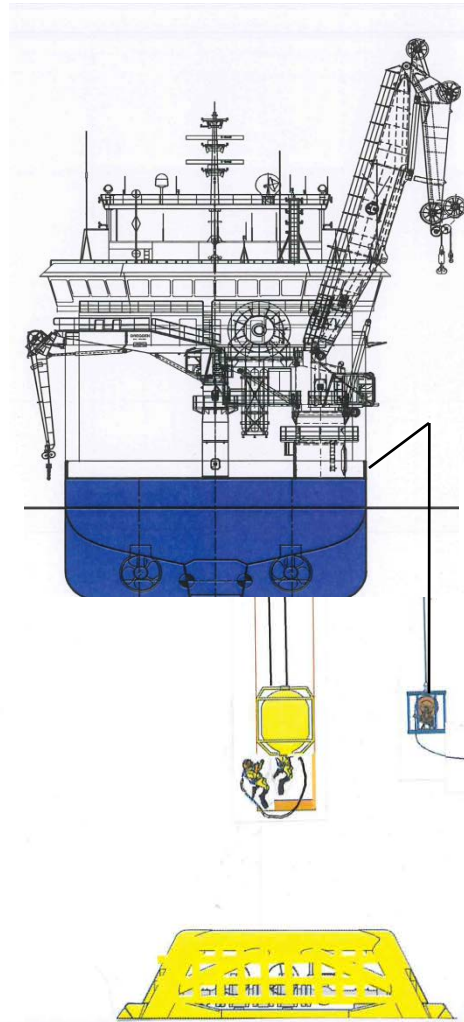
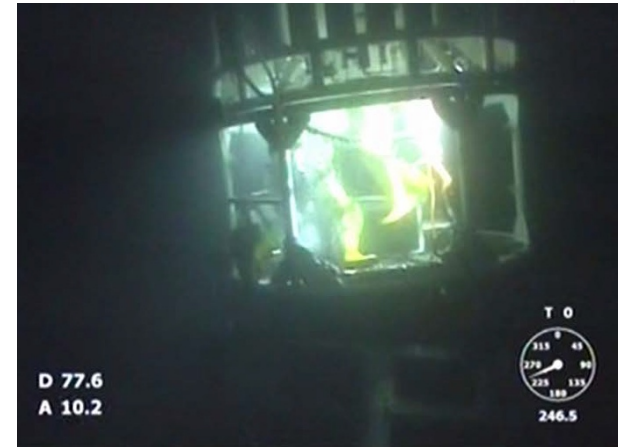
Time Line – 22.46

- Diver 2 recovered to bell, unconscious & breathing
- 23.04 Diver 2 stable, vital signs good, talking
- 23.13 Bell sealed and left bottom
- 23.38 Bell locked on
- 23.50 ROV recovered
- 24.00 commenced transit to port
