# Hawker Hunter

## Airworthiness Certification

AIR-230 Airworthiness Certification Branch  
Federal Aviation Administration  
Washington, D.C.  
January 18, 2013

Subject: Hawker Hunter Airworthiness Certification

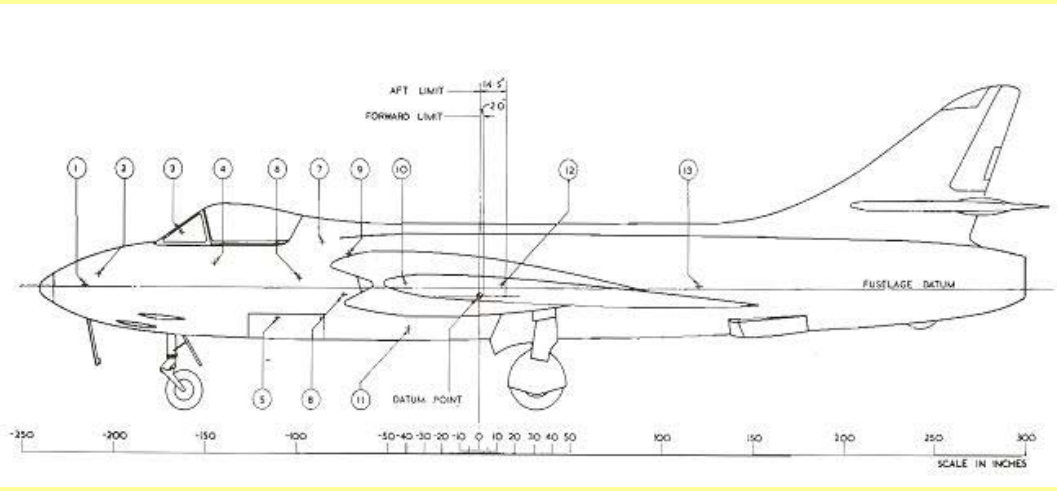
Issue#	Issue(s)	Recommended Review, Action(s), and Coordination with Applicant	Notes, Action(s) Taken, and Disposition
250.	Accurate Weight and Balance (W&B)	<p>Review original W&amp;B paperwork. Verify adherence to RAF/SAF guidance (TM NO. 73.920-12), as well as FAA-H-8083-1, <i>Aircraft Weight and Balance Handbook</i> if documentation by the applicant appears to be inadequate.</p> <p><u>Additional Information:</u> In the Hunter, W&amp;B is critical, as indicated by a CG range between aft and forward limit of 5.5 inches (see diagram below). Several former military combat aircraft accidents have been linked to center of gravity miscalculations. For example, in 1995, a U.S. registered Hunter was involved in a tail strike and it was determined that the aircraft, not fitted with its gun package/or the replacement modification suffered from an out-of-balance situation, which fortunately did not result in injury or destruction of the aircraft (see <i>Modification JH 037</i> above). Other components may have an impact on the aircraft's CG range. For example, part of the ARI 5820 ranging radar system (100 lb) and the 30 mm guns (793 lb) have been removed and 582 lb ammunition may not be carried. Removal of the three heavy Vinten F95 cameras in the Hunter FR10 (some FR10 were modified with a heavier package of KA56, KA93, 116 cameras and Red Linescan) would also be an issue, as would the replacement of the heavy radio equipment (i.e., the 56 lbs. Collins UHF) now replaced by modern and compact units, or removing the armor plating fitted to many Hunter around the cockpit area. As an example, the starter installation (upgrade from Avpin starter system) involves replacing some of this weight at the gun pack (between frames 15 and 17A). The datum was then defined as the foremost face of a spigot situated in the port wheel bay on the fuselage skin just forward of the undercarriage door hydraulic jack. This type of data is found in many U.K. Hunters, where aircraft are weighed by plane weighs. As examples, U.K.'s CAA Report 3943 dated August 27, 1996, Planeweighs Report No. 3562 dated January 11, 1996, and weight schedule JHL/H/EGH/25 dated March 7, 1996, can be consulted. This would also confirm whether the aircraft will remain within weight and CG limitation with pilots of 120 to 250 lb at any fuel state. CG to be between 1.0 inches forward of datum and 14.5 inches aft of datum. Datum is marked by a spigot in the port main undercarriage bay. Also, W&amp;B computations must include any addition or variation of external loads mounted on the wing pylons and the data must be based on the applicable military service guidance, i.e., Swiss Air Force. For example, the Swiss Air Force permitted certain types of loads in the outboard pylons, including the large 991 lbs. bomb on outboard pylons, but because these are aft of the CG, there were tight limitations in terms of speed range. Another Swiss AF example is that in the AGM-65 configuring weight on the outboard pylons, 290 lb. are needed in the cannon area.</p>

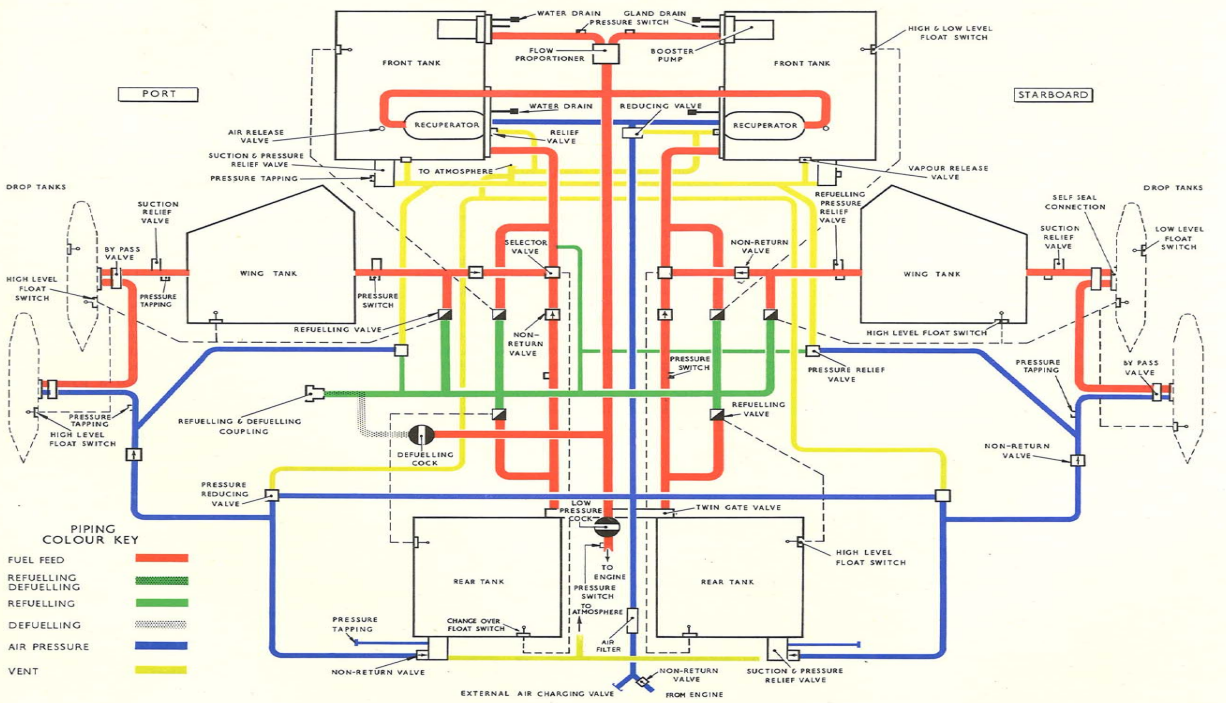
<p style="text-align: center;"><b>Fig. 2 Fuel system diagram</b></p>

Issue#	Issue(s)	Recommended Review, Action(s), and Coordination with Applicant	Notes, Action(s) Taken, and Disposition
372.	Fuel Mismanagement (General)	<p>Ensure SOPs emphasize on fuel management and fuel starvation. The Hunter has a very complicated fuel system, and it has been implicated in many accidents.</p> <p><b>Additional Information:</b> For example, the Hunter FGA9 has four flexible bag-type tanks in the fuselage and four in each wing. Front fuselage tanks of 200-Imperial gallons capacity and rear fuselage tankage is 52 Imperial gallons. There are issues with the fuel system, including determining total fuel, quantity remaining, fuel transfer/boost pumps, and fuel in external tanks. Several Hawker Hunter accidents, including a recent one in the U.S., were related to fuel mismanagement. A common Hunter fuel mismanagement accident would read the engine flamed out due to mismanagement of the fuel booster pump switches following fuel transfer failure. A British Hunter pilot describes the reason for a flameout on the aircraft: "...the reason for the flameout was also discovered. On the right-hand side of the cockpit were two switches and two 'doll's eye' indicators. The switches were to feed fuel from the wing tanks to the engine, and they were both found to be selected off" (Mercer, 2006). Hunter experts note one of the "most important skill that the new students had to learn was to understand and manage the Hunter's low fuel reserves. Managing the aircraft's fuel state was vital, and a great deal of attention was given to this aspect of instruction; indeed, most training sorties even required to radio fuel state reminders to each pilot as they flew their sorties." In the case of the Hunter Mk. 6, a detailed review and understanding of <i>Part III Handling of A.P.4347F-PN Pilot's Notes</i> is critical for safe flight. Boost pump failure is also an issue. A RAF Hunter pilot described a case where "one of the two boost pumps situated in the main fuselage tank had failed. This necessitated [the] switching off the working pump and accepting the fuel feed provided by tank pressurization and gravity. Normally, a booster pump failure represented no great problem. Pilot's Notes recommended that the engine be throttled back to about 80% of maximum engine RPM and this was fine for level flight below 20,000 feet. It was a bit dicey for overshooting [go-around] from a baulked approach, and was certainly not good enough for take-off – that last 20% of engine speed represented an important slice of power." White, <i>Lightning Up</i>, 2009.</p>

Issue#	Issue(s)	Recommended Review, Action(s), and Coordination with Applicant	Notes, Action(s) Taken, and Disposition
373.	Fuel Transfer	<p>Within the context of fuel mismanagement, give special interest to the fuel transfer system in the Hunter. SOPs should emphasize this.</p> <p><b>Additional Information:</b> A civilian Hunter pilot wrote that “the Hunter has a somewhat complex fuel system composed of six internal fuel tanks and an automatic fuel transfer system. The first two tanks (in the rear of the fuselage) are emptied soon after takeoff. Sometimes the automatic transfer lags, and you simply override it to the proper tank.” Fortin, <i>Back to Basics</i>, 2004. The following excerpt from the Hunter Mk.6 Pilot Notes is provided to illustrate the complexity of the Hunter’s fuel transfer system: “Air pressure for the transfer system is taken from a tapping on the engine compressor and is separately fed to the fuselage rear tanks, to the recuperators in the front tanks, and to the drop tanks or the wing tanks, if the drop tanks are not fitted. When drop tanks are fitted, fuel transfer is from outer tank to inner tank to wing tank. When Mod. 574 is embodied two magnetic indicators, one for each <i>outboard</i> wing tank, are situated aft of the fuel gauges. Each shows white when all fuel has transferred from its associated <i>outboard</i> drop tank. Control of the system is by two TANK SELECTOR switches, one for each side of the system. Each switch has three positions, AUTO (forward), REAR (central), and WING (aft). When the switches are set to AUTO the air pressure forces fuel from the rear tanks to the front tanks. When each rear tank is empty a float switch in the tank operates to alter the setting of the transfer cock, shutting off the rear tank and allowing the drop tanks to feed to the wing tanks and the wing tanks to feed to the front tanks. At the same time, the WING/REAR tank indicator operates to show that this is happening. Setting either control switch to WING or REAR causes transfer to take place from the respective tank. When changeover from either wing or rear tanks is taking place the indicator shows yellow and the action of the selector cock motoring over is audible over the R/T. Although all internal tanks are gauged, and the contents reading should fall when fuel from those tanks is being used, when transfer from the drop tanks (which are un-gauged) is taking place the fuel contents gauge should show a constant reading. Should the air pressure fail, very little fuel will transfer from the drop, wing, or rear tanks and TRANS. PRESS indicators will indicate failure by showing cross-line. At the same time the contents gauge transmitters in the rear and wing tanks will become inoperative and the gauges will only indicate the contents of the front tanks, that is, the amount of fuel available to the engine. If only one side of the air pressure system fails, the appropriate indicator will show cross-line and the associated gauge will indicate the available fuel contents.”</p>
