Reliable Home Inspections Property Inspection Report

, TX 75150 Inspection prepared for: Date of Inspection: 12/28/2016 Size: 47000 Weather: Clear 50 Degrees

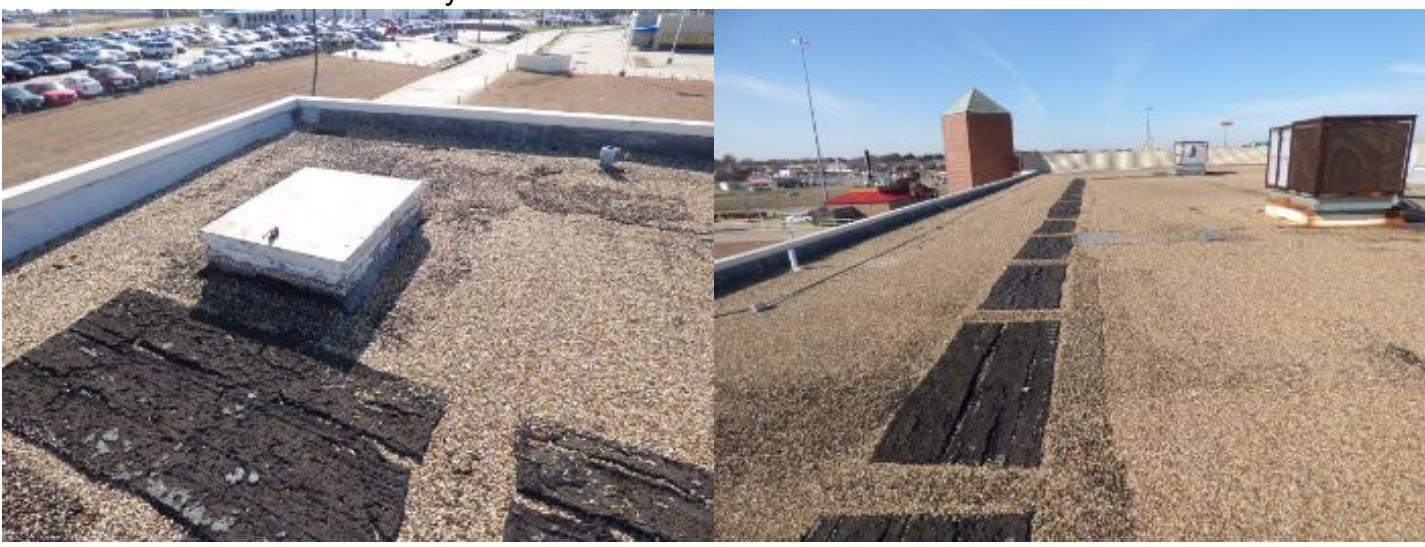
The Big Box roof is worn and has a short life expectancy. The roof does not appear to pond water and should be easy to recover.

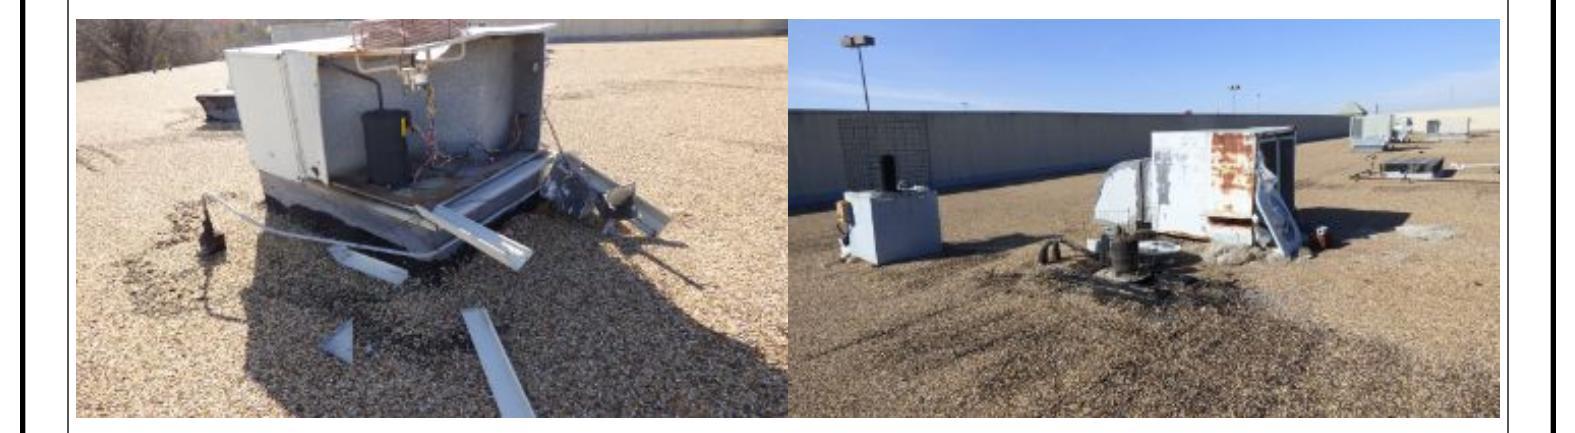
The Big Box does not have a working HVAC system. The current system has been discontinued and does not appear to be repairable. The new owner must consider replacement of the HVAC system and the removal of the old system. Removal will be a substantial expense and should be part of the new HVAC contractors bid. Roof mounted systems may be considered.

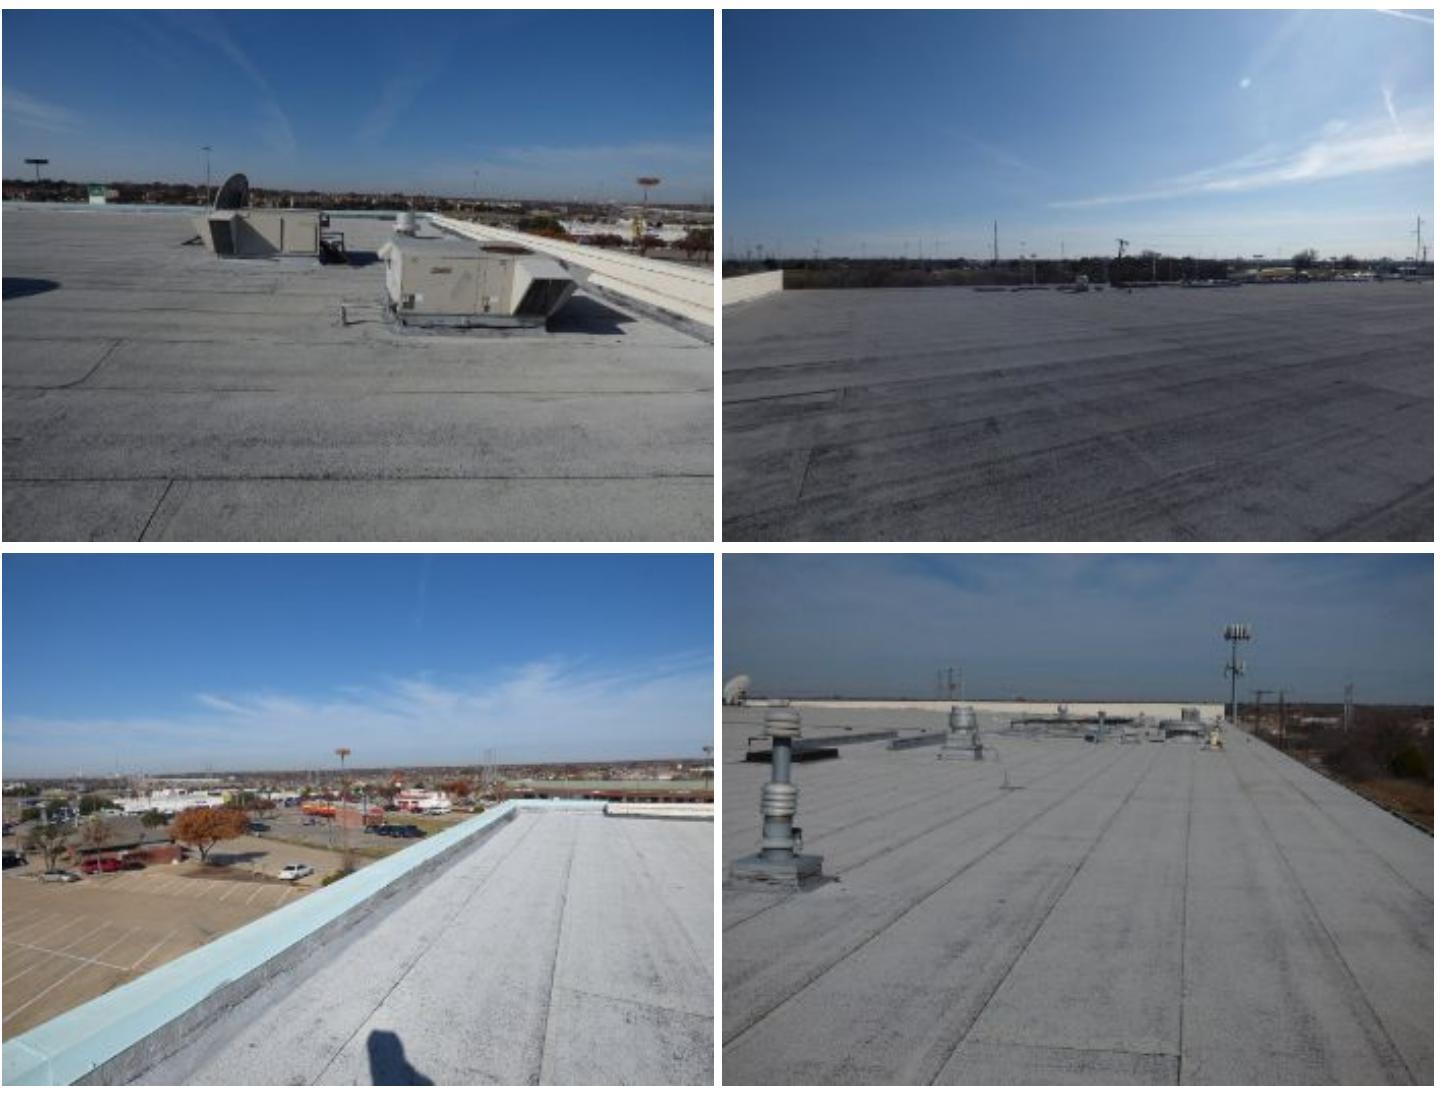
Big Box roof

Worn surface Big Box

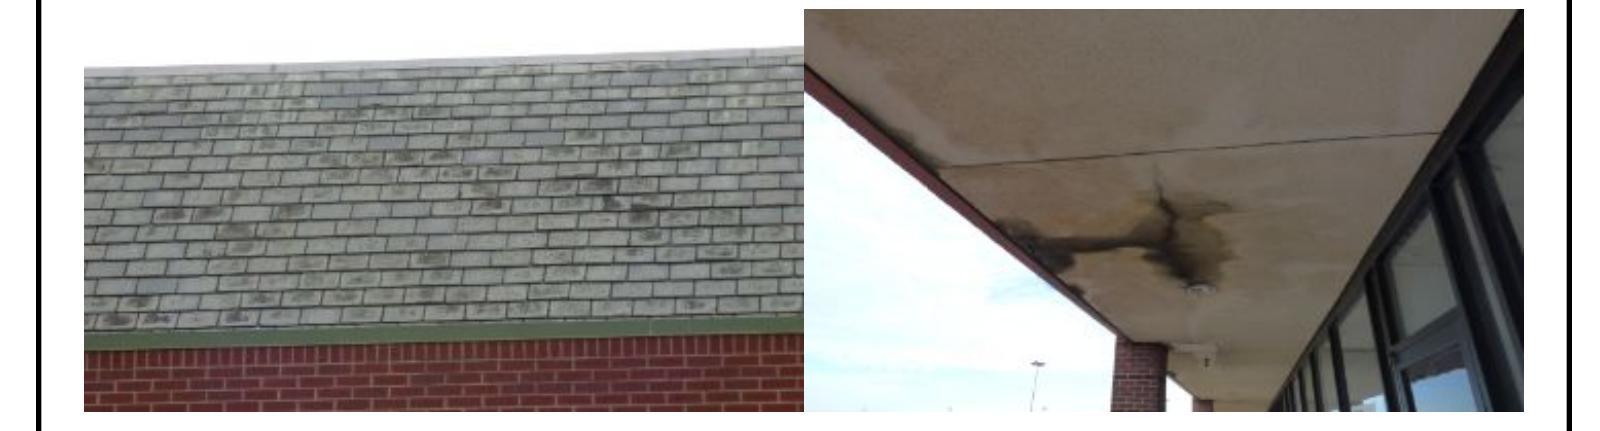
Slate roofing shingles are damaged and missing in many locations. The roof may have suffered previous hail damage. The roof material will need to be replaced and all underling damage repaired. (Slate replacement is \$10.00 per square foot @ 20,000 square feet). Total replacement cost \$200,000.

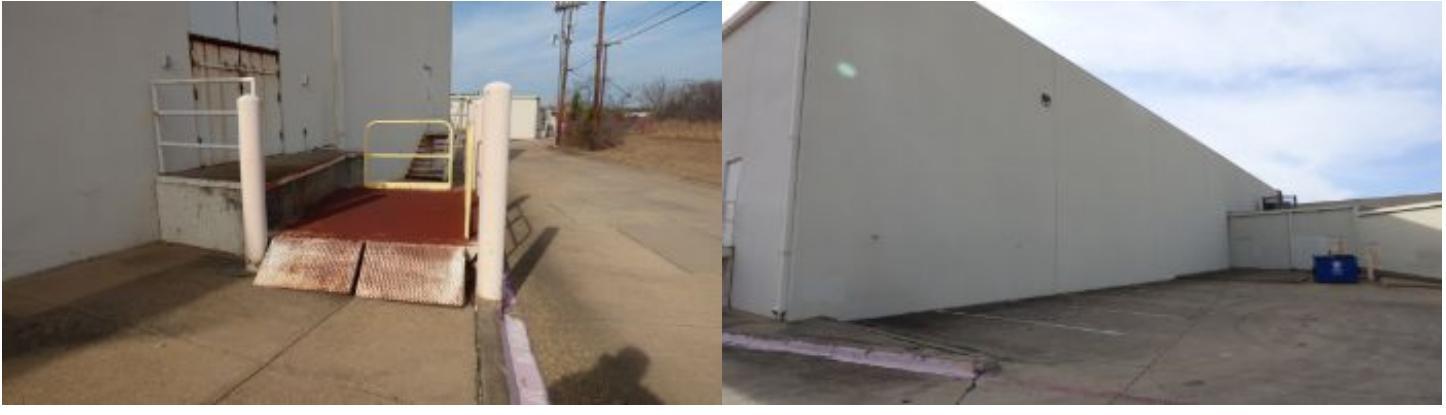
Loading Platform

The gutters needs to be repaired or replaced where damaged. The leakage can damage the exterior finish and cause substantial drainage issues.

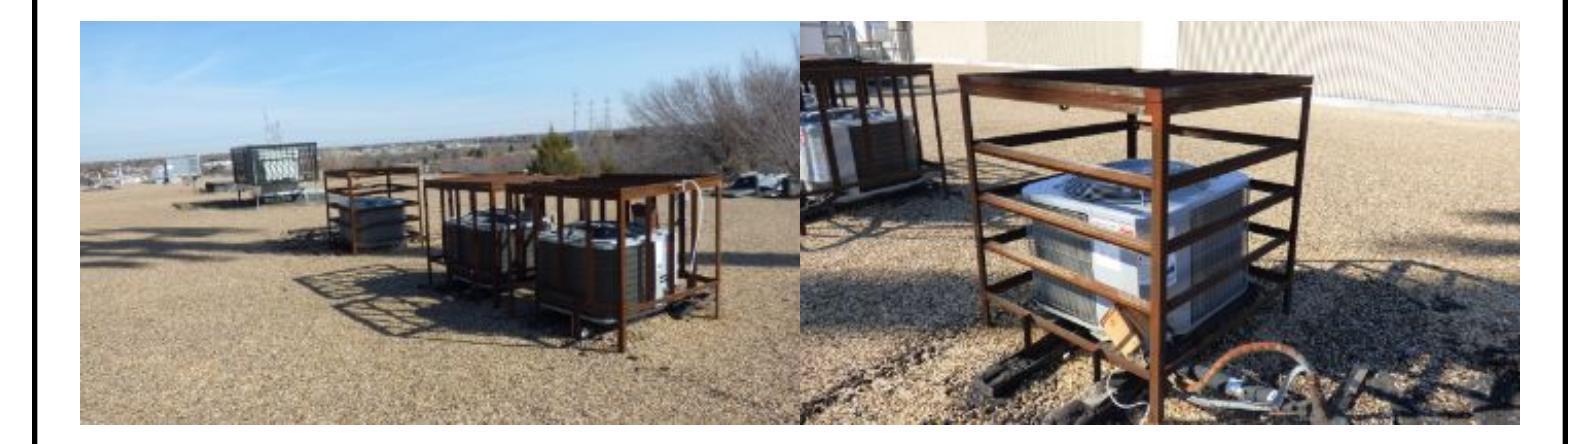
The Big Box does not have a working HVAC system. The current system has been discontinued and does not appear to be repairable. The new owner must consider replacement of the HVAC system and the removal of the old system. Removal will be a substantial expense and should be part of the new HVAC contractors bid. Roof mounted systems may be considered.

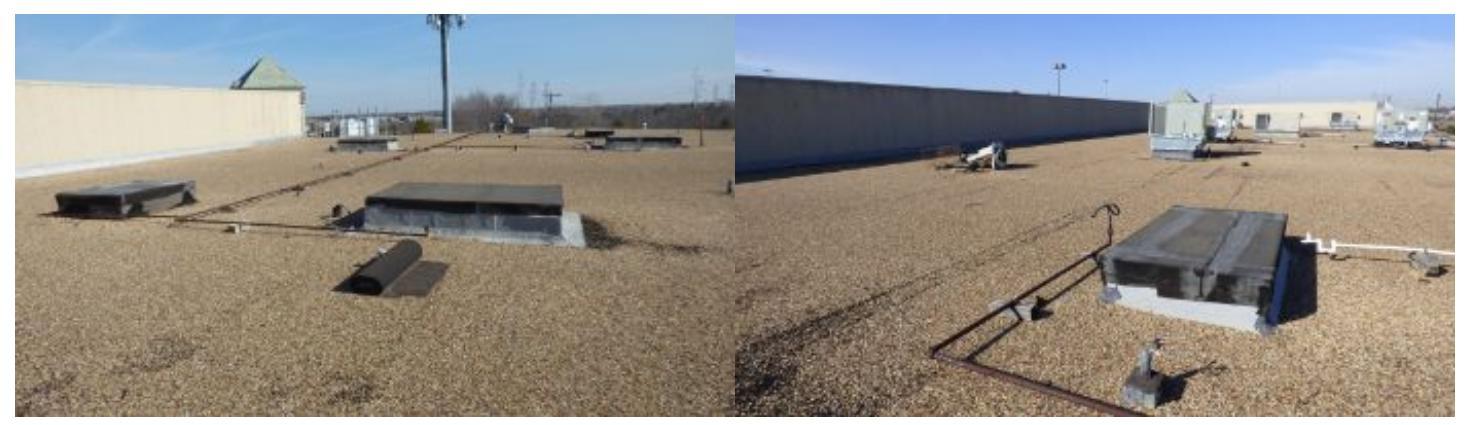
Removed Systems

Most of the vacant retail suites do not have exterior HVAC systems installed. The systems that were on the roof, have been striped for the condenser materials. Some of the suite do still have interior HVAC systems in the drop down ceilings, along with supply and return duct.

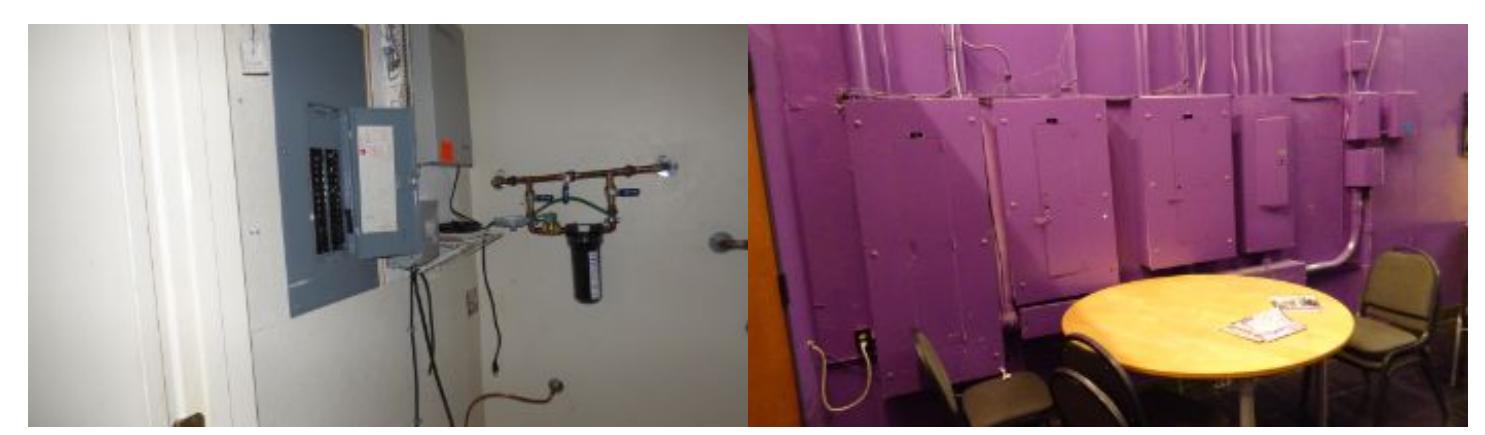
The Big Box electrical systems appear to be stripped of all electrical wiring. All electrical systems will have to be rebuilt.

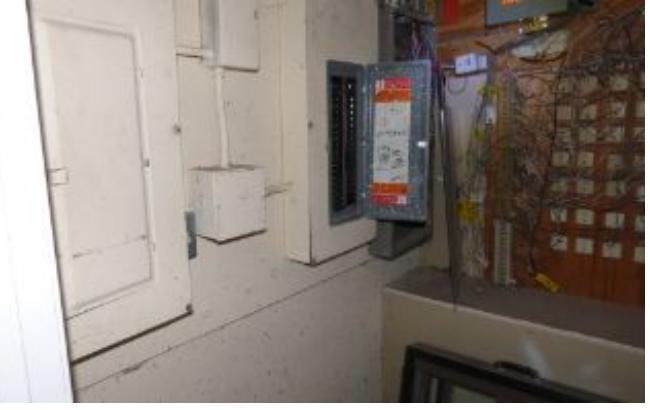
The Suites electrical systems are individually metered. The Suite have interior electrical panels appropriate for each unit at the size they are now.
