While the Saunders-Roe Lerwick was a handsome flying-boat, it flattered to deceive. It required many modifications but nothing cured its problems. As the RAF was faced with a paucity of modern equipment, the Lerwick was pressed into action and its brief service life was littered with accidents and fatalities.

THE LERWICK, BUT IT TURNED OUT TO BE AN ABJECT FAILURE. PETER LONDON

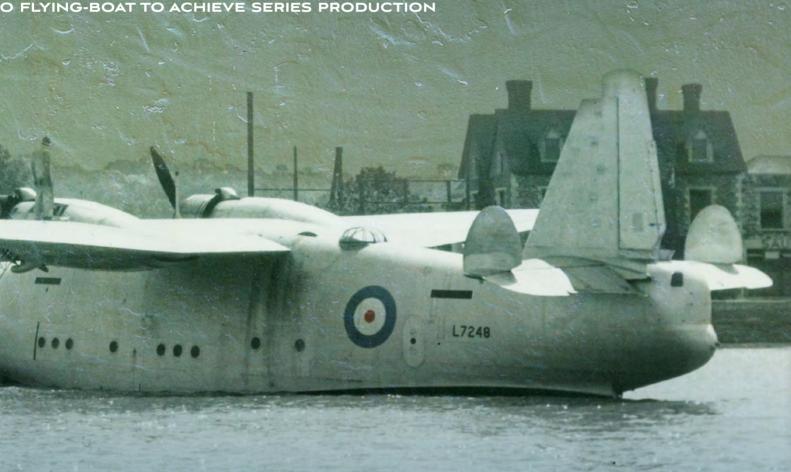
### Below

Lerwicks at East Cowes in the summer of 1939. All have extensions to their original upper rudder profiles, while LT248 (foreground) is fitted with auxiliary fins.

At MAEE, L7248's shortcomings were confirmed and it was returned to Cowes. It was given two auxiliary tailplane fins and an extended chord rudder, but no real improvement resulted.

Various combinations of enlarged and auxiliary tail surfaces, as well as an experimental twin fin and rudder configuration were tested. An enlarged fin extending from the leading edge and a rudder of increased chord and height were settled on, but it only marginally improved flight control. Investigations into water performance continued until 1941.

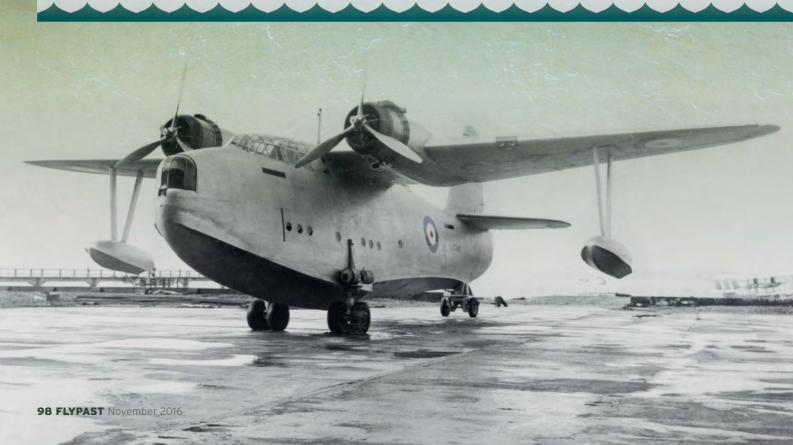
Below

The first Lerwick, L7248, at MAEE Felixstowe for assessment in March 1939. as war broke out across Europe, Ireland had declared its neutrality.

By January 1939 the second example, L7249, had begun testing, while L7248 passed to Marine Aircraft Experimental Establishment (MAEE) at Felixstowe, Suffolk, in mid-March. (MAEE moved to Helensburgh, Scotland, in September 1939.)
