Restoration Support 66 San Jose Unibody (Undercarriage)

The Process in Words

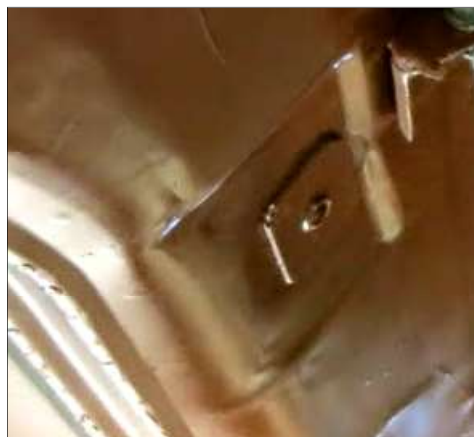
Front seat belt anchors without sealant.

There were periods of time at San Jose during the 1966 production run where the front inner seat belt anchors were sealed with a runny thinly sprayed on sealer applied before the floor color as applied as shown in the accompanying pictures on this page. At this time not pattern as to when this was done or not done have been established though earliest identified example with the spray sealant was from mid November. The final look, after the red oxide has been applied, often appears to be paint runs localized around the anchor.

- During much of the 1966 production at San Jose where the front inner seat belt anchors were sealed at this point with a thin runny sealant applied over and around the attachment bracket. Pattern has not been identified as to which cars did or didn't receive the sealant. Initial findings suggest that more cars were sealed than not sealed after mid October 1965. (Pg 5)

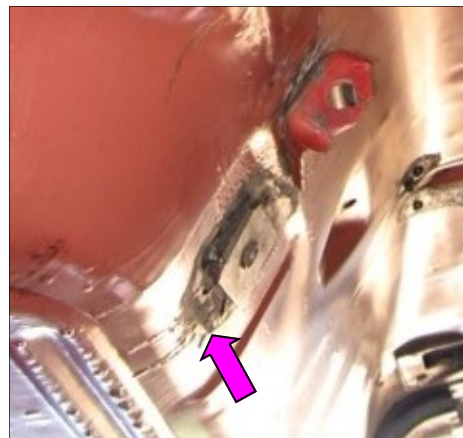
Front seat belt anchor with sealant. Top coat (red oxide) removed during cleaning

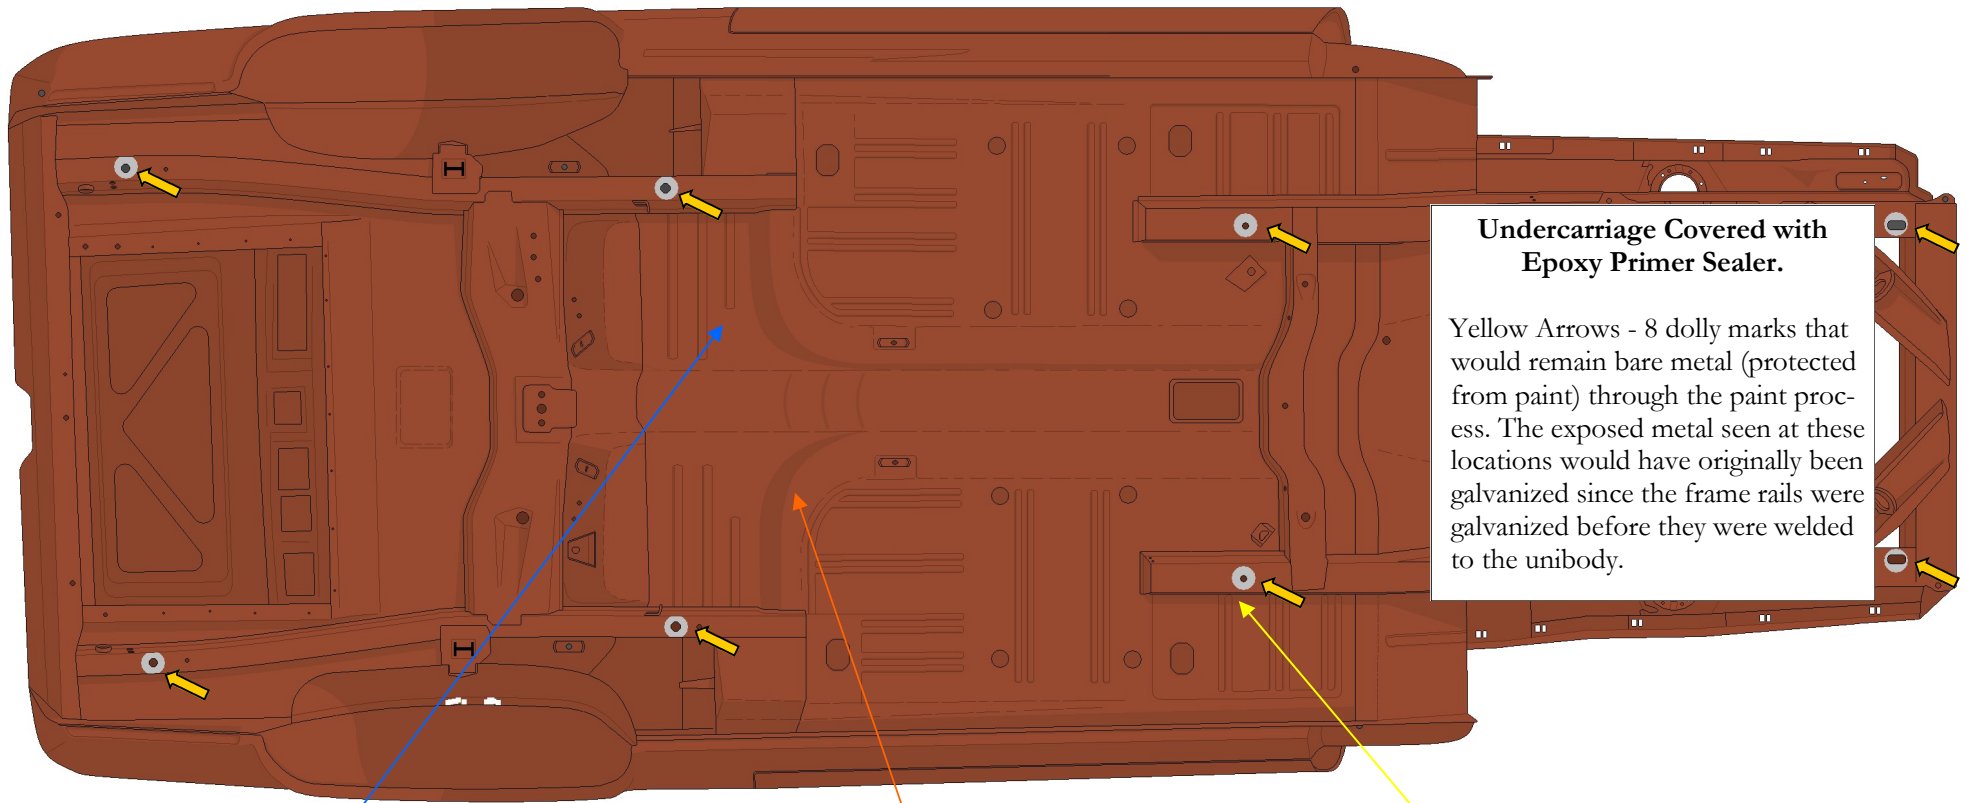
Undercarriage Covered with Epoxy Primer Sealer.

Yellow Arrows - 8 dolly marks that would remain bare metal (protected from paint) through the paint process. The exposed metal seen at these locations would have originally been galvanized since the frame rails were galvanized before they were welded to the unibody.

- Undercarriage is sprayed with a brownish red epoxy primer sealer in a slightly shiny (nothing like red oxide primer) final look. Color or tone appears to be more consistent through the year than what was found in 65 production at the same plant and can normally be seen as a reddish brown to muddy red, depending on time period though a period of pale red oxide color was applied near the beginning of the production year.

With the body sitting fairly level, red oxide epoxy primer sealer applied to the undersides of the car from firewall rearward, as it passed over a series of spray jets arranged below the track system the body traveled over. This application stopping approximately four inches short of the rear cross member. This process produced multiple runs to collect on the lowest

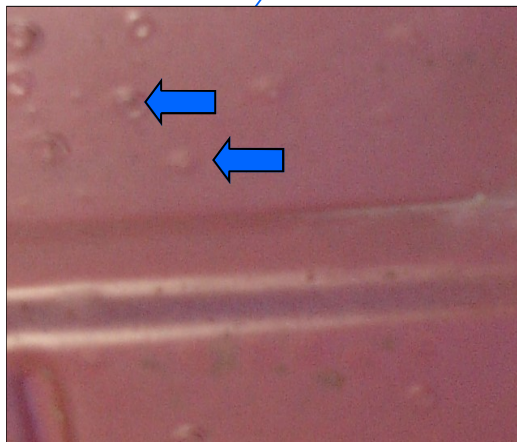
Heavy application produced drips in many areas

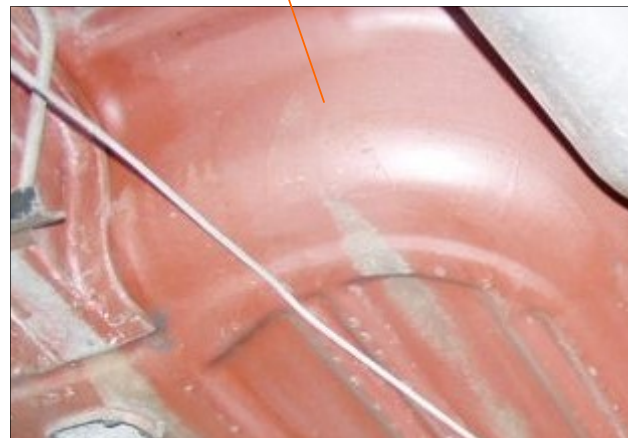
Example of overall finish

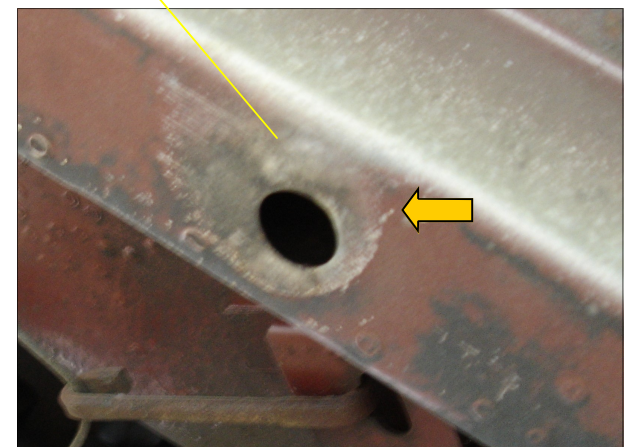
Example of dolly mark

- The unibody was assembled from subassemblies, on a pair of moving skids that were each attached at 4 different spots (8 total) to the body. Four of these attachments passed through the body and were tightened from above to hold the body tightly to the skids, in the interior and trunk areas, which produce round bare areas below the attachment fixture. Visible on a completed car from below, this process results in eight round sections (showing the galvanized metal of those panels) on the finished product. (Page 5)

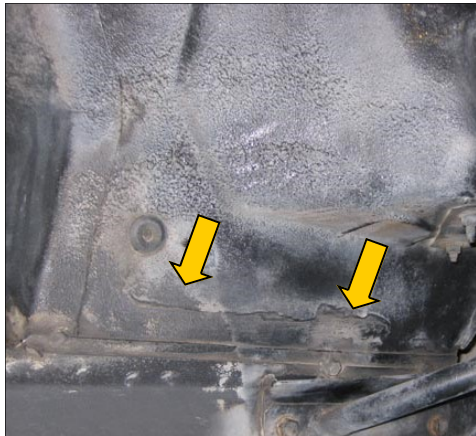
Yellow-Thinly applied, finished with brush along the inner to front frame seam. On late built cars this sealer was skipped and sealed during the sound deadener application step.

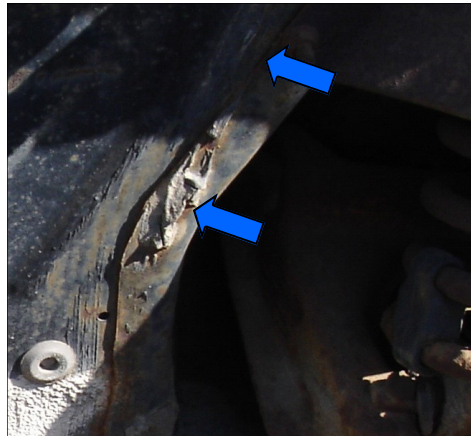
Blue-Very thinly applied along shock tower to inner joint. Was applied to only some of the cars built earlier in the production year.

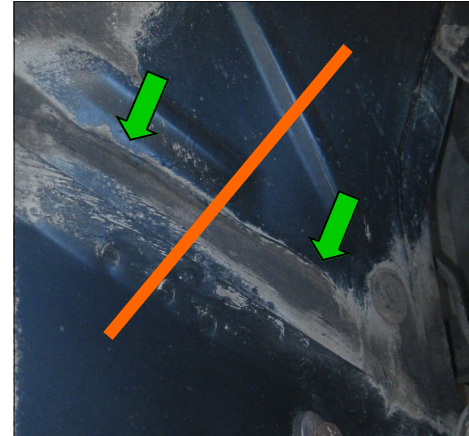
Green-Thinly applied, finished with brush along the inner to front frame seam. On late built cars this sealer was skipped and sealed during the sound deadener application step.

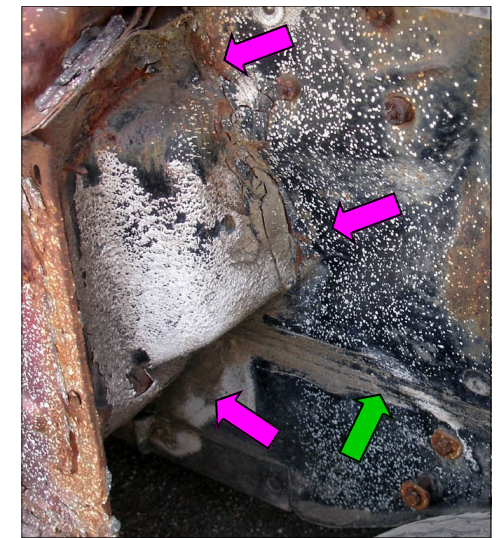
Purple-Heavy seam sealer application. Often filled corner between frame or inner panel to firewall/cowl panel

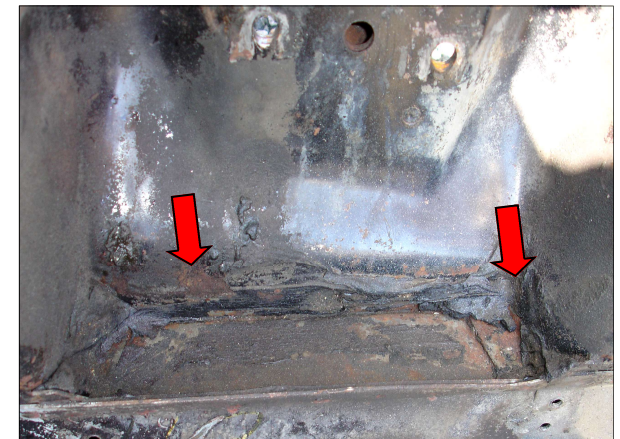
Red- A very thick application of sealer was applied to the valley at the base of the shock tower.

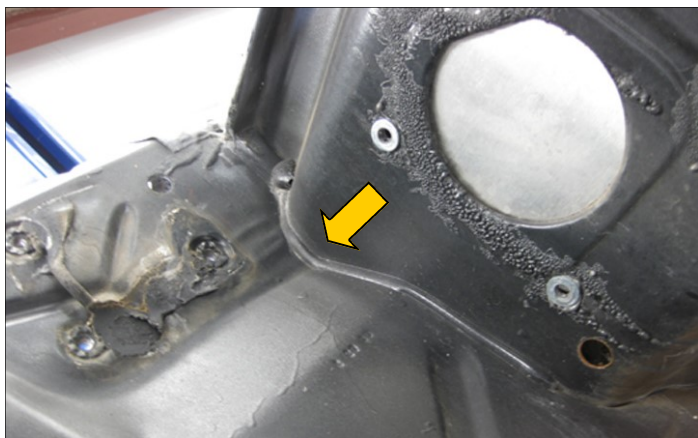
The strip of unsmeared chalking was typical along the passenger side of the firewall to rear inner fender panel seam. It normally stops midway down the seam and does not continue further. Likely due to access issues as it was applied from above.

- Seams sprayed and sound deadener applied in the interior area of the car
- Firewall (engine side) - Sealer applied from a chalking gun (not brushed) along the inner fender panel to firewall seam on passenger side. (Pg 8)

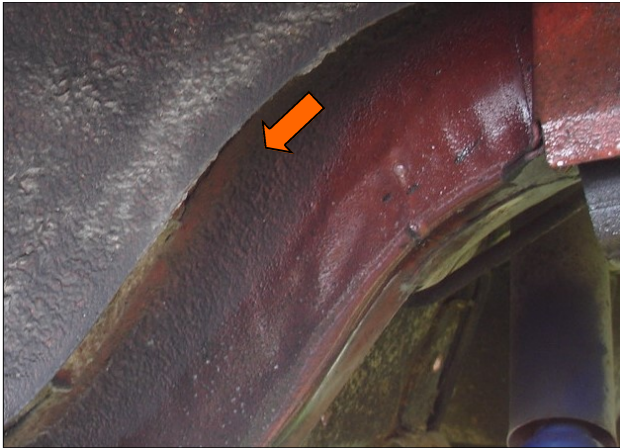
Visible sound deadener overspray on the frame rail though exterior paint has worn off.

- Rear Wheel Well - In the rear wheel wells the sound deadener was applied by a worker standing below the body so overspray was common onto the small sections of floor between the frame rail and wheel housing panel lip as well as onto the frame rail in those areas. (Pg 9)

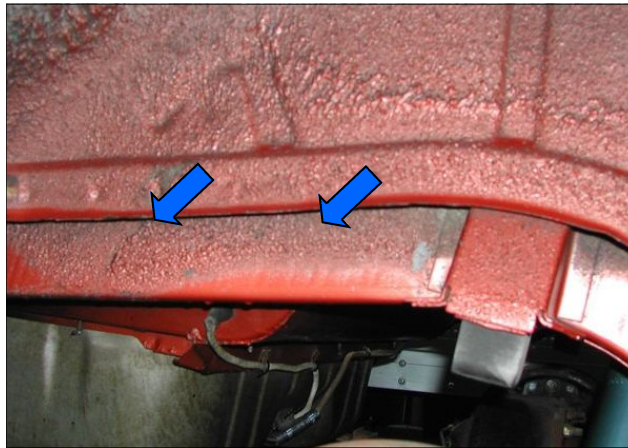
Another example of sound deadener and exterior color on frame and wheel well.

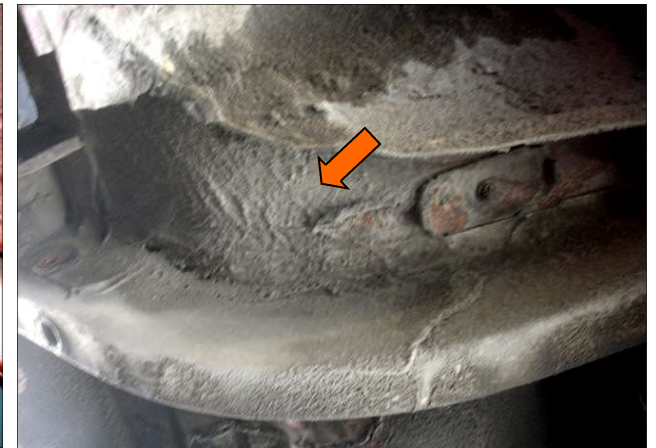
Heavy application on frame and floor section.

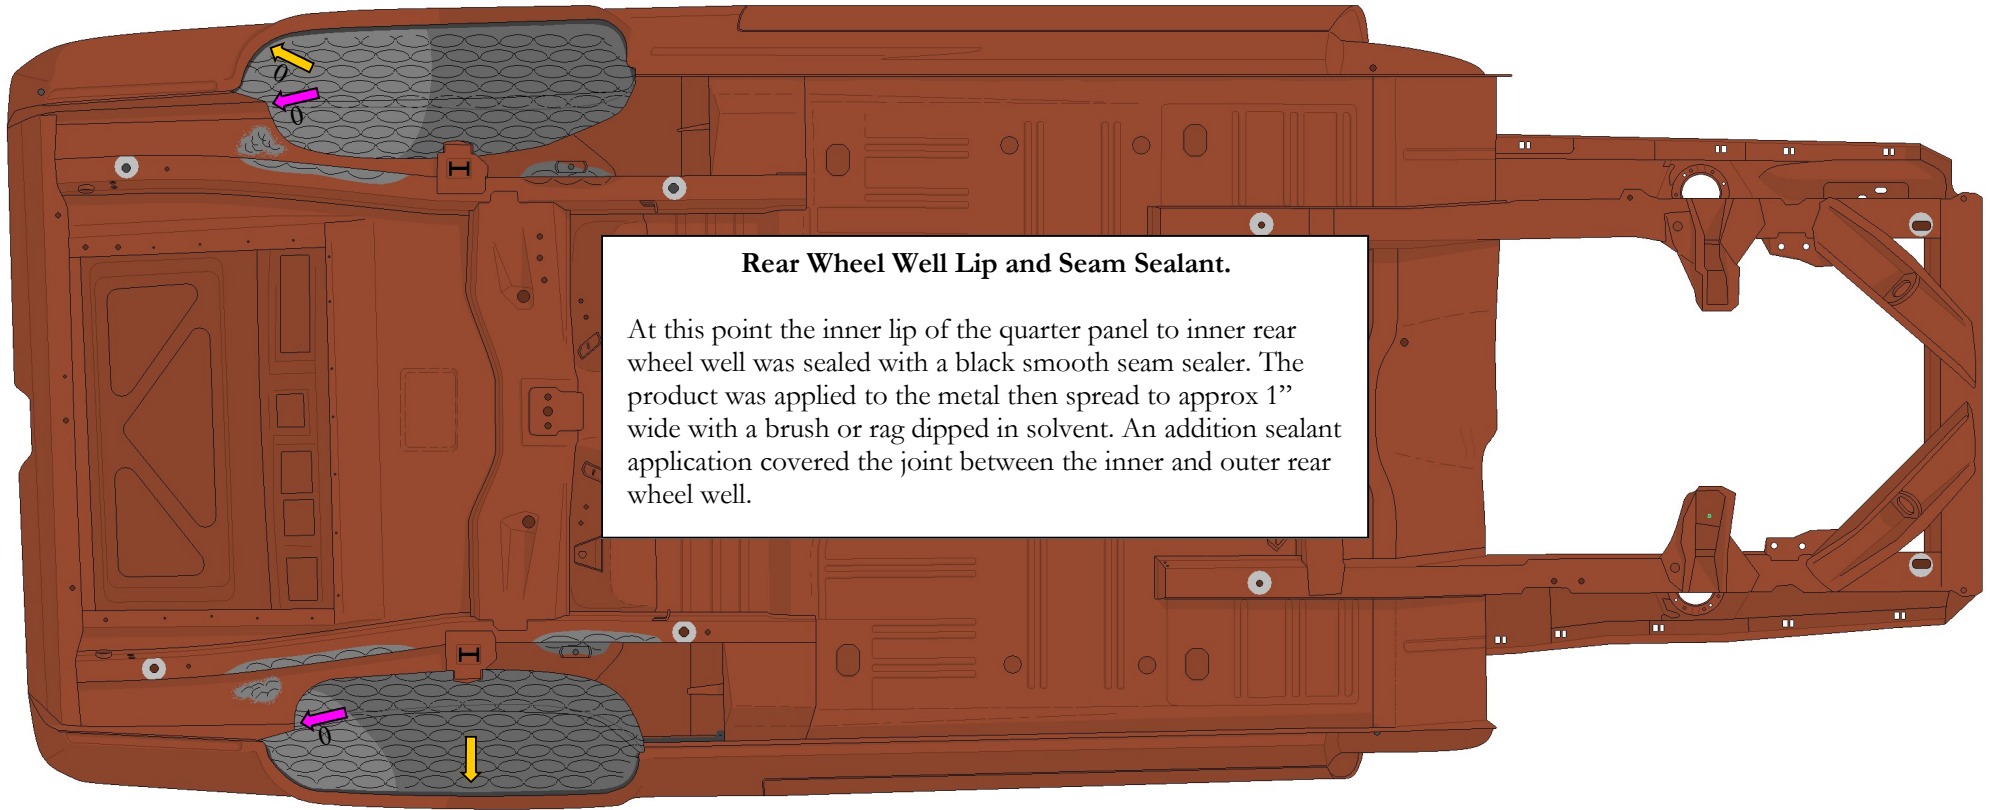
Rear Wheel Well Lip and Seam Sealant.

At this point the inner lip of the quarter panel to inner rear wheel well was sealed with a black smooth seam sealer. The product was applied to the metal then spread to approx 1" wide with a brush or rag dipped in solvent. An addition sealant application covered the joint between the inner and outer rear wheel well.

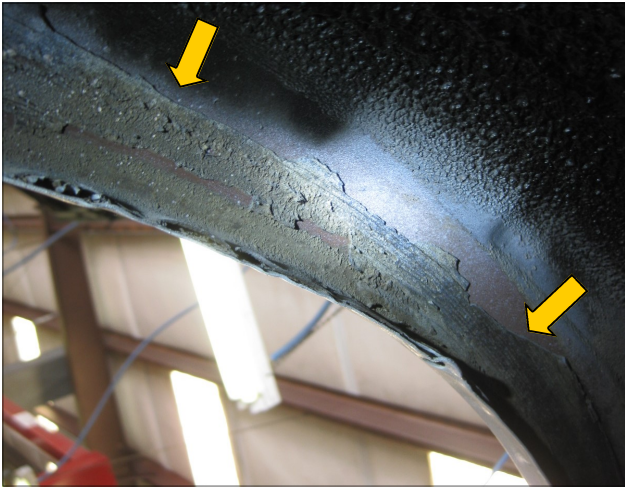
Example of lip sealant

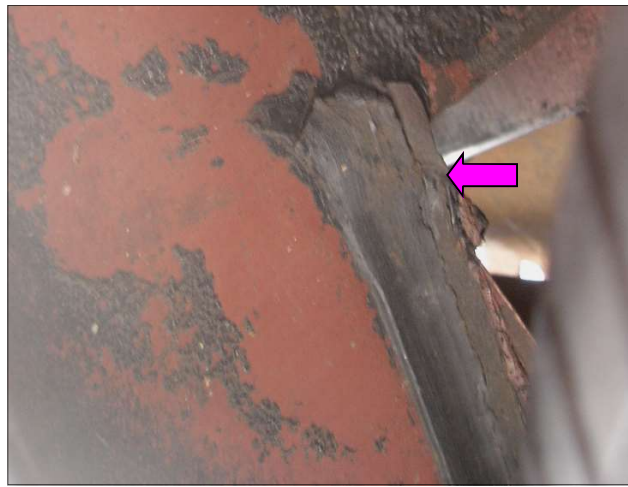
Rear wheel well to trunk drop seam seal paint removed

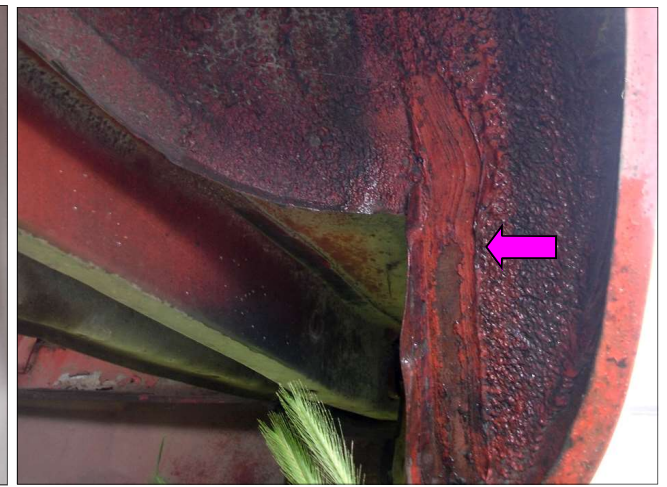
Rear wheel well to trunk drop seam seal

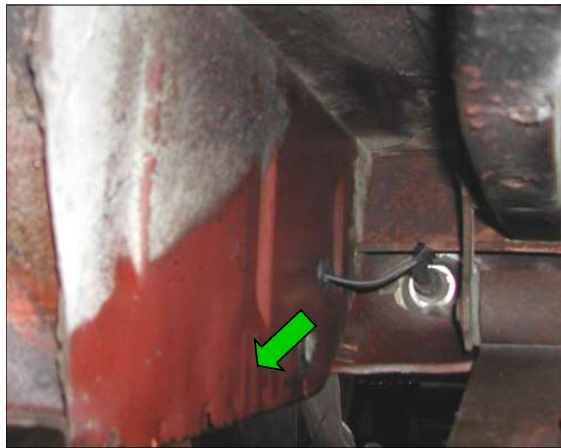
Trunk drop surface. No sealer at bottom edge

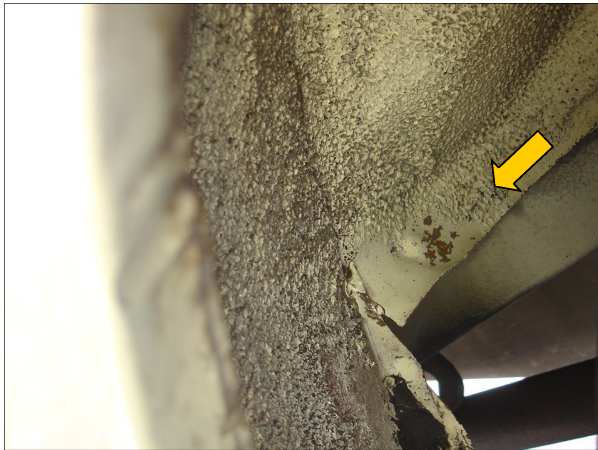
Example of amount of direct exterior color on the visible surface over sound deadener. In right picture

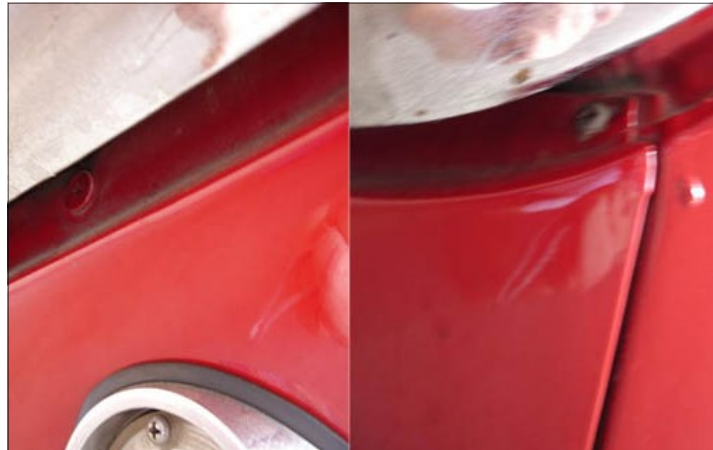
Example of the painted and unpainted screws holding the rear valance to the taillight panel on a later car.

- Rear bumper guard lower brackets were attached to the rear cross member and the rear valance was attached with two screws only at this point and allowed to hang from those points. Normally the screw holes used were typically the second or third one (most often the third) in from the ends of the rear valance. Type/style of mounting screw often differed between the two painted and the remaining screws as well as production period. Before this was done the rear bumper guard brackets were installed to the rear cross member and trunk surface.

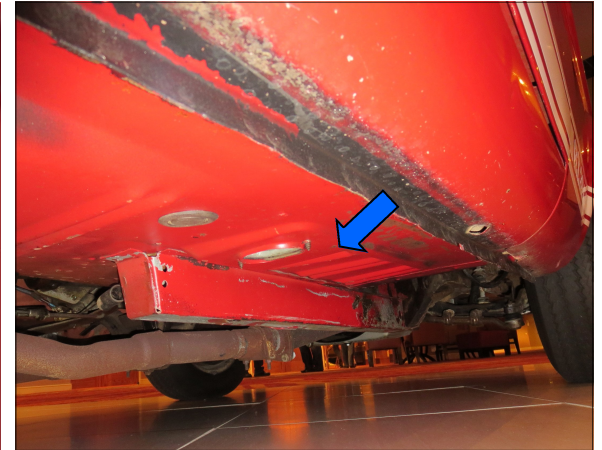
Example of a lot of body color

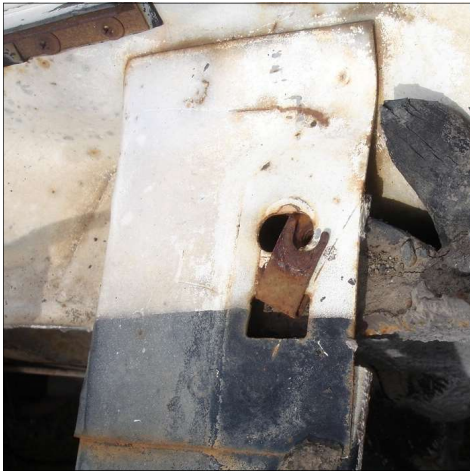
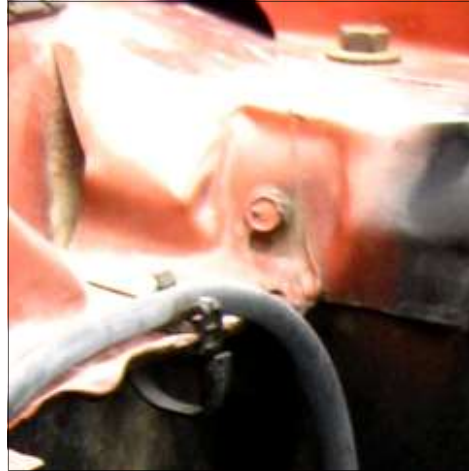
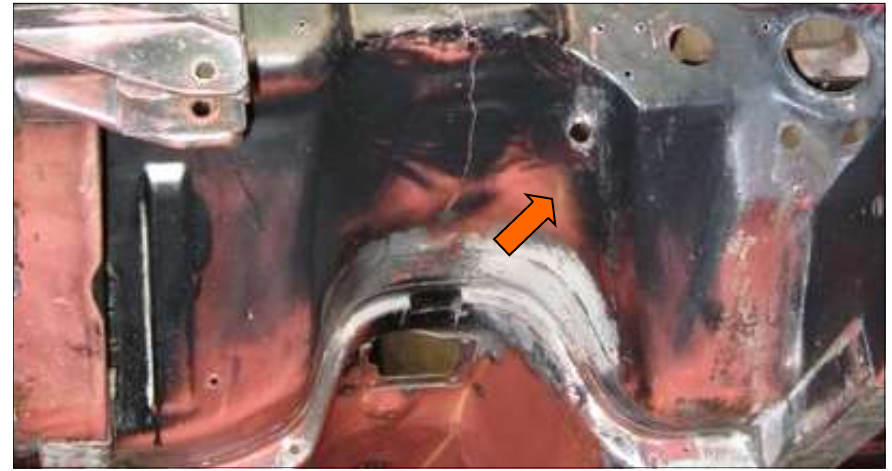
Typical location of black paint to cowl body color. Soft line/edge = not taped.
Picture, above right, shows the post mid March painted splash shield screw.

Transition from floor pan area still shows the red oxide color with black over it.
Amount of over and direct space could produce sharp shadows or smooth fading.

- The top edge of the inner fender panel at the rear edge, where the fender will eventually rest, was masked off at the leading edge of the cowl to firewall pinch weld typically. This was done in such a way so as

to not normally produce a sharp tapped like edge to the black paint. (Pg 13)

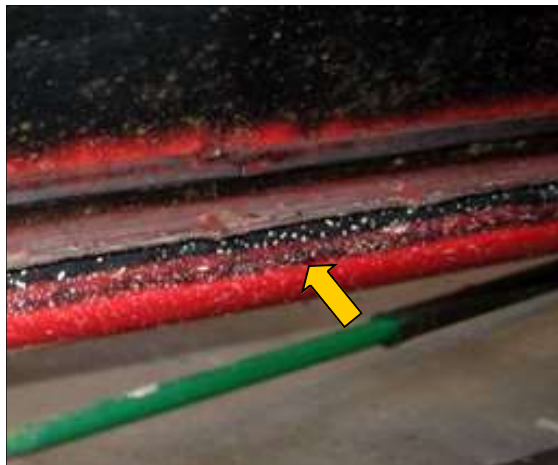
Rocker panel pinch weld blackout—often it is not as wide

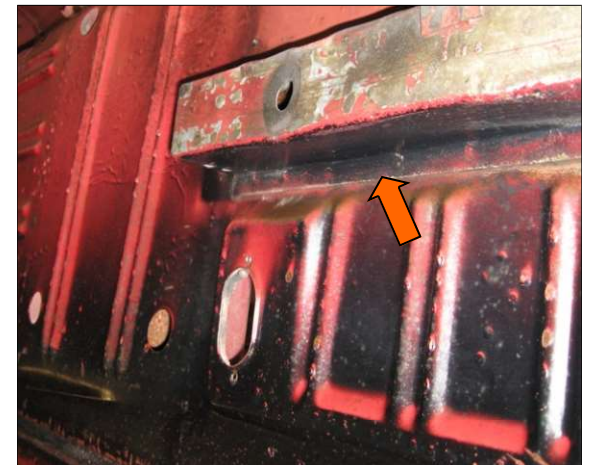
This car received a heavy (more overspray) coat close to the pinch weld likely due to paint gun angle

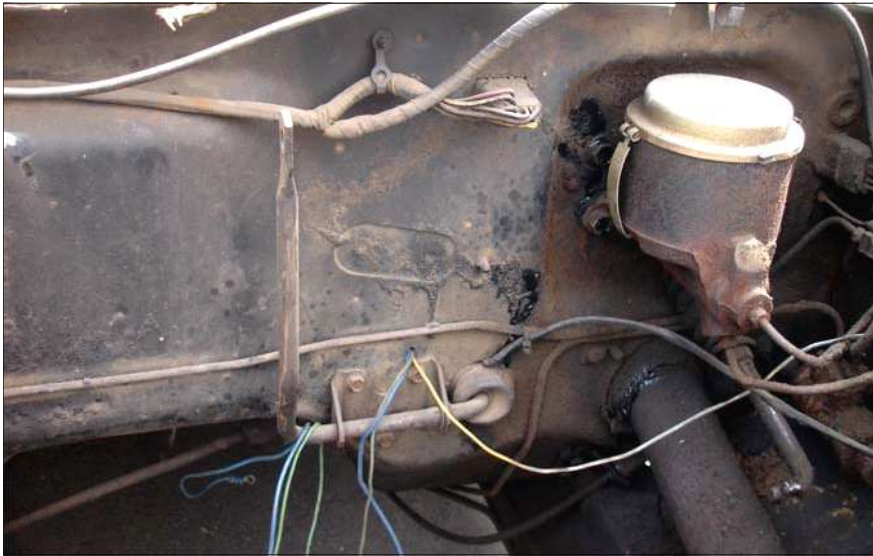
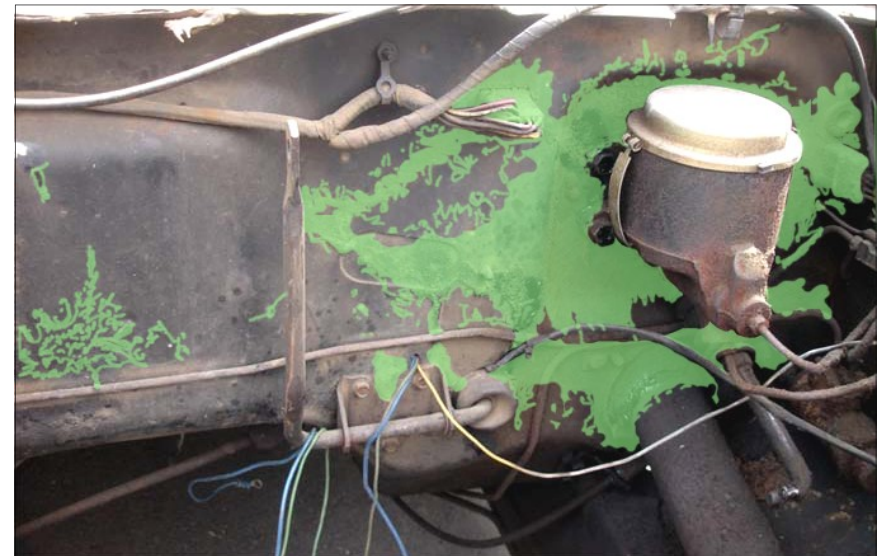
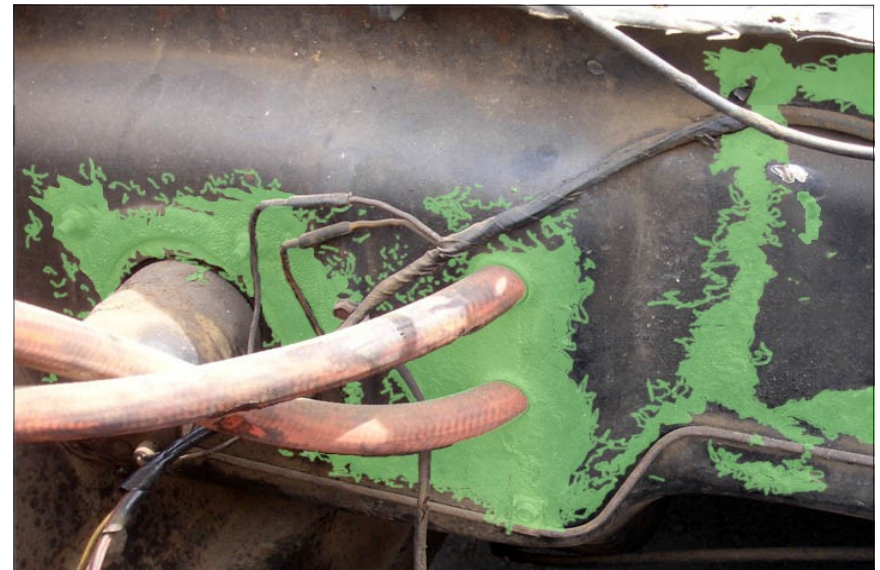
Example of typical sealant applied at or around all firewall attachments and pass-through locations (not engine ground). On the right I've highlighted the spray pattern. As you can see the product is a very fine spray similar to what is produced with spray adhesive (adhesive was the term for Ford used for the product) to a somewhat runny and thin undercoating later in the year.

Sealant normally applied in a continuous spray carried from point to point though the pattern between the target spots can vary from worker to worker..

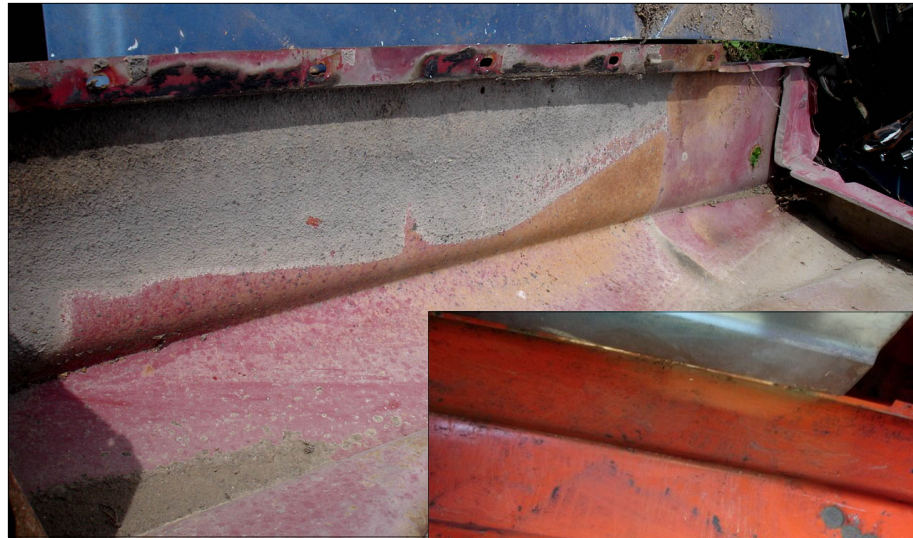
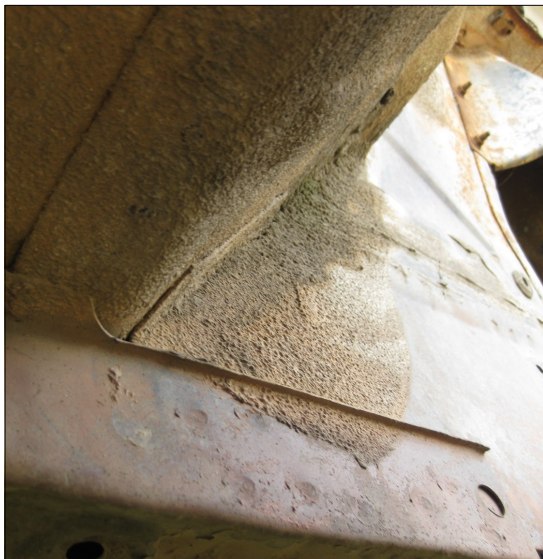
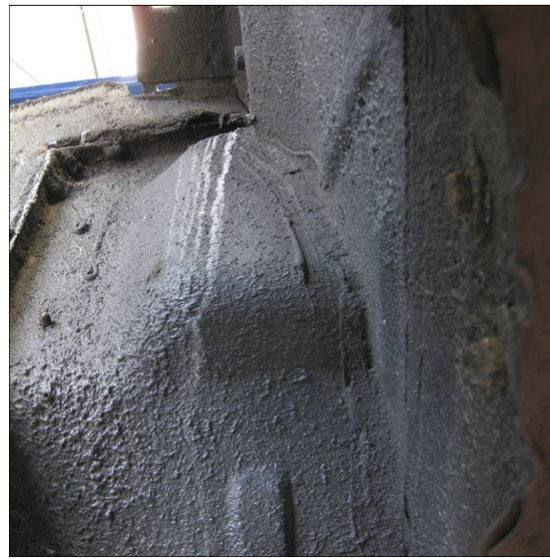
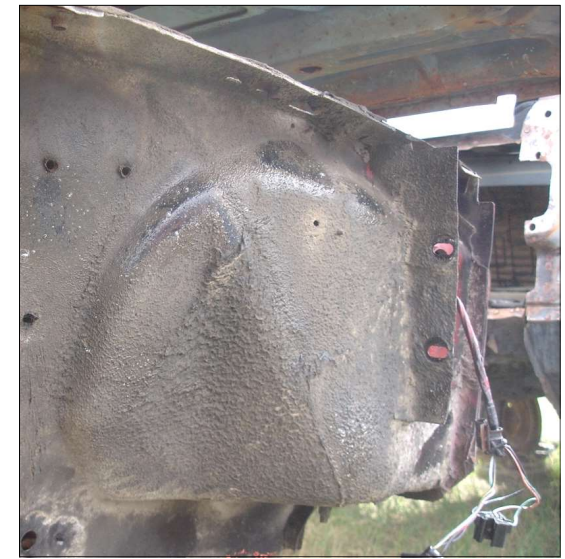
Front Wheel Well Sound Deadener Applied -
This is shown in the front wheel well detail article.

Once the car was completely assembled (minus front wheels and tires) sound deadener was applied to the front wheel well. The amount and area covered depended completely on the specific worker that applied it and what they did that day. Application falls between a little and a lot with no real identifiable pattern. But all original examples show some on the rear splash shield, firewall section exposed in the wheel well, inner fender panels forward and rearward of the shock tower (normally at a minimum from the lower rear to the top rear edge of the shock/spring cover then from the forward top edge of the shock/spring cover forward and down ward.) and finally on the front splash shield.

We often see examples where the bottom side of the fender received a single pass, upper right picture, with the application wand but not all cars received this.

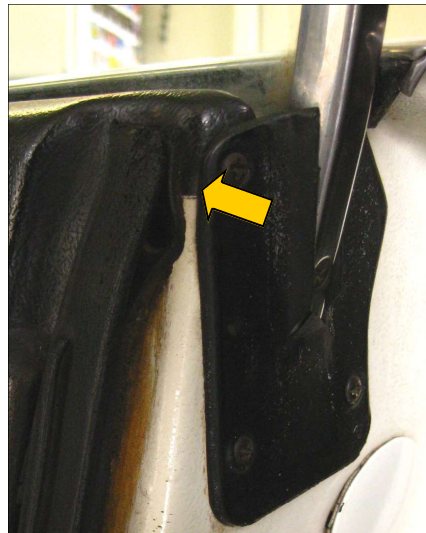
Upper door/interior paint detail

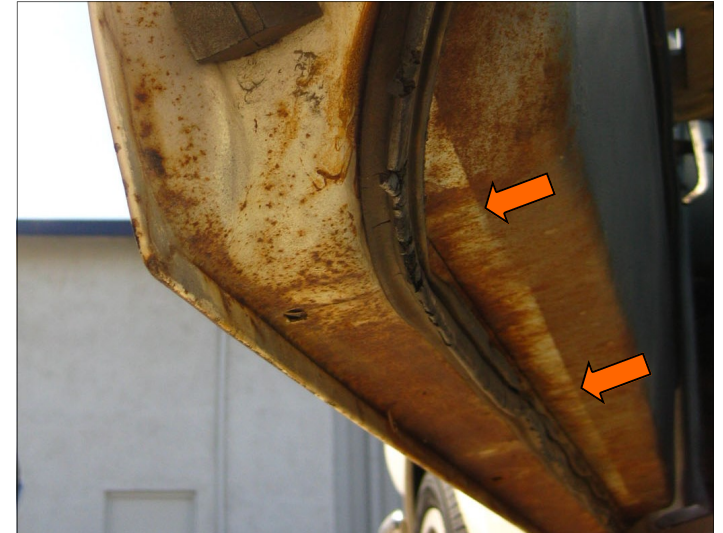
Bottom door edge paint break

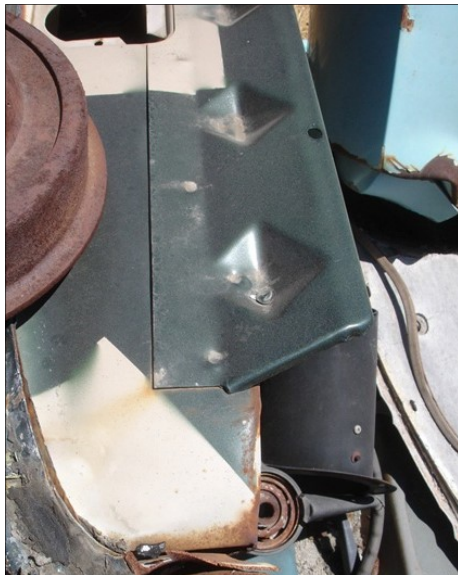
Dash paint details. Top coat green exterior over tan interior paint

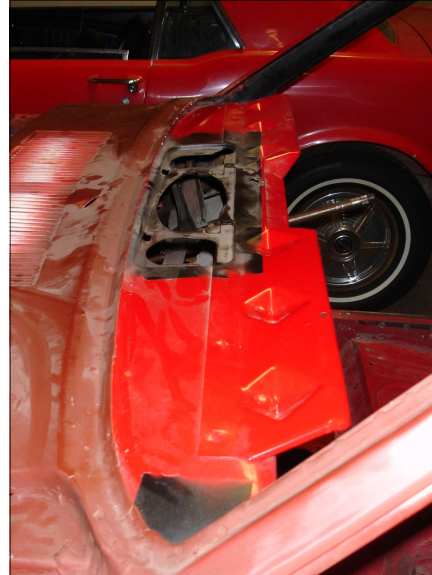
Dash paint details. Top coat red exterior over black interior paint

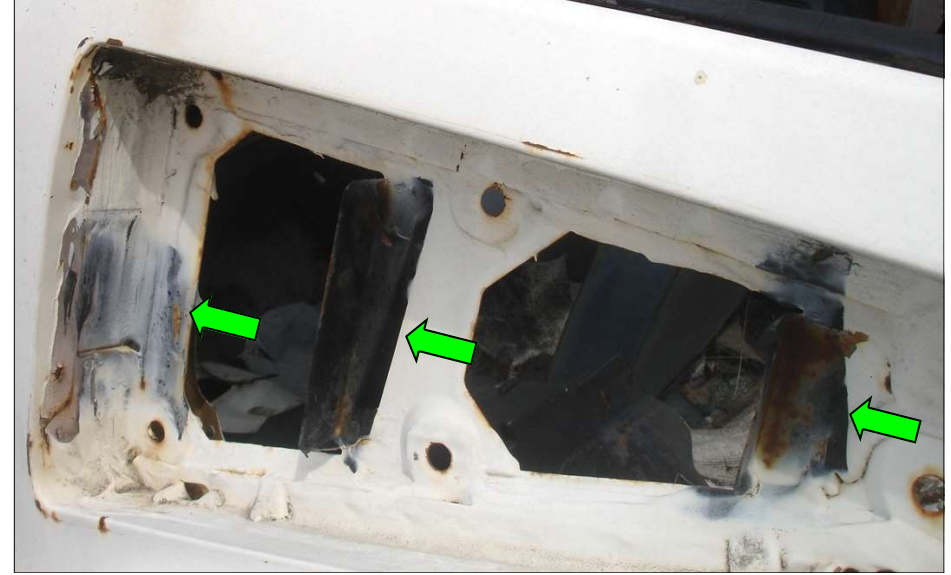
Fastback rear black out detail. What appears to be shadow is a blacked out area. The second and third surfaces (from left) are painted on front and rear surface.

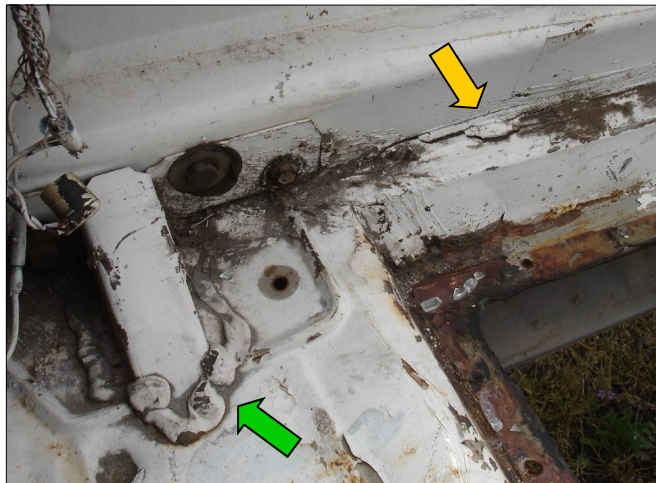
Green-Chalking applied but not spread or wiped

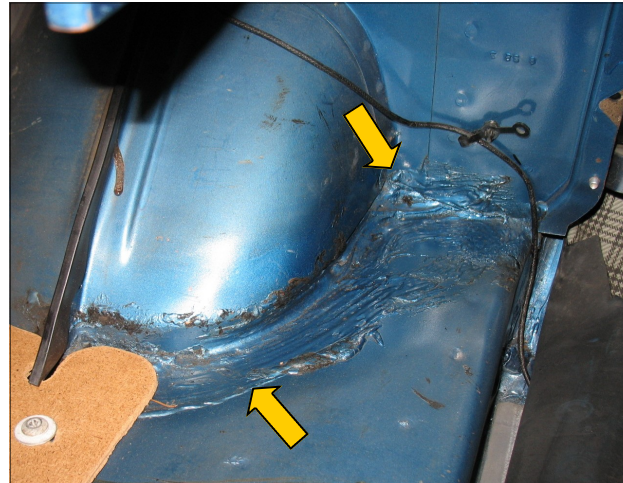
Yellow-Sealant applied then wiped with solvent rag
