Restoration Support 65 San Jose Unibody (Undercarriage)

This is an ongoing project of mine I expect to be continually updating as new information is documented, studied and discovered.

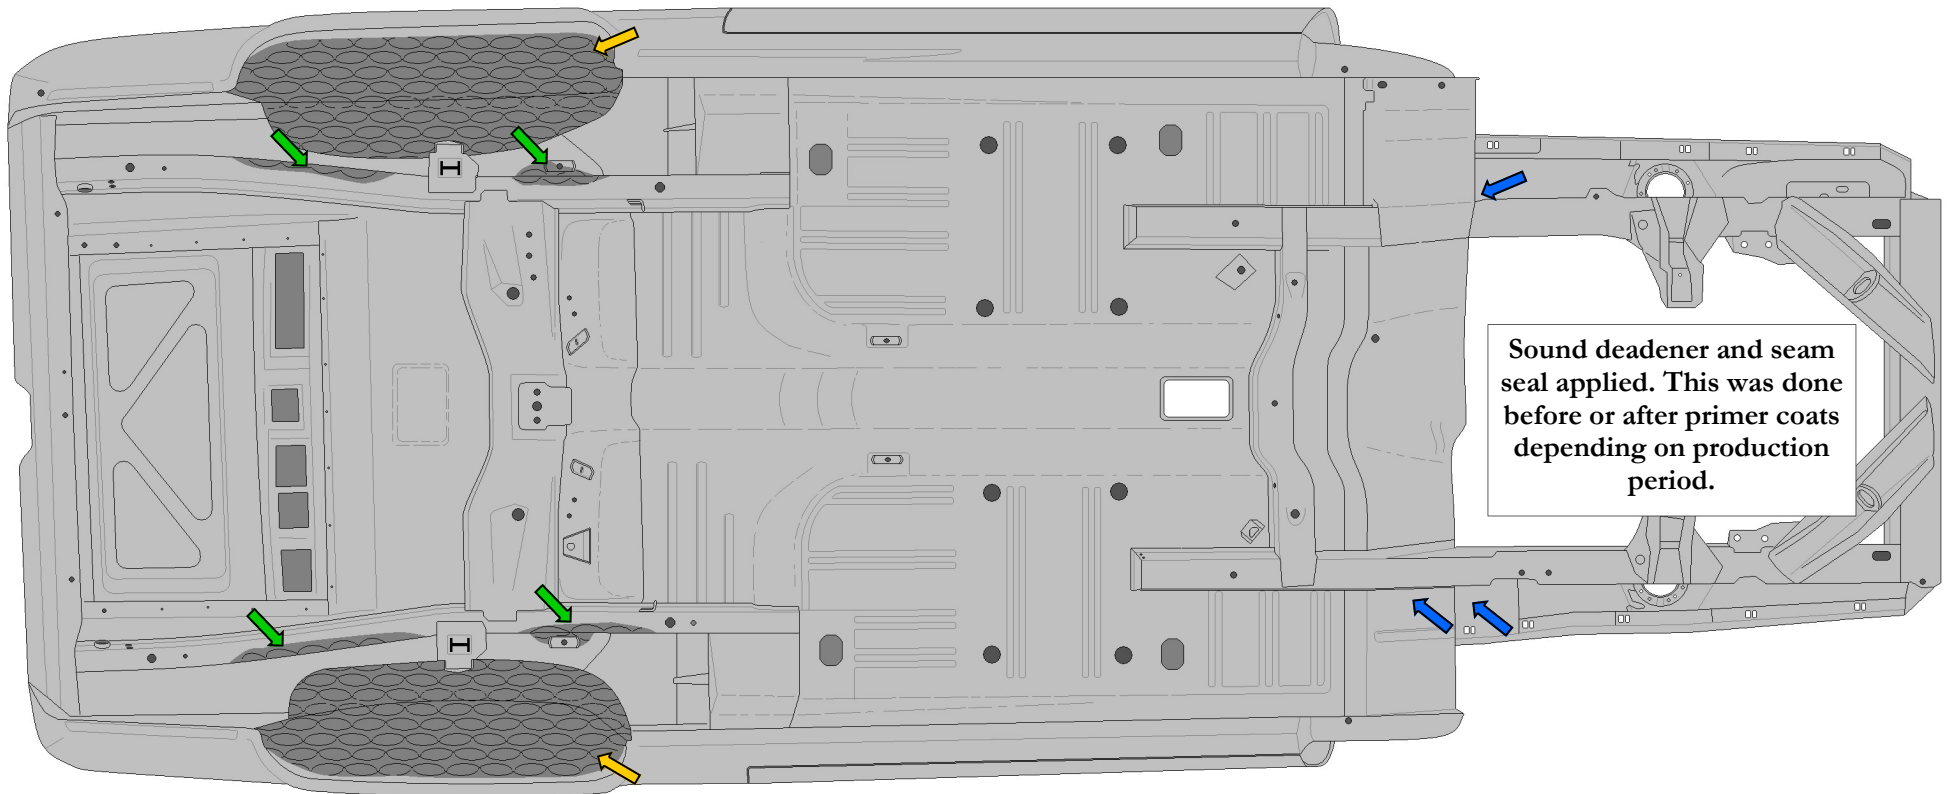
Sound deadener and seam seal applied. This was done before or after primer coats depending on production period.

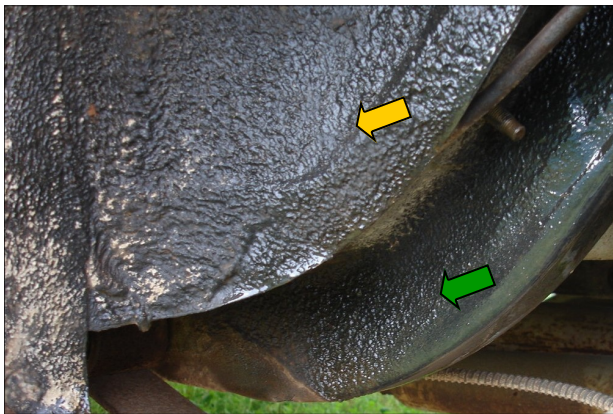
Yellow-Example of sound deadener - Typical application

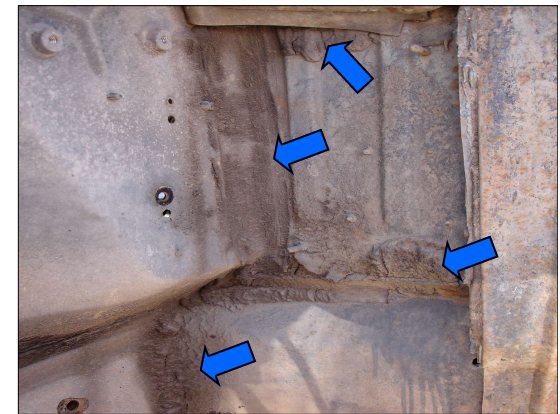
Front wheelwell sealer under/before sound deadener

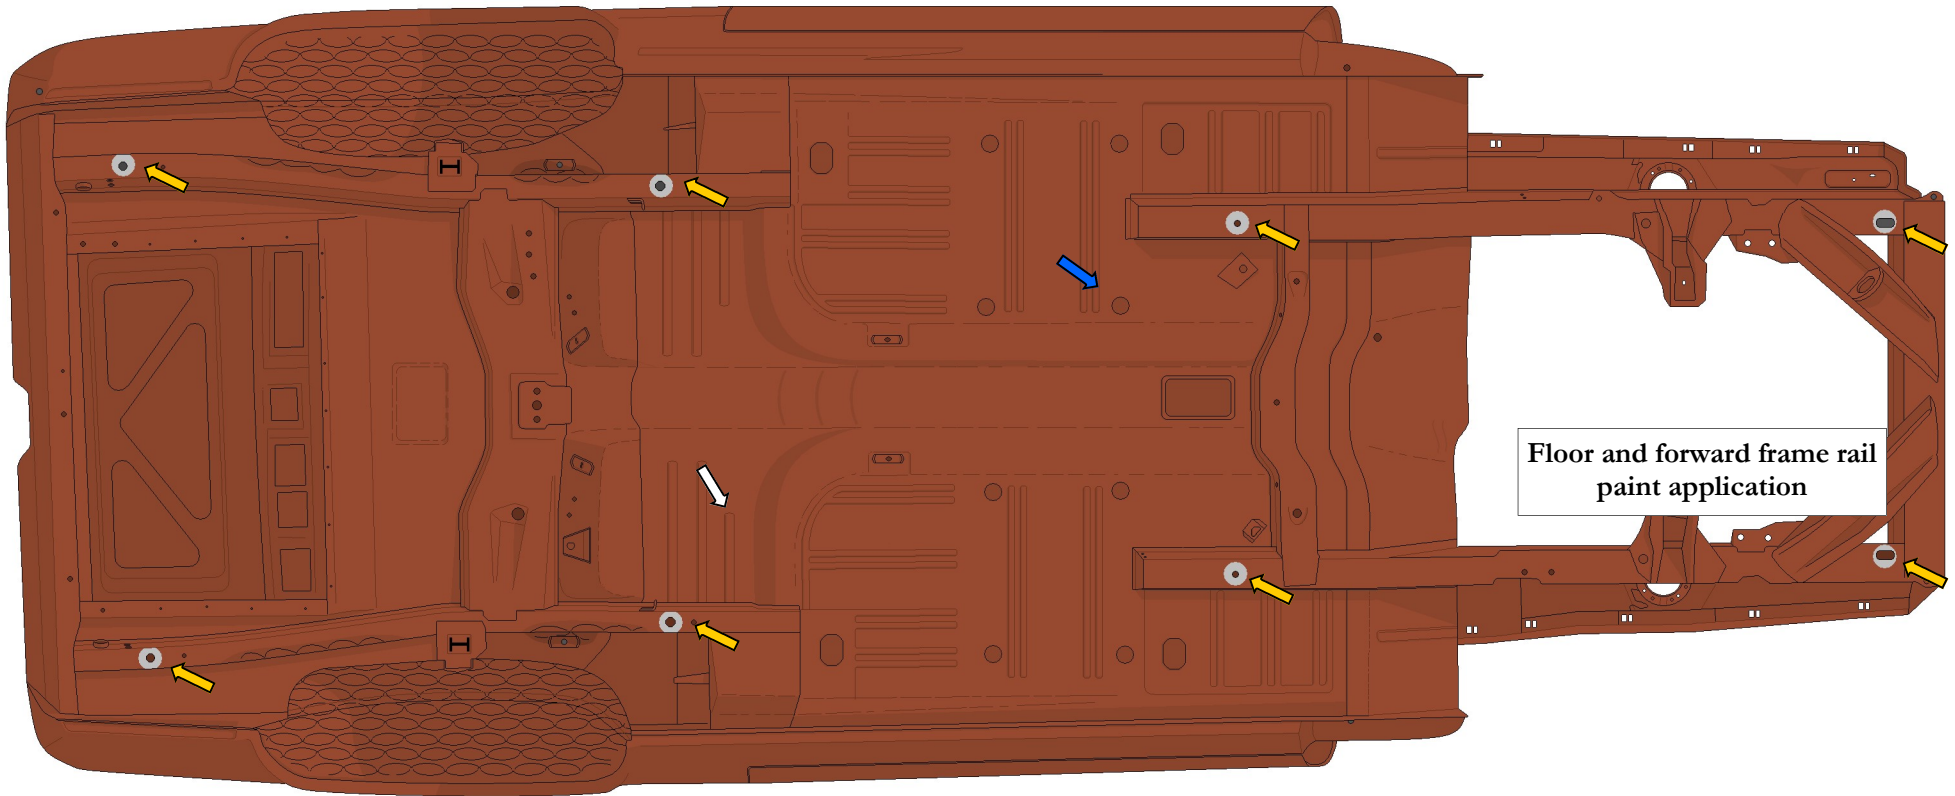
Floor and forward frame rail
paint application

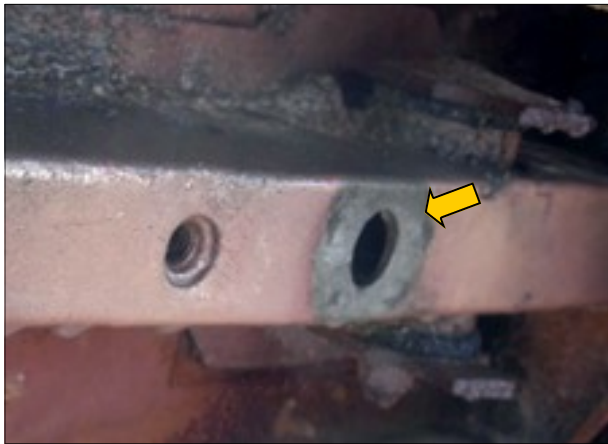
Example of dolly mark

- The unibody was assembled from subassemblies, on a pair of moving skids that were attached at eight different locations. Four of these attachments passed through the body and were tightened from above to hold the body tightly to the skids, in the interior and trunk areas, which produce round bare areas from above from the attachment hardware. Visible on a completed car from below, this process resulted in eight round sections (showing the galvanized metal of those panels) on the finished product. (Page 6)

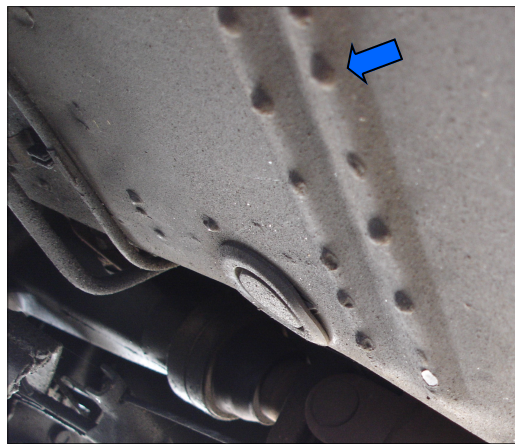
Heavy application produced drips in many areas

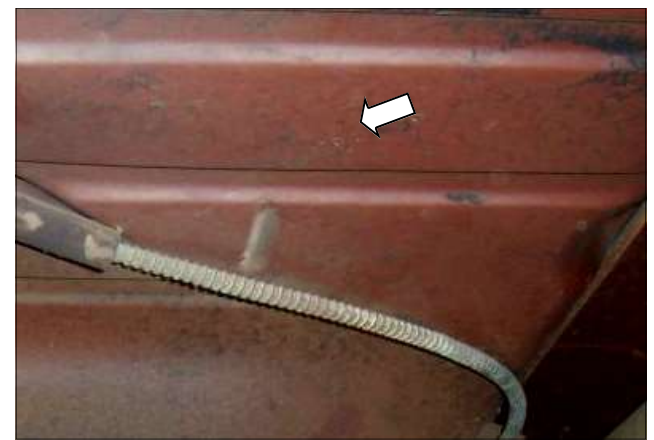
Example of overall finish

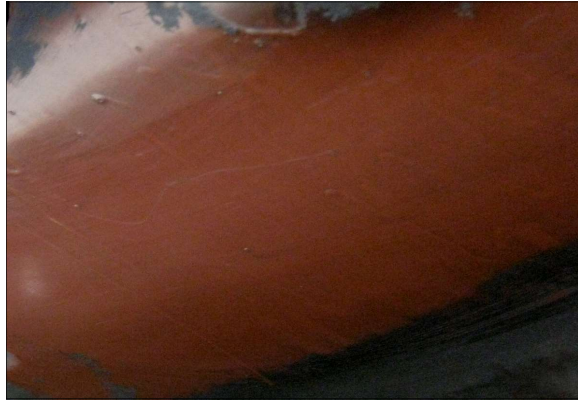
Examples of red oxide to muddy red oxide colored floor coating.

As mentioned in the text section of this article the color and tint of the epoxy primer sealer applied to the unibody from approximately the firewall rearward during 65 San Jose production varied during the year. These patterns related to specific production periods at the plant. Because there are no records of specific fates any of these cars were finally completed its impossible to determine the exact color each was coated one but predictions can be made from the data collected. The colors shown in the accompanying pictures should not be considered exact color matching samples but only for comparison purposes due to the differences in monitor settings, digital files, printer settings and other circumstances.

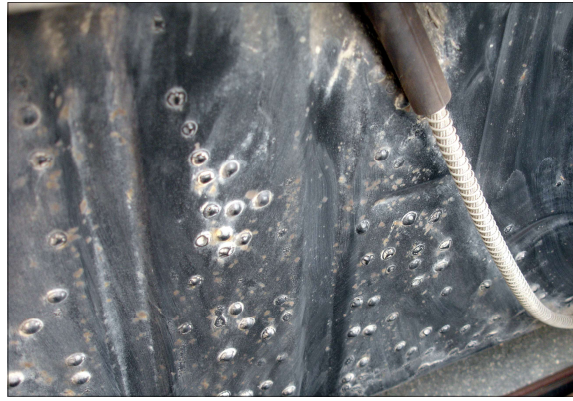
Examples of dark batch colored floor coating.

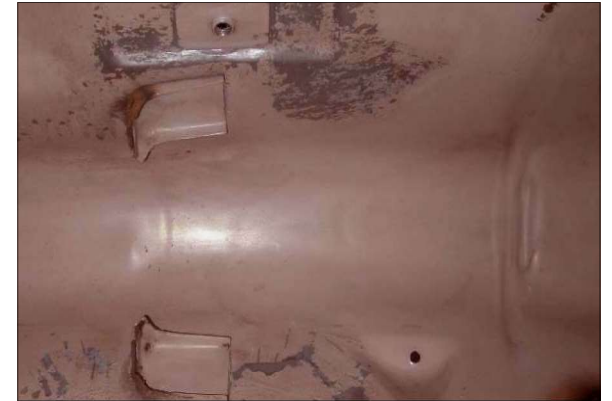
Examples of pinkish/salmon red oxide colored floor coating.

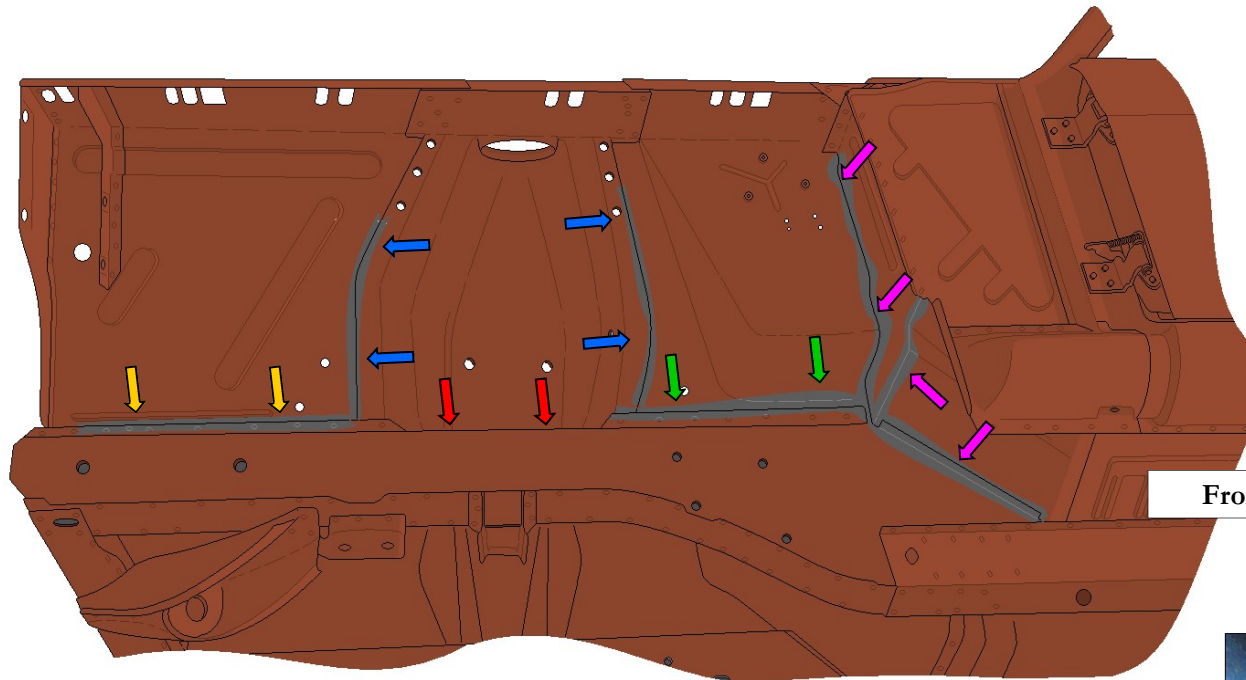
Front wheel well seam sealer

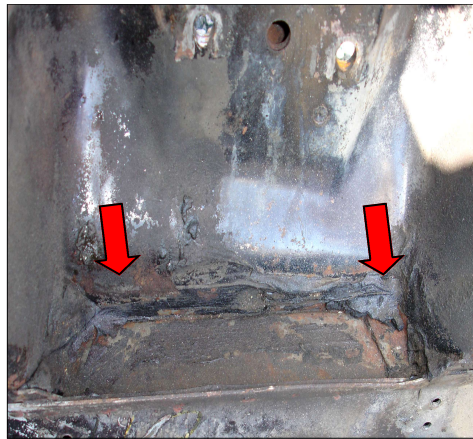
Red- A very thick application of sealer was applied to the valley at the base of the shock tower. **Blue**-Applied to only some of the cars built during the production year often very lightly.

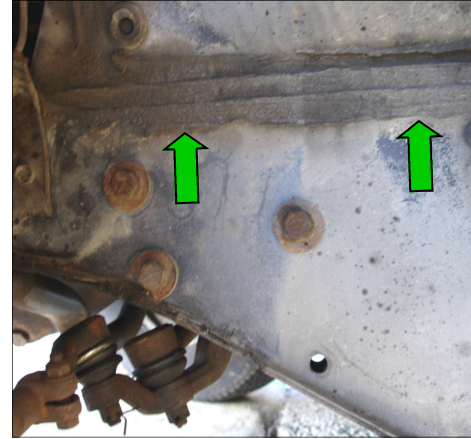
Green-Thinly applied, finished with brush along the inner to front frame seam. On late built cars this sealer was skipped and sealed during the sound deadener application step.

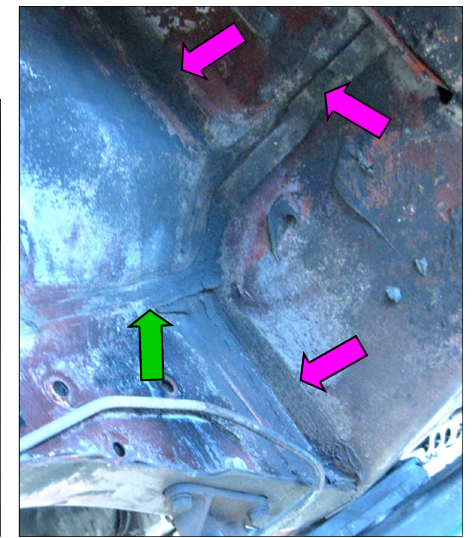
Purple-Heavy seam sealer application. Often filled corner between frame or inner panel to firewall/cowl panel

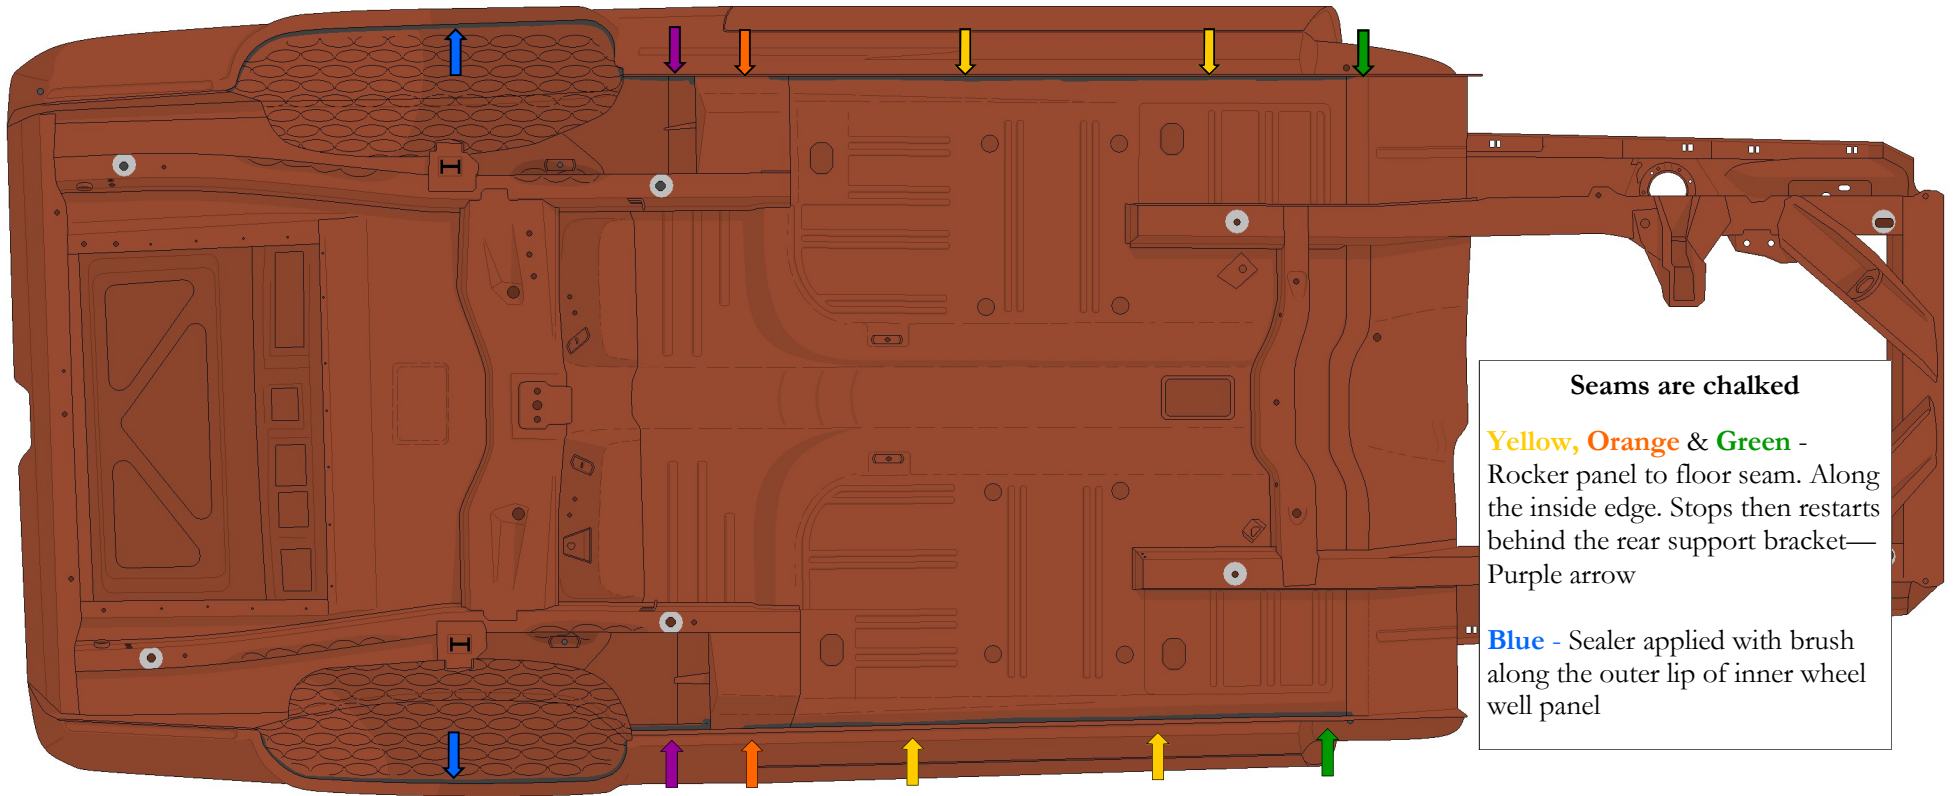
Seams are chalked
Yellow, Orange & Green -
 Rocker panel to floor seam. Along the inside edge. Stops then restarts behind the rear support bracket—
 Purple arrow
Blue - Sealer applied with brush along the outer lip of inner wheel well panel

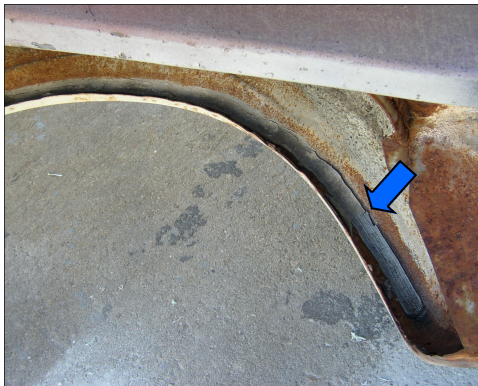
Wheel well lip sealant

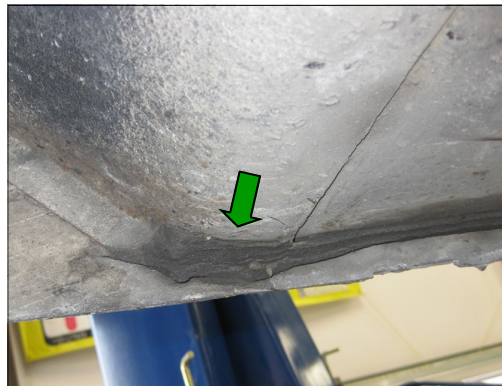
Rocker panel chalking

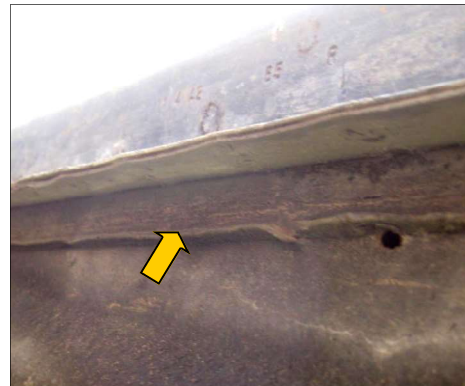
Rocker panel chalking

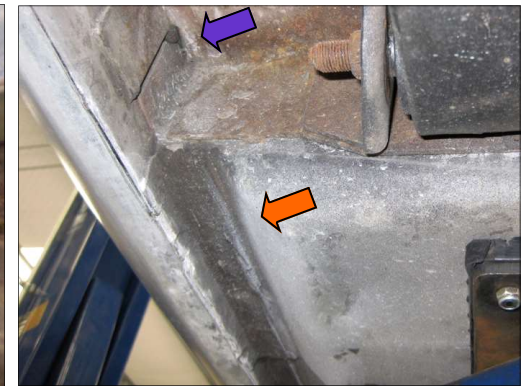
Rocker panel chalking

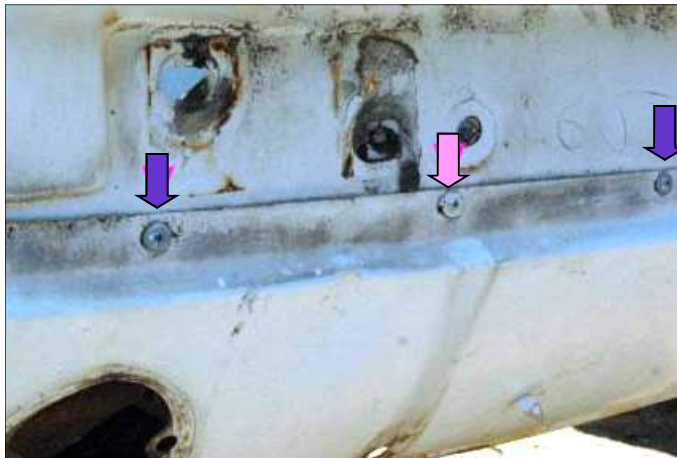
Rear valance hung by two screws (pink arrow) Others added after body color applied (Purple arrows)

- Rear valance was attached with two screws only at this point and allowed to hang from those points. Normally the screw holes used were typically the third one in from the ends of the rear valance. This is the one over where the bumper guard or exhaust tip on GT would be located. Because the screws were installed at two different stations typically you will find two different type of screws installed.

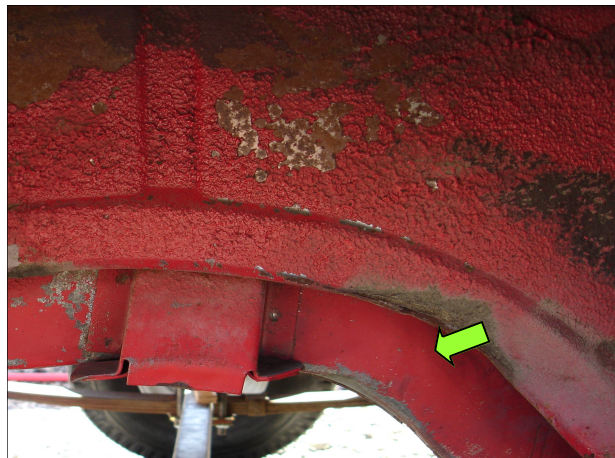
Paint worn from sound deadener in spots from use. Arrow shows nice exterior coat on frame rail

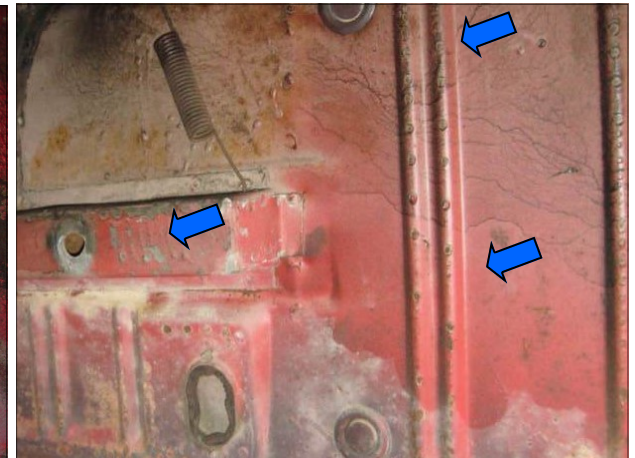
Blue arrow - Body color overspray

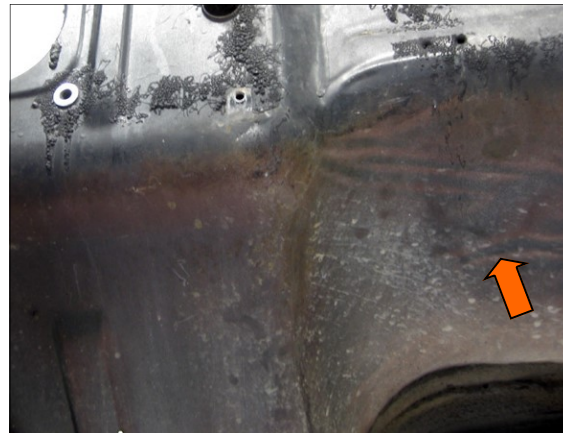
Typical transition/fade of black engine compartment black over firewall red primer.

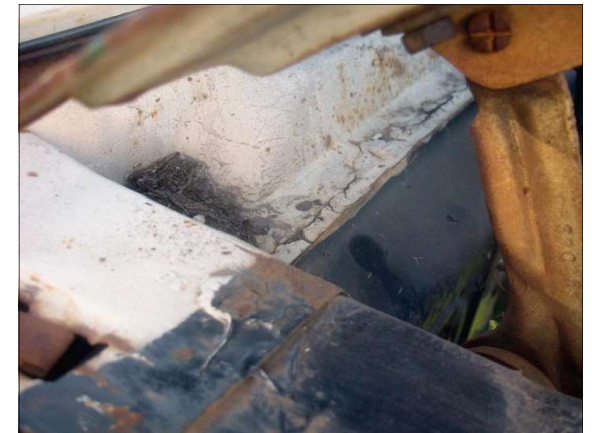
Typical location of black paint to cowl body color
Soft line—not taped

- Normally the exterior color was applied up to the front edge of the firewall to cowl pinch weld and the cowl/A pillar sections on both sides of the car. At times the painter extended forward with the body color but all would be covered with black later in the process.

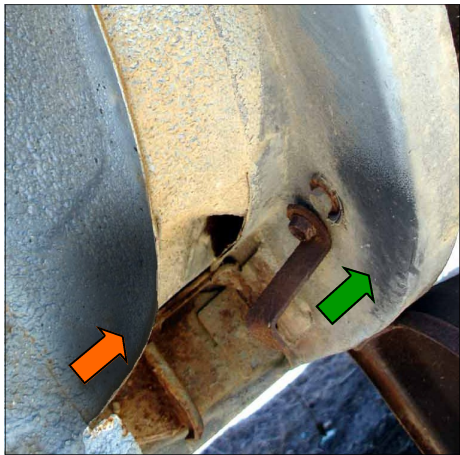
What is left of the pinch and rear wheelwell black out

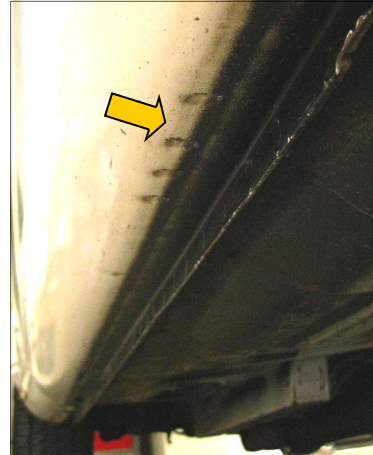
Rocker panel pinch weld black-out-often it is not this wide

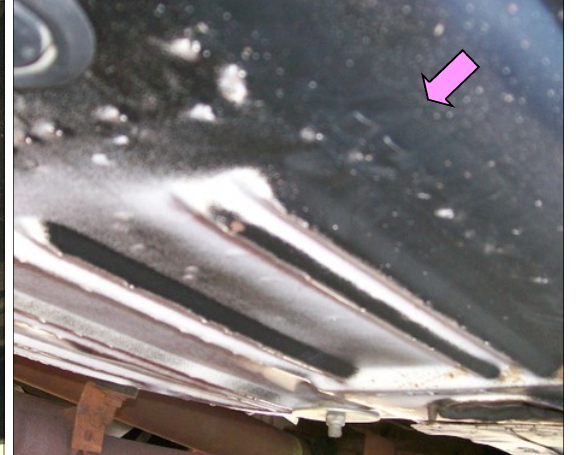
This car received a heavy (more overspray) coat close to the pinch weld likely due to paint gun angle

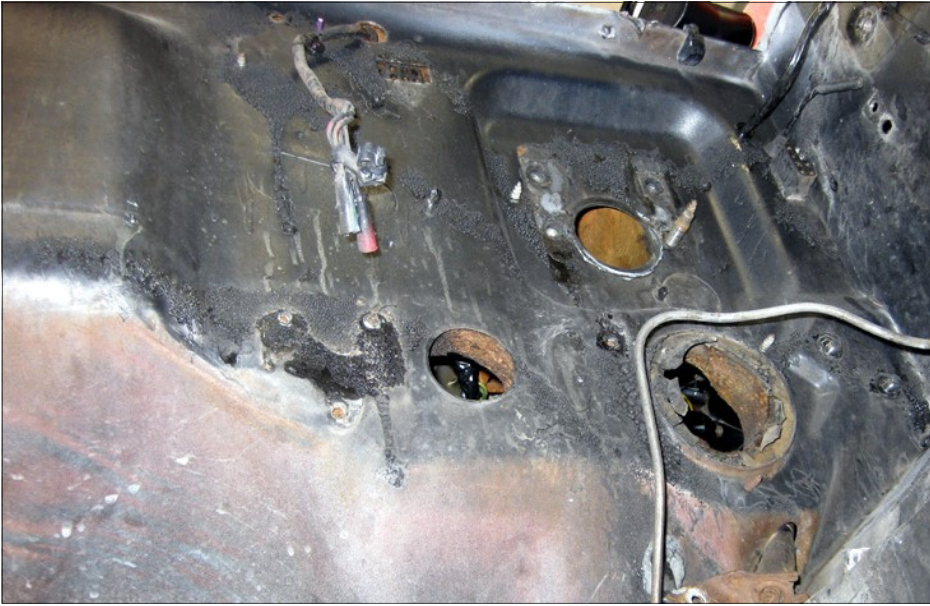
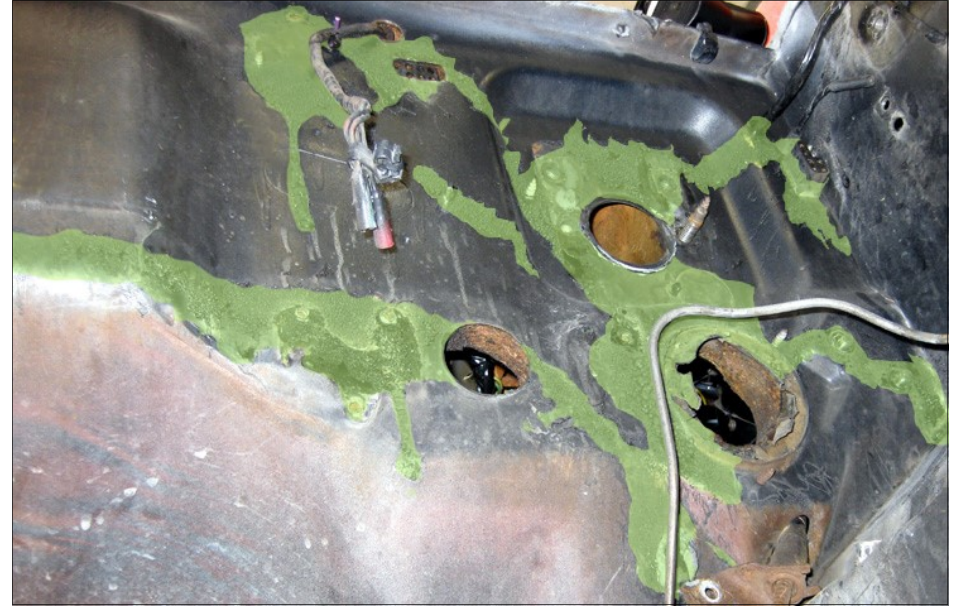
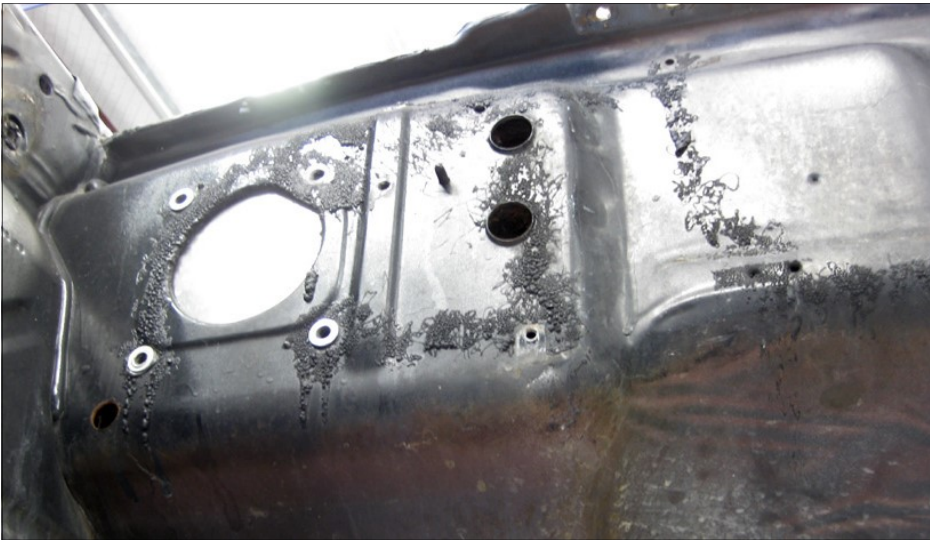
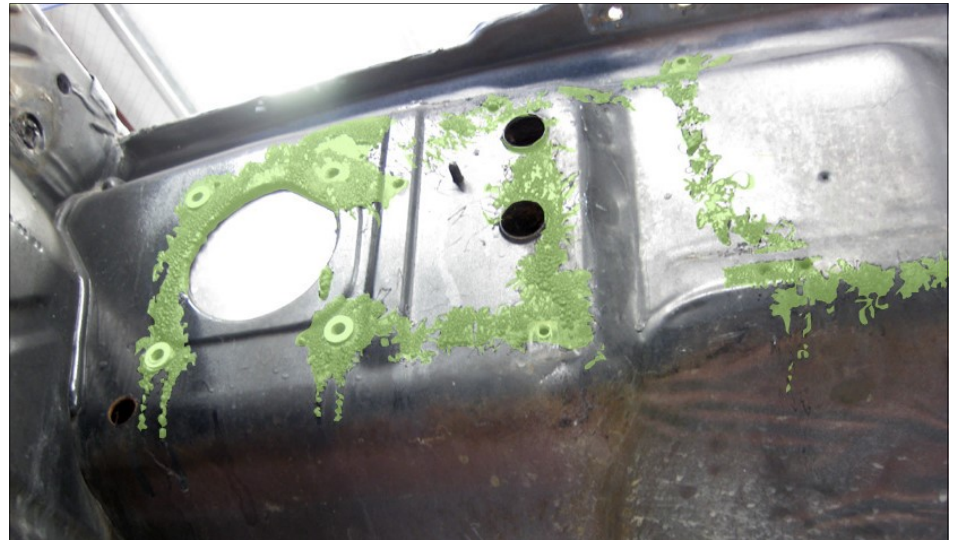
Firewall Sealant

Example of typical sealant applied at or around all firewall attachments and pass-through locations. On the right I've highlighted the spray pattern. As you can see the product is a very fine spray similar to what is produced with spray adhesive (adhesive was the term for Ford used for the product). Sealant applied in a continuous spray carried from point to point.

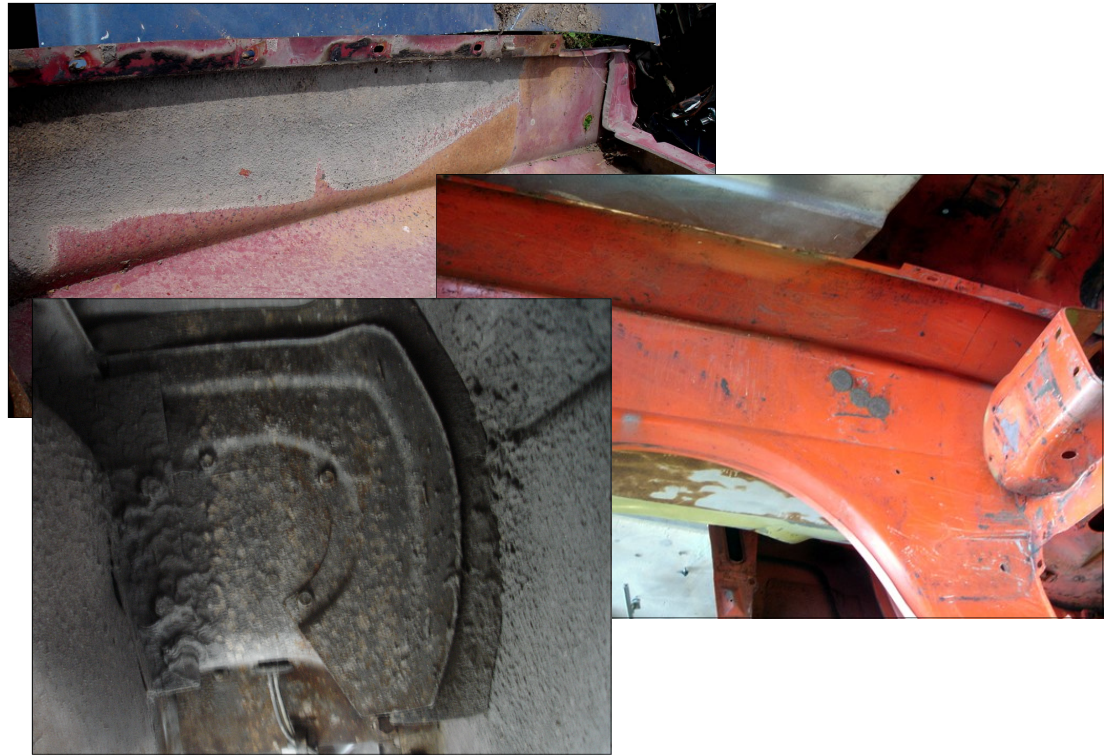
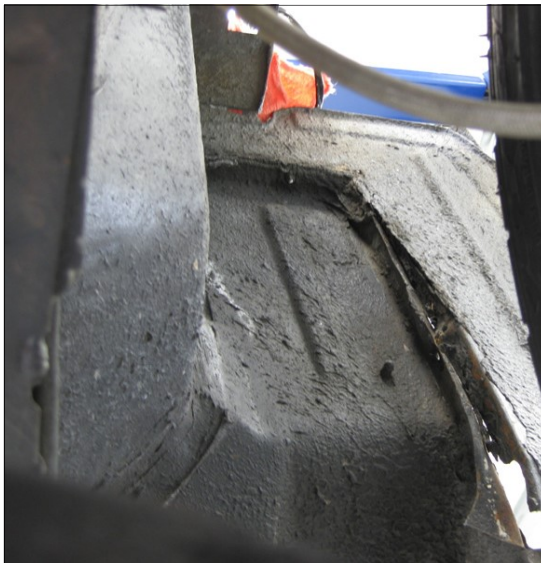
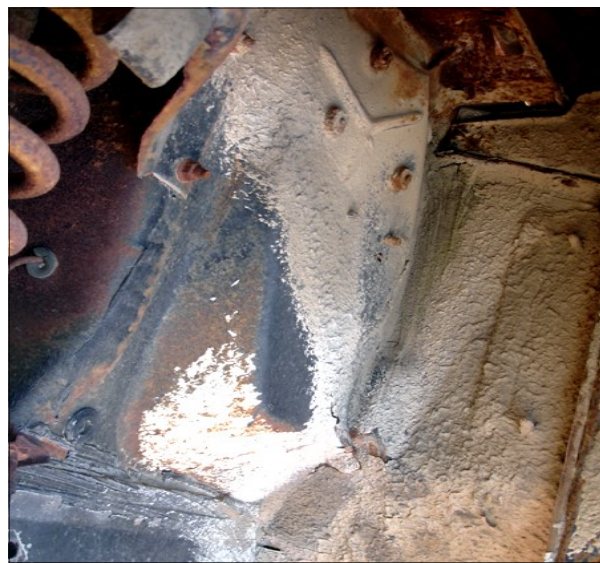
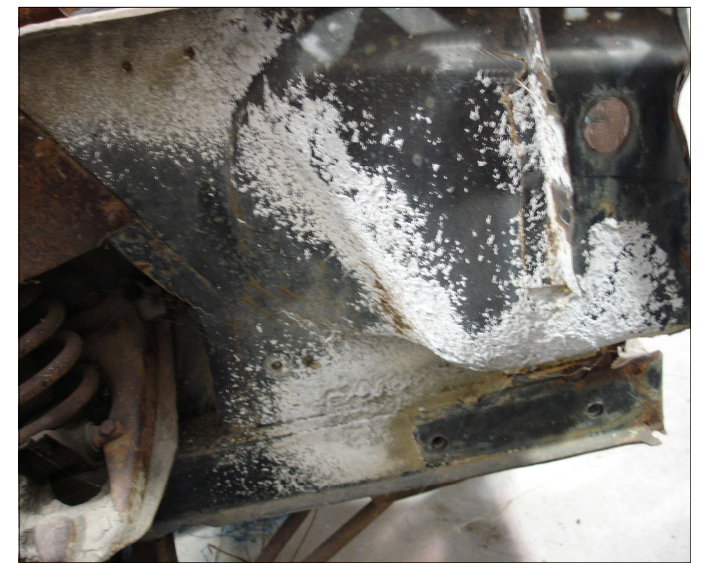
Front Wheel Well Sound Deadener Applied

Once the car was completely assembled (minus front wheels and tires) sound deadener was applied to the front wheel well. The amount and area covered depended completely on the specific worker that applied it and what they did that day. Application falls between a little and a lot with no real identifiable pattern. But all original examples show some on the rear splash shield, firewall section exposed in the wheel well, inner fender panels forward and rearward of the shock tower (normally at a minimum from the lower rear to the top rear edge of the shock/spring cover then from the forward top edge of the shock/spring cover forward and downward.) and finally on the front splash shield.

We often see examples where the bottom side of the fender received a single pass with the application wand but not all cars received this. The sound deadener shown in the two (lower center and right) pictures below has changed colors over time and with exposure to the elements and has turned an off-white in color but the contrast helps us see the areas originally coated in those examples. Originally it was much darker, as shown in the picture below far left.

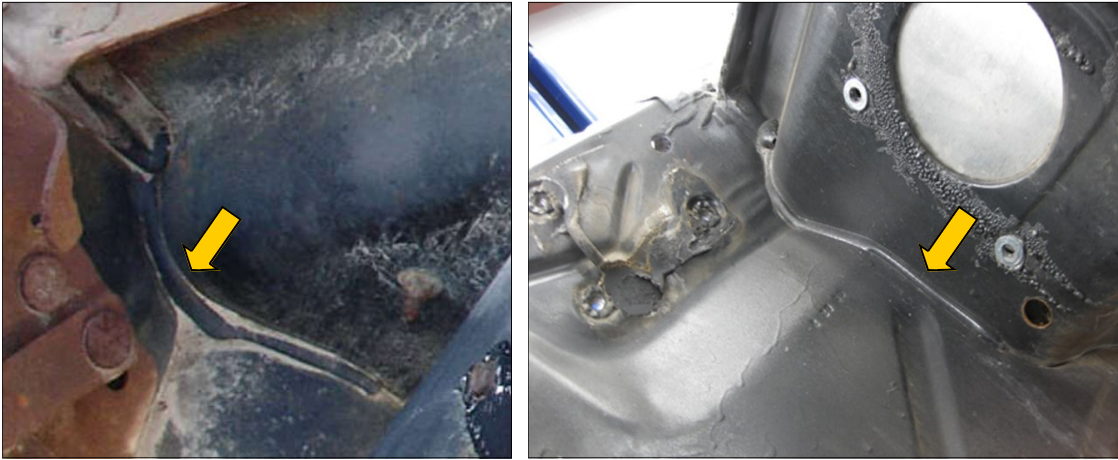
The strip of unspread chalking was typical along the passenger side of the firewall to rear inner fender panel seam. It normally stops midway down the seam and does not continue further. Likely due to reach issues as it was applied from above.

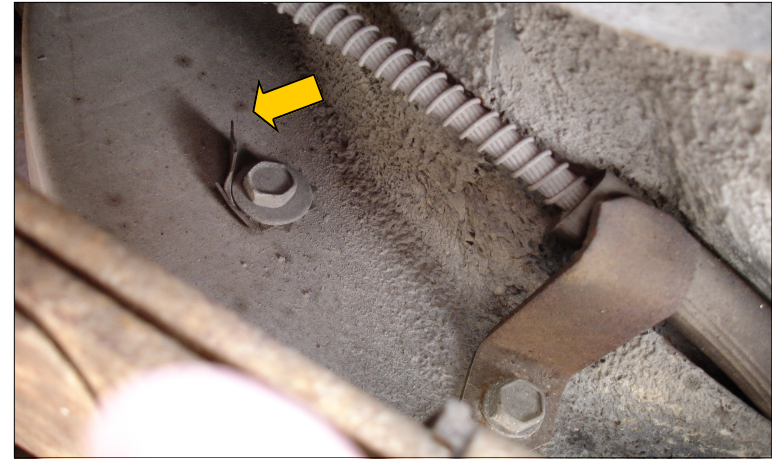
This bolt originally (located in both rear wheel wells) held a thin opaque plastic strap that held the emergency brake cable (one on each side) up and out of the way as the body was lowered onto the rearend. Once the rearend was in place the worker would reach up pull down on the emergency brake cable, and finishing the install and in process breaking the strap.

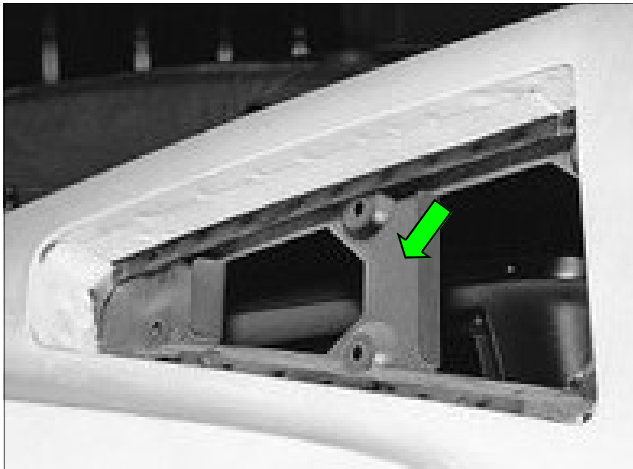
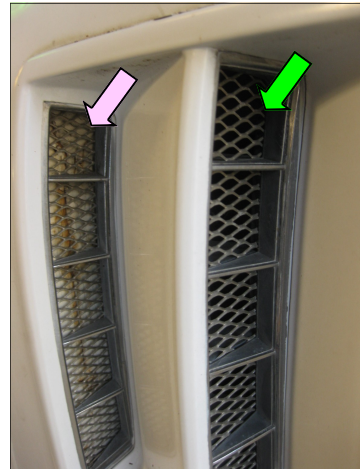
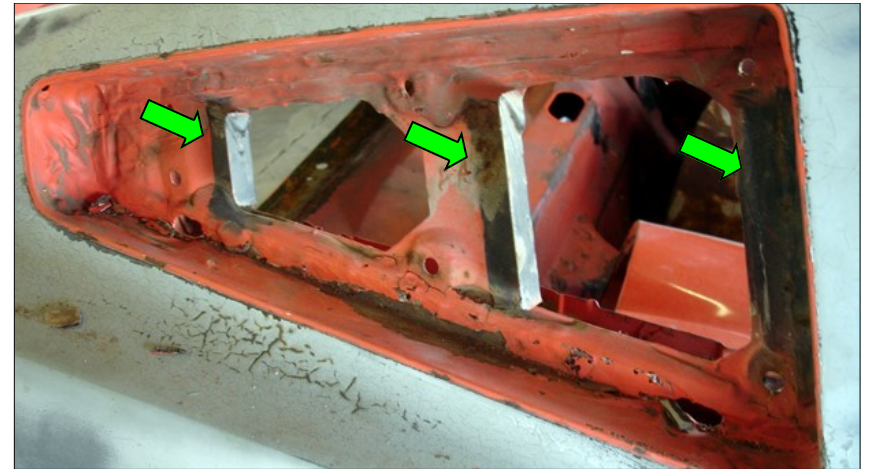
During 1965 production the methods used to black out the quarter louvers or air extractors changed. Early in the year (before approx 5R171xxxx) the whole recessed area was painted black then masked off leaving the majority of the outer surround body color and in turn this allowed body color to show through the forward most grill area as shown in the middle picture. On the later cars only the two dividers and now an expanded forward area were masked off producing what we see in the picture to the right above.

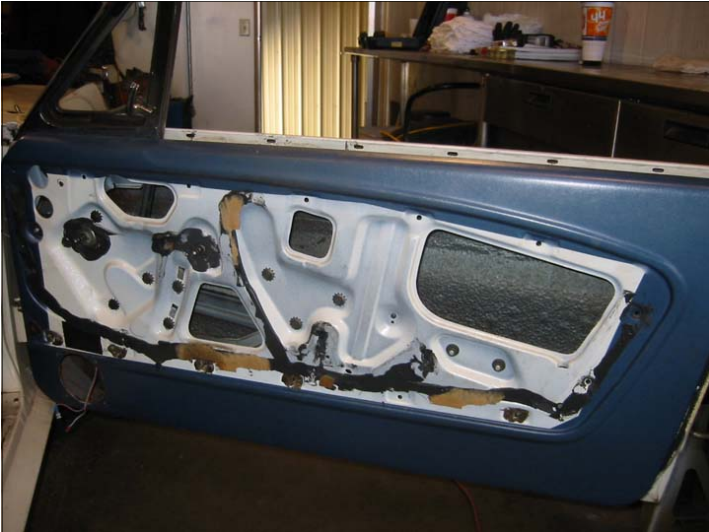
Inner door mask off pattern

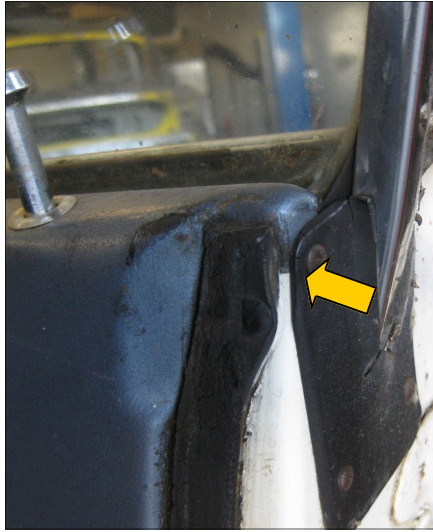
Upper door/interior paint detail

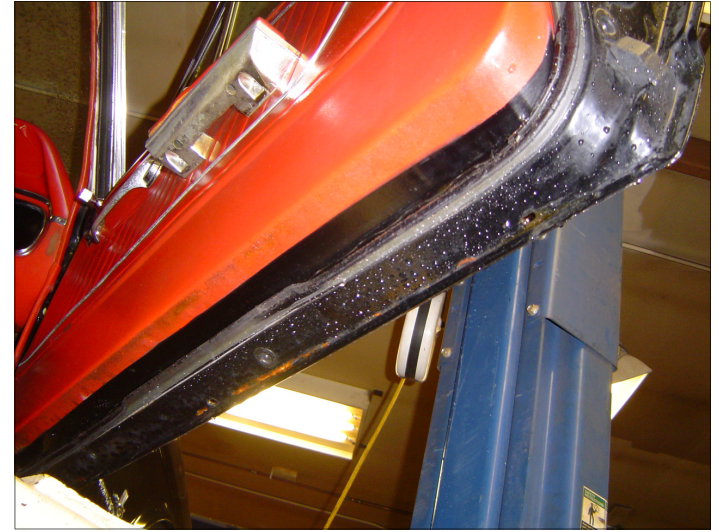
Bottom door edge paint break

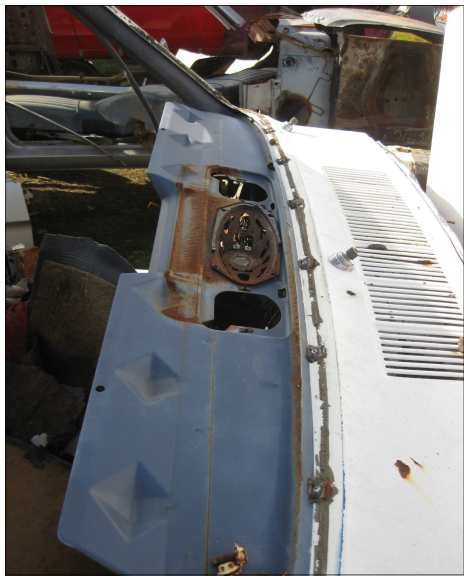
Interior/Dash paint details

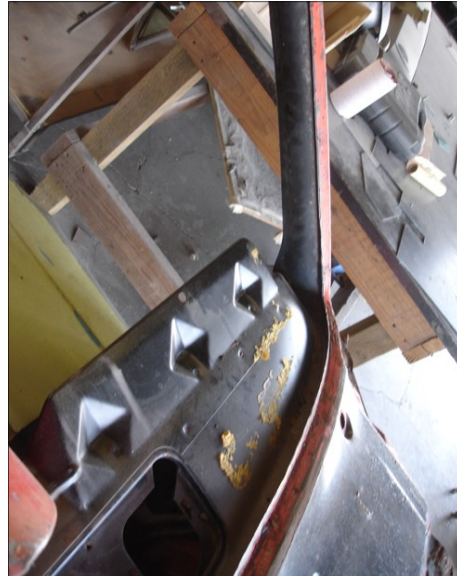
Interior/Dash paint details

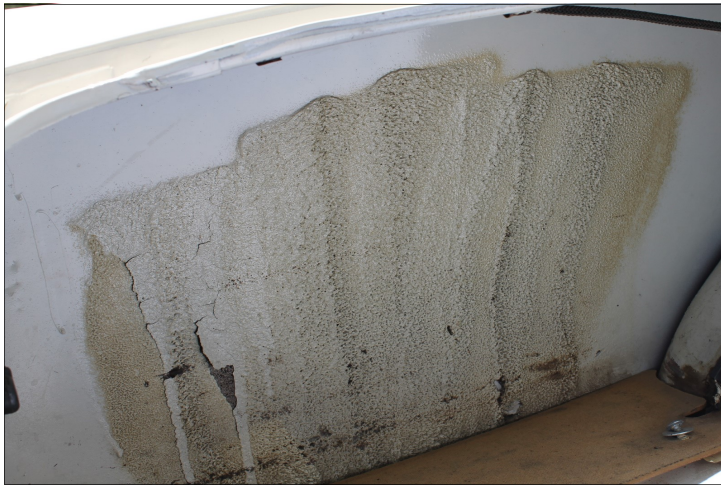
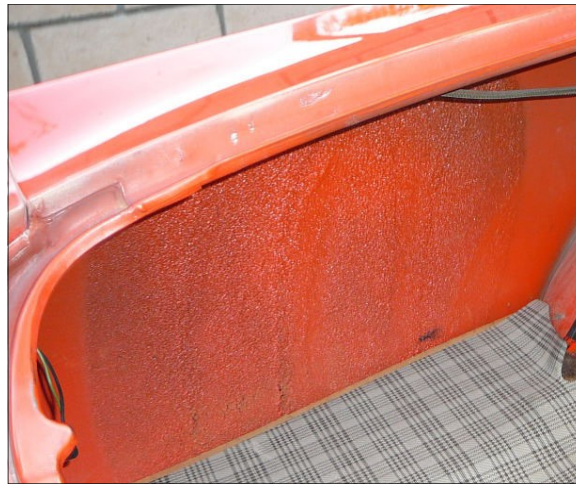
Trunk sound deadener and seam sealer application seal applied

Typical sound deadener application onto the inner surface of the quarter panels.

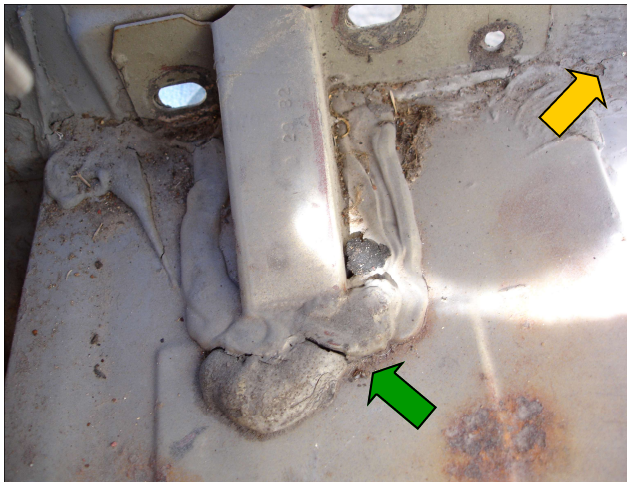
Yellow-Sealant applied then wiped with solvent rag

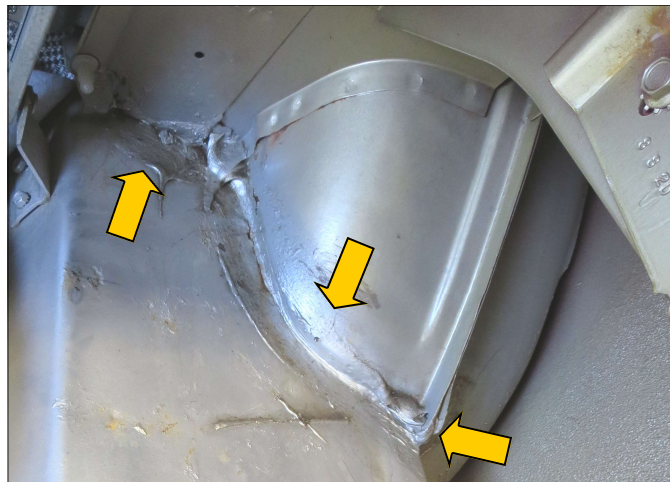
Green-Chalking applied but not spread or wiped

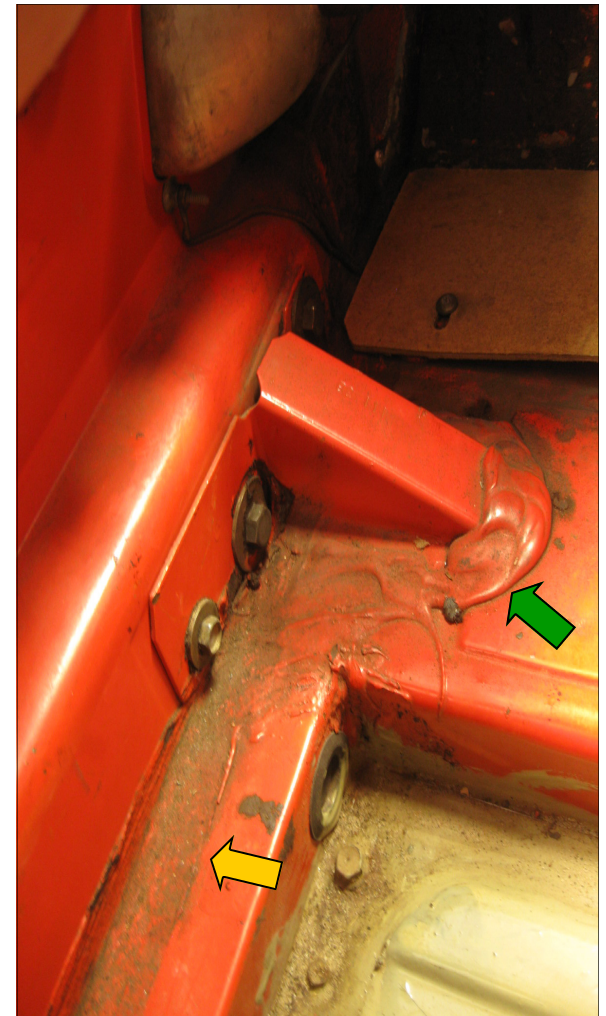
During periods of time in 65 production at San Jose the taillight panel to rear trunk floor seam sealant was applied much neater and did not require nor get, spread out with a rag as the one in the picture (yellow arrow) was. Instead a neat 1/2" bead is found.

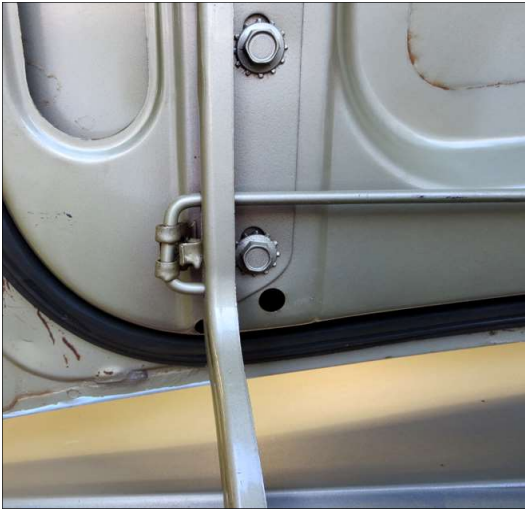
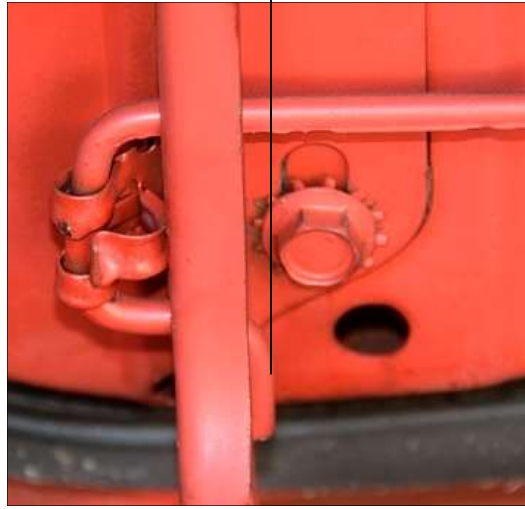
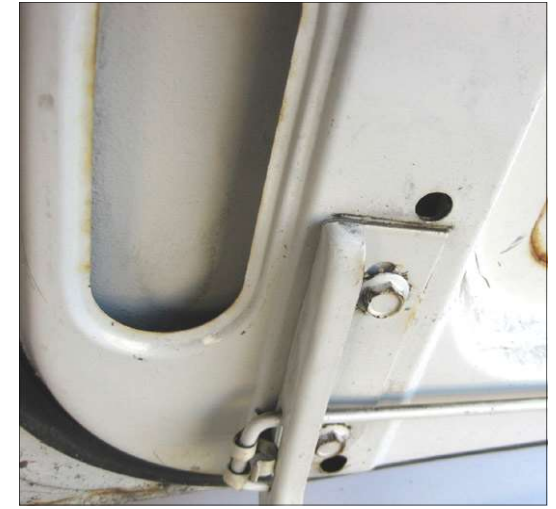
Miscellaneous Paint and Sealant Details

At San Jose on fastback models, workers placed on the trunk lid spring, an clip typically used to secure electrical wires to the body, to the driver's end of the spring. As shown in the pictures.

It's believed that this made the process of installing the trunk lid spring easier and kept the rod from falling out during the process. Because of this, the electrical clip was painted body color along with the surrounding metal as illustrated in the examples to the left. Original unrestored cars with this detail have been found. So far it appears this practice was done on cars built during October 1964 and was stopped sometime between January and March 1965.
