69 Dearborn Unibody (Undercarriage) Restoration Guide

This is an ongoing project of mine and just one section of a much larger project. It is a work in progress so it will hopefully be continually updated as we discover additional or new information and it is researched and accepted.

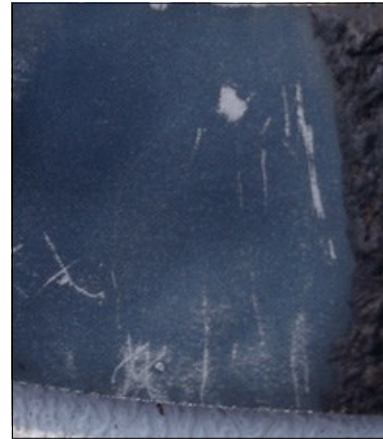
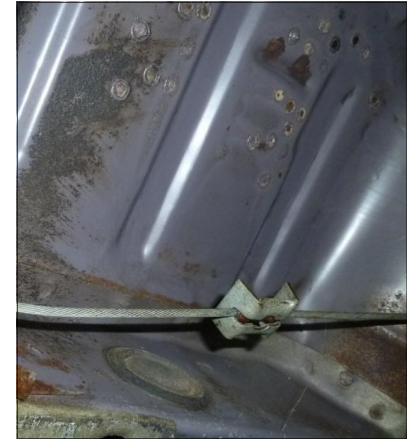
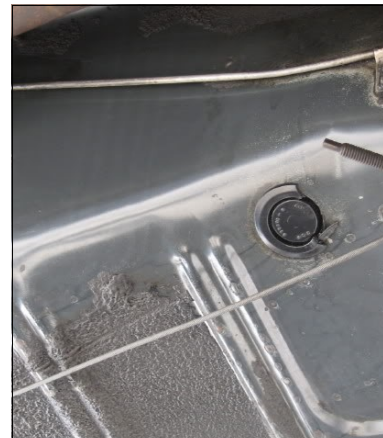
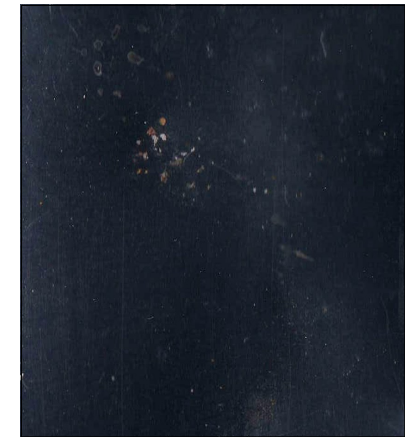
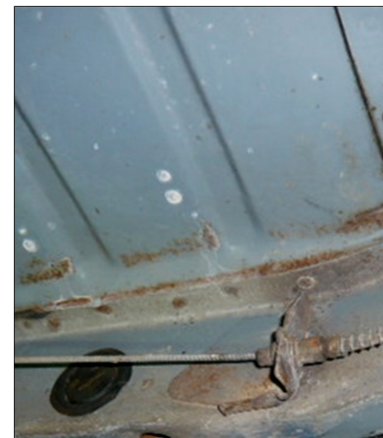
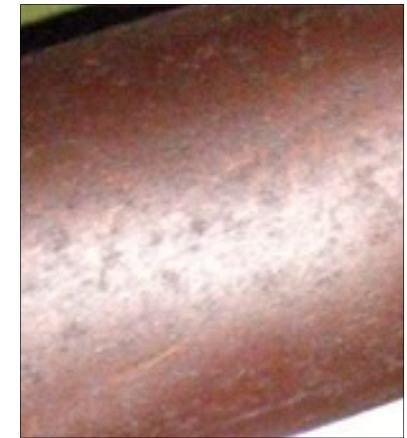
To the right are just a few examples to illustrate the wide variety of colors found of batch paint from 1969 Dearborn built Mustangs & Cougars.

In the later months of production the color of the batch paint applied to the floor panes (firewall rearward) varied greater than in earlier production. The bottom two examples reflect the ongoing change that continued into 1970 production.

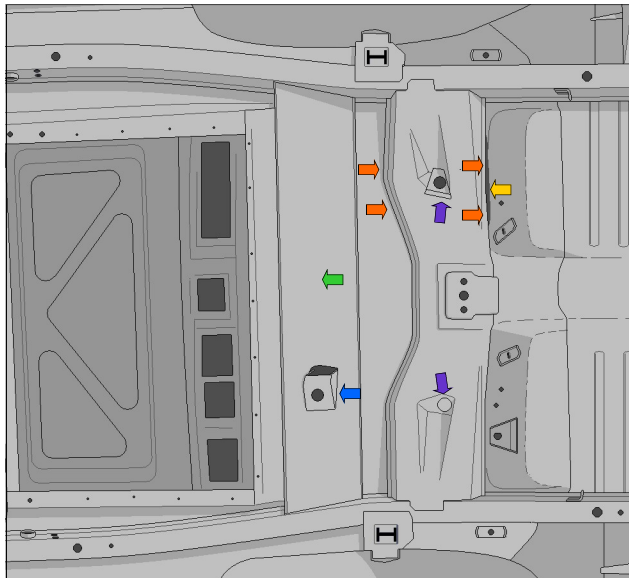
During the assembly of cars with the rear staggered shock feature support brackets (blue arrow) and panels (green arrow) were incorporated into the build of those unibodies. In addition the standard passenger side shock location was reinforced with a plate (purple arrow) and the unused drivers side shock mount hole was covered with a round plate to cover the opening (lower purple arrow)

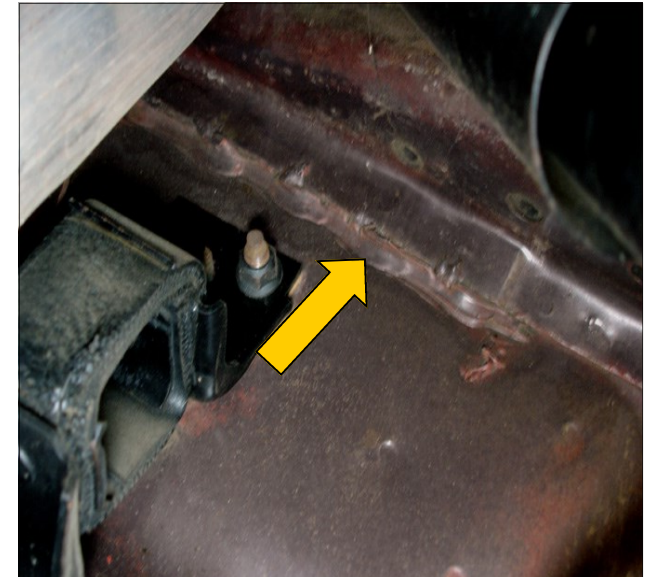
Typically on Boss 302 & 429's received a group welds along the edge of the standard rear shock mount to the rear floor, spaced approximately two inches apart. Along and over the welds along the forward edge of the shock support (yellow arrow) as shown in the original example in the picture to the right.

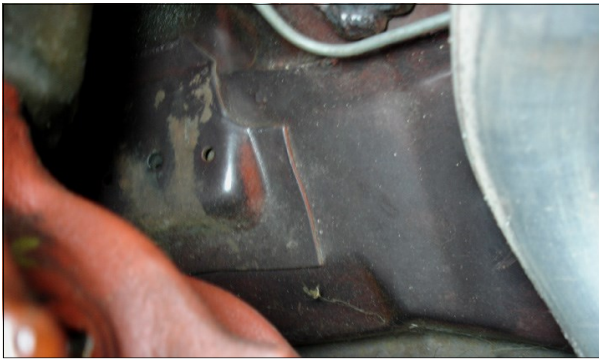
The arrows show the location of the dolly shadows produced by the fixture that the unibody was attached to through the complete paint process and the shadows it left on the frame rails as shown in pictures below.

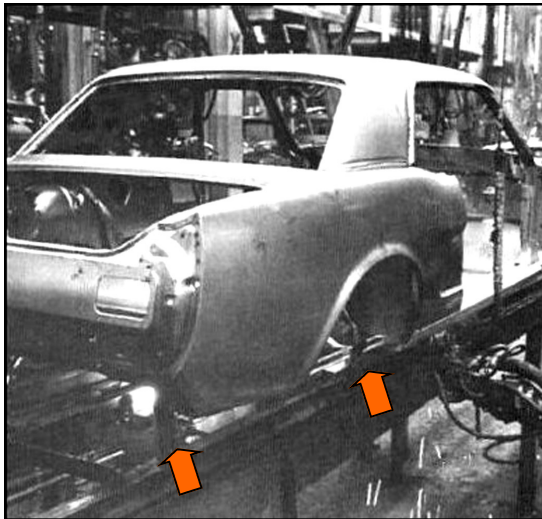
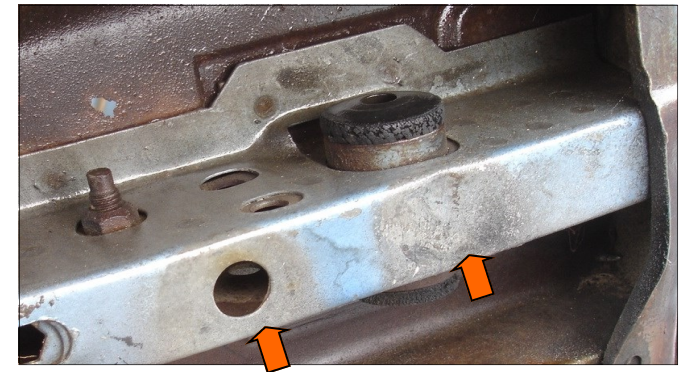
Main floor color can vary between a red oxide color and a primer sealer mixed with left over exterior colors producing a variety of different colors most often a dark gray look with, sometimes, metallic, or blue or green tint.

The rear most dolly stand had two attachment points to accommodate both Mustang and Cougar bodies. This left an additional shadow on both models. Above a Mustang

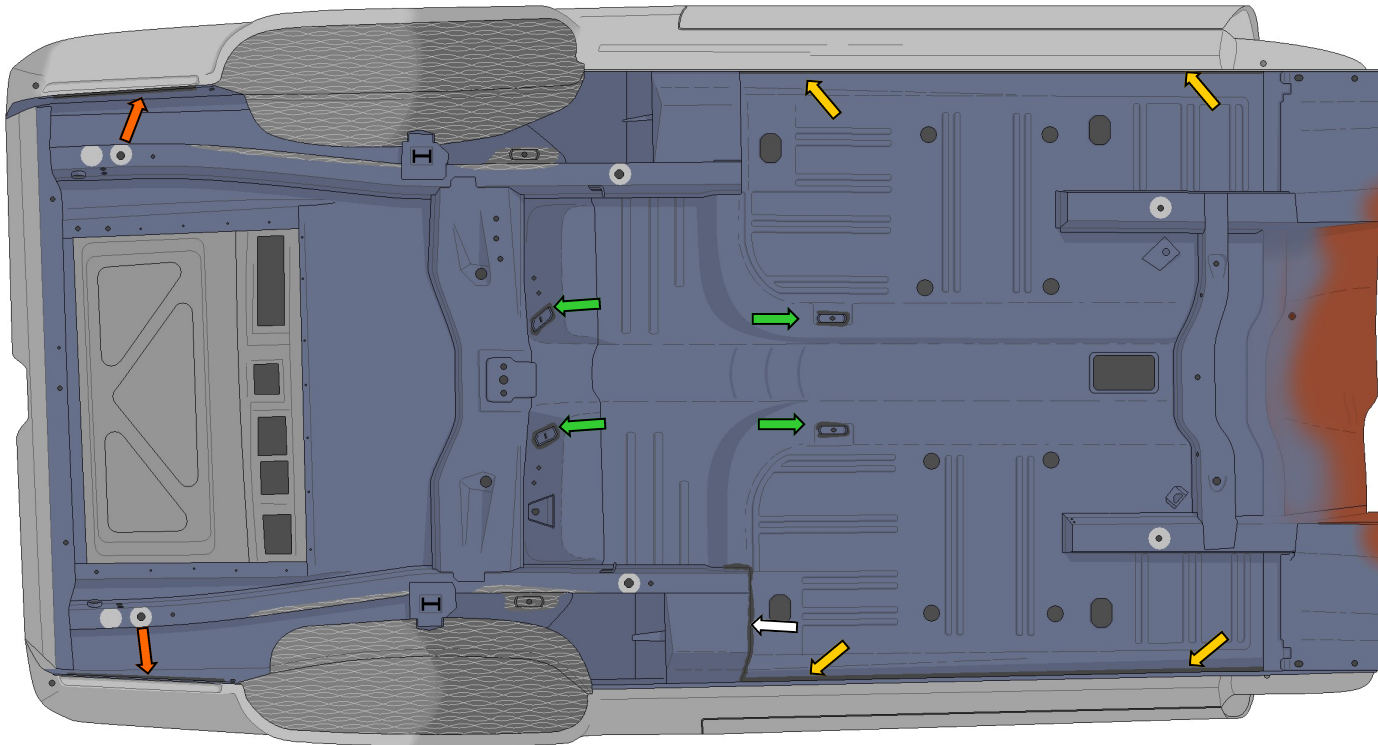
Seams are chalked. Determining if this step took place before or after body color is still being studied.

Yellow - Rocker panel. Along the inside edge. Application can continue along the front edge of the rear spring torque support. Some times the worker continued the sealant along the forward edge of the rear spring torque support (White arrow)

Green - Seat belt mounting points

Orange - Trunk floor drop. Approx 1" wide strip along bottom of inside edge of the trunk drop/extension panel over the pinch weld spot welds

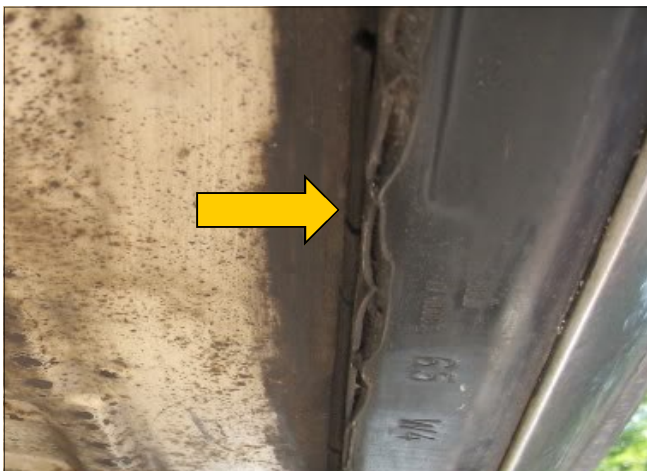
Rocker to main floor seam seal. Examples show this thin straight from the chalking applicator style as well as a examples where there was more product applied then wiped to spread out the coverage

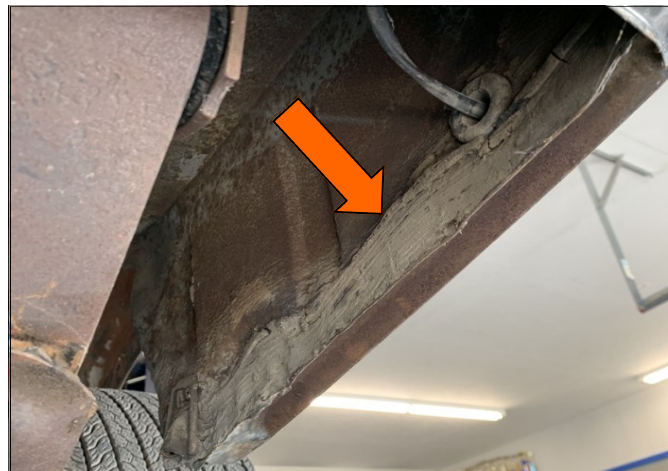
Trunk drop sealant applied over the quarter panel and trunk drop pinch weld and often continues up along the edge behind the rear valance.

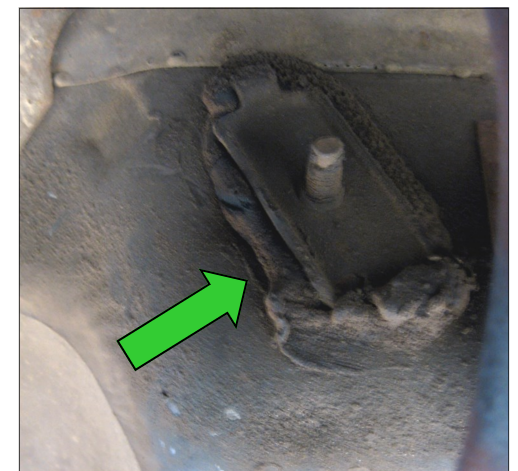
One example of the inner seat belt anchor bracket sealant

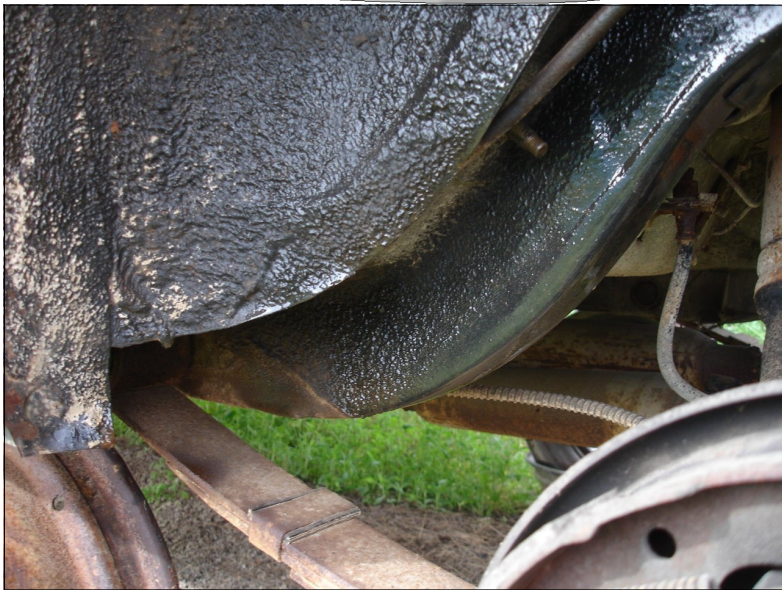
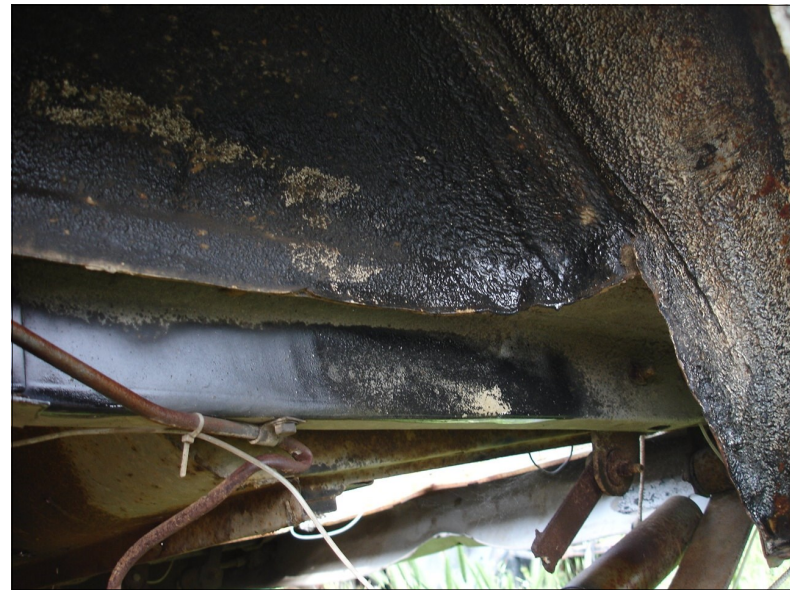
Sound deadener next applied to the rear wheel wells and trunk surfaces.
