### SUMMARY OF SHAFT SINKING TO THE 530 LEVEL

#### McARTHUR RIVER EXPLORATION SHAFT

## 1.0 INTRODUCTION

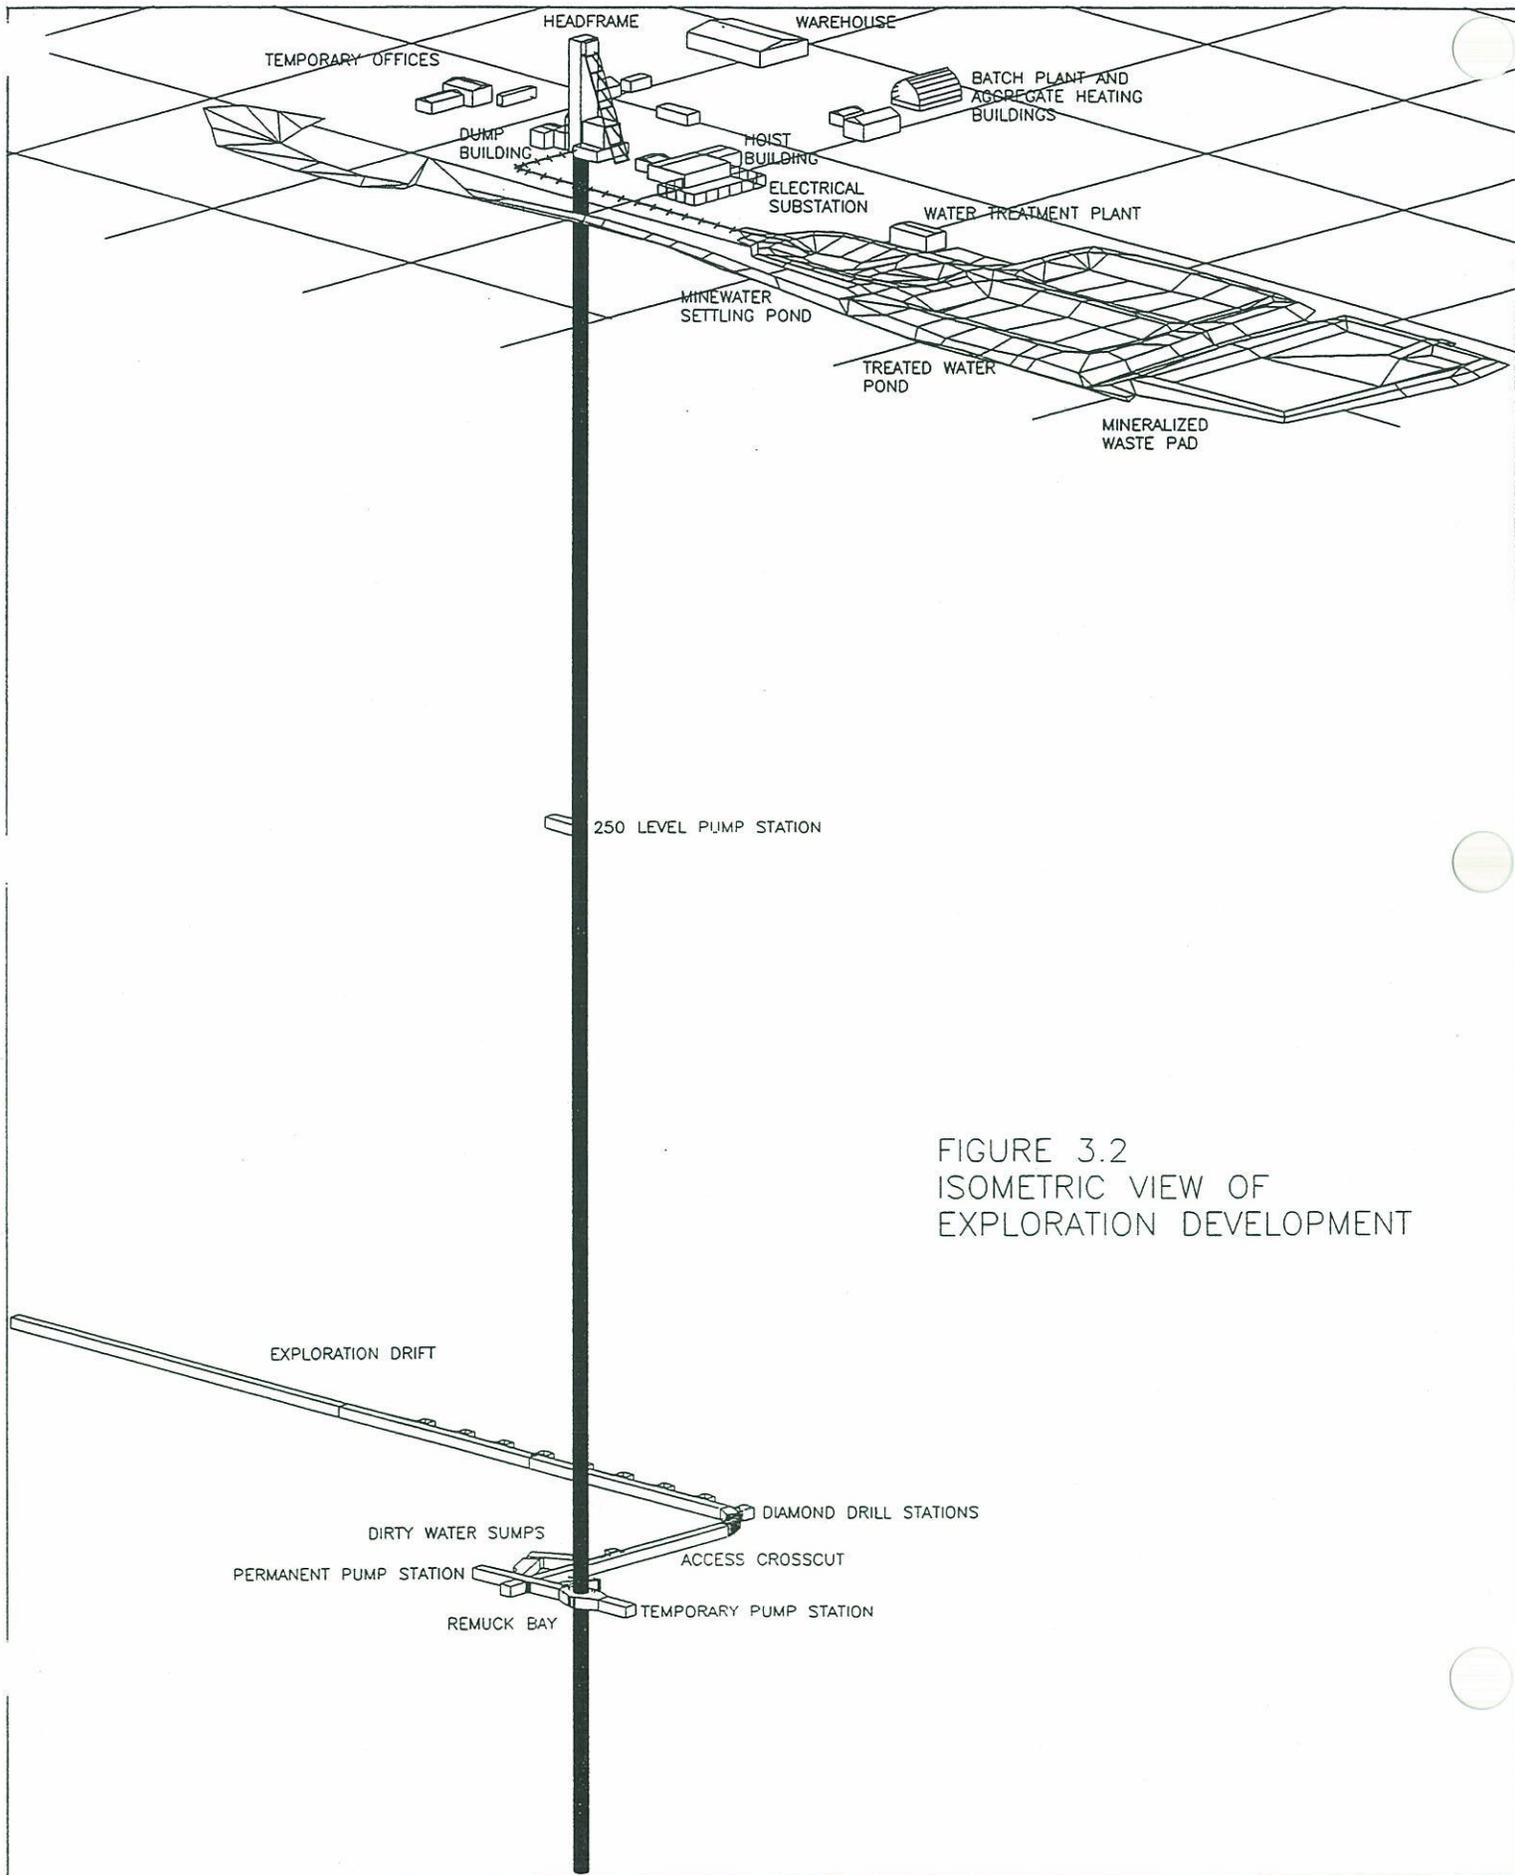
FIGURE 3.2  
 ISOMETRIC VIEW OF  
 EXPLORATION DEVELOPMENT

A total of five companies bid on the sinking contract. This contract was awarded to Thyssen Mining and Construction Company (TMCC) of Regina. Figure 3.1 illustrates the shaft cross-section with necessary concrete lining thicknesses. This would entail an initial sinking diameter of 6.1 metres which would progressively increase to 7.9 metres. The planned development is illustrated isometrically in Figure 3.2.

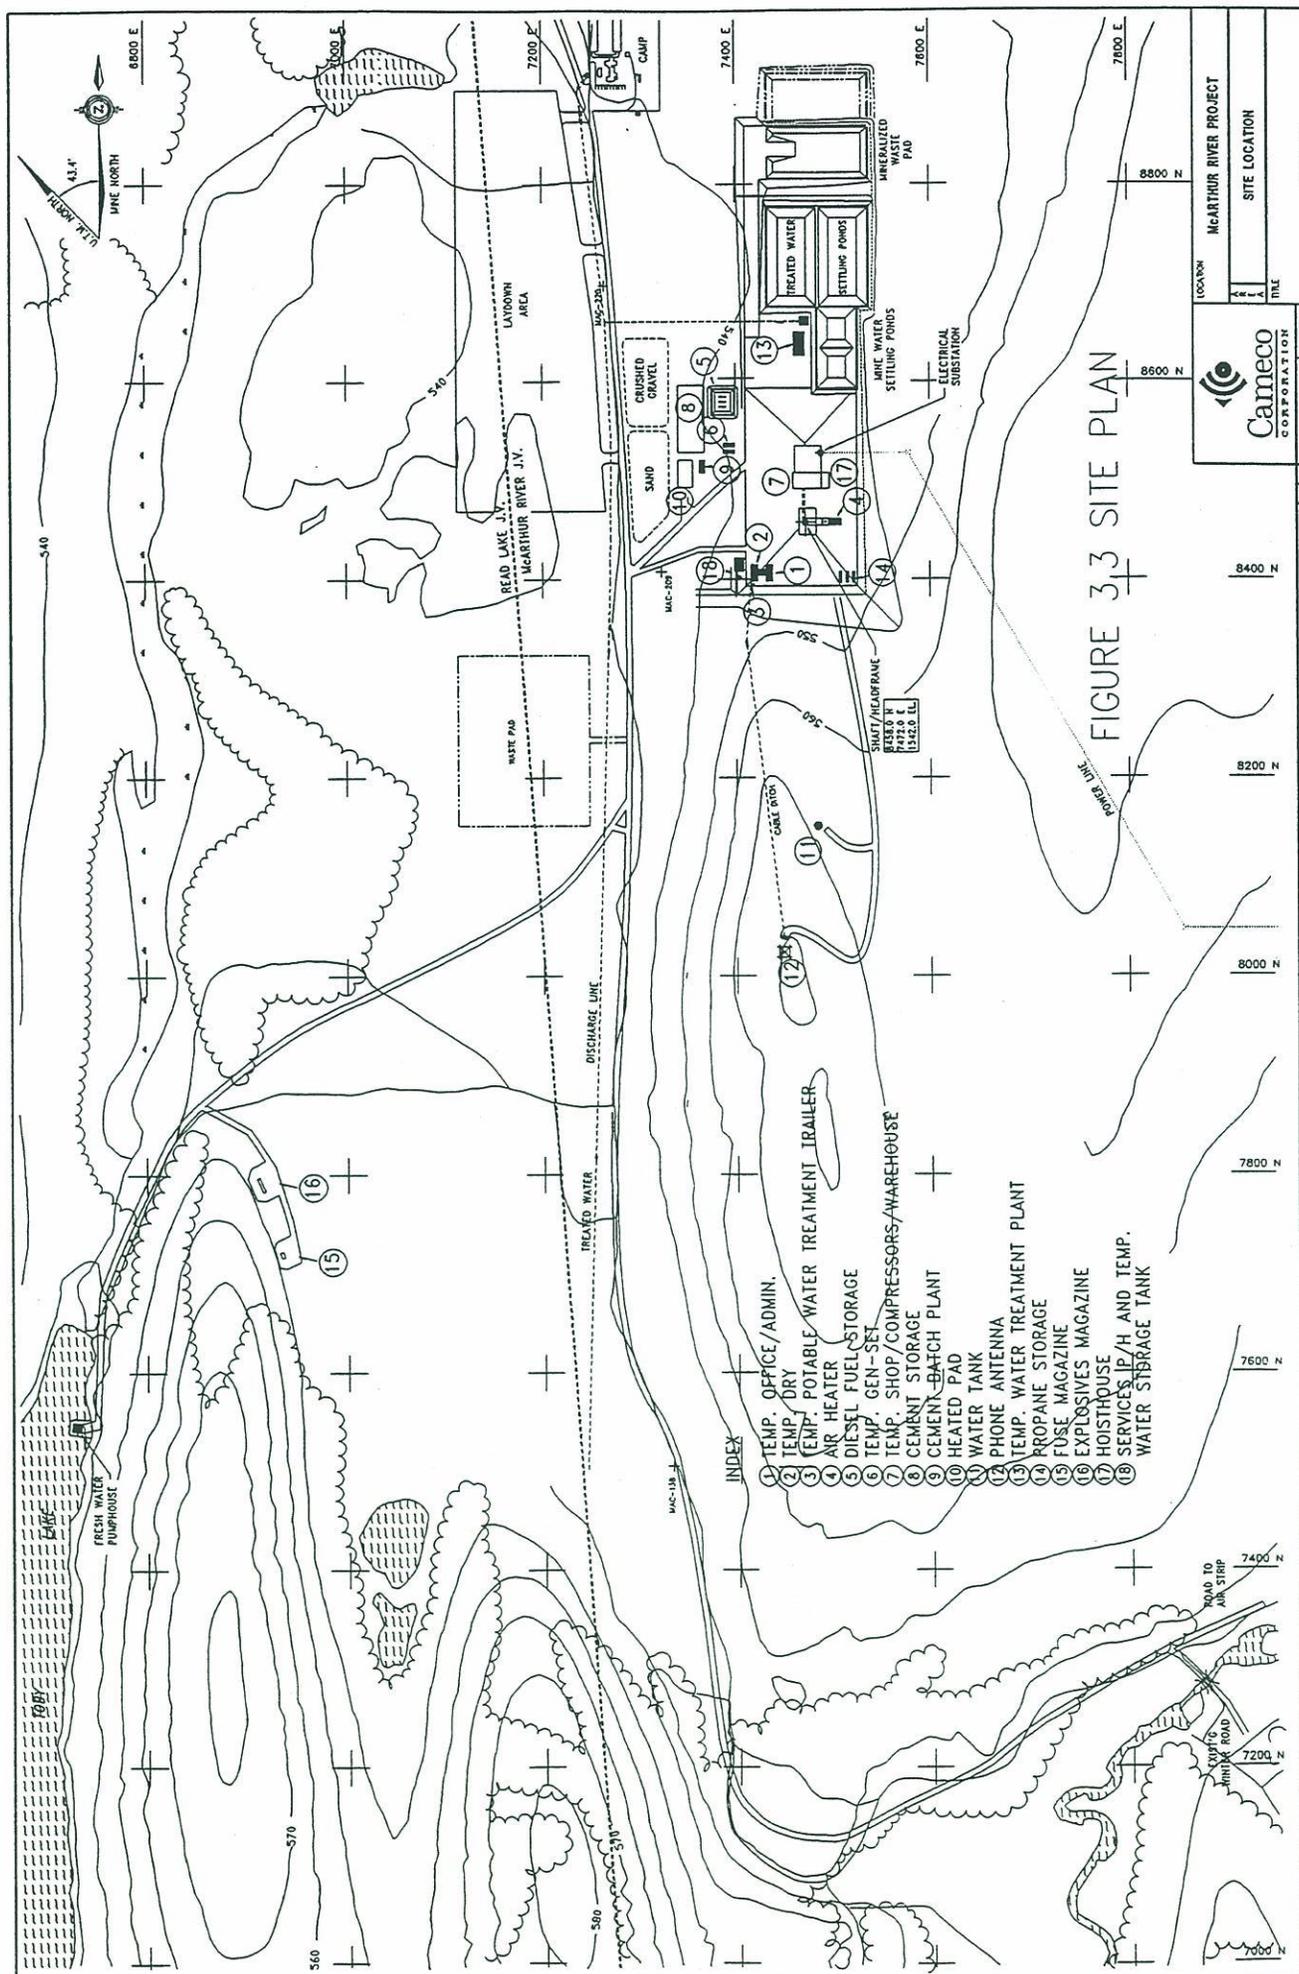
FIGURE 3.3 SITE PLAN

A general site arrangement was produced by the Cameco Engineering group in Saskatoon and is illustrated in Figure 3.3. The Engineering group was also responsible for designing the minewater treatment and fresh water facilities and played an important role

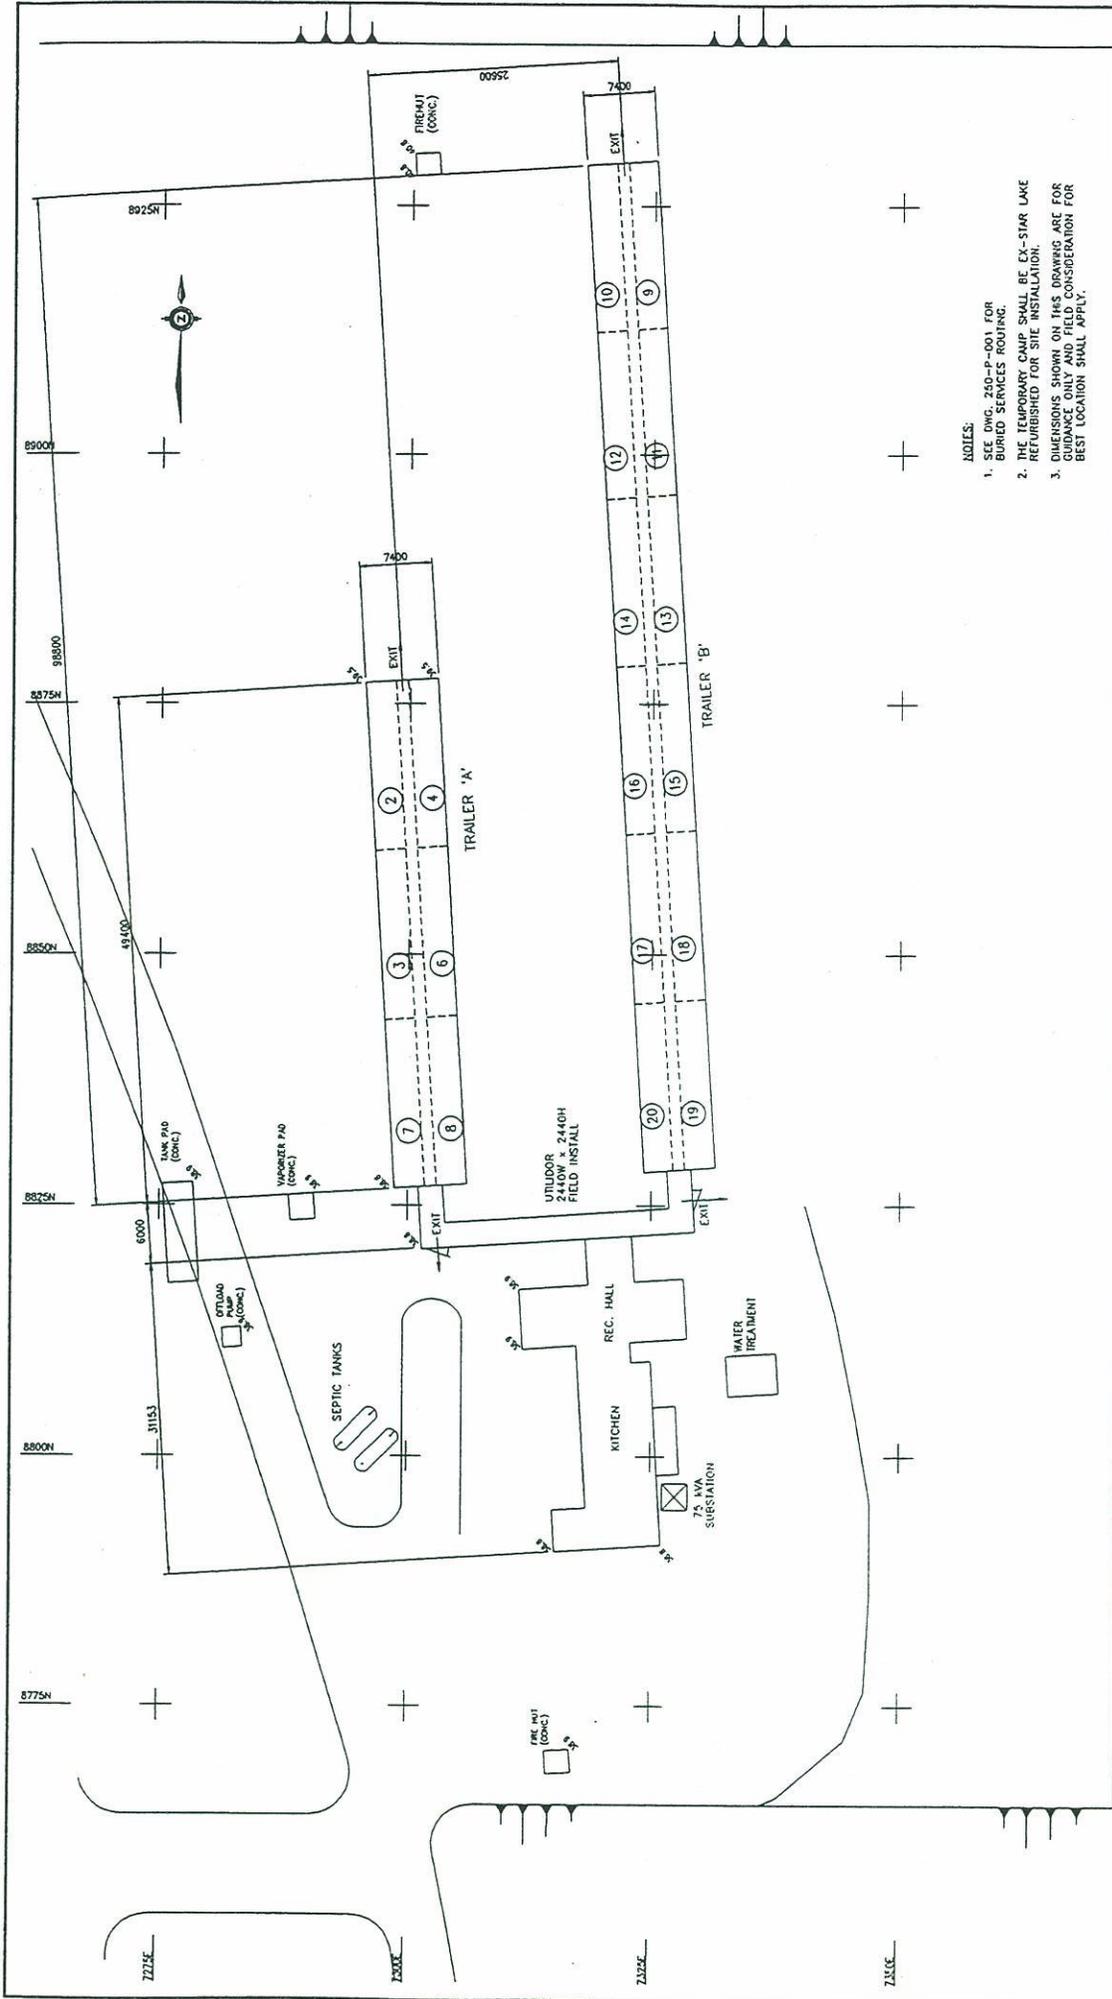
FIGURE 4.1

The construction camp trailers arrived during the second week of February and work commenced to place, roof and connect all services for these buildings. The camp was ready for partial occupation by mid-March. The general arrangement is shown in Figure 4.1.

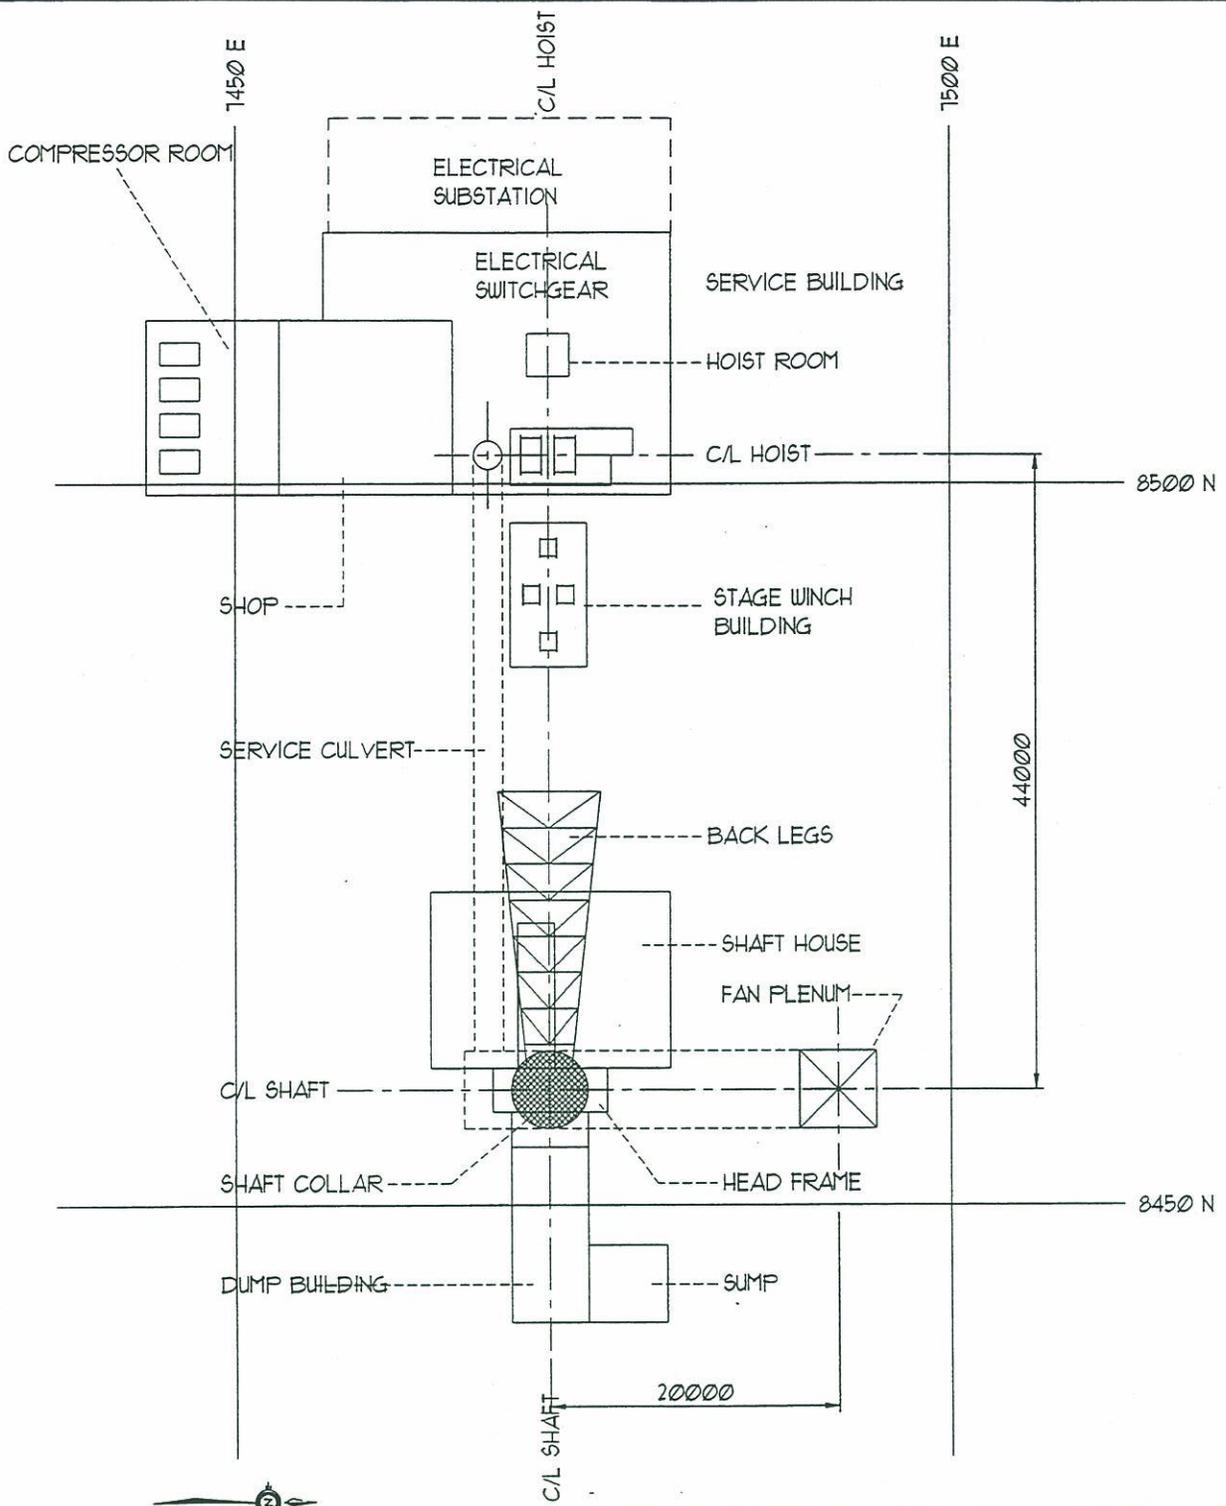
FIGURE 4.2 SHAFT COLLAR GENERAL ARRANGEMENT

The shaft collar general arrangement is shown in Figure 4.2. As illustrated in Table 4.2, the shaft construction activities began in late March with the installation of a concrete batch plant and excavation of the eight metres of sand overburden above the bedrock in the shaft collar area. Upon removal of this overburden shaft sinking commenced utilizing air pluggers and one mucking clam. Concurrently, pouring of the hoist foundation commenced.

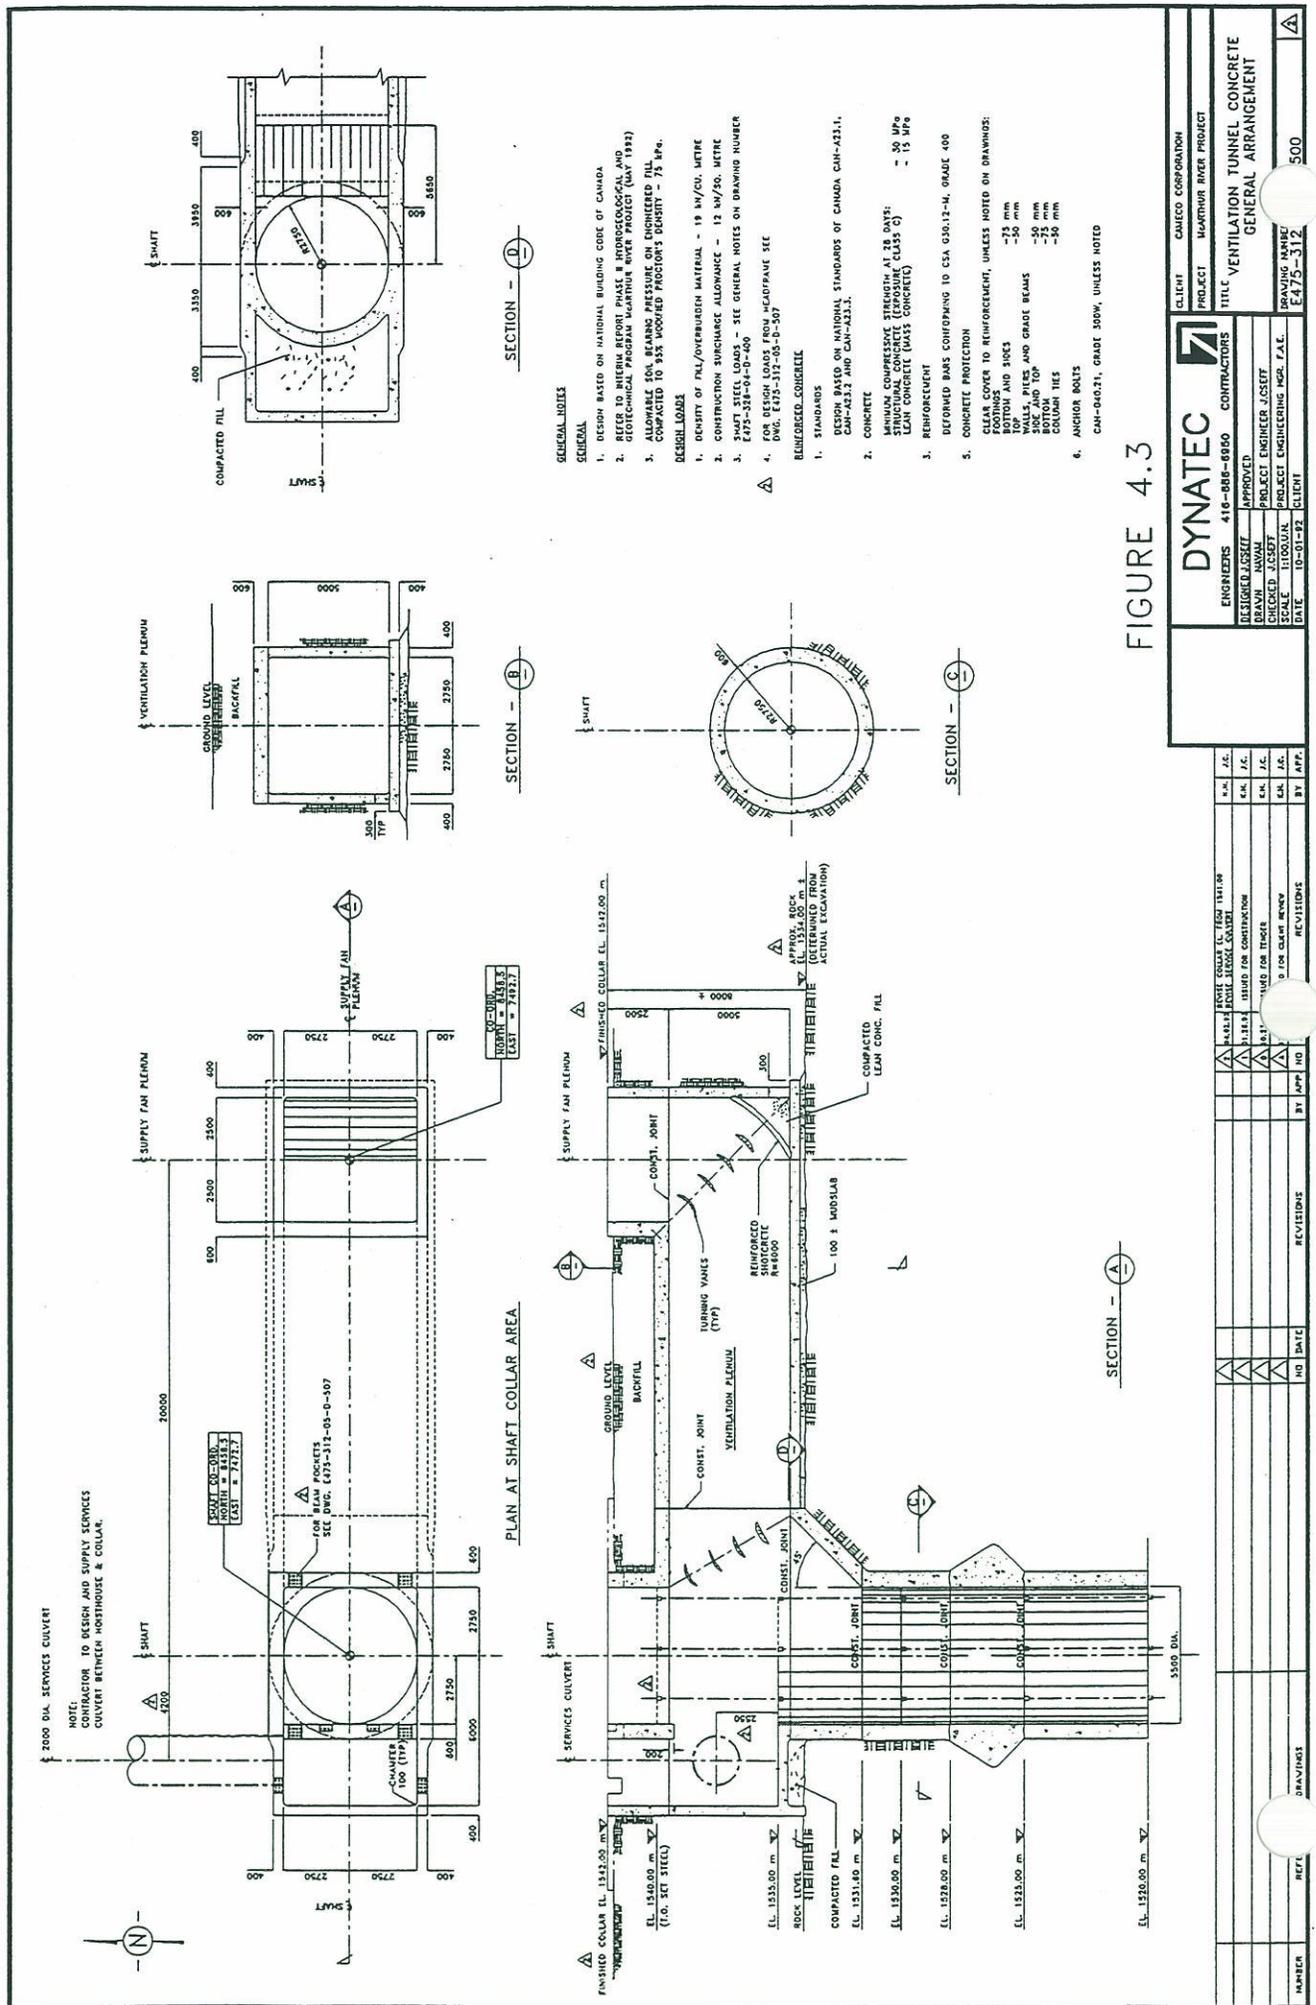
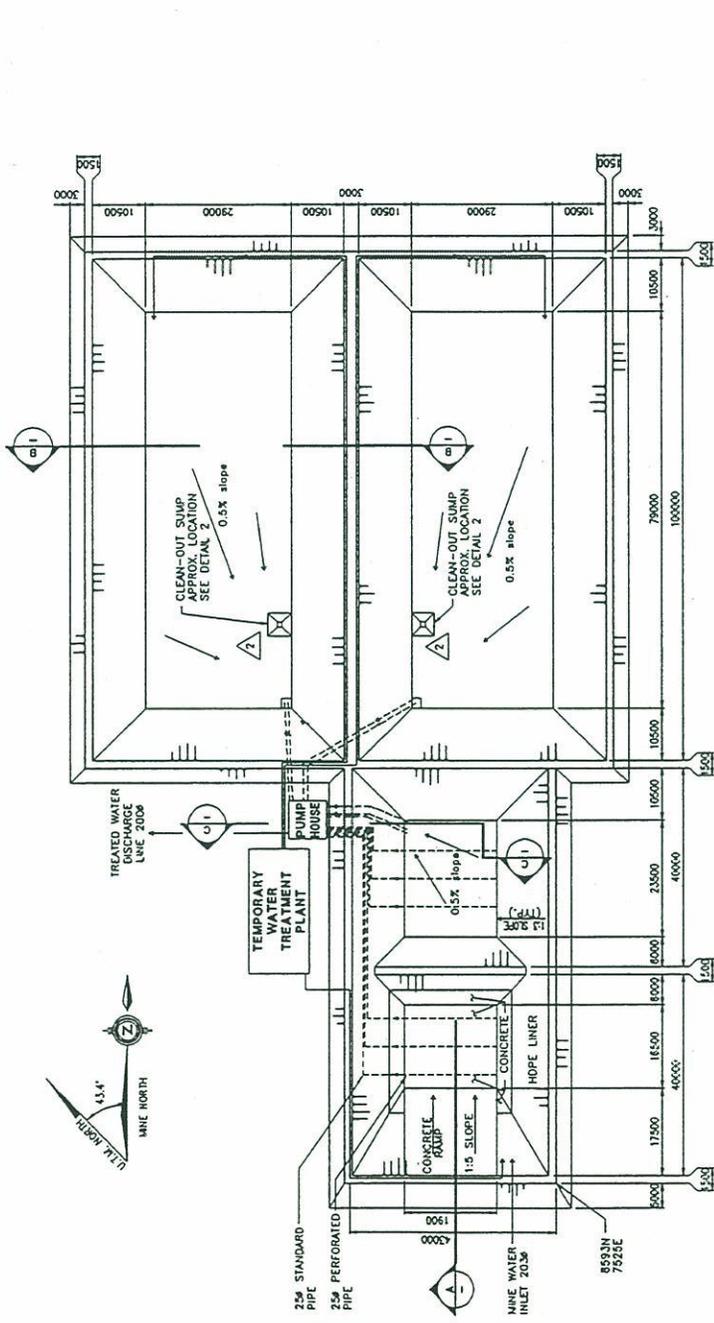
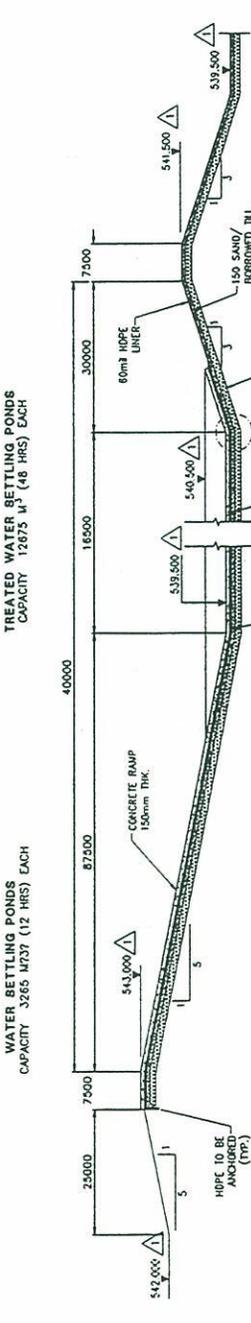
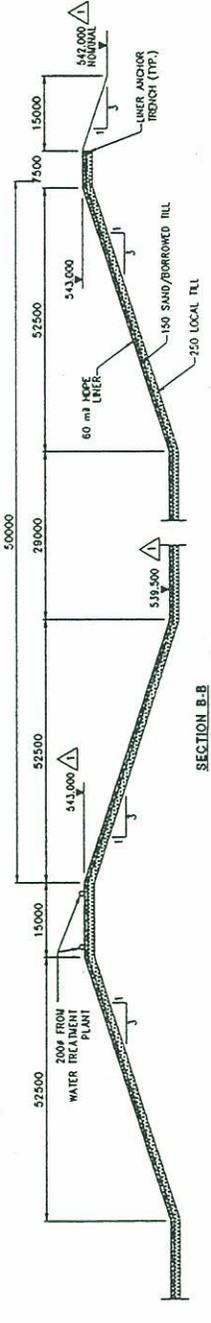
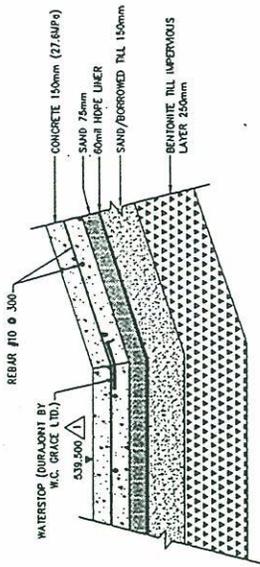
FIGURE 4.3

The shaft collar and ventilation plenum were constructed from the end of April to the end of May. Concrete details are illustrated in Figure 4.3. This entailed the pouring of 736 cubic metres of concrete for the shaft lining and hitch, ventilation plenum and shaft collar. Upon completion of the collar, headframe installation commenced.

DETAIL 1  
SCALE 1:10

SECTION A-A  
SCALE 1:100

SECTION B-B  
SCALE 1:100

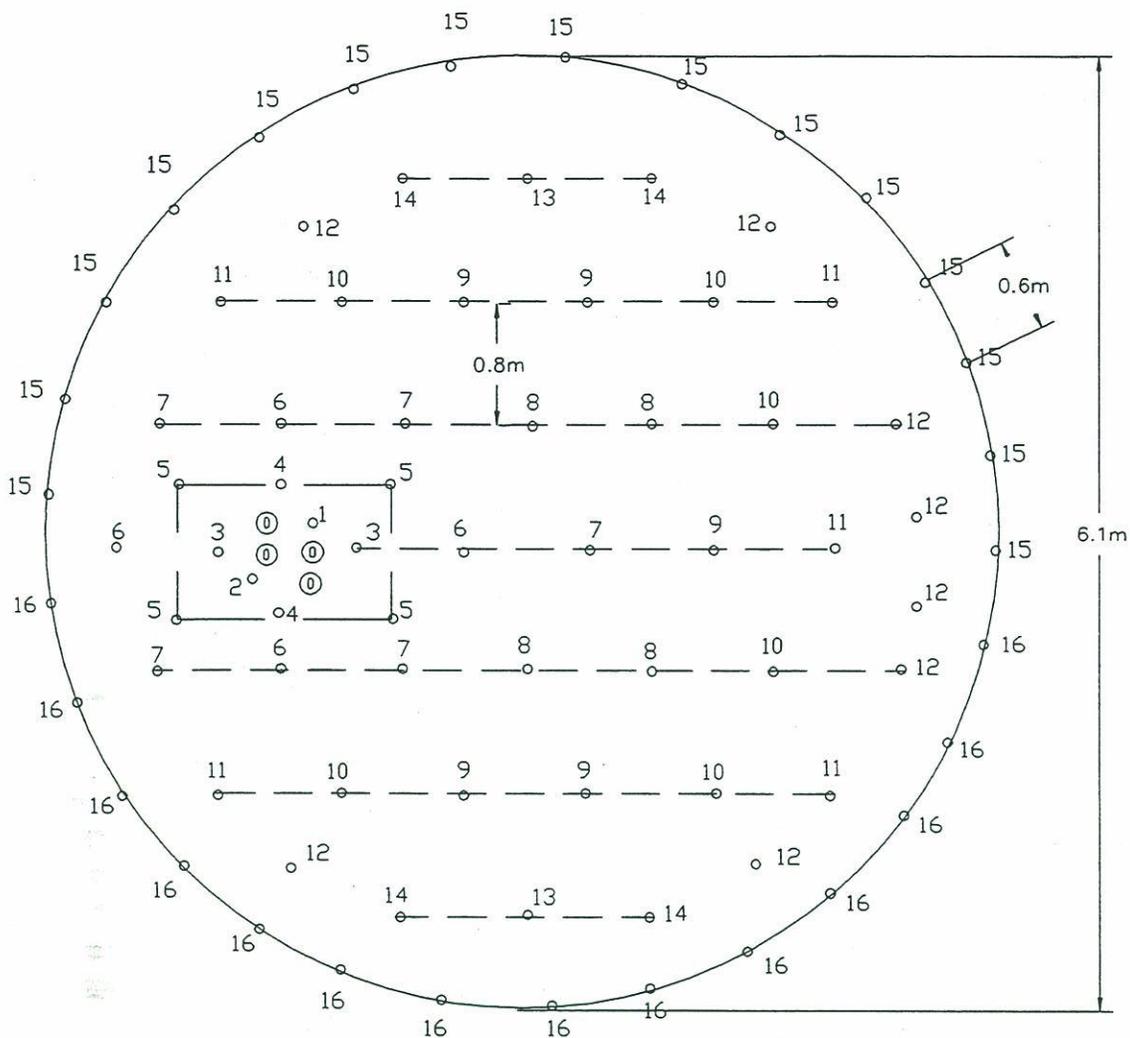
# FIGURE 5.1 BLAST PATTERN DESIGN

For Shaft Segment One, 300mm Concrete Lining

Full face rounds were drilled off using the shaft jumbo. The initial plan was to take five metre rounds with five metre concrete lining pours using three specialized crews to do each phase of the mining cycle, namely drilling and blasting, mucking and concrete pouring. As discussed later, the five metre rounds were cut back to three metres due to cross detonation of the nitro-glycerin based explosive (70% Forcite) through the horizontal bedding planes in the sandstone. The initial blast pattern is illustrated in Figure 5.1. Conversion to slurry based explosives improved matters but the varying bedding plane thickness of 10 centimetres to 4 metres frustrated attempts at blasting five metre rounds. Cycle delays led to quick abandonment of the

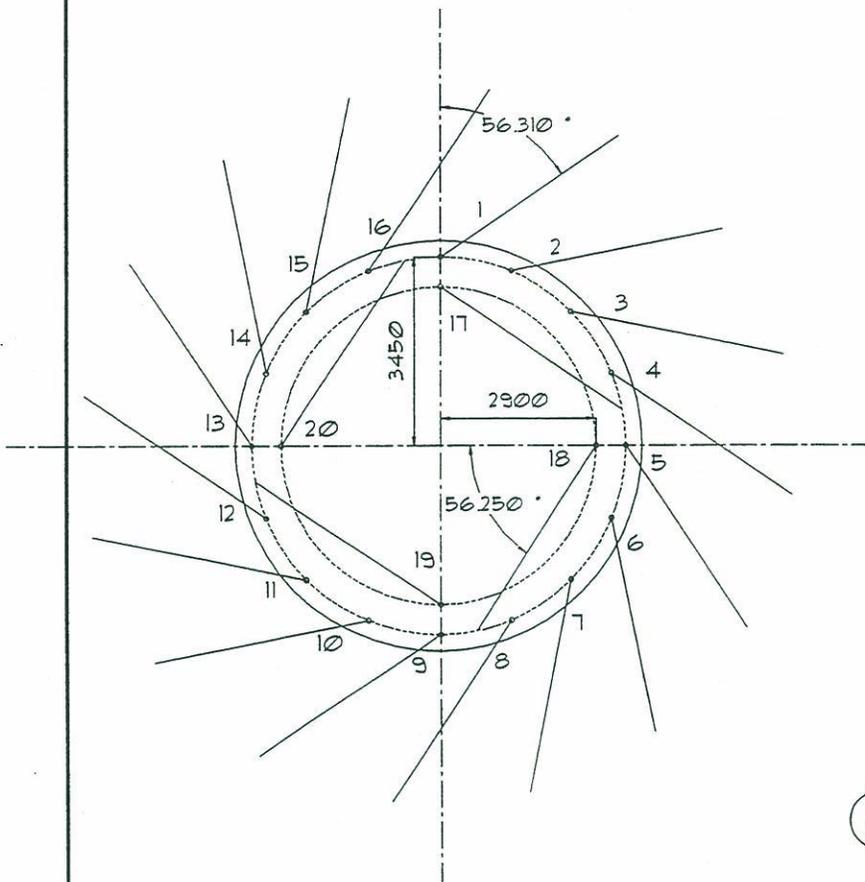
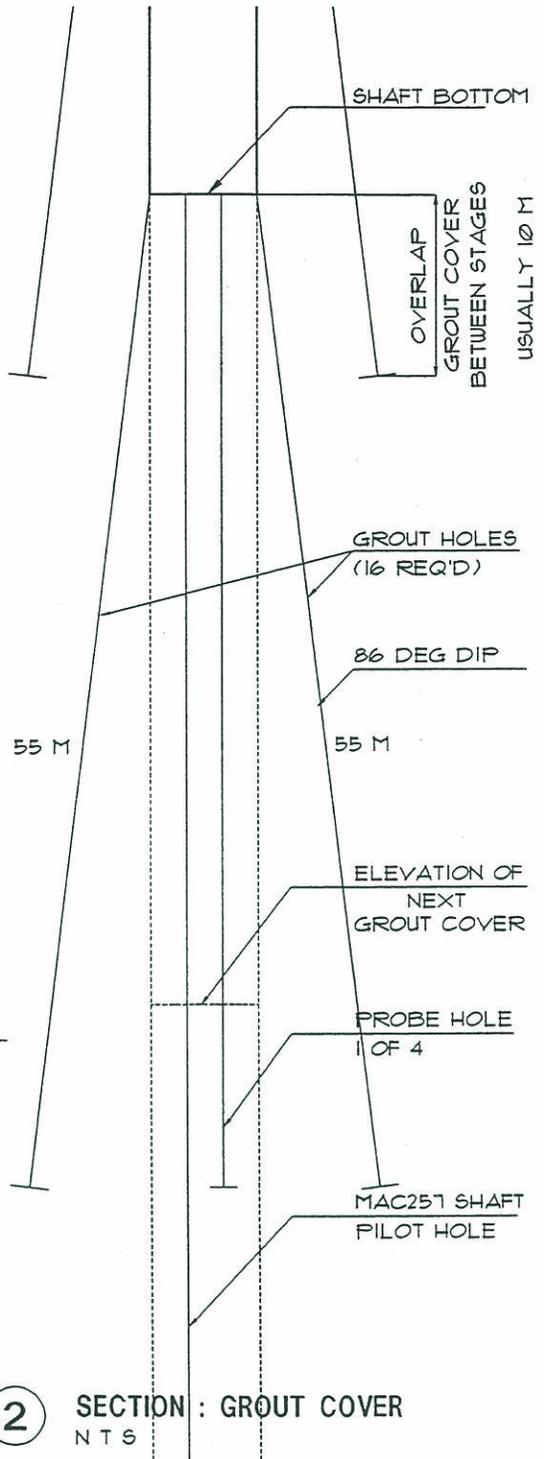
FIGURE 6.1  
STANDARD GROUT HOLE PATTERN

1 GROUT COVER : HOLE LAYOUT  
NTS

2 SECTION : GROUT COVER  
NTS

Phillips recommended that shaft sinking proceed in stages spaced 40 metres apart vertically. Upon reaching the sinking limit of a given stage a total of twenty standpipes would be installed in the shaft bottom to allow drilling of twenty 45 metre grout or probe holes. Sixteen of these holes would be drilled near vertical tangentially to the shaft wall with the four remaining holes drilled to depth inside the future shaft perimeter as illustrated in Figure 6.1. Eight tangential holes, either the odd or even numbered holes, would be designated primary grout holes and the remaining eight would be deemed the secondary grout holes. In conjunction with TMCC, Cameco staff decided to lengthen the interval between stages from 40 metres to 55 metres. This would be achieved by drilling 61 metre grout and probe holes.

All standpipes would be pressure tested for leaks to a pressure at least 100 psi above potential hydrostatic groundwater pressure. Upon completion of these tests the primary holes would be drilled. Two options would be available for drilling these holes. All eight primary holes could be drilled to a common elevation, say perhaps 20 metres below the shaft bottom, or holes could be drilled until each hole hit a predetermined minimum water inflow rate, generally 5 gpm each. Primary holes would then be cement grouted. Flow testing by opening all (termed "open hole testing") or one standpipe valve at a time (termed "closed hole testing") would provide useful information on the connectivity between drillholes.

When all primary and secondary holes had reached design depth, the effectiveness of the grout cover would be tested by drilling four probe holes. These holes would be drilled to 61 metres with inflow rates carefully noted as drilling progressed. Should probe hole inflow rate be low (typically less than 30 gpm) the grout cover would be considered successful and shaft sinking would recommence upon completion of probe hole grouting. If the probe holes produced significant water (typically greater than 50 gpm), the depths at which this water was intercepted would be analyzed. If this depth was within 45 metres of the current shaft bottom additional grout holes would be considered. If the water make was below 45 metres depth then sinking could proceed but to a depth no greater than 40-45 metres.

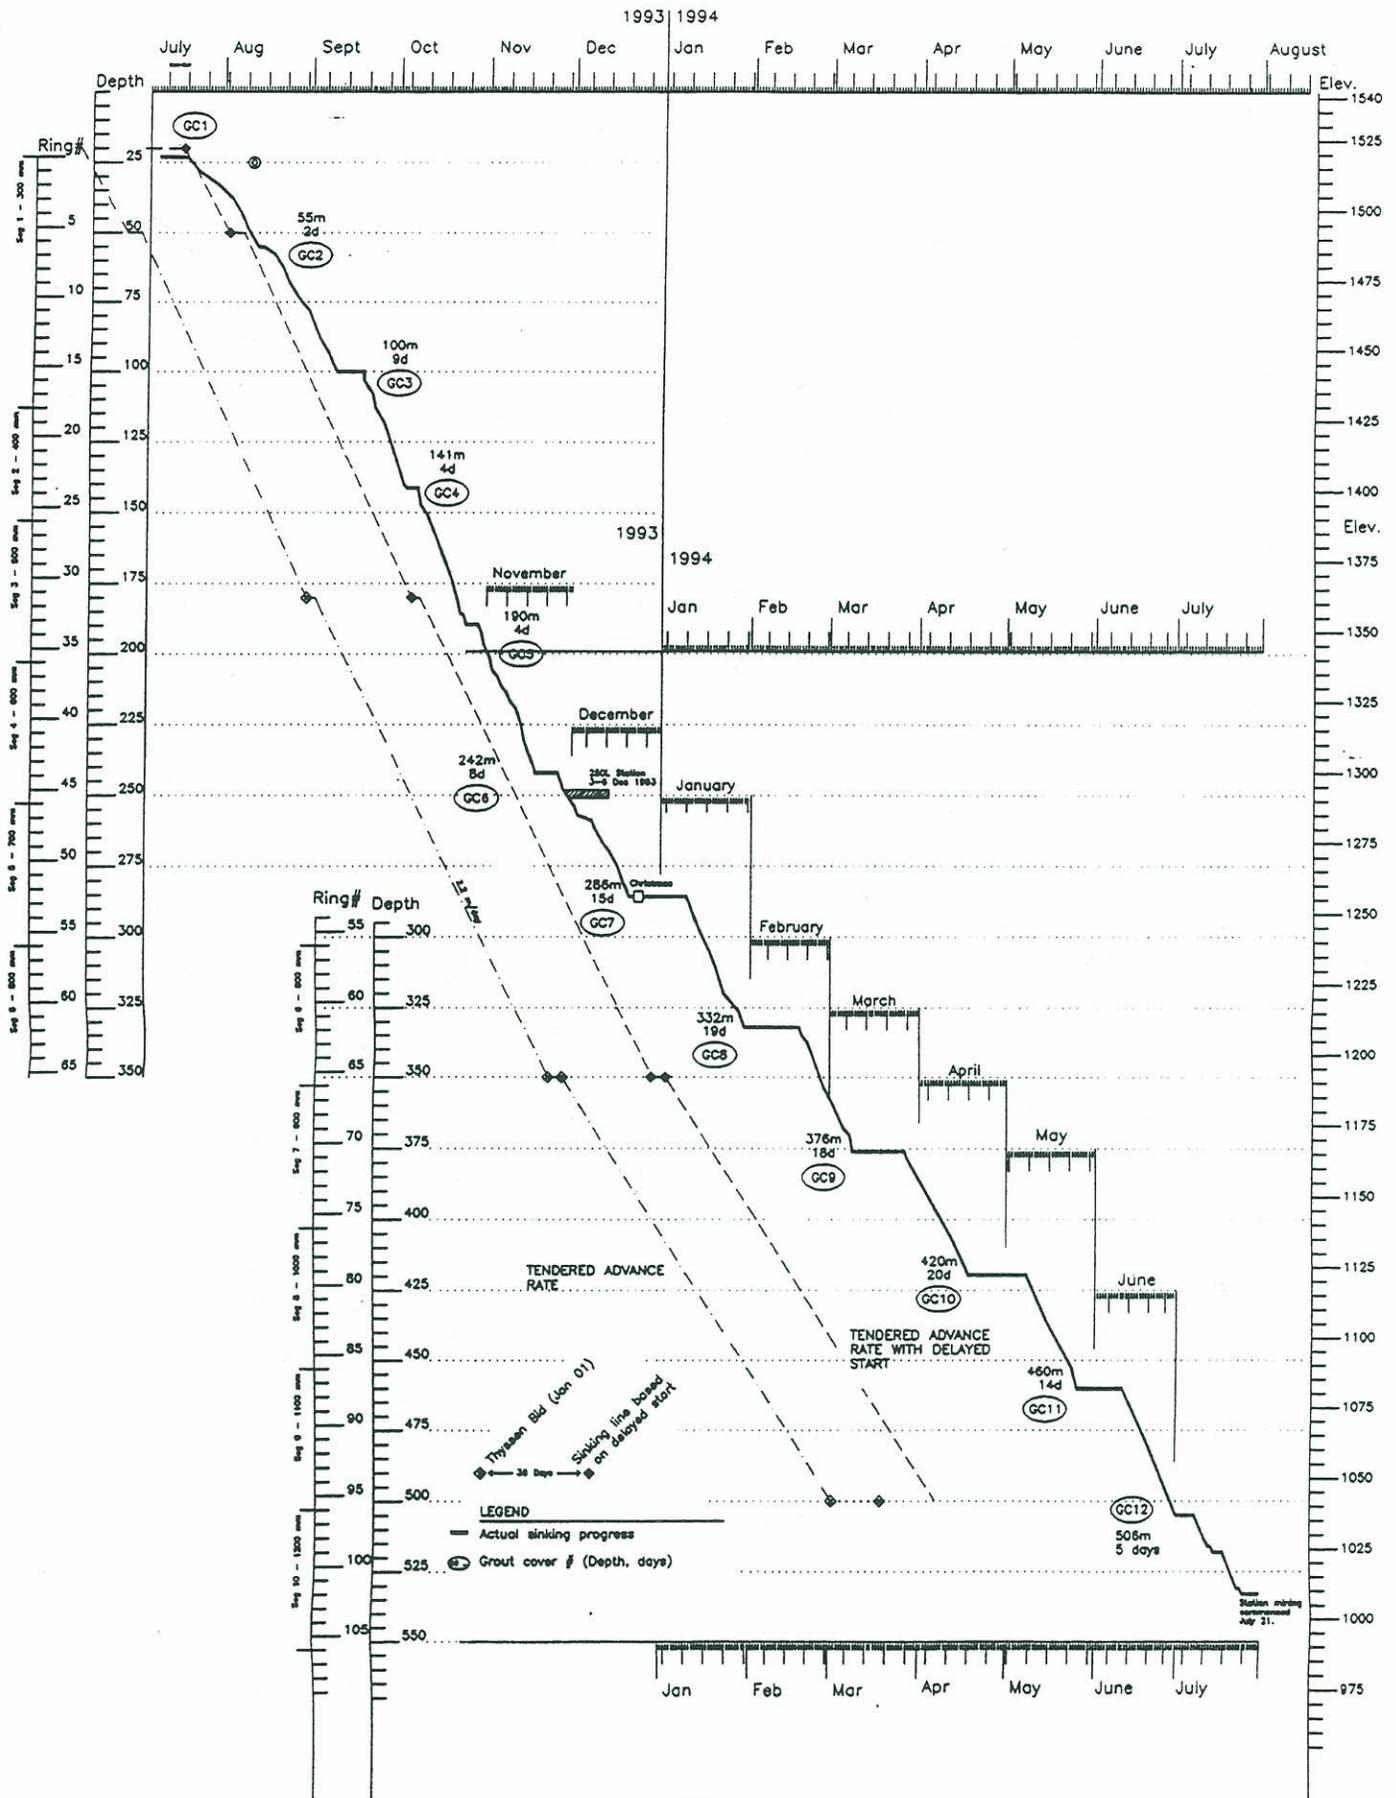
**Figure 9.1**  
**McArthur River - Shaft Progress**

Figure 9.1 graphically illustrates the advance rate achieved in the shaft. The long grout stages are clearly evident. Grout covers were under the supervision of Cameco staff or Steve Phillips of Phillips Geotechnical, Mining and Grouting Inc. Extended grout covers began at a depth of 286 metres. Grout covers seven to eleven took two to three weeks to complete.

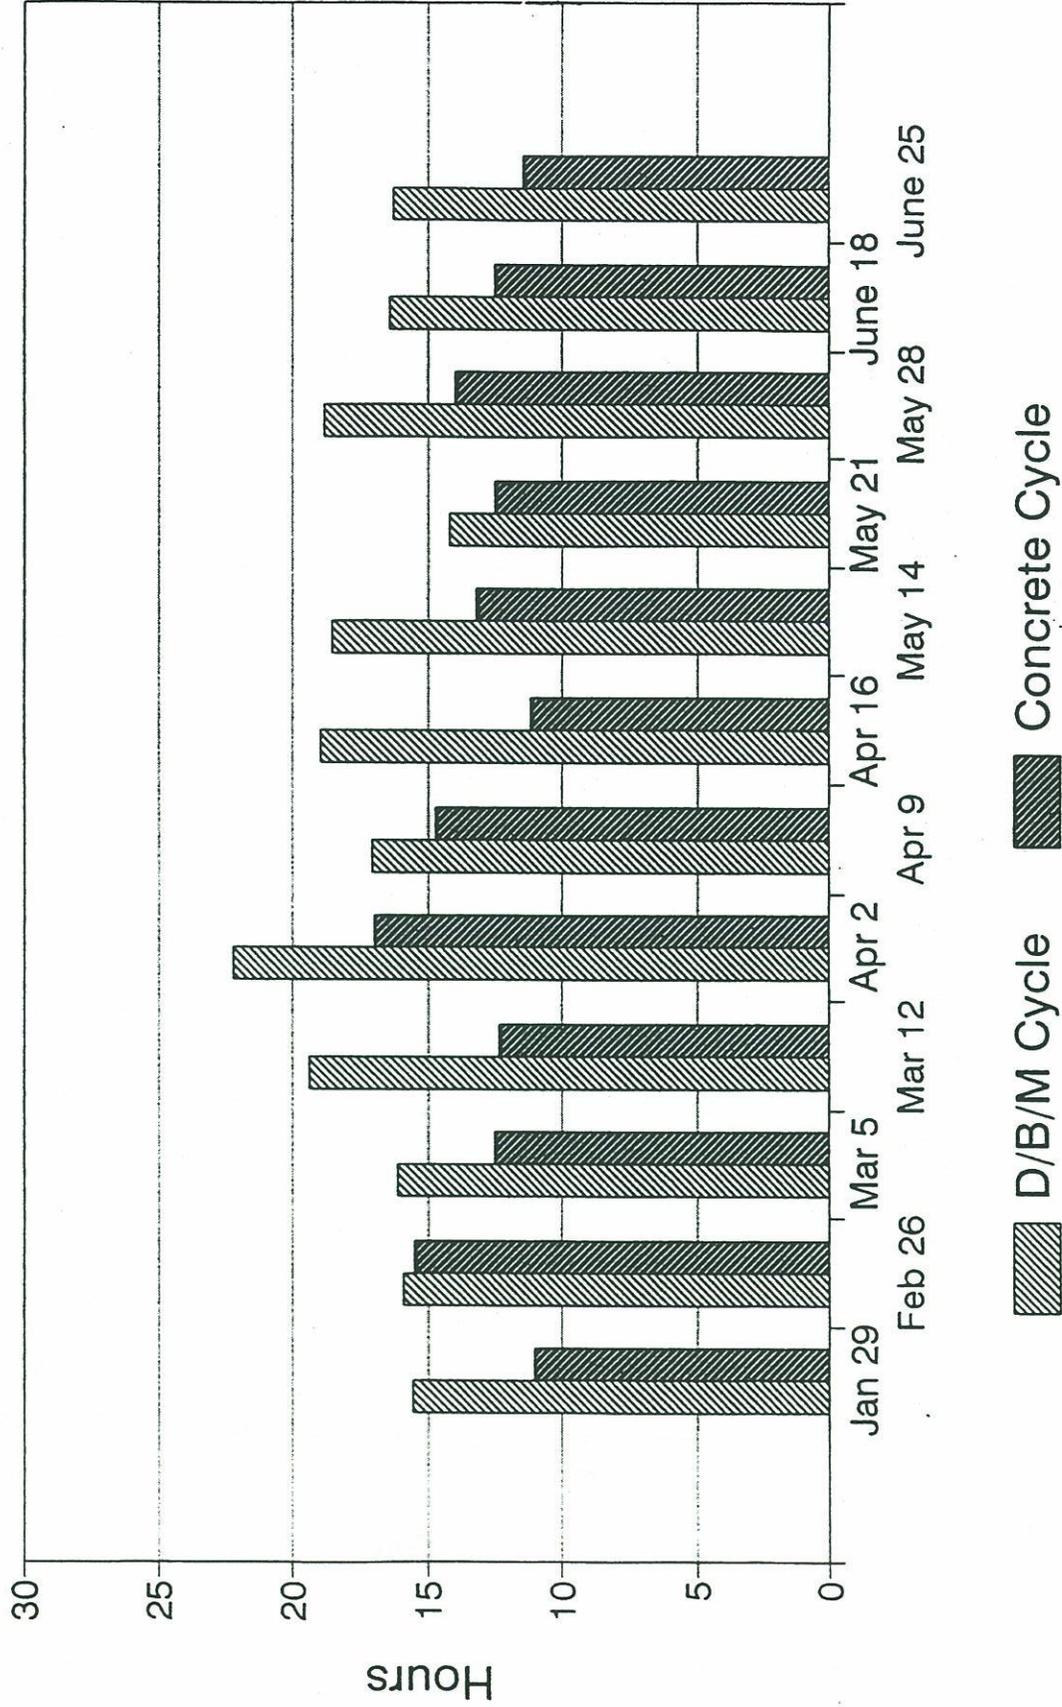
Figure 9.2 illustrates the shaft sinking cycle time over a six month period. The drill/blast/muck cycle averaged 17 hours varying from 14 to 22 hours. A 2.7 metre advance was achieved with each cycle. The concrete lining cycle averaged 13 hours varying from 11 to 17 hours. The shaft was lined in five metre sections meaning that in general two blasts were made for each pour.

## Average Cycle Times - Weekly
