### SUMMARY OF SHAFT SINKING TO THE 530 LEVEL

#### McARTHUR RIVER EXPLORATION SHAFT

## 1.0 INTRODUCTION

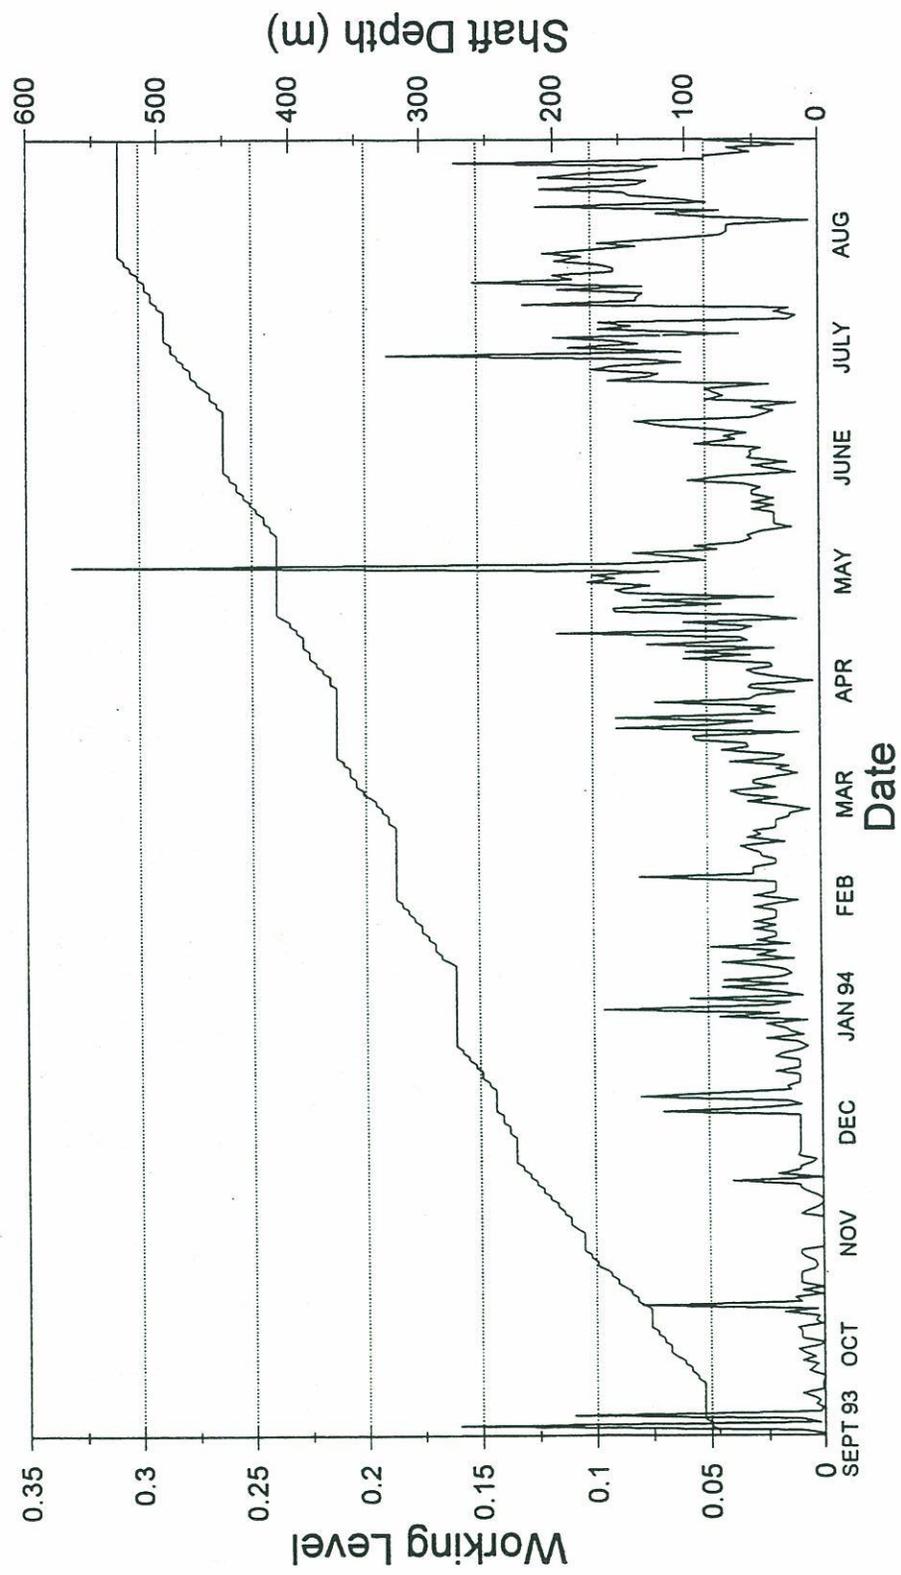
Figure 9.3  
Shaft Exhaust Working Level Readings

Figure 9.3 highlights the working level readings at the collar as the shaft deepened. The gradual increase in levels with time can be attributed to the increase in shaft water produced with depth and the increase in air age at the collar with depth.

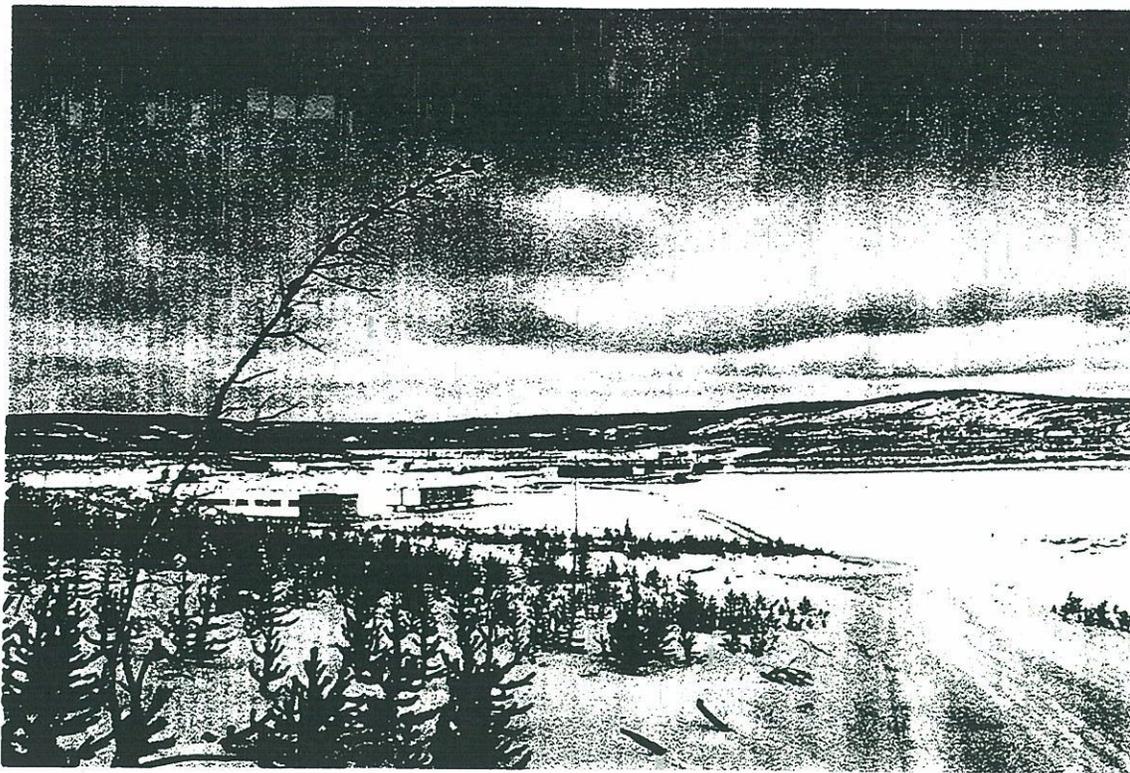
Site Mobilization. Picture taken late February 1993. Cameco offices located in foreground. Diesel tank farm is located in the middle and camp trailers are placed in the background.
