Bad Vibrations

Solving the Hawker Typhoon's structural problems

Digging deep into the archives, **RICHARD SETH-SMITH** uses contemporary documents, and a recently rediscovered letter written by Hawker's chief test pilot Philip Lucas in 1976, to piece together a trail of evidence revealing exactly how Hawker and the Royal Aircraft Establishment solved the structural problems that blighted the Typhoon's early career — and which killed his test-pilot father

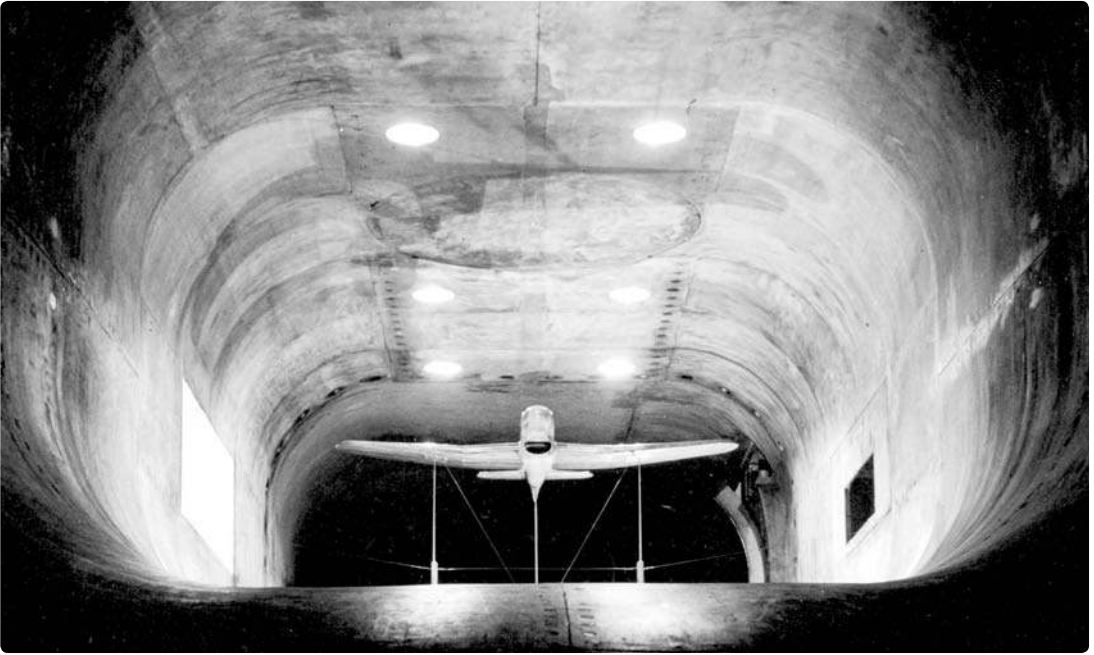
ABOVE A Typhoon model in the high-speed windtunnel at RAE Farnborough. The tunnel was opened in November 1942 and was designed to test scale-models of up to 6ft (1.8m)-span at windspeeds up to 600 m.p.h. (965km/h). **BELOW** A contemporary schematic showing the circuit-test details for the elevator's mass-balance system.

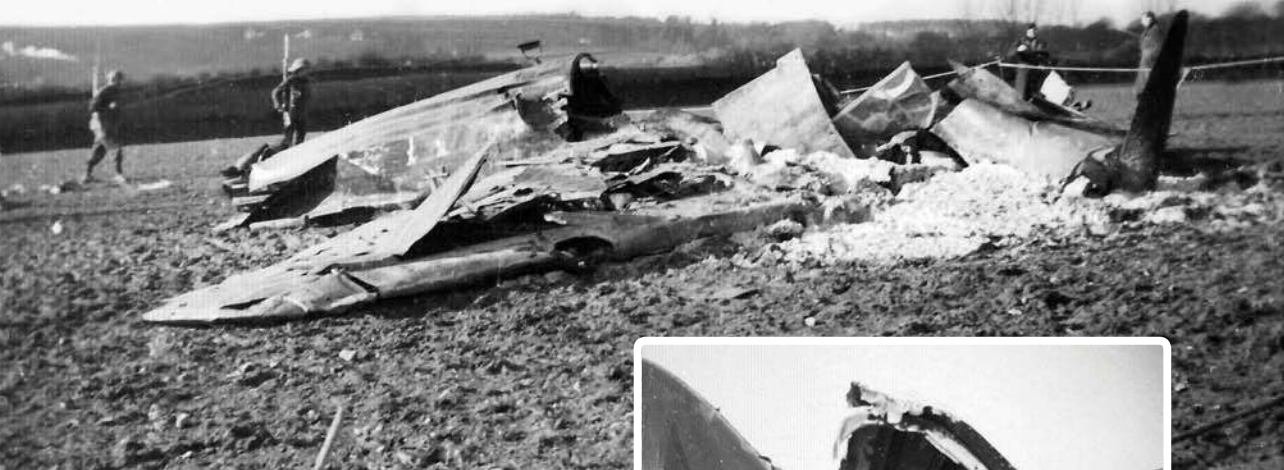
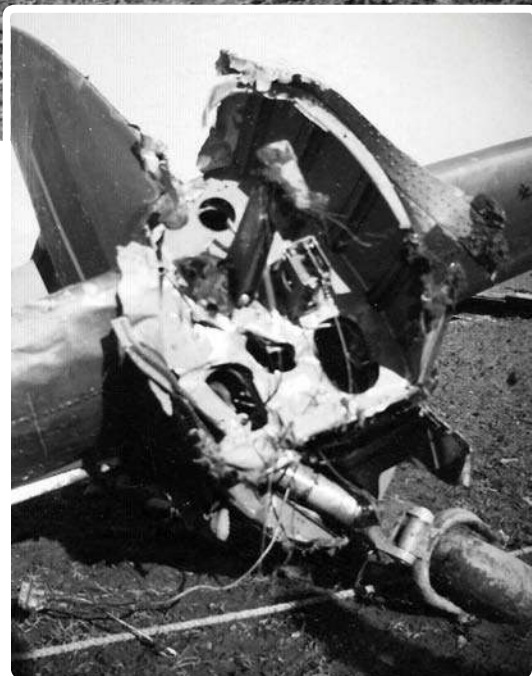
ABOVE & RIGHT *The wreckage of DN510 at Meavy, on the south-west edge of Dartmoor in Devon, after its tailplane failed on February 4, 1943; the only instance of such an accident in which the pilot lived to tell the tale. Note the static balance lever still attached to the bracket on the bulkhead in the photograph at right. In some of the earlier tailplane failures the lever had sheared off from the bracket altogether.* FAST VIA AUTHOR

Then on February 4, 1943, Typhoon IB DN510 of No 193 Sqn, based at Harrowbeer in Devon, was on a test to height when its tailplane failed. This is the only Typhoon tail separation to have been survived by the pilot, although another survived an in-flight break-up in late 1944, which may have been due to other factors.

The pilot of DN510, Plt Off A.W. Kilpatrick, reported that at about 27,000ft (8,200m) he moved the controls forward and then commenced an aileron turn, but after turning through about 270° he experienced severe buffeting, such as that induced by very bumpy conditions, so took off aileron. At about 380 m.p.h. (610km/h) indicated airspeed (IAS) he then attempted to ease out of the dive, but there was little response, so he immediately throttled back and eased the stick forward slightly, then back without result.

The aircraft then began turning to port, and when an attempt was made to correct this with rudder there was a "terrific bang"; the canopy flew off, some seat-straps failed and Kilpatrick was partly thrown out. He managed to regain his seat, released the other straps and was thrown clear. He pulled his ripcord and alighted on *terra firma* with injuries to scalp, eyes and legs. Eyewitnesses confirmed that the tail had separated, landing half a mile from the main wreckage, which burned out. Kilpatrick had accrued a total of 210 flying hours, four of which were on Typhoons; his clear description of the event confirmed the rapid catastrophic failure of the aircraft — but offered no clues as to the root cause.

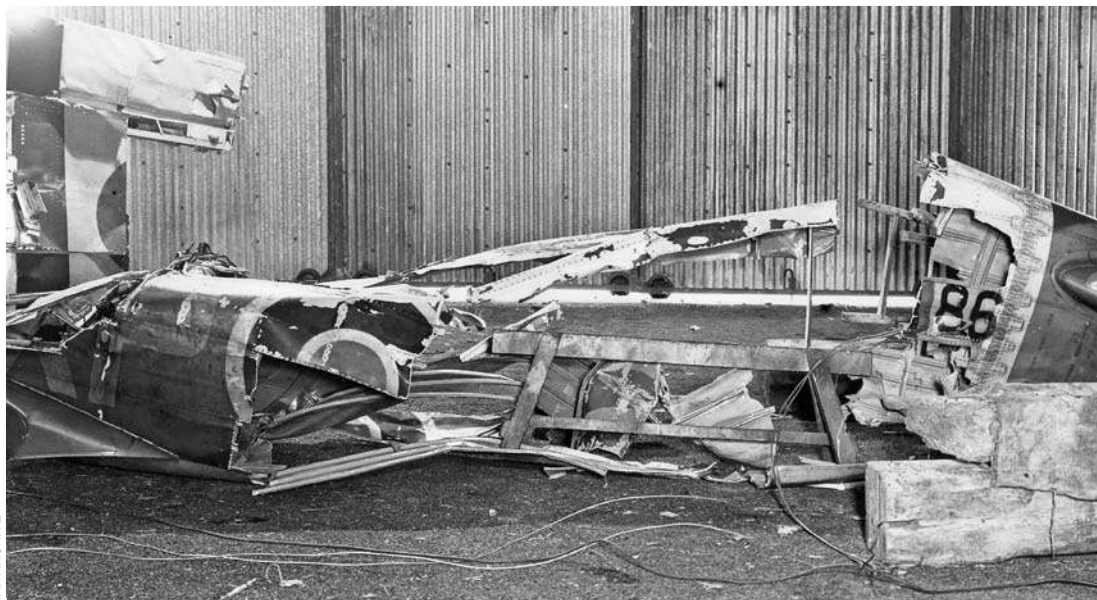
ABOVE With the distinctive fishplates added at the transport joint as per Mod 286 clearly visible immediately aft of the serial, the wreckage of EK186 awaits further inspection after having broken up in mid-air near Redhill on May 4, 1943. The cause of these failures continued to mystify the investigation teams at Hawker and the RAE.

In March, April and May 1943 four aircraft — DN481 of No 609 Sqn; DN265 of No 56 Sqn; EJ932 of No 266 Sqn and EK186 of No 174 Sqn, all fitted to Mod 286 standard — were lost, although at least one of these may have been owing to extraneous factors. What now appeared to be occurring was failure either in front of, or behind, the
