Restoration Support 67 San Jose Unibody (Undercarriage)

This is an ongoing project of mine I expect to be continually updating as new information is documented, studied and discovered.

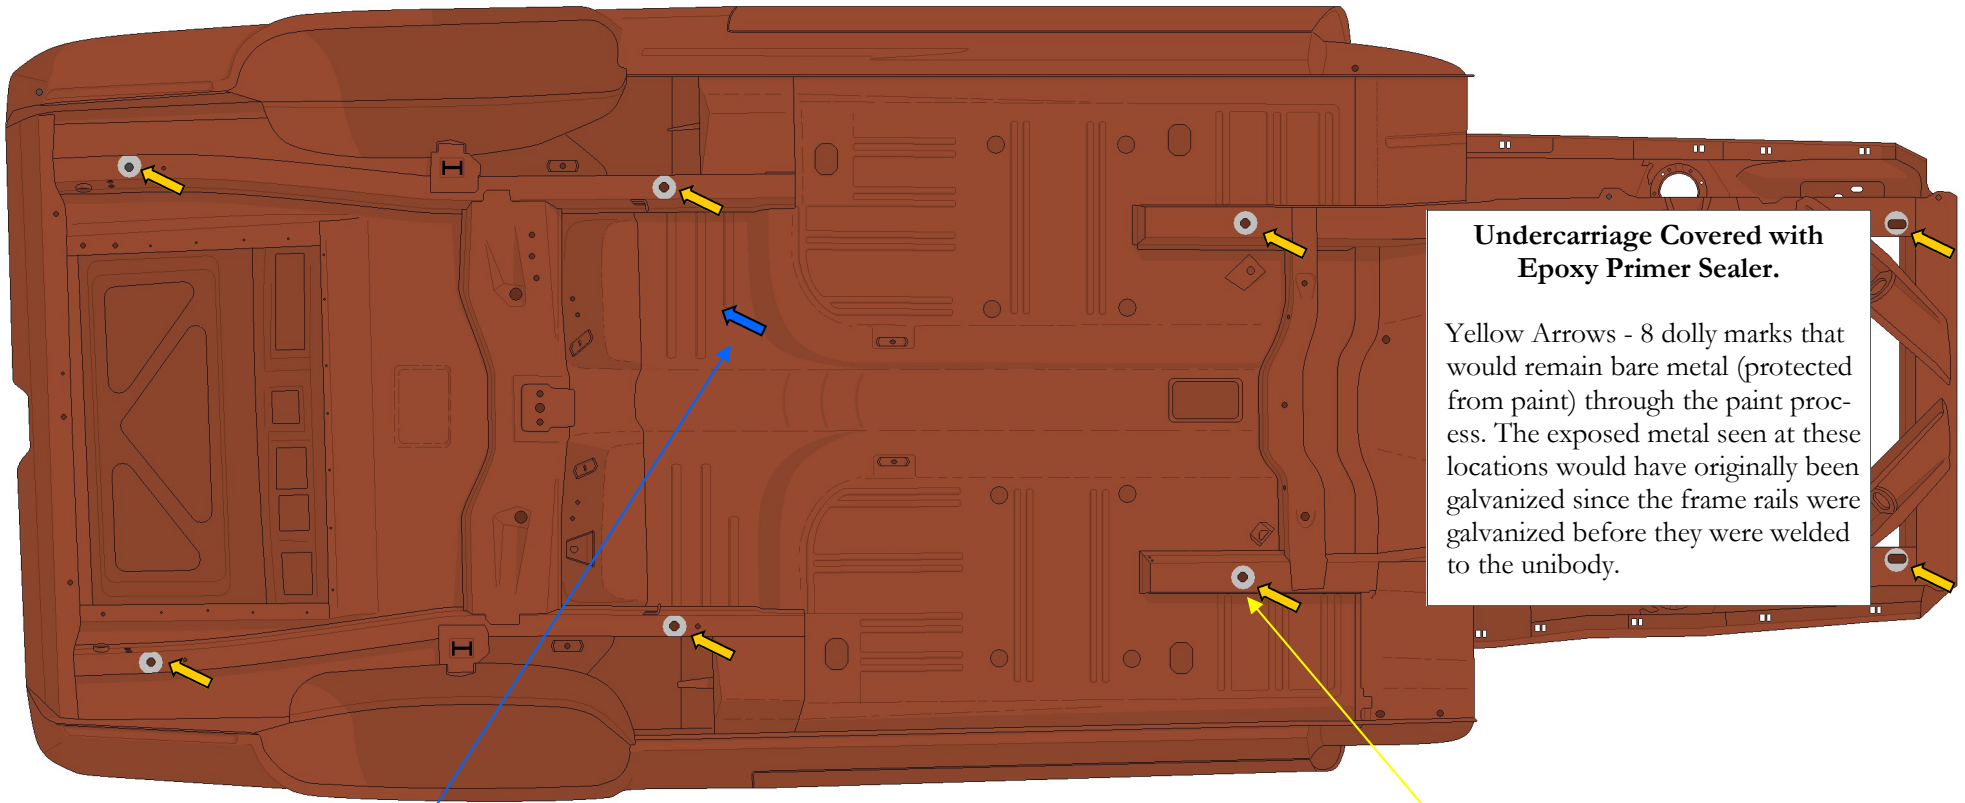
Undercarriage Covered with Epoxy Primer Sealer.

Yellow Arrows - 8 dolly marks that would remain bare metal (protected from paint) through the paint process. The exposed metal seen at these locations would have originally been galvanized since the frame rails were galvanized before they were welded to the unibody.

- The unibody was assembled from subassemblies and single panels on a pair of moving skids that were each attached, at eight different location, to the body. Four of these attachments passed through the body and were tightened from above to hold the body tightly to the skids, in the interior and trunk areas, which produce round bare areas visible on the finished vehicle at these points. Visible, on a completed car from below, this process resulted in eight round sections (showing the galvanized metal of those panels) on the finished product. (Page 6)

- Undercarriage, from approximately the firewall rearward, was sprayed with a brownish red epoxy primer sealer in a slightly shinny (nothing like red oxide primer) final look. During identified periods of production the red oxide color became lighter, more pale or salmon in tone and tint. During another production period a very dark, almost black tone of epoxy sealer

was applied to this same area. The primer sealer, no matter the color, was applied to the undersides of the car from firewall rearward, stopping approximately four-six inches short of the rear cross member. This was accomplished with the body sitting fairly level as it passed over a series of spray jets arranged below the track system the body traveled over. This process produced multiple runs that collected on the lowest surfaces and edges of the lower body panels. (Pg. 6)

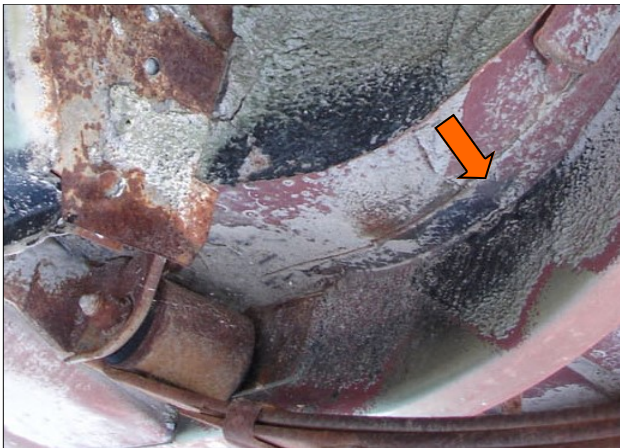
Visible sound deadener overspray on the frame rail though exterior paint has worn off.

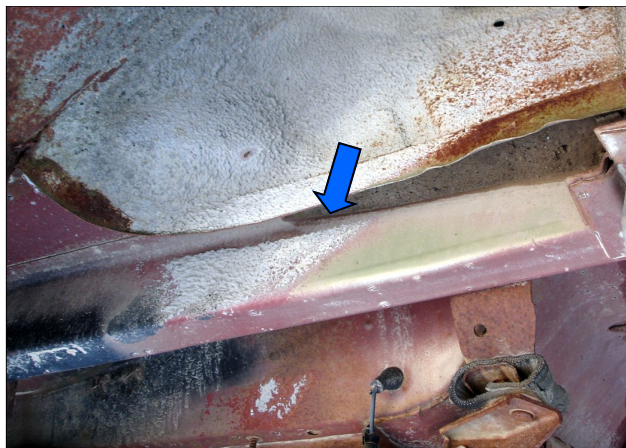
Another example of sound deadener and exterior color on frame and wheel well.

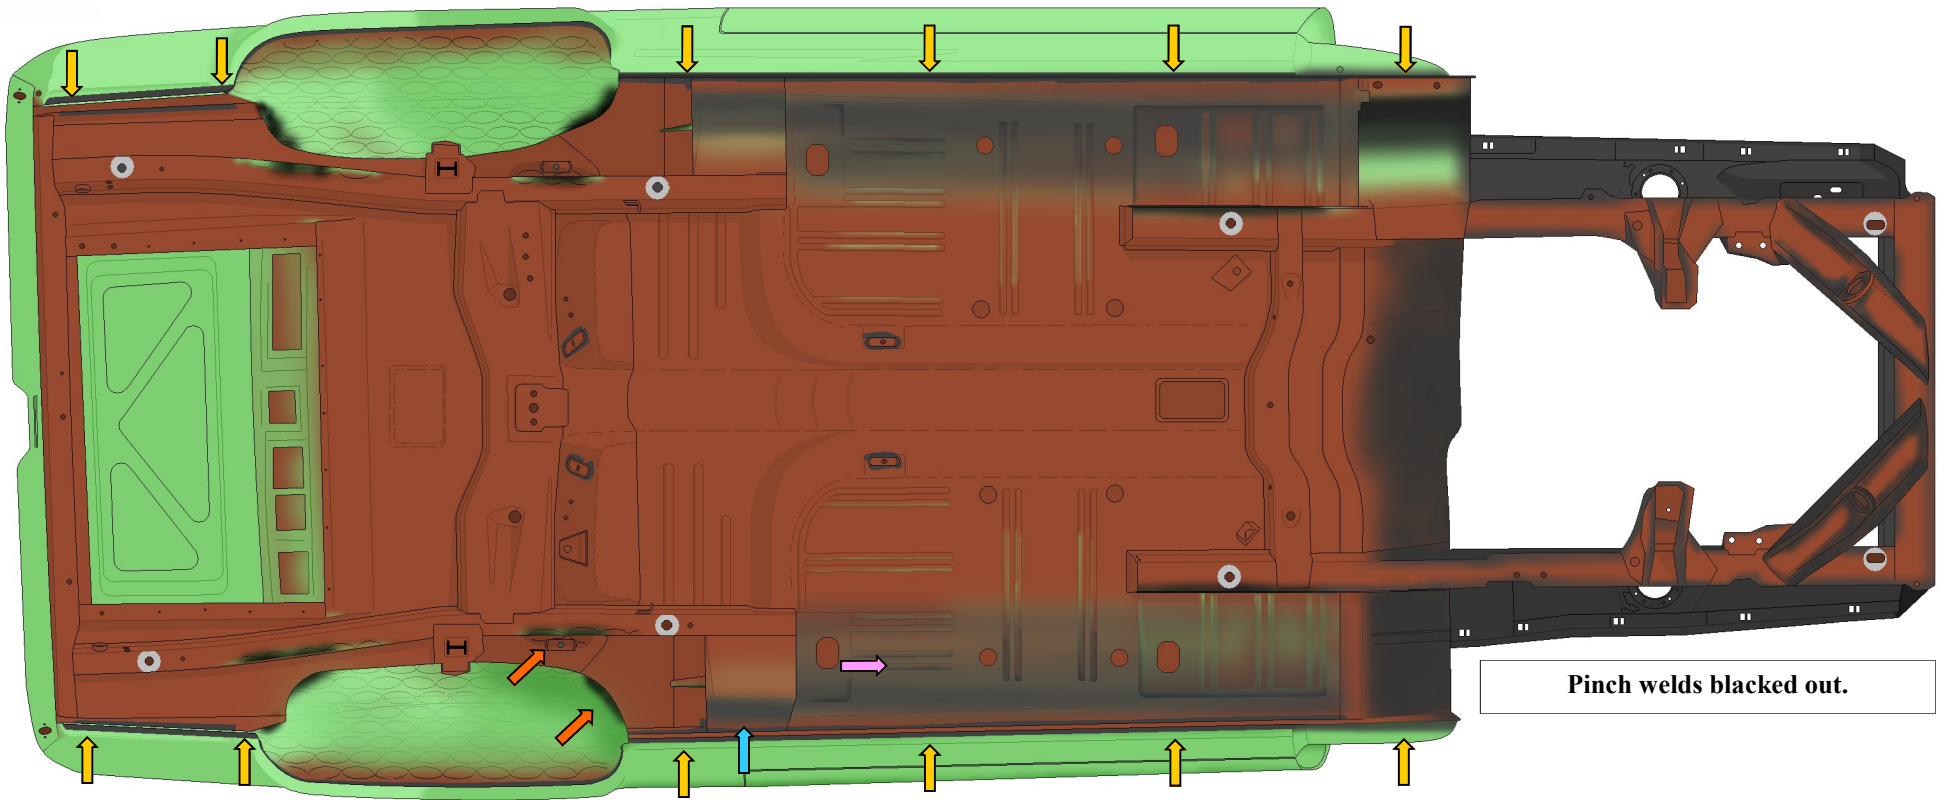
Pinch welds blacked out.

- 10- Next the pinch welds were blacked out from the front edge at the front wheel well, to the rear valance, surface stopping and restarting at the front and rear edge of the rear wheel well. This stopping and starting produced black paint being applied to the rear wheel well, frame and floor sections in that immediate area. (Pg. 10) Because of the angle of the gun the overspray from the pinch weld black out travels across and onto the undercarriage/floor and any bracket, panel or detail that hung down as well as floor surface closer to the rocker panel. Because of the pinch weld and the angle of the gun a shadow from the spray of black paint was produced immediately behind and inward for a very short distance. Many today use a backwards masking technique or foam tape to produce a straight but soft paint edge to the black out.

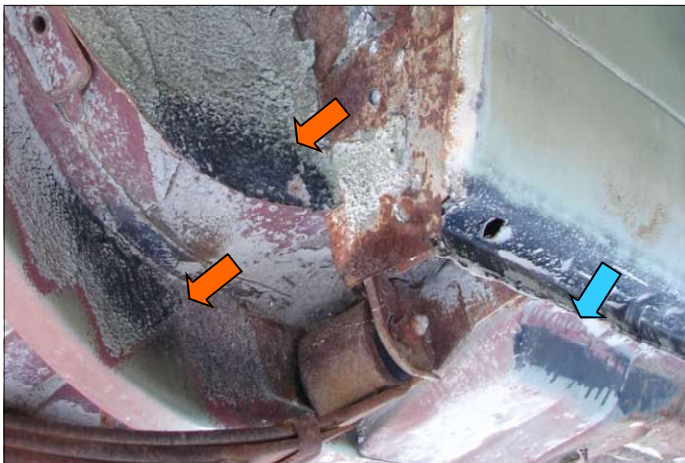
What is left of the pinch and rear wheel well black out

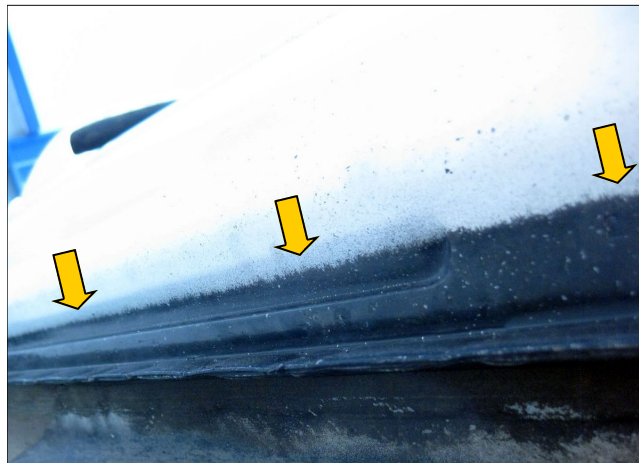
Rocker panel pinch weld blackout

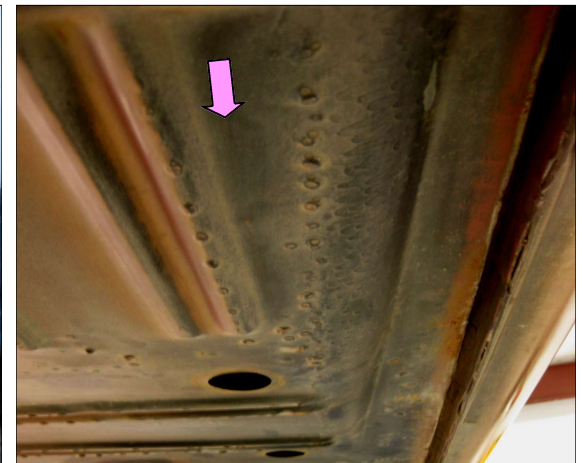
Floor behind rocker lip showing paint shadow.

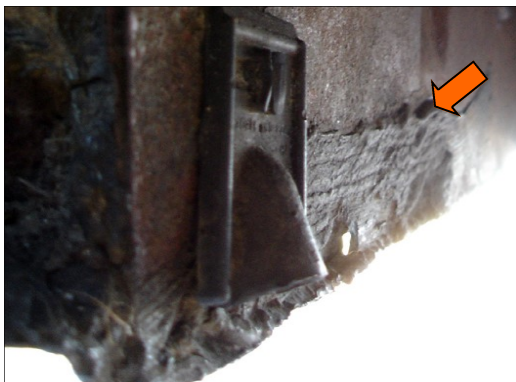
Trunk drop sealant Drain added later

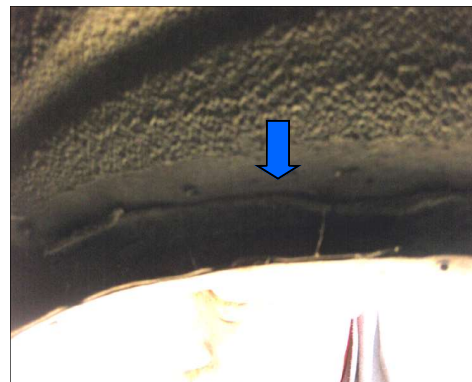
Wheel well lip sealant

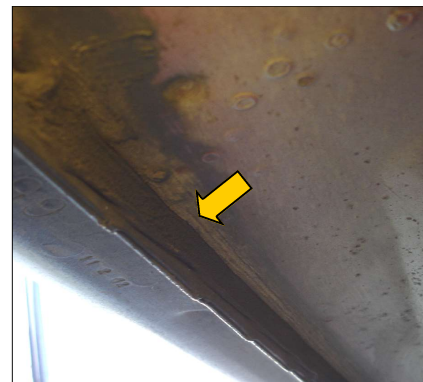
Rocker panel chalking

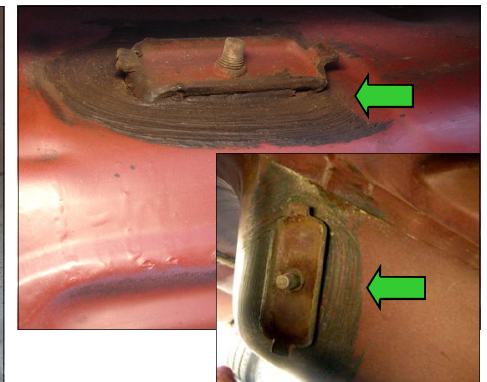
Seat belt anchor sealant example

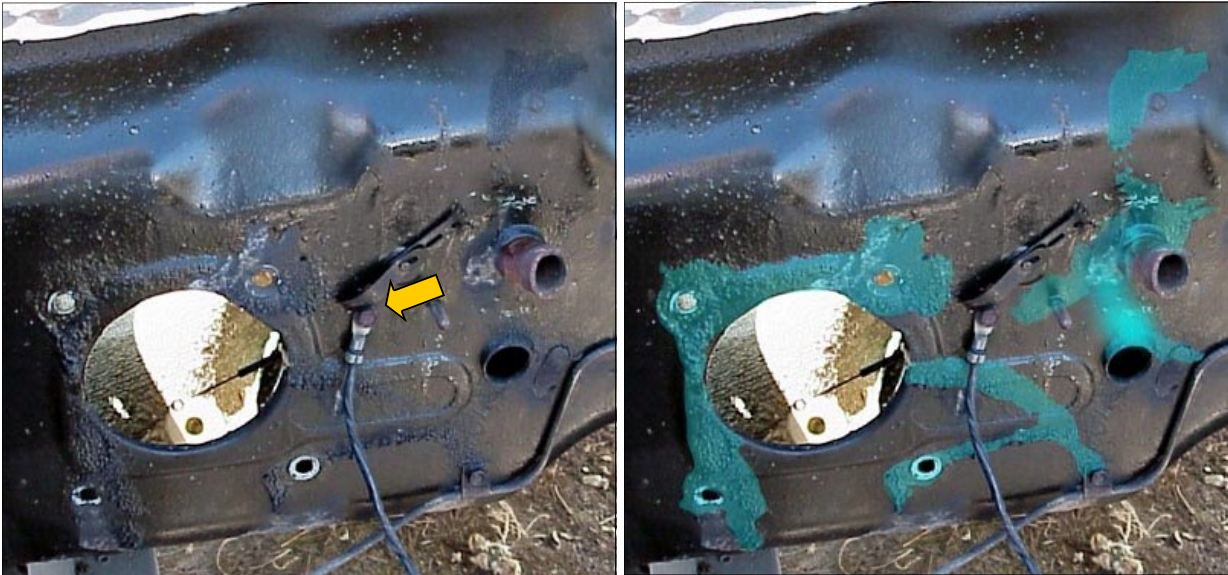
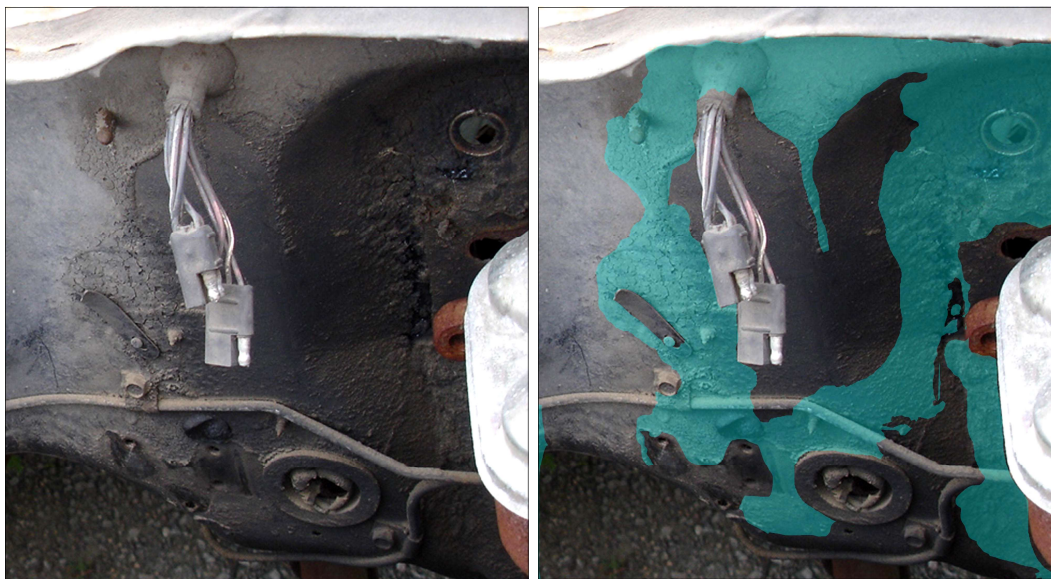
Example of typical sealant applied at or around all firewall attachments and pass-through locations except for the grounding wiring and attaching screw. They were attached to the firewall later in the assembly process. For each of the picture I've highlighted the spray pattern to make it visible on each. As you can see the product is a very fine spray, in areas, similar to what is produced with spray adhesive (adhesive was the term for Ford used for the product) while in other areas where the product was applied heavily it was thicker. Often you will find it was thin enough to produce runs even where not much sealant was applied.

Patterns vary from car to car. The example above is one worker's efforts to cover all required points as instructed.

Sealant normally applied in a continuous spray carried from point to point though the pattern between the target spots can vary from worker to worker.

13- Once all of the items were installed to the firewall and before the engine was installed the firewall openings, pass-throughs and attachment points were sealed using what Ford referred to as an adhesive. (Pg. 12-13) This includes the master cylinder, brake lines and retaining clips, electrical connections, emergency brake and throttle brackets. Only the engine ground strap would not be attached to the firewall at that point and because of that not have sealer at firewall attachment point. Typically, with a wand, the worker would apply the sealant while moving the wand from spot to spot sealing and spraying as he went. This practice often produced a connect-a-dot pattern or look of the finished product.

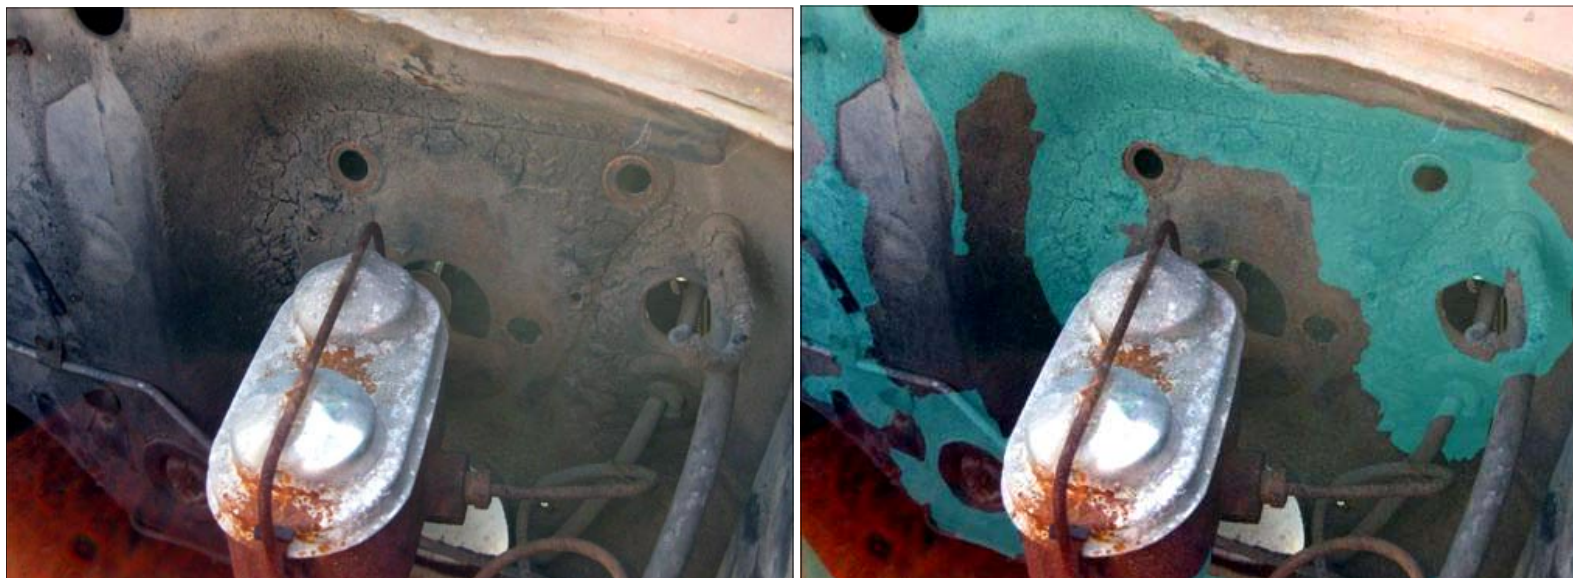
Front Wheel Well Sound Deadener Applied - Inner Fender Aprons

Highlighted areas show two applications of a spray sealer. One (highlighted in purple) a narrow, heavier, closer application designed to fill and seal and a wider, lighter application designed to deaden sound and vibrations. Ignore the thin back and forth pattern you see on the panel to the left. It's a results of someone attempting to clean the surface using a method that removed some sound deadener.

Once the car was completely assembled (minus front wheels and tires) sound deadener was applied to the front wheel well. The amount and area covered depended completely on the specific worker that applied it and what they did that day. Application falls between a little and a lot with no real identifiable pattern. But all original examples show some on the rear splash shield, firewall section exposed in the wheel well, inner fender panels forward and rearward of the shock tower (normally at a minimum from the lower rear to the top rear edge of the shock/spring cover then from the forward top edge of the shock/spring cover forward and downward.) and finally on the front splash shield.

14- Once the car was completely assembled, minus the front wheels and tires, sound deadener was applied to the front wheel wells to seal out water and reduce road noise. Typically the minimum application of sound deadener to the inner fender panels was a single diagonal pass of the application wand (all of this applied from below the car in the pit) from around the front bumper bracket attachment point to the top just in front of the spring cover on the front inner fender panels. Product on the spring cover

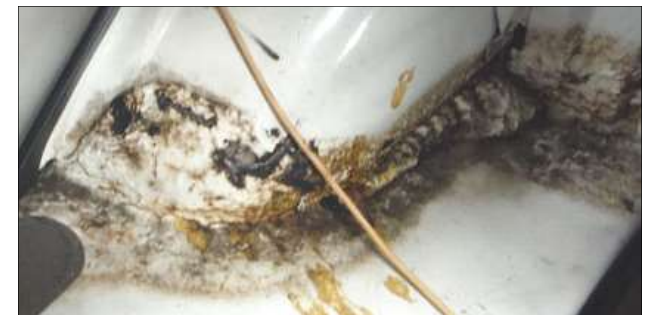
Sealant applied straight out of the chalking applicator and left untouched. This product tends to match the product used during this period, the product used above for the taillight panel seam.

This style of sealant application, sprayed, was applied from one quarter panel to the other side producing a finish similar to the other sprayed seams in the trunk area.

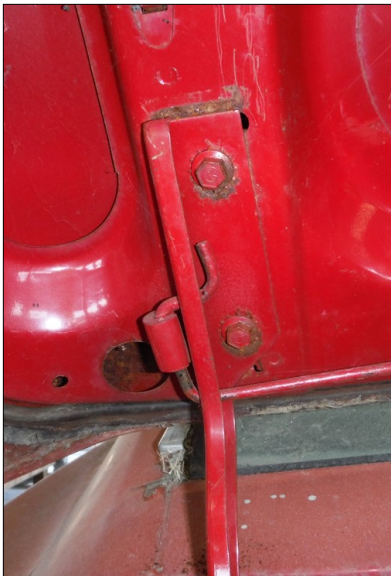
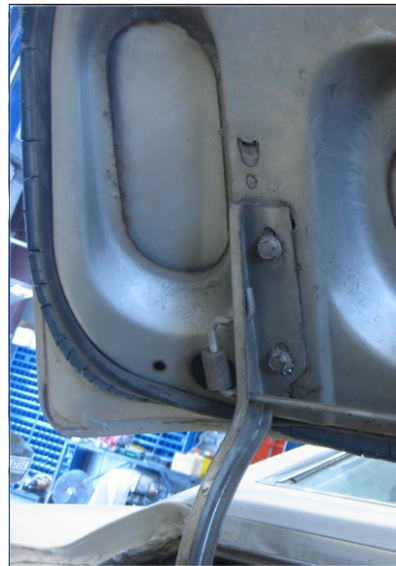
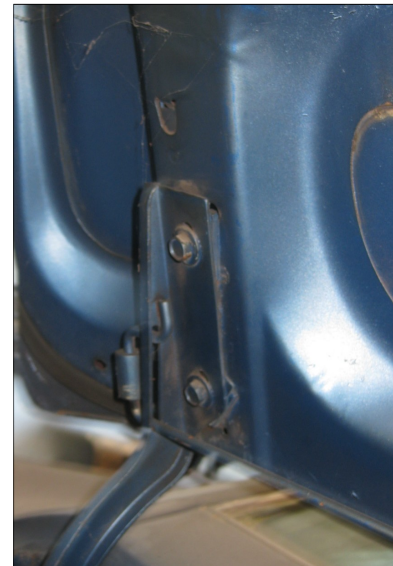
At San Jose on fastback models, workers placed on the trunk lid spring an extra trunk spring insulator, like the one attached to the trunk lid in the middle with the bracket, to the driver's end of the spring. As shown in the pictures to the left.
