Program Bulletin

CUSTOMER SATISFACTION PROGRAM

SUBJECT: Infotainment System Software Upgrade

MODELS: 2011 Chevrolet Lumina & Caprice

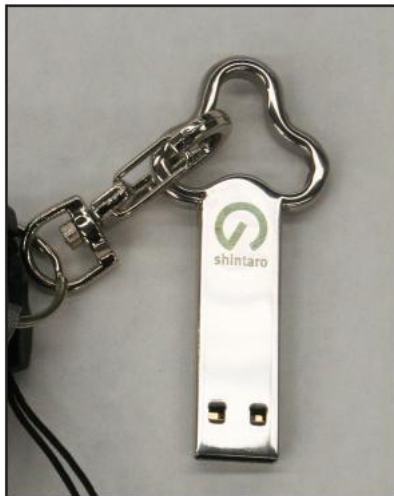
Figure 1

- General Motors approved **programming** USB memory stick 4GB (figure 1)
- General Motors approved **programming** SD card 4GB (figure 2)
- Computer with Global Connect access and an SD card slot. If your computer does not have an SD card slot then an SD card to USB port adapter is required.
- MDI

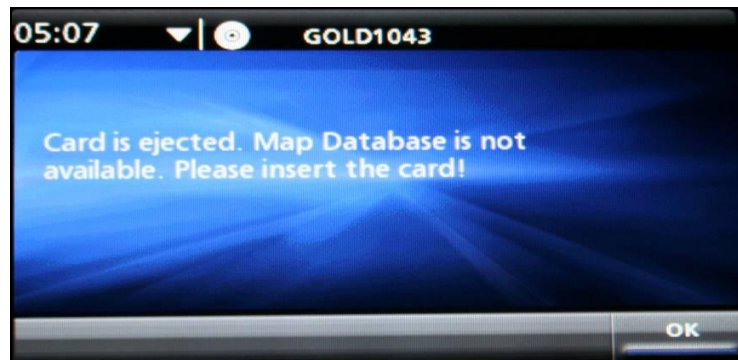
Figure 12

15. When the **Map** SD Card is removed from the vehicle a warning screen will be shown on the touch screen shown in figure 12.

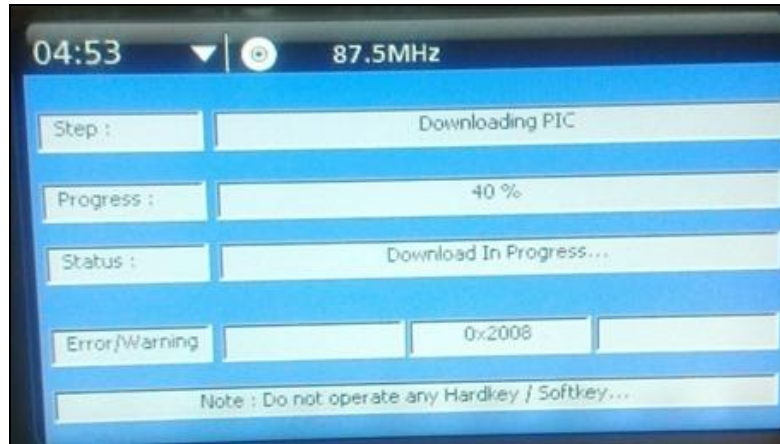
Figure 13

16. Insert the **Programming** SD card (previously removed from the PC) into the card slot of the radio.
 - The Nav programming will start automatically after approx 15 seconds.
 - A blue screen will appear on the touch screen as shown in figure 13.
 - **NOTE** - Do NOT touch any keys during the programming. If the screen changes to a different view, wait as the programming view should come back.

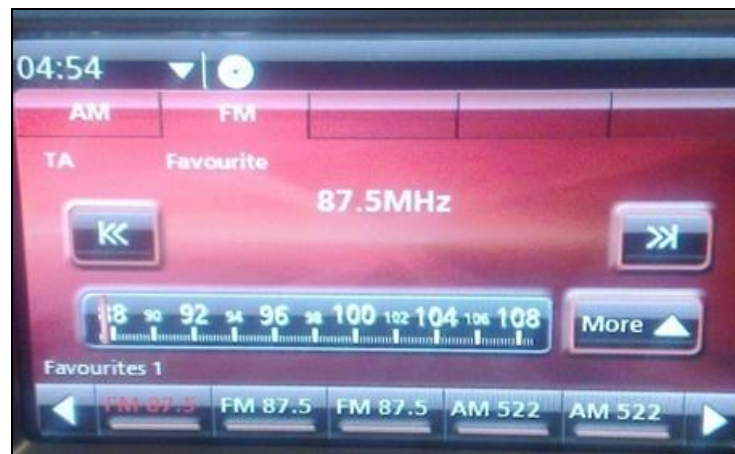
Figure 14

- After the programming has finished the radio screen will display as shown in figure 14.

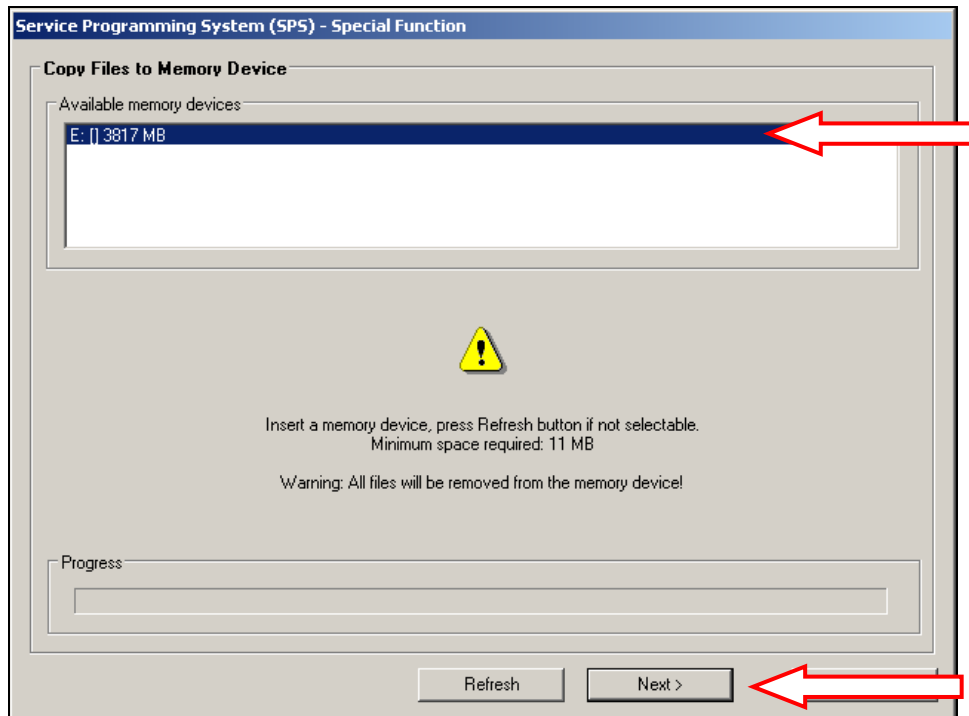
Figure 19

24. Select the USB Device and click “Next” as shown in figure 19.

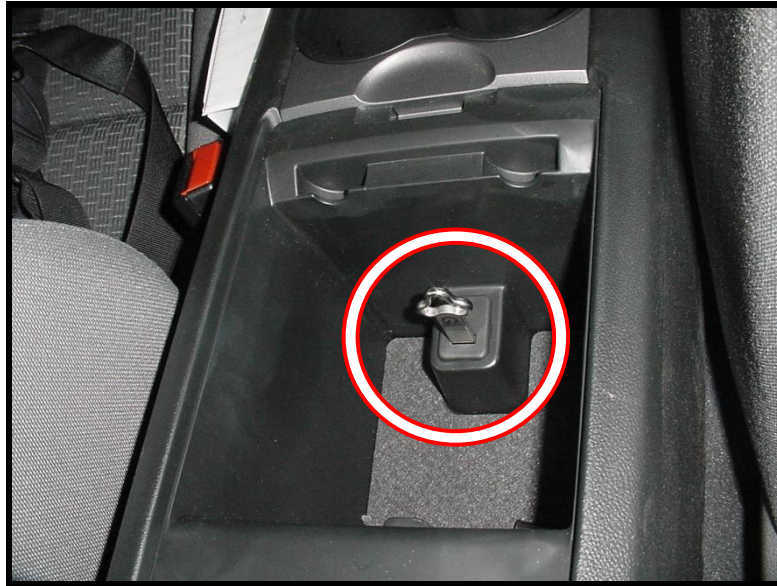
Figure 21

26. Remove the USB stick from the PC. In preparation for programming later, insert the USB stick into the vehicle USB Port as shown in figure 21.

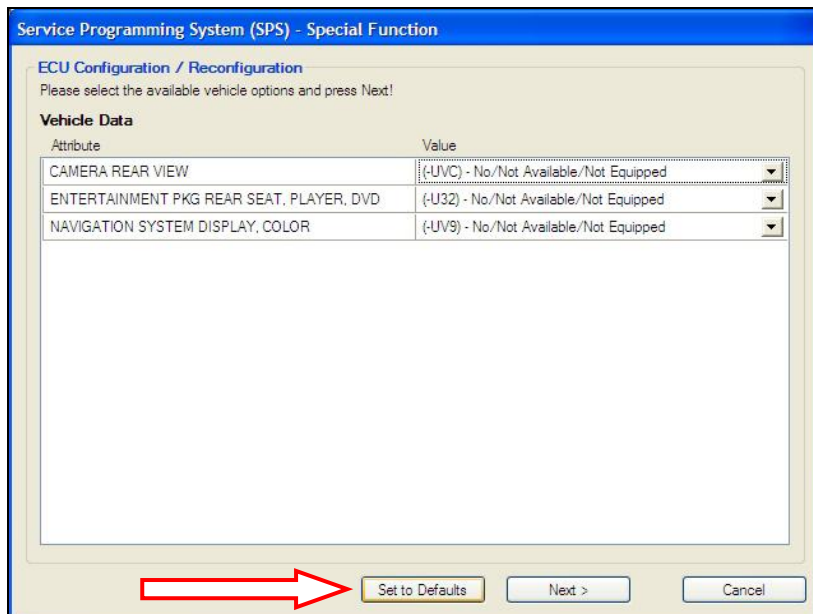
Figure 31

37. Set the configuration options by clicking the “Set to defaults” button as shown in figure 31 Verify the displayed values are correct for the vehicle then click “Next”.
