Quick Solder Installation Manual

Xenium Quick Solder Installation Manual

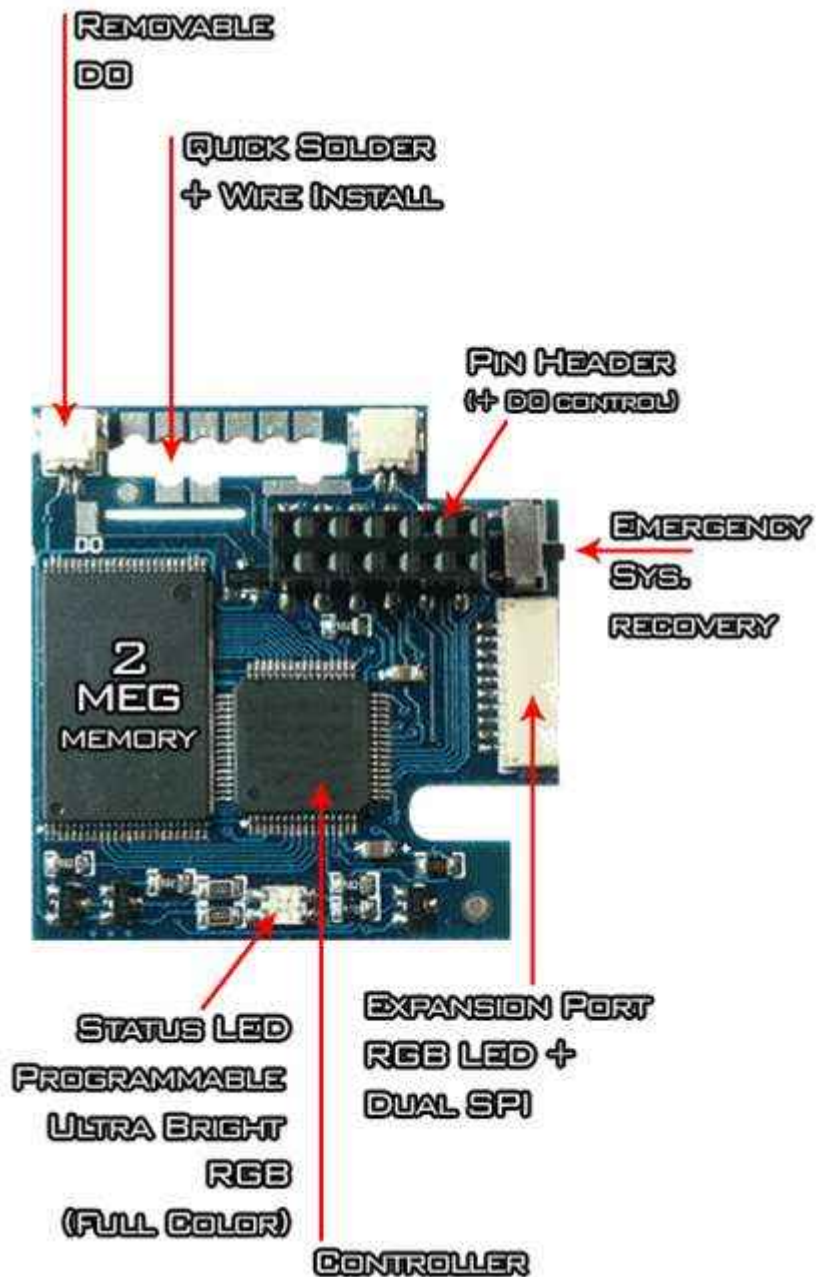
The Xenium hardware

The Xenium has been designed to cater for a variety of installation options including Pin Header, Quick Solder, Wire and solderless methods. The photo below labels the hardware on the Xenium

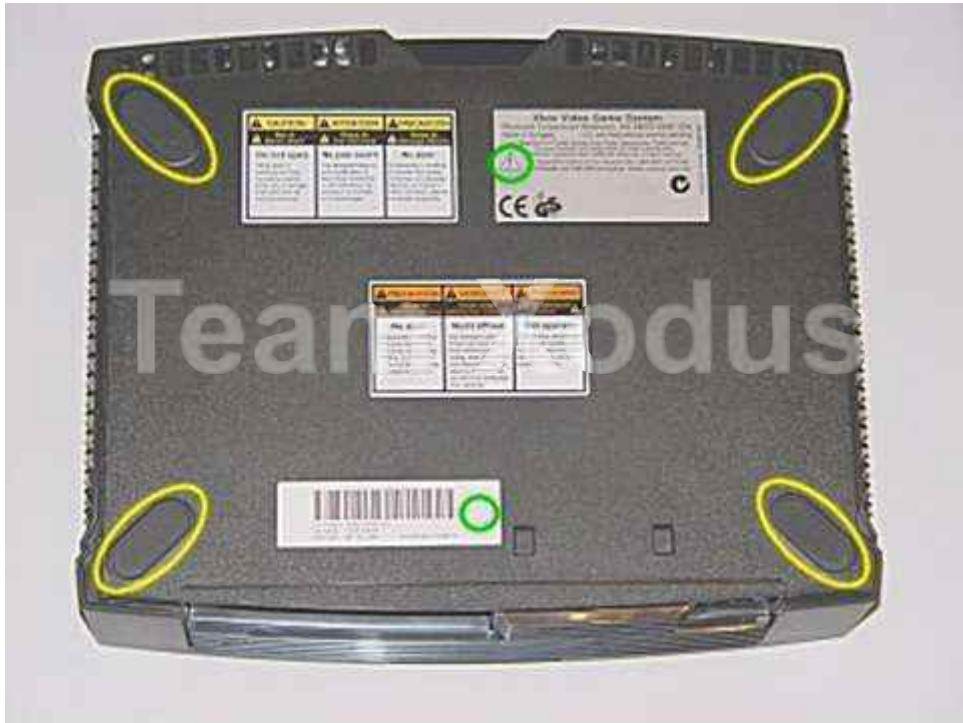
To disassemble your Xbox console you must first remove the cover, you will need a Torx 20 screwdriver to do this and the image below indicates the location of six torx screws that must be removed.

You will need to lift the consoles feet up as displayed in the picture below to access four of the torx screws. The green circles above indicate the location of two torx screws that are hidden under stickers, remember that breaking these stickers will void your warranty but it is the only way that you can install the Xenium.

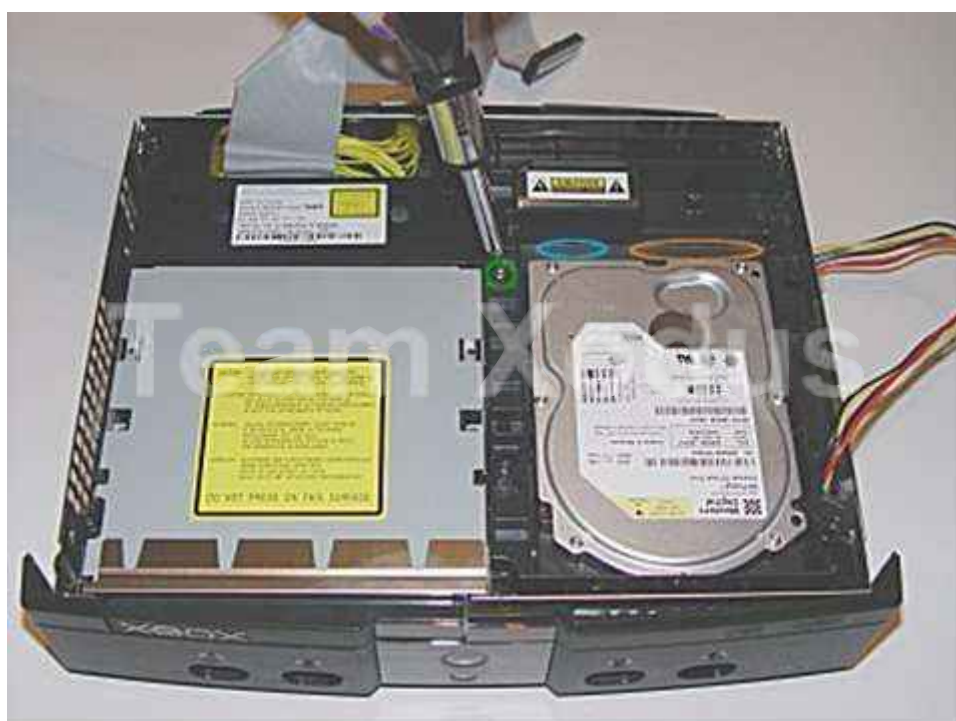
Now remove the IDE cable (marked in orange) and the power cable (blue) from the hard disk drive.
A torx 10 screw as indicated in green needs to be removed to allow the hard disk to be removed from the console.

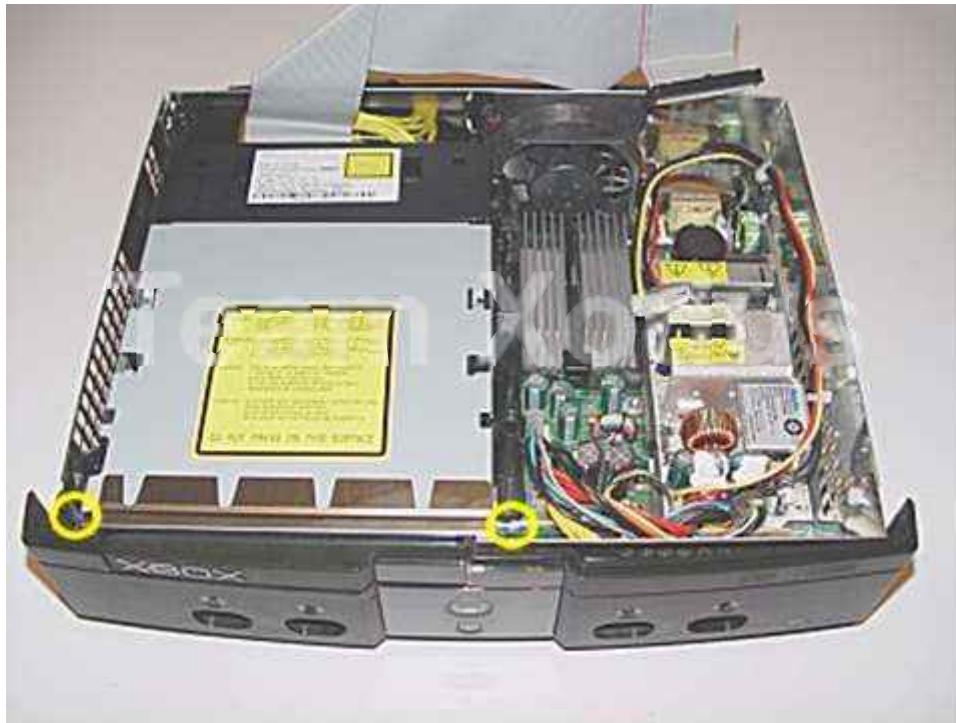
With the hard disk removed you must now remove two torx 10 screws as indicated by the yellow circles.

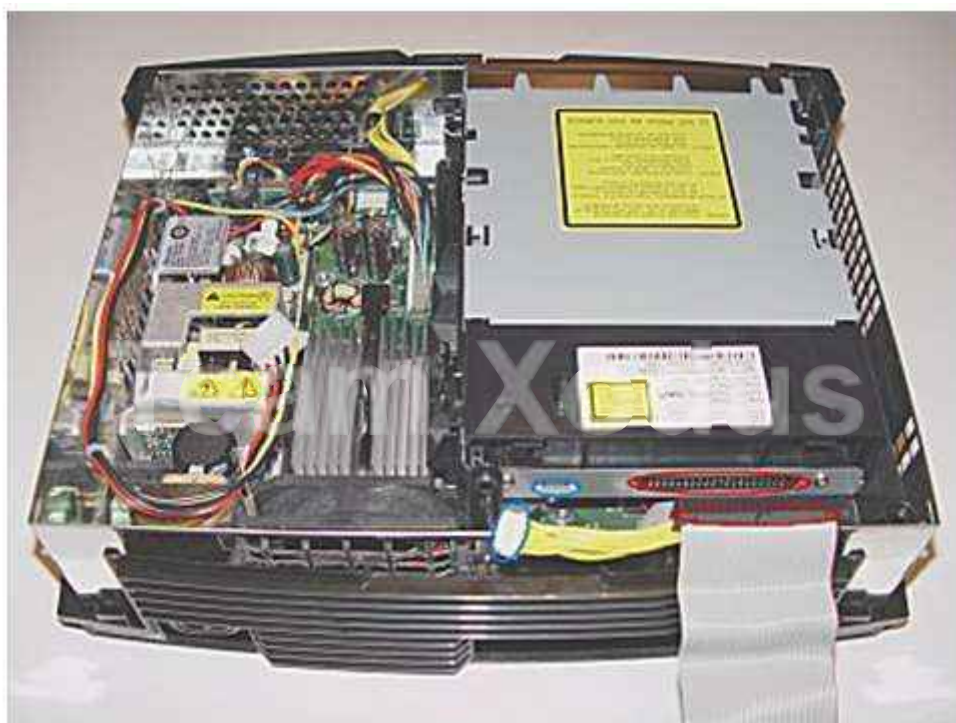
Remove the IDE and power cables from the DVD-Rom drive as indicated by the red and blue circles. You can then remove the DVD-Rom unit and the IDE & Power cables.

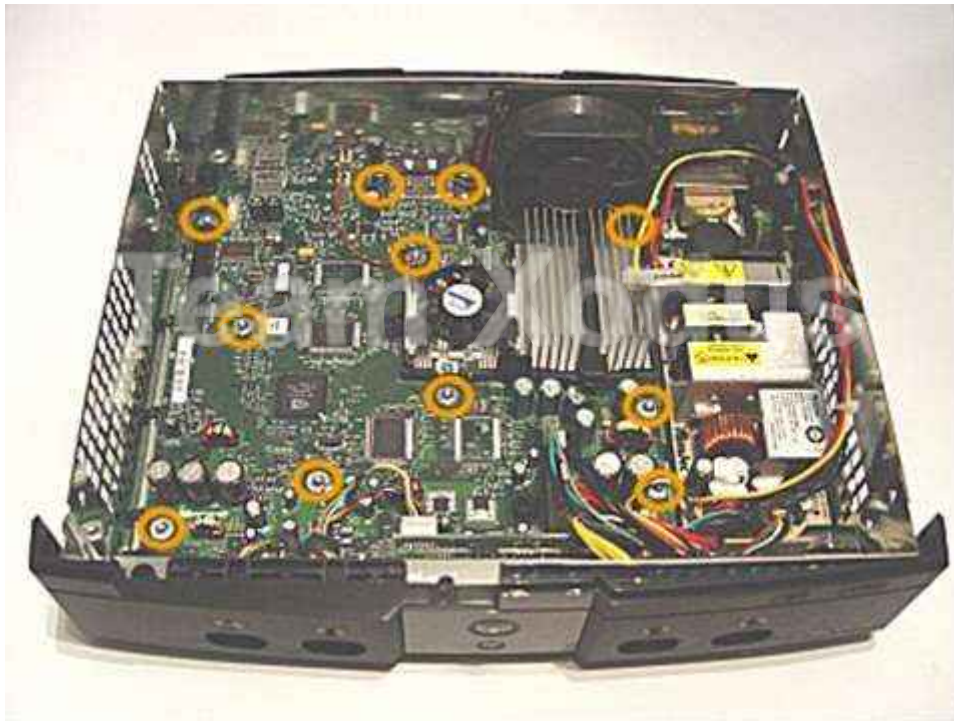
You can now clearly see the Xbox's motherboard, to remove the motherboard you need to unscrew the eleven torx 10 screws as indicated by the orange circles. The fan on the GPU heatsink indicates a version 1.0 motherboard.

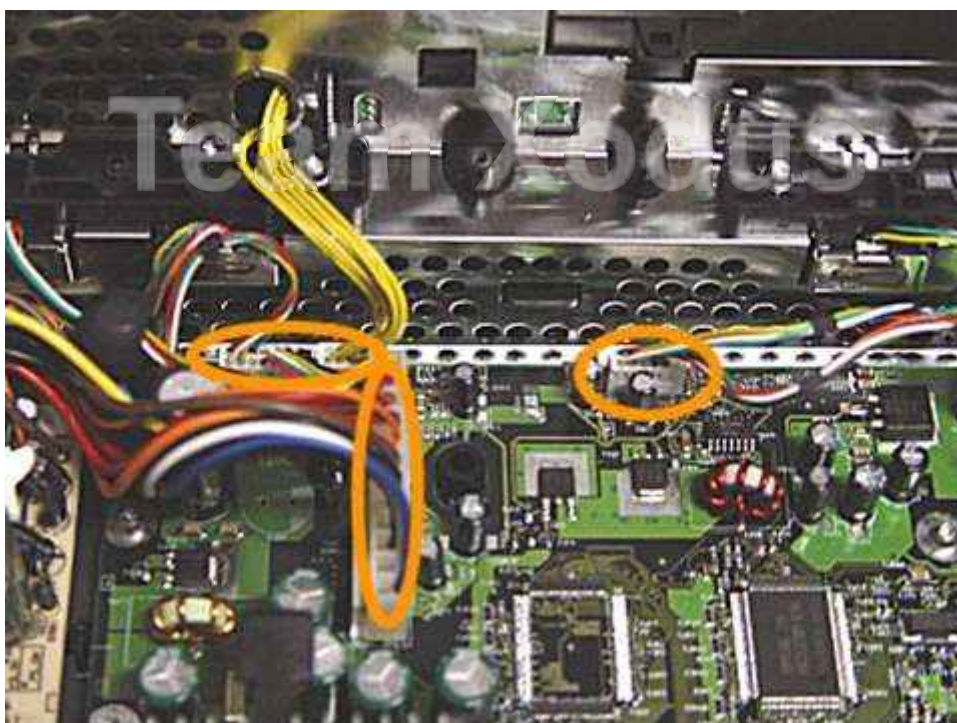
Once the screws have been removed you will need to remove the power supply connector and controller ports from the motherboard. In a version 1.0 motherboard the controller ports are connected to a daughter board that needs to be removed. The picture below shows a version 1.1+ motherboard.

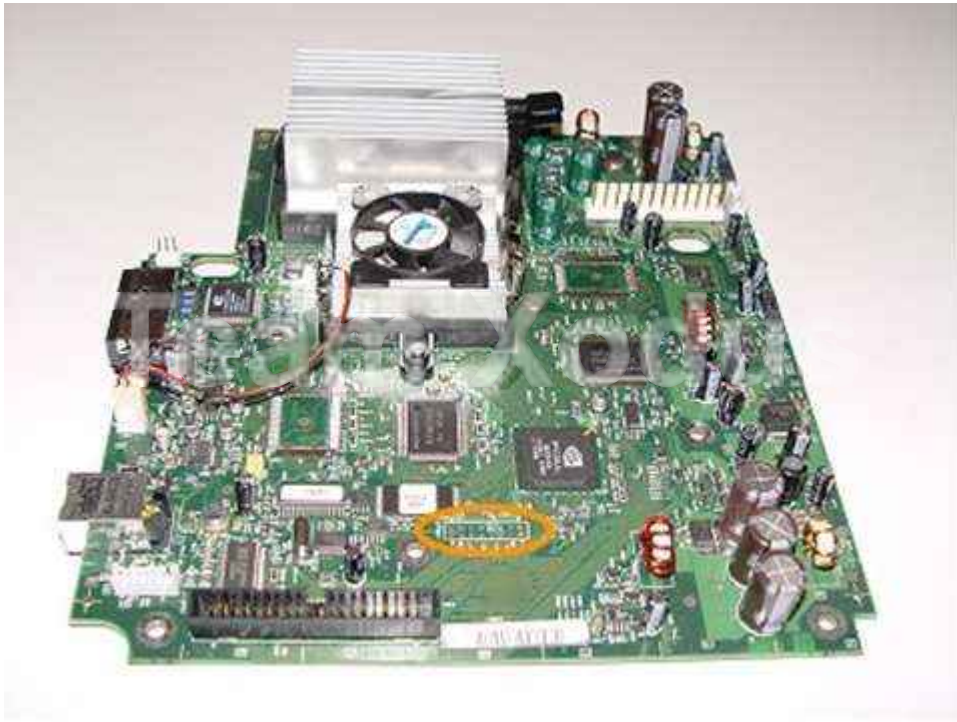
The following picture shows the location of the LPC port on the top side of the motherboard.

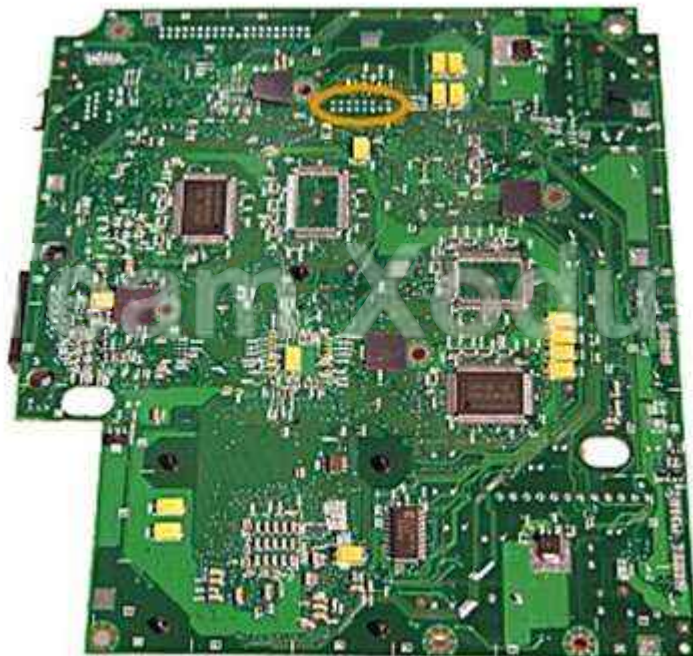
The picture below shows the location of the LPC port on the underside of the motherboard.

Version 1.0 motherboards have solder in the LPC port whereas later versions do not as shown in the picture below. The pink rectangle in these pictures indicates the area of the LPC that is used by the Xenium.

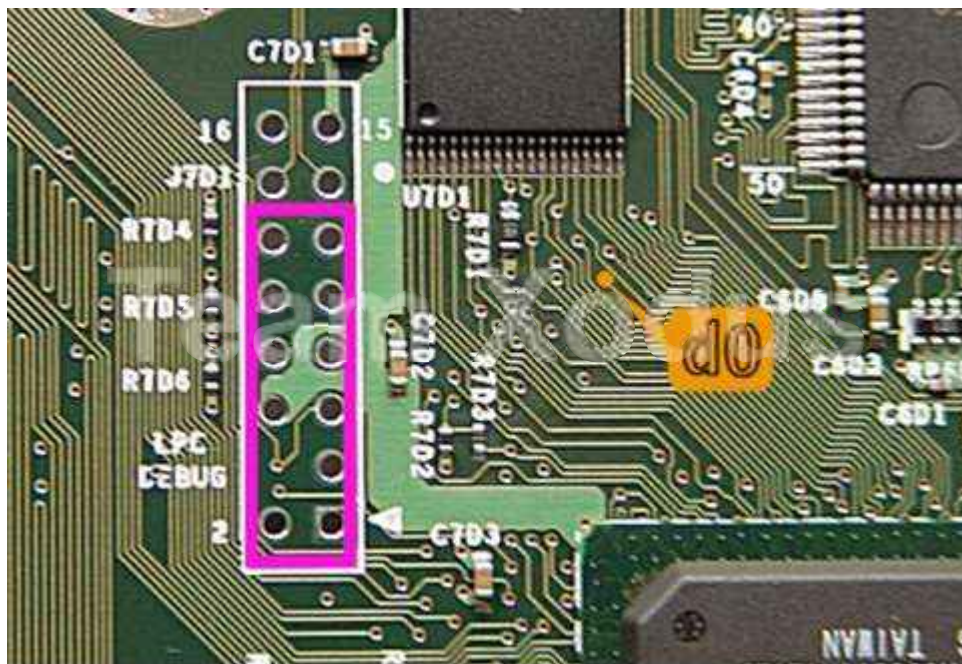
Upper d0 point on Version 1.0 and 1.1 Motherboard

You also need to locate the d0 point on your motherboard, there is a d0 point located on both the top and bottom of the motherboard. The location of the upper d0 point will differ for motherboard versions 1.0-1.1 and 1.2-1.5. The underside (and slightly larger) d0 point is the same for all motherboard revisions. Either the upper or underside d0 is needed for the installation of the Xenium, OzXodus recommends the underside d0 point for those who have limited soldering skills.

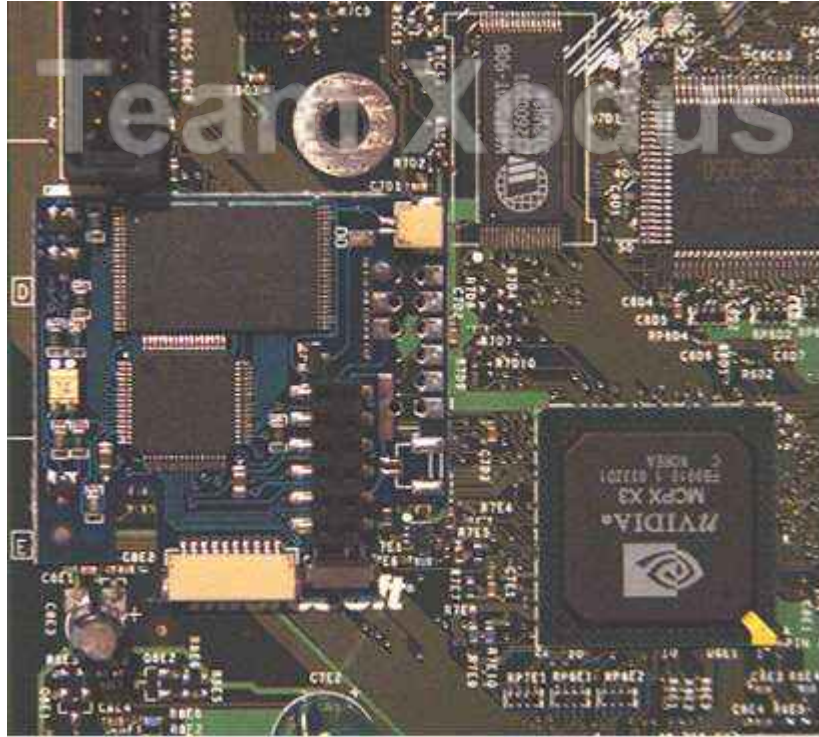
Looking at the top of your console's motherboard place the Xenium over the LPC as shown in the picture below:

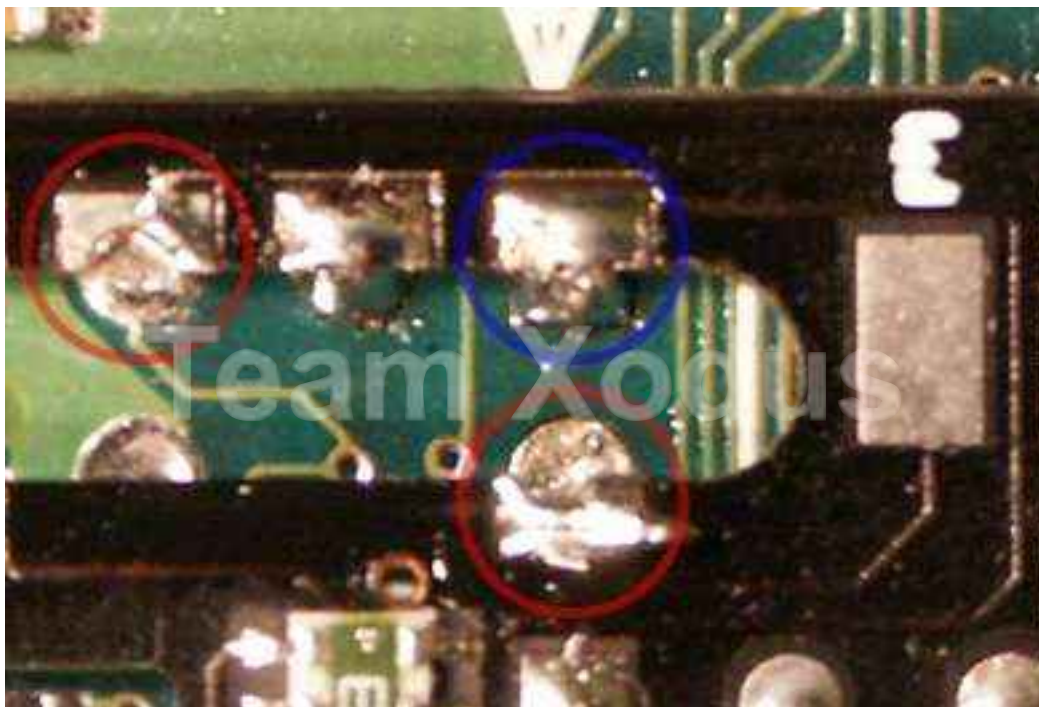
Use a good quality soldering iron with a relatively thin tip and ensure that your soldering iron tip is “wet”. Heat both the Xenium pad and the pad on the motherboard while applying some solder. The photo below shows a good solder joint in Blue as compared to a bad joint in Red.

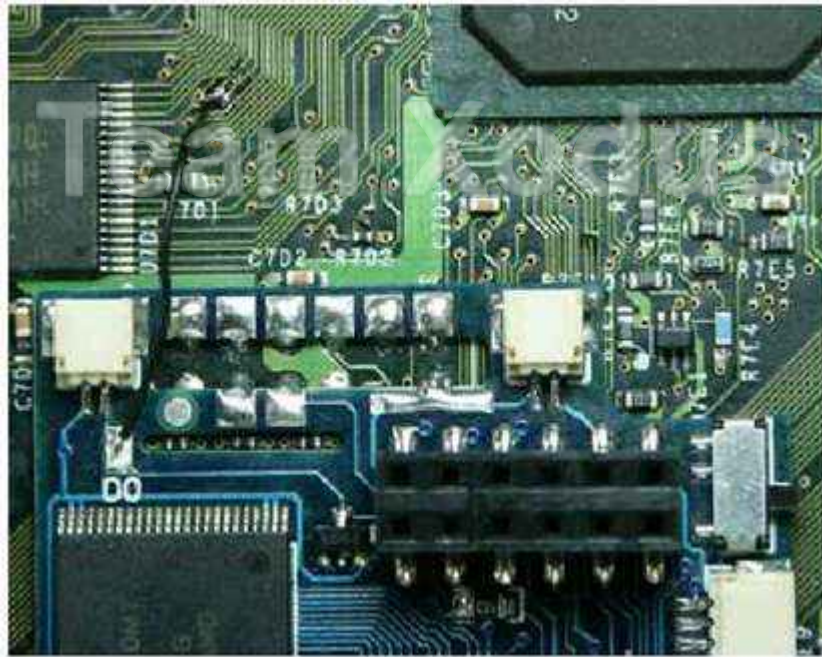
Once you have determined which d0 point you wish to use for your installation you need to solder a piece of single strand wire (Kynar 30AWG) from this d0 point to the d0 solder pad located on the Xenium as shown below.

The photo above shows the Xenium's d0 pad connected to the upper d0 point.

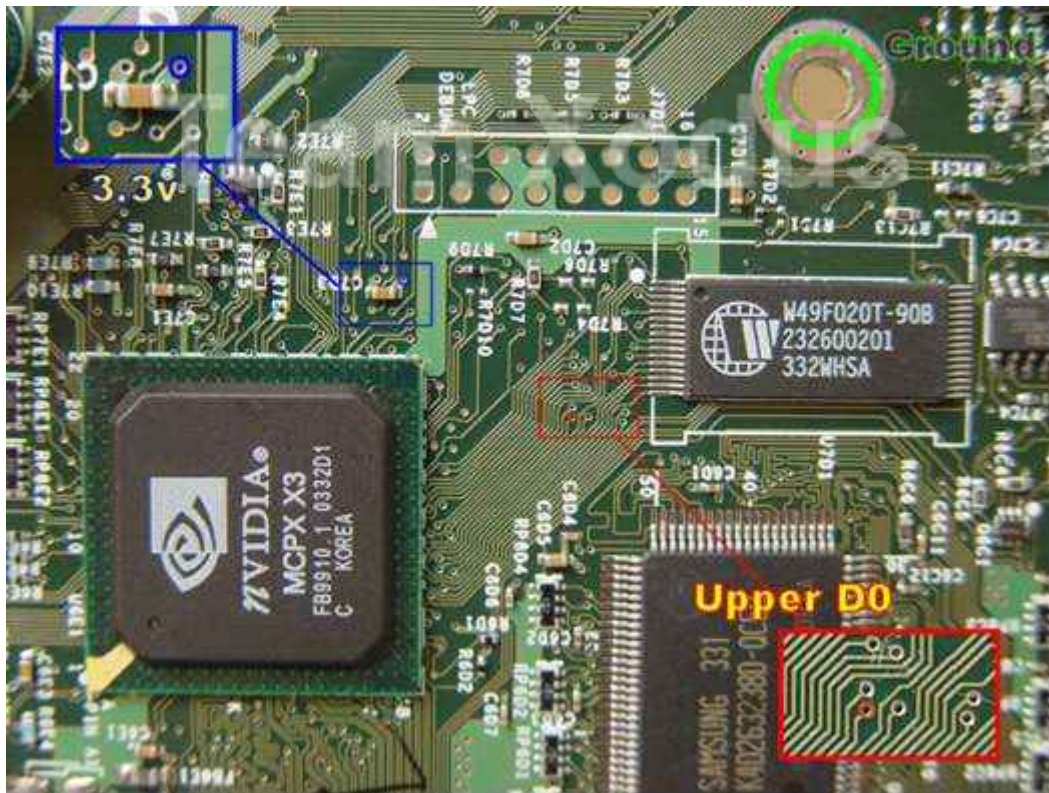
Version 1.5 motherboards have had the 3.3v & Ground removed from the LPC, as such the installation procedure for the Xenium for this version requires the installation of an additional two wires.

The photo below shows the location of a 3.3v point (marked in blue) and Ground (marked in green).

Solder a piece of wire between the blue point shown in the photo above and the solder pad marked in blue in the photo below. This will provide the Xenium with the 3.3 volts it needs. Also solder a piece of wire between the screw-hole as shown above in green and the pad on the Xenium that is marked in green for the Xenium's Ground connection.
